DISUSED WHALING STATIONS

Grytviken Harbour Gazetteer

Purcell Miller Tritton LLP, 3 Colegate, Norwich, Norfolk NR3 1BN
norwich@purcellmillertriton.com www.purcellmillertriton.com
July 2011

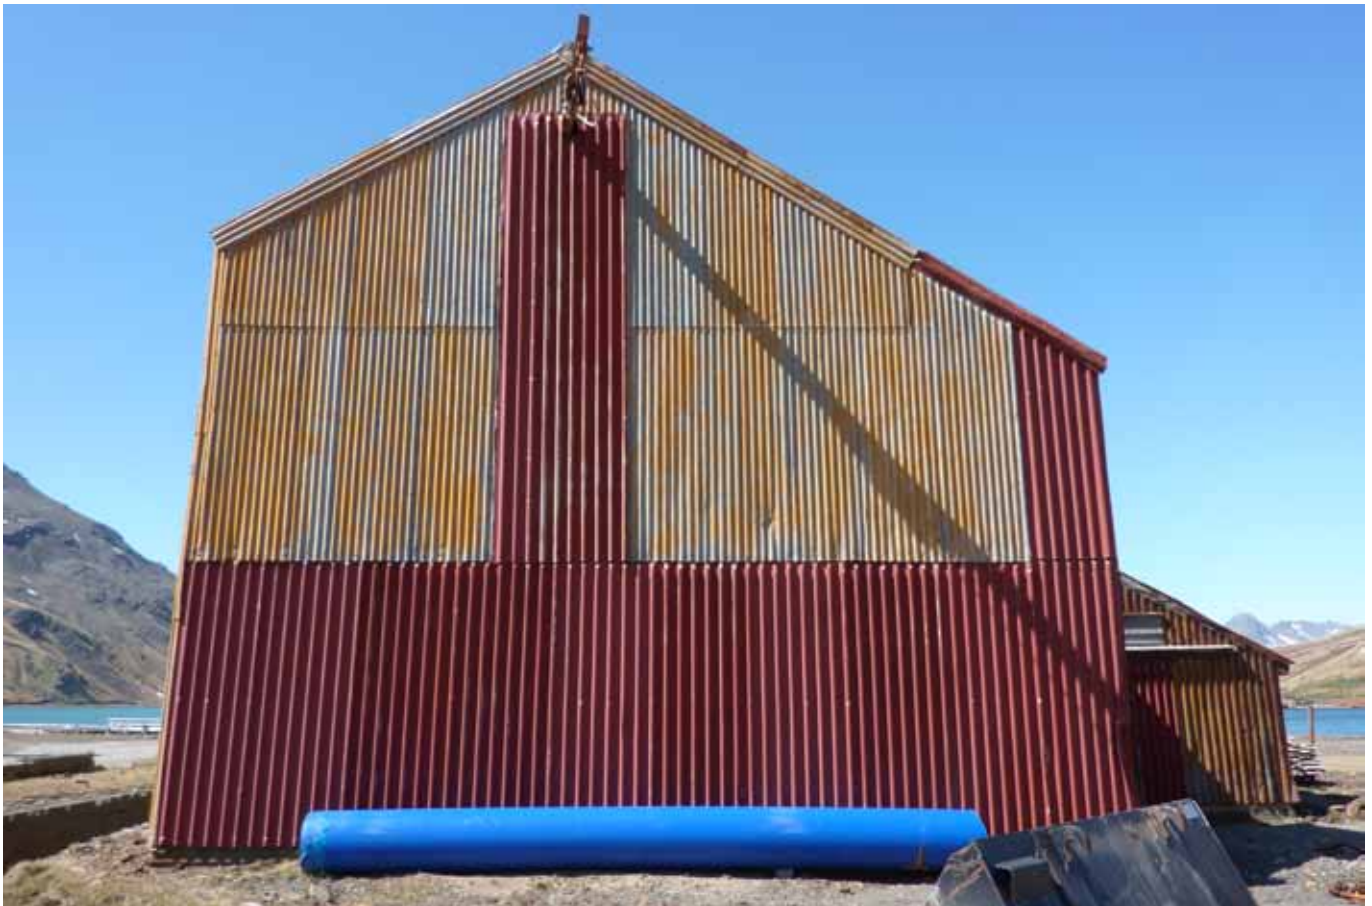
10.4 West elevation showing the extent of the repair in modern sheeting of the wrong profile

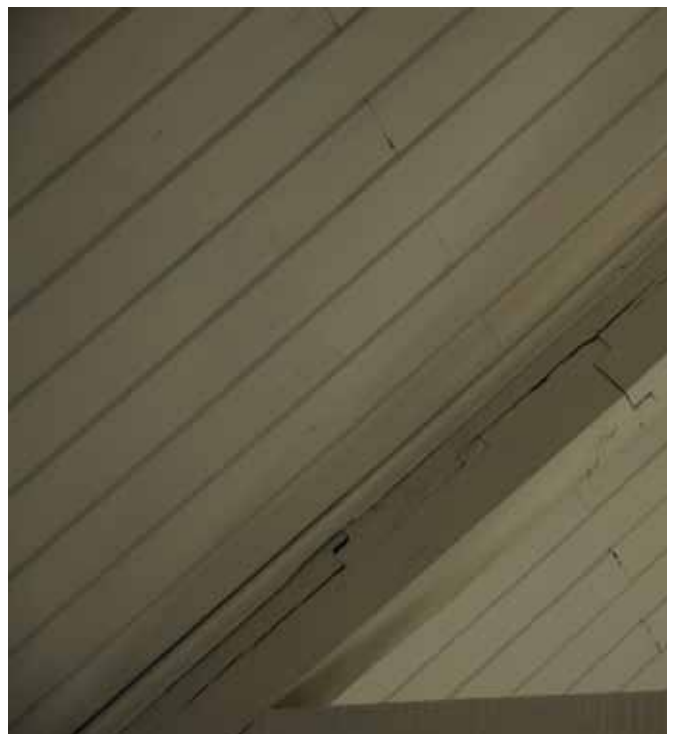
34.15 Cracking in the principal beams

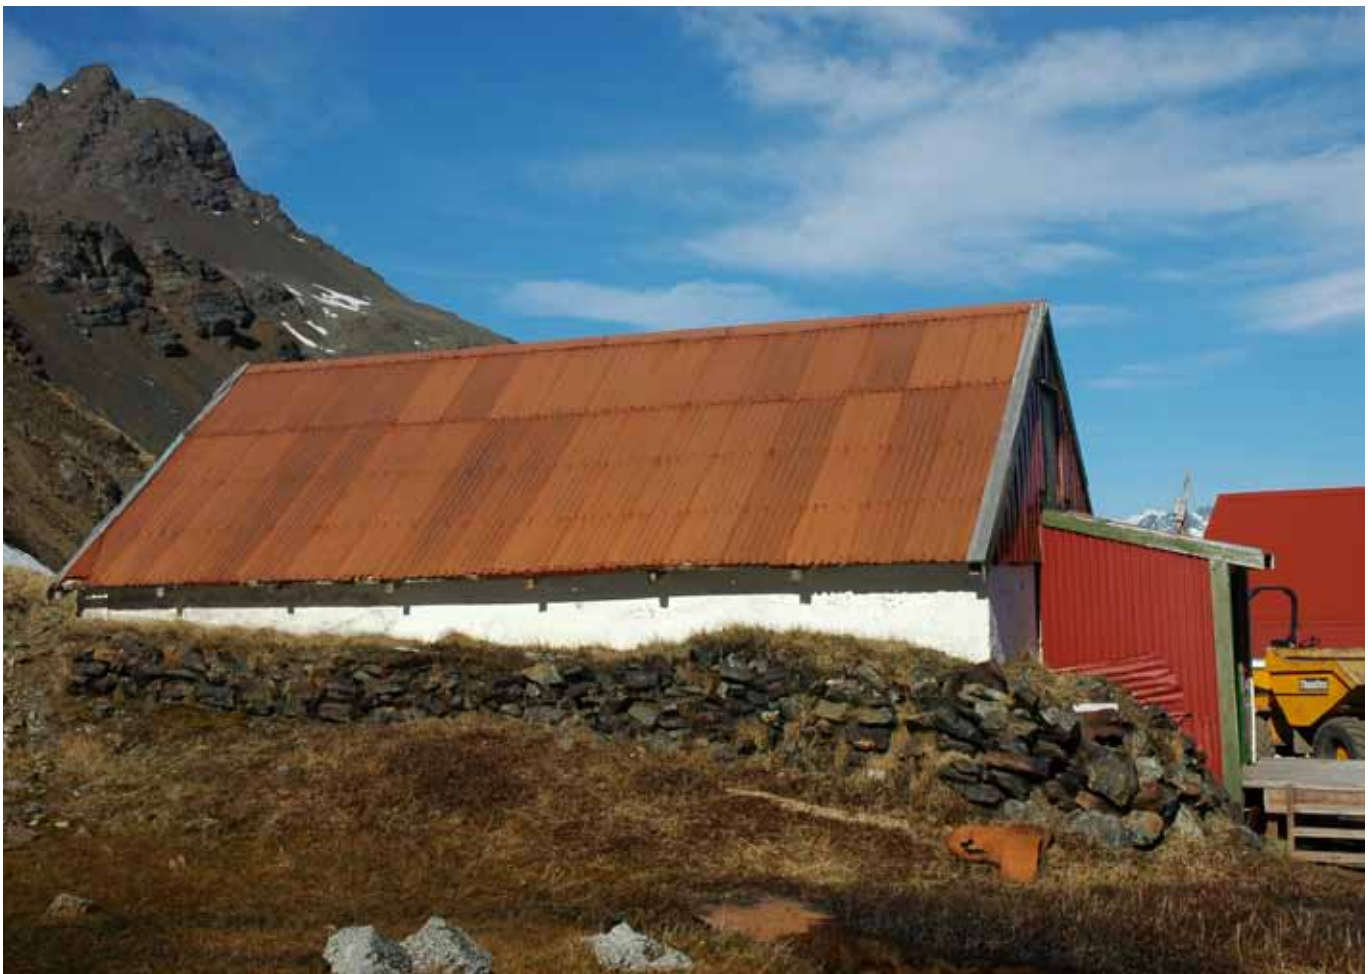
41.2 The west elevation with rock piled up against the walls

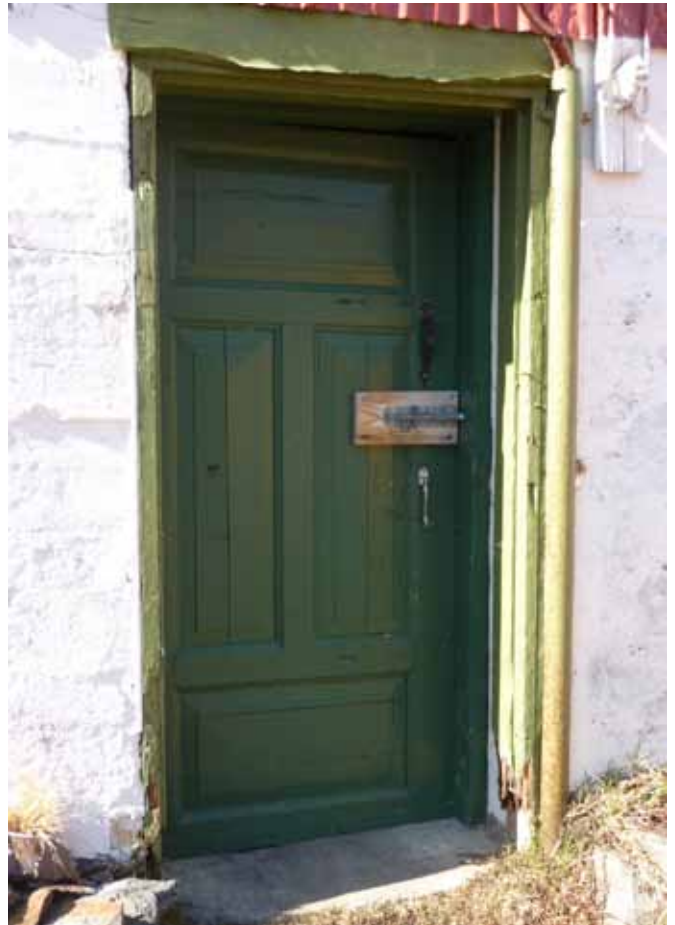
42.2 The door spoiled by the modern bolt and fixing block

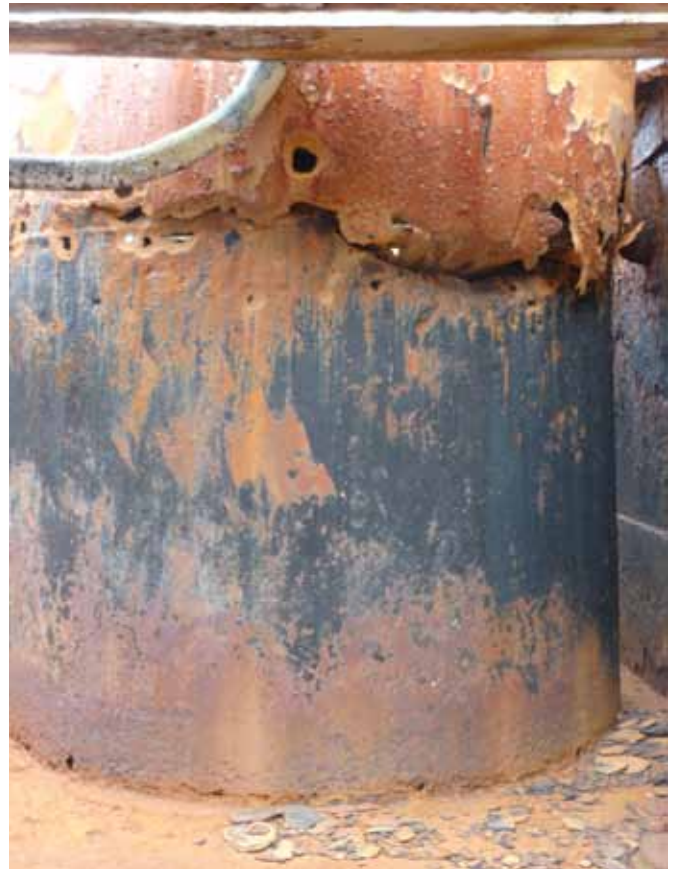
The base of the funnel had corroded to the point where it has started to collapse in on itself. The steel sheet of the surrounding deck was also seriously corroded. The conclusion of the inspection was that there was not sufficient sound material left to enable a temporary repair solution and that the funnel should be removed as a safety measure – hopefully with the possibility of it being replaced at some point in the future.

52.5 The corrosion allowing the funnel to collapse and tip over

One obvious reason for the removal is the unlikely chance that the falling funnel could injure someone. The rather more likely concern, however, is that in falling the funnel would most probably tear a good sized hole in the deck and expose the asbestos in the engine compartment.

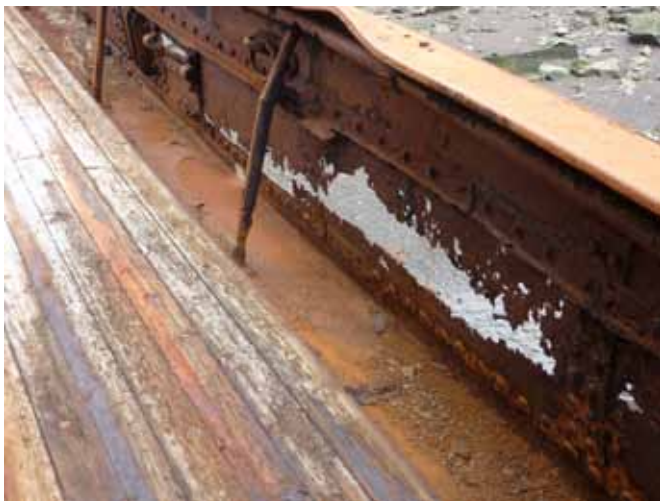
Corrosion is affecting the decks, the bulwarks and the side and top of the wheelhouse and engine compartments. Dias was accessed (in the company of Dave Peck) specifically to look at the chimney stack. This funnel had been stayed in the past with wire rope; however it had begun to lean to the northeast. There was some urgency about making a decision as to what to do with the funnel – if it needed to be lifted down the big Volvo Caterpillar tractor was only available for a few weeks until it was removed.

52.4 The corrosion of the bulwarks of the Dias

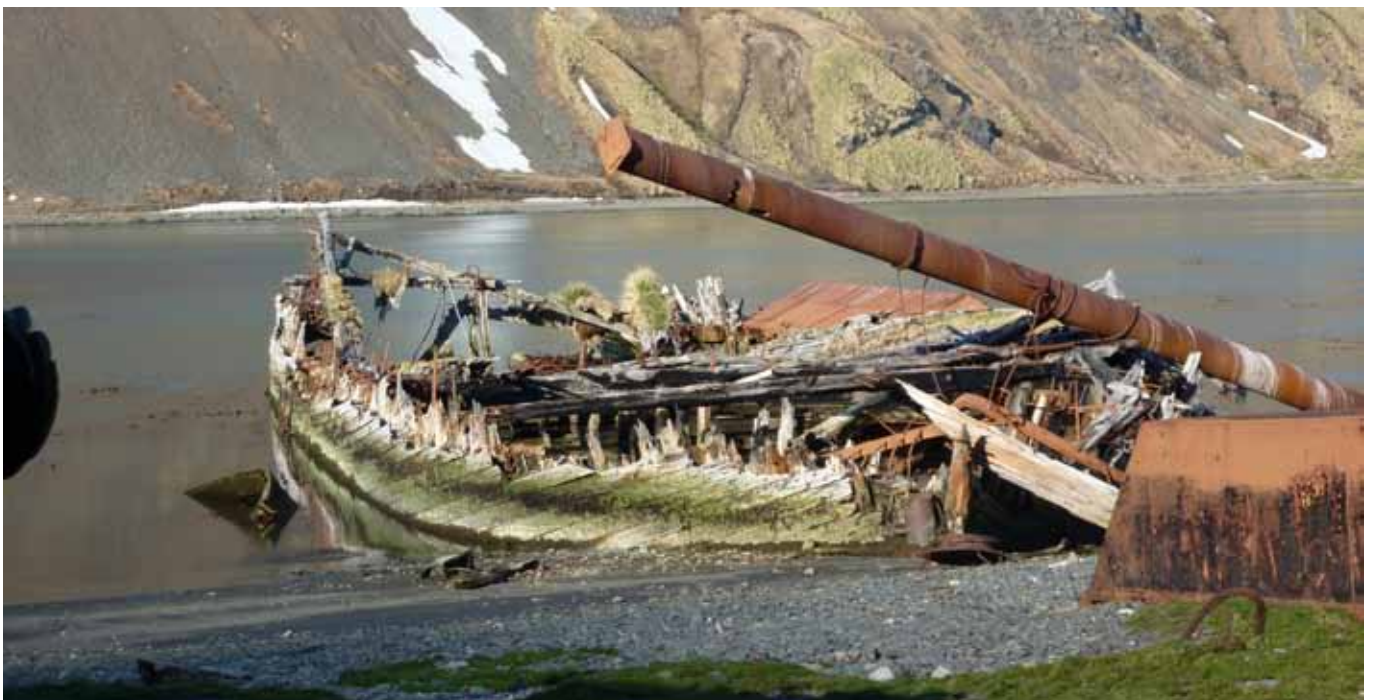
The Louise is burnt out pretty much down to the waterline. What little remains is beyond any sensible repair. One iron mast lies propped up against the side of the vessel with its top in the water. There is an iron barge lying on its side against the east side of the Louise. On the shoreward side there are two old steel barges lying upside down, both much rusted.

55.2 The bow of the ship looking northeast and showing the very poor condition of the hull

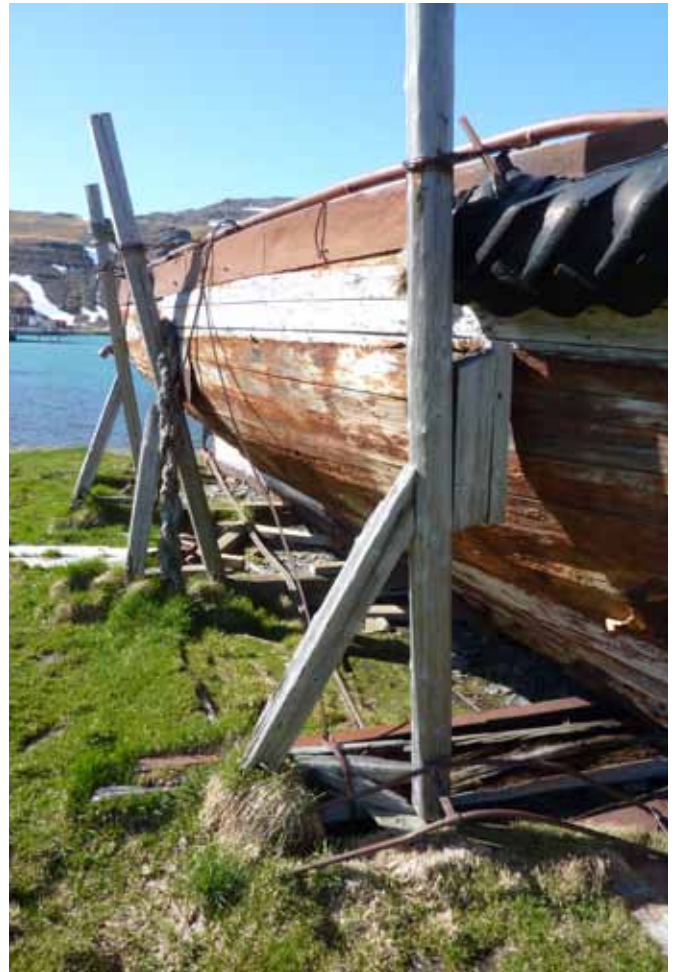
This is of timber carved construction on oak ribs. The motor, the drive shaft and the propeller are all missing. The hull has been covered in a canvas and thin steel plating, much of this has disappeared but a little remains. There is also rather more substantial metal edging around the gunnel with a metal pipe above that. The keel and stern are both covered in metal sheeting. The boat is currently propped up on a number of timber stays. These are in poor condition and could do with some immediate attention if the boat is not to fall over.

56.1 The rather slender cradle supporting the motor boat

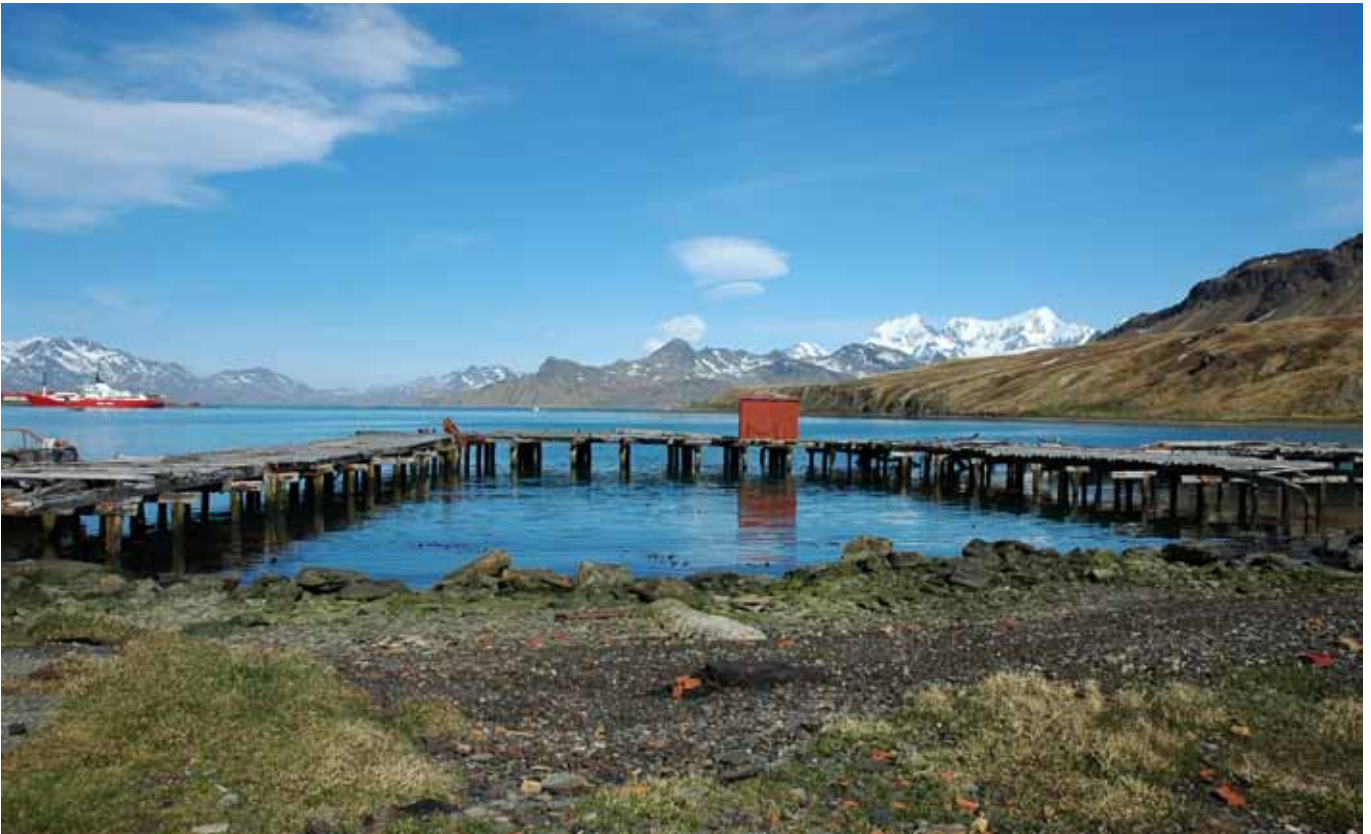
Three sections of this jetty remain but all are in poor order. The jetty is not attached to the shore in any position, although this may have been deliberately dismantled. It would require a great deal of work to repair it. A small hut sits on the outer section of the jetty, built in corrugated iron. There are various iron bollards and other fittings which are now in danger of falling through and into the water.

58.3 General view of the Harpoon Jetty

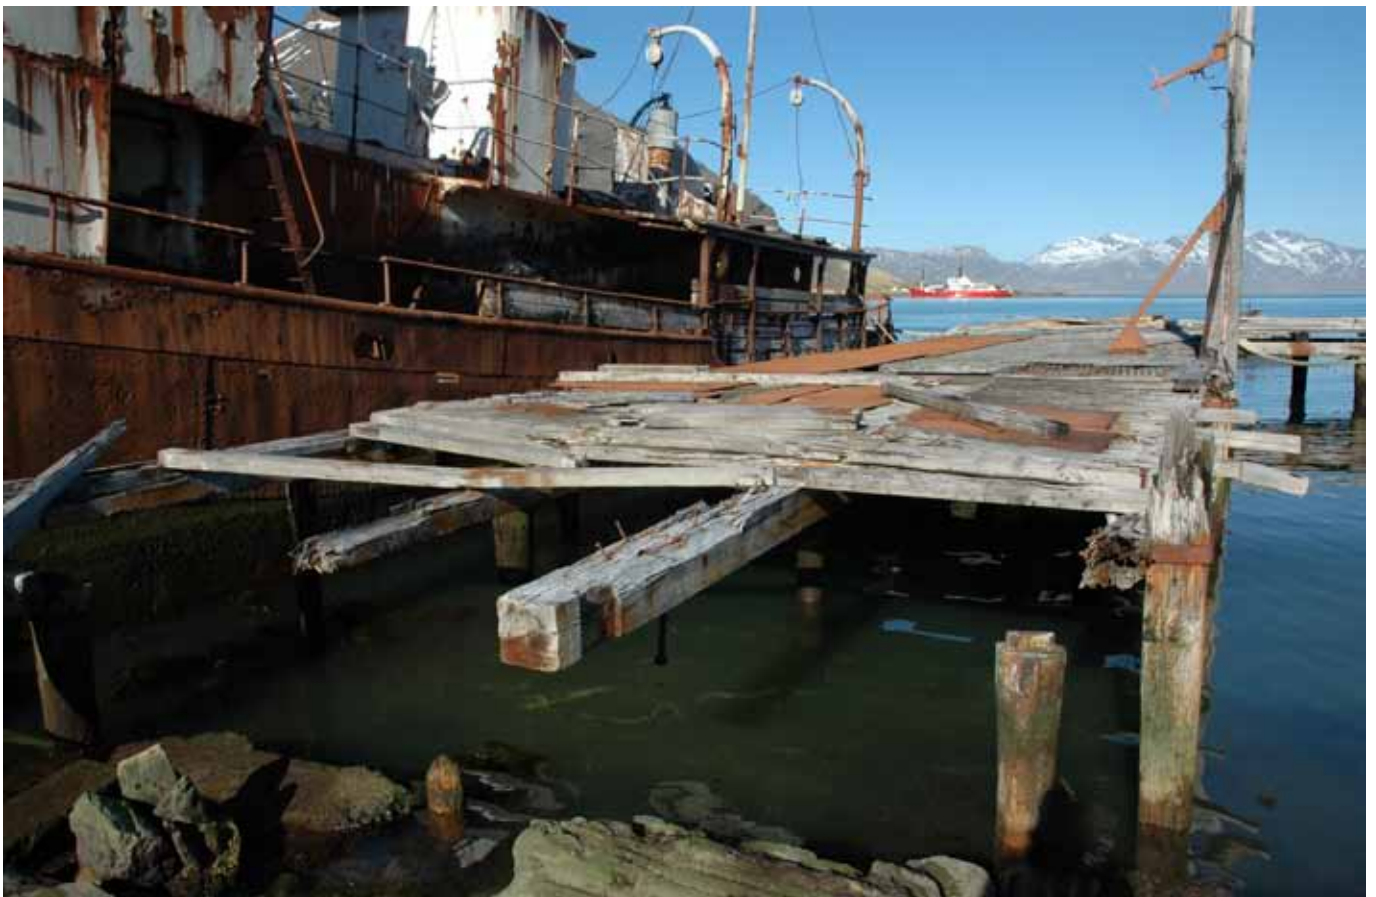
This is in a very poor condition. Unusable and no longer attached to land. It would require extensive repairs if it were to be put back in working order.

78.1 The pier adjacent to Petrel which no longer joins the land

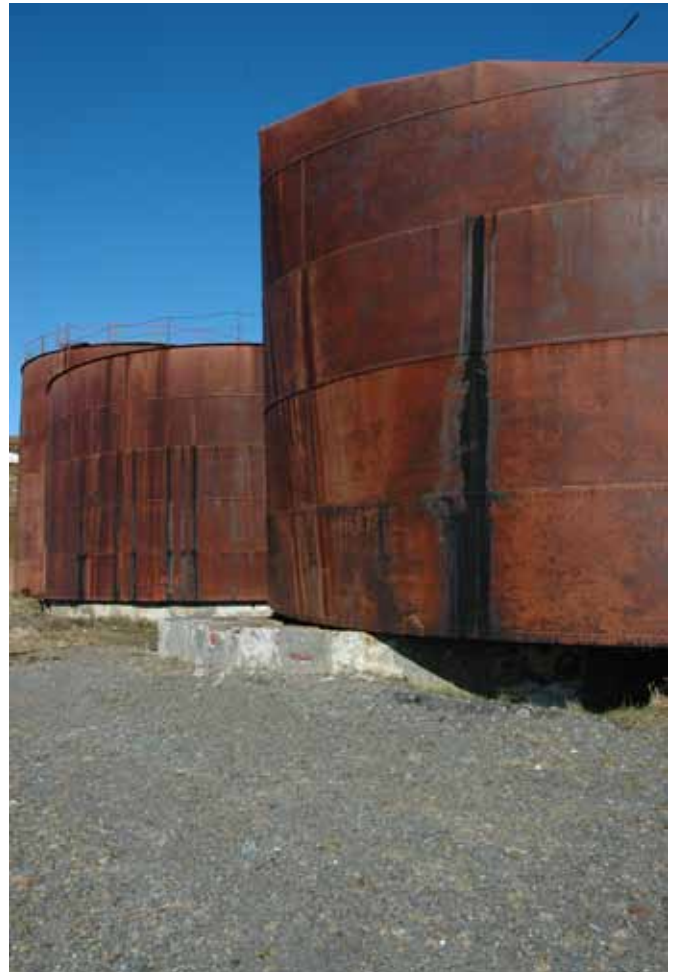
Two of the tanks have moved off their original bases. This would appear to be mechanical damage as they were pushed out of the way by mechanical digger when access was needed for draining the tanks in the centre of the group (this is according to a verbal report by Dave Peck).

The bases generally are in poor order with supporting walls collapsing. There is also a good deal of corrosion around the edge of the roof where standing water can collect. It is likely that more roofs will collapse in the next few years.

78.1 Tank displaced off its base by the salvage work
