DISUSED WHALING STATIONS

Husvik Harbour Gazetteer

Gazetteer, July 2011

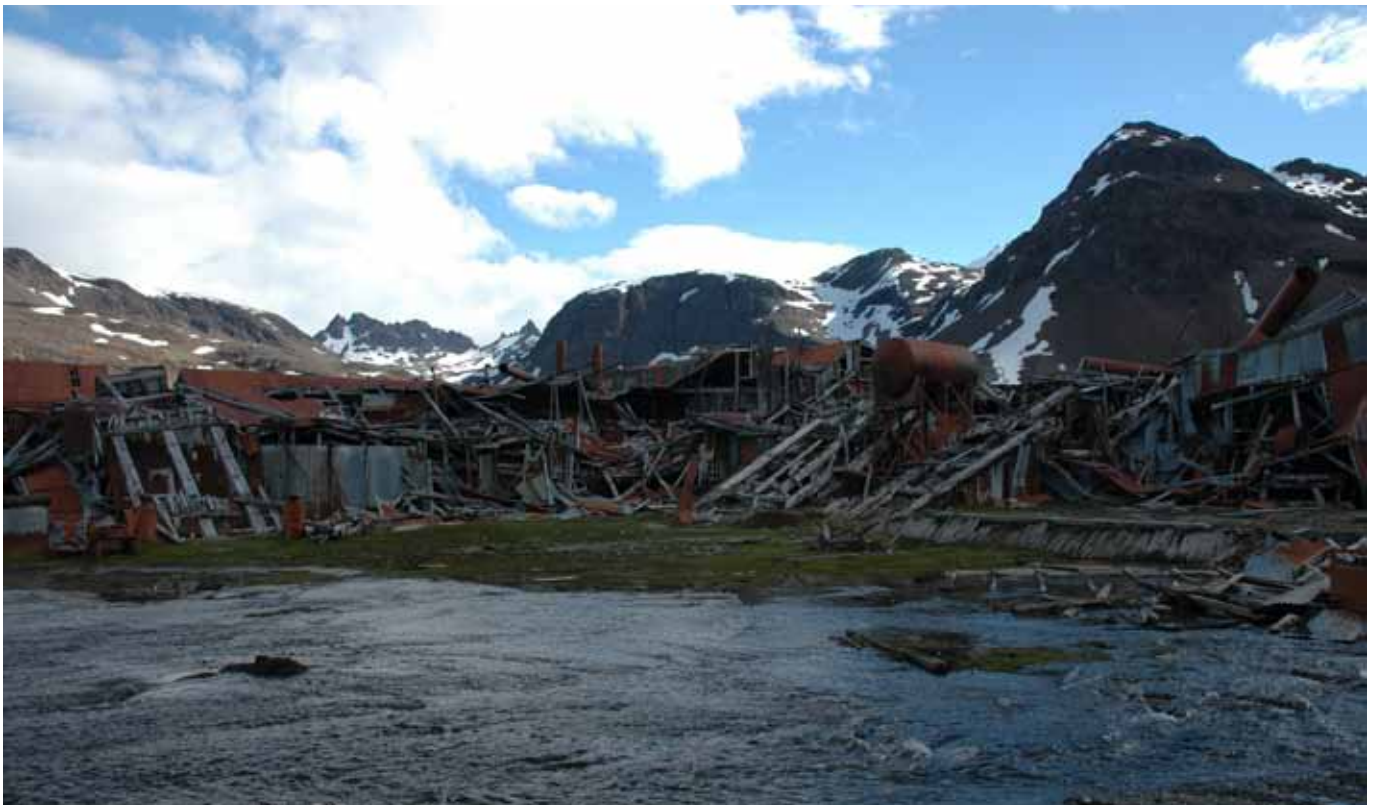
The Plan still exists and is defined by the three cookery buildings despite their collapsed state. Some of the timber boarding, possibly a good deal of it, survives but the majority of the area is now under water. The stream which was contained to the north of the blubber cookery has burst its banks and now runs diagonally across the Plan, the majority of the water running through and around the blubber cookery, but with some running through the bone cookery area. The water has deposited a good deal of gravel on the Plan. There is also some vegetation growing between the boards. A number of winches and one small winch shed remain in position.

1.2 General views of the Plan looking towards the Meat Cookery

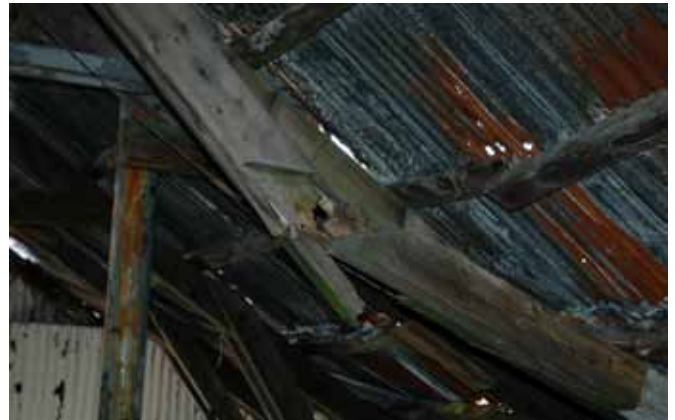
The area to the east of the main part of the meat cookery has been used as an area for extraction plant. A heavy concrete frame has been inserted into the area to provide a solid concrete deck at high level where the extractors are mounted. This has then been extended with a section of timber flooring supported on timber framing. To accommodate the extractors and to create a working area the roof has been modified with a raised section to the west. The roof generally through this area is very poor and one principal rafter has shattered through and collapsed and its neighbour is also fractured. Water has been pouring through this section of the roof and the timber floor at high level and the supporting timbers are all heavily affected with wet rot. This whole area is now in very poor order.

2.1 Fractured roof timber over the area

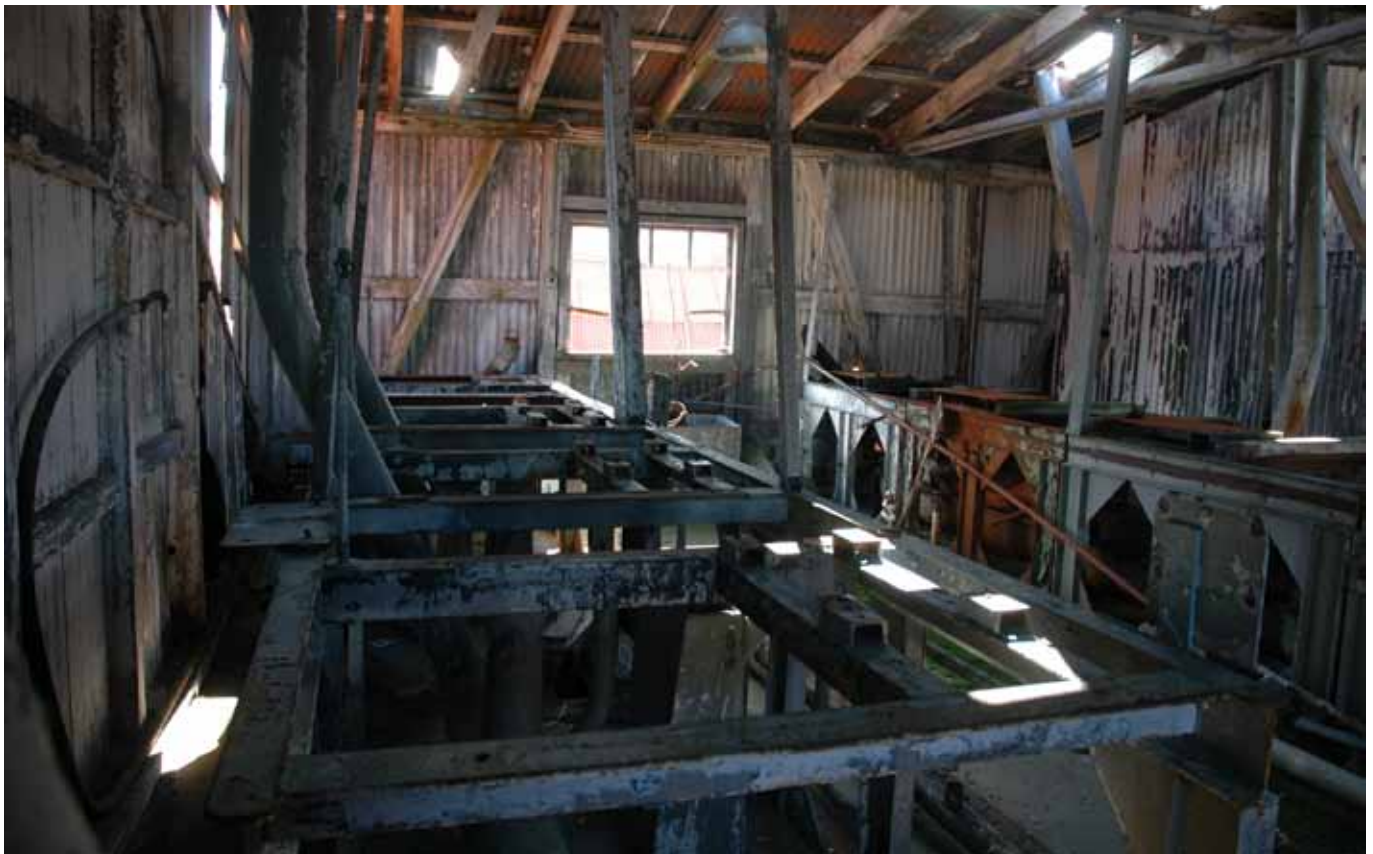
2.2 General view of the high level extractor area looking west

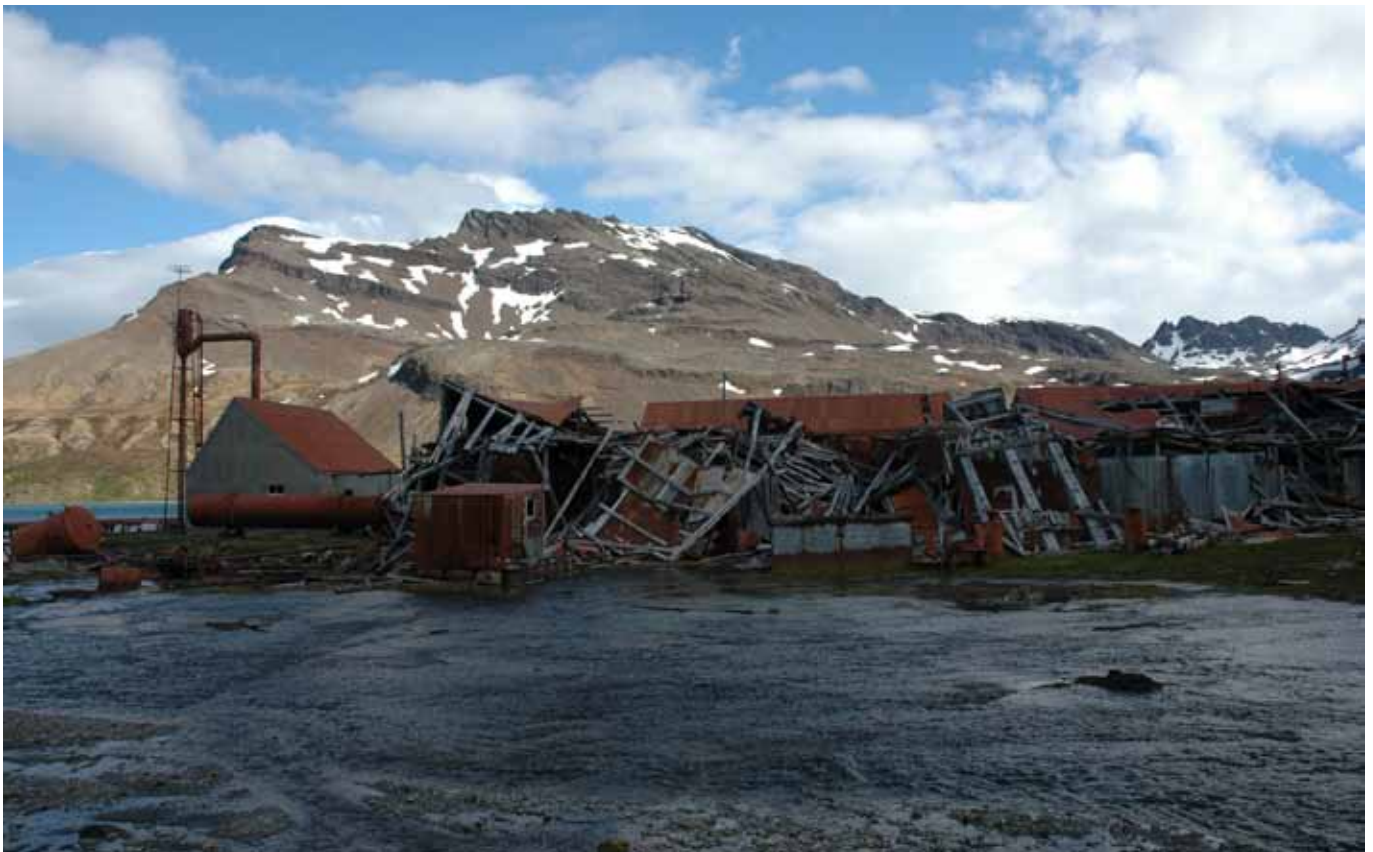
The meat cookery area stands in the eastern arm of the central building on the south side of the Plan. The cookery was not inspected in any detail as this area is very full of asbestos in poor condition. The building was timber framed with a corrugated iron roof. It is no longer clear how much of the area over the cookers had a floor as the area has fallen in and a tangle of timbers and corrugated sheeting lies on top of the cookers and the asbestos. Bjorn Basburgh notes that there are 20 cookers of three different types - presumably these are all still present under debris, certainly the first row of vertical cookers is still standing.

To the south of the main meat cookery area the building has been extended to the south with a lean-to to accommodate a further row of cookers. This lean to has also collapsed.

203.1 General view of the Meat Cookery north side

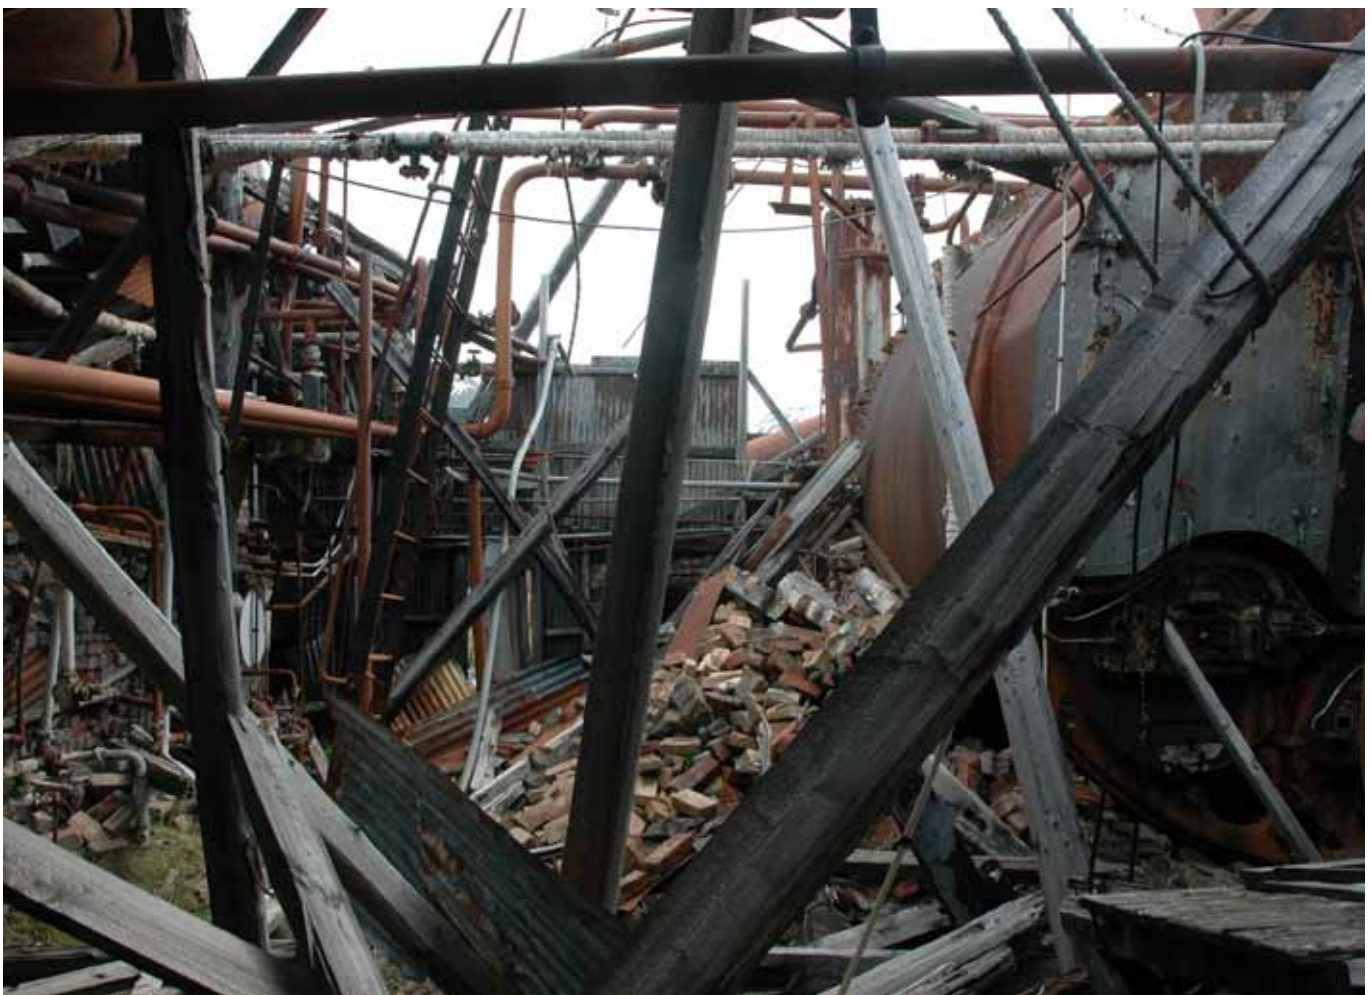
At the north end of Building No.2 is the bone cookery area. This is probably the most derelict area of the whole plant. Again it was not inspected in any detail as there were some concerns about asbestos and considerably more concern about the actual structural condition of the area. The structure around the bone cookers and supporting the bone loft were all of timber. The whole of the loft above the cookers has collapsed and the winch houses which were on the west side of the loft are on the point of collapse. These structures are supported on long poles and relied for stability on the floor of the bone loft. They are now on the point of collapse.

207.1 Looking east into the collapsed Bone Cookery

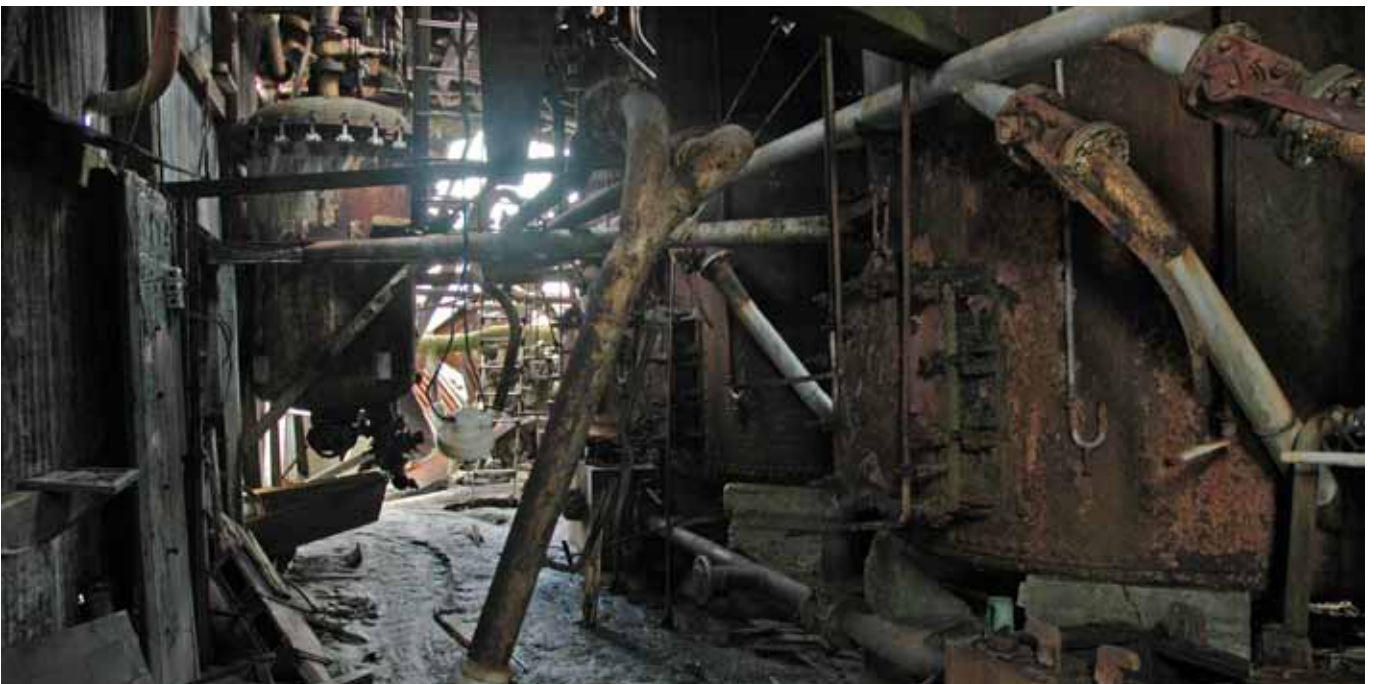
A stream of water has also been running through the Bone Cooker House for some time, entering through the northwest corner of the building and running down the length to the sea. This area is also likely to be heavily contaminated with asbestos and it will be impossible to clear this without first removing the remnants of the structure.

It seems to be impossible that any of the existing structure can survive this.

207.3 The northwest corner of the Bone Cookery showing the stream flowing into the area

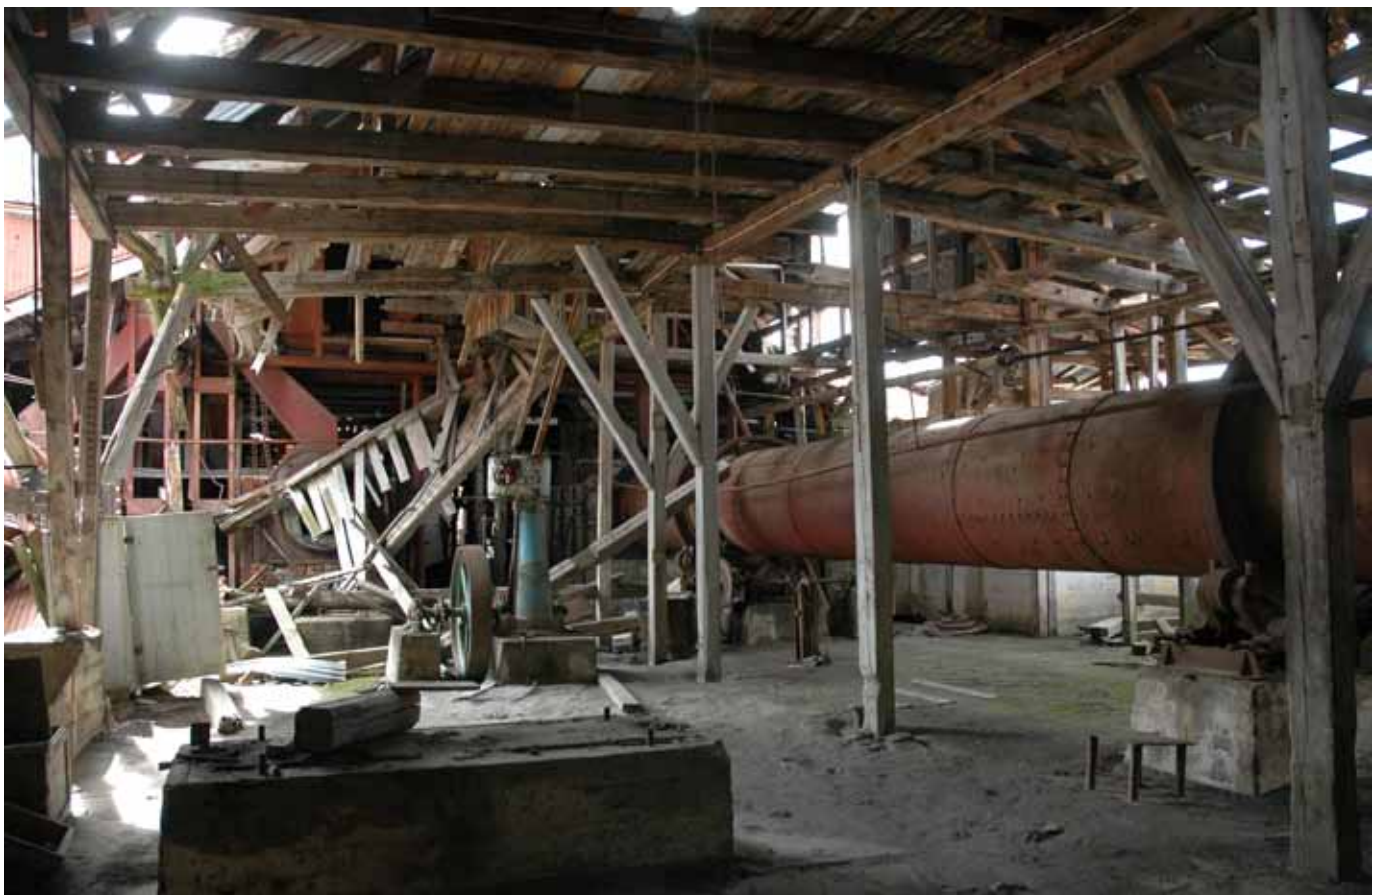
The guano factory was clearly built before the guano store and is a timber framed building with three rows of propping to the roof which is slightly more steeply pitched than the adjacent store. The propping also provides the structure for the floor above the cookers. The roof generally over this area of the plant is in poor condition.

A section of roof over the central raised floor is missing and the floor timbers and some of the structural timbers below this area are affected with wet rot. A large section of the roof on the west side has collapsed leaving a good deal of the fabric of the building dangling dangerously. There is also an area of collapse where the roof of the store meets the east wing which contained the whale line store. This section of the building still contains two of the rotary cookers and associated bagging equipment and augers and conveyors. A third rotary cooker has been withdrawn and is lying in the guano store shed, though its original location is clearly shown by its concrete base.

208.1 General view looking northwards of the Guano Factory showing one of the rotary cookers

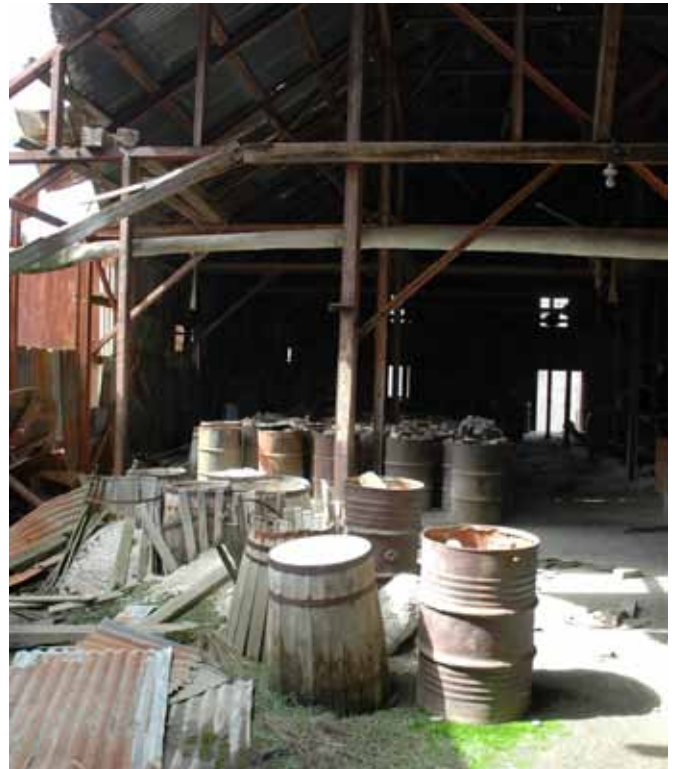
To the east of the main section of the guano factory is a steel framed pitched roof shed which has been used as a whale line store. This is a steel framed building with doubled up channels used as columns and principals. The roof is tied at wall plate level and the roof trussed with steel angles. The purlins are in timber and the corrugated sheeting remain reasonable with the exception of the west end where it joins the main building.

The lean-to on the side of the main building next to and north of the whale line store has collapsed and has taken part of the roof and some of the wall sheeting of the whale line store. There are timber windows on the northeast and south sides though the frames are generally missing. There is a doorway for a pair of doors in the east wall, but the doors are missing. The area is currently being used to store bricks. Apart from the west end this building is solid.

200.1 Whale Line Store looking east

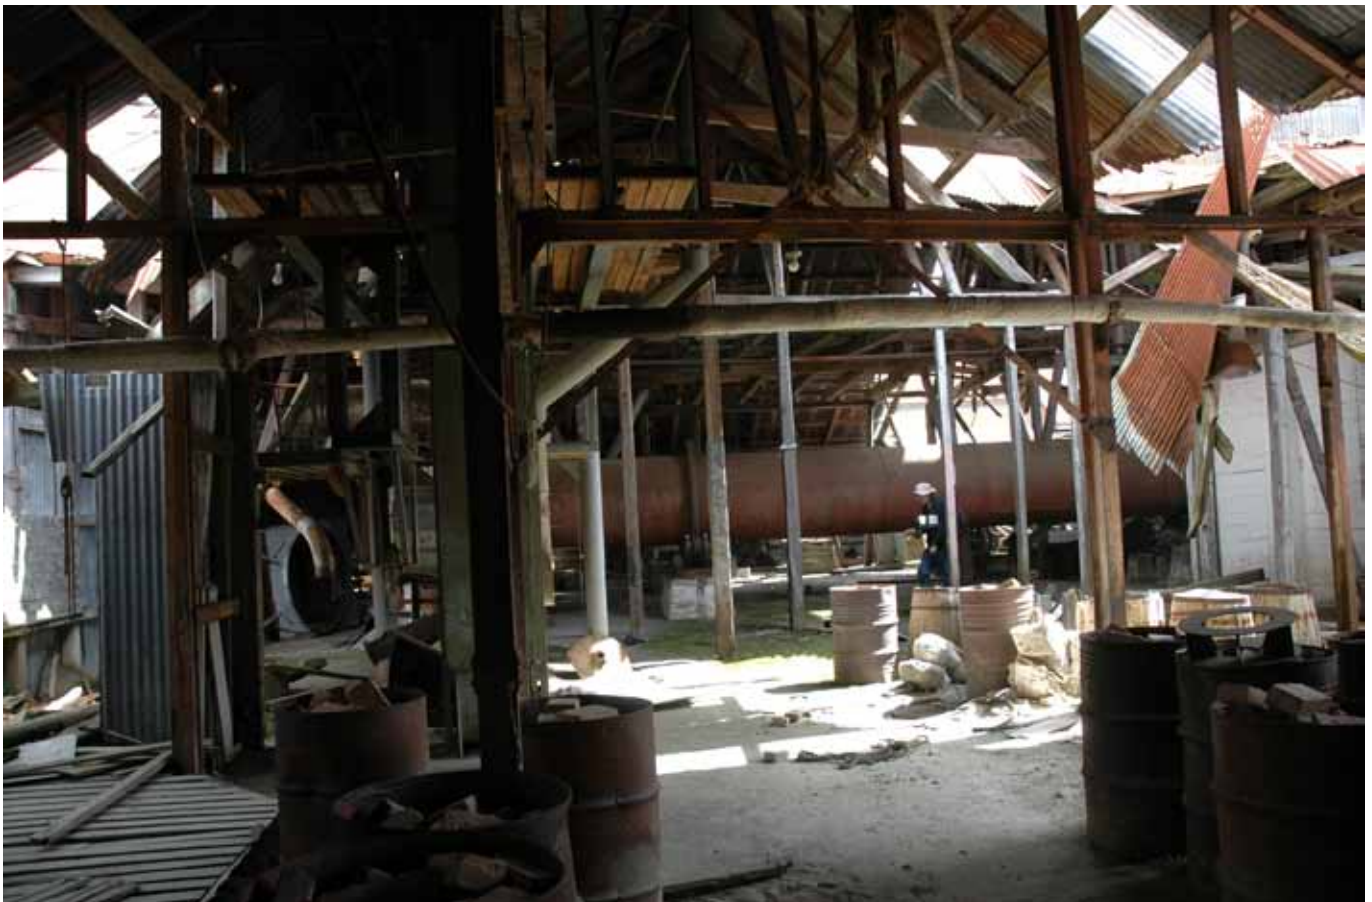
200.2 Whale Line Store looking west towards the Guano Factory

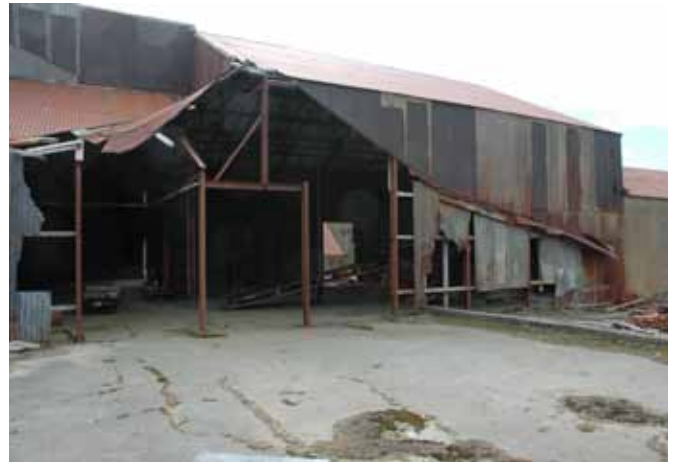
There has been a south wing to the Guano Store shed. All that now remains of this is the concrete base suggesting that it may have been taken down rather than collapsed. However, little has been done to attempt to make good the scars where the building has been removed and there is now a gaping hole in the south end of the guano store where the wall has gone and where the roof was previously hipped into the main building roof. In the southwest corner of this building has been a tractor shed. This is now partially collapsed with the roof lying over the materials previously stored in here.

211.1 The scarred south end of the Guano Store where a building has been removed

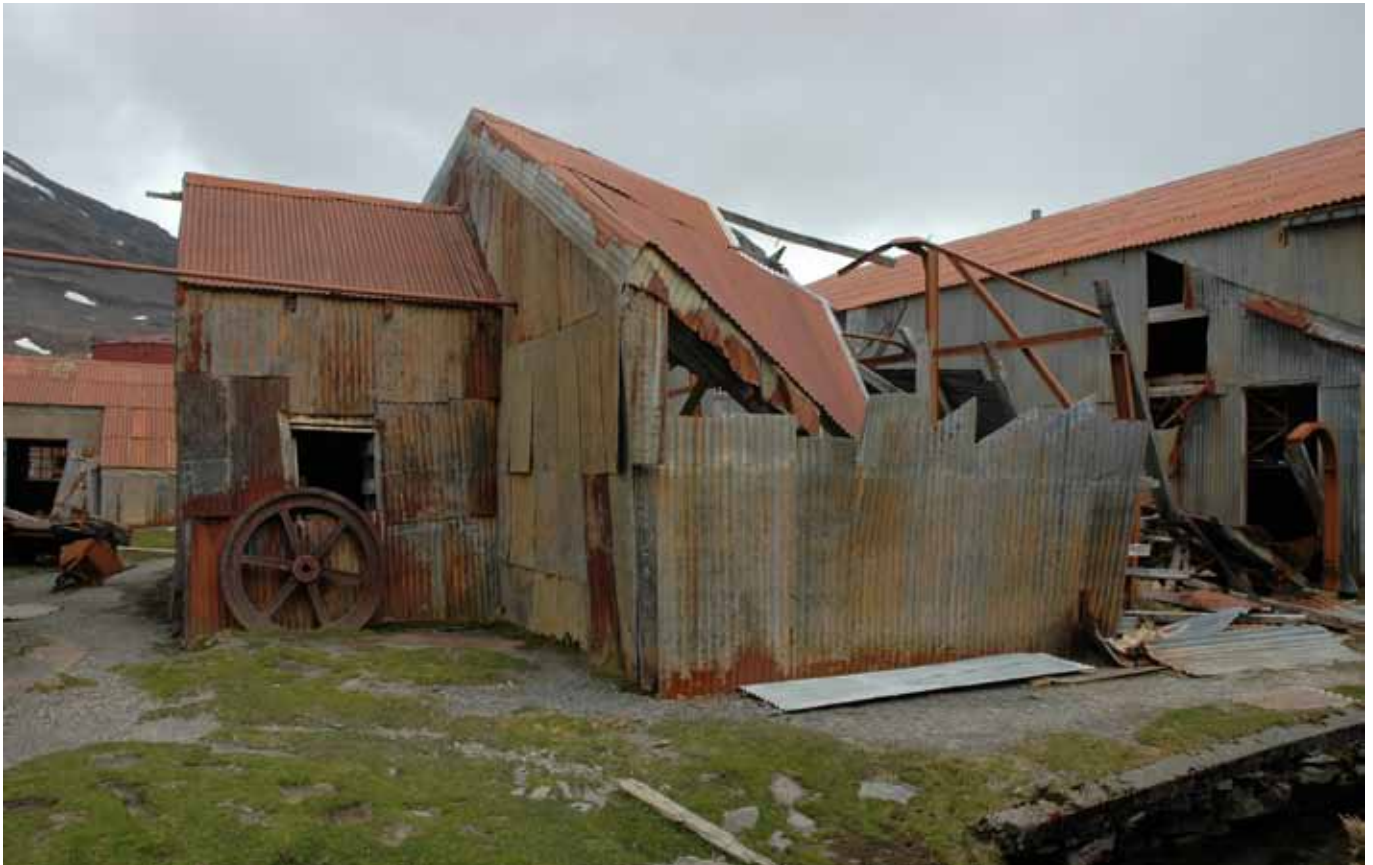
Off the east side of the guano store there is a wing that has been used as a brick store. This has now almost entirely collapsed. The only section remaining in position is the east gable, the rest of the building being a tangled heap of timber and corrugated iron. The store still has a substantial number of refractory brick and some commons inside it. On the east side of the brick store is an extension to the building which appears to be a general store. This has a pitched roof and is timber framed and corrugated iron clad with a timber boarded ceiling which is sagging ominously. The building has had a timber floor but only sections of this remain in place. The east wall of the building is leaning outwards. This is really an integral part of the brick store structure and is likely to collapse when the east gable of the brick store finally comes down.

203.2 North and east sides of the Brick Store with the Guano Store in the background to the west

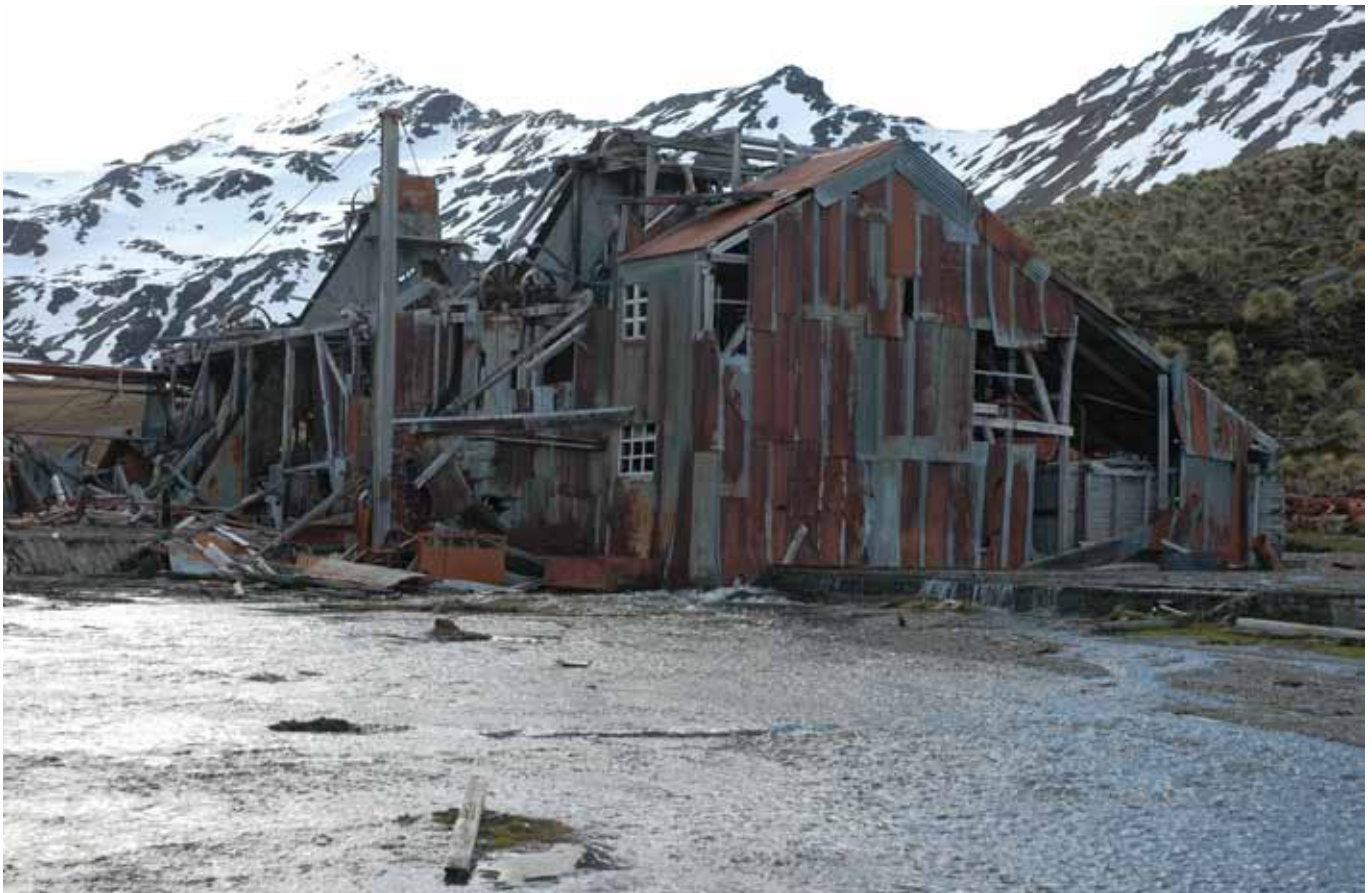
Seen from the Plan the building still appears to be reasonably intact. The corrugated iron cladding of the east gable and part of the south wall is still present, as is the roof over the enclosed east end of the building. The sheeting has fallen away from the timber framed south wall but the conveyors are still present and the loft above the cookers appears to be intact.

3.2 The south and east sides of the Blubber Cookery

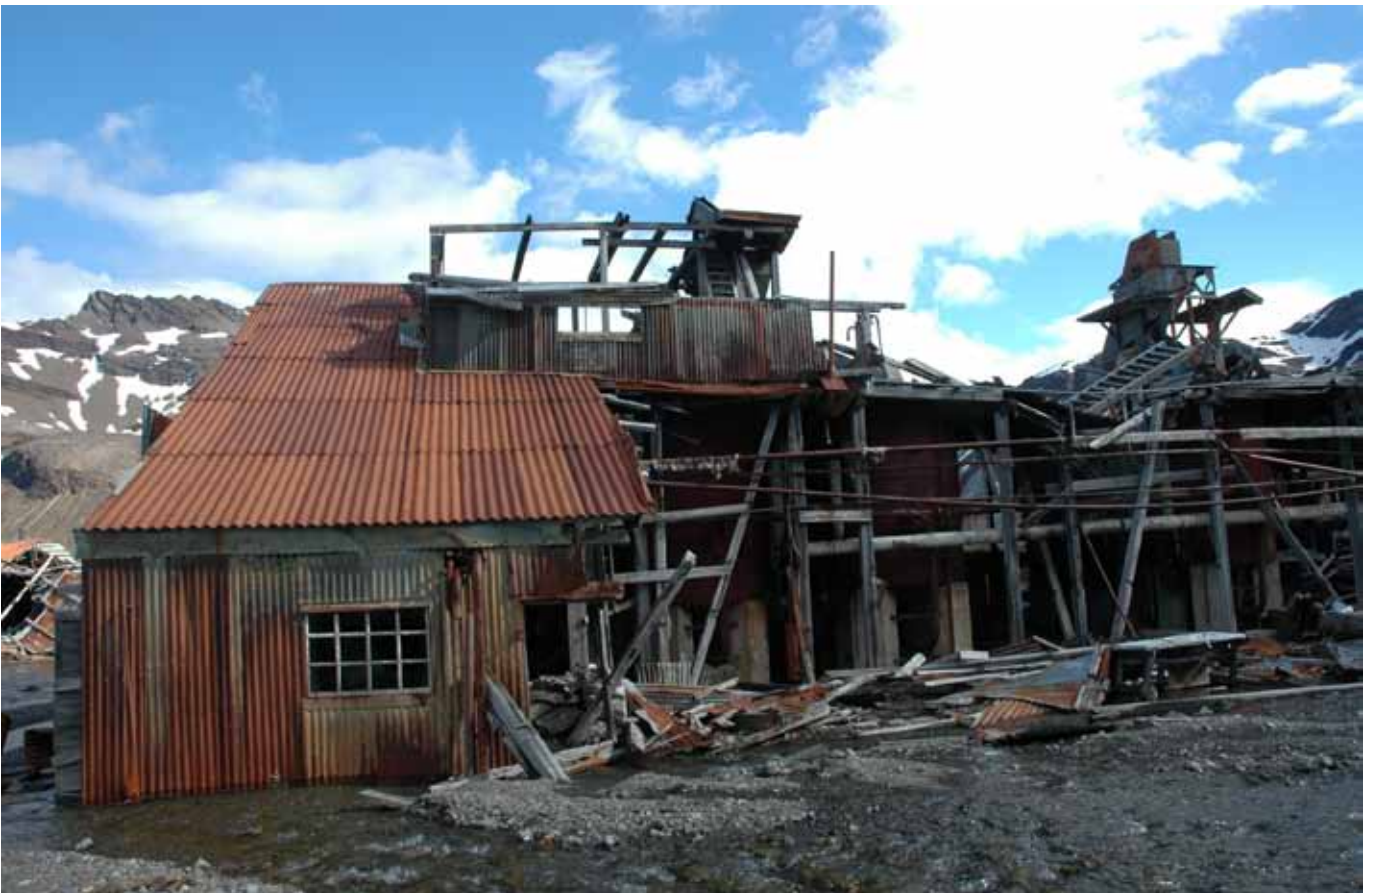
It is, however, a different picture seen from the north and west. The west end of the building has now collapsed and the timber floor above the cookers is falling in. The north wall has lost its cladding and the timbers that frame up the building are starting to fall away. There are still vertical steel cookers inside the building on concrete piers. These are probably now the major support of the deck above the cookers.

3.5 The northeast corner of the building

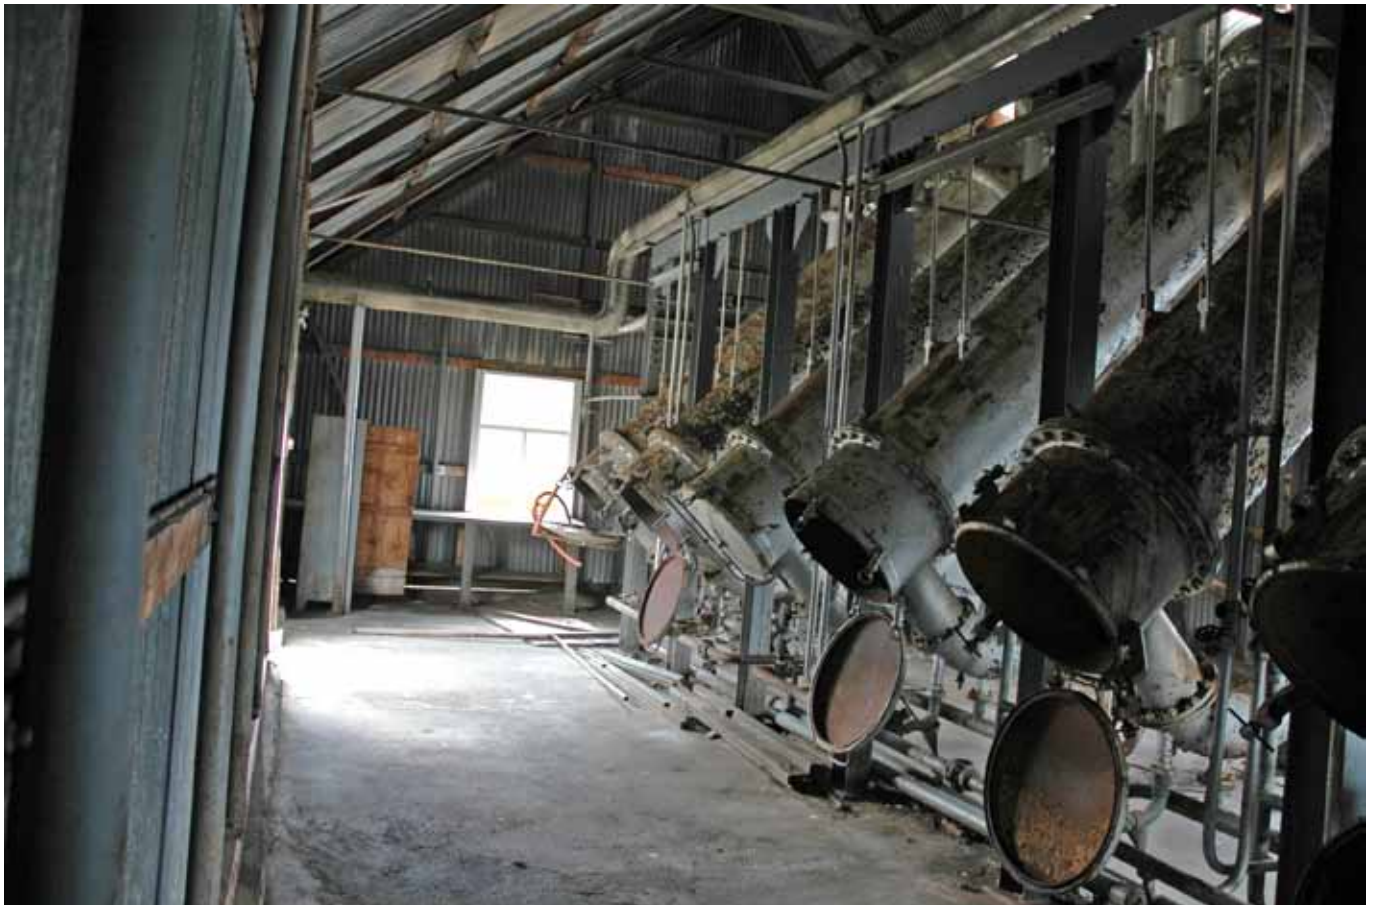
4.2 Interior looking north

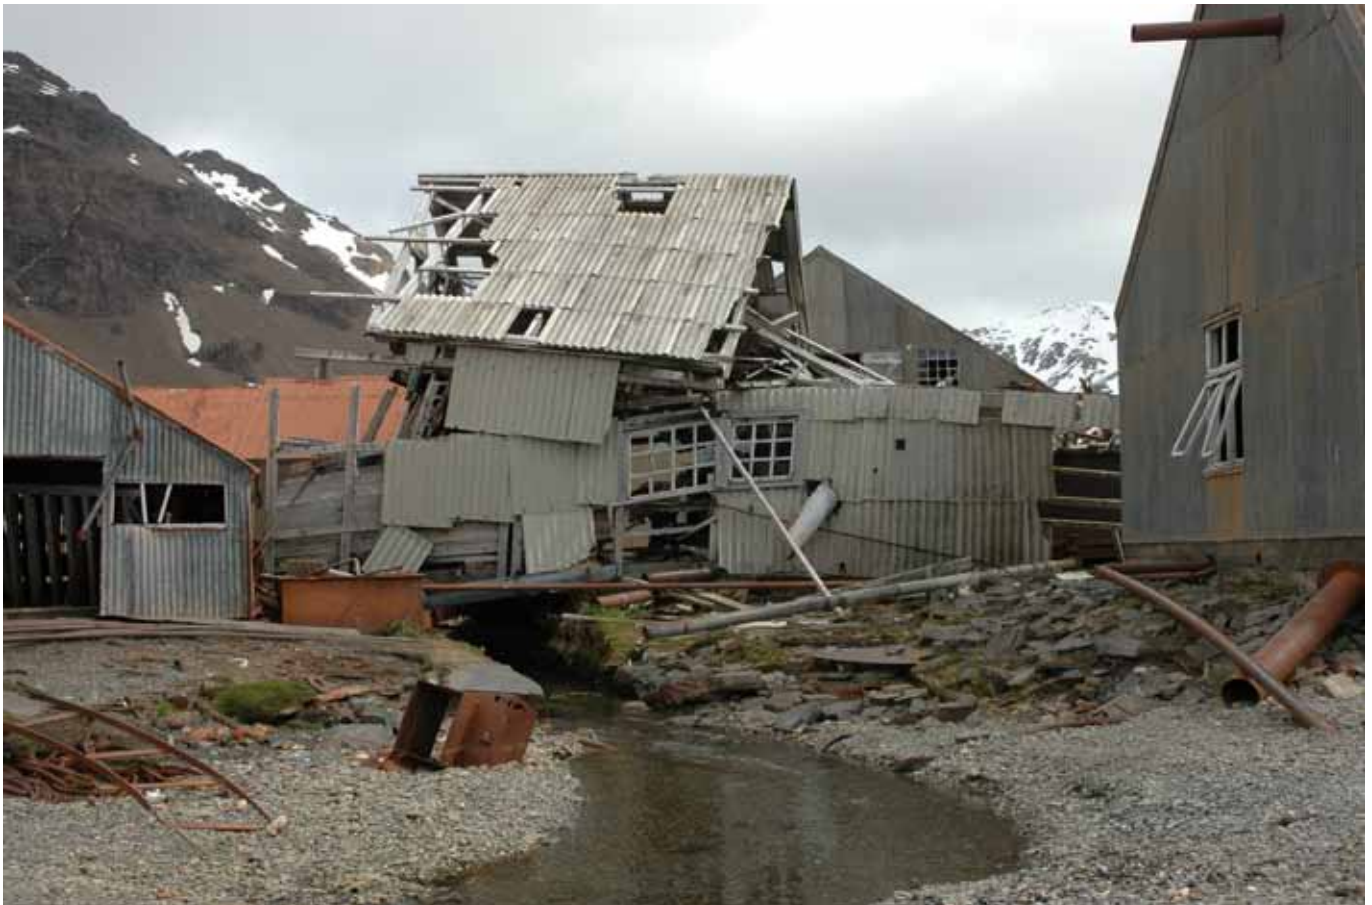
5.2 General view of the building

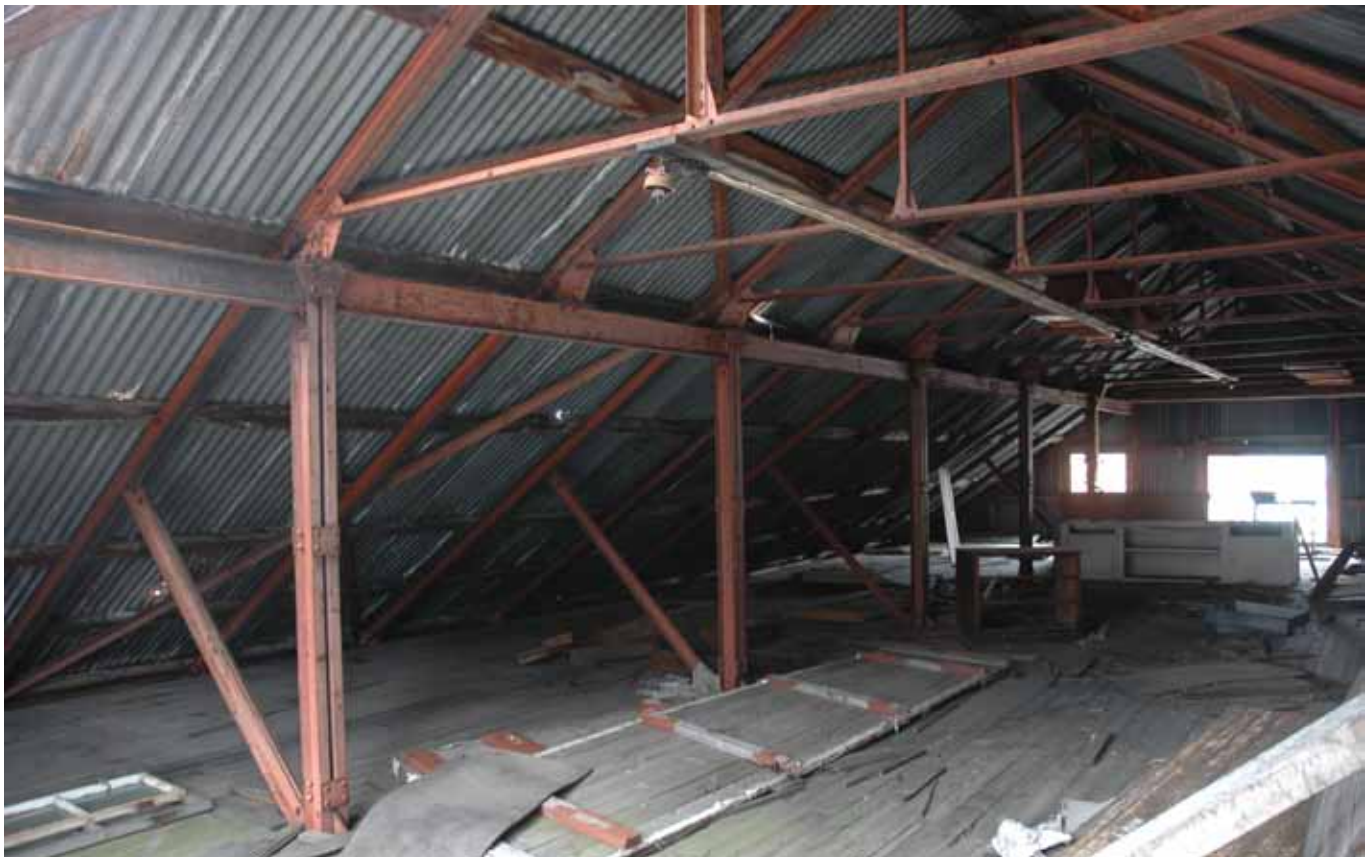
A substantial rectangular building with a pitched roof running east/west. The Laboratory and Store is something of a composite with the principal framing being in steel but with the secondary members of the frame and the floor all being in timber. The timber floor joist in particular looking as though, in part at least, they may have been added later. Columns in 125 x 50mm channels and the rafter in 100 x 50mm channels. Substantial purlins above the columns and a framed up steel truss above. There are windows in either gable end and large doorways - doors and windows both missing and the floor condition is poor inside these openings where the rain drives in. The corrugated sheets of the walls and roof are generally sound apart from one loose sheet on the south side of the roof. This is still a substantial building.

6.1 Roof and storage loft over the main store area

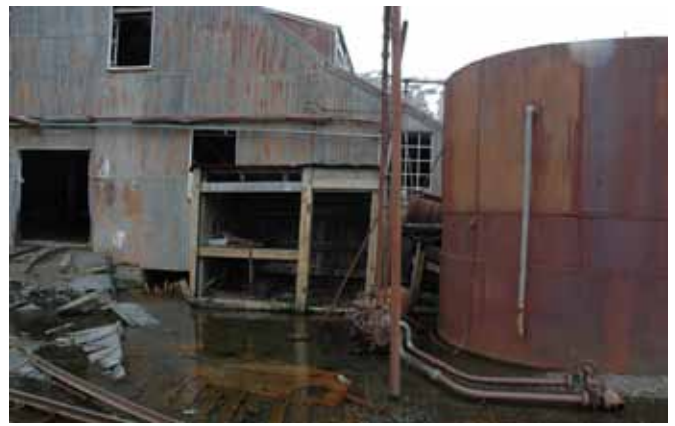
The window openings remain but the frames have gone from the gable end windows and the floor is also in poor condition by the north gable end. There are three windows on the west side of the building at ground level, again with no casements remaining. A door and window on the south side both missing. There are three lean-tos against this building: that to the north is still in solid condition but those to the east and south have both partially collapsed.

7.1 South and west elevations

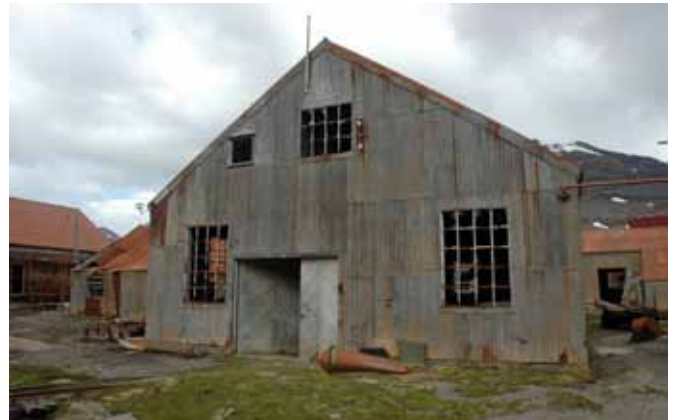
The Workshops are effectively two separate buildings. The eastern arm with a ridge running east/west houses the Foundry and Blacksmith's Shop. The much more substantial western arm, with a ridge running north/south, houses an engineering workshop. The eastern arm has two forges in it, both still present complete with hoods and flues, but it is in very poor condition with three of the principal rafters split and the roof partially collapsed. The north wall has been pushed out by the falling timbers and is leaning northwards. The rotation has also kicked out the south wall which has cracked. The roof is in imminent danger of complete collapse. At present the roof further west is in better condition but it is difficult to imagine that this can survive the collapse of the adjacent section of roof.

8.1 North elevation of the west wing

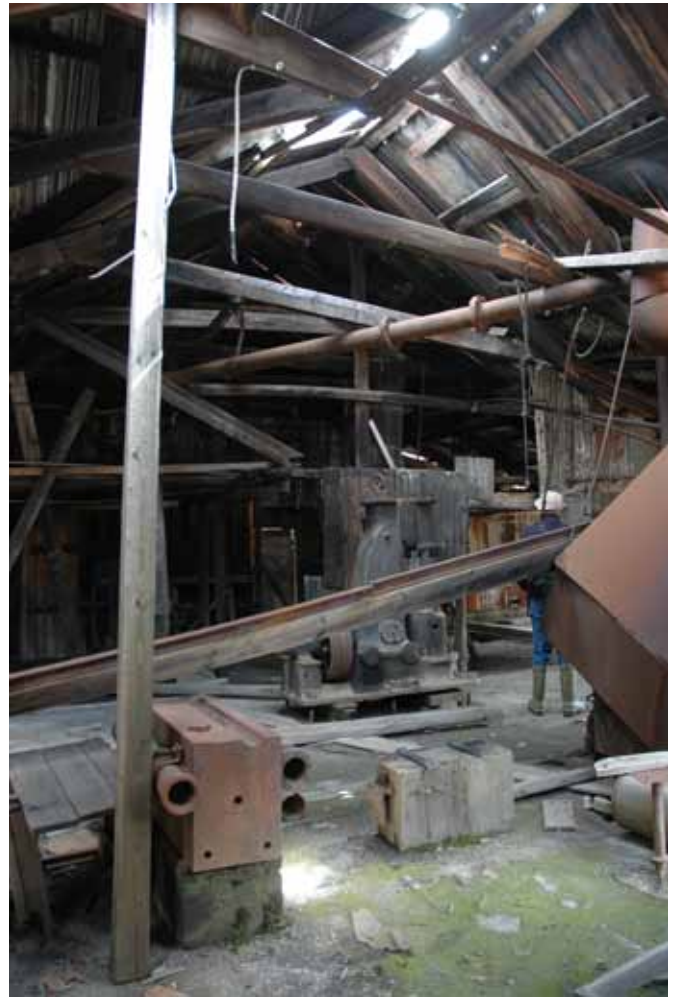
8.4 Interior of the collapsing east wing showing the Blacksmith's Shop

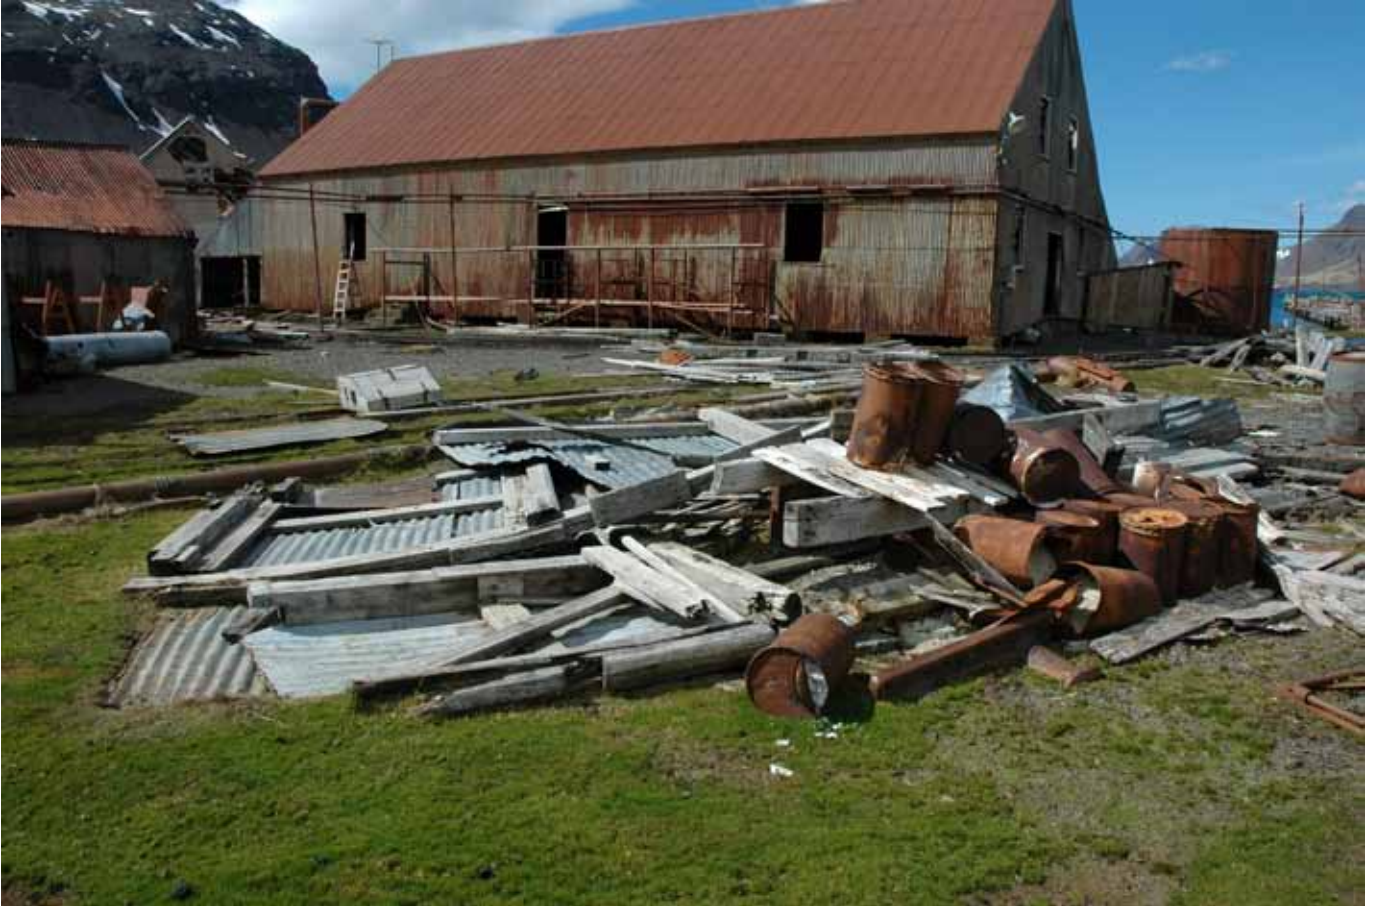
The outline of the concrete floor and the base walls still remain but the building itself has entirely collapsed. All that remains is a heap of timber and corrugated iron.

9.1 The remnants of the building with the Catcher Store in the background
