DISUSED WHALING STATIONS

Husvik Harbour Gazetteer

Gazetteer, July 2011

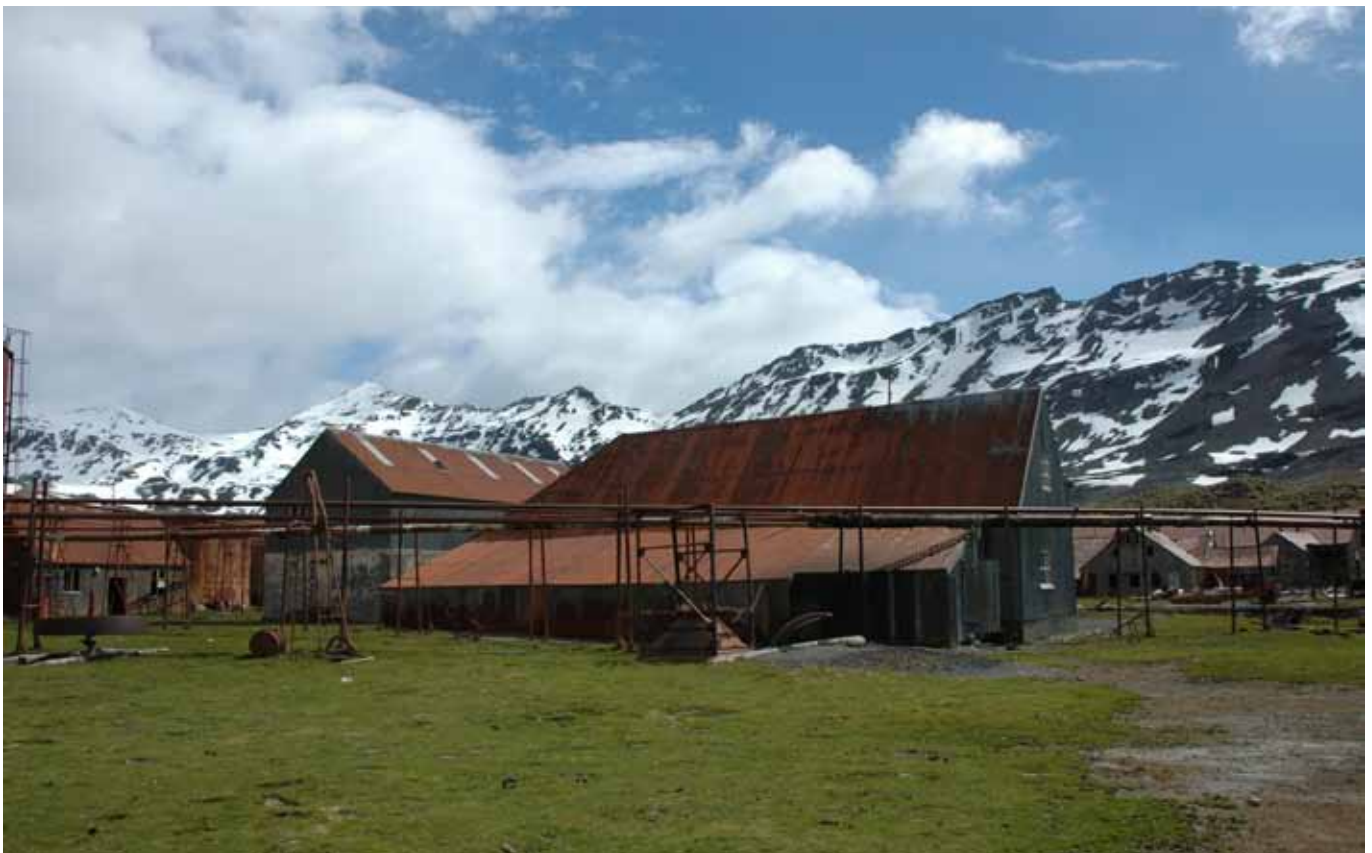
There is a timber framed lean-to running the full length of the south side of the building with a low timber framed wall supporting the rafters of a mono-pitch roof with a wall plate roughly at the level of the first floor in the main building. Rafters are propped at mid span by timber posts. The main building has a continuous loft space over both store and workshop, accessed by a stair at the east end of the building; this is also racked out with shelving. Main doors were on the north side of the building but these are now missing. This building remains in reasonable shape.

10.2 South elevation

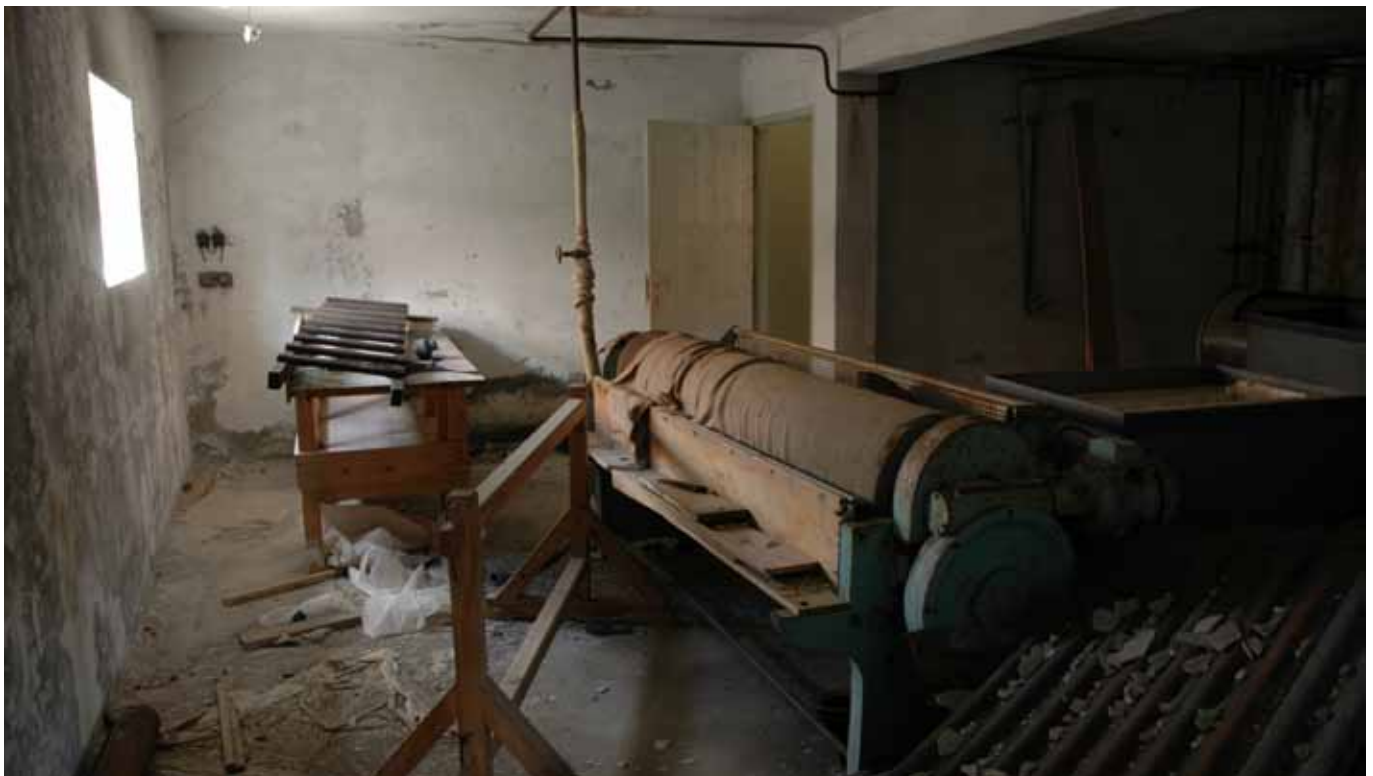
11.3 The storage area over the Slop Chest and Laundry - apparently used by the Army/Navy as a dormitory area

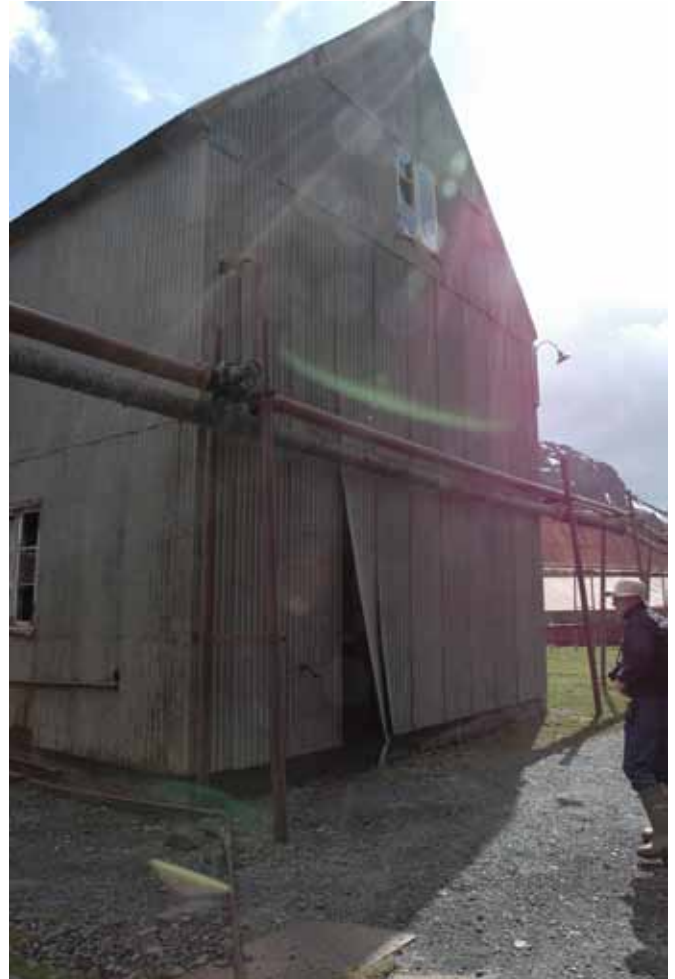
A two storey high rectangular building (though with no upper floor other than access gantry), built to house large tanks that run through to eaves level. Walls and roof are timber framed with principal rafters of the roof at 2m centres. The rafters have ties and collars and support purlins that in turn support the corrugated iron sheeting. The roof sheeting is all still present on the building though some are working loose. There is a missing sheet of corrugated iron to the west wall, two sheets are missing on the south side and sheets at the southeast corner need to be refixed. There are also some loose sheets to the south side of the roof.

The entrance door is on the northeast corner with only four small timber windows, two to the east, one to the west and one high in the south gable. There is a small lean-to building on the northwest corner of the main building which is now in a state of collapse. The main building looks solid enough at present - but the fact that sheets are starting to pull away from the walls suggest that deterioration is likely to accelerate.

12.2 South elevation

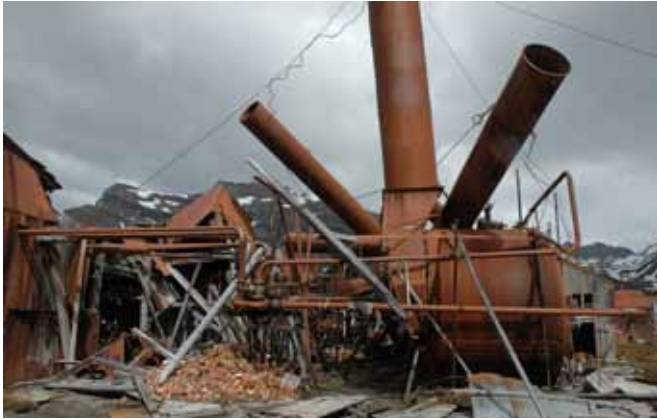
The Boiler House stood immediately to the west of the Bone Cookery. A tall single storey building constructed with a timber frame and timber pitched roof, all clad externally in corrugated iron. This building was not looked at very closely as it is in a state of collapse with its seven tall steel chimneys all having fallen across the roof. Only the south end of the building retains some of its roof though, even here, sheets are missing and the walls are bulging.

14.1 The north end of the Boiler House

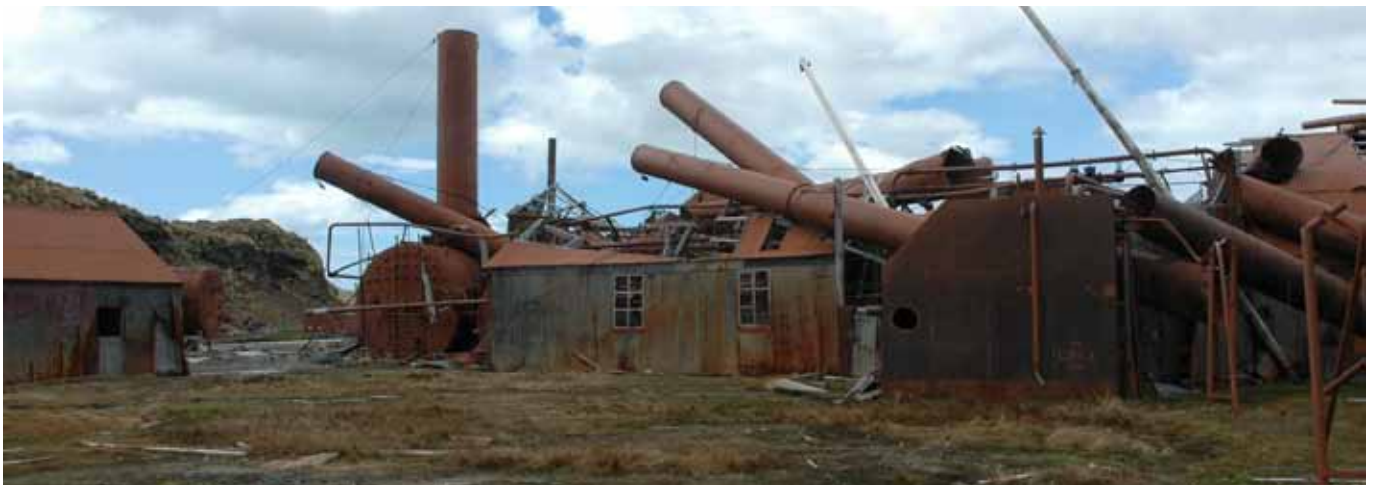
14.3 The north end of the west face

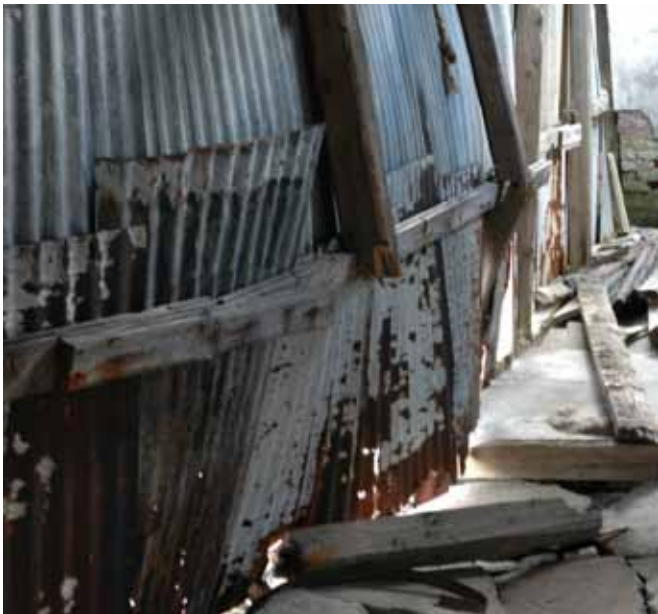
A single storey building although there has been some use of the loft space. The provision store at the north end has a floor at wall plate level which is heavily propped with iron posts to the south and timber posts to the north. The upper floor here has been used for storage. The ground floor has been in concrete, but is now completely broken up. This area has probably had water flowing through it at some time. The south wall in corrugated iron is buckled and several of the timbers are cracked. The western section of the provision store has earth banked up around a masonry wall. The floor above this area is of heavy timber construction with cinders between the joists for insulation, the floor being propped with two rows of timber posts. The section of the wall on the north side has fallen in and there is plenty of loose corrugated iron here.

16.2 Detail of the collapsing south wall and the broken concrete floor

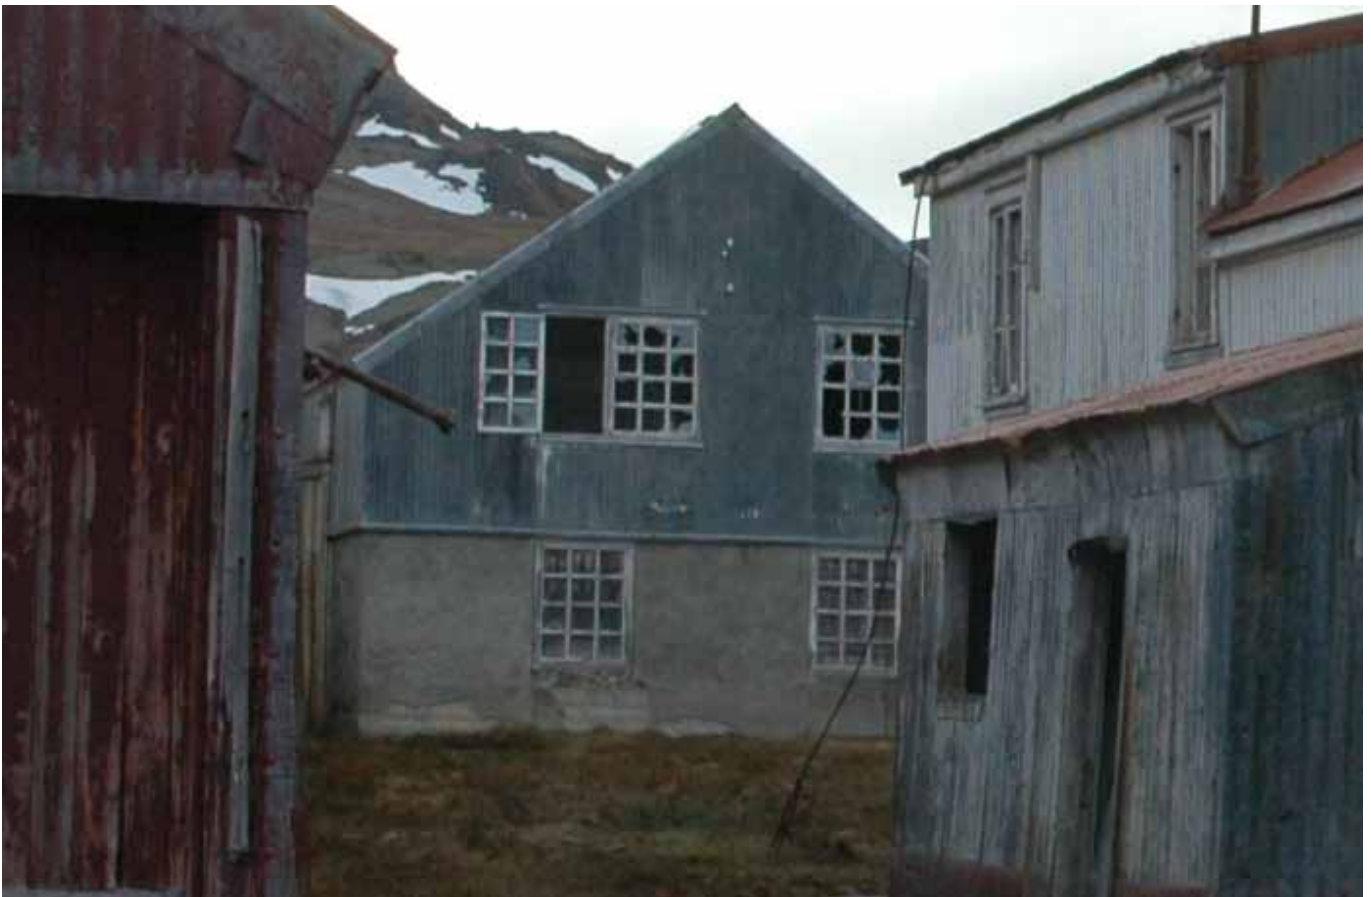
There is a lean-to extension on the south wall with walls and roof clad in asbestos cement sheeting. This is now failing and sections are missing.

17.1 East elevation

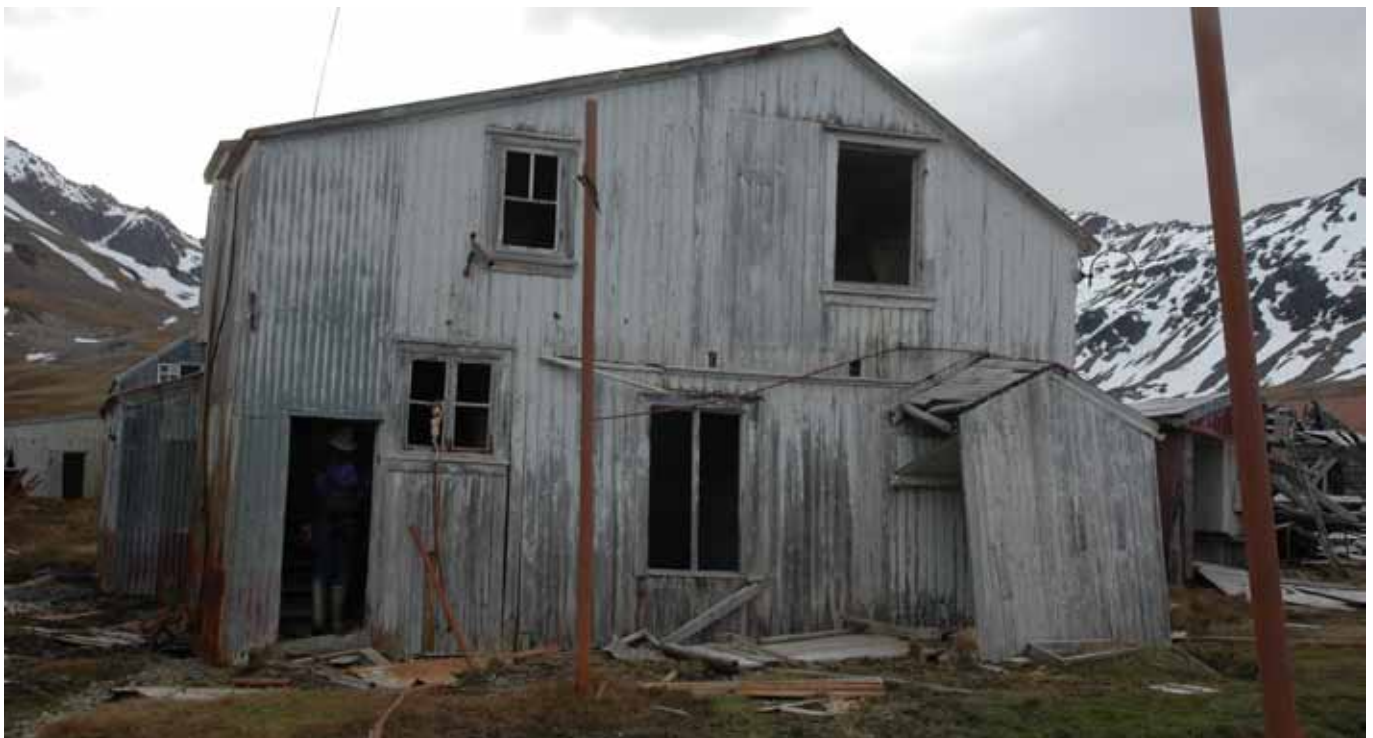
This building has been altered and extended on more than one occasion. It is a two storey building, timber framed and clad externally in vertical timber boarding with a corrugated iron roof. Windows are timber casements and the building was entered by porches on the north side. The building has been severely affected by water with the concrete ground floor broken up, much of the lower timberwork of the walls rotted away, particularly on the north side. The walls are now bulging and the collapse of this building must now be imminent.

18.2 The east elevation

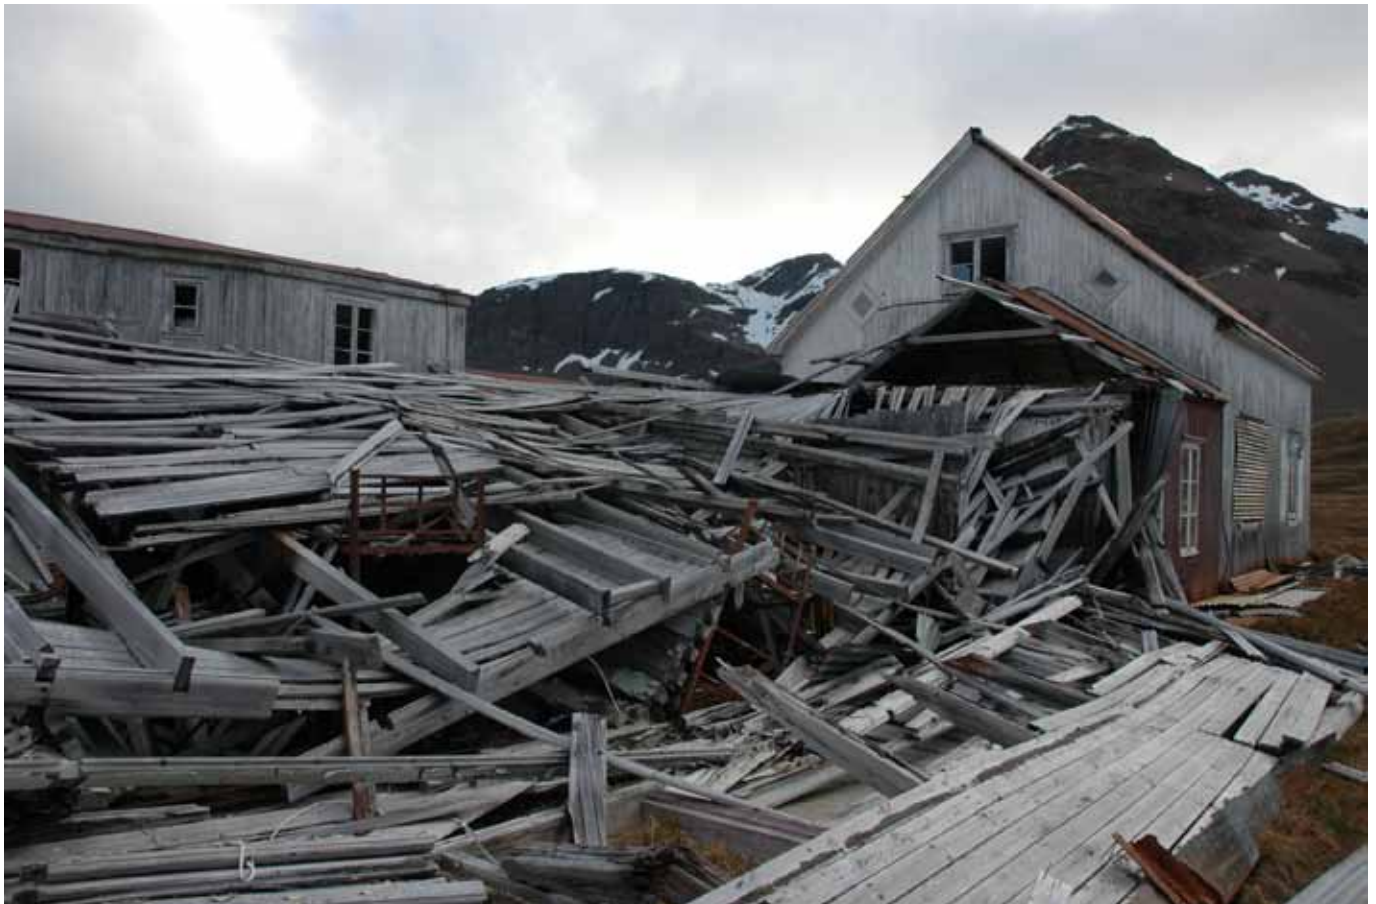
19.2 The north side of the collapsed building looking west

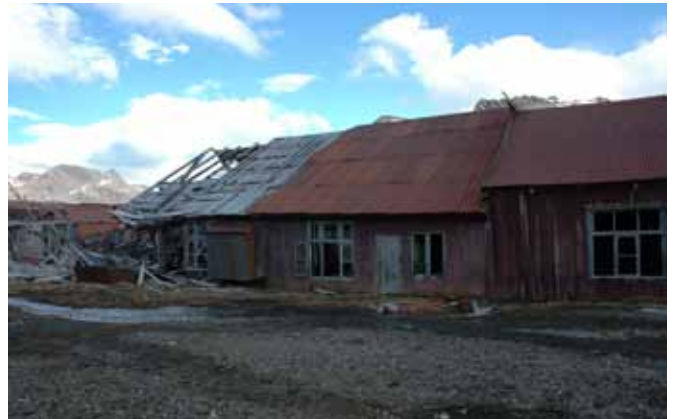
The central section of the building has walls covered with vertical timber boarding and is in slightly better shape but it is suffering from some subsidence and there are missing sheets of corrugated iron from the roof and the later addition of the south passage wall is leaning outwards.

The newest section of the building at the west end is in the best condition, this is fully clad in corrugated iron which remains in reasonable order - but this section of the building has also been affected by water running adjacent to the wall. There does not seem to be any realistic prospect of saving this building.

22.1 The north face of the building looking east

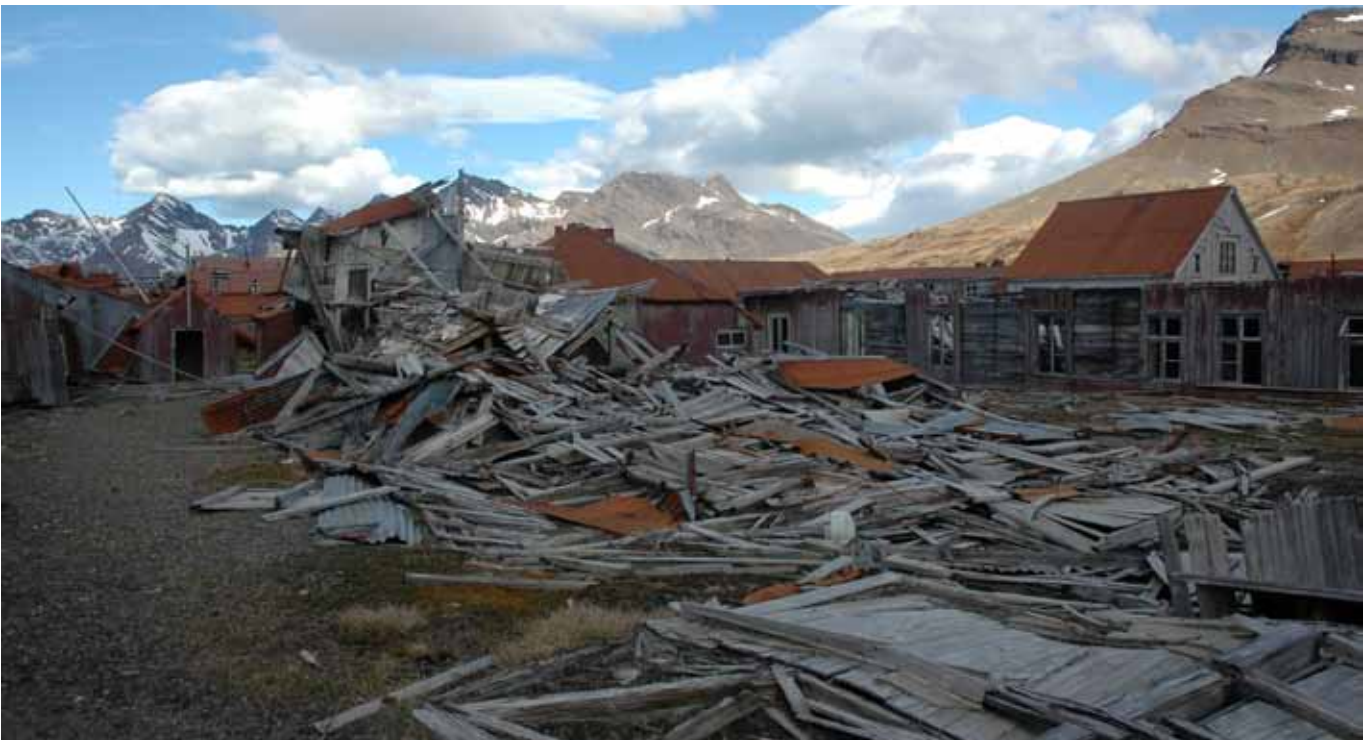
24.3 The remains of the Cinema looking eastwards

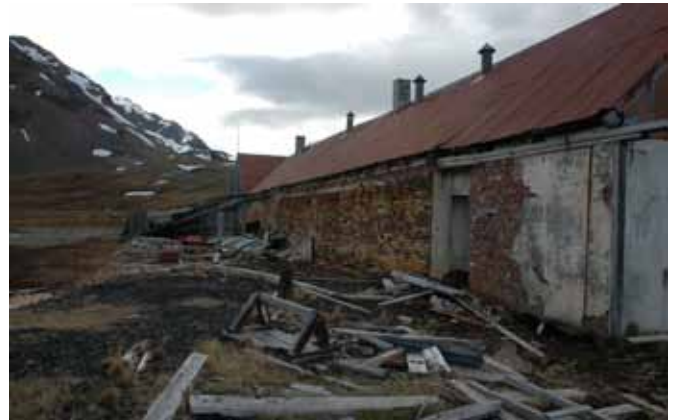
The walls of the Pig Sty are in brick which has previously been rendered though much of the render has now fallen off. The Pig Sty appears to have been built in at least two, and probably more, phases. The timber roof is covered in corrugated iron which is generally still in reasonable condition with only one section missing on the north side. Flues and ventilators remain in position. There has been a lean-to extension to the building along the south side - this has collapsed. Other than this the building is reasonably upright.

25.2 Collapsed lean-to on south wall

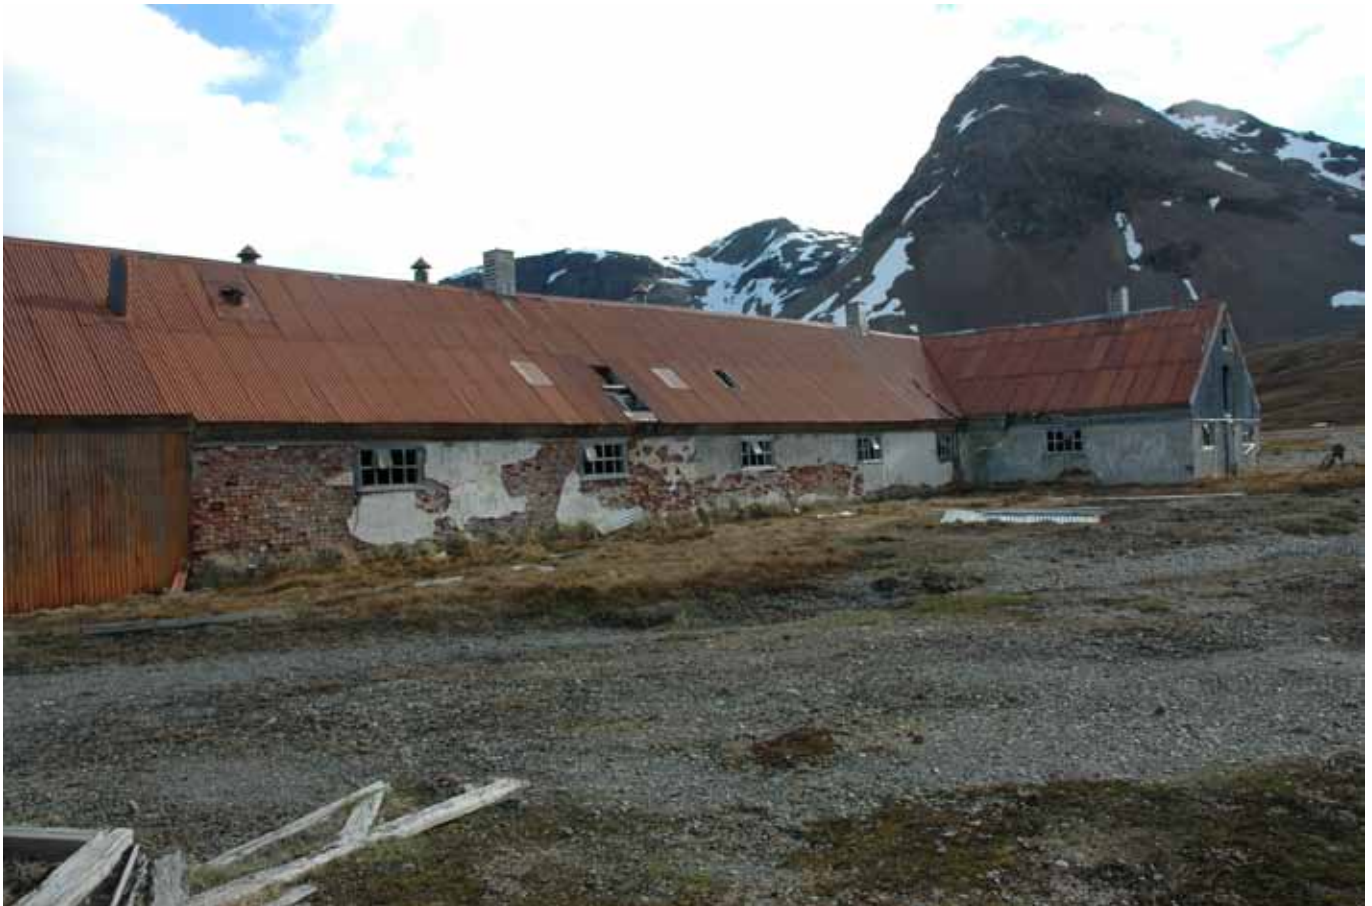
Internally the building is in poorer shape with some subsidence and/or heave disruption and cracking to the floor and pens.

25.1 The north elevation

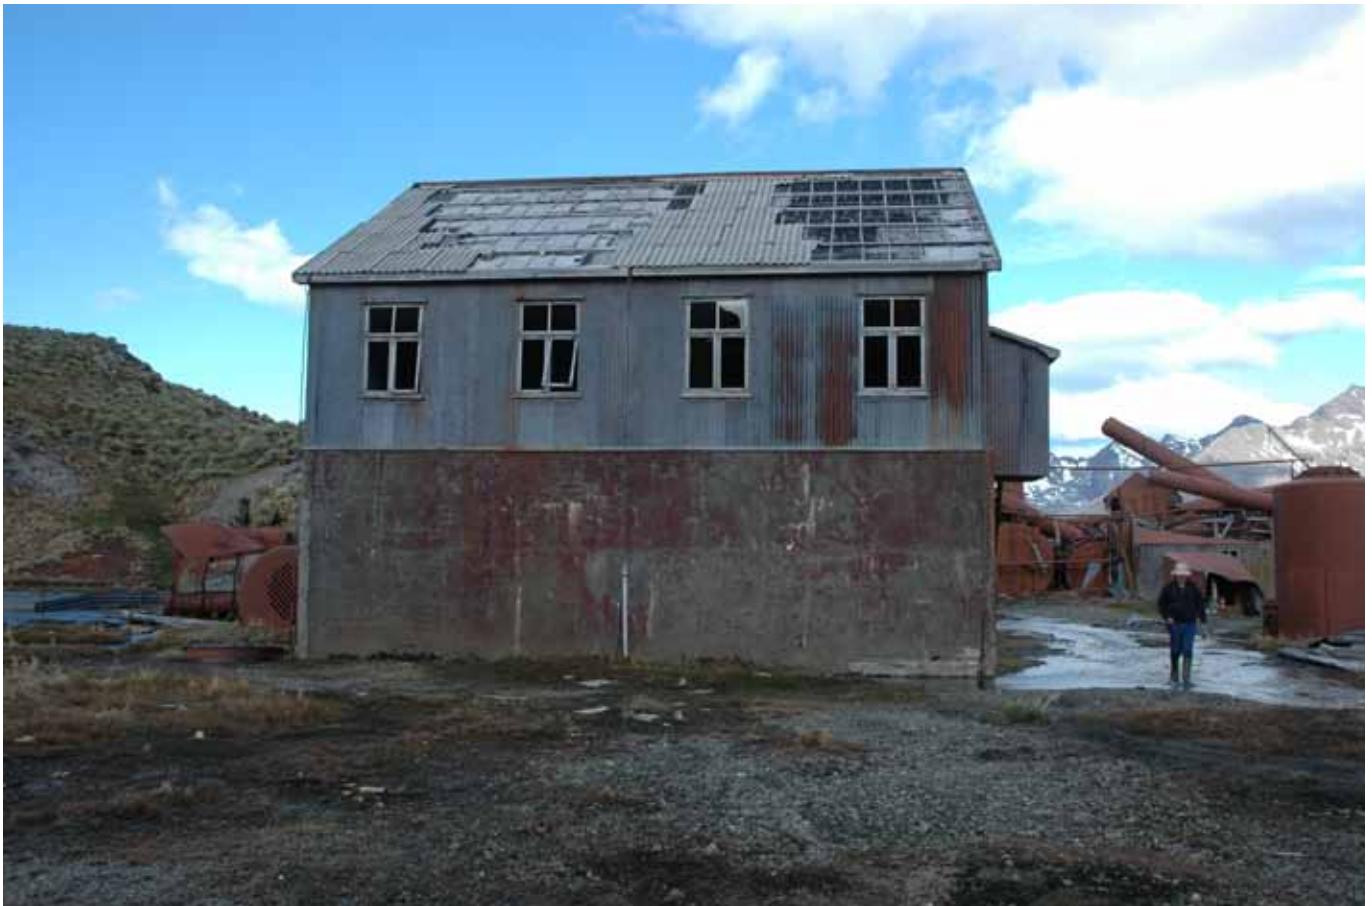
This building has rendered masonry walls up to the first floor level and then a timber frame clad in corrugated iron above. The timber framed roof is covered in corrugated asbestos which is now badly damaged with perhaps 50% missing. The upper floor is reached by an external stair on the south end of the building and the barrack rooms are lit by casement windows, four to the east and four to the west. The solid ground floor is reached up steps and a door on the east side. The ground floor is full of polystyrene blocks and could not be inspected.

26.1 The west elevation

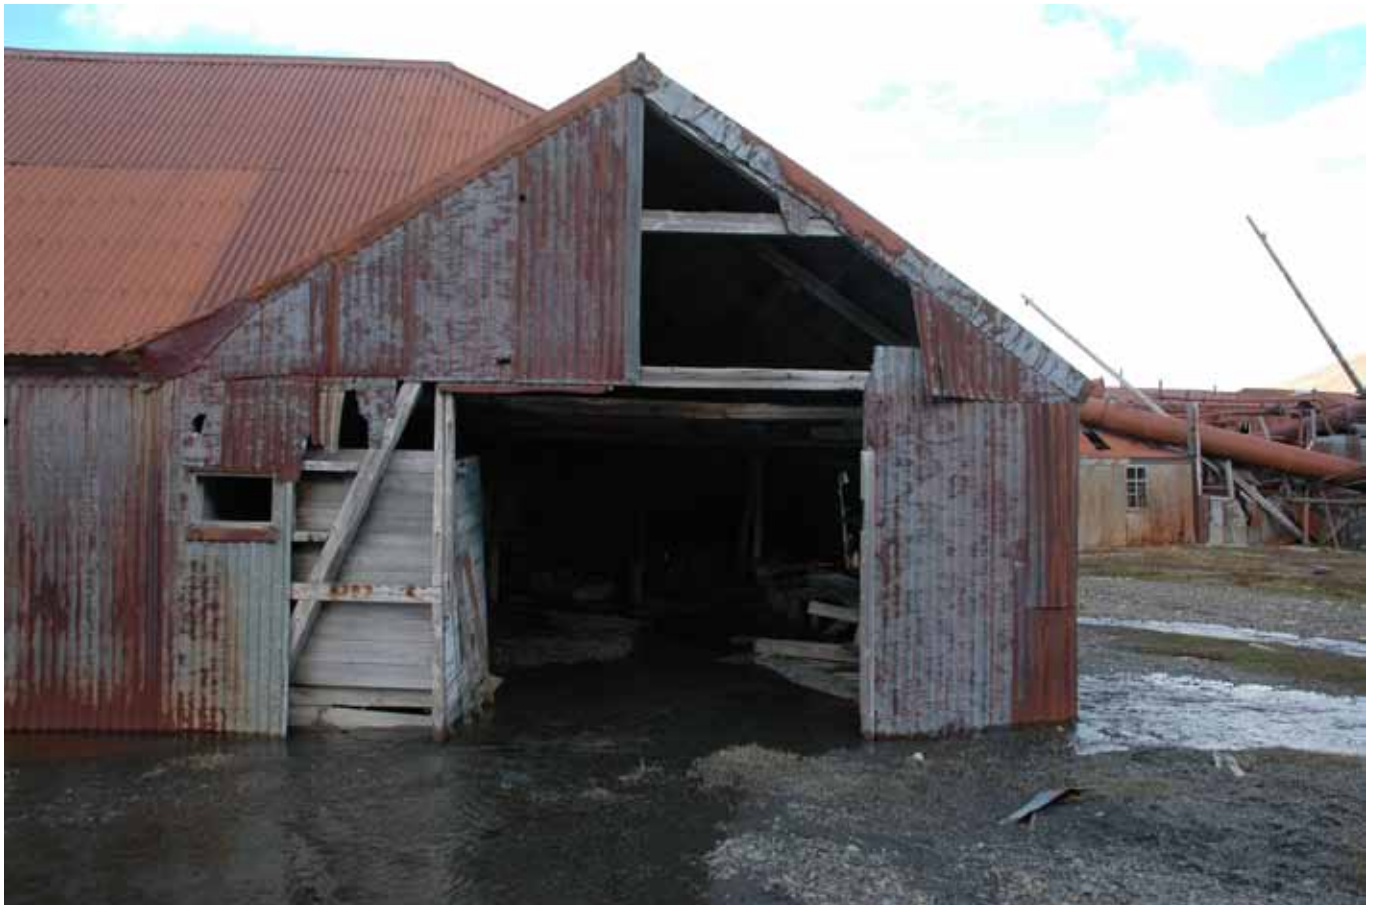
This is an 'L' shaped building with the Carpenter's Shop in the east wing. The building has timber framed walls and roof clad in corrugated iron. It has had a timber floor but at present the stream is running through the centre of the building both damaging the timber and undermining the footings. This has caused the south wall to start to fail and lean outwards and the roof slope is now distorted. This building is likely to collapse soon unless the stream course is altered.

28.2 Shows the stream now running through the building

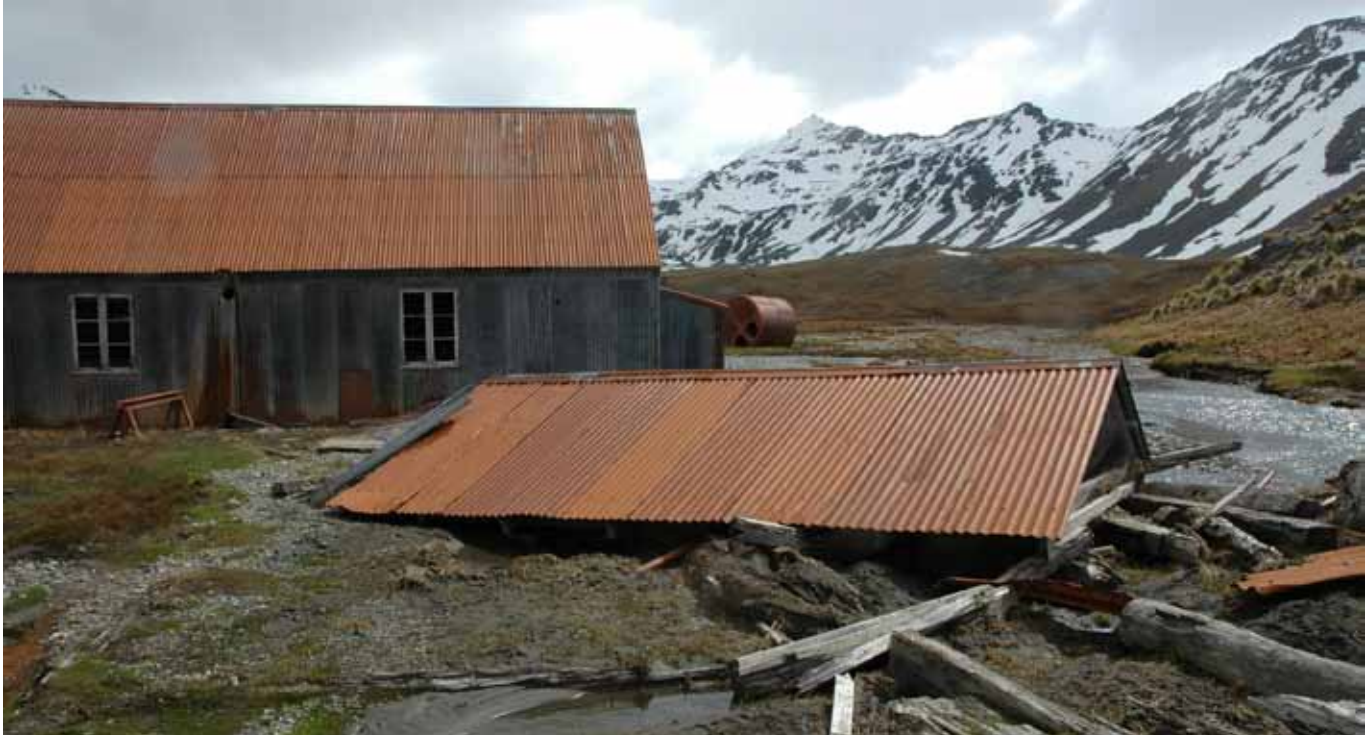
This building was probably always set below ground level for temperature control; however, it has now collapsed and the roof is still framed up and covered in corrugated iron but lying on the ground a little distance from its original location and the remnant of the store is full of water.

29.1 The surviving roof of the Whale Meat Store

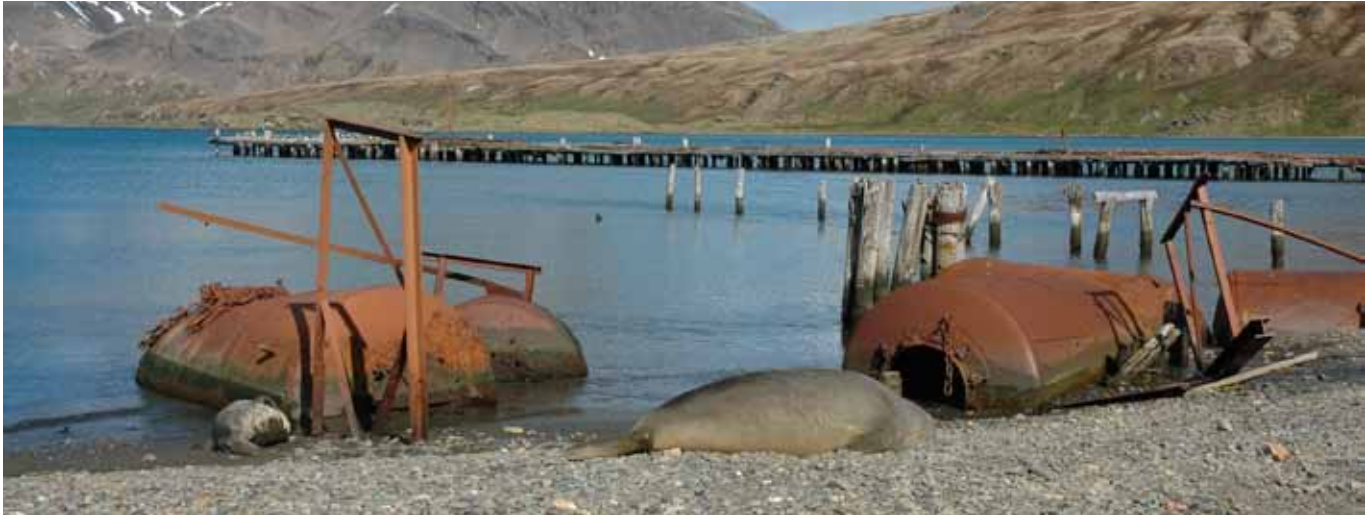
This jetty has collapsed with only a few timber posts indicating where it has been.

35.1 The remnants of the Jetty are behind the boilers. The long main Jetty can be seen in the background.

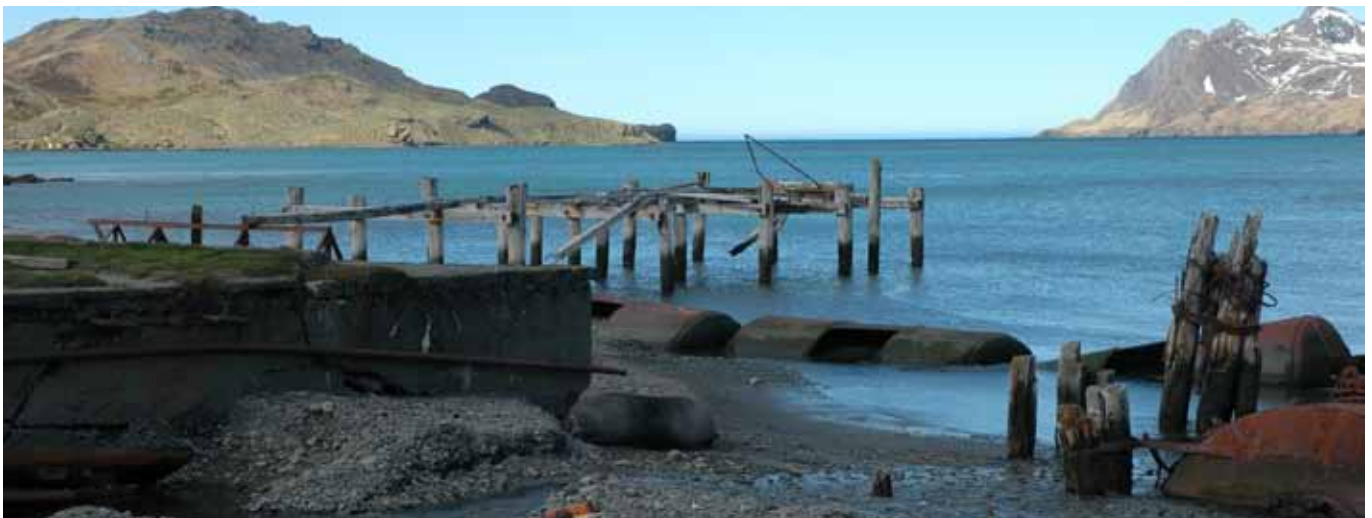
This jetty has collapsed with only the timber posts and a few of the main timber cross pieces remaining in position.

37.1 The Jetty seen from the southwest

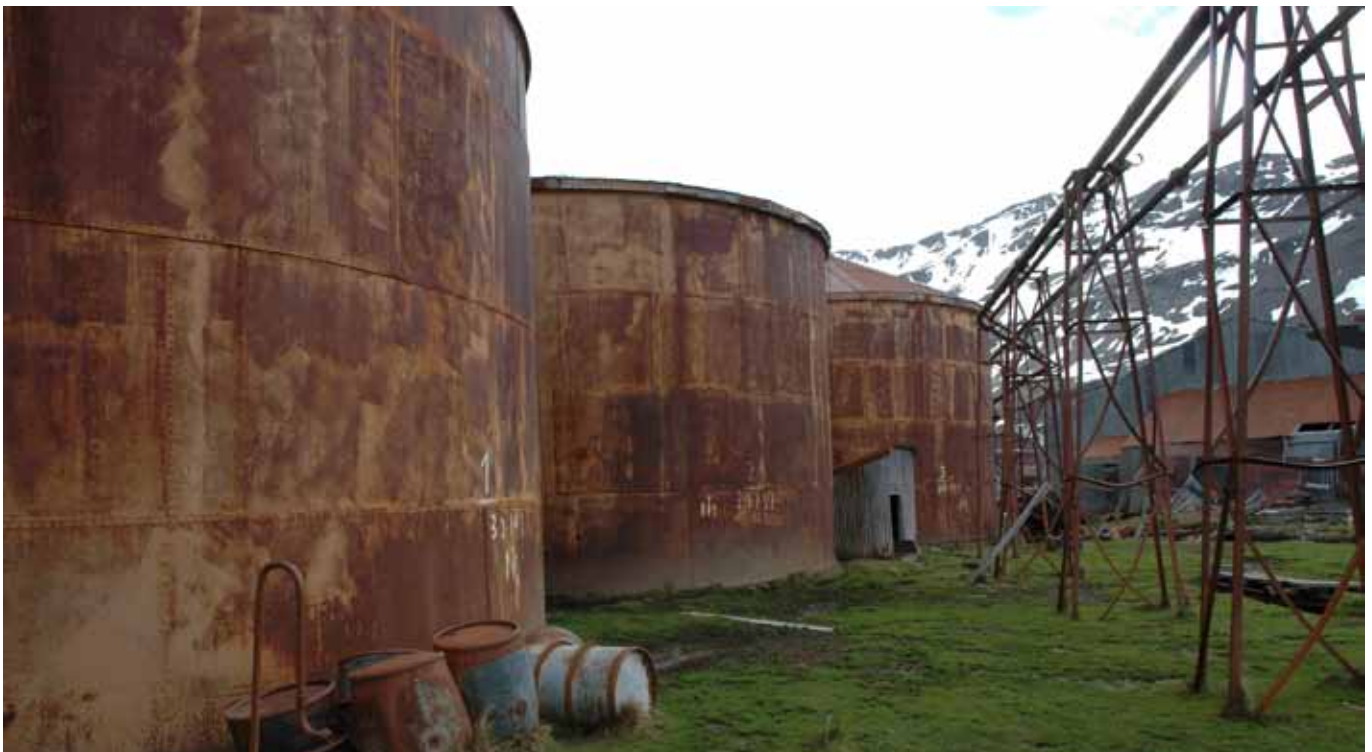
The tanks were not looked at in any detail. Generally the tanks are in fair condition with no signs of major disturbance or any signs of imminent collapse. Specific problems were noted on a number of tanks.

Tank No.42 has one plate which is severely corroded and its neighbour above has corrosion starting. Above this, at the junction between the roof and the side walls, there is a line of corrosion showing as small holes which is introducing a significant weakness into this tank. Plates are also corroded on the south side at the same level. Possibly this was the level the tank was left filled.

38.2 The east side of the main row of Tanks looking northwards

The two tall tanks, Nos.45 and 46, have had wire stays to brackets at their top rim at some point in the past; these have failed and the tanks are now unstayed.

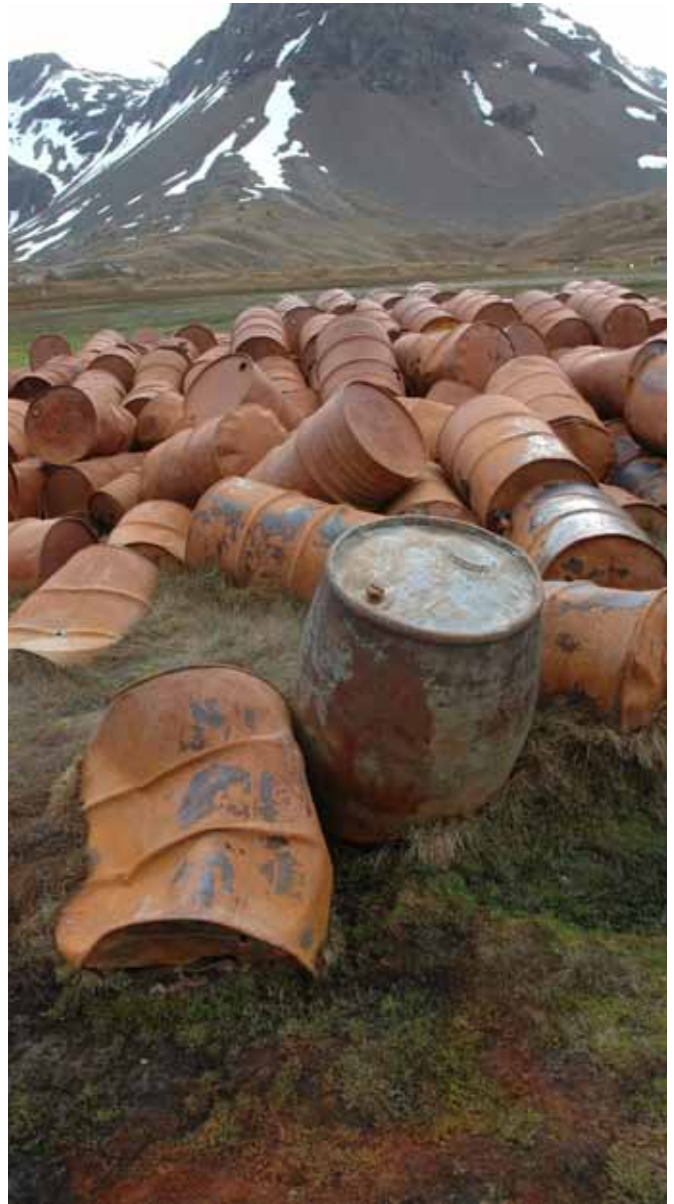
Adjacent to tanks Nos.49 and 51 is a barrel dump of 50 gallon drums now all considerably rusted. There are probably in excess of 400 drums in this heap.

38.4 The heap of 50 gallon drums lying to the east of the Tanks

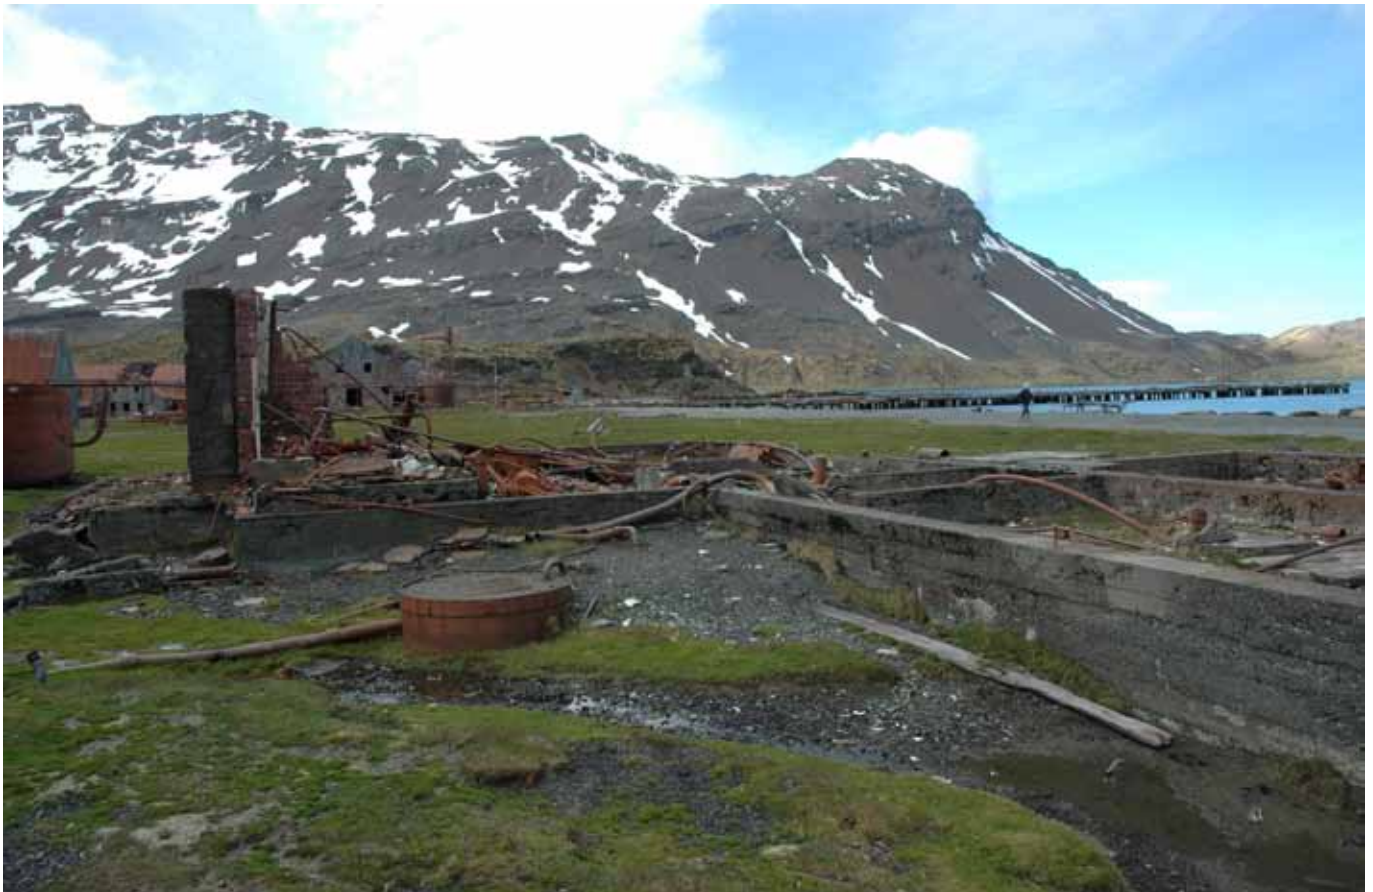
This building collapsed a long time ago. All that now remains is the concrete walls that would have supported the wall plates and floor. There is a remnant of a brick wall where the chimney stood.

67.1 The site of the building looking north

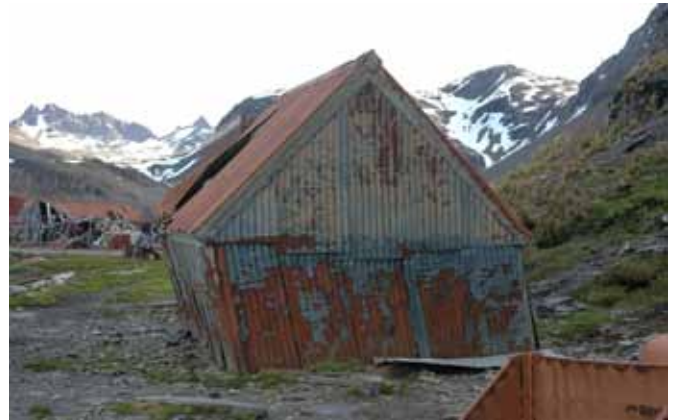
The store to the north is in poorer condition. The sheeting on the east side of the pitched roof is damaged and the building is leaning to the northeast. This building looks likely to collapse in the near future.

68.1 The northeast face of Store No. 69

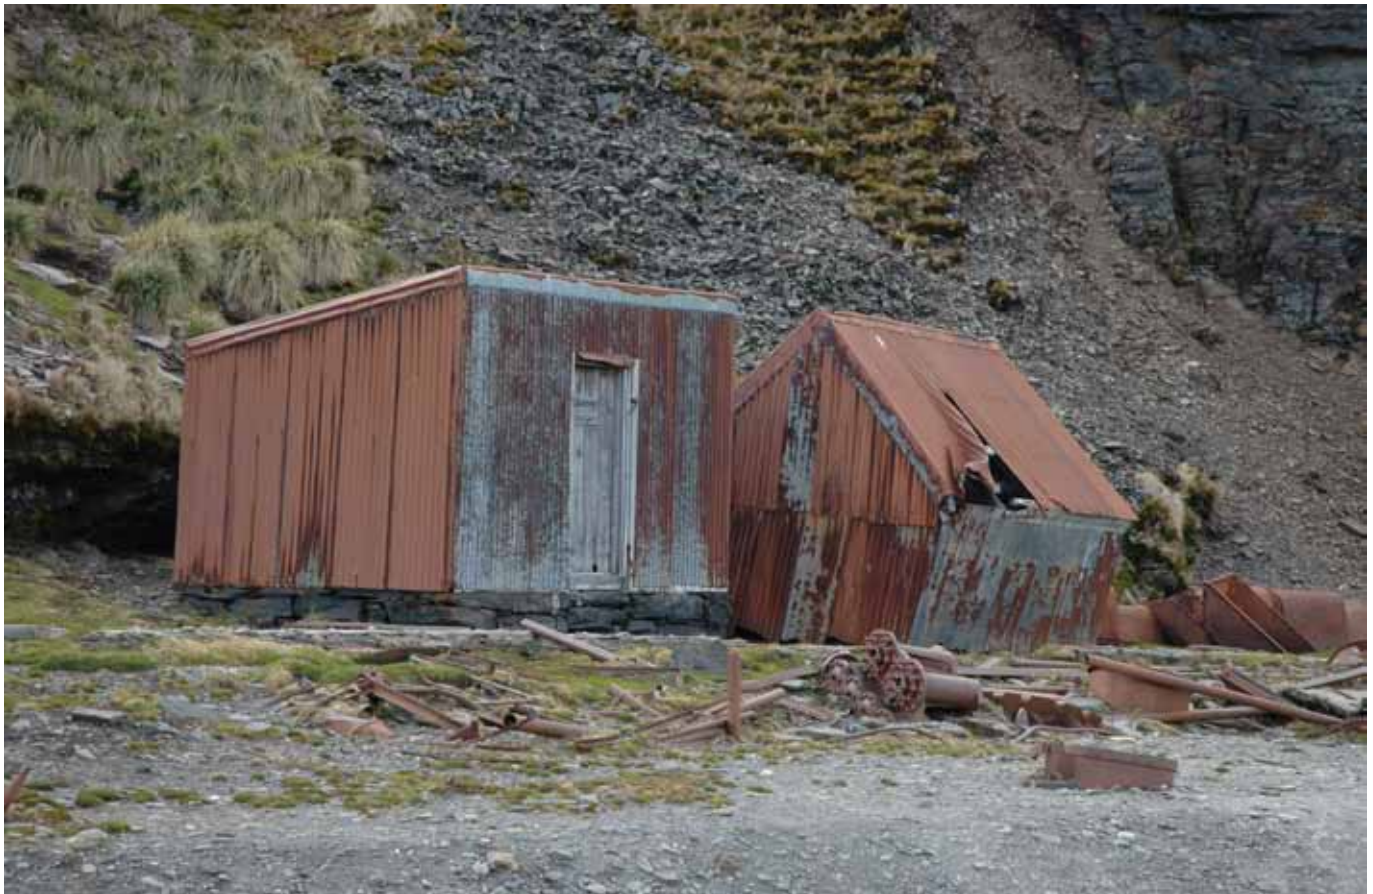
Two small corrugated iron covered timber framed sheds. The southernmost being the Gunpowder Store with a mono-pitch roof and walls clad in corrugated iron and an entrance door on the east side. The building stands on a stone plinth. Apart from the corroding corrugated sheet this building appears to be reasonably sound.

68.2 The southeast side of the buildings, the Gunpowder Store to the left
