DISUSED WHALING STATIONS

Husvik Harbour Gazetteer

Gazetteer, July 2011

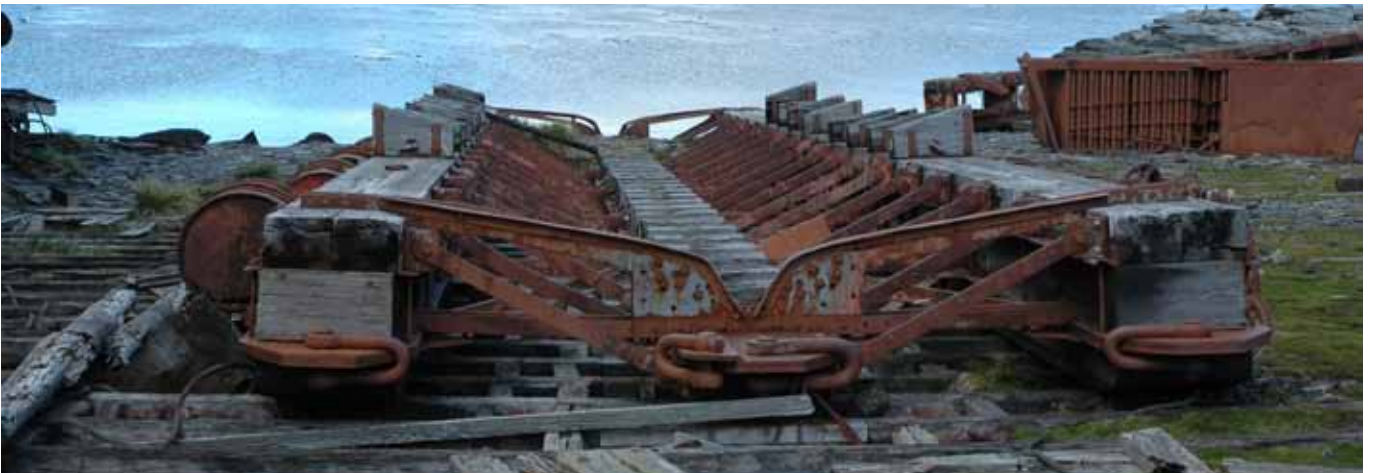
The slipway is still in remarkably sound condition. There are two of them, one of which now has Karrakatta sitting on it.

71.1 The slipway adjacent to the Karrakatta

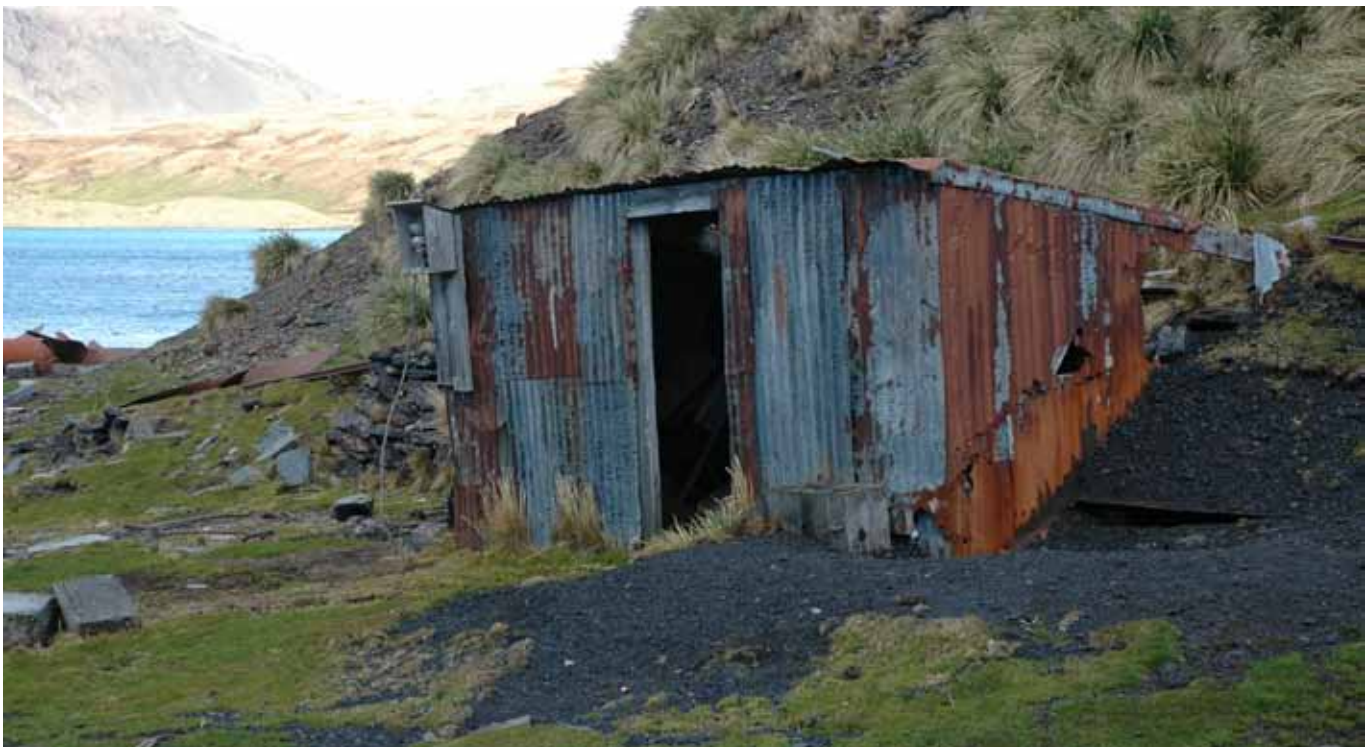
A small timber framed building built into the bank behind it. The walls and roof are covered in corrugated iron with holes in the back wall to the bank and in the roof. The door is missing.

73.1 The north and west faces of the building
