DISUSED WHALING STATIONS

Leith Harbour Gazetteer

Gazetteer, July 2011

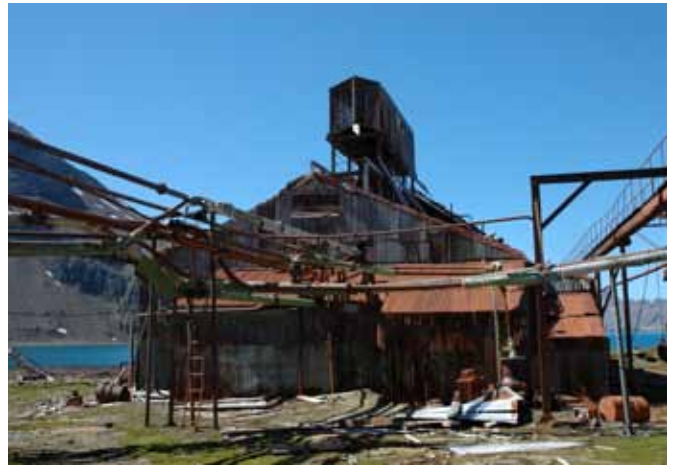
2.1 The west elevation

At the east end of the blubber plant, really a separate building, is the separator plant. A steel framed building with steel trusses, with cookers to the west and separator plant to the east. The building is open up to the roof with steel trusses supporting timber purlins and corrugated sheeting. The sheeting of the west end is missing where it is adjacent to the blubber cookery. Some big steel windows, now damaged, on the north side and some sheets of corrugated iron cladding missing here. Similar windows on the south side with one or two sheets of cladding missing.

This building still looks reasonably solid although there is a fair amount of corrosion at the base of some of the stanchions.

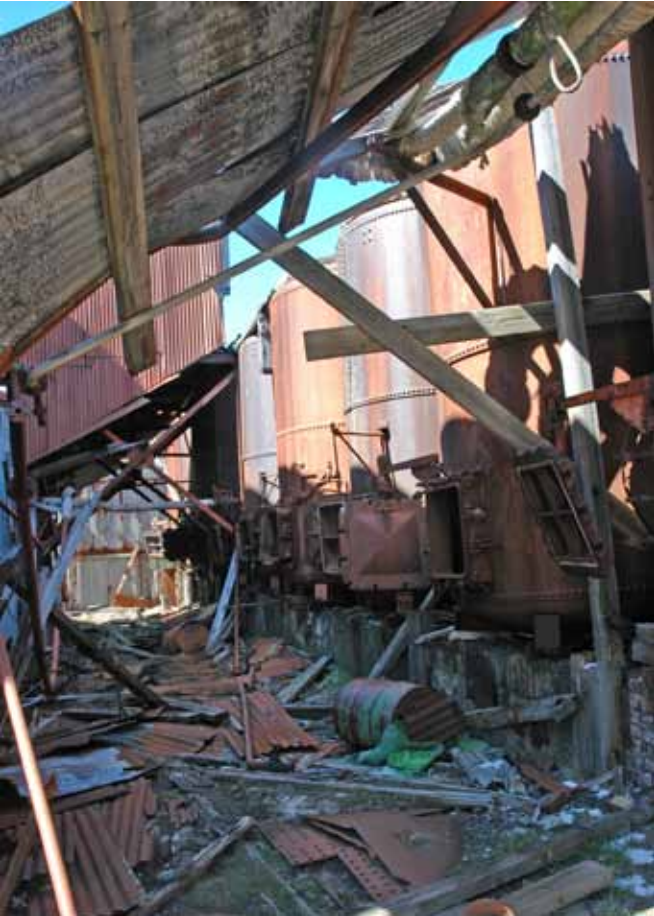
4.4 The north side of the building looking eastwards down the line of the cookers

There are two bucket conveyors leading up to the platform level. The platform itself is still present but is in very poor condition, the walls around the meat cookery building are in timber and corrugated iron and have all fallen away leaving the metalwork of the platform at the south end exposed and the cookers themselves.

There is sufficient of the building left to be able to see how the processes operated but collapse here is likely to accelerate over the next few years.

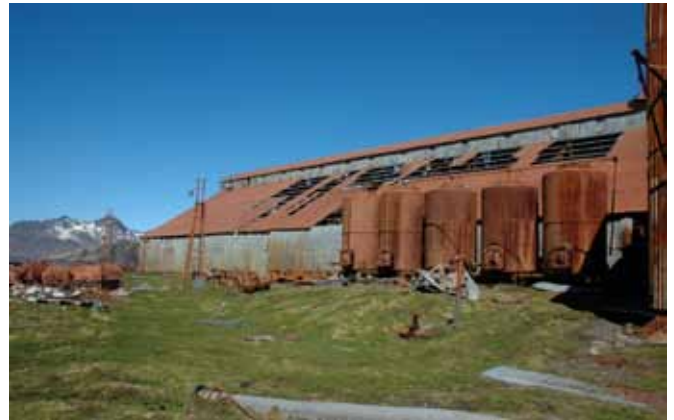
There is a significant amount of damage to this building. A small amount of wall sheeting is missing on both north and south sides. Ten bays have lost half or more of their sheeting. On the north side of the east end several of the columns are bent, though this looks as though it's where they have been hit by machinery. The structure is reinforced at the west end by the additional steel work to support the machinery above and around the plant. On the north side of the building are two outshots, both would appear to be earlier buildings which have been left in place when the new building was erected with doors cut through into them. The building to the northwest is timber framed and partially collapsed. That to the northeast is a bigger more substantial building with a heavier steel frame and trussed roof. The majority of the cladding sheets on this building are still intact although the roofing sheets are starting to go in the northeast corner.

10.1 The east end of the north elevation

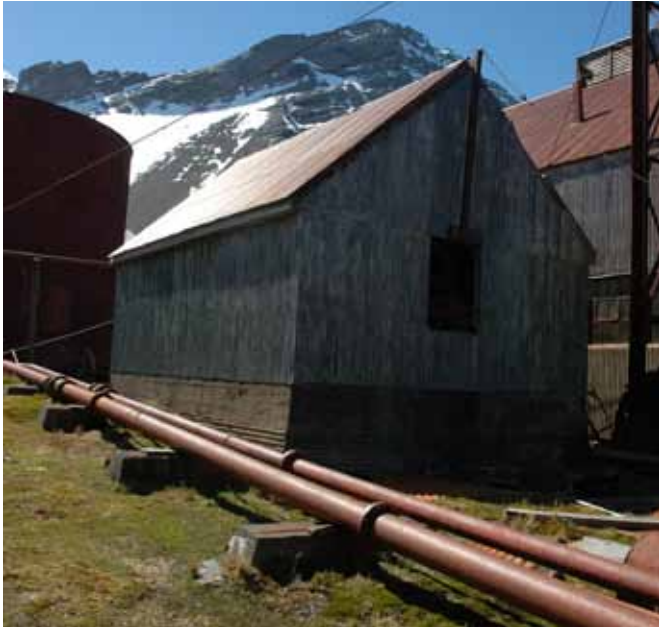
This building has a shuttered concrete base like most of the buildings, with a timber frame with corrugated iron cladding above. The wall sheeting is all present but 30 percent of the roof sheeting is missing on the east side.

13.1 West and south elevations

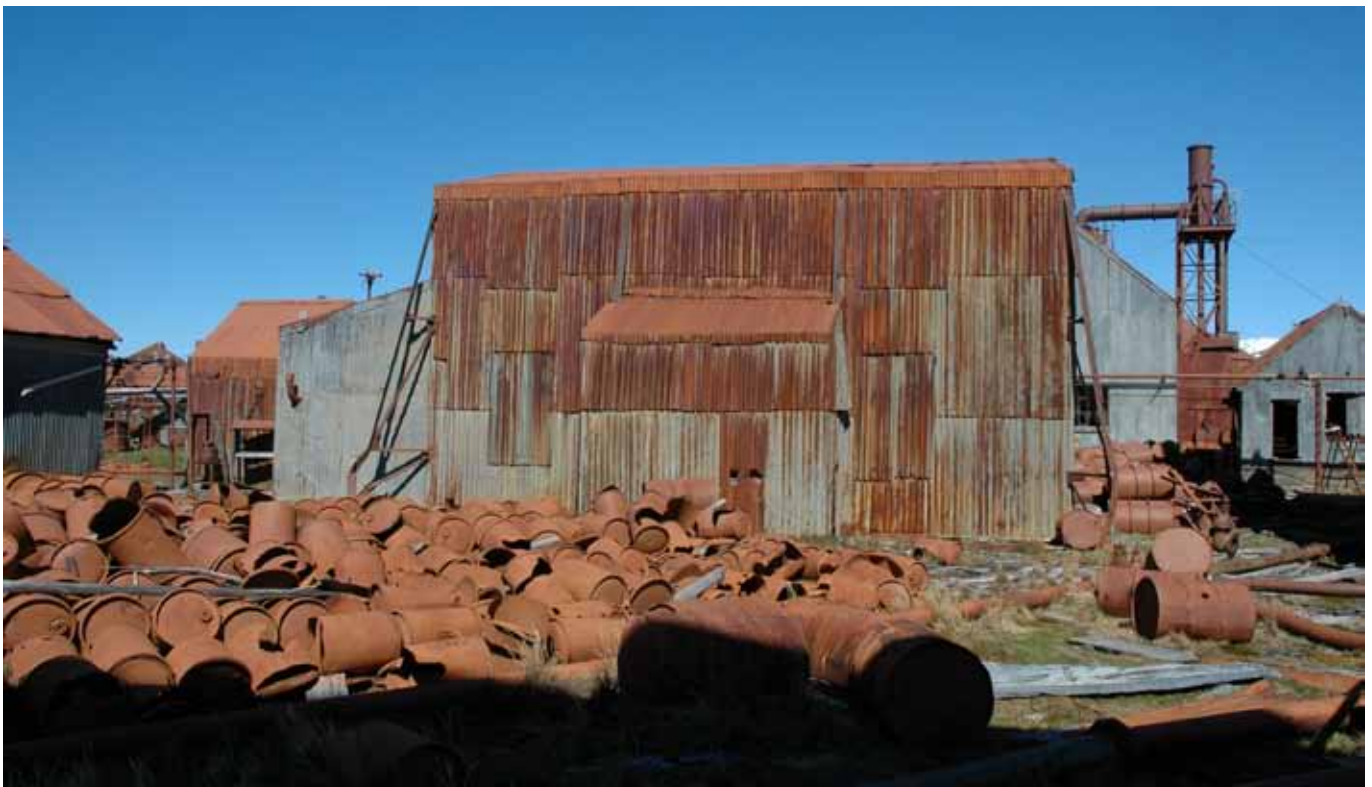
19.3 The north elevation

Externally the building has some curious trussed steel buttresses to the main columns. These have all the appearance of an afterthought with holes cut in the corrugated cladding, plates welded on to the steel columns. Several of the angles making up the main part of the buttress are distorted, probably as a result of being hit by vehicles. That to the southeast corner is severely decayed. These buttresses may have been added when the building was turned into a store space. The west end of the building being piled high with sacks of 'Johns-Manville High Flow Super-Cell'. This is a 'high class filter aid' and is made in Japan.

The original timber floor has rotted away and props have been added under the centre and either end of the balcony. The rather slender steel channels making up the walls are corroding and cracking the masonry away from them. Infill between the columns is in single skin brickwork which is damaged and falling away in several places, particularly on the south wall. This building is in poor condition and not likely to last a great deal longer.

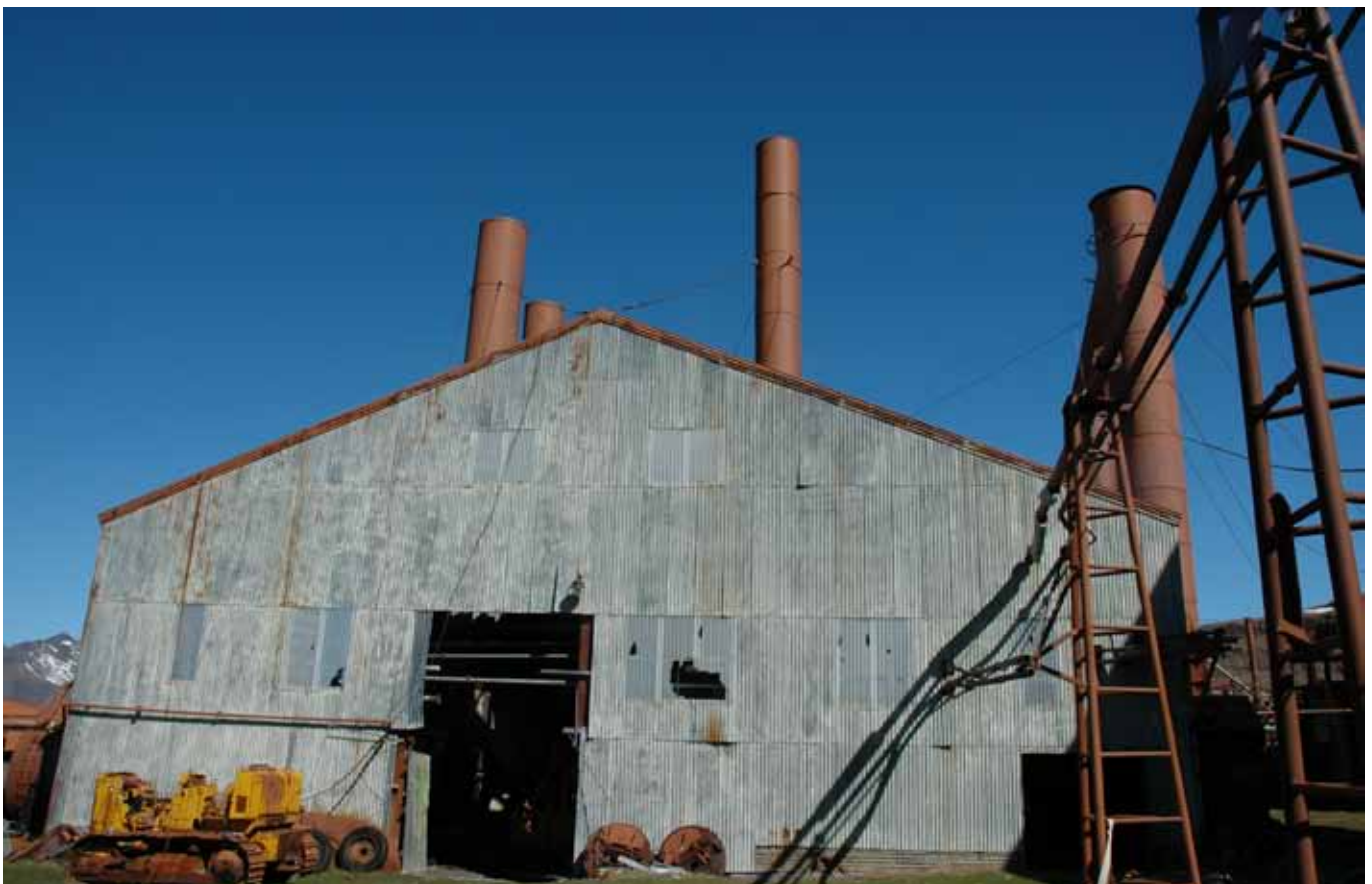
25.2 The north elevation

The render is failing and the brickwork starting to fall away. The southernmost flue has cracked and dropped approximately 750mm. It is now wedged on the remains of the flue and leaning against the adjacent northern flue. It is unlikely to remain like this for long and in coming down may well bring more of the flue with it. These two main flues have been stayed, the stays to the broken flue are now ineffective but three ties remain in position and reasonably taut on the northern flue.

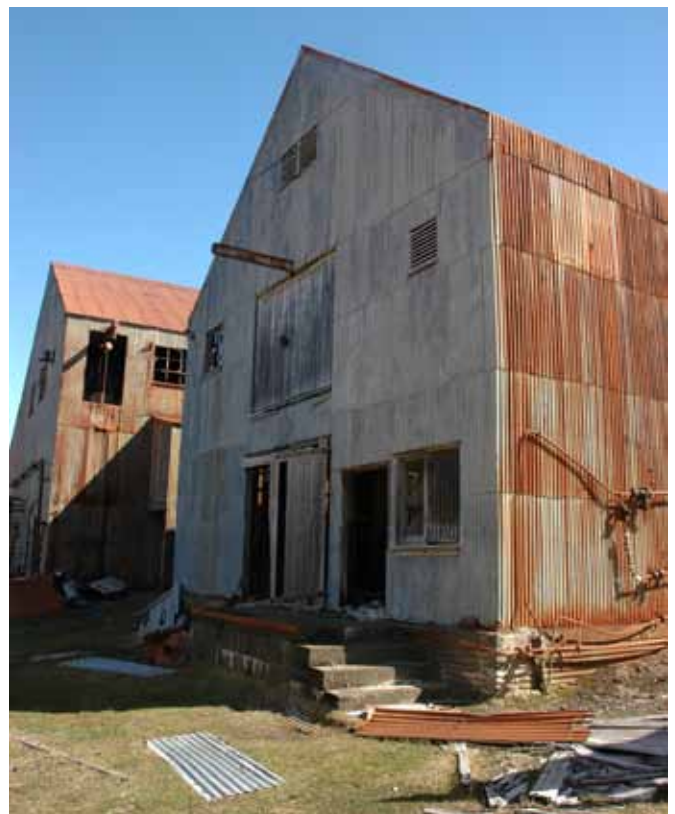
28.3 The east elevation

The wall sheeting is generally in reasonable condition other than the plastic which has been used in the ground and first floor to give daylight. This has failed on both north and south sides.

Both the pedestrian door and the large loading doors on the ground floor have failed but the first floor doors are in position.

Roof sheeting generally looks to be in fair order, this is dressed down over the eaves.

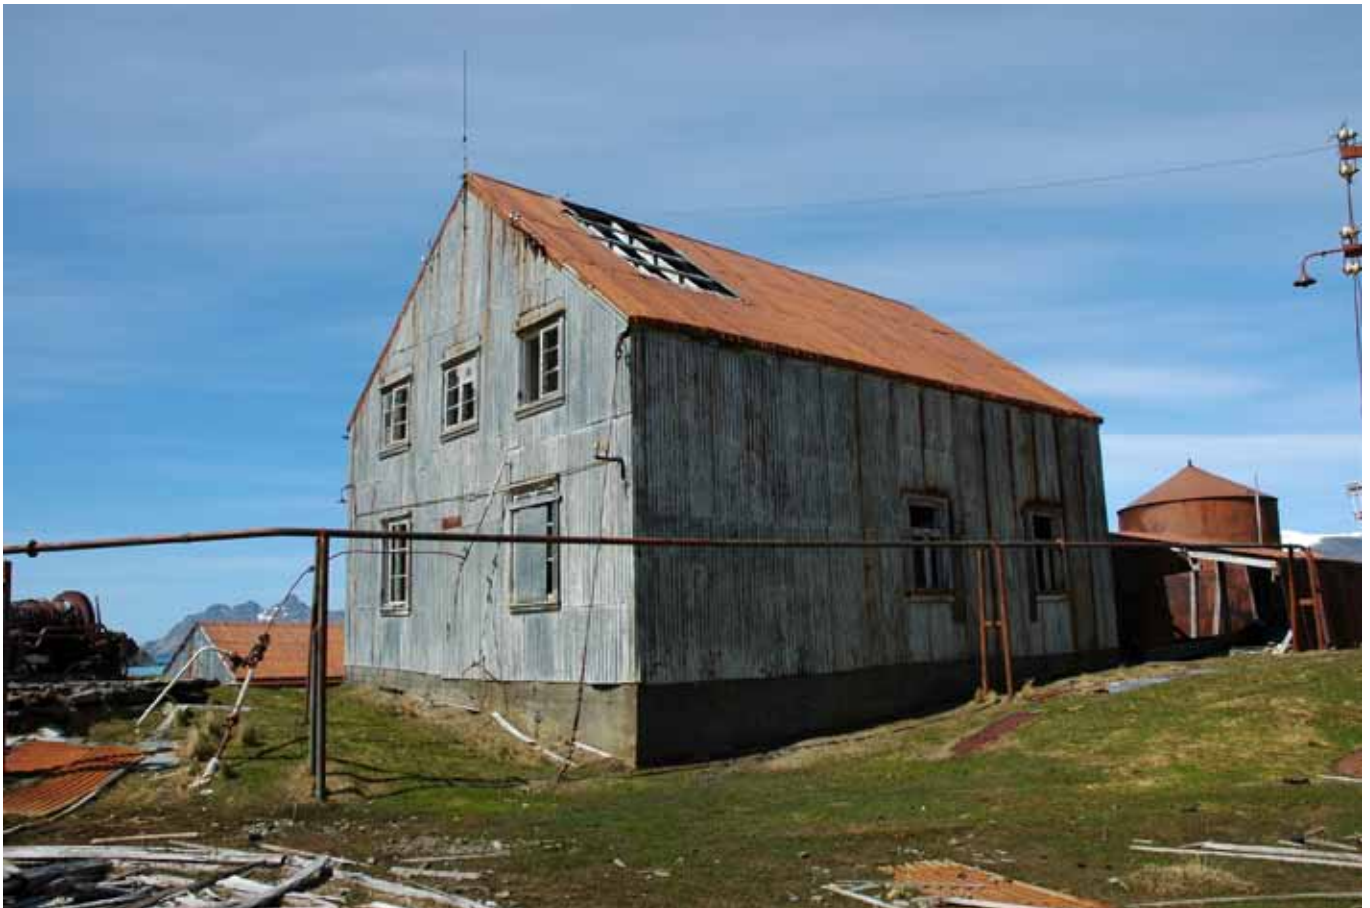
43.2 North and west elevations

The roof is intact on the east slope but there is a substantial hole on the west slope with perhaps some 10 percent of the roof slope missing. The timber roof structure can be seen here. Timber trusses with timber purlins. There would appear to be storage accommodation or possibly further bedrooms in the attic although this area is unlit apart from one small window in the south end gable.

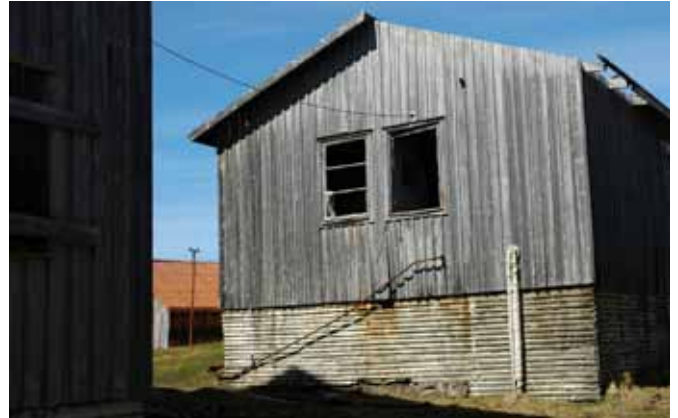
This hut is built on a higher concrete base to take account of the steeper ground level at this point. The ground floor is 1700mm above the lowest point of the external ground. A single storey rectangular building with a pitched roof running north/south. The building is in Bratiled timber boarding. There are four windows and an entrance door on the west side, two windows on the south side, five windows on the east side and two windows on the north side. The external timber cladding is generally in fair condition although there are some loose boards on the north side of the building. The roof is relatively shallow in pitch and is covered in timber boarding with some roofing felt held down by battens and then corrugated iron over this. The corrugated iron has gone completely from the west side of the building and a small amount remains on the east side.

Internally there is a suspended floor with timber boarded partitions and a ceiling probably of softboard. The floor has collapsed letting partitions drop with some sagging of the boarding on the centre of the west side and the boards are missing completely from the north end of the west side.

This hut is beyond sensible repair.

48.1 The north elevation

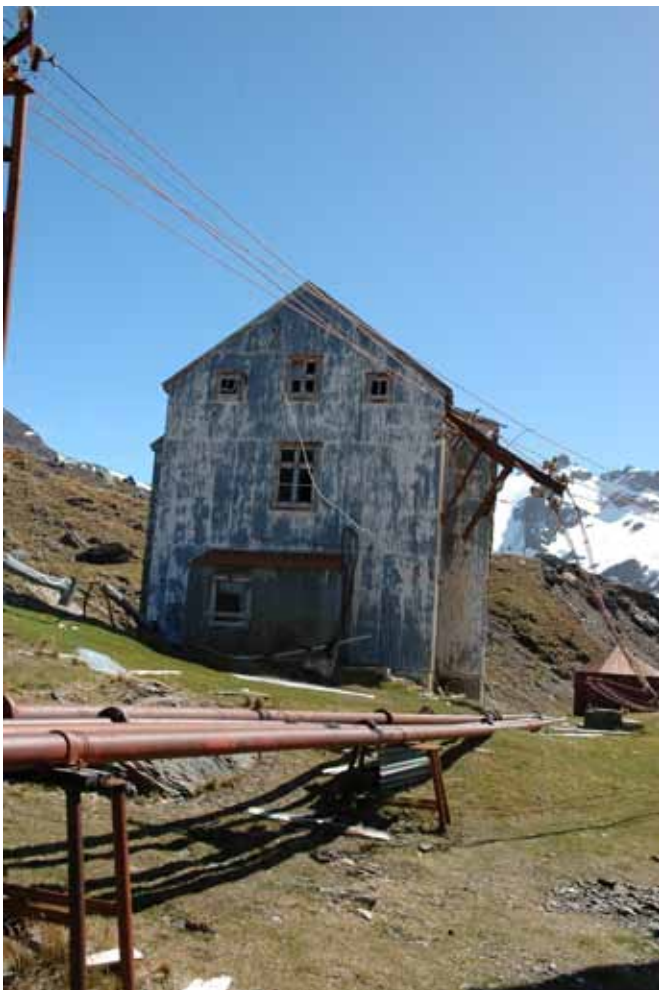
Whereas the roof is in reasonable condition on the west side, on the east side the whole of the north section is missing and a good deal of the boarding has also fallen in. Internally at first floor level the floor under this area now has a substantial amount of wet rot. It seems likely that this end of the building will collapse in the next few years.

50.4 Southeast elevation

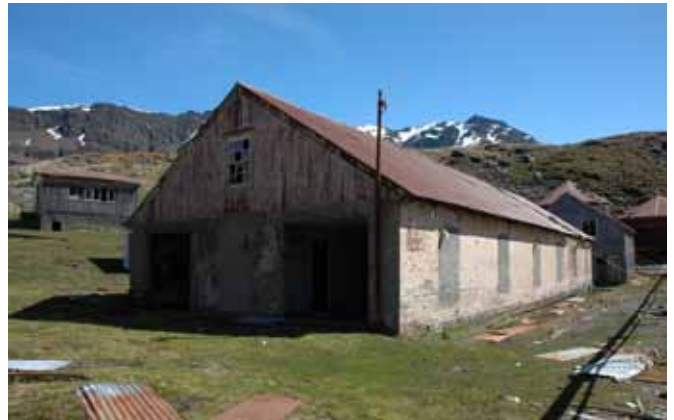
The roof is covered in corrugated iron and large sections are missing on both the east and west sides, perhaps 15 percent to 20 percent of the roof in total missing. The brick walls are in fair condition except at the south end where there is cracking around the opening though this is probably mechanical damage from being hit by vehicles.

52.1 Southeast end and northeast elevation

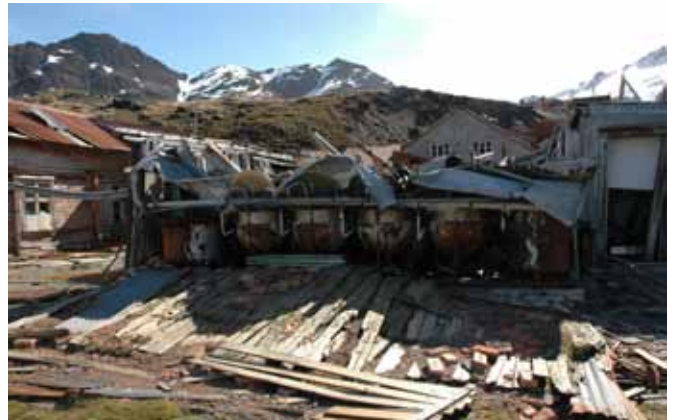
63.4 The east end of the buiding which has collapsed completely

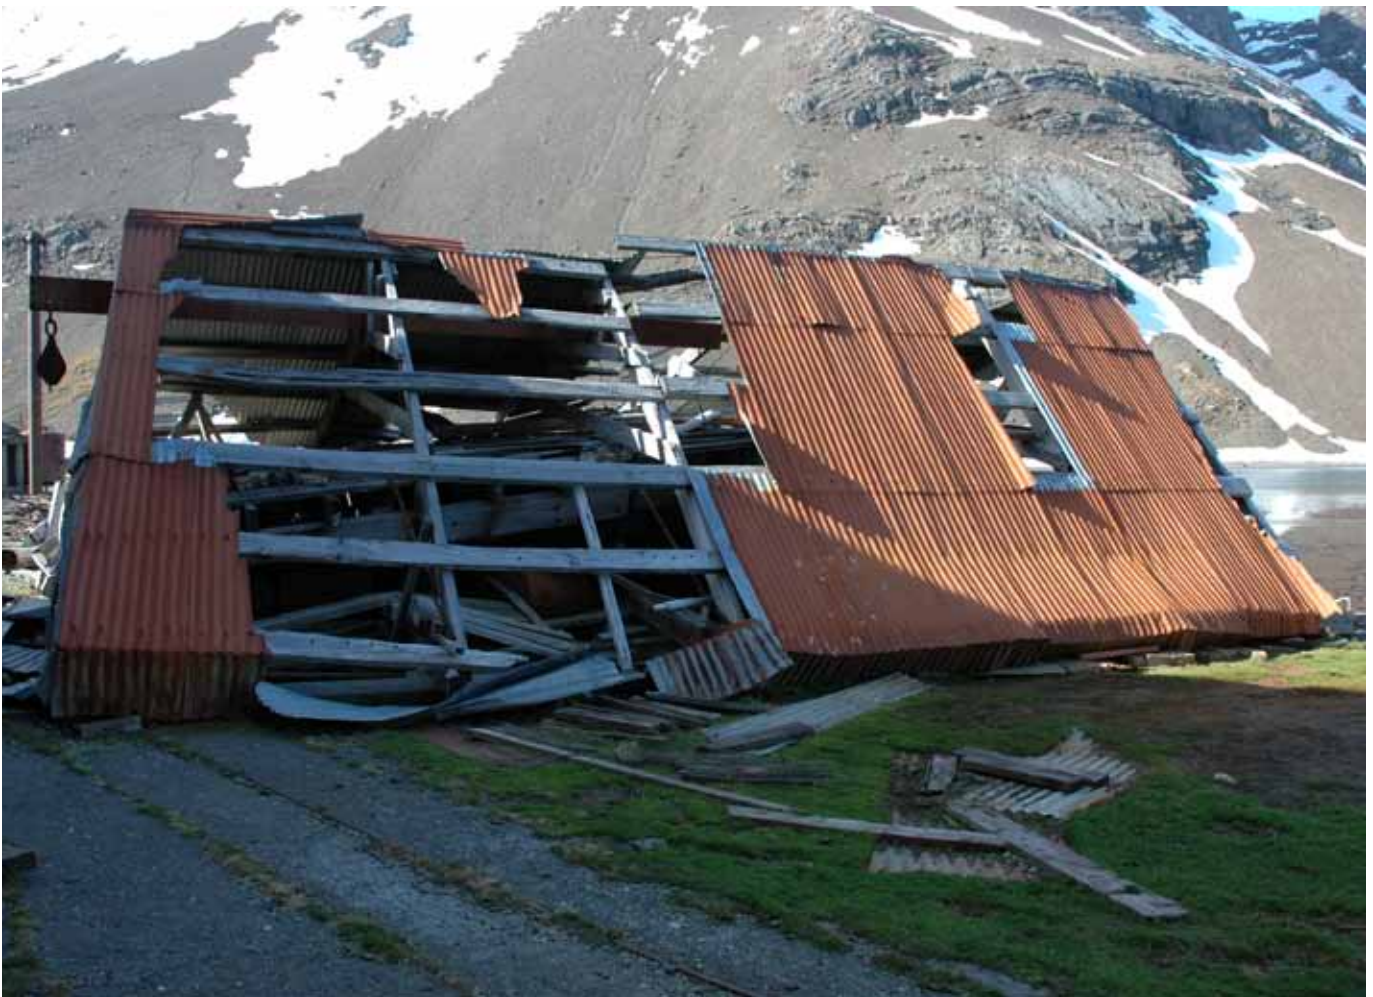
73.4 The south side of the roof which remains surprisingly intact

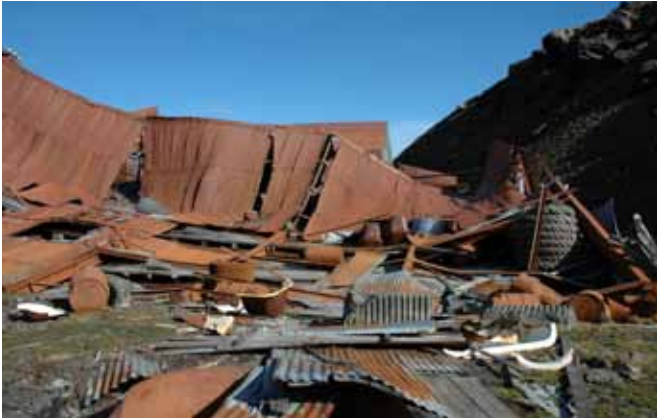
This was a substantial steel framed building but it has entirely collapsed with only the front gable remaining more or less upright. There does not appear to be a great deal wrong with the steel frame but the holding down bolts are very inadequate and appear simply to have pulled out of the concrete in which they were located allowing the whole building to turn over.

74.1 The north side of the building
