# DISUSED WHALING STATIONS

**Prince Olav Harbour Gazetteer**

## Gazetteer, July 2011

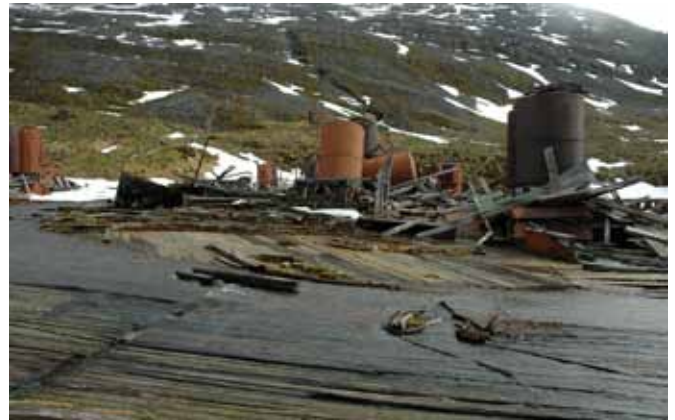
1.1 Looking north to the Lower Meat Cookery

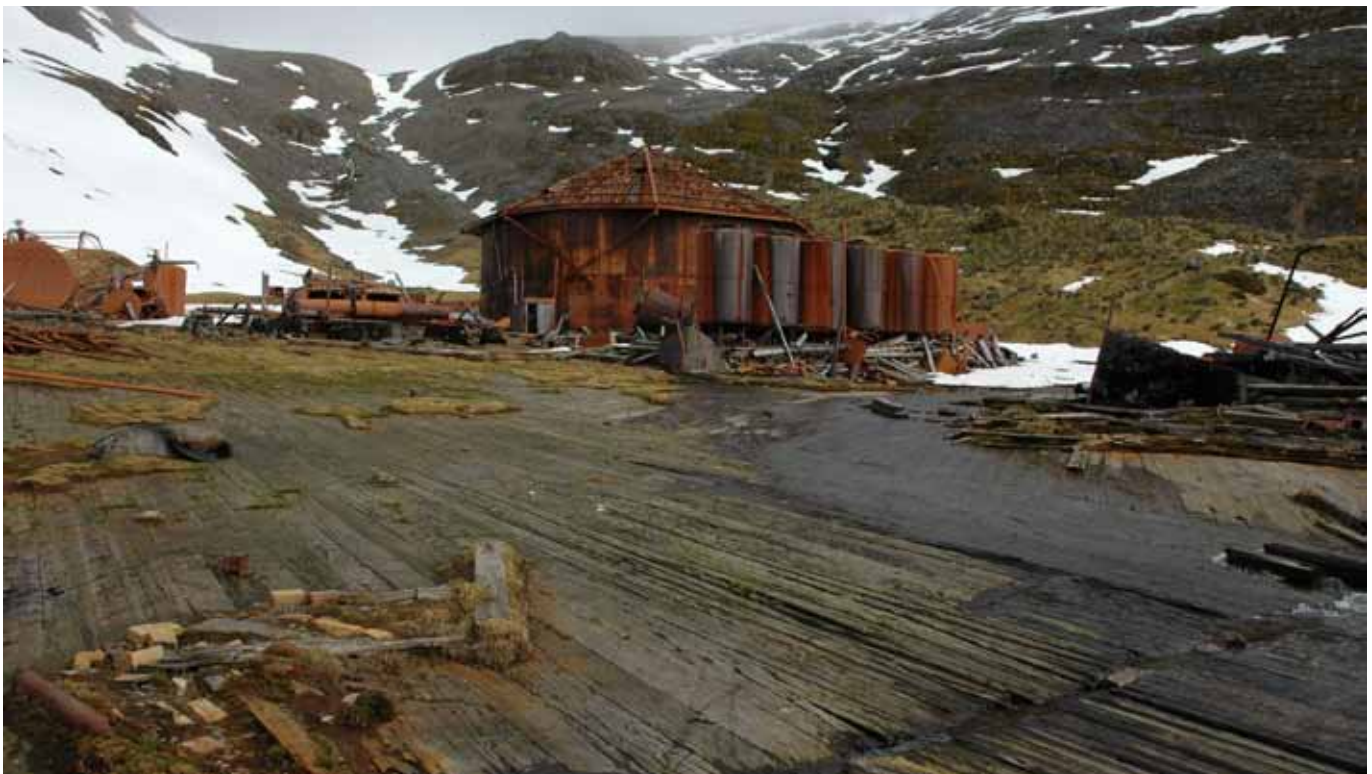
1.2 Looking northwest towards the Upper Meat Cookery

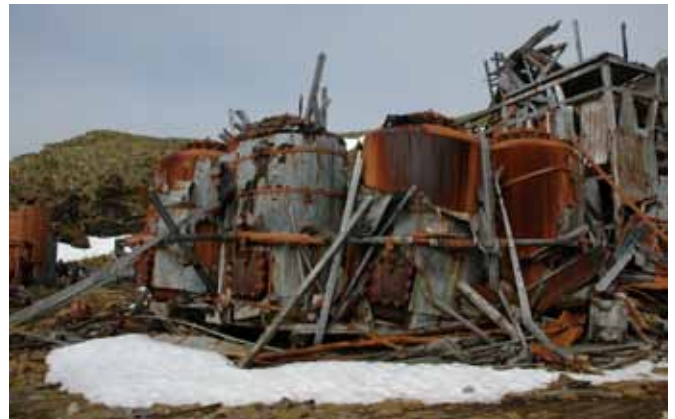
2.1 Additional cookers at the northeast corner in what appears to have been a later addition to the main building

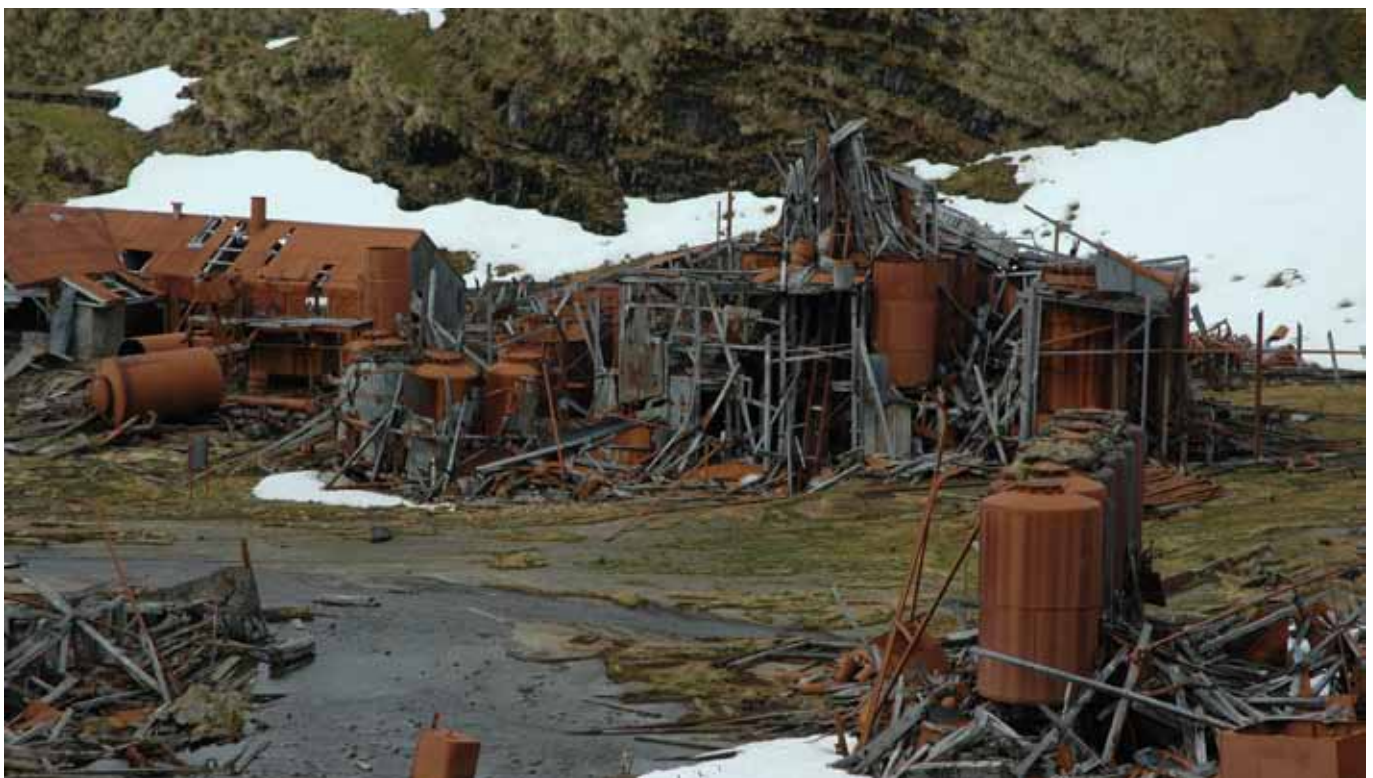
The whole of this building is in the state of collapse. The various boilers are still in position but they are now quite seriously corroded. They stand on timber bases and these are beginning to fail. It would seem that it is too late to save anything significant here.

2.2 General view over the Blubber Cookery from the higher ground to the north

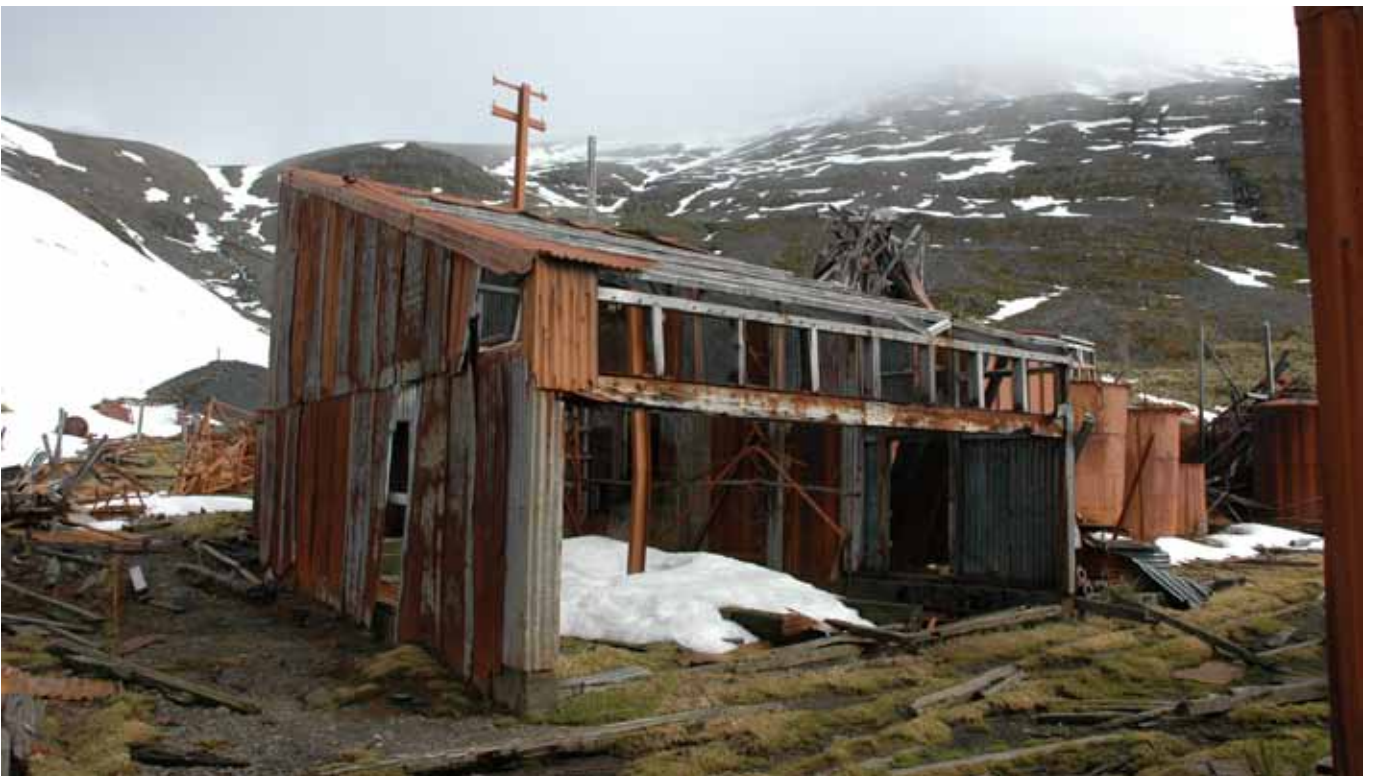
2.6 The extension at the southeast corner

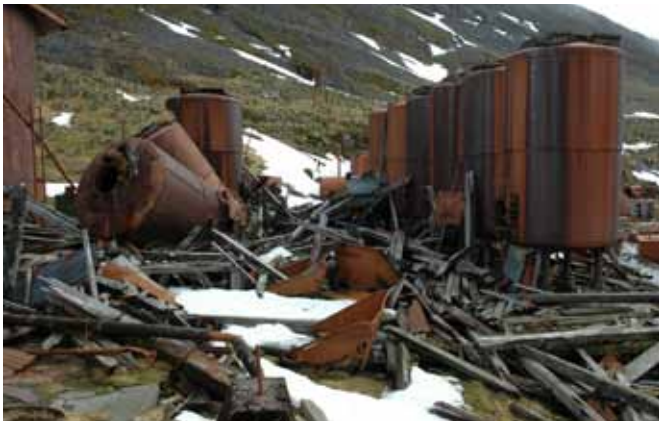
This was a timber framed building framed out of substantial timbers the main pieces measuring 159x159mm in a cross section. There are two rows of six cookers: the western row standing on timber bases, one cooker is missing and two have fallen and the others look insecure. The eastern row of cookers stands on iron legs on concrete bases but the concrete is spalling and in poor order. The boilers themselves are still reasonably sound although doors are missing in several cases. The building and the platform above the meat cookery has entirely collapsed and lies in a heap between and around the boilers.

3.1 General view of remains of the Upper Meat Cookery looking northwards

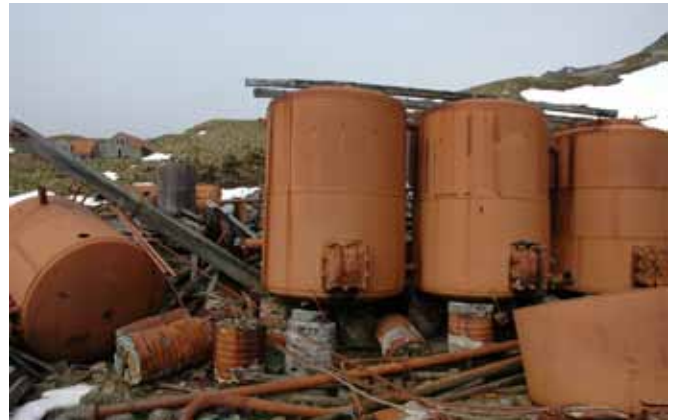
This too was a timber framed building and like Building No.3 it has collapsed entirely. Four boilers remain standing on timber bases which are failing. Two boilers are now leaning sideways against each other. A fifth boiler is in a semi-upright position having fallen through its frame to the floor. There were certainly six and possibly more boilers standing in one central row. There are four concrete bases and two timber bases for a second row of boilers to the west although the boilers themselves have disappeared. There may have been a northward extension to the plant, as there is a row of four boilers on bases cast out of concrete (using old oil drums for shuttering) immediately north of the original timber building through the remaining position, although the concrete bases have fallen away in many cases, one has fallen completely. As in Building No.3 this was built out of substantial timbers 150x150mm which appear to have been used for the posts and there are more substantial 300 square timbers possibly used at the corners, although the collapse is so complete it is extremely difficult to tell what belongs where.

4.1 Detail of the remaining line of cookers north of the original building in what looks like an extension

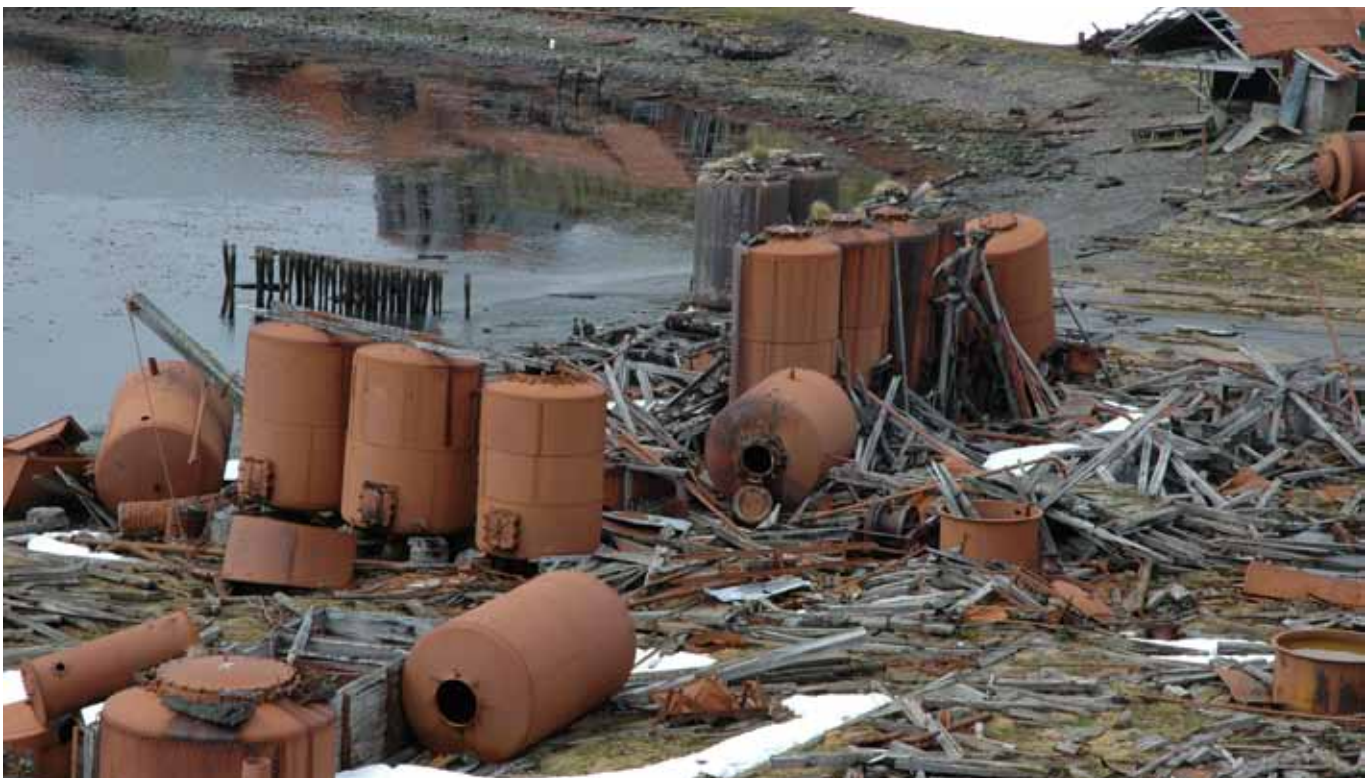
4.3 General view over the Lower Meat Cookery seen from the high ground to the north

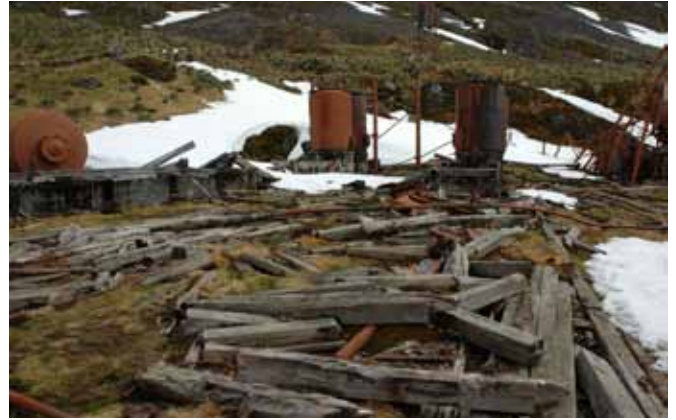
This has disappeared almost entirely. Timber wall plates and some small evidence of concrete footings is all that is left to indicate the outline of the building, various heavily rotted timbers lie in place. Four cookers remain in place on timber packers on concrete bases. Part of the timber is decaying but they still look reasonably solid. There are nine further bases which are on the west side of the building suggesting there were 11 cookers in rows on either side. The bases on the east side have very little fabric left. The floor appears to have been covered in heavy timber (around 100mm thick). There is a small section of steel framing at the north end of the building but none is evident elsewhere. It seems likely that this was a timber framed building.

5.1 Detail of the remnants of the building

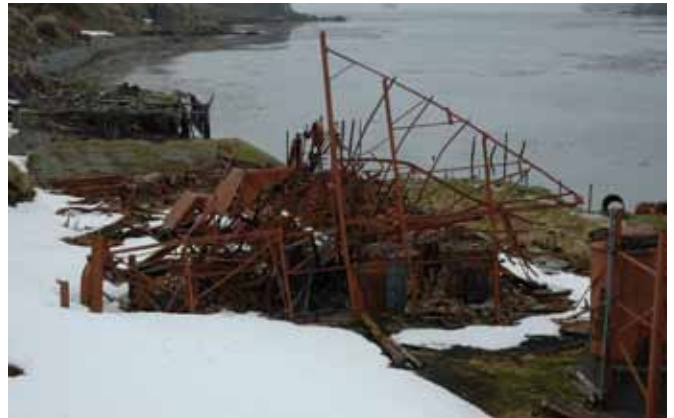
This was a steel framed building and a small amount of the steel frame remains standing at the west end. The rest of the building has completely collapsed. From the ovens that remain in place it would appear that there were three rotating cookers for processing the meal. One remains clearly visible, the other two are now buried in the wreckage. The brick boilers are all in poor condition and are beginning to collapse. At the southeast corner of the building there is a fine steam engine with a large fly wheel.

6.1 General view of the Guano Factory from the higher ground to the northwest

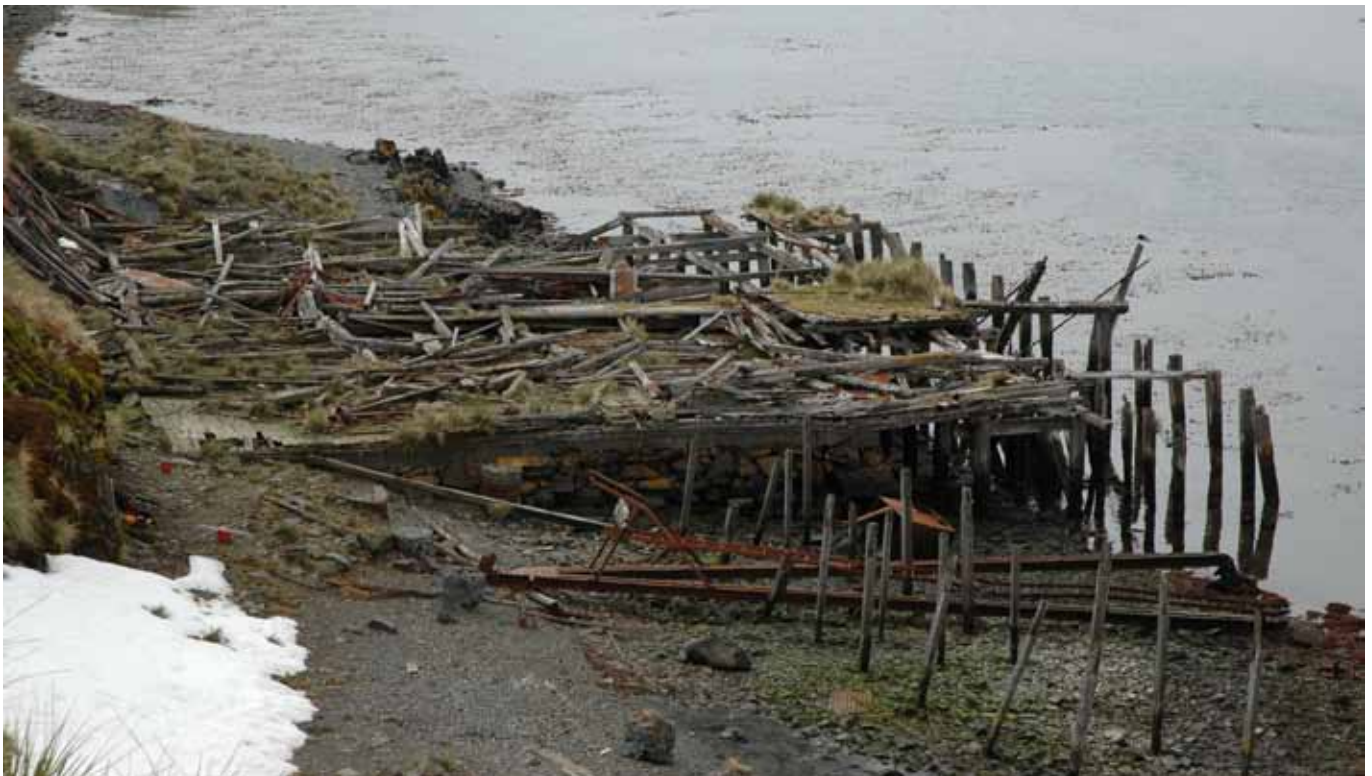
This appears to have been connected to Building No.6 by a railway and a raised walkway; possibly the elevated railway also served this area. There is a steel 'A' frame with an access ladder and a platform which might be part of this. Building No.7 appears to have been a timber frame building of some size, little or nothing remains other than the north wall which has fallen against the adjacent bank. This shows corrugated iron cladding and timber framing – the building was built up out of rock on the beach with a concrete platform cast over the top of it and the seaward, south side being supported by timber piles. This outer edge of deck has now partially collapsed and the inner deck of timber on concrete is in poor condition and falling away.

7.4 General view of the Guano Store looking eastwards

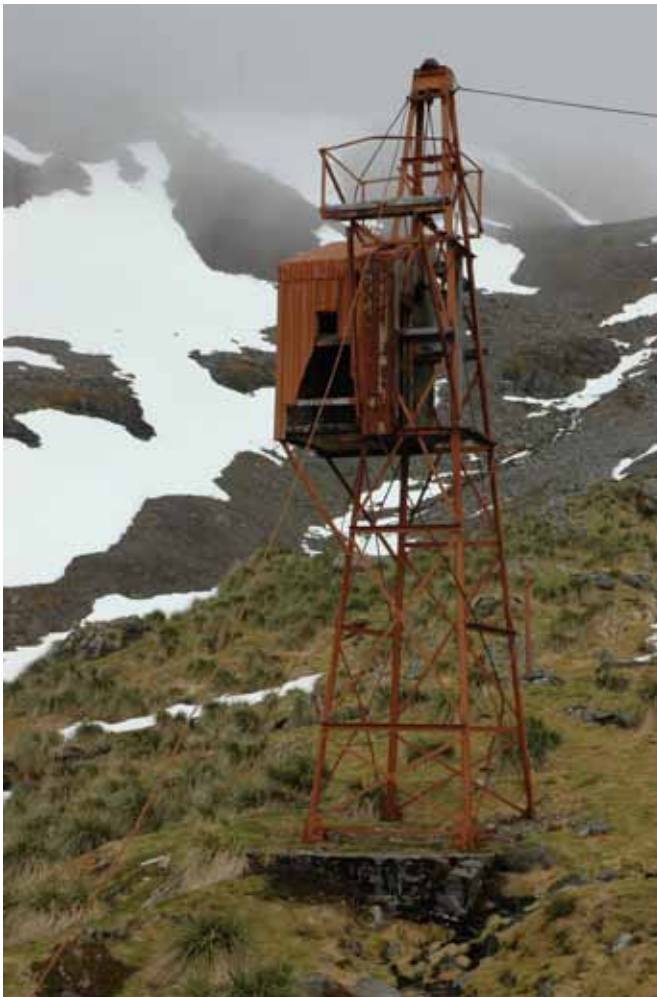
The corrugated iron is falling away from the control hut but otherwise the pylon looks sound enough. The wind load on the hut must be considerable and wind is likely to bring the whole assembly down in due course.

8.1 The upper station of the Elevated Railway looking north

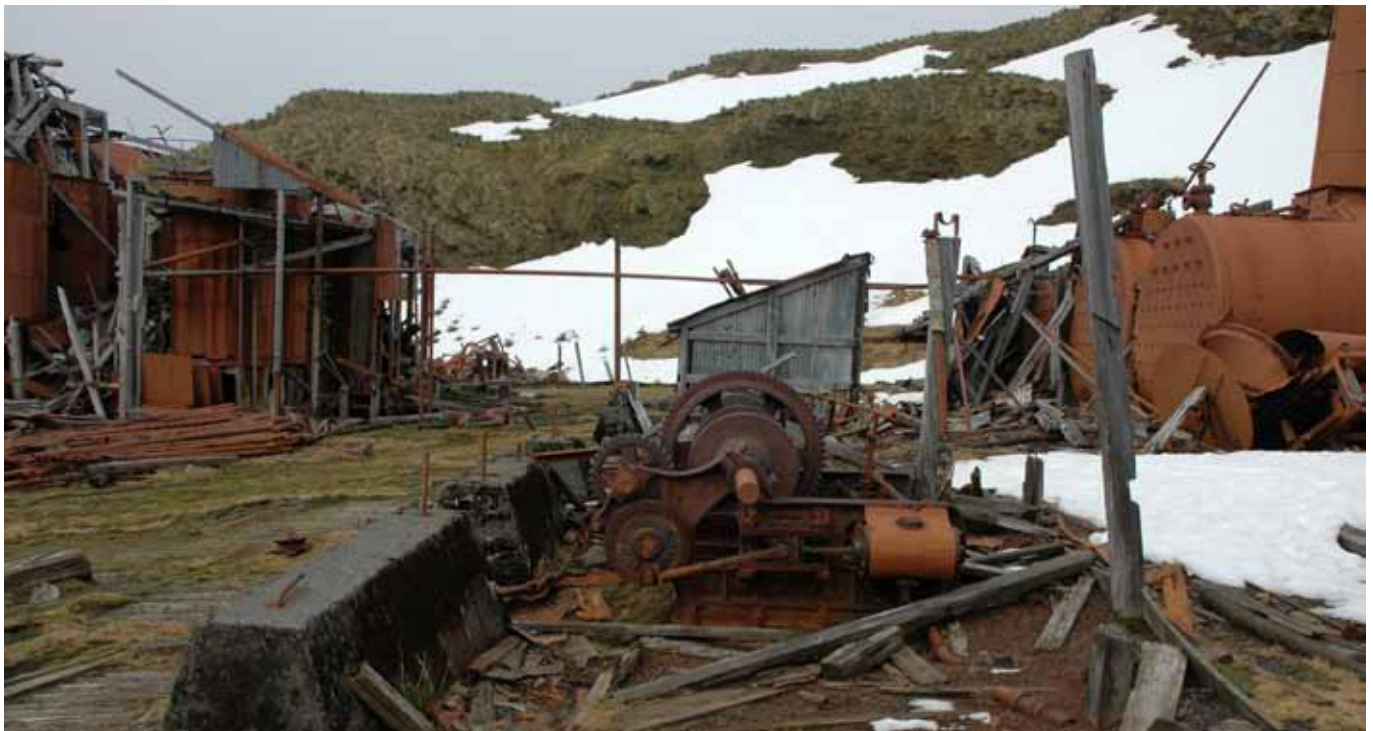
9.4 General view of the remains of the Winch House

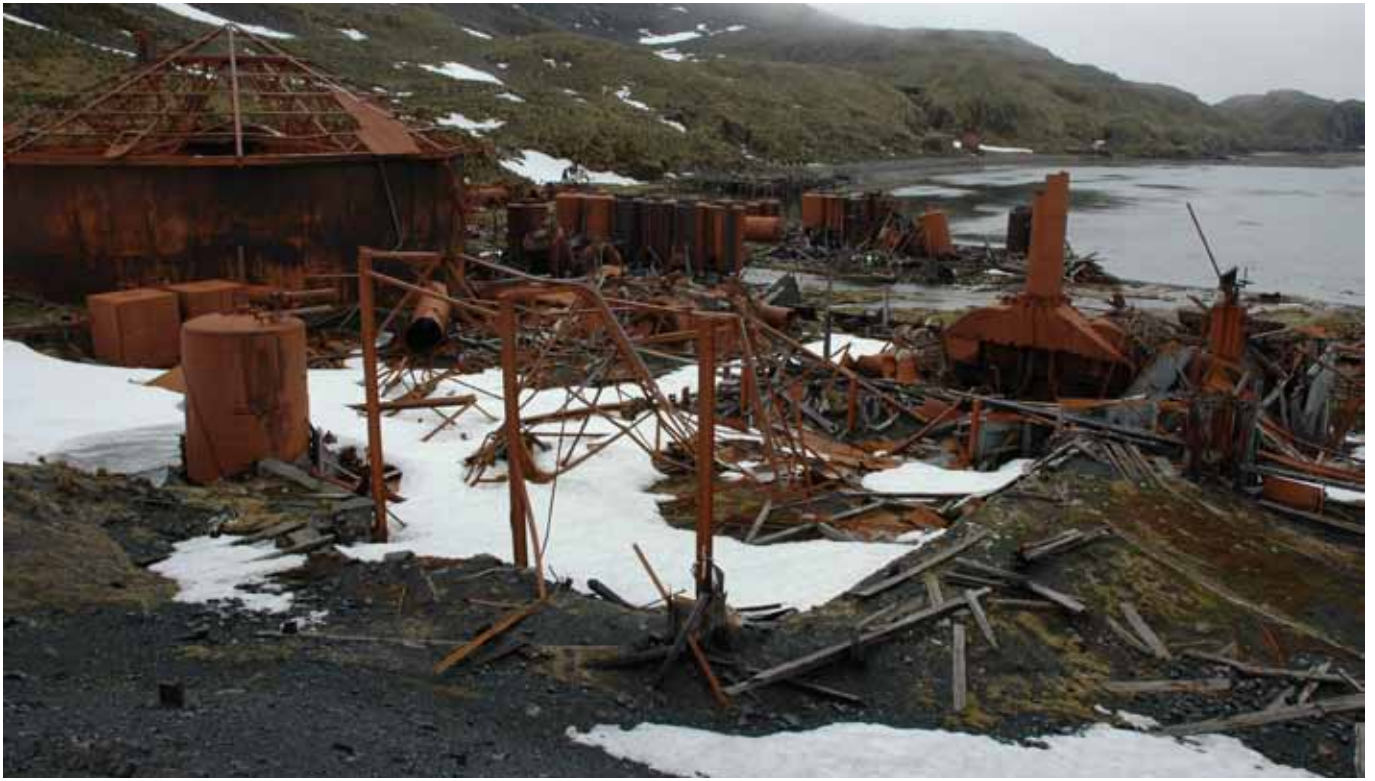
This too appears to have originally been a timber structure – very little of this remains at present. Five boilers remain in position with various sections of steel chimney scattered in the debris. The boilers appear to have been coal fired and there is a good deal of coal both within the boiler house itself and the large heap outside to the west. To the west of the boiler house is a later steel frame building which appears to be an extension to the original building. This western extension was a relatively lightweight construction with RSJ measuring 125x200mm and angle iron trusses in the roof. Some of the roof trusses remain partially attached to the remaining columns but little else remains of the building other than some concrete walls which define the perimeter of the building.

10.4 General view of the Boiler House from the southwest looking northeast

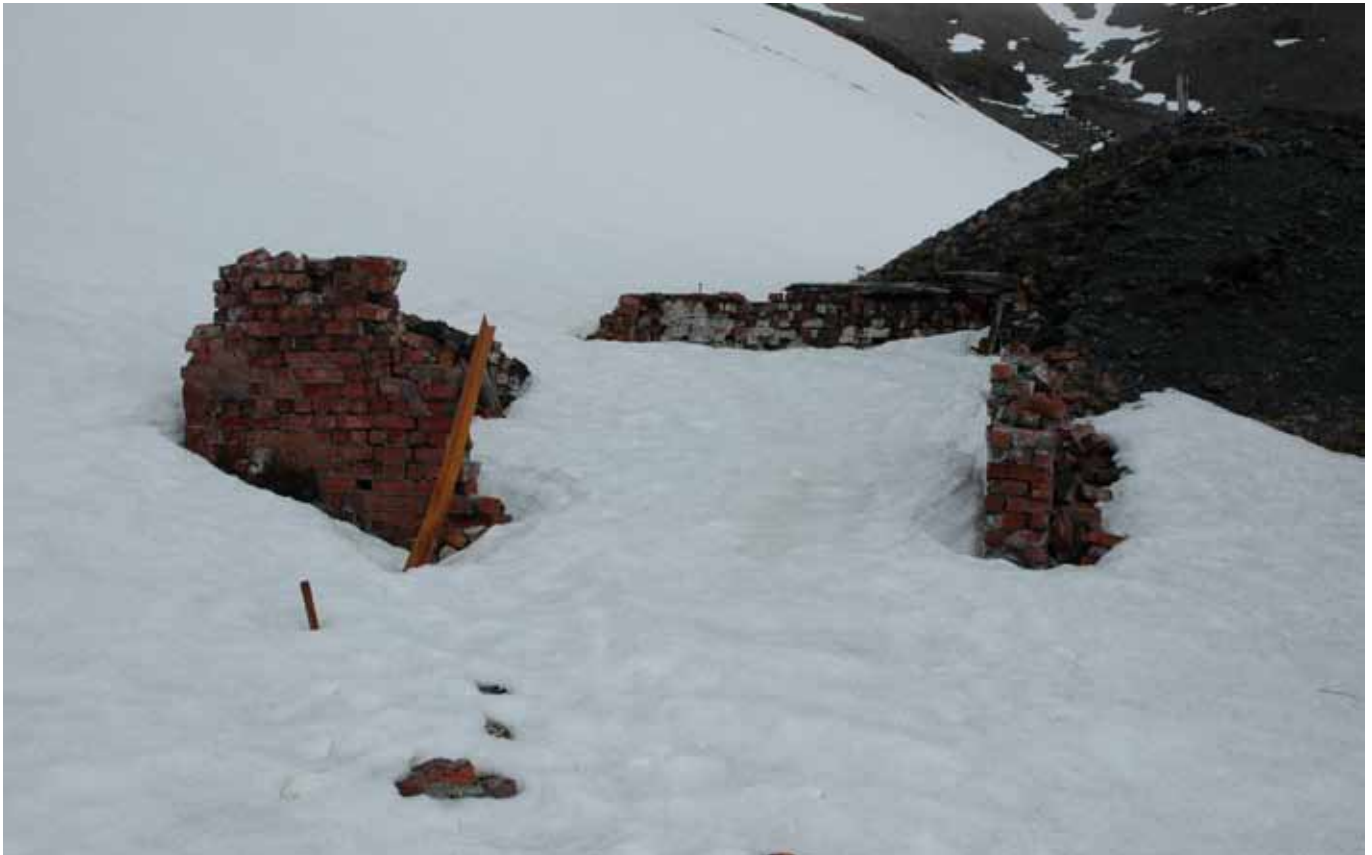
A small rectangular brick building that was built partially into the hillside and is now surrounded on the north and west sides by the coal heap. The roof of the building has collapsed and disappeared completely and only a small amount of the wall plate remains on the north wall. The bricks are rapidly falling away with all the remaining courses all being loose.

11.1 Remains of the Provisions Store

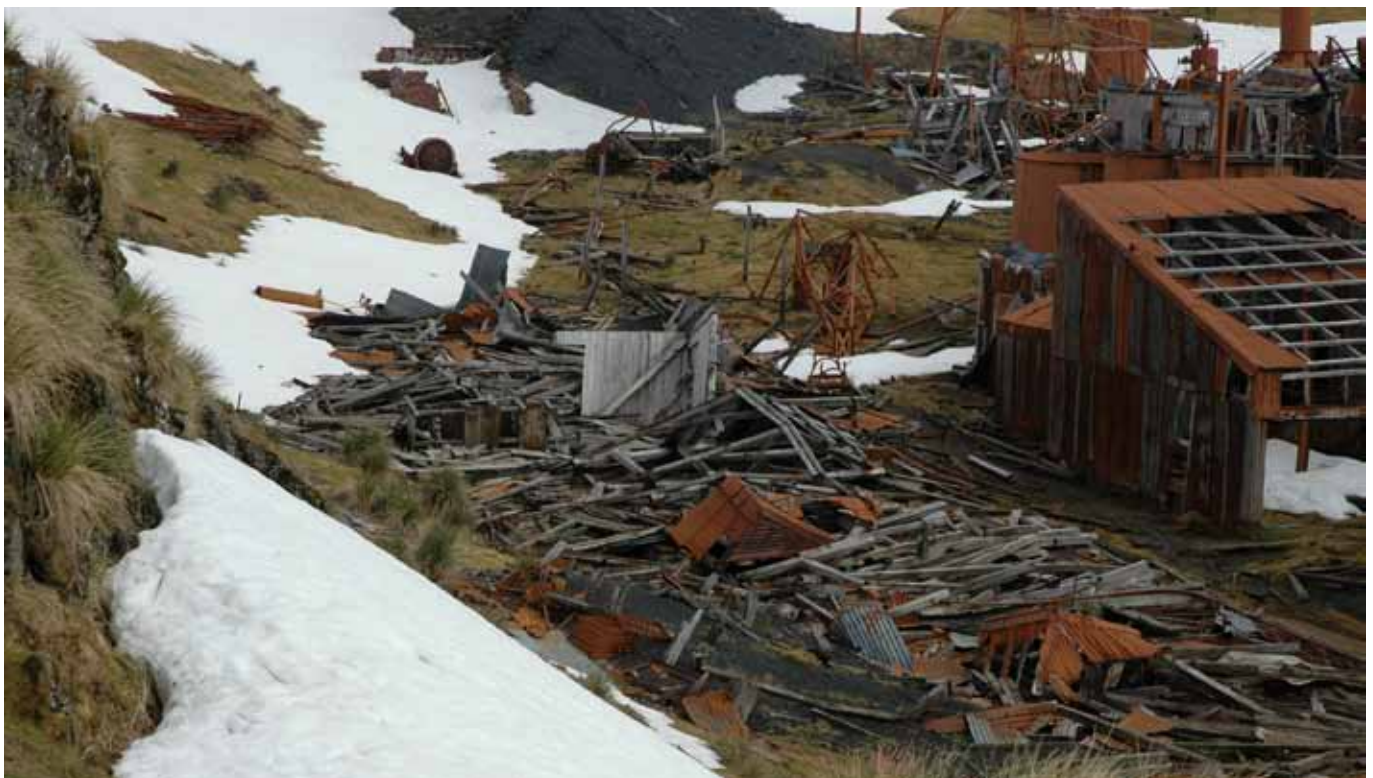
This building has entirely collapsed and is now simply a heap of timber and corrugated iron. It would appear to have been raised approximately 450mm off the ground level with the timber base plate being supported by heavy timber bearers and in some places a concrete pier. The floorboards generally appear to have been very thick at around 75mm. It is difficult to determine where building No.12 ends and Building No.15 starts. Building No.15 is also in a state of complete collapse, the most visible part being the west gable end which appears to have been built up above ground level with a suspended timber floor and the outer walls of heavy stud framing with corrugated cladding externally and horizontal boarding internally. The main timbers of the stud frame being roughly 125x125mm. The same timber appears to have been used for ties and for principal rafters of the roof. These two buildings are well beyond the point where any repair is possible.

12.2 General view over the remains of both buildings from higher ground to the southeast

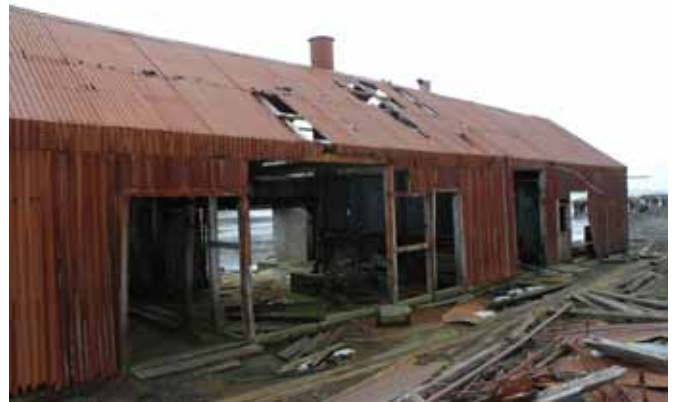
This building is still standing although in very poor condition. At the west end is a butchery and, adjacent to it, what appears to be a blacksmith's shop in that it has what looks like a forge in the centre of the building with part of the flue remaining in position and wide doors opening out to the adjacent waterside. This section of the building appears to have been built later than the adjacent eastern section – it is a simple timber frame with trusses consisting of a tie beam, two principals and a hanger.

14.1 The south elevation

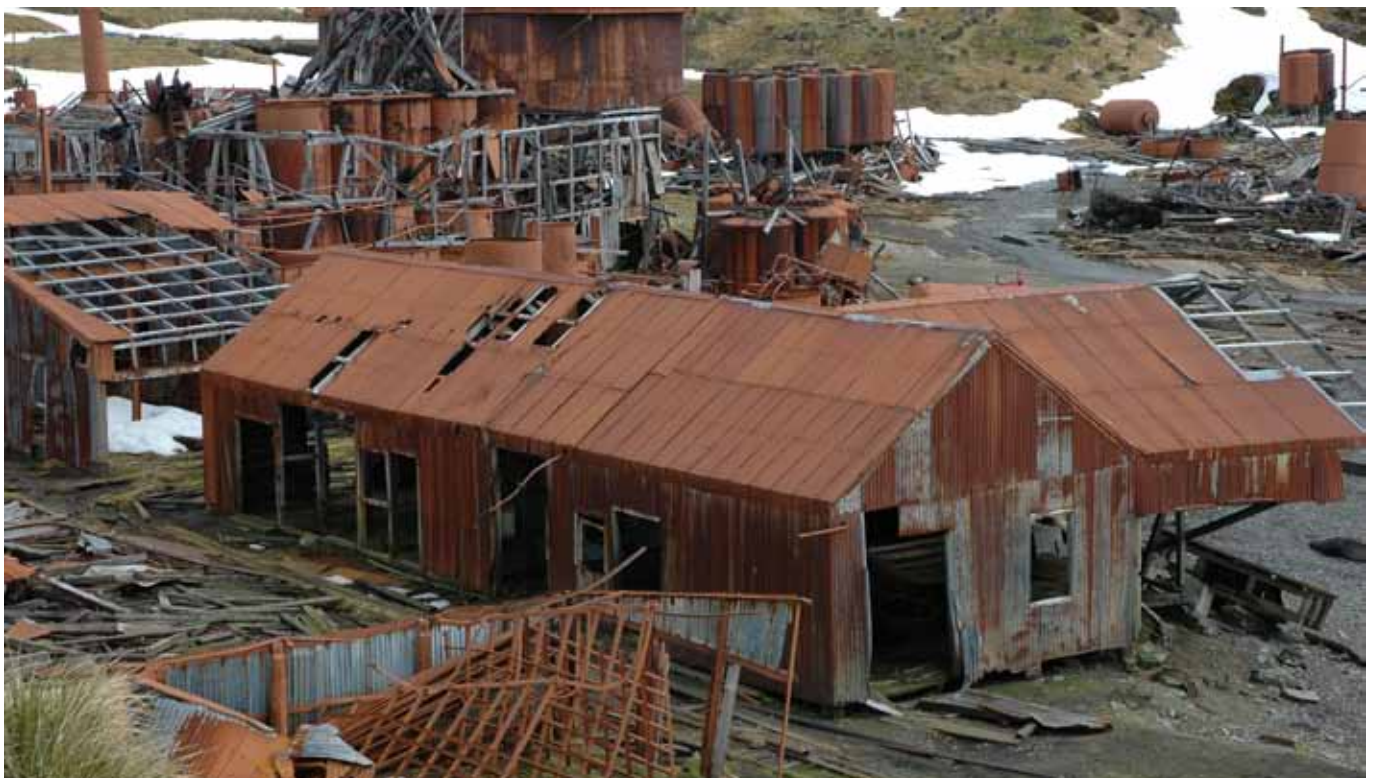
The carpenter's shop is similarly framed out of 125x125mm timbers clad externally with corrugated iron. The main roof was east/west with what appears a later addition running out northwards. This northern extension of the carpenter's shop was supported on concrete bases cast onto the beach. These have now fallen away leaving the timber plates supporting the floor exposed and allowing the corner of the building to drop. This section of the building is in very poor condition and is also being used by elephant seals as a moulting area which must give the remaining structure considerable battering. It seems likely that this will collapse in the fairly near future. The roof over the westward arm has holes in both sides with, perhaps, 15 percent of the sheeting missing and 50 percent of it damaged to some degree.

14.3 General view of the south and east elevations

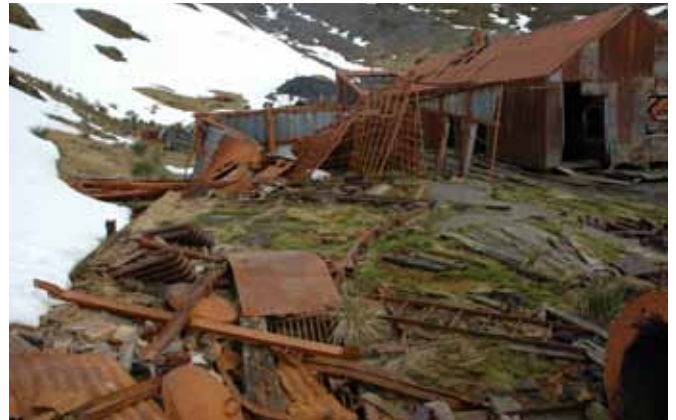
The concrete base remains at the foundry but apart from this the only surviving structure is the west wall. This appears to be an extension to the original building with a lean-to roof falling to the west. It is framed up in steel work with three heavy columns, no doubt adapted from something else supporting the north wall. These columns will be here for some years to come. The rest of the building was presumably of timber and corrugated iron.

16.2 Looking eastwards and showing the remnant of the west wall

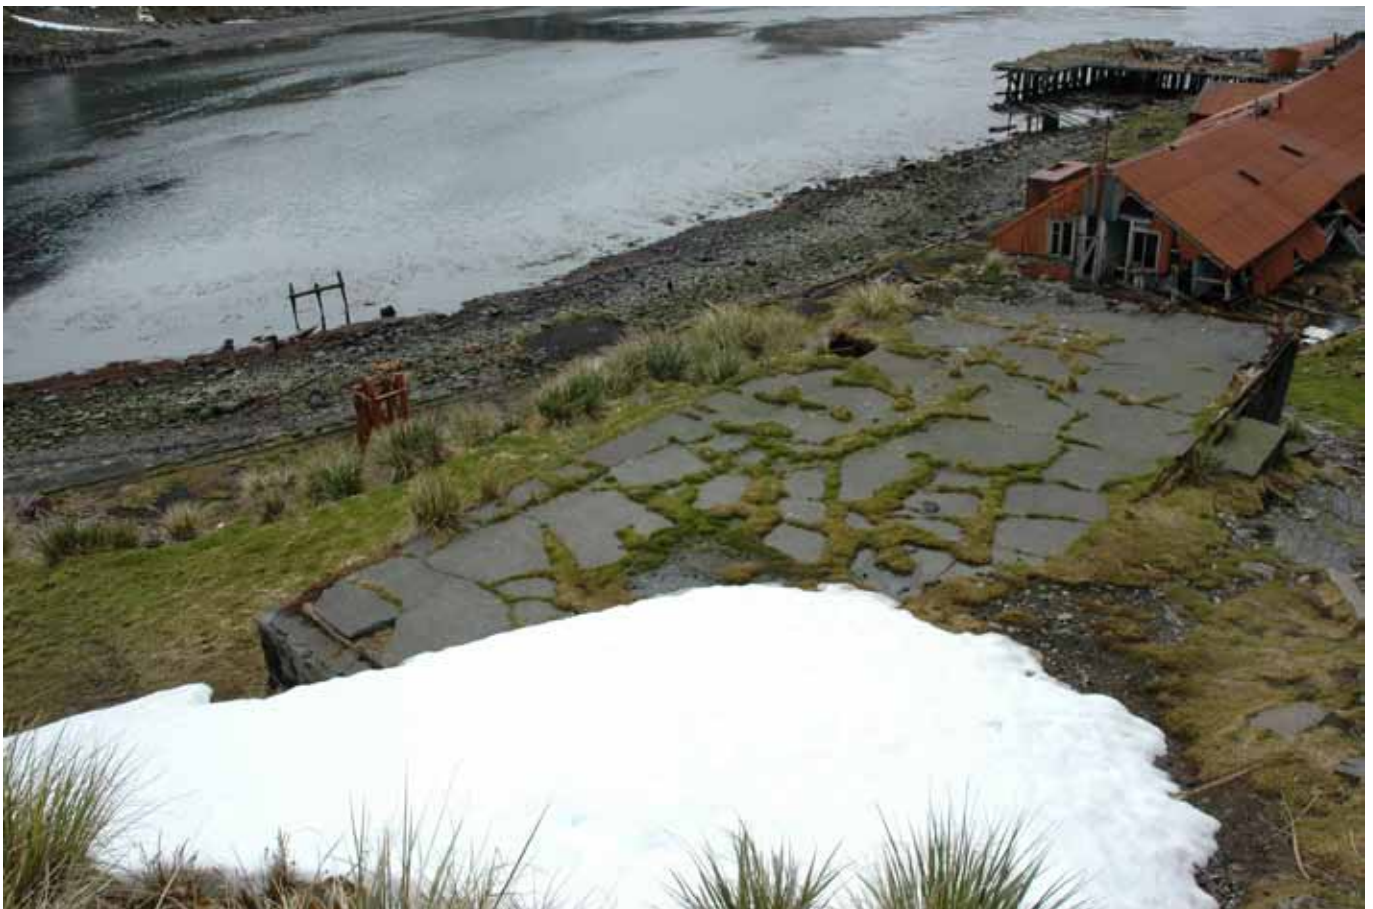
A concrete wall has been constructed to level a platform for the Bath House and the concrete wall and the concrete floor slab on top of it remain in position though the floor slab is now much cracked – the whole of the super structure has disappeared entirely.

17.1 The remaining base of the Bath House

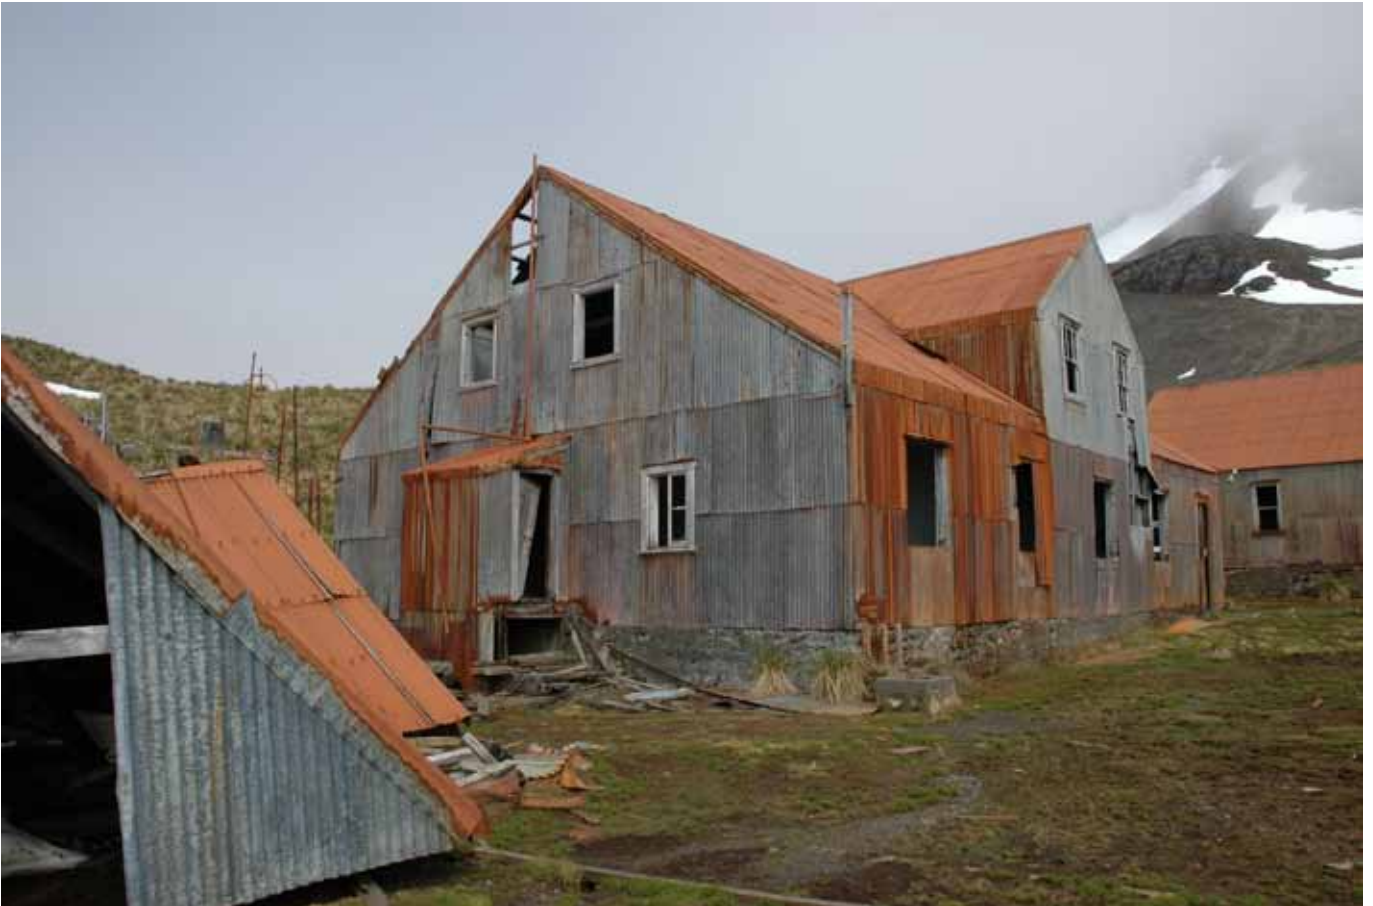
The building is in poor condition with the suspended floor on the ground floor collapsing and the ceiling coming down. The first floor was not accessed.

19.5 East and north elevations

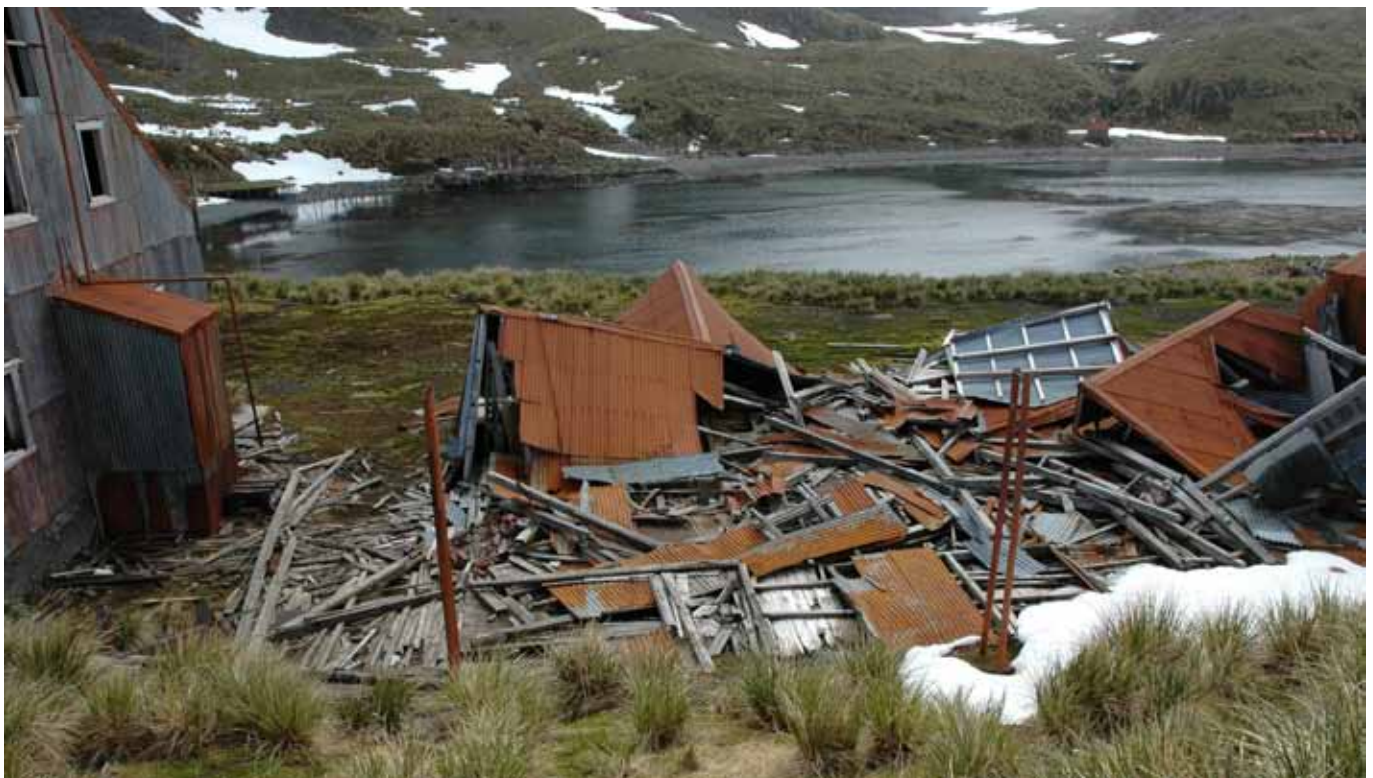
This building has collapsed completely and only the roof trusses and the corrugated cladding to the roof remain intact. The whole building has fallen northwards so the roof now sits some 6m forwards of the original building line. From the size of the walls this would appear to have been a single storey building with a loft which was accessible as a solid flight of stairs remains in the wreckage. The structure of the building seems to have been based on 60mm thick tongued and grooved vertical boarding as an internal skin with battening fixed to it externally and corrugated iron on the outside of that.

20.4 General view of the collapsed building from the south

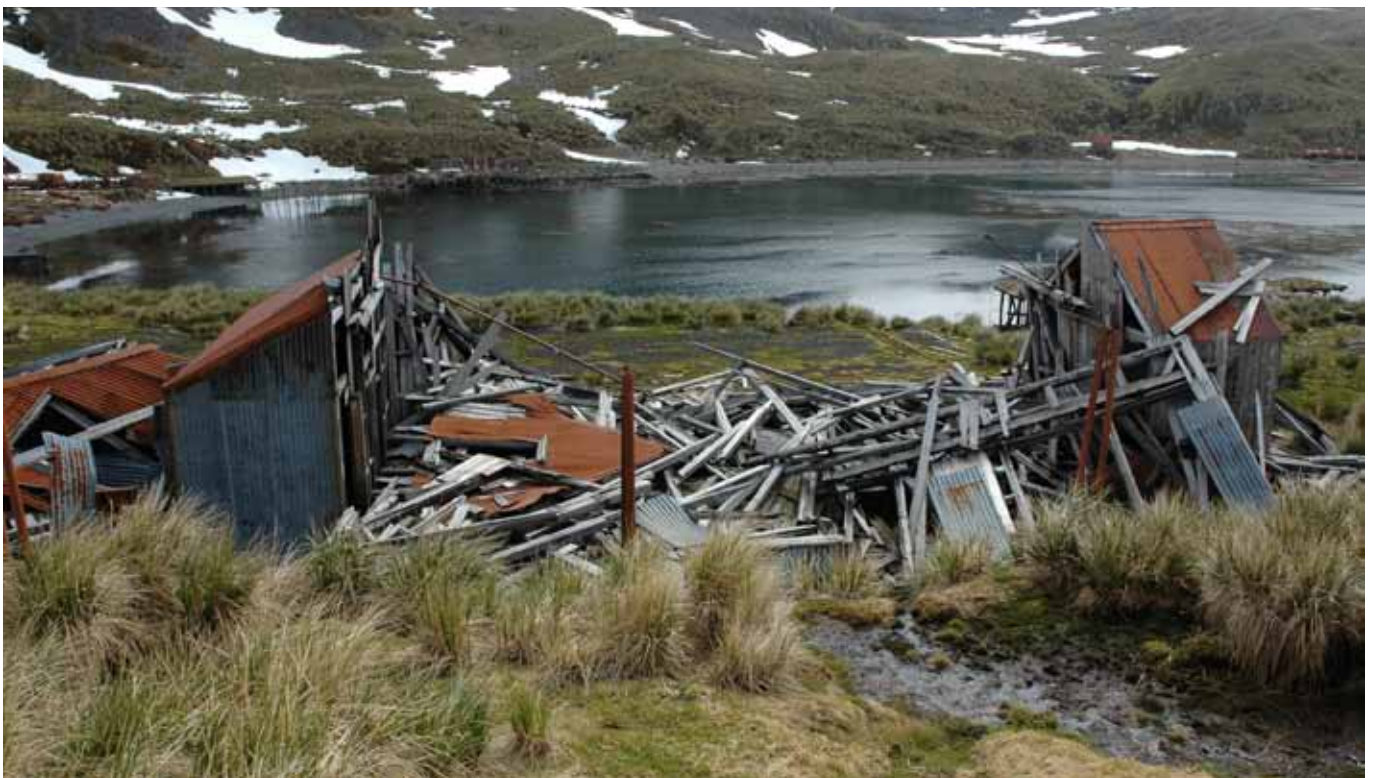
This building has entirely collapsed with the exception of small sections at either end, a lean-to on the west side and an entrance porch on the east side. It appears to have been a single storey building although the roof space was probably accessible as there appears to be a window in the gable end. The wall structure appears to be vertical boarding covered directly with corrugated iron on the exterior and with vertical boarding internally.

21.2 Remnants of the Hospital seen from the higher ground to the south

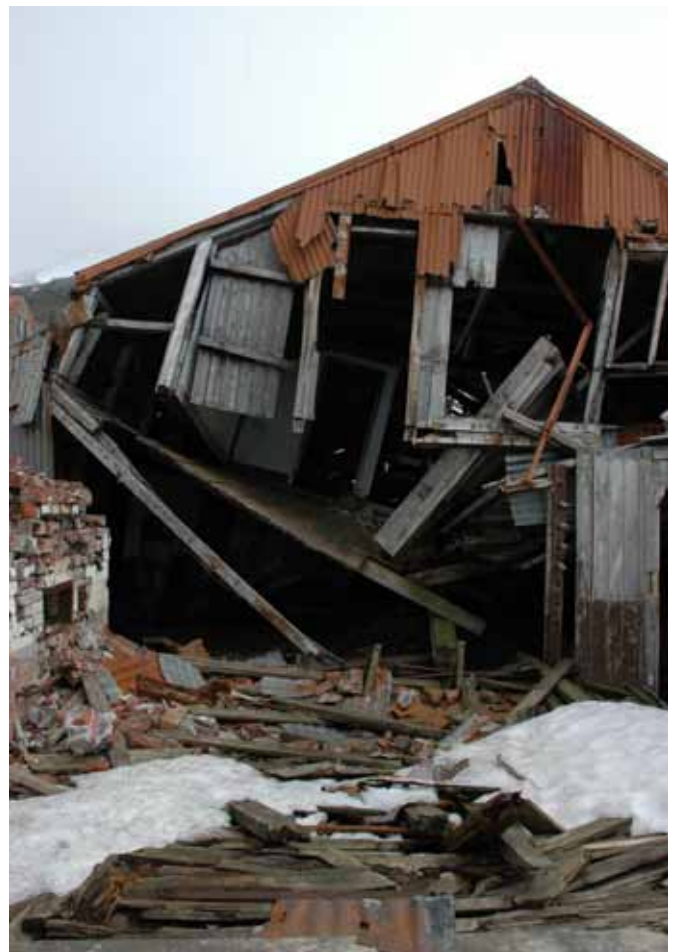
This building remains standing although only just. The whole building appears to have fallen northwards so the upper storey is now at ground floor level. The building was single storey with an accessible loft space with a continuous long dormer on the north side and possibly a pair of roof lights on the south side, although these may be vents for stoves. The roof covering miraculously remains more or less intact though with a substantial wave along it. At the east end of the building the southeast corner remains more or less full height. At the west end the upper floor is now at ground floor level. The concrete base remains and inside this is visible some remains of kitchen equipment and some tables of the old mess room.

22.6 The remains of the east elevation showing that the building was two storeys high
