# DISUSED WHALING STATIONS

**Prince Olav Harbour Gazetteer**

## Gazetteer, July 2011

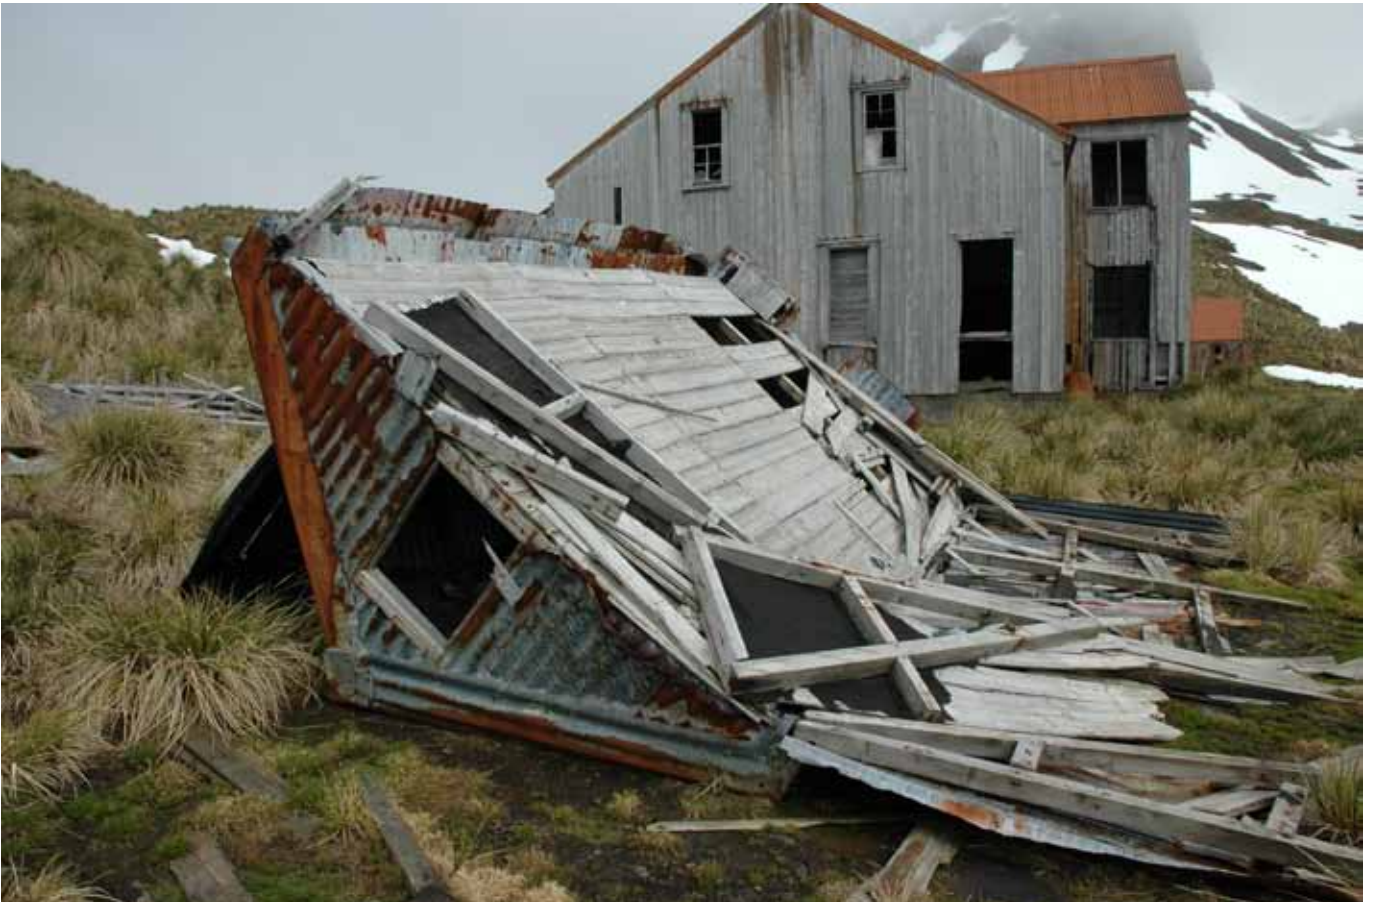
The Hen House has collapsed completely. The roof appears to have flipped over the north wall of the building, leaving the roof lying upside down and the south wall exposed having moved through 180°. The nest boxes for the hens remain on the south side of the building, the roof, remarkably, remains intact.

28.3 The roof which has overturned northwards

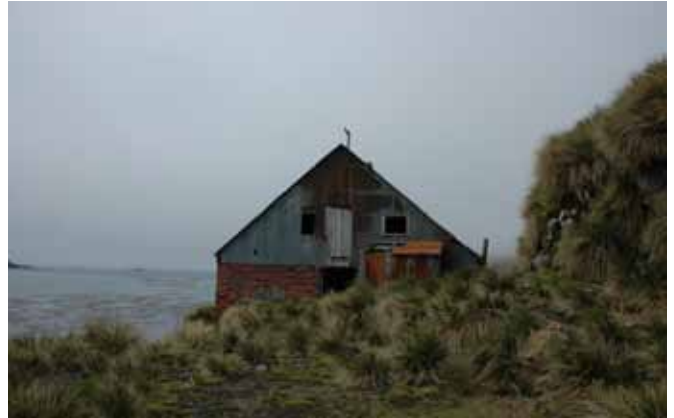
This building is in slightly better condition than the other brick buildings on the site. It is built in brick-and-a-half bond of the 'rat-trap' type with headers tying the inner and outer skins together. The wall has failed under the windows on the north side and in a substantial area of the east elevation. The east wall which is built on top of an escarpment is the most precarious of the building. The walls have been rendered externally but most of this has now fallen away.

32.1 West elevation of the Pig Sty

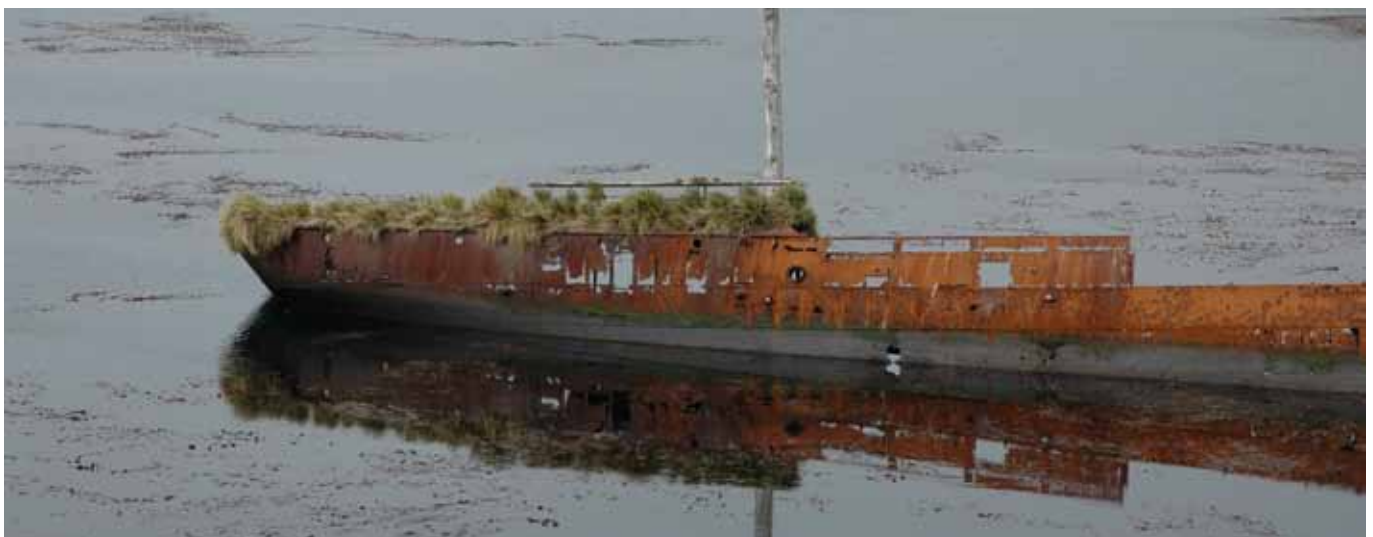
37.2 The stern showing the corrosion of the steel plate and vegetation growth
