DISUSED WHALING STATIONS

Stromness Harbour Gazetteer

Gazetteer, July 2011

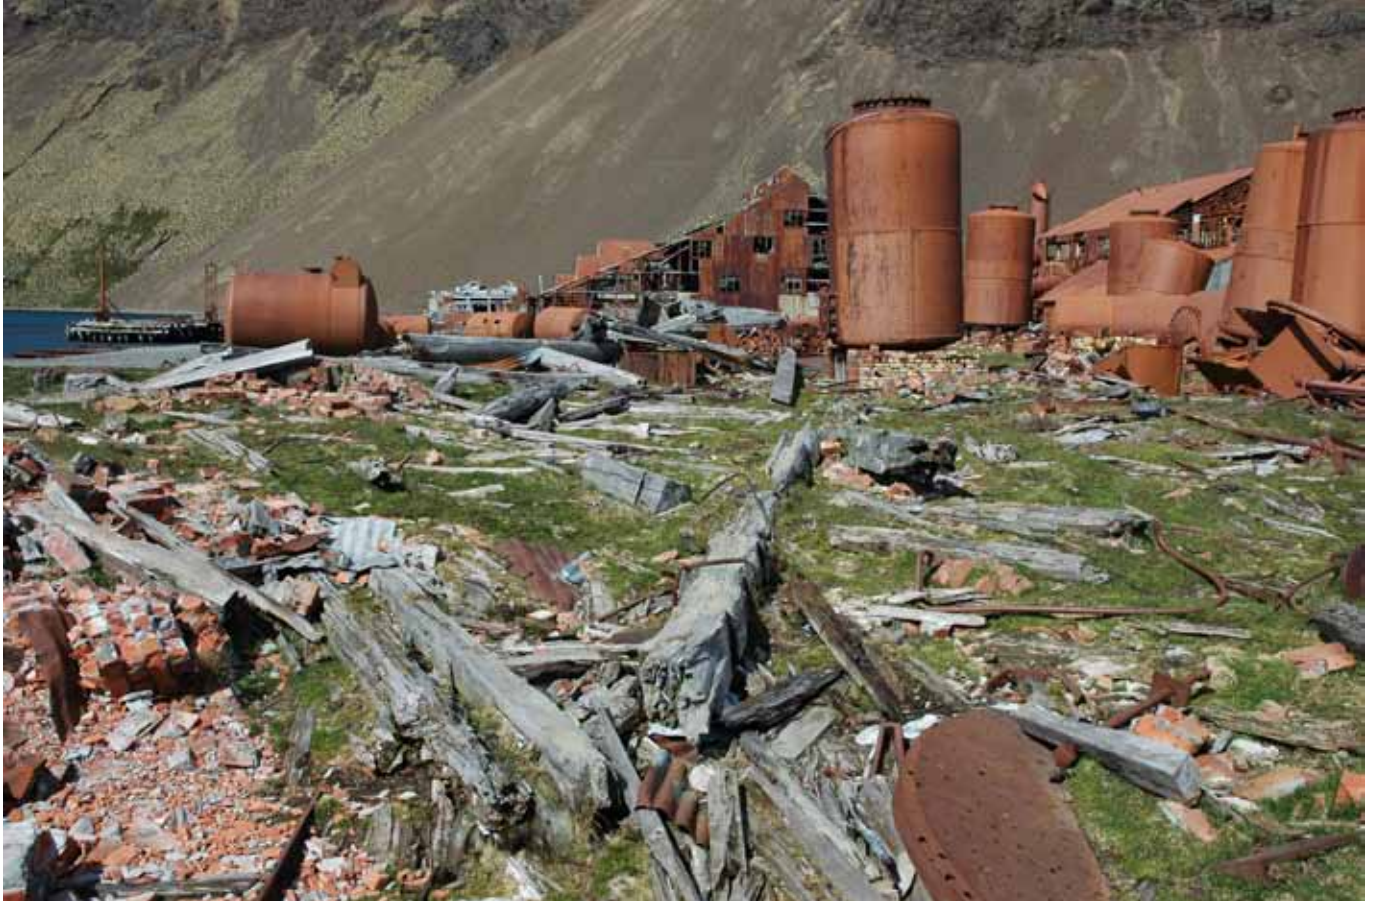
The Bone Cookery no longer exists. All that remains is some concrete footings and the timber base plates for some of the walls. This building was noted as 'dismantled' in Bjorn Basberg's survey in the 1990s.

2.1 The remnants of the Bone Cookery looking south

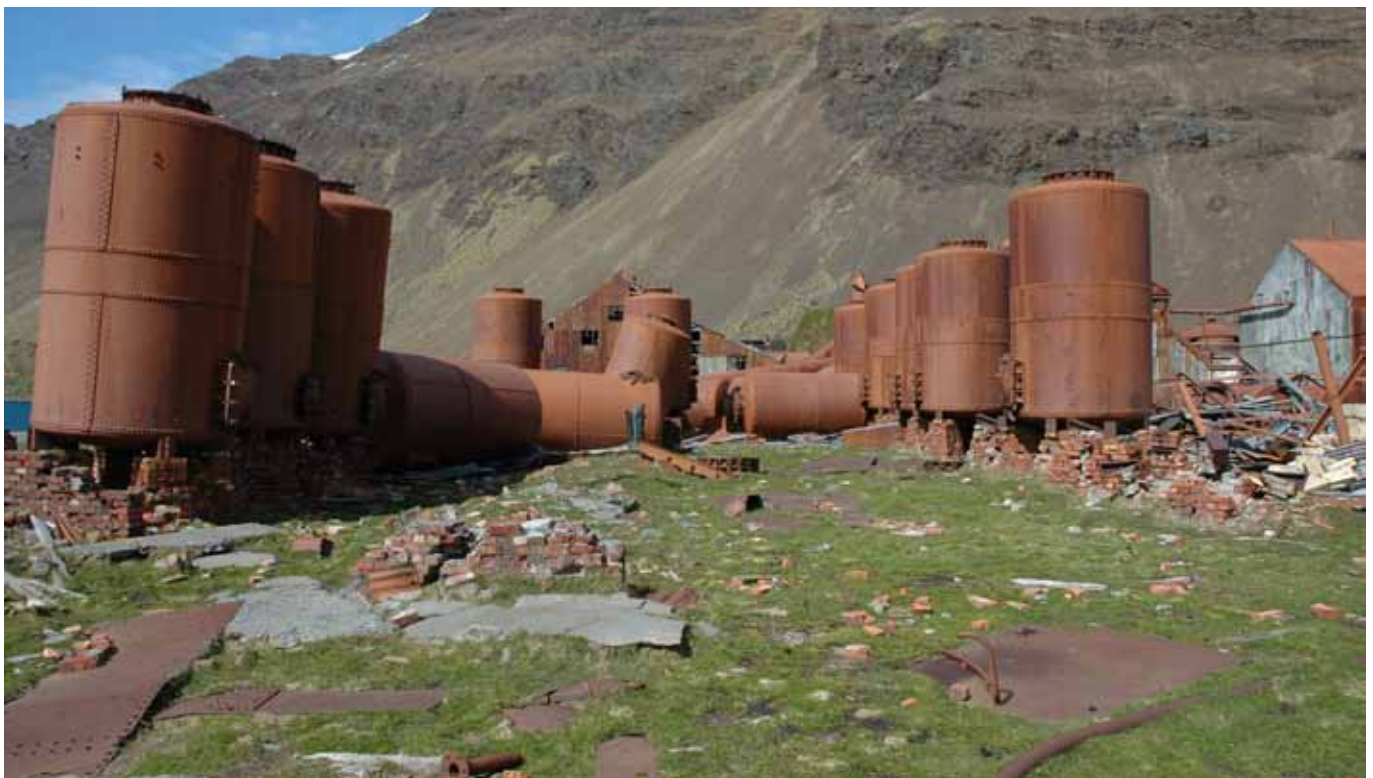
The building has either collapsed or has been deliberately dismantled. Little remains of the original structure although there is a good tangle of dumped pipework.

3.3 The remnant of the Meat Cookery looking southwards

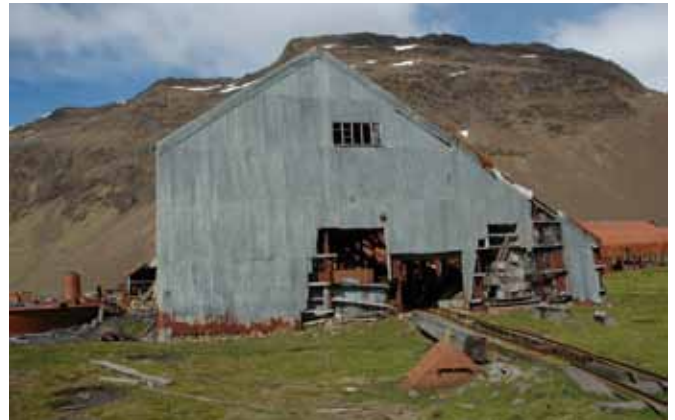
The steel frame looks to be solid enough but around 25% of the wall sheeting and 30% of the roof sheeting is now missing. The purlins and fixing rails are of timber and a good deal of the remaining sheeting is now at risk of wind damage.

4.1.1 The north elevation of the North Wing

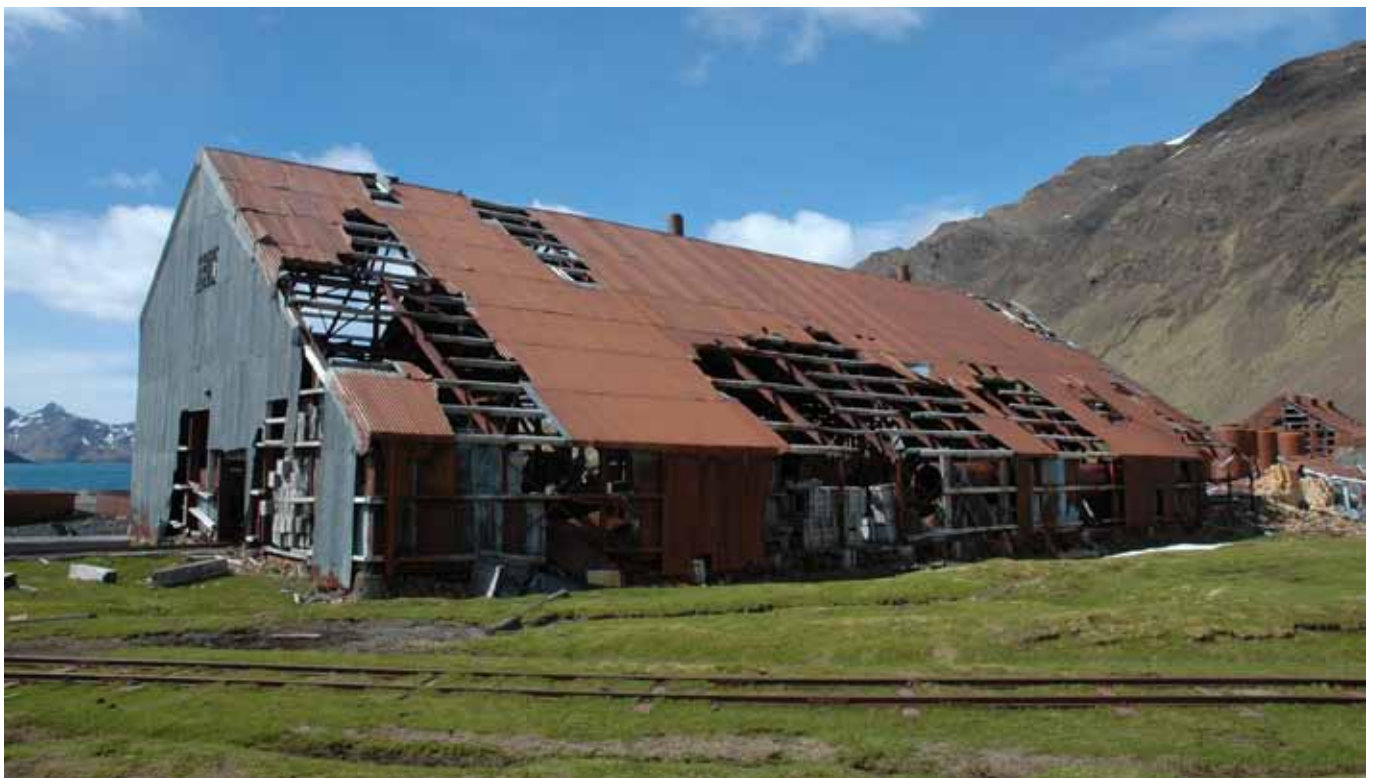
4.1.3 The west elevation of the North Wing

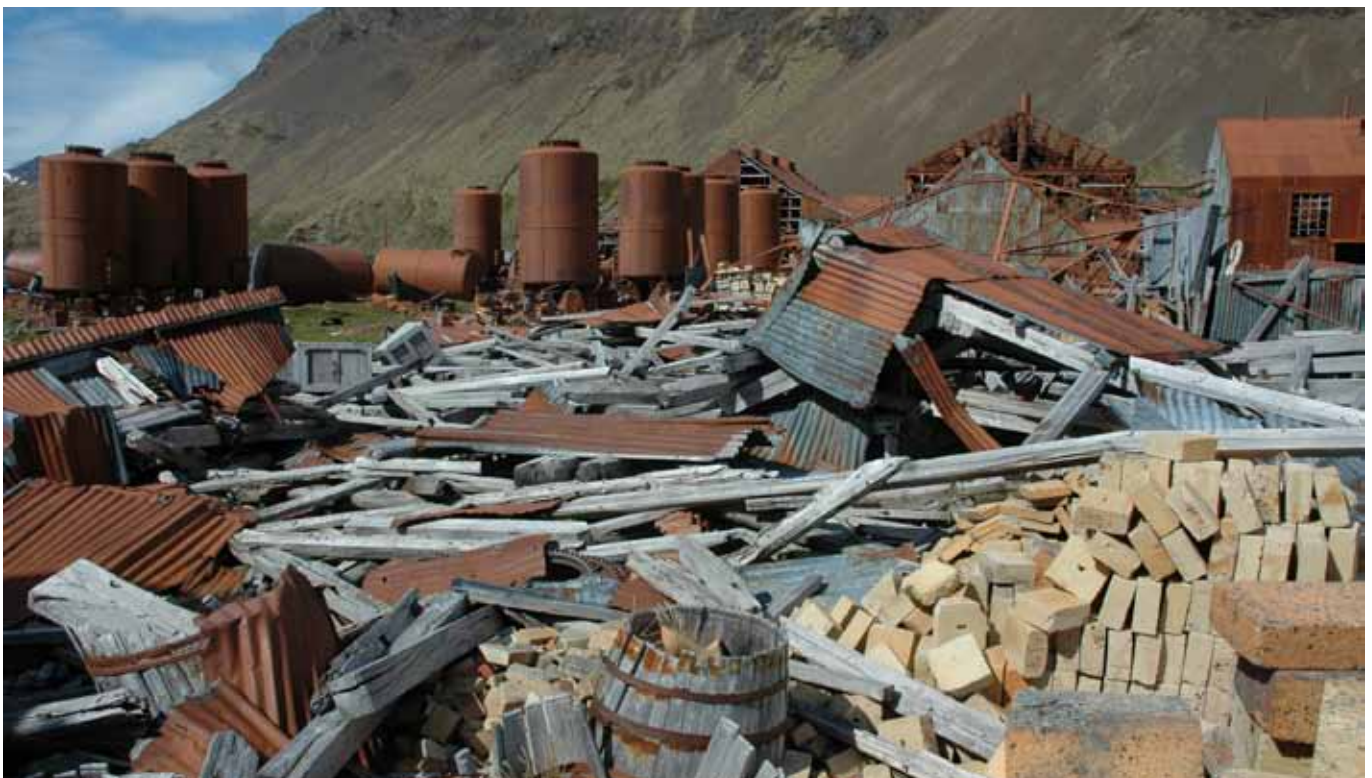
This area joined the north and west wings of Building No. 4 together. The building has collapsed completely and there is now only a tangle of timbers and corrugated iron. There is no sign of any of the plant (conveyors, rotary cookers, screens, bagging plant etc) that one might expect, suggesting that all the plant had been withdrawn for use at another site (Leith presumably?).

4.2.2 The site of the Guano Factory between the two wings looking south

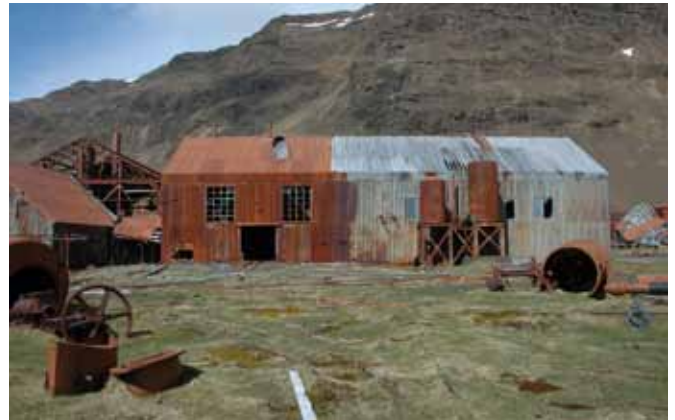
The north slope of the west wing roof has lost some 50 percent of its covering and sheets are now starting to come loose on the south slope.

5.1.1 North elevation of the West Wing

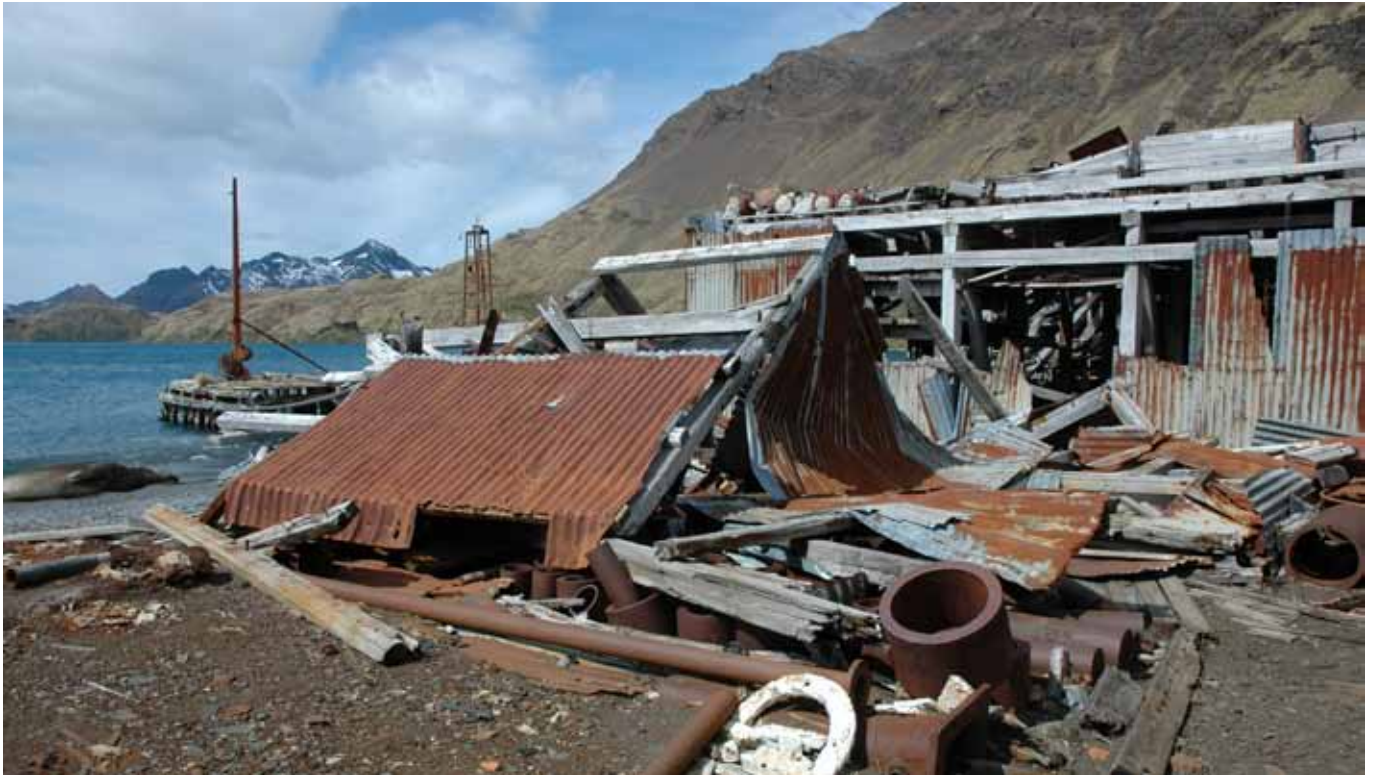
This small building has collapsed entirely. It was timber framed and clad in corrugated iron. The roof framing is still partially intact.

7.1 The north and west sides with Building No. 8 in the background

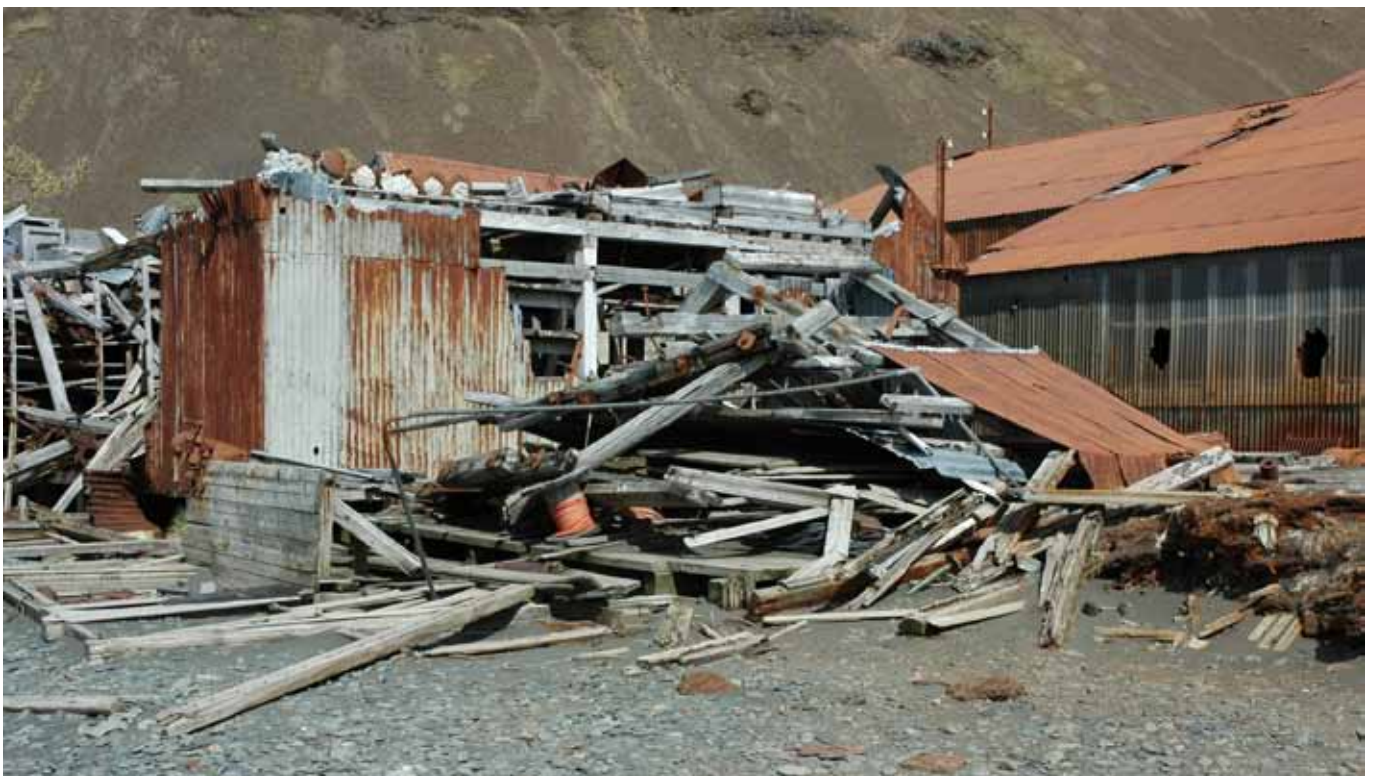
7.2 The east side of the collapsed building with Building No. 8 to the left and Building No. 6 to the right

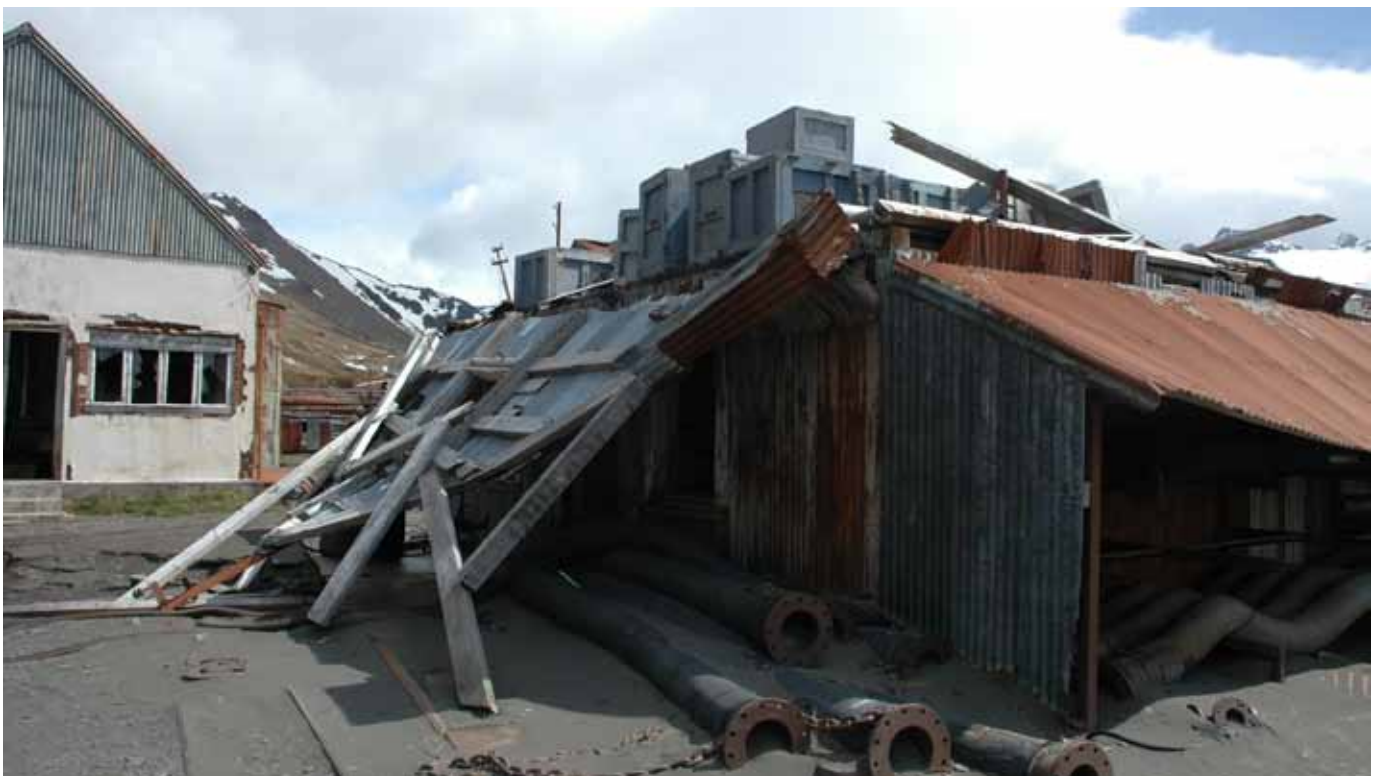
The roof of the building has fallen in with the southern gable overturning southwards. The attic floor remains at the end of the building (still with packing cases stacked on it at the south end) but has collapsed in the central area. The suspended ground floor remains in place though the floor joists are in poor condition. There is a lean-to pipe store on the east side of the building which has a seriously sagging corrugated iron roof.

8.4 The south gable end with Building No. 9 in the background to the left

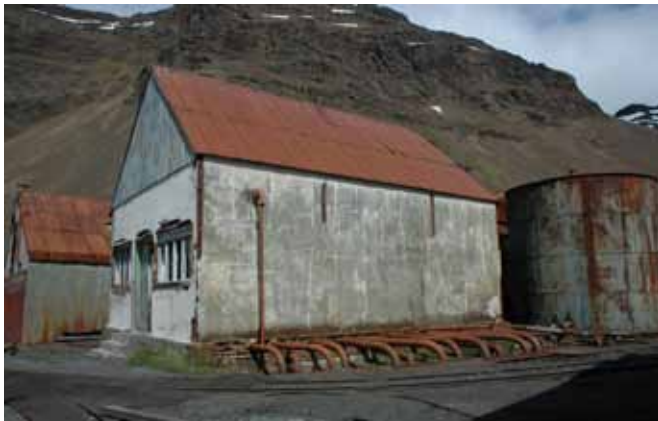
The space still contains pumps and pipework (with asbestos insulation). The brickwork is decaying around the penetrations of the pipes through the walls.

9.1 East elevation

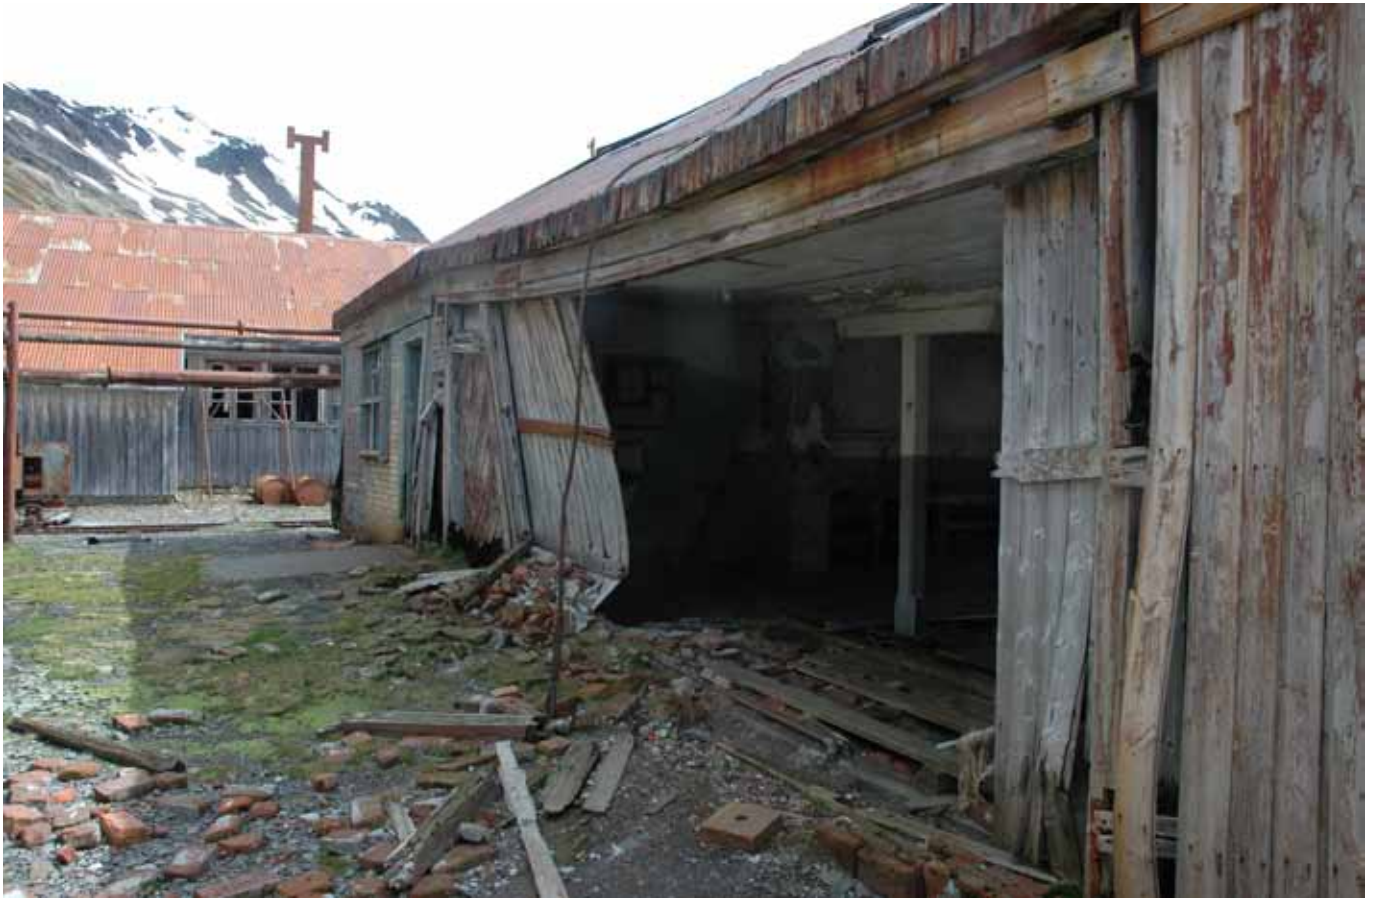
14.4 The collapsing west end of the south wall

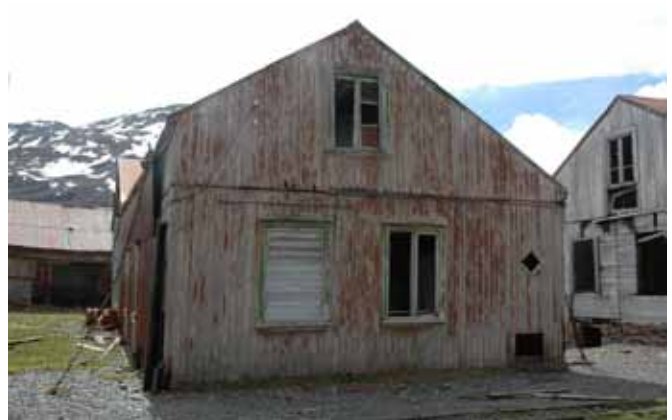
The general condition of the whole building is poor with the external cladding falling away and rotten elements of the structural frame. The roof covering is missing from the south sides of the west wing and the upper floor ceilings are coming down. The ground floor is also collapsing in places.

15.1 South elevation of the west wing

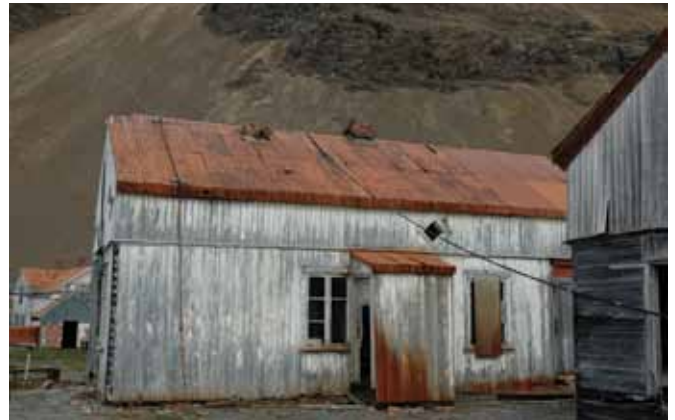
There is an entrance door in the east front and an entrance porch (with a collapsed floor) on the north side. The cellar is accessed down steps and through a door on the west side of the house. Side hung timber casement windows largely remain in place though no glass remains and some of the windows are boarded up.

The suspended timber ground floor has fallen into the cellar at the east end and has sagged visibly over the rest of the floor. The upper floor all remains but this too is distorted. Where the structure is visible it is clear that there is a good deal of rot in the lower courses of the structural boarding. It would also seem that this is not a new problem as repairs have been carried out previously.

This building is now fully open to the elements and is in a poor way. Its destruction is likely to be accelerated over the next few years.

16.4 The north elevation

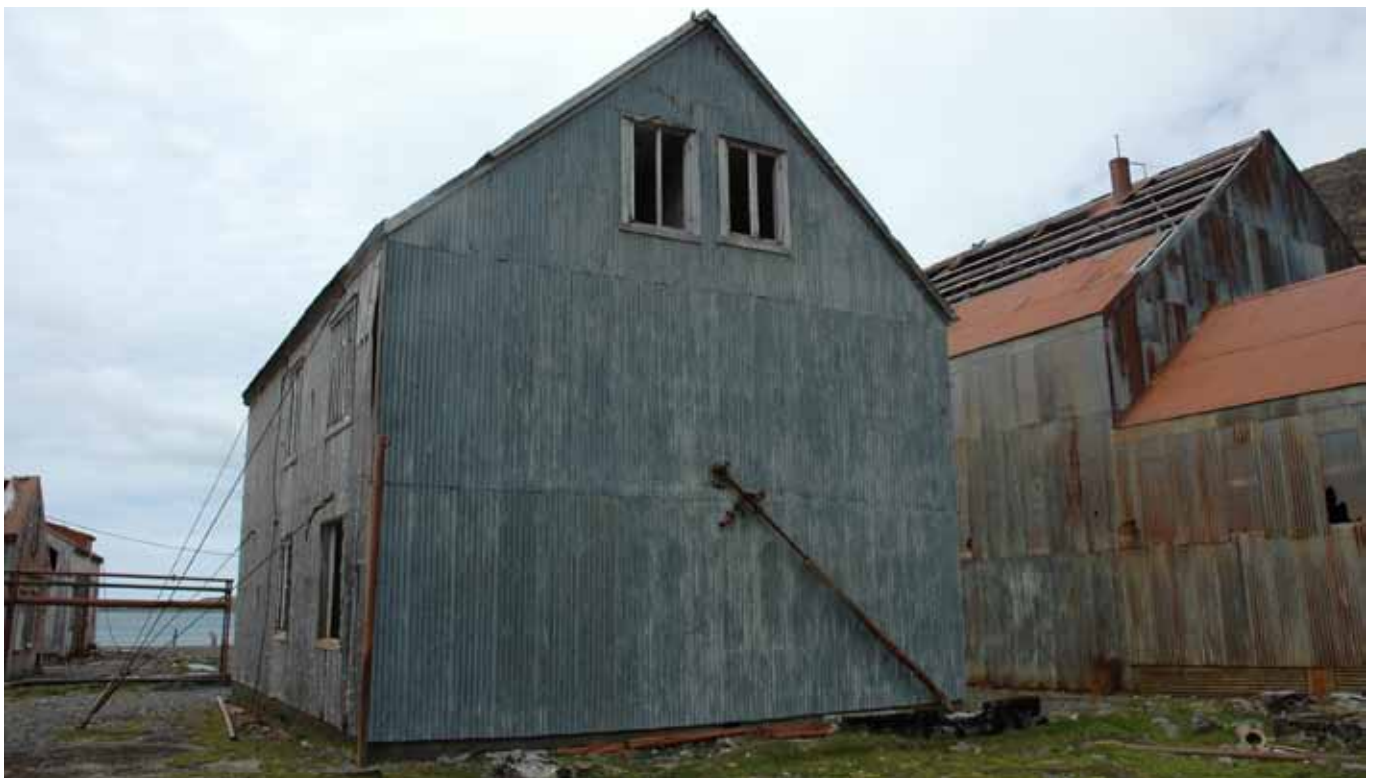
7.3 North and west elevations

The ground floor has largely collapsed inside the building and the first and second floors were not accessed. The rooms had loose bunk beds so it is not easy to see how many people used each space. There is a central brick chimney through the ridge. The corrugated iron on the south side is in reasonable order but it is missing from the west end of the north side, perhaps 15 percent of the roof sheeting is missing here. The boarding of the walls in poor condition below this area and there is also damage on the southern side adjacent to the porch.

The building has been stayed and guys remain in position on the north side.

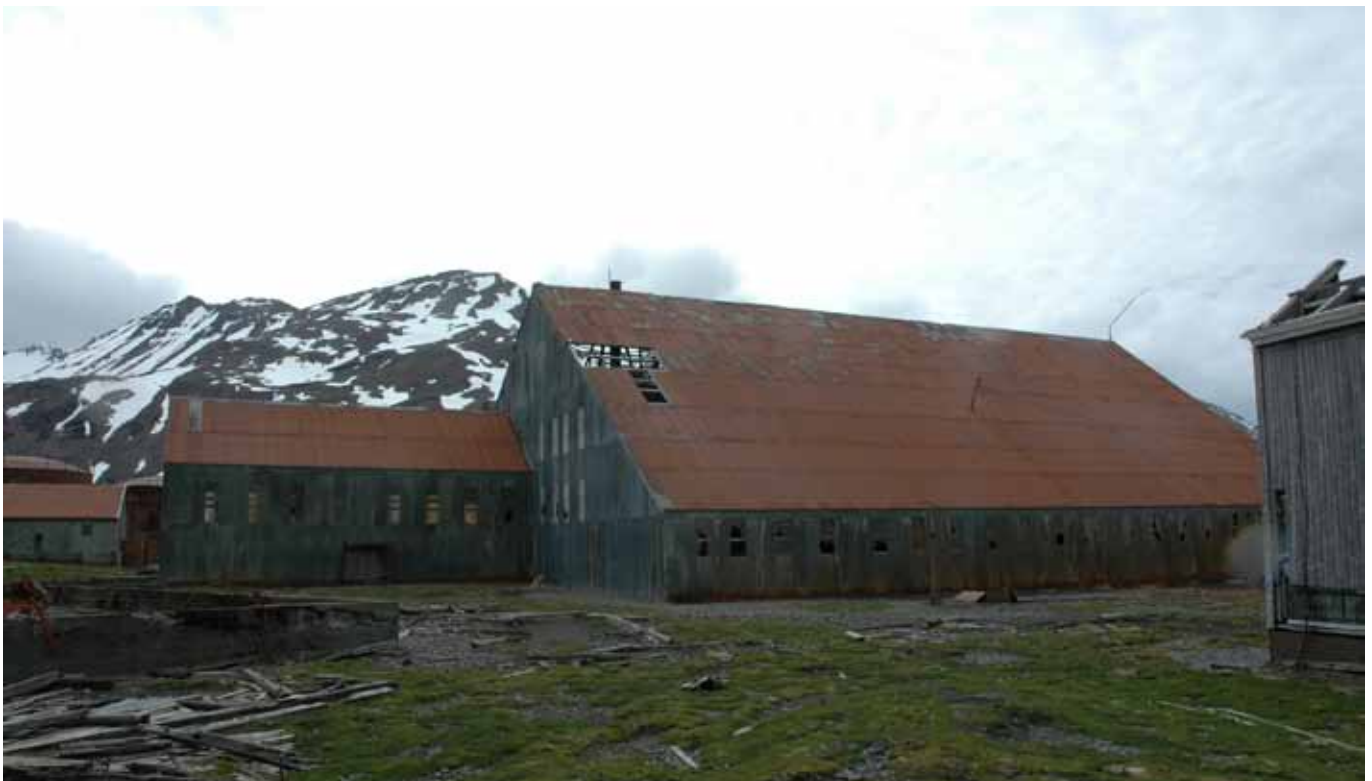
This is a substantial steel framed building with the plating shop being a smaller, but still substantial, extension to the west on the north side of the west elevation. The roof and walls of the plating shop are generally in good order. The sheeting is in good condition with the exception of the plastic panels used as window lights. These have cracked and four have now failed. There is some disturbance in the northwest corner where some sheets are missing. The plating shop is raised on concrete plinth approximately 350mm above the adjacent floor level. The sheeting of the main part of the building comes down to the floor at the rear but the concrete plinth raises approximately 400mm above ground level on the east side. The wall sheeting of the mechanical workshop is generally good, again with the exception of the glazed window panels. There are twenty of these on the south side and all of them are damaged. The south roof slope is generally intact but half the ridge is missing and there are now ten sheets missing from halfway up the west side of the slope.

The sheeting on the north wall is also in reasonable order with the exception of the window lights. There are two rows of eighteen lights; thirteen of them now have holes in them, some of them substantial. A large portion of sheeting on the north slope of the roof is now missing. The top three sheets are missing over 70 percent of the roof slope with perhaps 60 percent of the

19.2 South elevation

total roof area now blown off. The wall sheeting on the east side is reasonable, again with the exception of the plastic lights of which six are damaged.

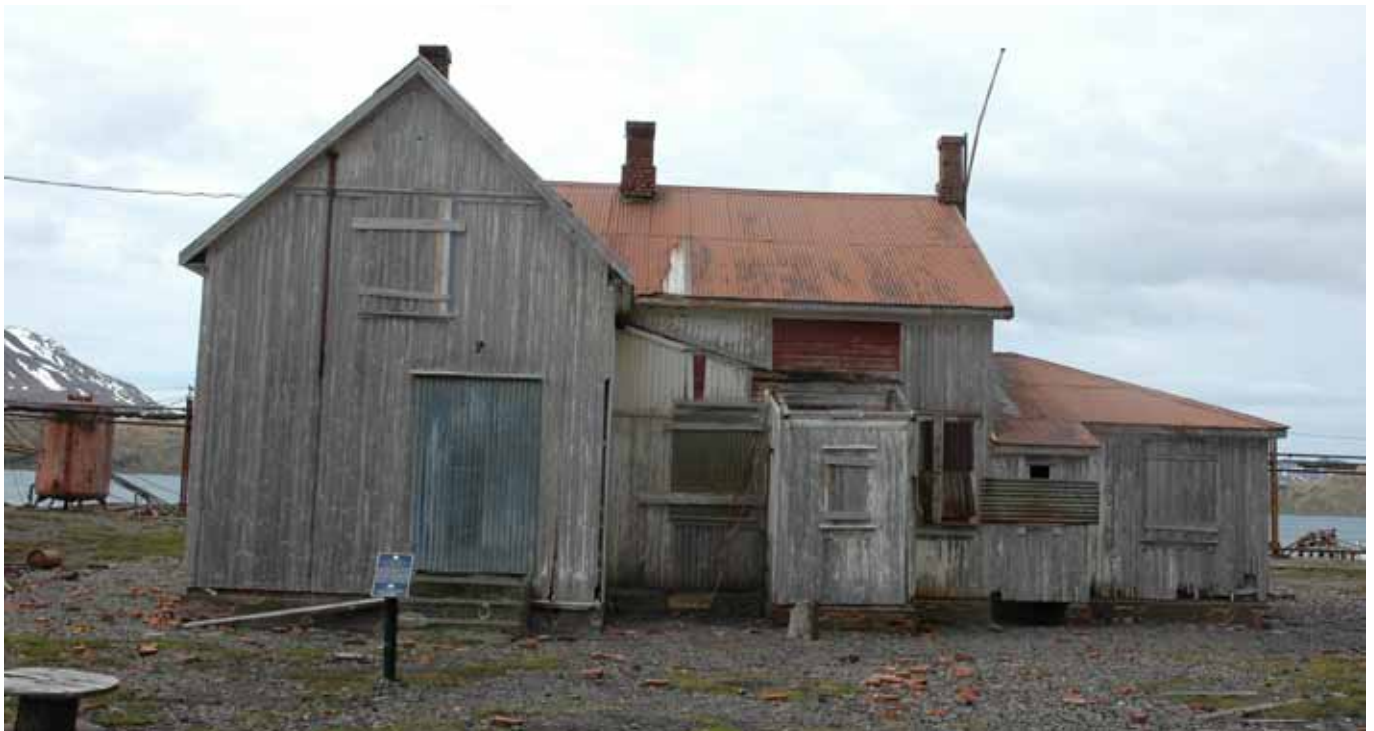
20.3 West elevation

Roof sheeting is missing on the outshot on the west side. There is one missing sheet on the main west roof slope above this area. One sheet is starting to tear away on the north side of the west projecting gable roof. There are three brick chimneys all still standing and the remains of a radio aerial attached to one of them with the stays fallen away. The building has had a tie down wire running across inside the roof which remains in position on the north and east sides; only one can be seen on the west side and none on the south side, possibly being concealed by later extension.

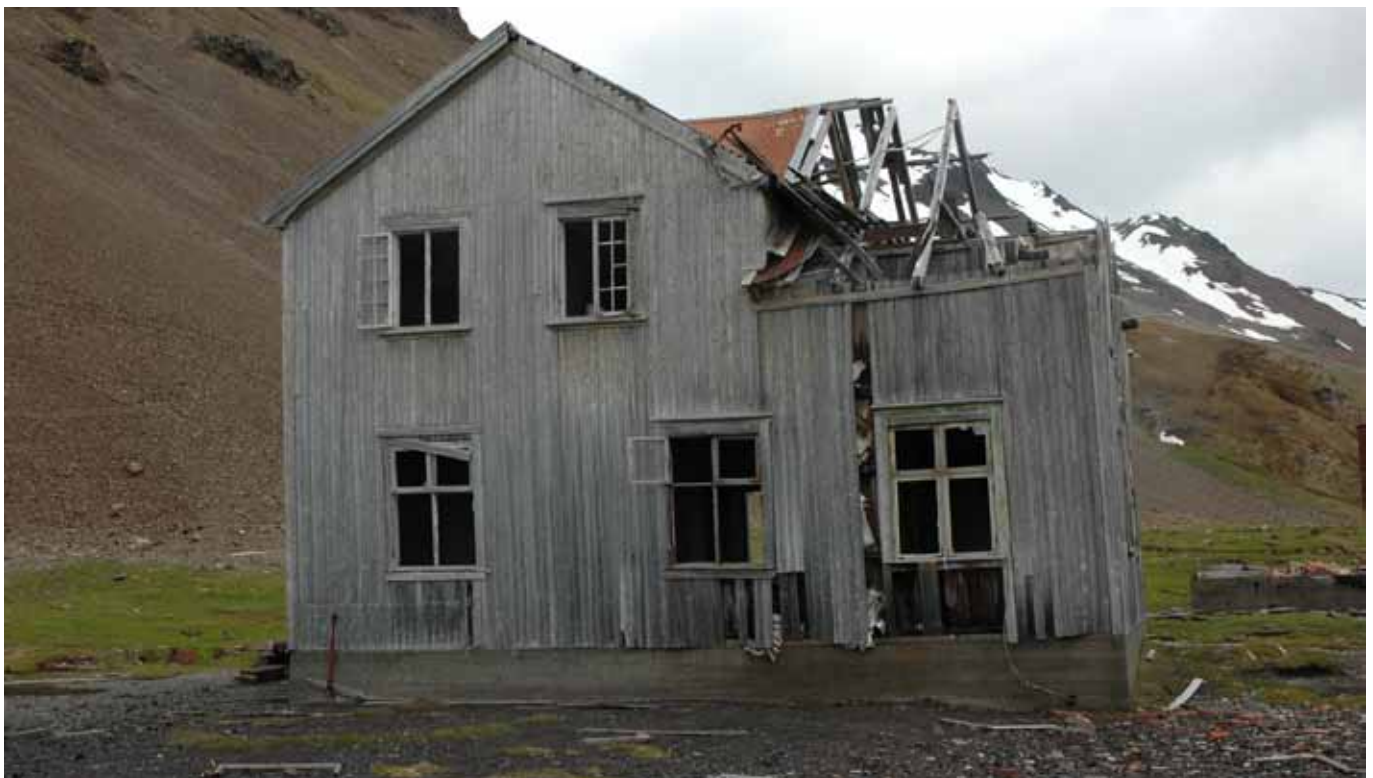
22.3 The east elevation

Internally the whole of the ground floor has collapsed. The walls are generally covered with vertical tongued and grooved boarding except in the rooms where it has been covered with hardboard. The ceiling is also covered with tongued and grooved boarding with a simple coving piece around the top of the walls. There are four panelled doors throughout the building with simple architraves. The whole of the corrugated iron is missing from the west roof slope and the northeast corner of the building and the northern section of the roof has collapsed completely. The east wall is now seriously buckled and looks likely to collapse fairly soon. This building is now probably beyond the point of salvation.

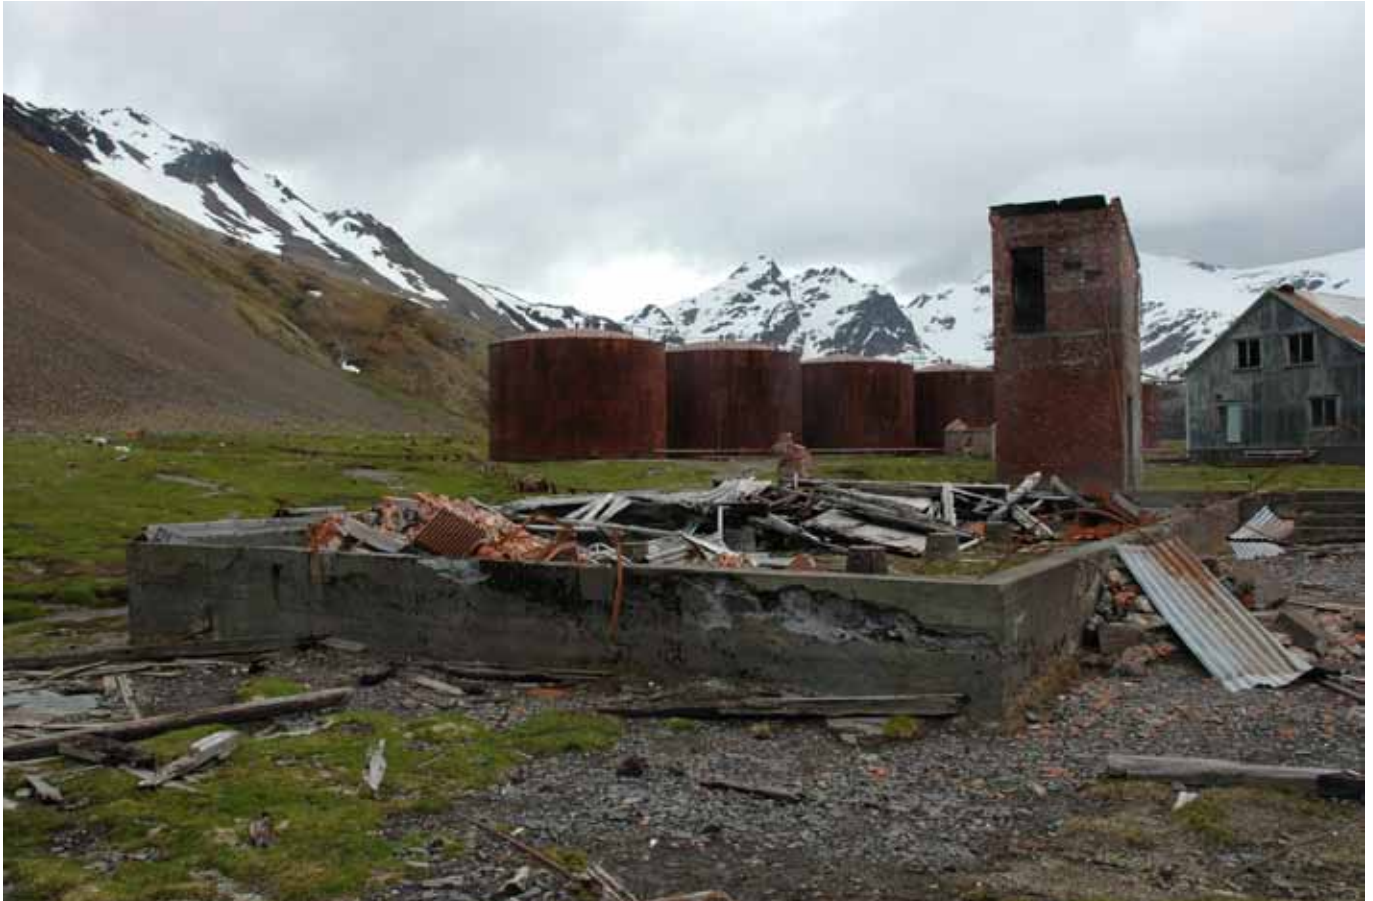
Only the concrete base and small remaining amount of timber and brickwork shows where this building has been apart from the brick built projection room at the north end of the building. Access to the projection room must have been from the back of the gallery as no stair remains.

23.1 The remains of the Cinema looking northwest

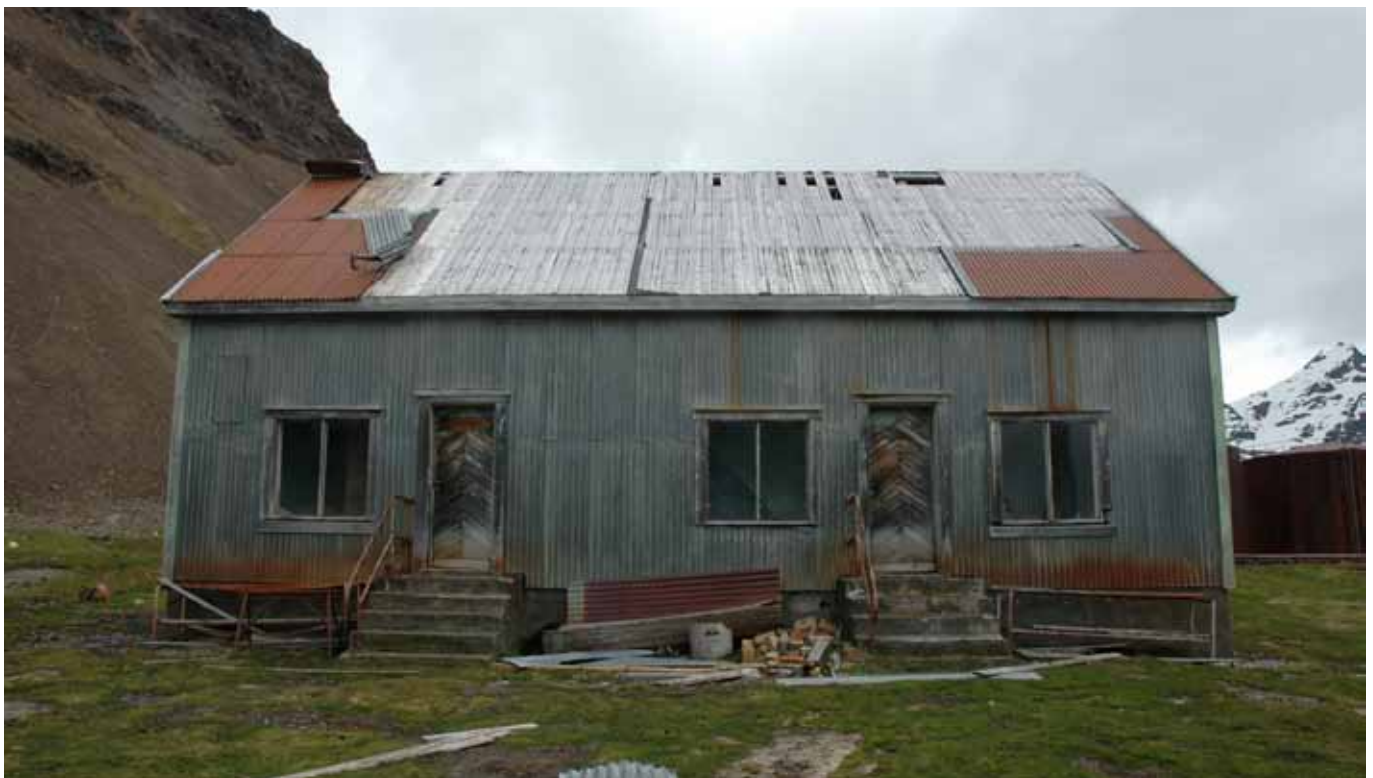
All the sheeting is generally in satisfactory condition although some sheets are coming loose. On the north side of the building at present is reasonably solid but it has now lost the whole of its corrugated sheeting from the west side and the majority of it, 85 percent, from the east side and is now completely exposed to the weather.

The building at the moment is relatively solid but deterioration is likely to start soon.

24.3 East elevation

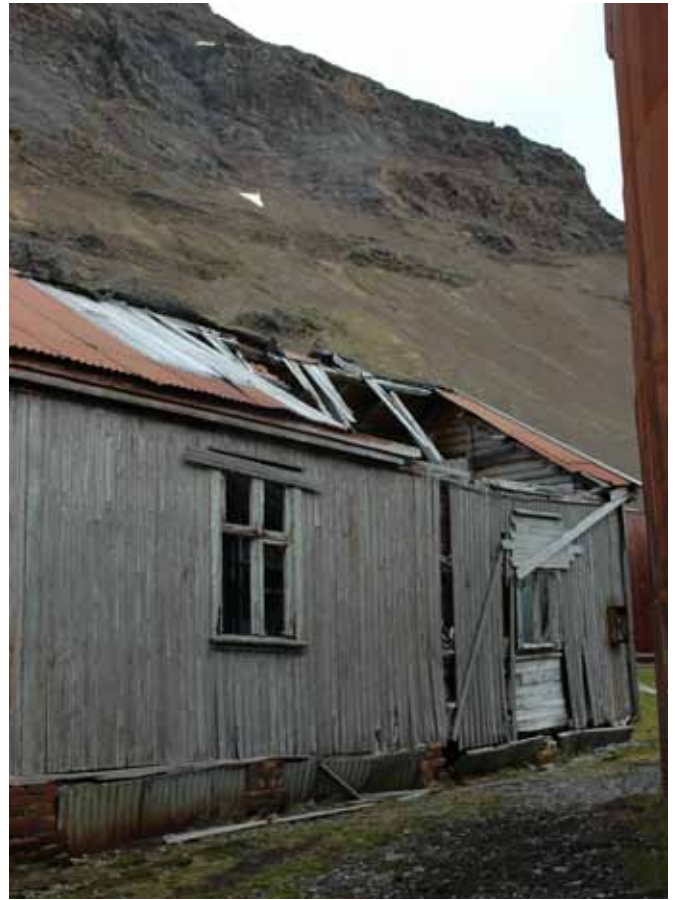
There are six windows along the north side suggesting that there are six rooms each fitted out with four double bunks (i.e., 48 men in the building). Internal walls are boarded out and with fitted bunks and there are timber boarded ceilings in all rooms. The roof space has small lights at either end but does not appear to have been used as there is no boarding in this area. The windows were side opening casements which have now largely fallen away. The roof slope on the south side is intact but the roof sheeting is missing at the northwest corner of the north slope and the roof is collapsed around this area.

25.1 The northwest corner

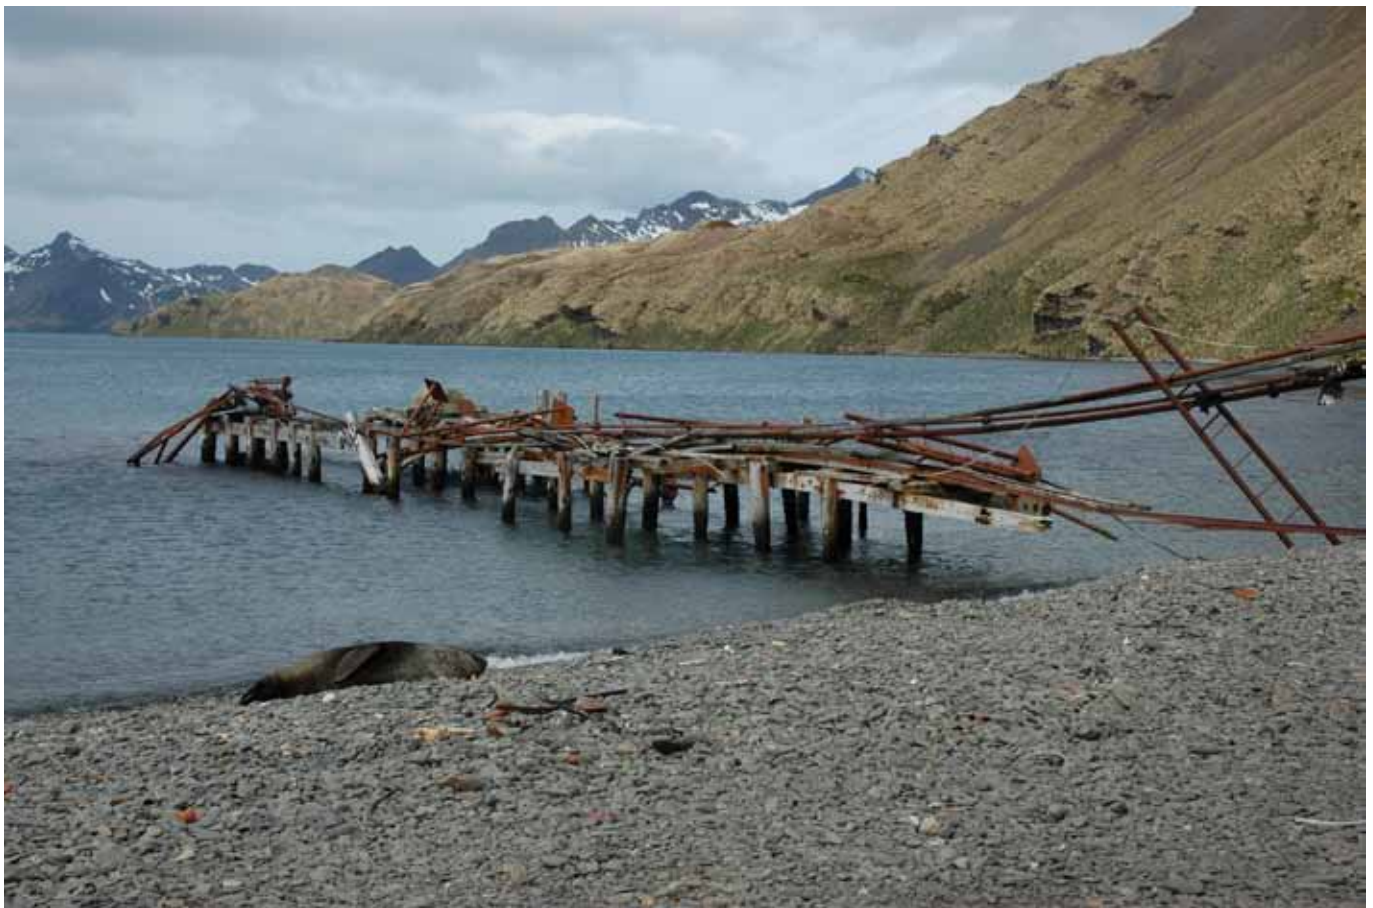
Jetty No.28 is the smallest and in least good condition with no decking remaining and several of the timbers now eroded to the point of almost none existence. This too has pipework running out to the end of the pier presumably for refuelling boats. A winch remains right out on the end but little remains of the decking.

28.2 North side of Jetty No.28
