GRYTVIKEN  
CONSERVATION  
MANAGEMENT PLAN  
ISSUE 06  
SEPTEMBER 2018

# GRYTVIKEN CONSERVATION MANAGEMENT PLAN

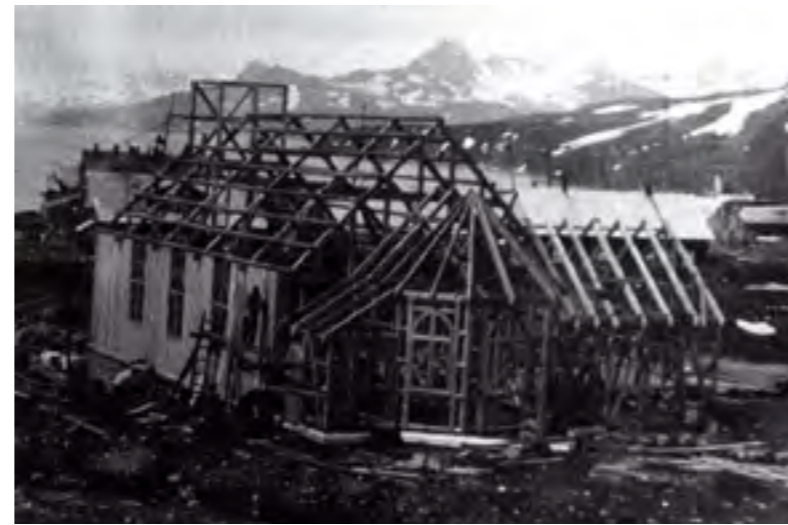
*Construction of the frame of the Church in November 1913, reproduced courtesy of the South Georgia Museum*

Construction of the Church began on 25 November and it was consecrated on 24 December. It was a prefabricated wooden Lutheran chapel made by Strømmen Trævarefabrik in Norway to a design by Adalbert Kielland, an architect and husband of Larsen's daughter, Signe. It cost 10,400 kroner (c.£600). The Church had seating for 200 (it would remain the only church on the island) and had a writing and reading room.<sup>10</sup>

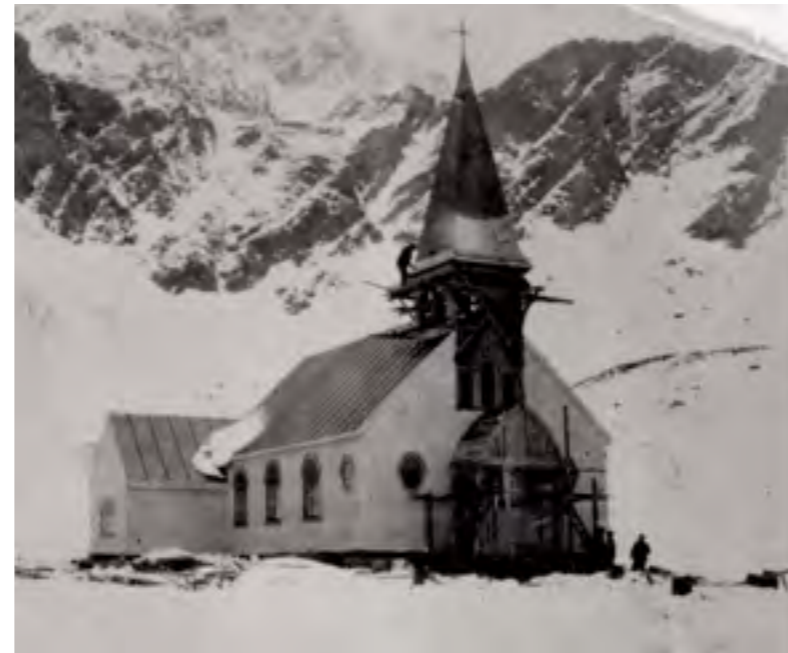
*Construction of the spire of the Church, reproduced courtesy of the South Georgia Museum*

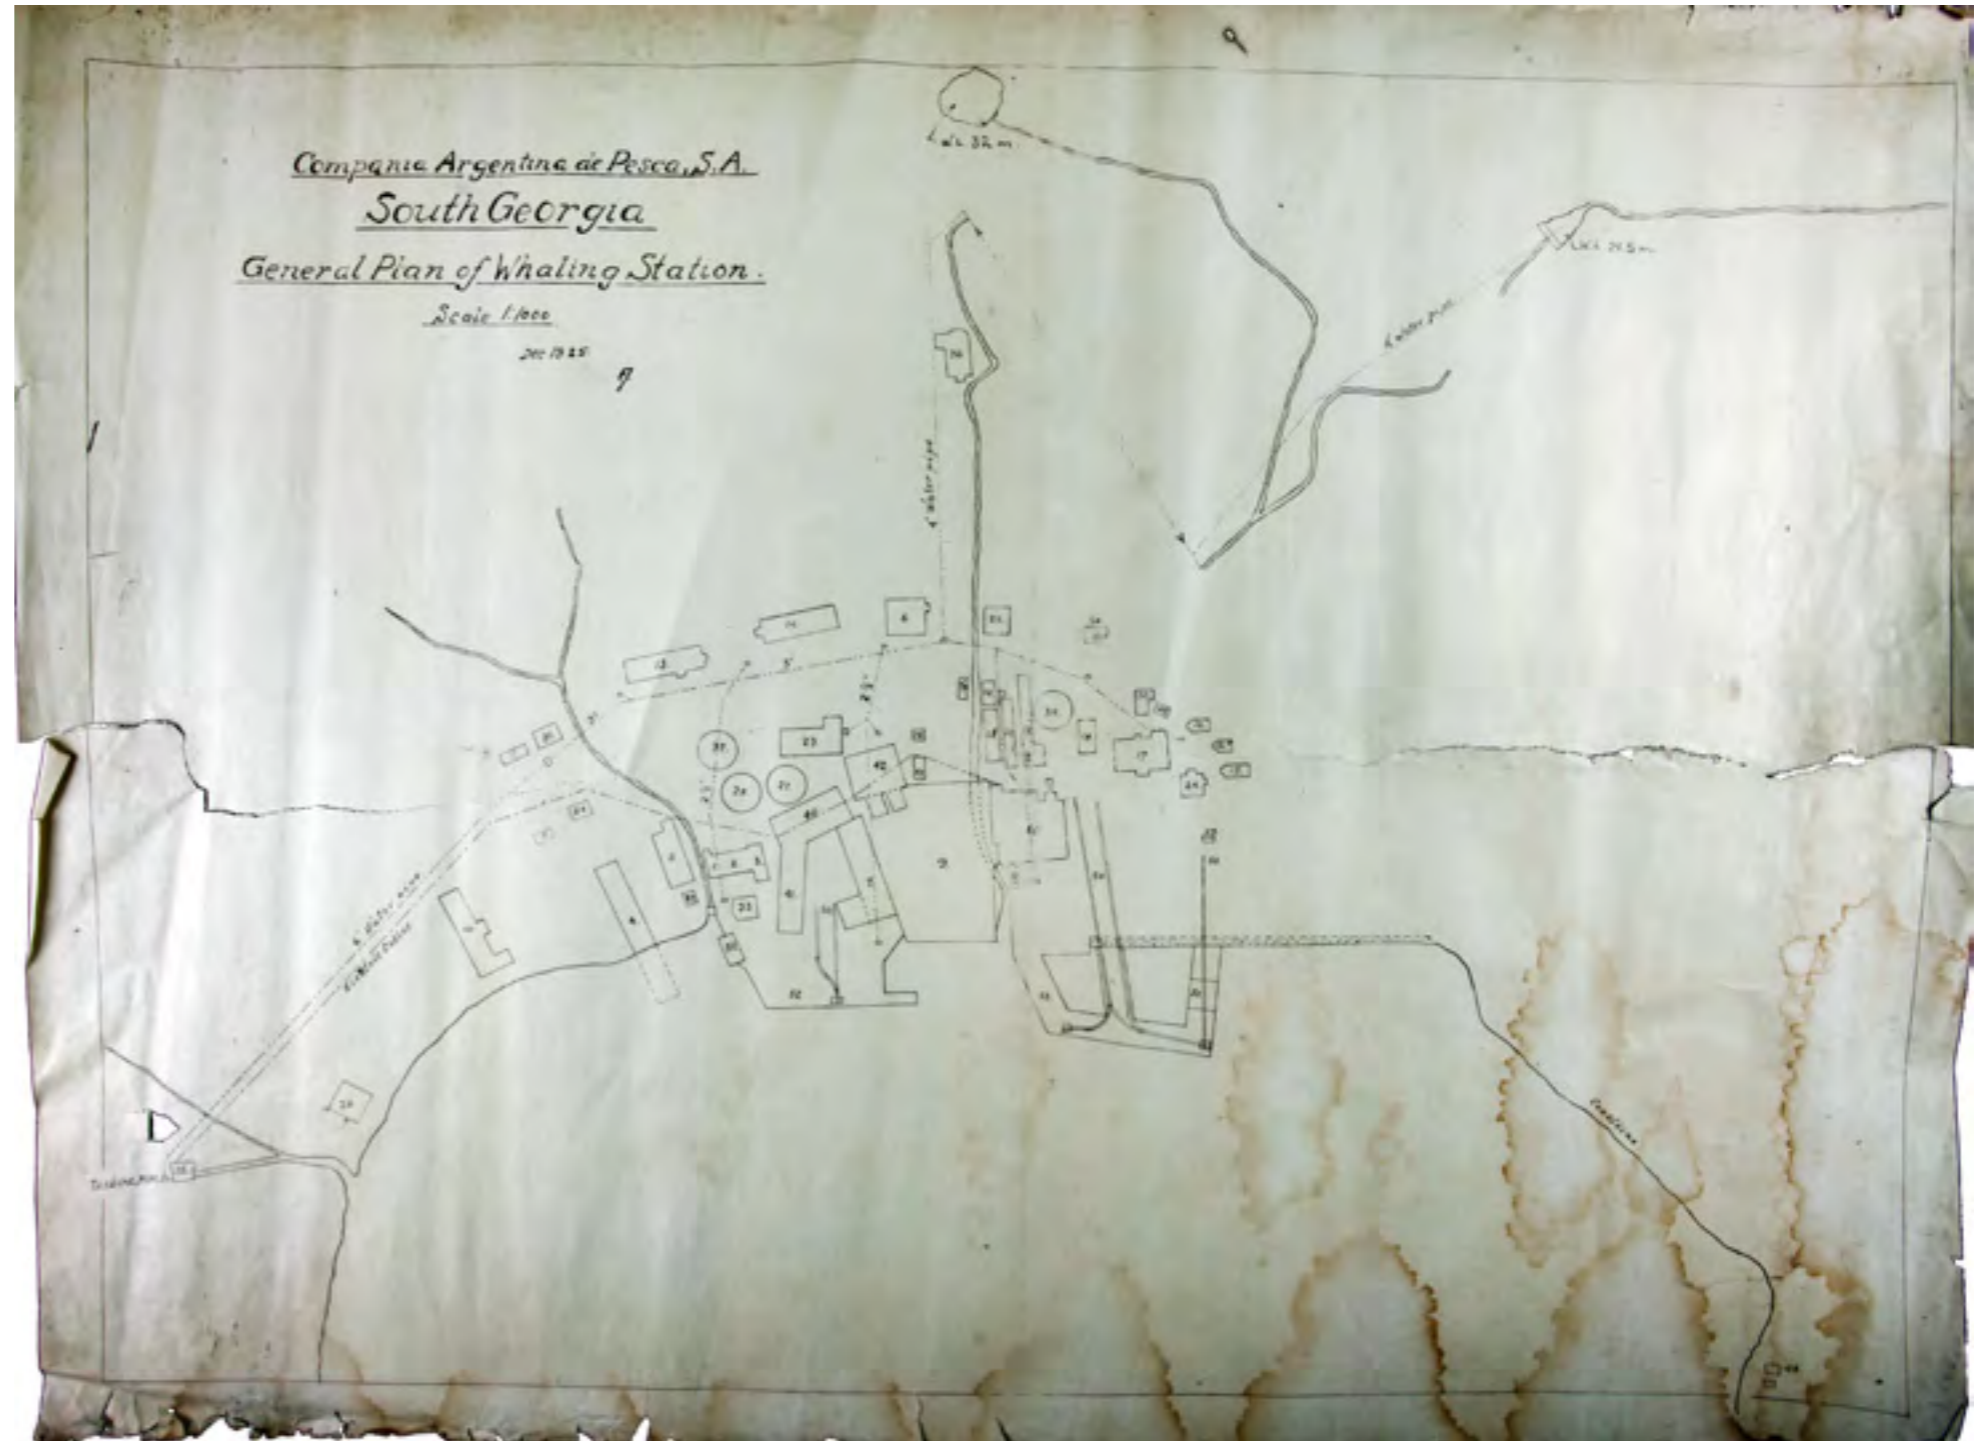
1925 Plan of Grytviken prior to redevelopment. (MS 1991, item on loan to the Scott Polar Research Institute)

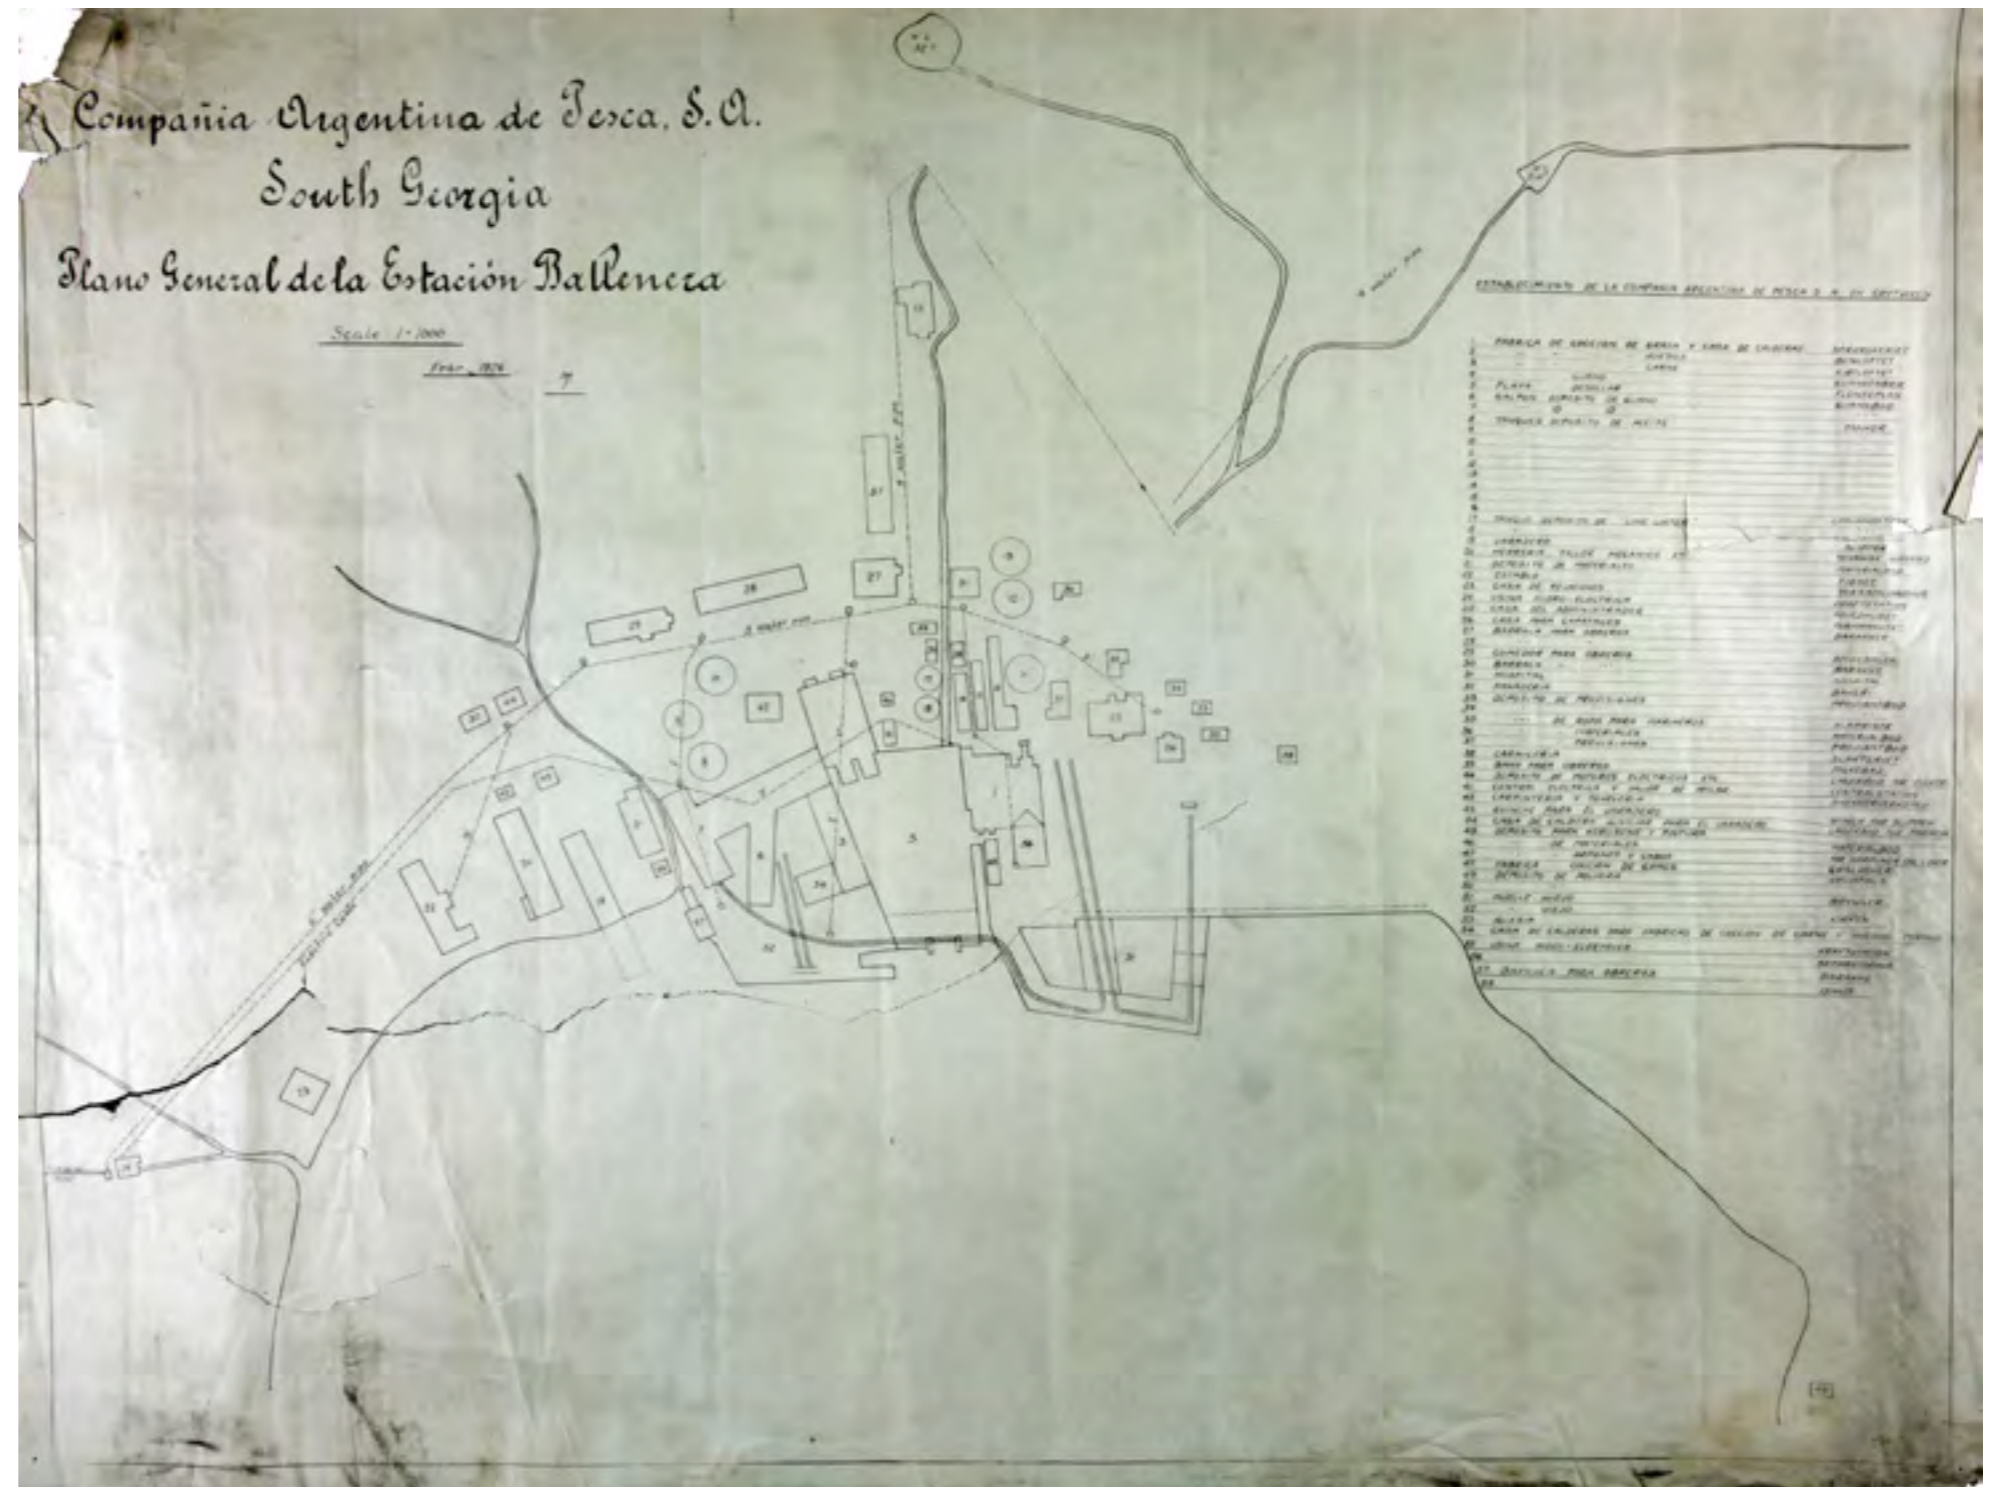
1926 Plan for proposed redevelopment of Grytviken. Not all changes were enacted. (MS 1991, item on loan to the Scott Polar Research Institute)

The Magistrate, Edward Binnie, produced a report on the whaling stations in South Georgia describing the plant and processes at each and commenting on production output and efficiency with reference to whether licences should be renewed. It was based not only on visits to all the stations but also figures and information supplied by the whaling companies. The report described the South Georgia Company at Leith as the best, followed by the Southern Whaling and Sealing Company at Prince Olav. Pesca's gradual improvements were noted but its reduced output was criticised and ascribed to obsolete methods and lack of plant. The quality of the oil was said to be poor because of the bad stowing of meat in the cookers and the need for a chemist to grade the oils was noted. In January, Pesca had sent Binnie a list of works which had been, were being or would be undertaken to modernise Grytviken:

- Two **new whalers** to be purchased for the fleet.
- **Hydro-electric plant** to be investigated regarding enlargement of the dam.<sup>13</sup>

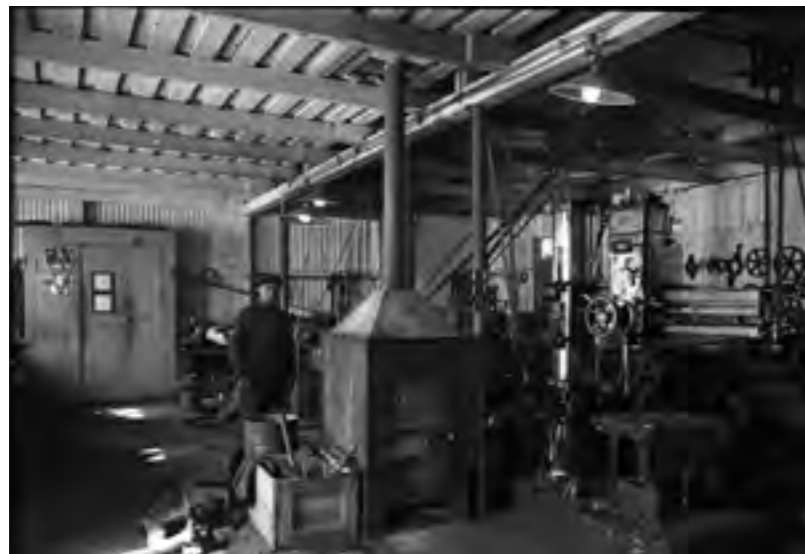
View inside the mechanical workshop, reproduced courtesy of the South Georgia Museum

A floating dock was installed together with a modern mechanical workshop. Previously cleaning and repair of boats had been done on the slipways. The dock was 40.6m long and 10.4m wide, taking vessels drawing 4.6m. The floating dock plates were made at Framnæs Mekaniske Værksted, Norway and reassembled and riveted at Grytviken by Framnæs employees.

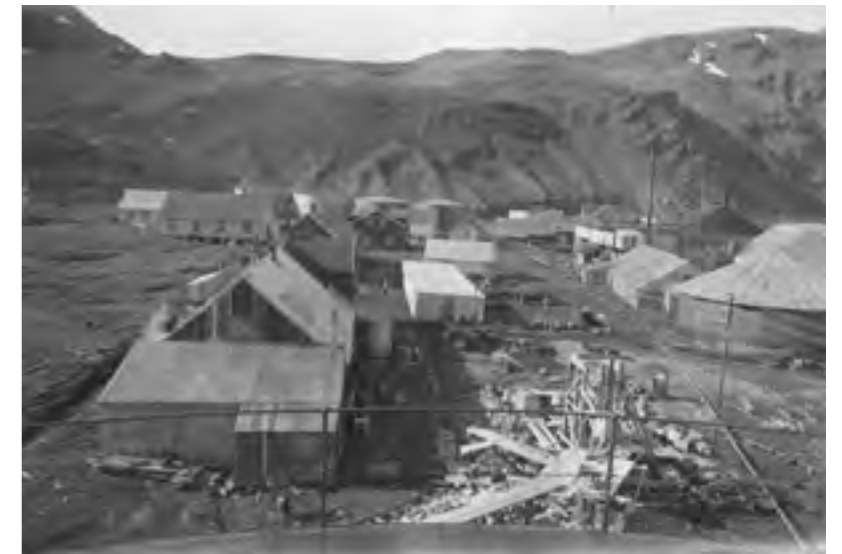
Grytviken in the early 1930s viewed from the south. The communal mess is the long building in the foreground. The factory buildings are smaller and so the main track through the site runs closer to the sea adjacent to the oil storage tanks. The Kino projection room is visible on the extreme left, reproduced courtesy of the South Georgia Museum

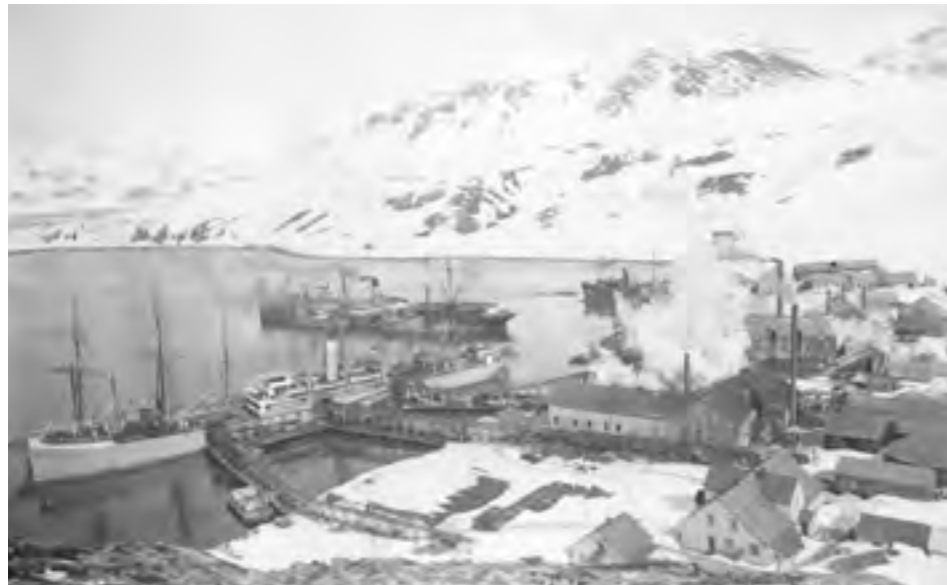
Grytviken in the early 1930s with the Manager's Villa in the bottom right corner. The raised tracks along Harpon jetty are clearly visible on the left, reproduced courtesy of the South Georgia Museum

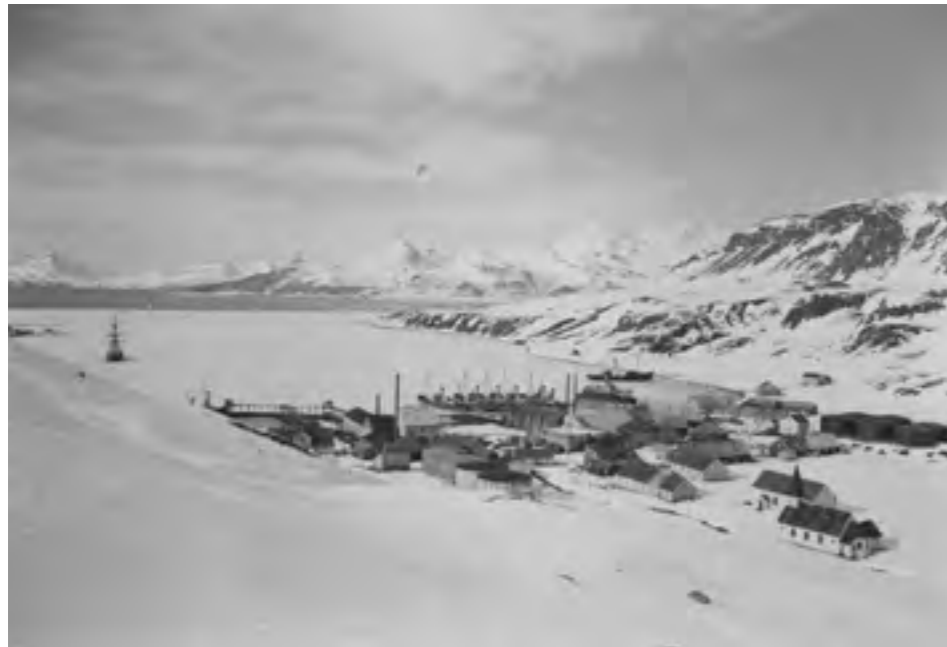
Grytviken in the early 1930s with the whale catcher fleet at anchor and a vessel undergoing repair in the floating dock, reproduced courtesy of the South Georgia Museum

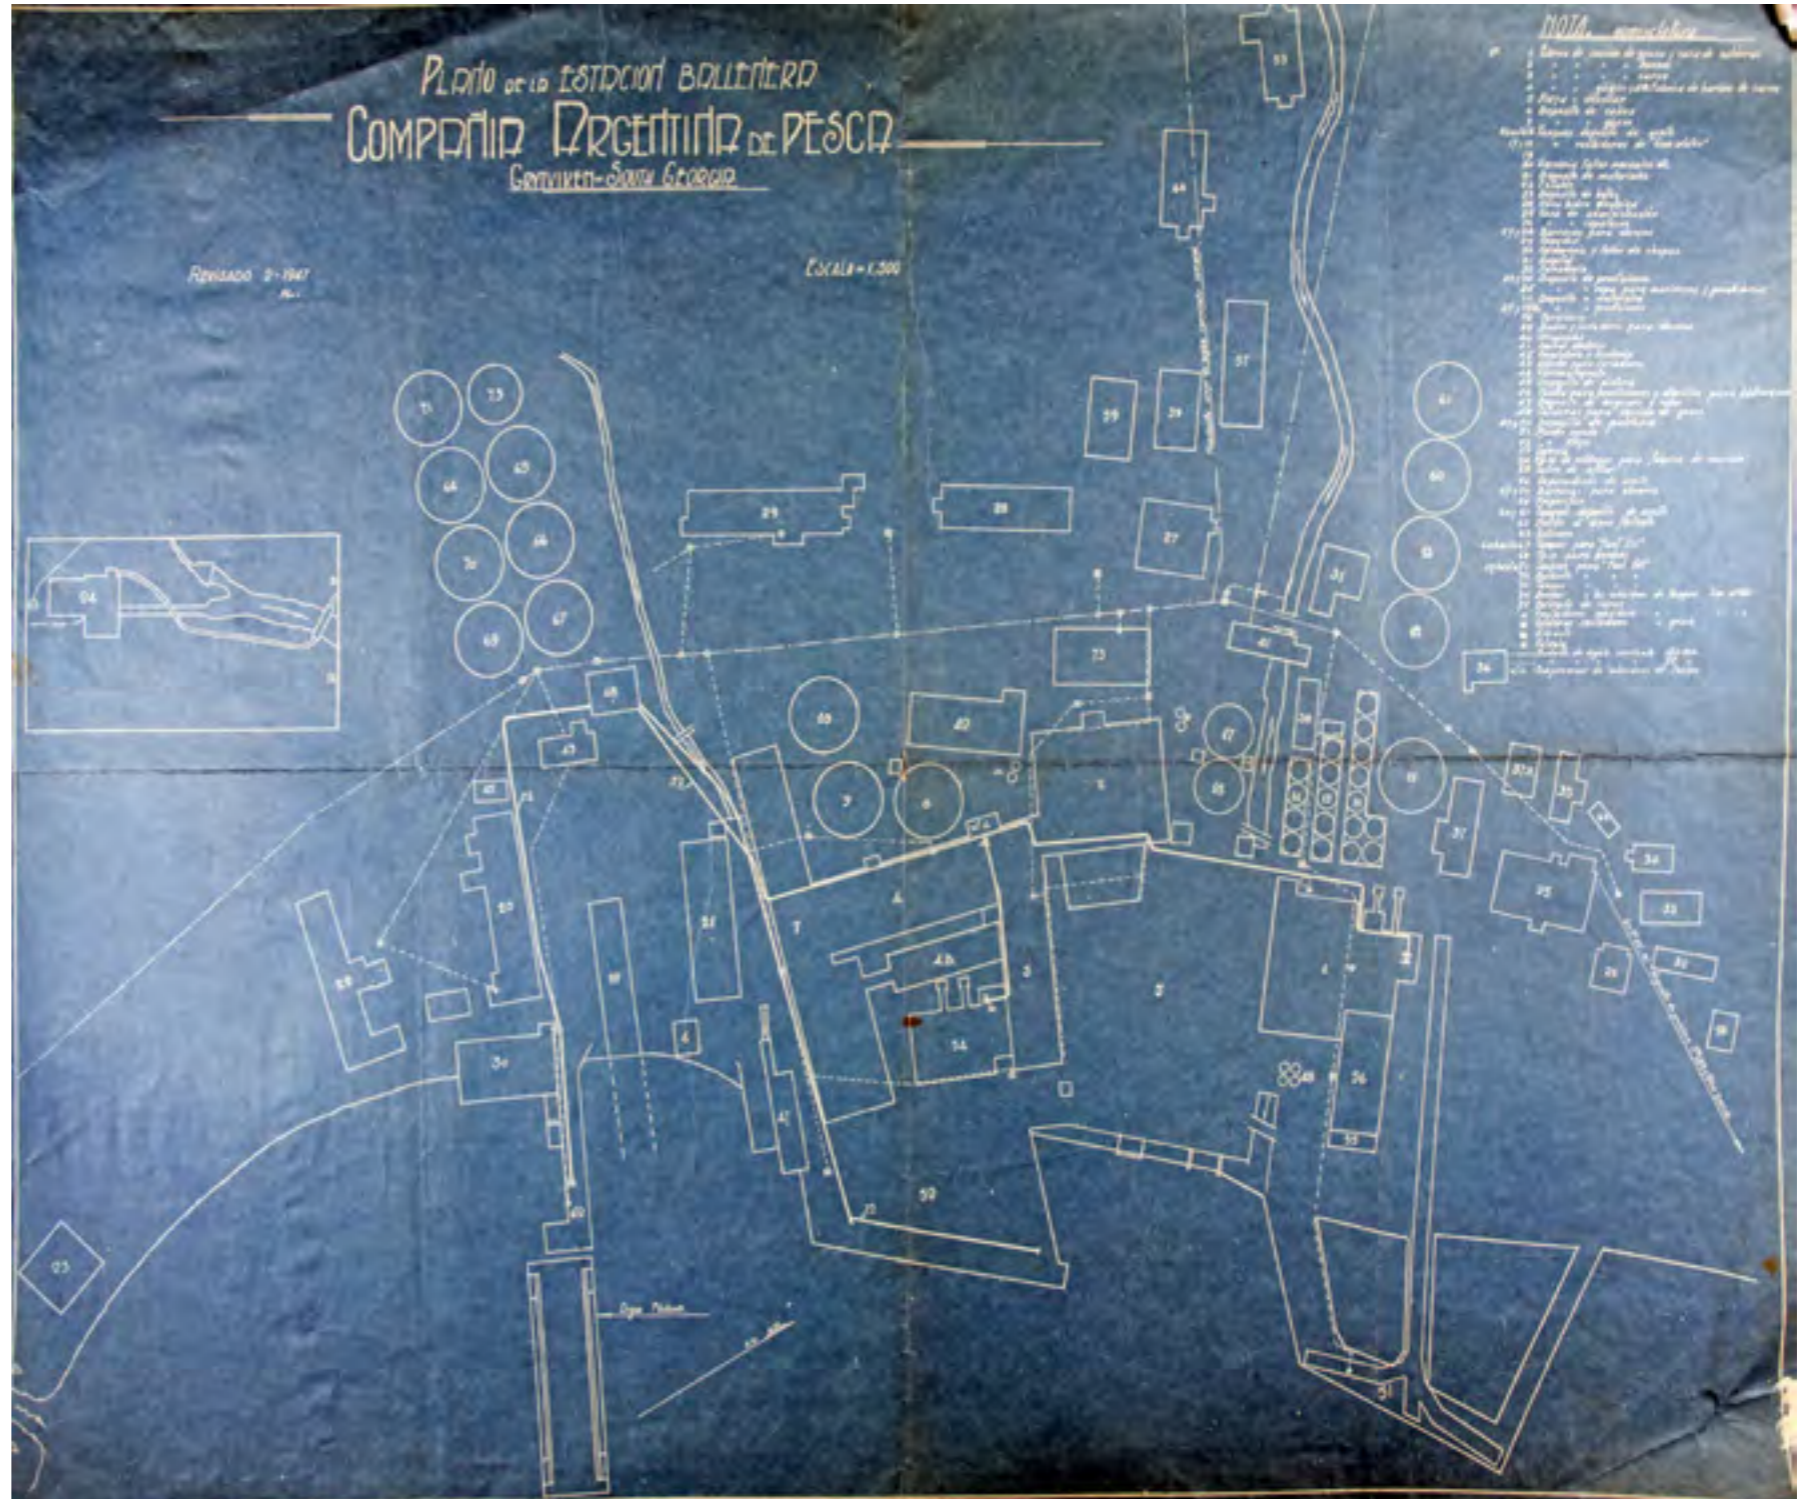
1947 Plan of Grytviken prior to the major redevelopment in the later 1950s. (MS 1991, item on loan to the Scott Polar Research Institute)

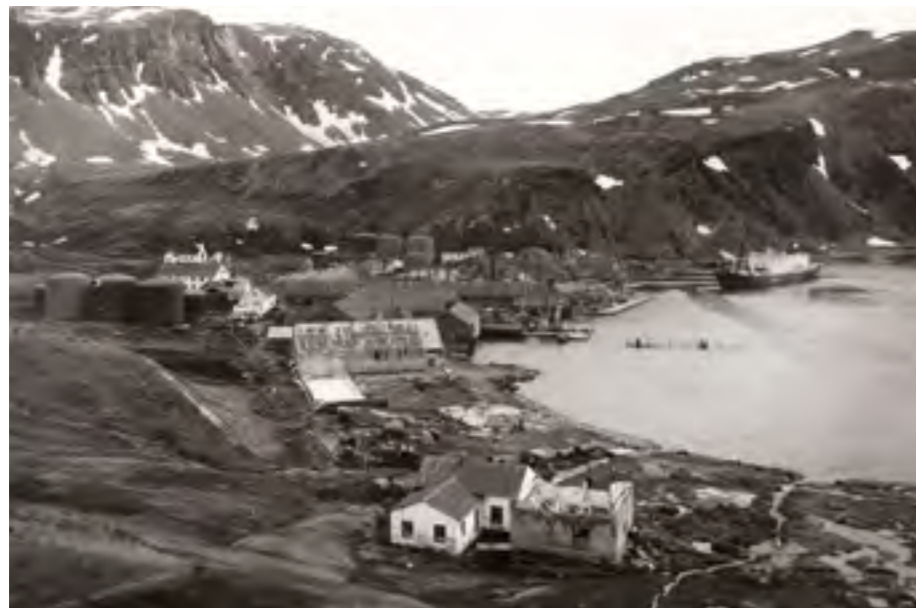
Grytviken viewed from the south in 1989. In the foreground, the roof of the hydro-electric power station had already collapsed whilst *Petrel* can be seen sunk at her moorings. Reproduced courtesy of the South Georgia Museum

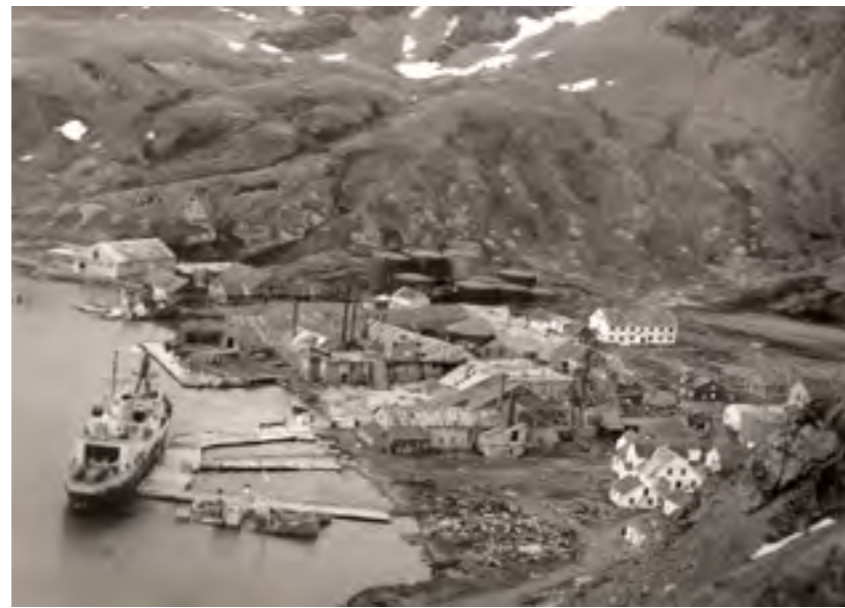
Grytviken viewed from the north in 1989. The foremen's barracks and the barracks and bath house north-west of Russebrakka had already disappeared whilst other buildings were in a poor condition. *Albatros* and *Dias* had sunk at their moorings. Reproduced courtesy of the South Georgia Museum

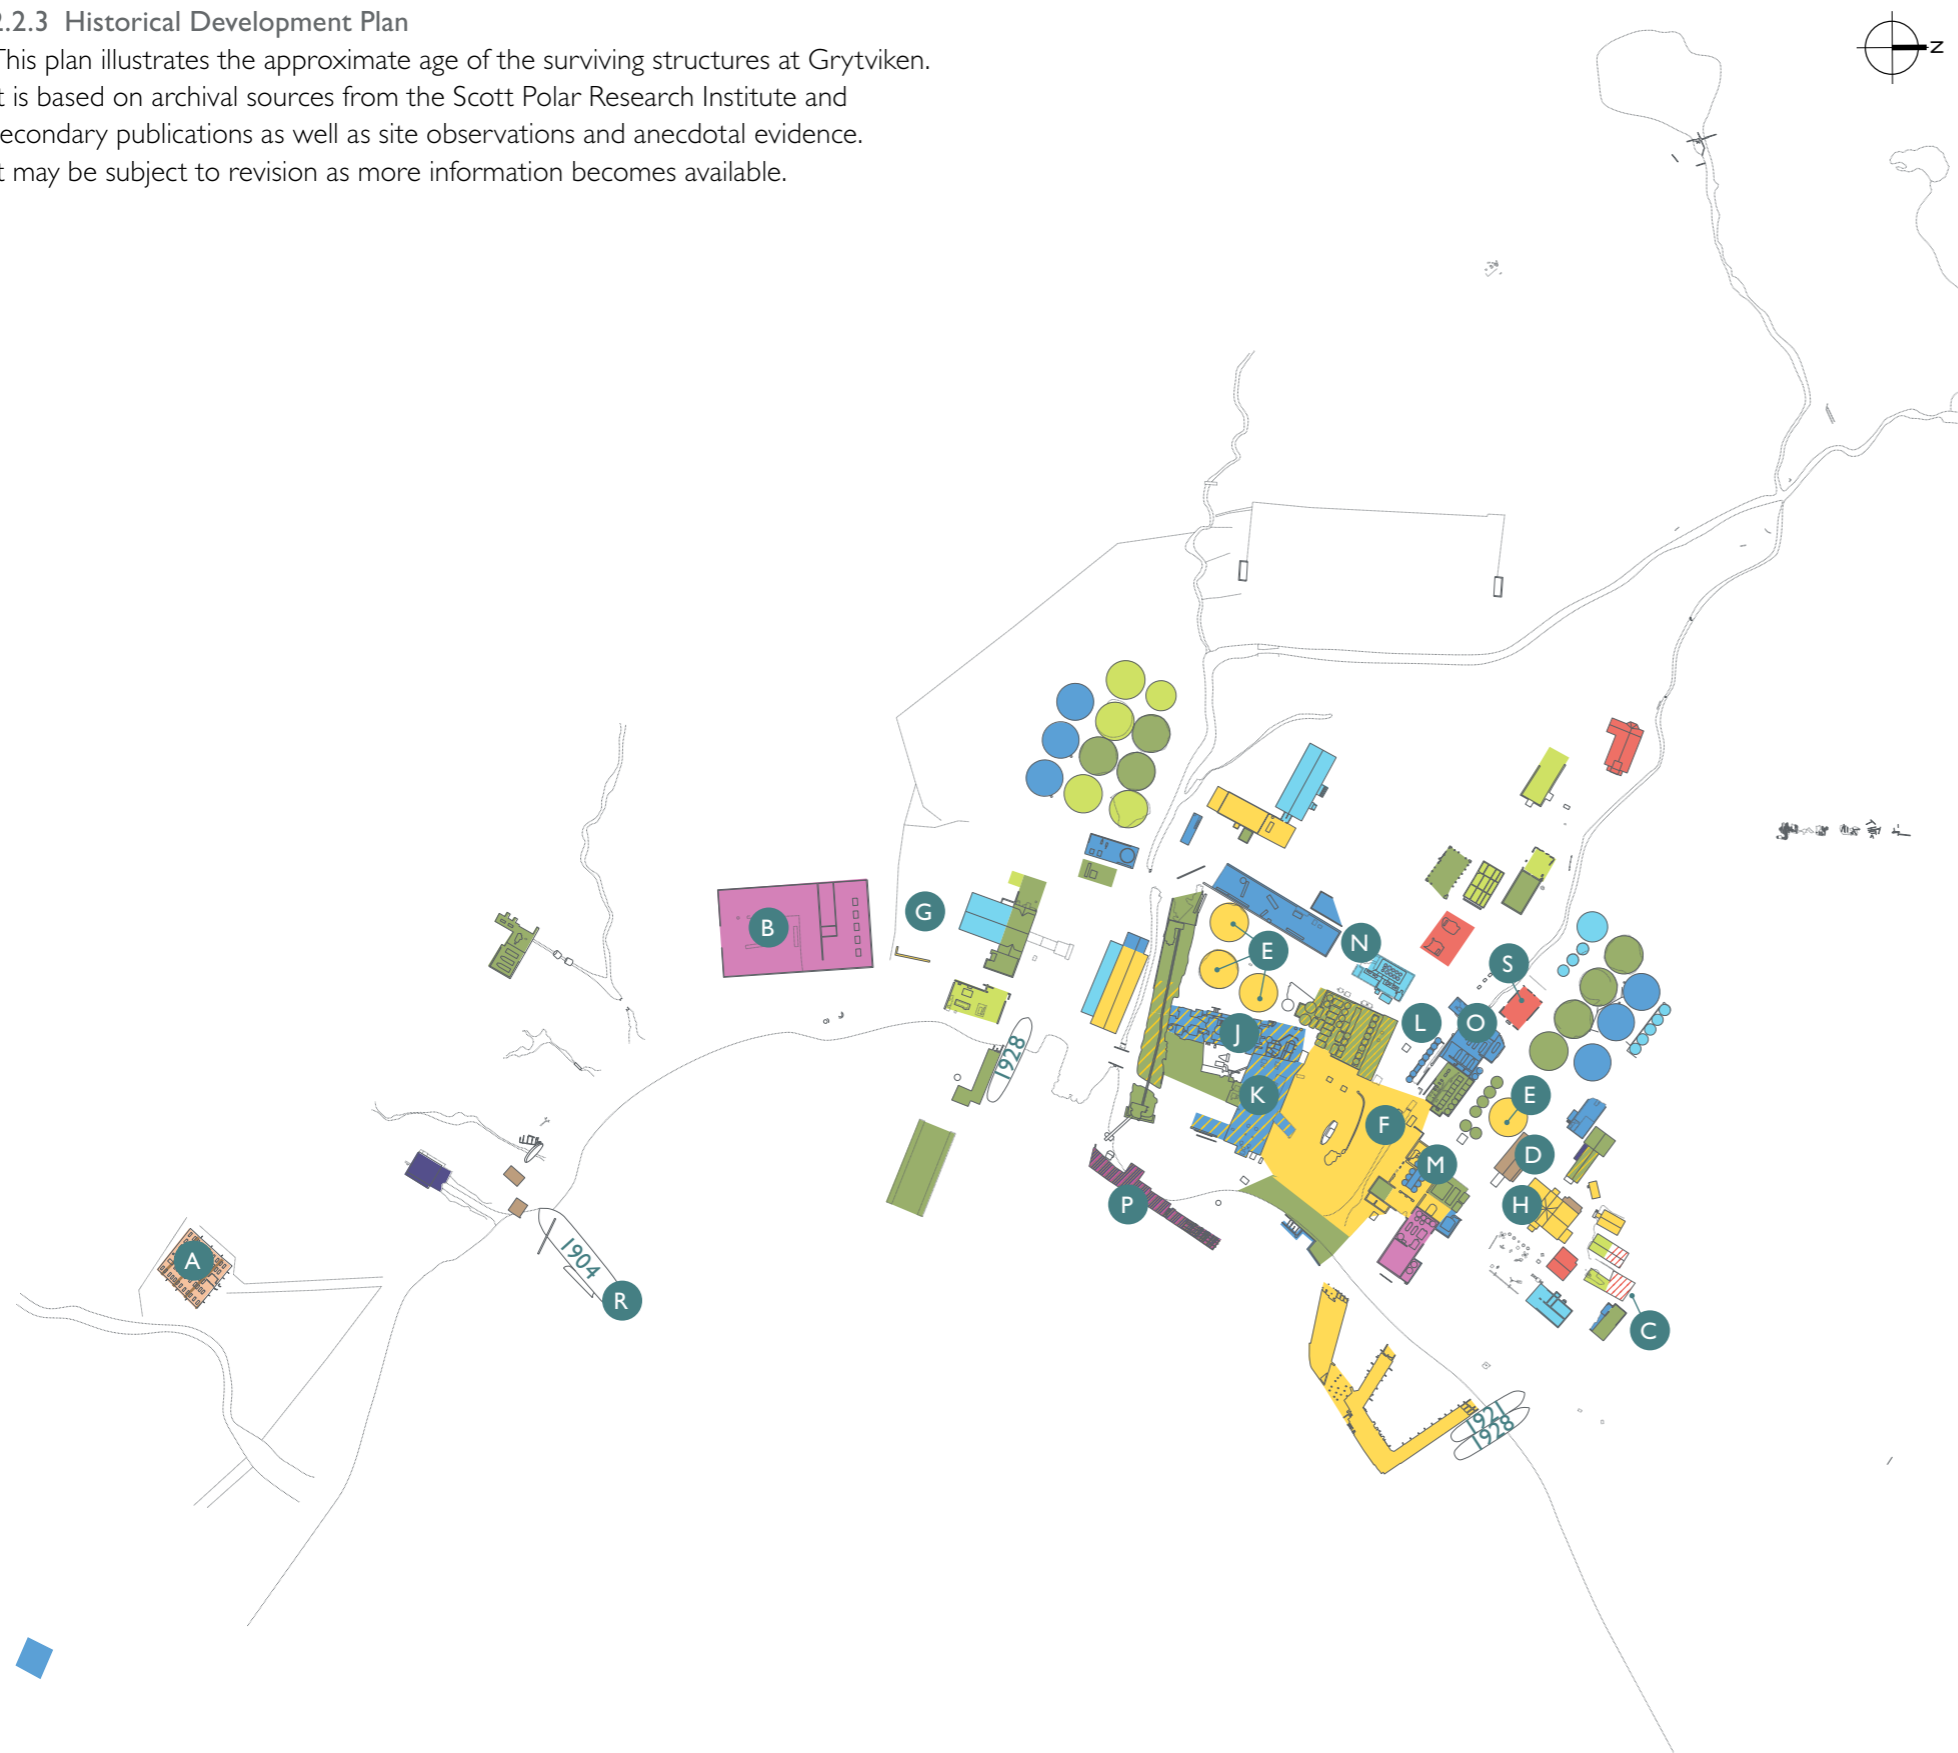
PLAN SHOWING THE AGE OF SURVIVING BUILT FABRIC AT GRYTVIKEN

This plan illustrates the approximate age of the surviving structures at Grytviken. It is based on archival sources from the Scott Polar Research Institute and secondary publications as well as site observations and anecdotal evidence. It may be subject to revision as more information becomes available.

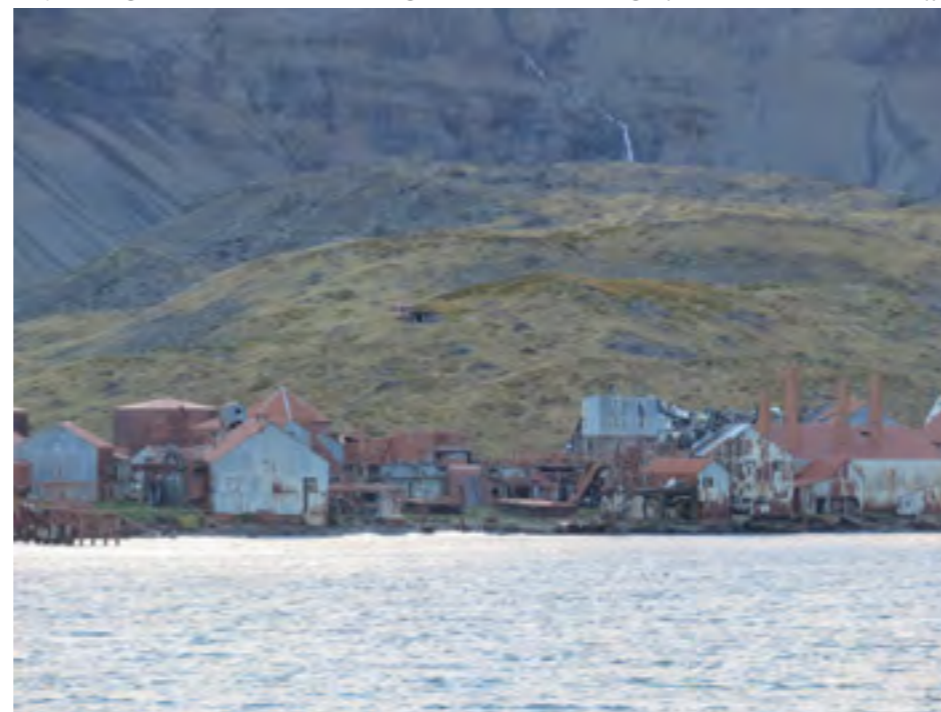
Flensing Plan and factory buildings at Leith Harbour Whaling Station

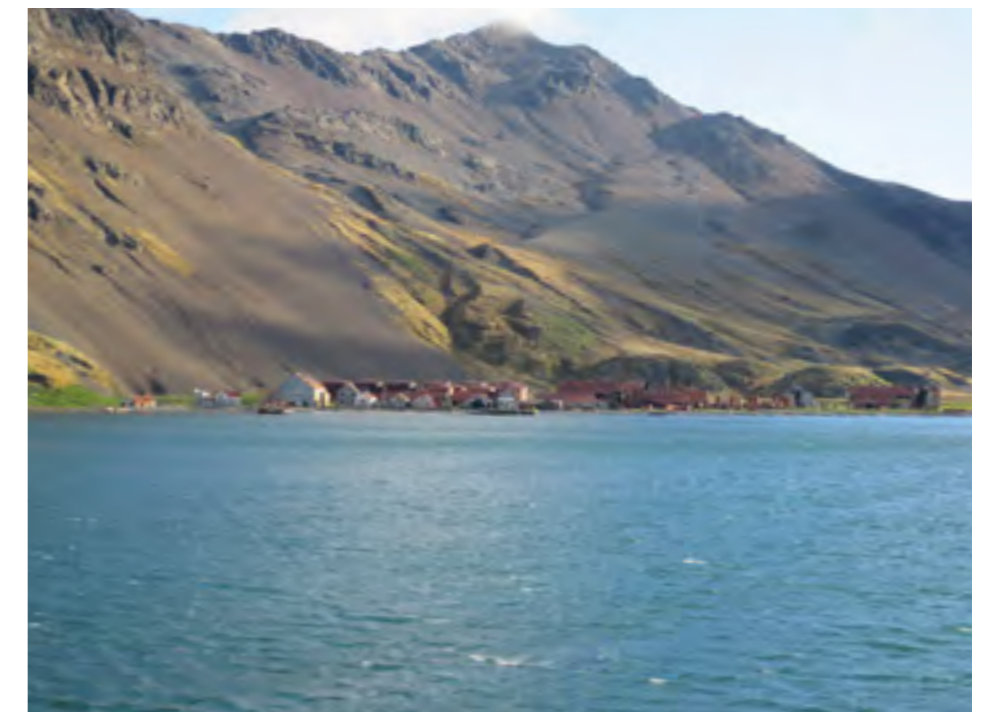
Stromness, which was converted from a whaling station into a ship repair yard to serve Leith

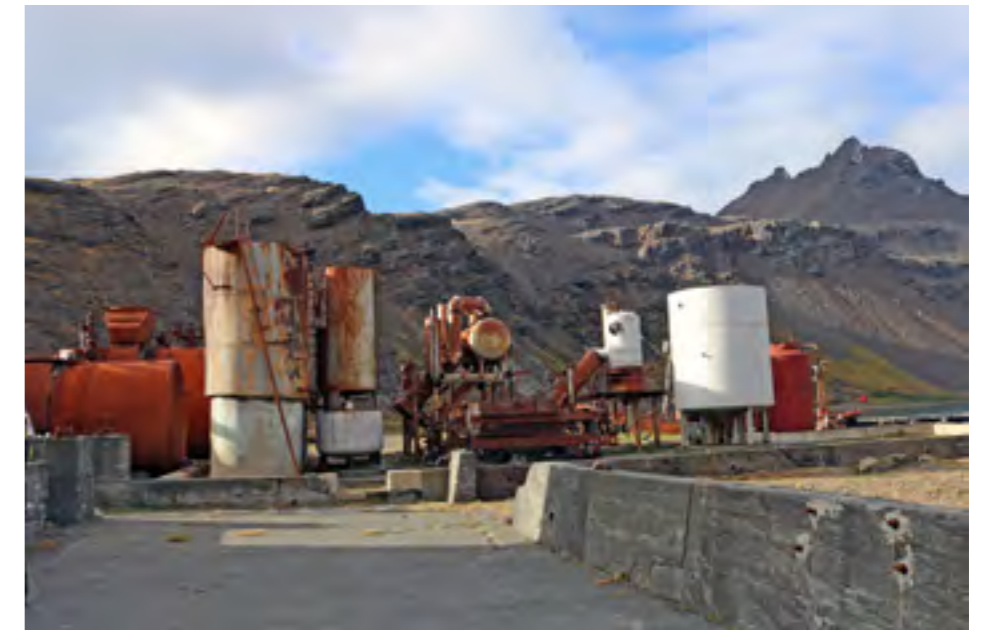
Meat extract plant to the east of the Blubber Cookery

Meat extract had become sought after for flavouring foodstuffs so in 1959 it was decided to establish a plant for meat extract (in preference to trying to produce frozen whale meat, which was not popular in Europe). To ensure no contamination, a separate meat plant and meat plant equipment was needed, (e.g. Strømmen cutter and Kampen expeller). It was built on the seaward side of blubber factory where there had been an oil separator. It consisted of 10 mild steel tanks and a stainless steel tank for storing meat juice, two Johnston frame filters (filter presses), a two-stage evaporator and a last stage evaporator made by A/S Limvann.

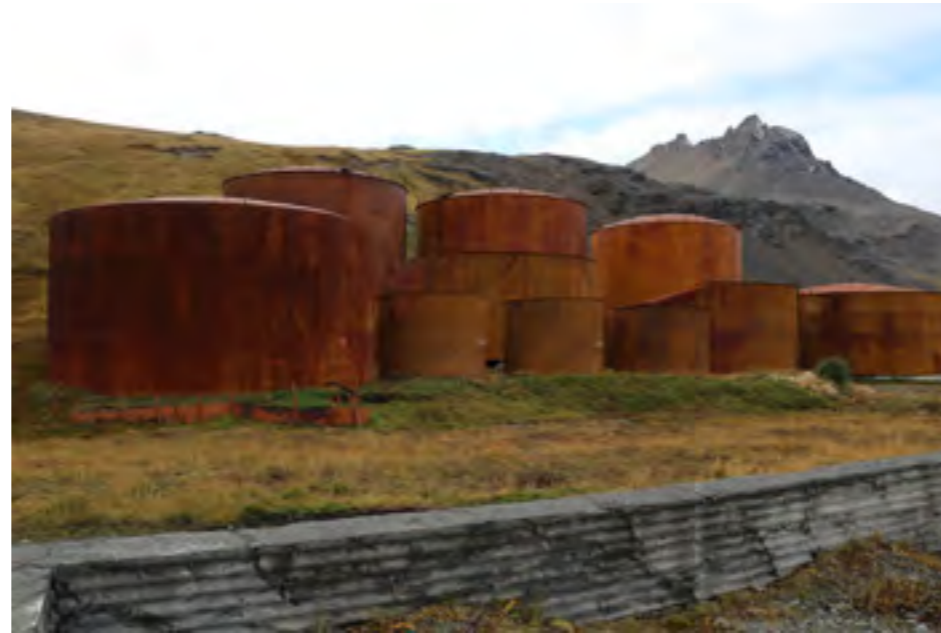
North-west storage tanks

Two large groups of tanks are located to the north-west and south-west of the factory buildings. These are rivetted steel, cylindrical tanks of various sizes that were used for both whale oil and fuel oil storage. The groups were amassed from the mid-1920s onwards with more tanks being added until the end of the 1950s. Raised on concrete or rendered brick plinths, some of the tanks have started to distort and their shallow domed roofs to collapse inwards. Some of the damage to the southern group behind the Pump House is thought to be the result of the Falklands conflict.<sup>31</sup>

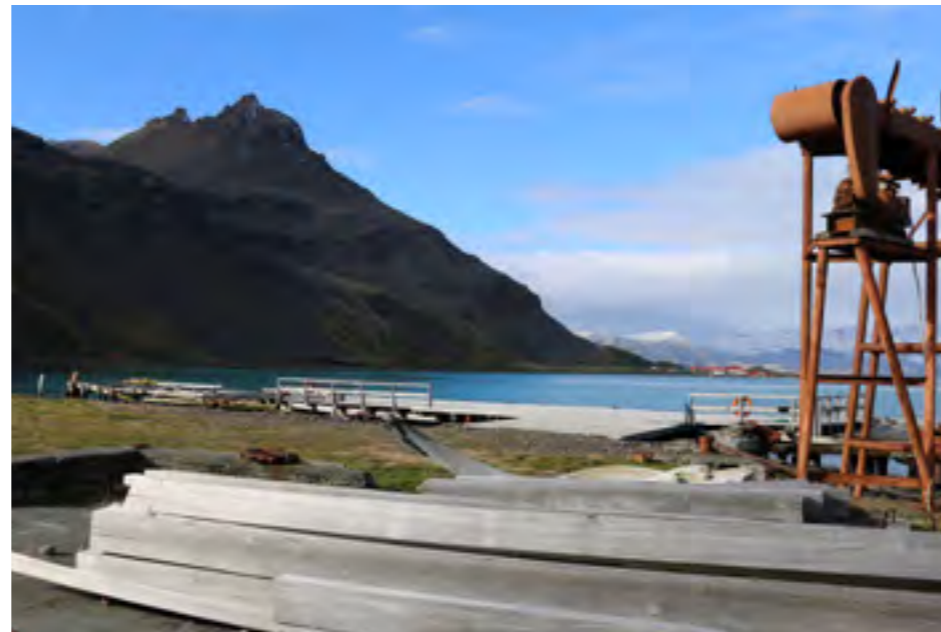
*Tijuca Jetty*

To the south is the remains of Tijuca Jetty, which was approximately an inverse 'T' shape. Like Harpon, its timbers are deteriorating but part of it has been made structurally sound and reboarded to enable boats to moor there.

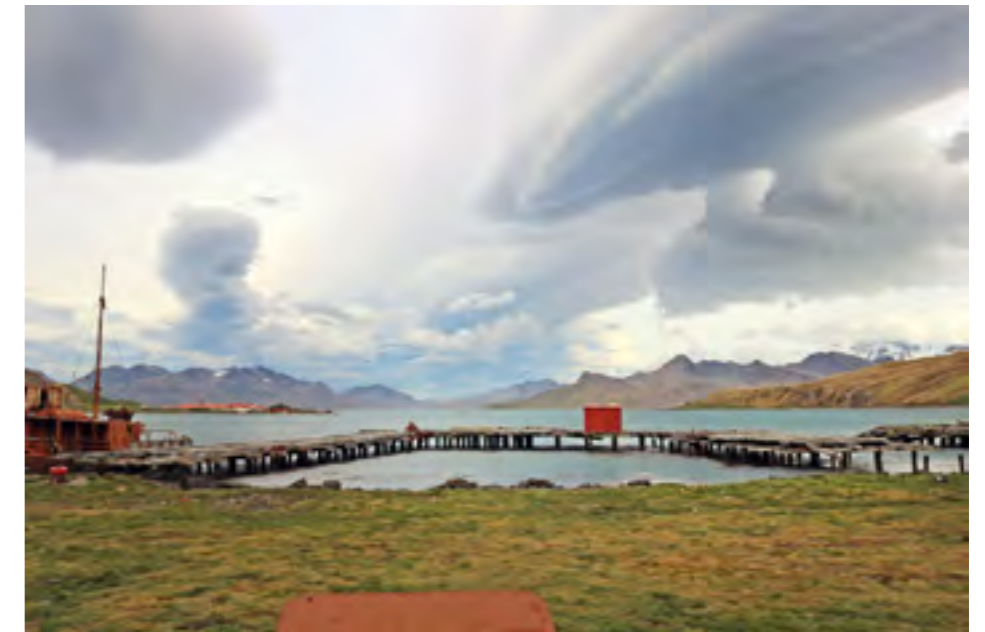
*Harpon Jetty*

The largest jetty, Harpon Jetty, is located at the north end of the station. It originally had three points of connection with land but, with the deterioration of the jetty, the landward sections were removed to prevent access to the jetty. This means it is no longer connected to the shore at any point.

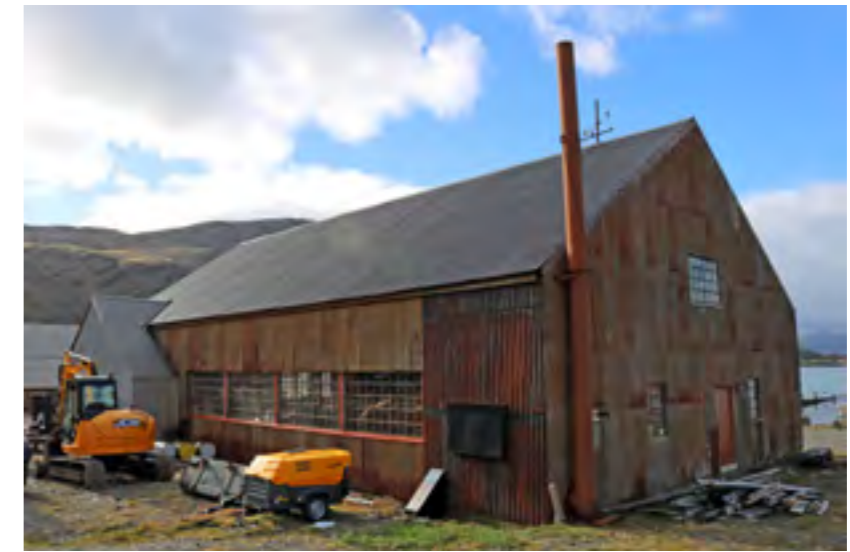
To the south, across an area recently built up and laid with historic metal sheeting to form a helipad, is the Engineering Workshop. This is a two-storey building with a recently replaced black tin roof and ochre painted corrugated sheet clad walls. Although timber-framed like the Main Store, it has a very different character deriving from its large expanses of metal windows. Internally, some of the historic workbenches and machinery, including overhead systems, survive on the ground floor and some of the historic storage on the first floor. The layout of the building has been somewhat altered by the addition of new partitions.

Immediately west of the Engineering Workshop is the partially buried remains of the base of the Blacksmith and Tinsmith Workshops that were attached to the Engineering Workshop. Some of the plant survives here as it does on the base of the Foundry that was located immediately east of the Engineering Workshop.

Engineering Workshop and remains of the Blacksmith and Tinsmith Workshops

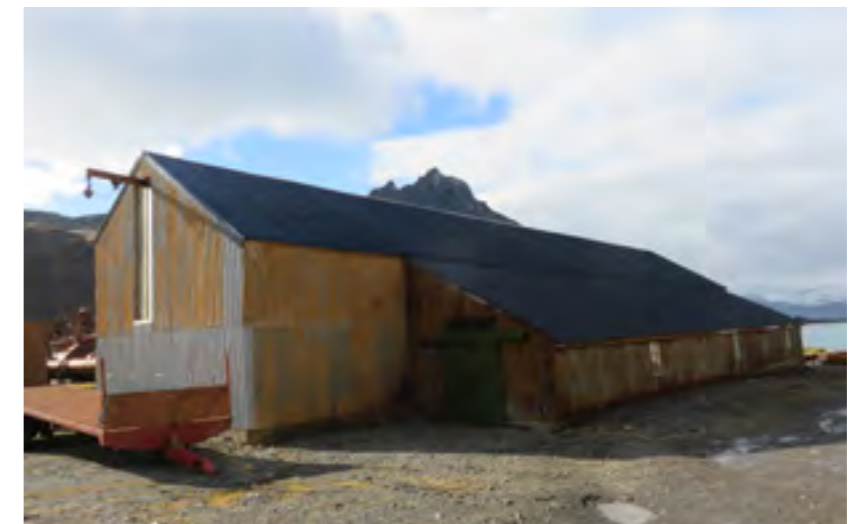
Main Store

To create a self-sufficient factory and community, the Whaling Station had its own repair yard. Defining its north side is the large two-storey building of the Main Store. Predominantly timber-framed, apart from the steel-framed west extension, it is clad in corrugated iron sheets. The walls were historically painted ochre whilst its black roof was replaced with new tin in 2017/18, apart from the southern lean-to section. The windows and doors are painted timber. Internally it retains historic shelving in the main section on both floors. Offices are located in the north-east corner on both floors with the upper office retaining its Cardex system. The lean-to section is currently being used for storing items from the Engineering Workshop.
