GRYTVIKEN  
CONSERVATION  
MANAGEMENT PLAN  
ISSUE 06  
SEPTEMBER 2018

# GRYTVIKEN CONSERVATION MANAGEMENT PLAN

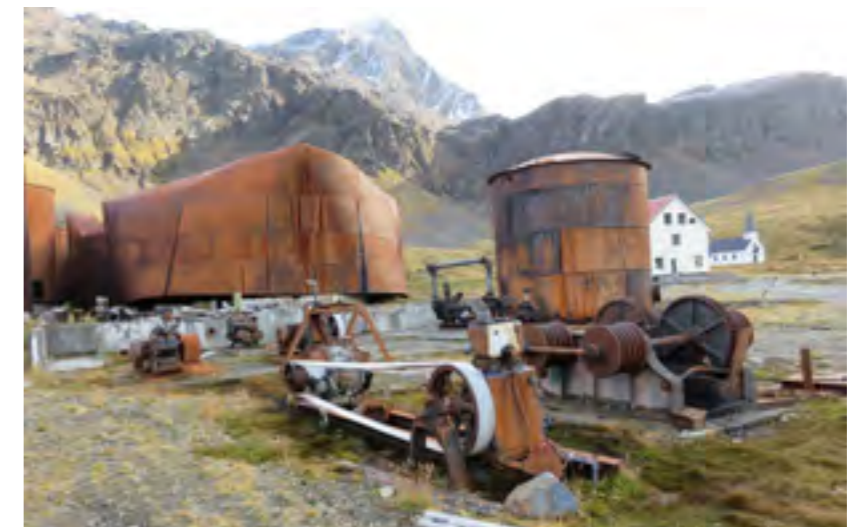
At the west end of the repair yard are the concrete bases and upstand walls of two smaller buildings, the Winch House and the Pump House. Both also contain associated plant.

Winch House plant with Pump House plant behind. The traction winch in the foreground was originally on an early steam whale catcher and was converted for use on the slipway

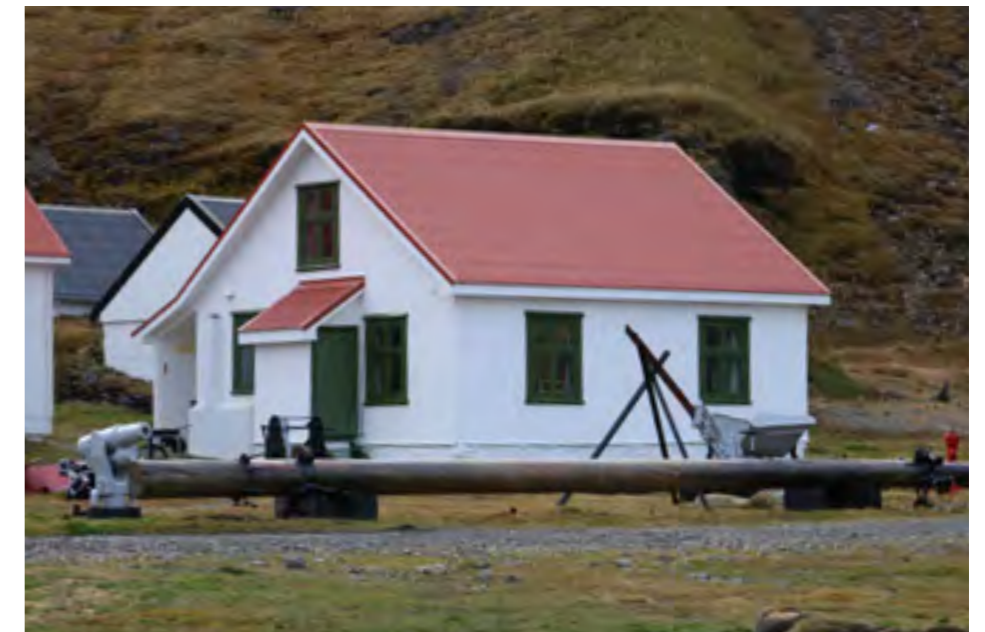
*Drukken Villa*

To the north-east of the Villa is the smaller Drukken Villa, which is slightly older. It was built for the Magistrate in 1909/10. The base of the walls is rendered whilst the upper parts are white painted timber clad. The roof has been replaced with the same material at the Villa. Internally, it has been comprehensively refurbished with no evident historic features. Comparison of the current layout with the 1992 survey drawing ([Appendix A](#)) shows that there have been alterations and additions to the layout since 1992.

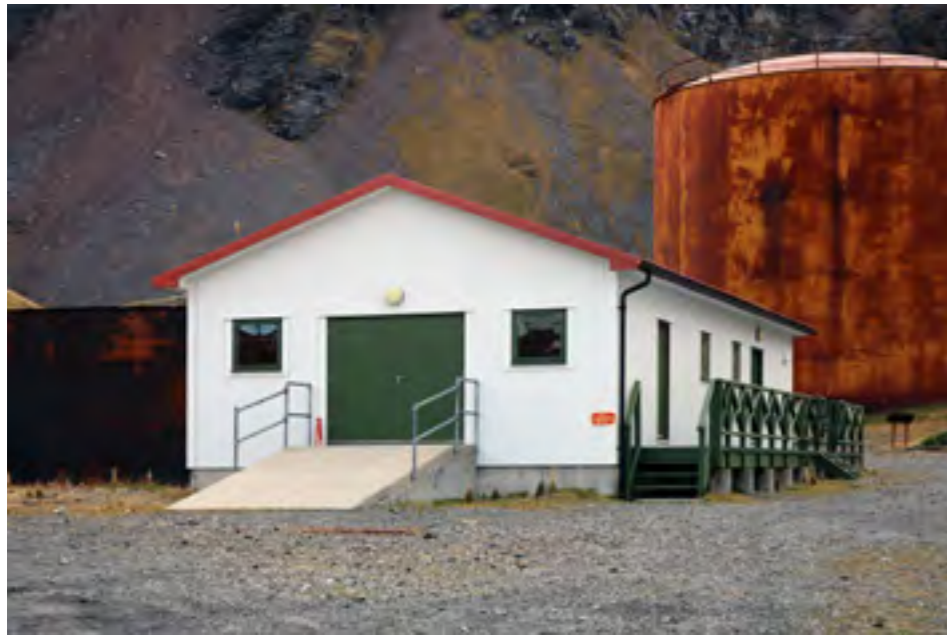
To the south of the Museum is the Carr Maritime Gallery with a workshop and public toilets at the west end. The building replaced in the 2005/6 season an earlier historic structure. The profile of the tin cladding makes it evidently a new building. A raised timber walkway runs along the north and west sides whilst a concrete ramp provides access to the double doors of the gallery at the east end.

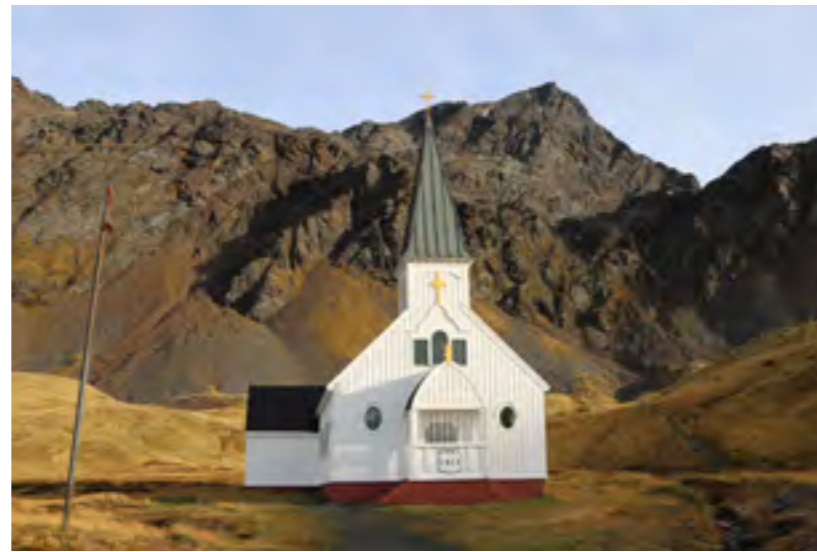
The Church is a well-maintained timber building that is typical in its design of Norwegian churches. Though much repaired, it retains its historic character inside and out. The timber panelled walls contain painted timber windows with a hood detail whilst the roof is clad in felt. The small spire is augmented with a painted cross. Internally the structure has been strengthened but the original building is legible. The historic pews, pulpit and altar have been retained. There is also a small library lined with bookshelves that still contain the historic books in English, Norwegian and other languages.

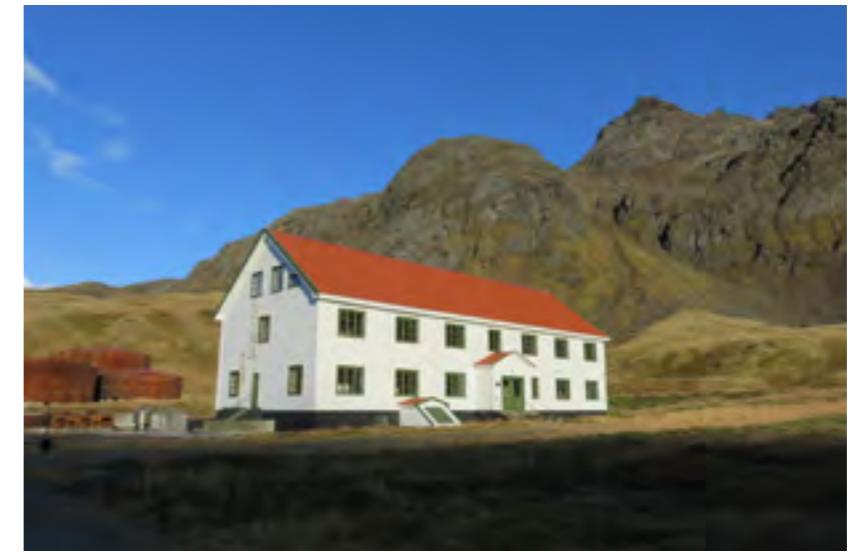
The Nybrakka was refurbished externally in 2014/15 and has timber clad walls and a red painted modern tin roof. The historic windows were repaired. Internally the layout seems to have been largely preserved but the walls are scarred with bullet damage and graffiti from the post-1982 military presence on the island. Some of the original bunk dividers, shelves and cupboards have been retained along with the historic panelling, newspapering of some walls and staircase. It has been converted to an emergency shelter with modern toilets and kitchen fitted in some rooms. The basement, which contained the toilet and shower facilities and darkrooms, is the best preserved area with many of the original shower partitions, fittings and sanitaryware surviving although in a poor condition due to flooding.

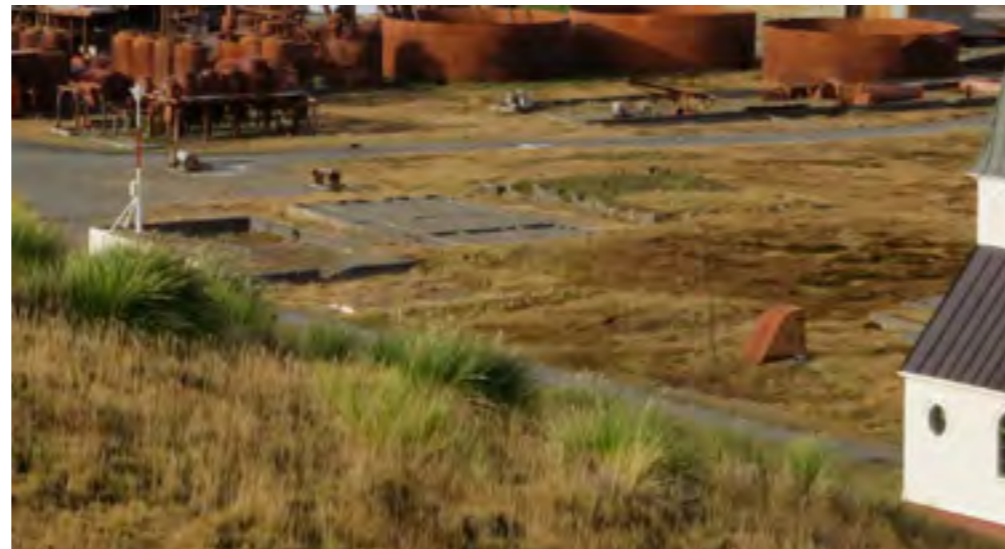
The concrete bases and some upstanding walls survive of the Kino, Russebrakka, bath house, two barracks, communal mess, slaughterhouse and hospital. Apart from bedrooms, the Russebrakka contained the laundry and two, relatively modern pieces of laundry machinery survive. The rendered sinks of the slaughterhouse and some plant also survive as do the cookers and tile flooring of the kitchen attached to the communal mess.

The bases of the Russebrakka (with laundry equipment) and two other barracks with the bath house between

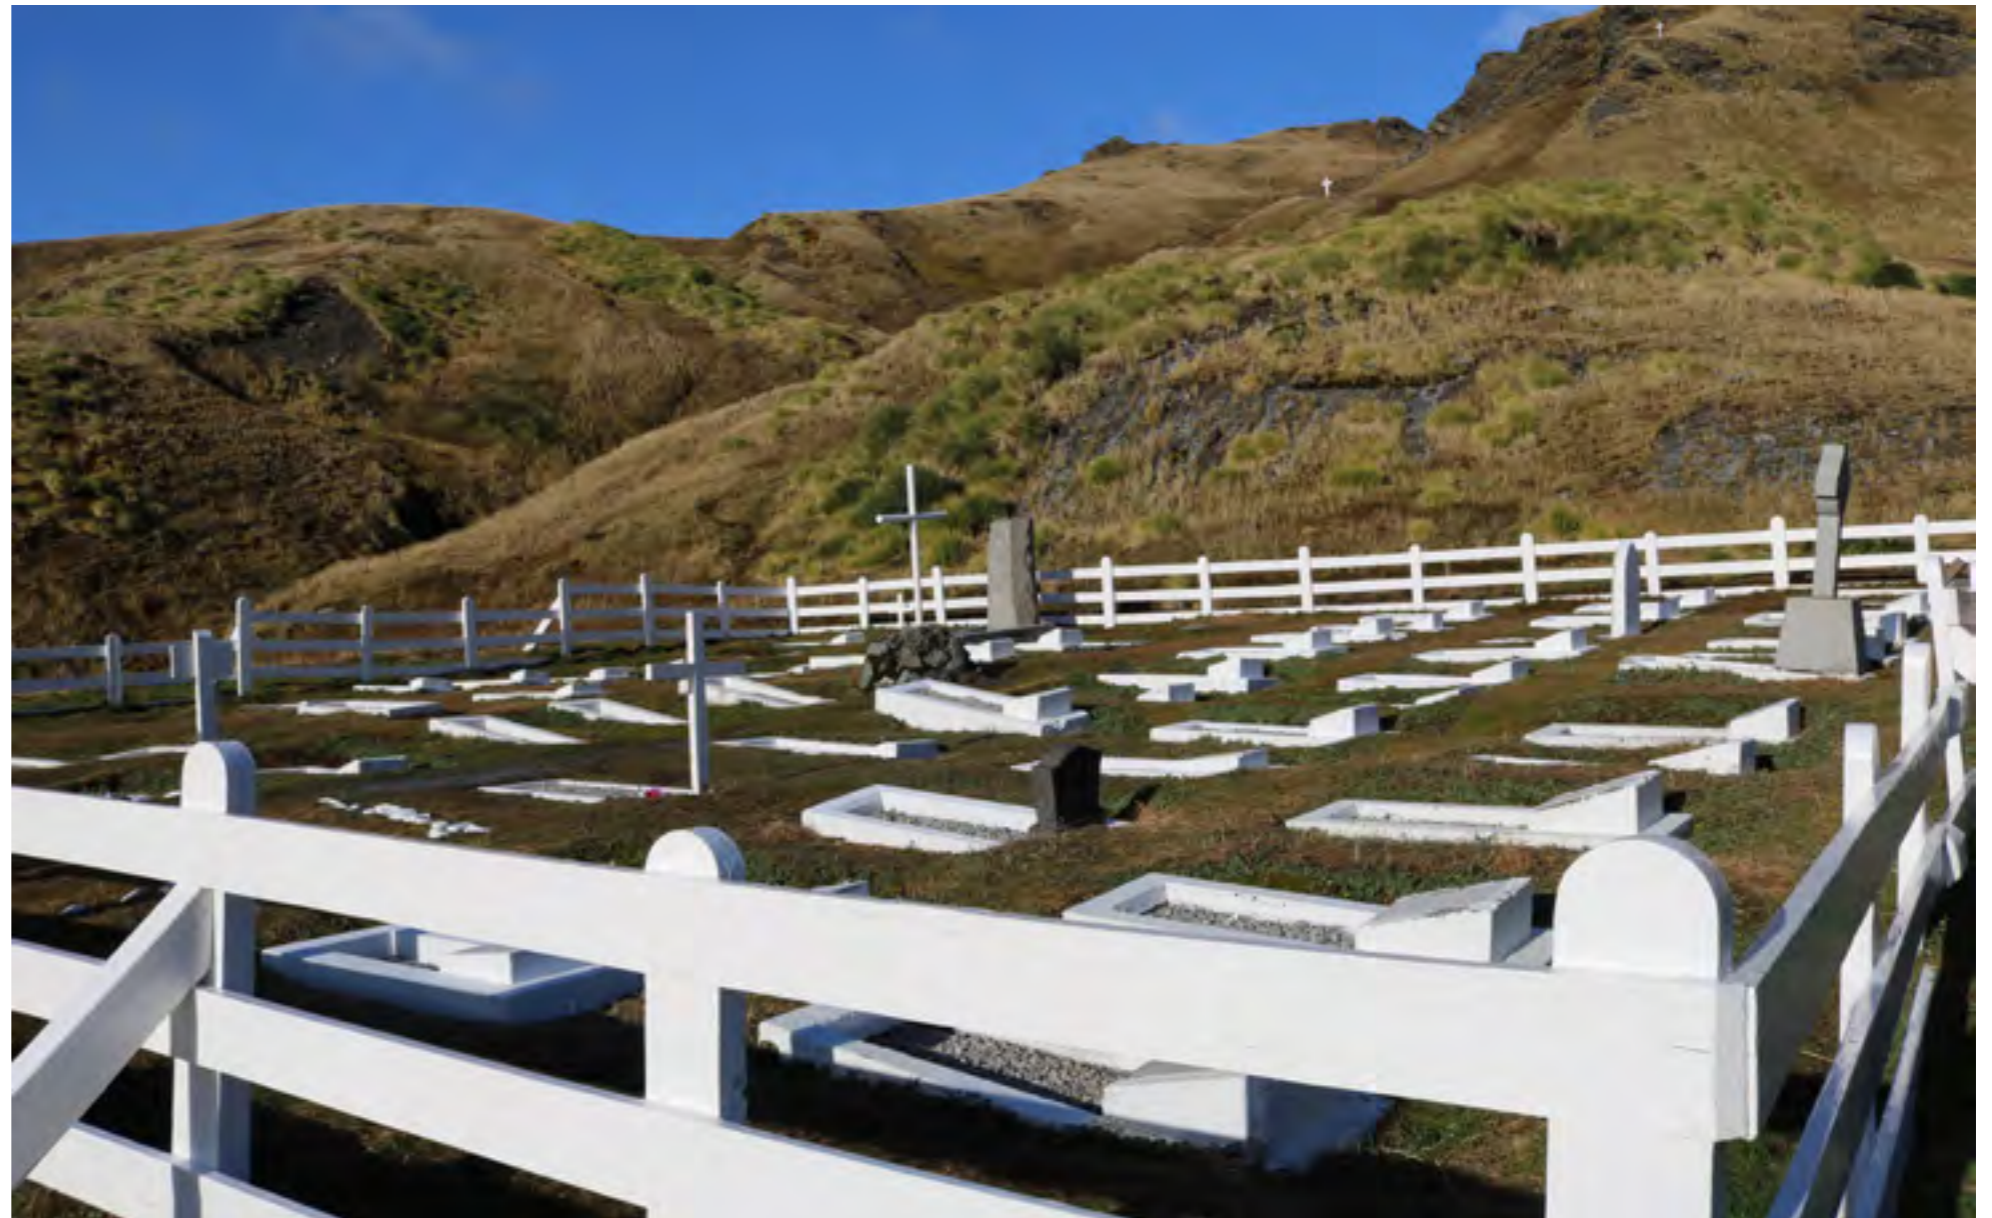
The Cemetery is located on higher ground to the south of the station. Most of the graves are marked with white painted concrete surrounds and angled grave markers, some of which may have been replaced with marble or other stones. Some of the graves have sunken with the subsidence of the ground. There are a small number of different gravestones and at the centre of the graveyard is a painted metal cross. The dominant feature is the stone monolith that marks the grave of Sir Ernest Shackleton.

The Cemetery is enclosed with a white painted three-bar timber fence installed in the 1990s. The design is slightly different to that shown in a historic photograph.

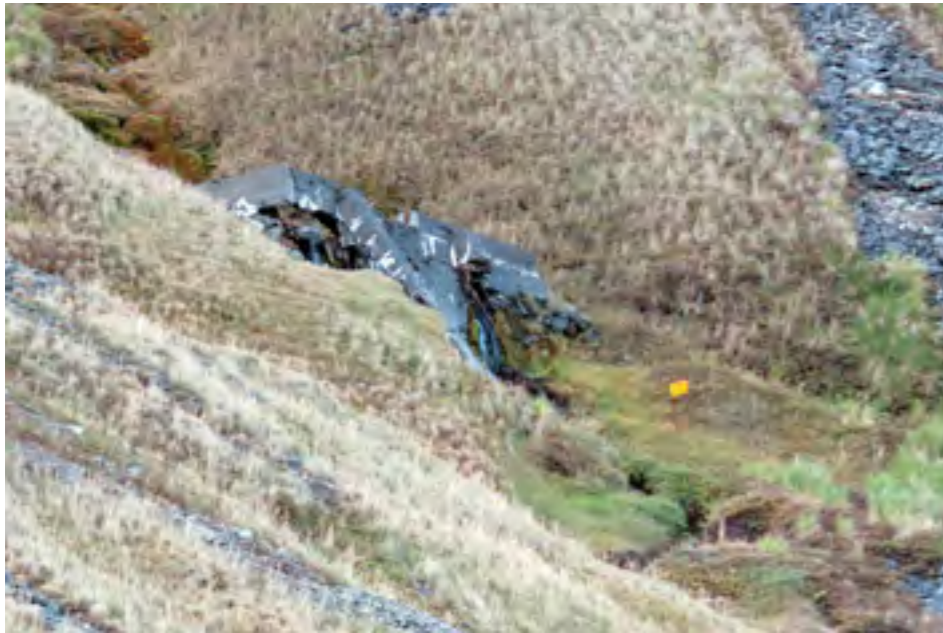
*Remains of dam above KEP*

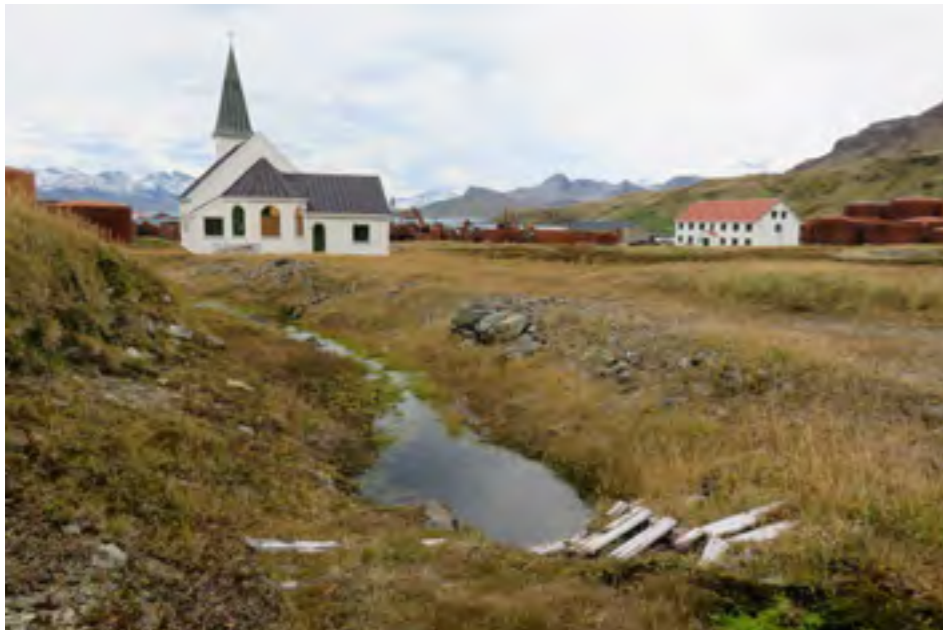
*Remains of a bridge near the Church*

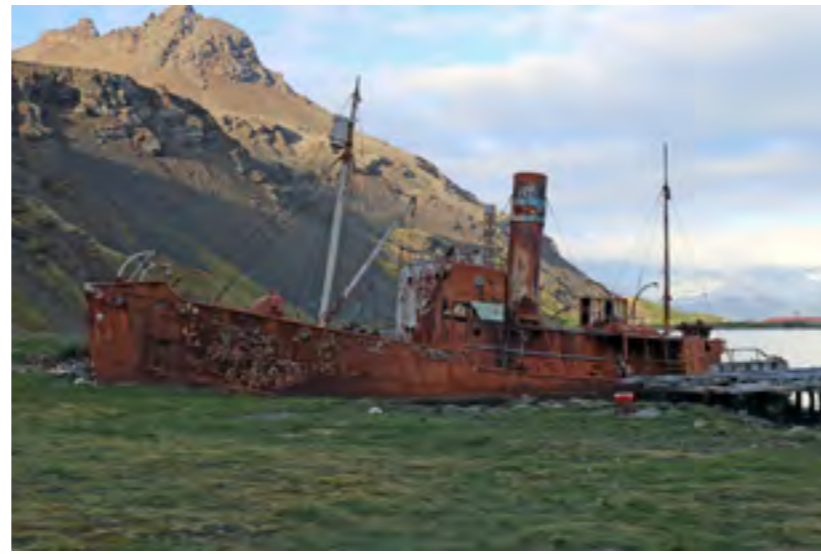
Albatros

The vessels and the jetties are highly significant features of Grytviken but they are all now in poor condition. The catchers *Albatros* and *Dias* in particular are in a poor way. They have been beached but the stern of each ship remains in the sea and water flows in and out of the hull with each tide. If these ships are to have a long-term future then some major and very expensive conservation work is going to be needed.

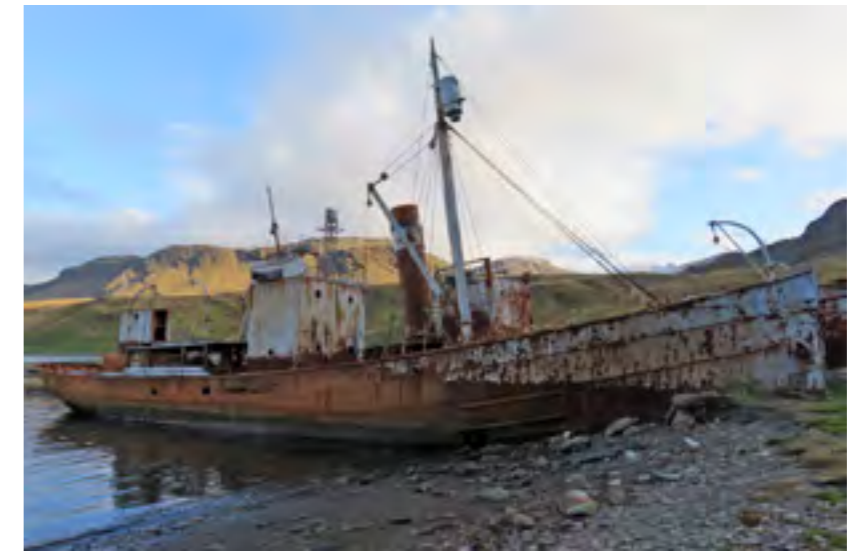
Dias

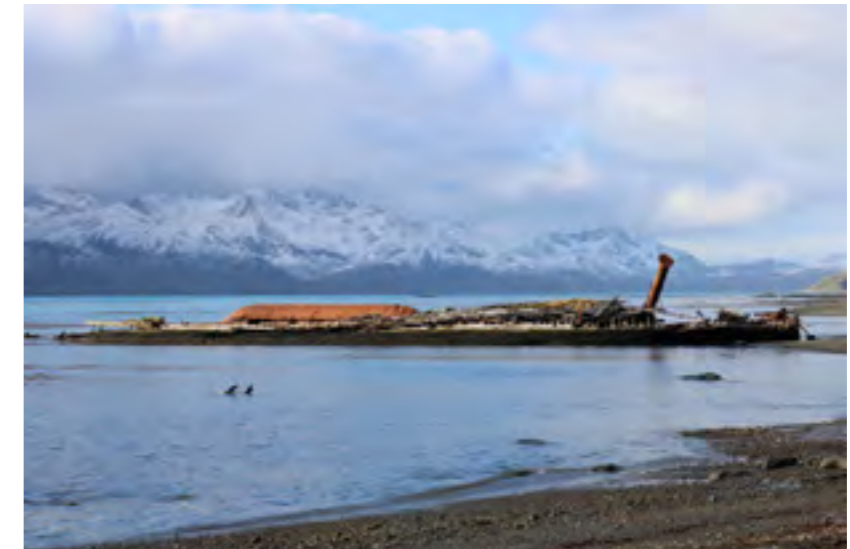
Further round the bay are the remains of the barque *Louise*. This has been at Grytviken since the establishment of the Whaling Station. She was a fine surviving example of a 'down-easter' before she was inadvertently burnt to the shoreline during a military training exercise.

Louise

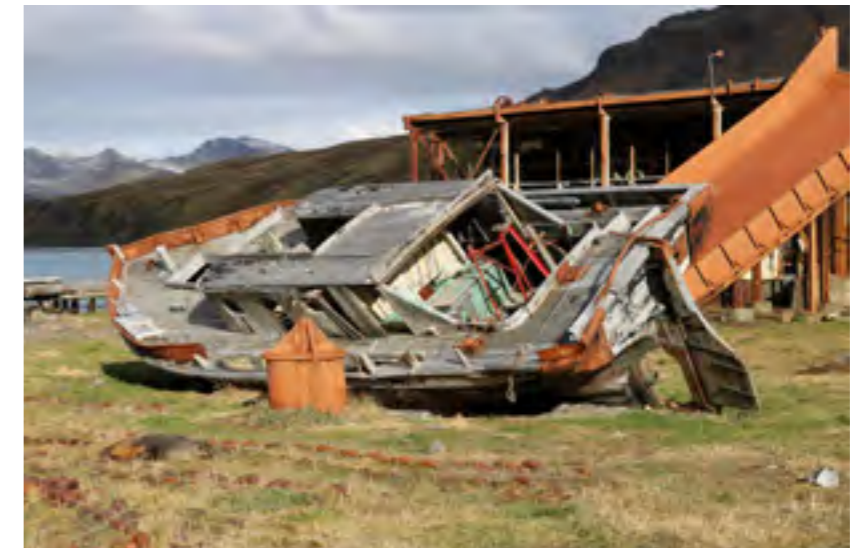
Two motor boats of unknown date also survive on shore at Grytviken: one near the *Louise* and the other located in the middle of the Flensing Plan. The supports for both have failed and they lie on their sides. The timber boats are deteriorating.

Motor boat on Flensing Plan

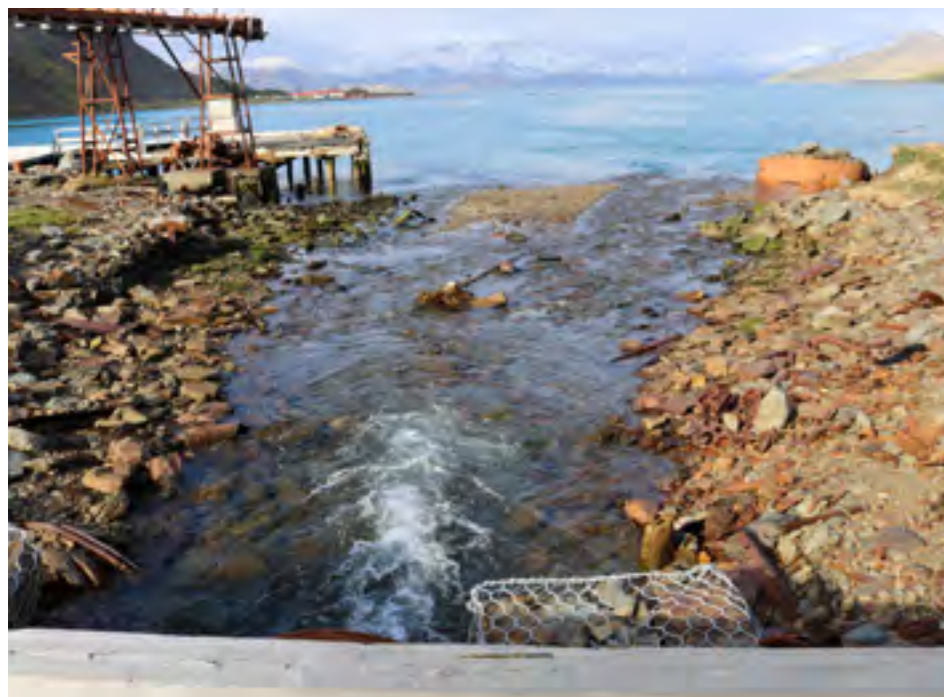
The eroding shoreline is revealing the industrial detritus used to reclaim land for the station

Grytviken's location on the shore means that it is exposed to coastal erosion caused by the sea. Much of the immediate shoreline was reclaimed during the whaling period and this is, in turn being reclaimed by the sea. This is not only exposing the industrial archaeology of the material used to make up the ground but also changing the shape and size of the Whaling Station. There are some pieces of equipment, such as a winch at the south-east corner of the Flensing Plan and a piece of equipment in the Plating Store, whose bases are starting to break up and which are at risk of falling into the sea. The impact of the sea is compounded by icebergs, which can reach as far as Grytviken, mainly from the local glaciers in Cumberland Bay. In 2017, considerable damage was done to the jetties by icebergs being blown against the shore. The sea also presents a further conservation challenge in terms of salt water corrosion, particularly to the beached vessels.

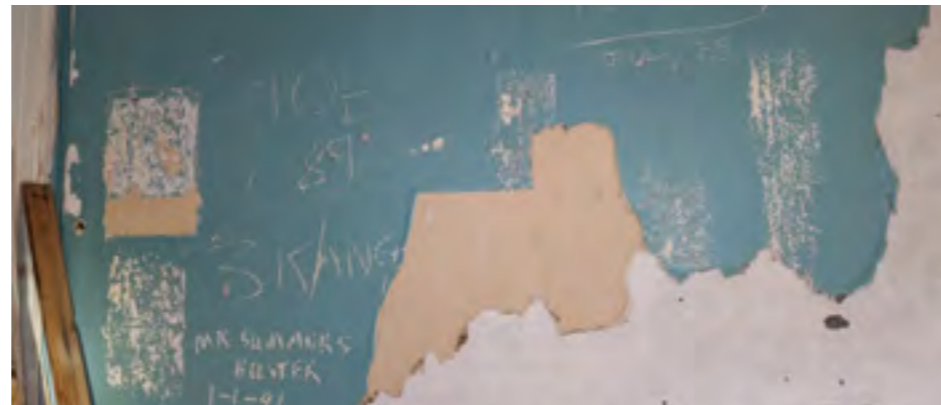
Soldiers' graffiti from the late 1980s and early 1990s in Nybrakka

Some of the buildings and the burnt-out wreck of the *Louise* are illustrative of the late twentieth century history of the Whaling Station. Many of the buildings, from the Main Store to the Provisions Store, have bullet holes in their tin walls whilst internally Nybrakka has numerous bullet holes and some bayonet damage as well as soldiers' graffiti.

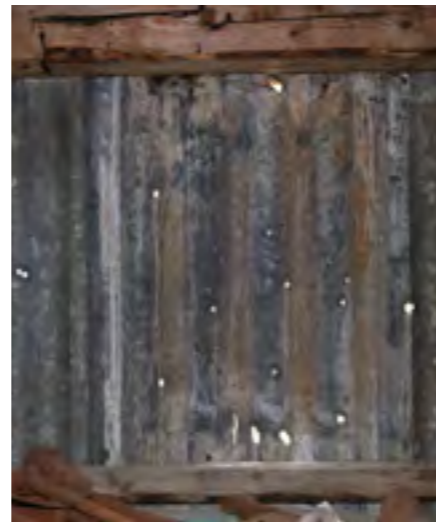
Bullet holes in the Main Store wall

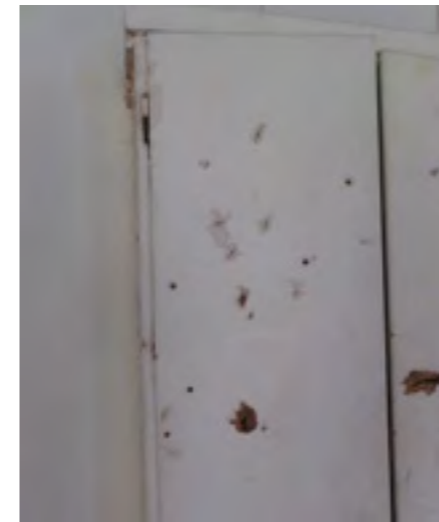
The scars of military presence: bullet and bayonet damage to a cupboard in Nybrakka

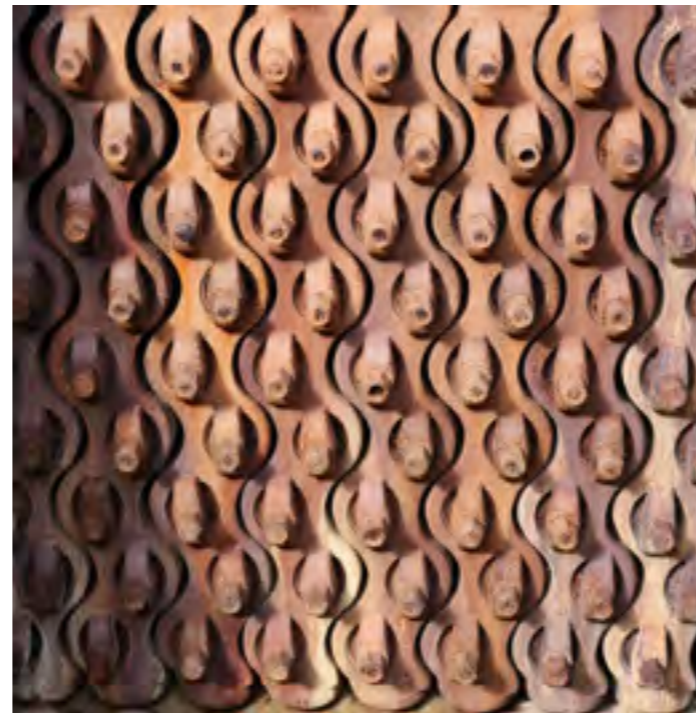
*Detail of the boiler in the Blubber Cookery*

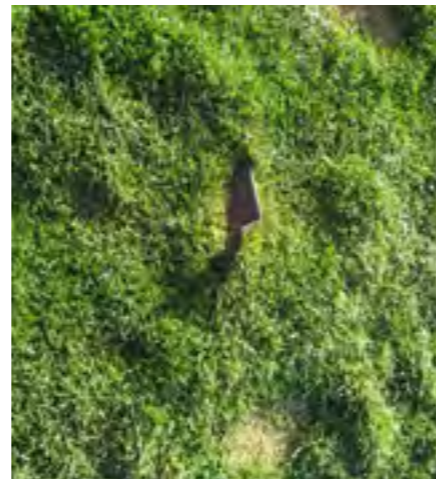
Metal sticking up out of the ground

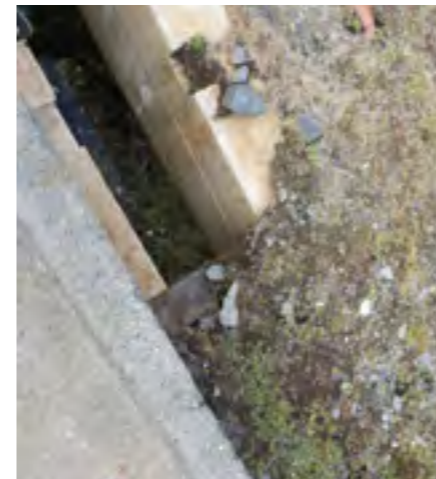
Exposed culvert near the Separator House

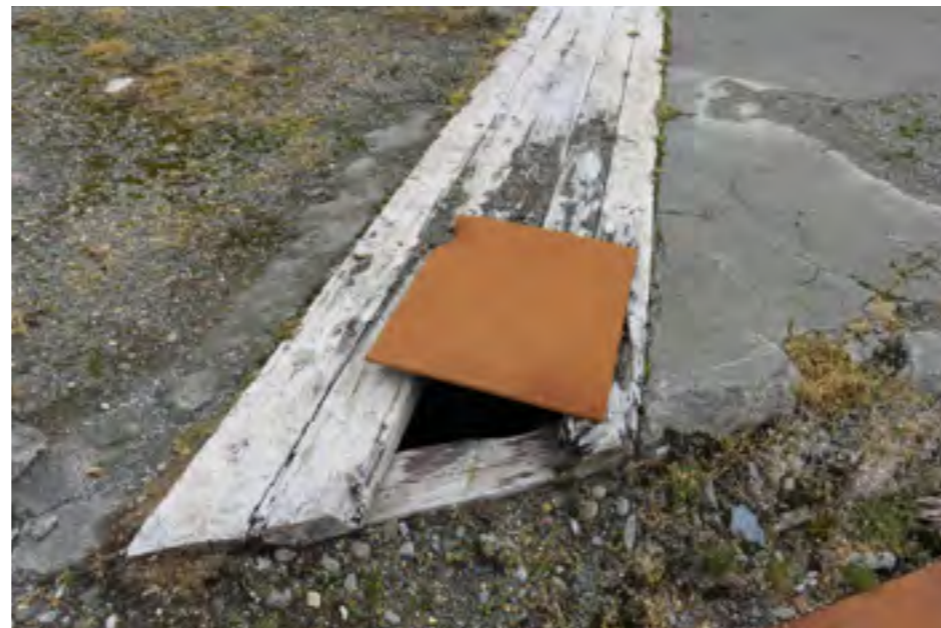
Hole over the culvert in the Guano Store

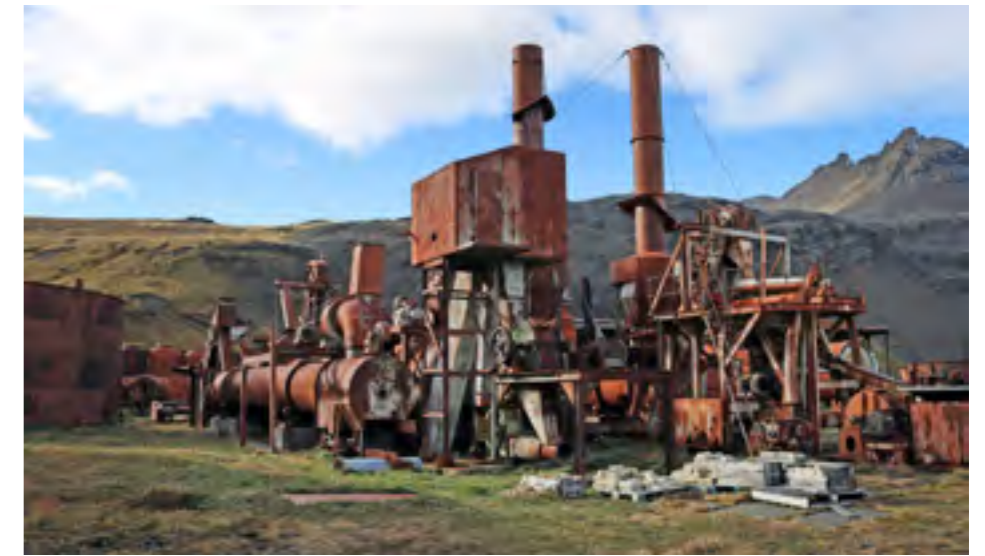
The chimneys of the Guano Factory are secured with ties

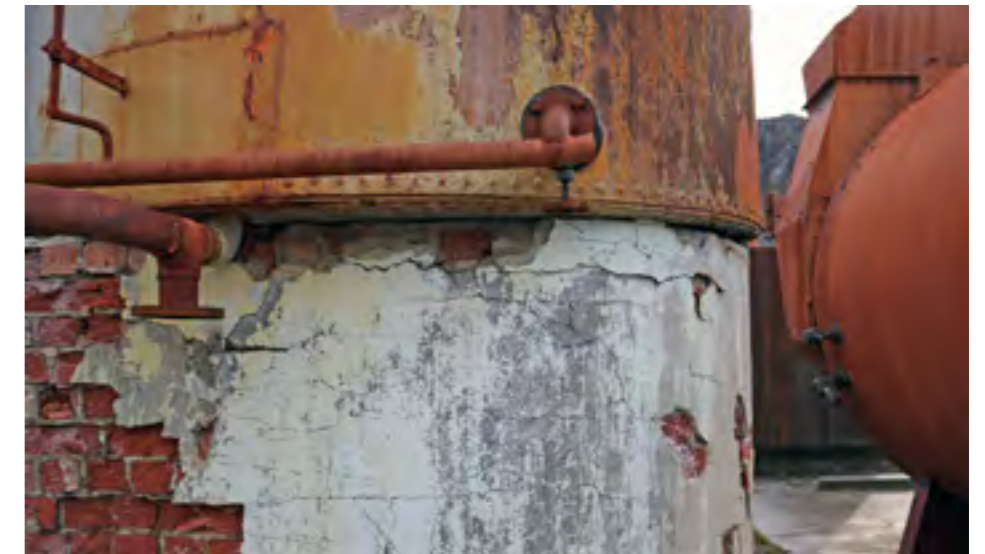
Boiler that has shifted on its base

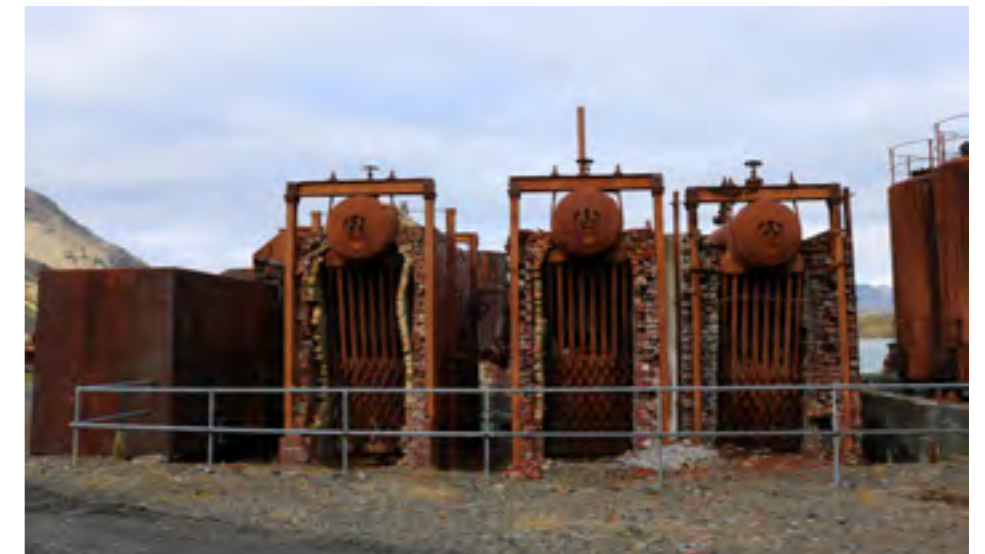
Barrier in front of the boilers with failing brickwork in the Boiler House

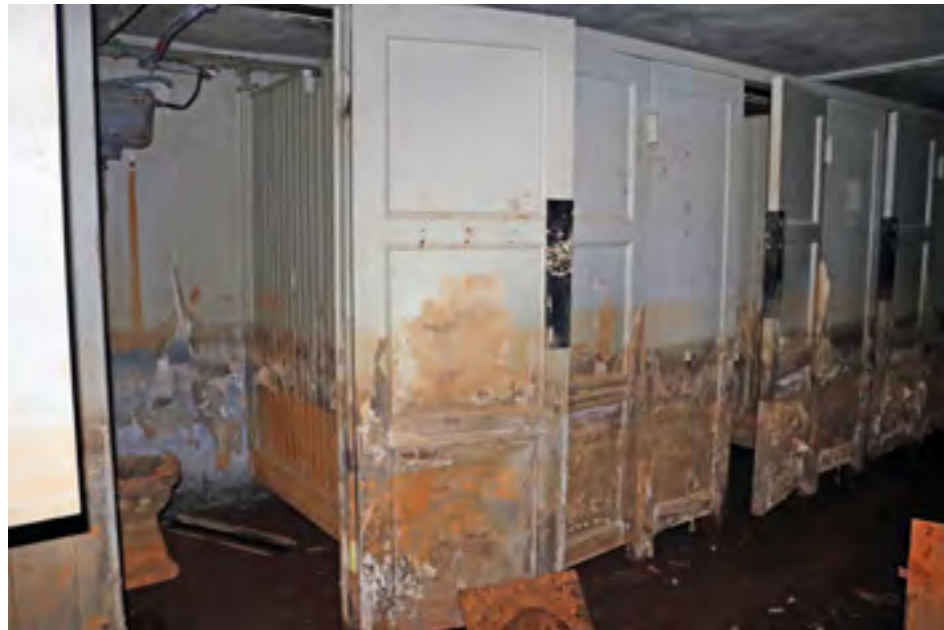
Evidence of past flooding in the Nybrakka basement

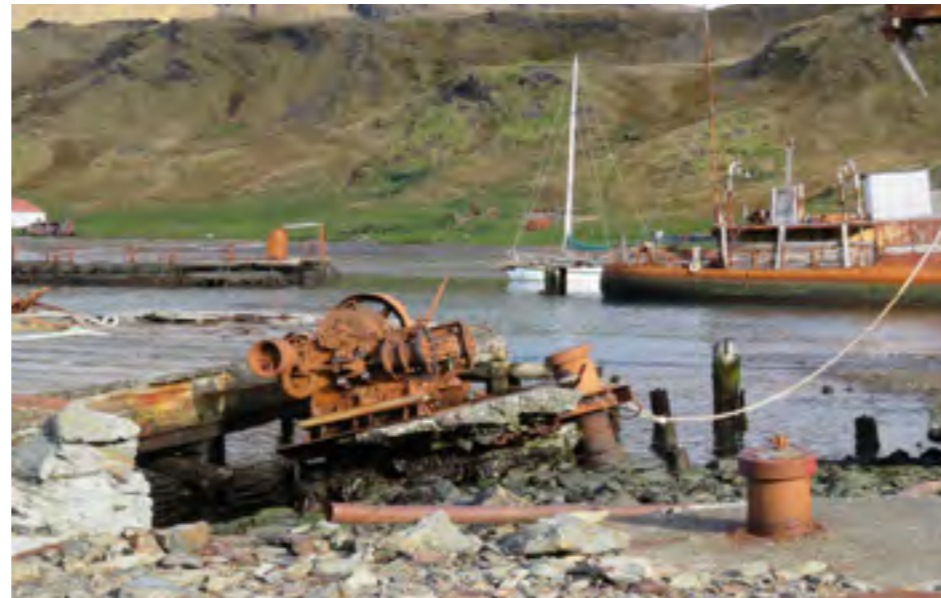
Winch at the south-east corner of the Flensing Plan

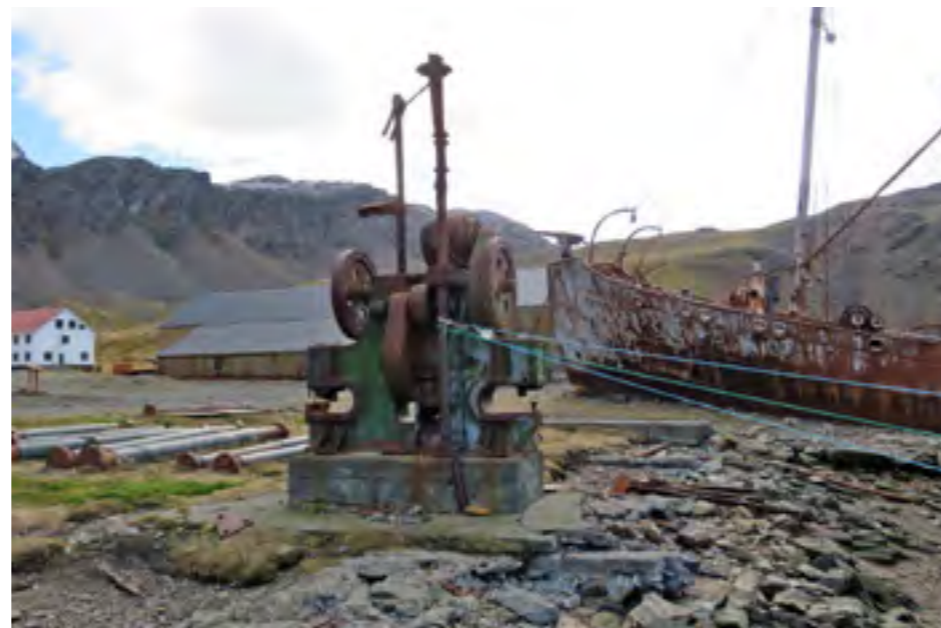
The Plating Store floor is crumbling due to the effect of the sea

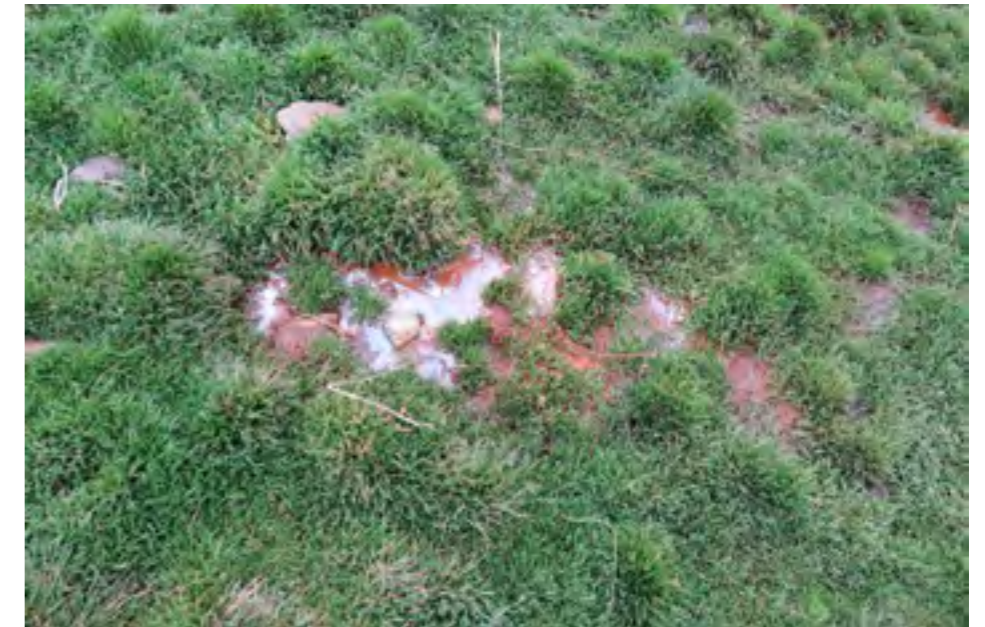
Oil seeping out of the ground

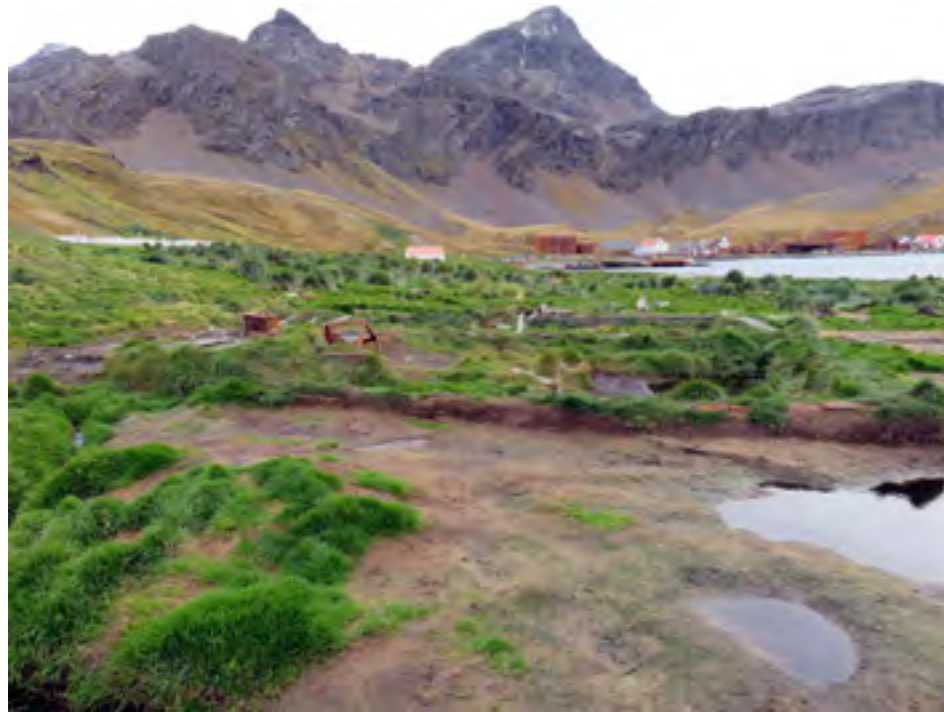
A further threat to the built heritage comes from the wildlife. The greatest risk of damage is on the south side of the Whaling Station where the fur seals move across the remains of the radio workshop, hastening its decay, and also get into the Cemetery. When there are large numbers of seals on the beach, it can impact on visitors and staff, impeding access between KEP and Grytviken and especially access to the Cemetery.

*The Radio Workshop with grass worn down by fur seals*
