DISUSED WHALING STATIONS

Grytviken Harbour Gazetteer

Purcell Miller Tritton LLP, 3 Colegate, Norwich, Norfolk NR3 1BN
norwich@purcellmillertriton.com www.purcellmillertriton.com
July 2011

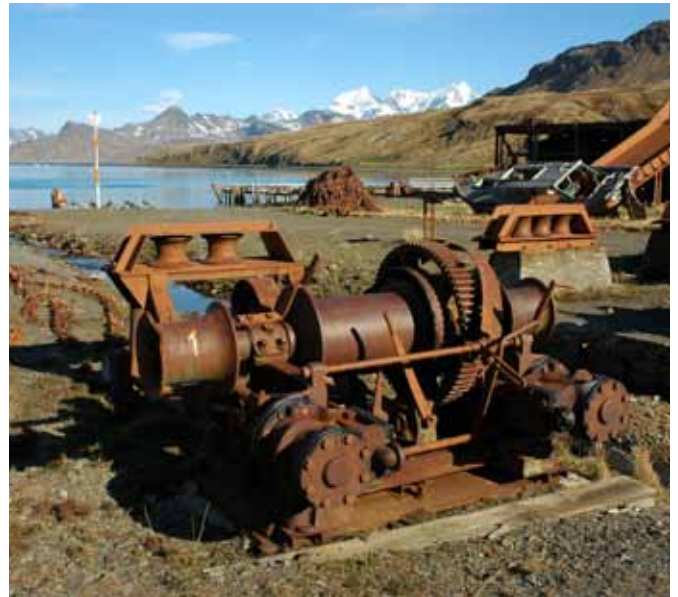
1.1 One of the winches at the top (west) side of the Plan

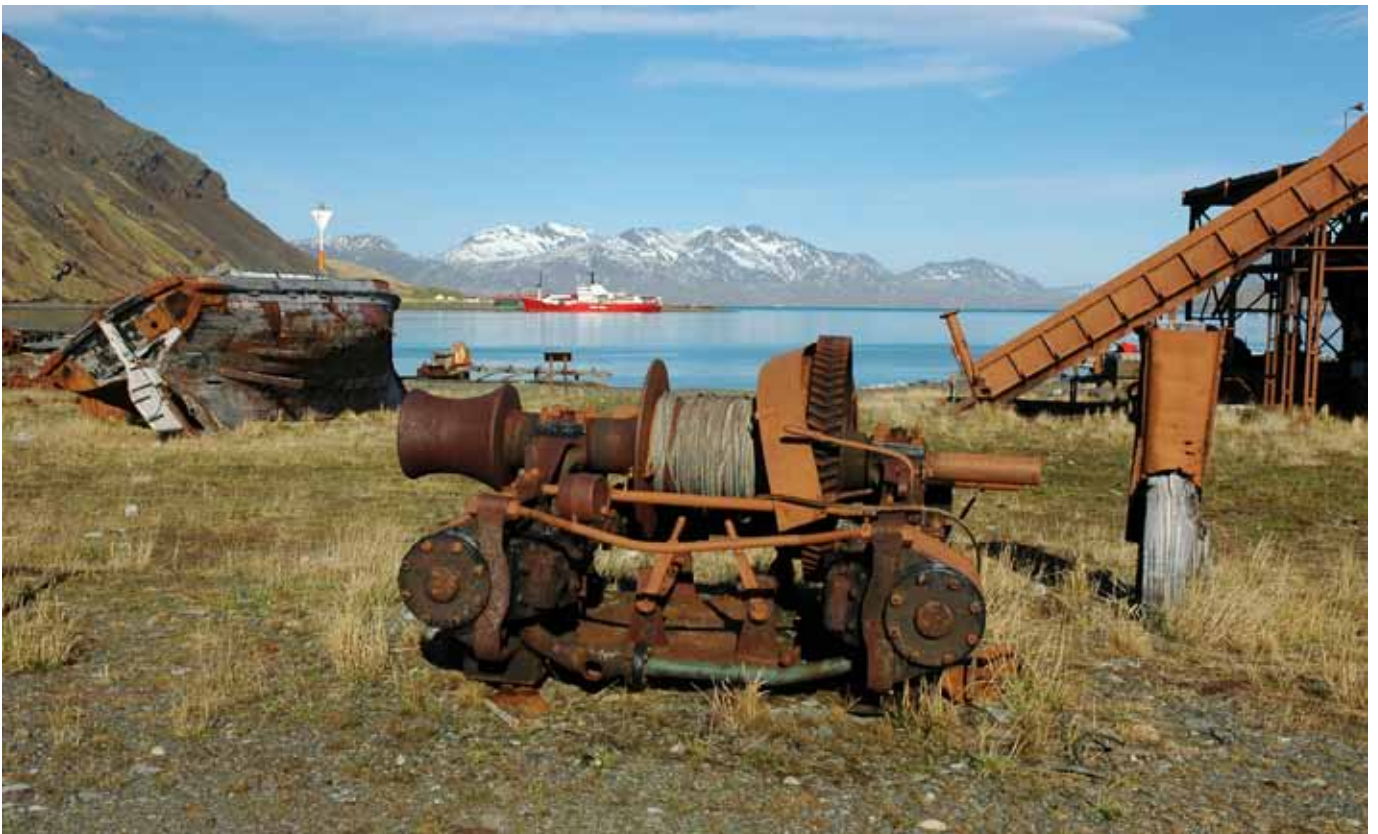
All the timber decking has been removed from the Plan, with only a small area remaining near Building No.3. This remaining section is in poor condition. There is a good deal of splintered timber lying about.

The Plan area is now covered in rough stone with grass growing through it. There is a motor launch lying in the middle of the area and a large amount of chain, of which some is heaped up in the centre of the Plan. The metal slipway remains where the whales would have been pulled in but Jetty No.59 (Tijvca Jetty) has disappeared.

1.2 General view across the Plan looking east towards King Edward Point

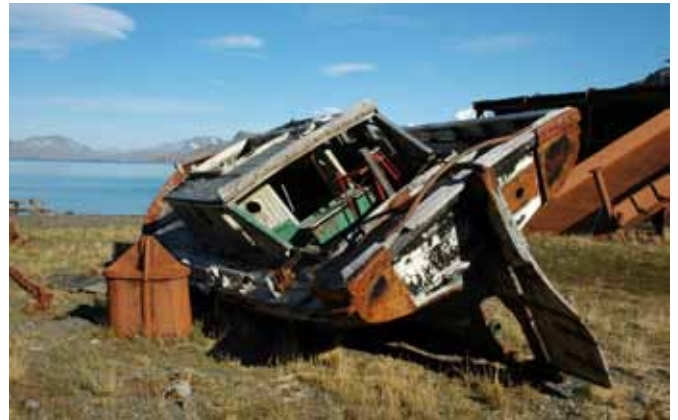
1.5 Motorboat in the centre of the Flensing Platform

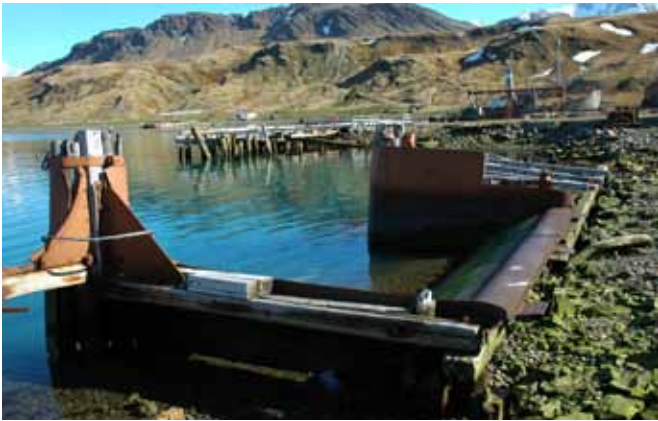
1.4 The slipway for hauling whales onto the Flensing Platform

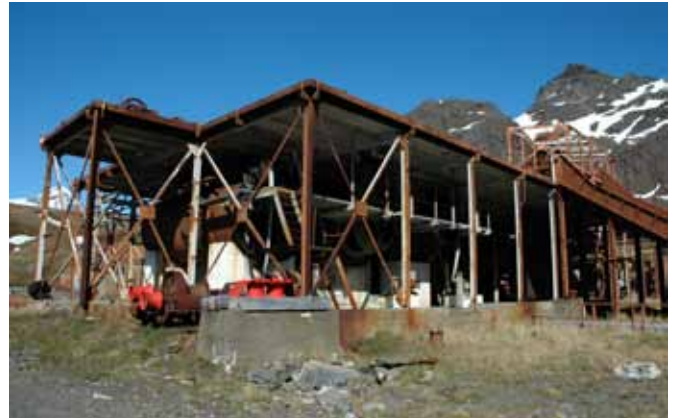
2.1 Remaining support structure of the Meat Cookery northwest end

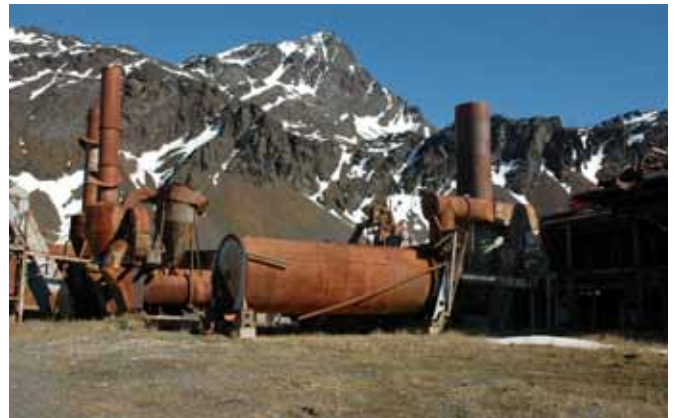
2.2 The rotary guano cookers on the south side of Building No. 2

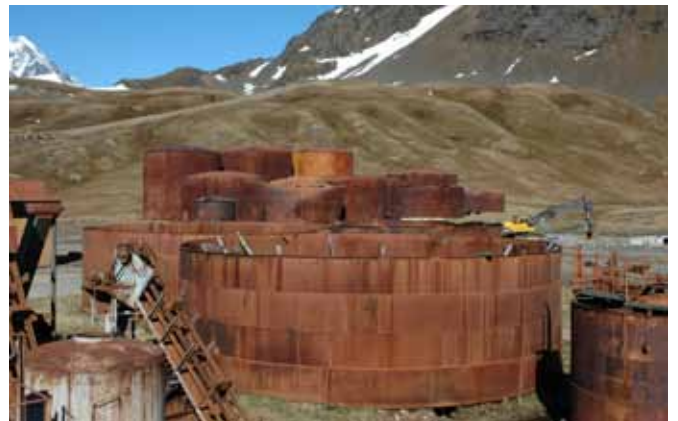
Standing between the arms of Building No.2 are a number of structures: three large tanks, approximately 4m high. These remain in position and appear reasonably solid although one has a sizeable dent in one of its sheets. These tanks do not appear to be on particularly good footings, (loose rock is all that can be seen) and at least one of the tanks appears to have shifted.

2.18 The storage tanks enclosed by the northwest arm of Building No. 2 and the Bone Cookery

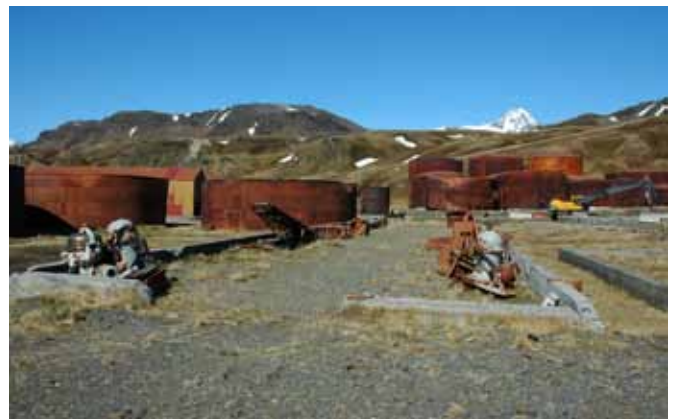
2.19 The remaining outline of the northwest wing of Building No. 2 looking southwards

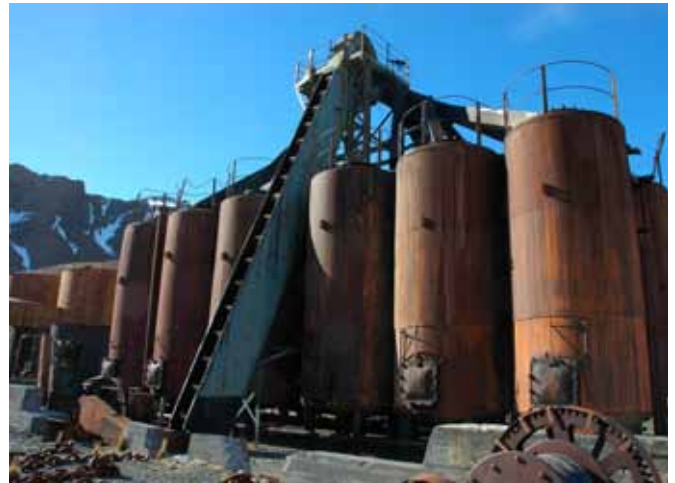
The supporting framework for the distribution system remains in place, together with a steel and timber deck at the top of the vertical cylinders. This would appear to give a fair amount of bracing to the cylinders themselves. Some of the pipe work and controls in the central area remain in position.

3.5 Blubber cookers and remains of hoist system looking northwest

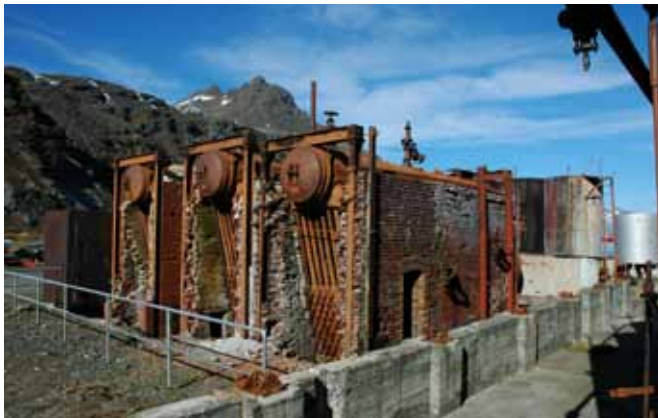
Immediately east of these are two large boilers which appear still to be fitted for burning solid fuel. The boilers are on different bases: that to the north is on steel cradles and looks secure; that to the south has a brick cradle which is decaying with a good deal of it fallen away and little remaining other than wedges. This boiler is going to need some attention relatively soon. Between boilers is a pump.

3.3 Southwest corner of the boilers

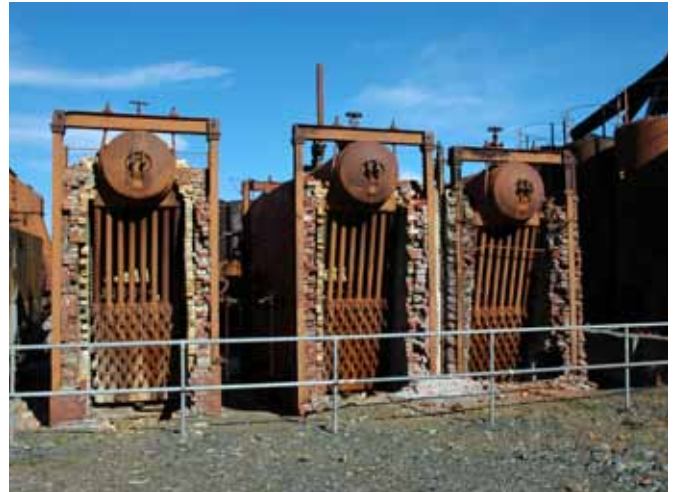
This building has also been taken down with only the floor slab and the concrete walls and the plant base plates remaining in position. To the north side three boilers with brick walls: the brick walls are falling away and brickwork on the top level is loose and probably likely to blow off in the wind. These three boilers are all fitted with oil burners.

3.6 West end of boilers

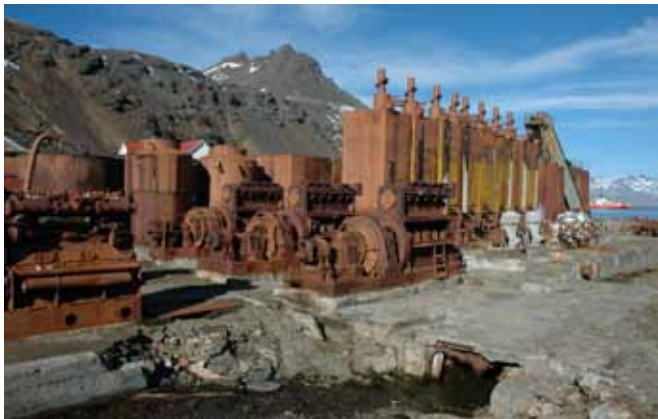
The building has been entirely taken down with only the concrete bases remaining indicating the wall positions. There are seven diesel electric generator sets in here, all manufactured by Blackstone, all rusting but still very apparent what they were and how they worked.

4.1 General view of Separator and Power Plant looking northeast

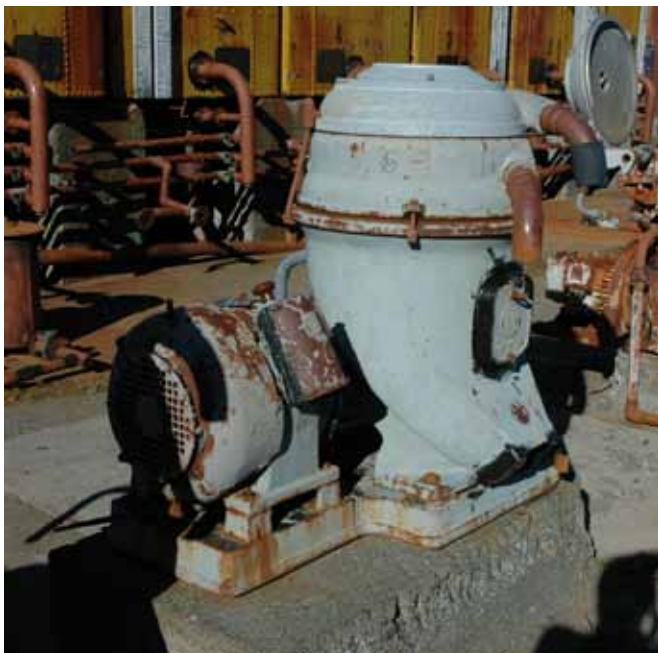
The separator plant appears to consist of eight vertical tanks within the building and eight centrifuges. Tanks remain either side of the building; seven cylindrical tanks to the south (originally eight but one has been removed) and five cylindrical tanks and four rectangular tanks to the north side of the building. These sit on brick bases within a concrete bun and appear to be in fair order. Those to the south sit on a raised steel frame made out of RSJs.

4.2 Detail of centrifuge

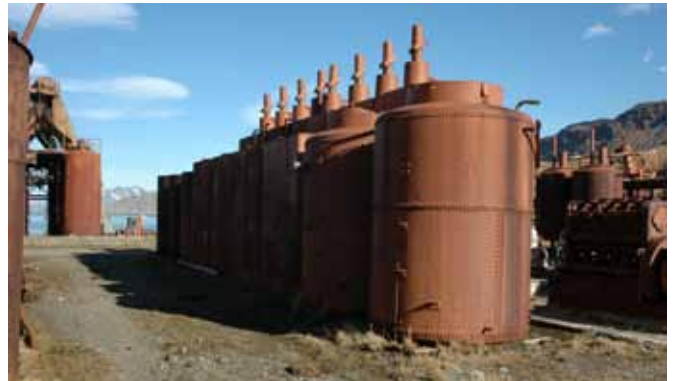
4.3 Cylindrical tanks to south of the building

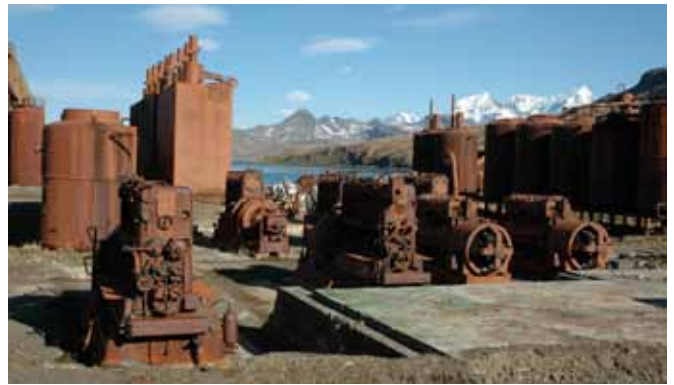
4.4 General view of the generator sets

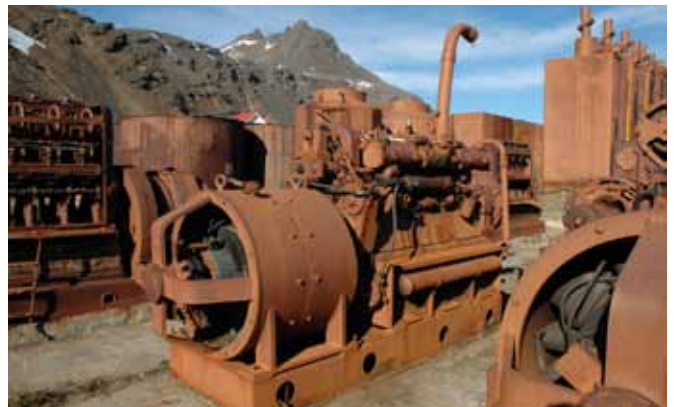
4.5 Detail of generator set

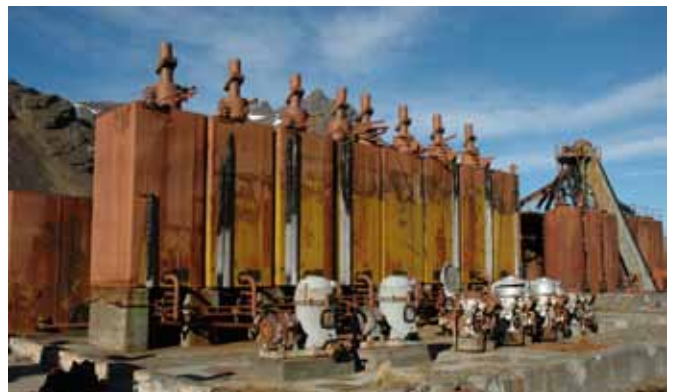
4.6 Tanks and centrifuges

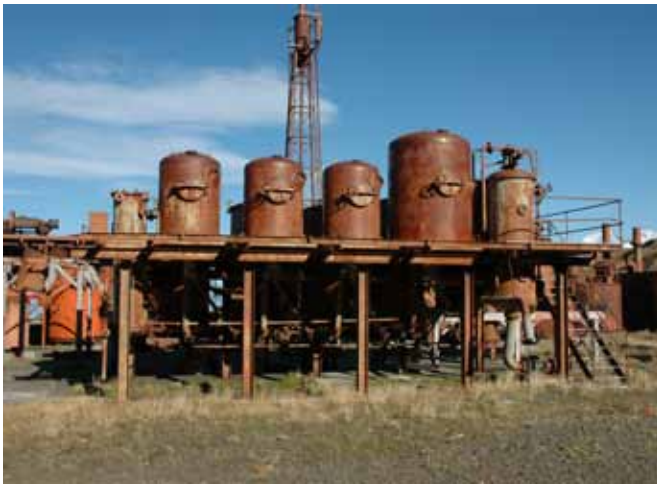
The Glue Water Plant has been entirely taken down with only the concrete base remaining. The plant and steel supporting structure remain in place and again all appears to be reasonably solid at the moment given its degree of exposure.

5.1 West side of Glue Water Plant

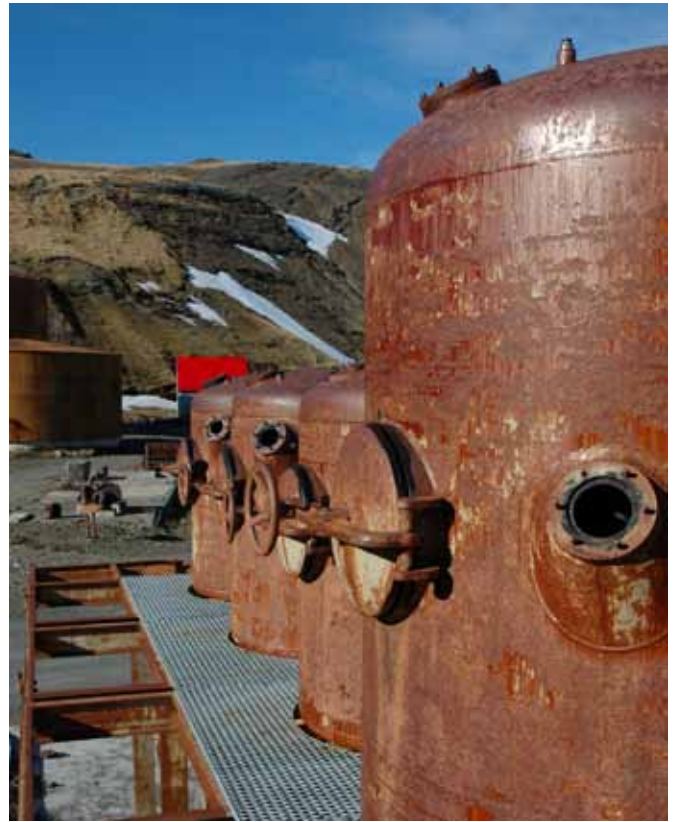
5.2 Detail of boilers

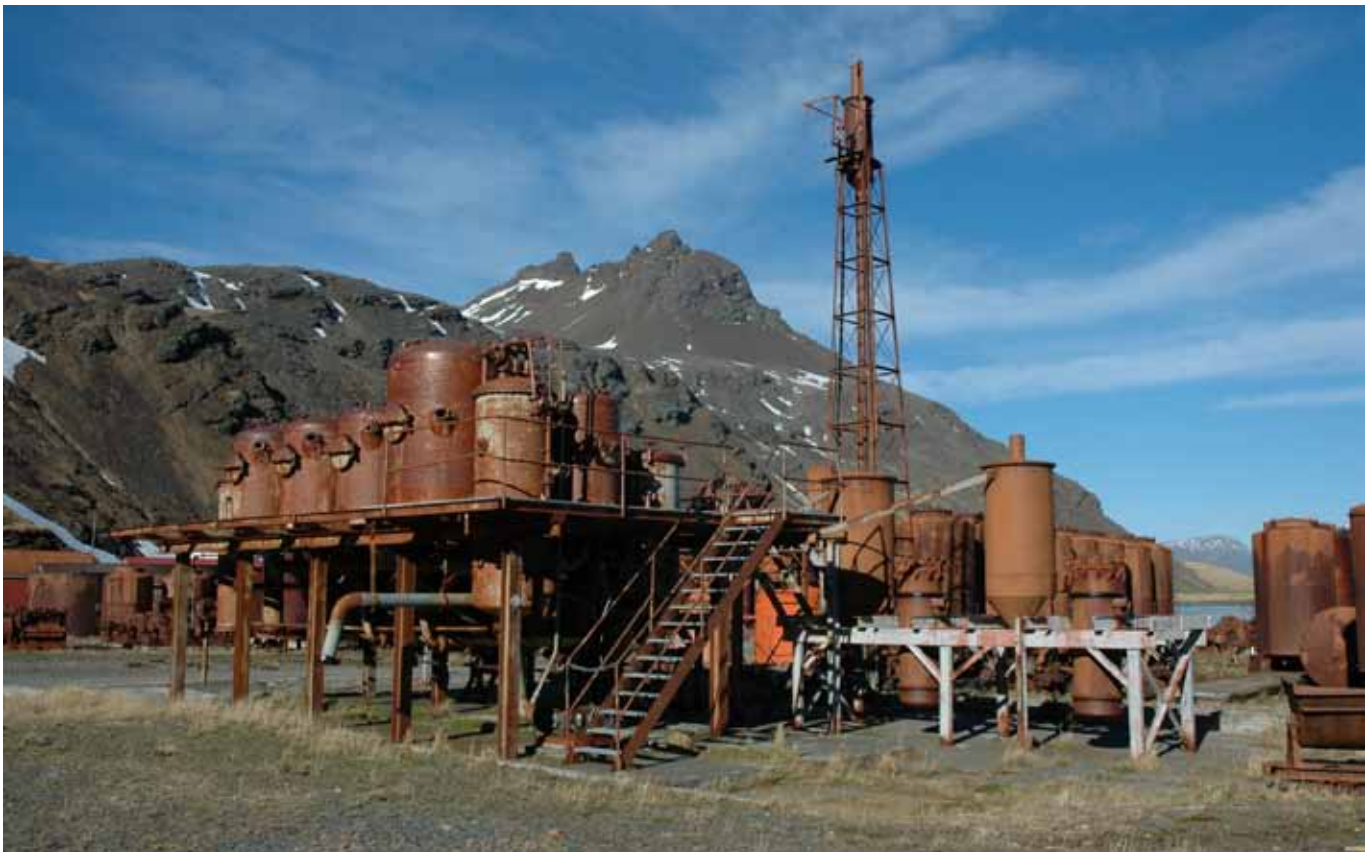
Immediately to the east of the glue water plant is a pylon supporting (?) a pressure vessel. This appears to have had a ladder up to a platform but this has been removed.

5.3 General view of the Glue Water Plant looking northeast

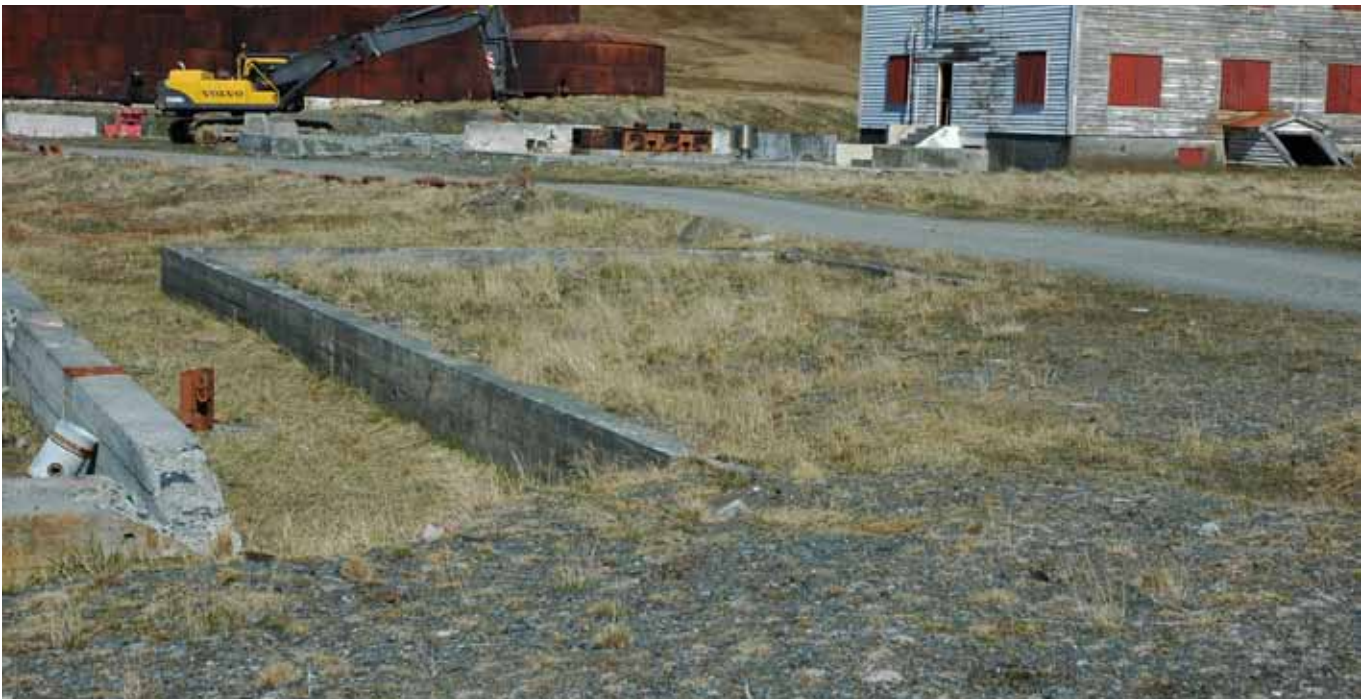
Nothing remains of this building other than part of the concrete foundation wall.

7.1 Foundation of the Building No. 7 Laboratory and Store

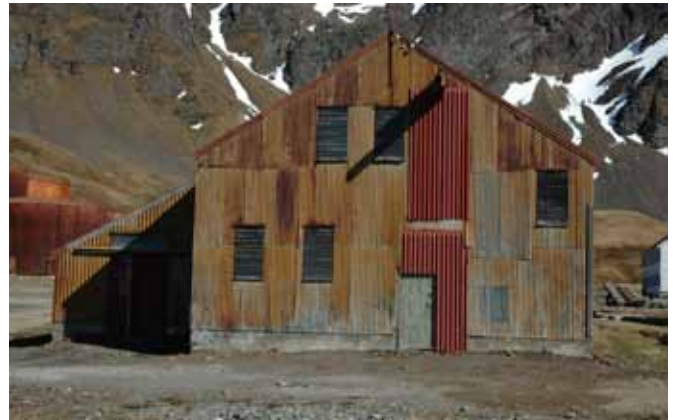
The Main Store remains in position. This is a two-storey timber framed, clad in corrugated iron, built off a concrete base. All doors and windows are now covered over with new corrugated iron sheeting. There has been a small amount of patching to the roof and some new (non-matching) corrugated sheet has been used at the west end on the north side. The same sort of repair has been carried out on the west side. This new sheeting has a different pitch to the original sheeting and this makes for an uncomfortable junction as well as spoiling the appearance of the building. The roof on the south side generally appears to be okay with one small disturbed area at the southwest corner. There is some mechanical damage to the bargeboard and corrugated sheeting in two or three places, presumably this occurred whilst the demolition work of adjacent buildings was being carried out.

10.1 East elevation

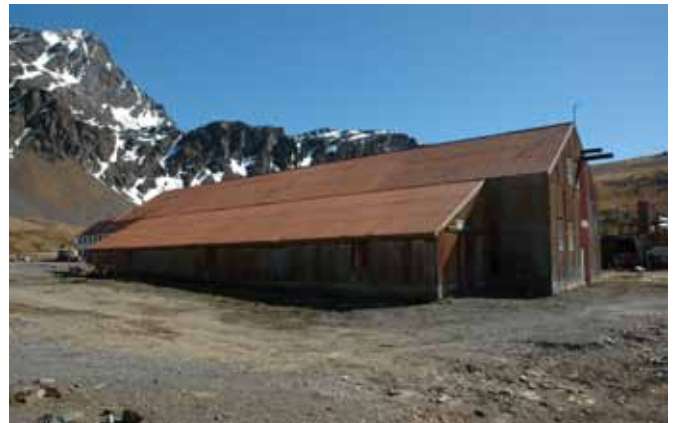
The lean-to on the south side of the main store building would appear to be a later building which has been added to the side of the main outer wall. Built from lightweight timber framing supporting a wall plate with rafters, approx 100 sq at 1.2m. A wall plate has been tacked onto the side of the existing building with props approx 200 x 100mm deep running back to prop the main rafters. Purlins approximately at 1m centred support the corrugated iron sheets of the roof. Neither the walls nor the roof have any internal cladding. The

10.2 South and east elevations

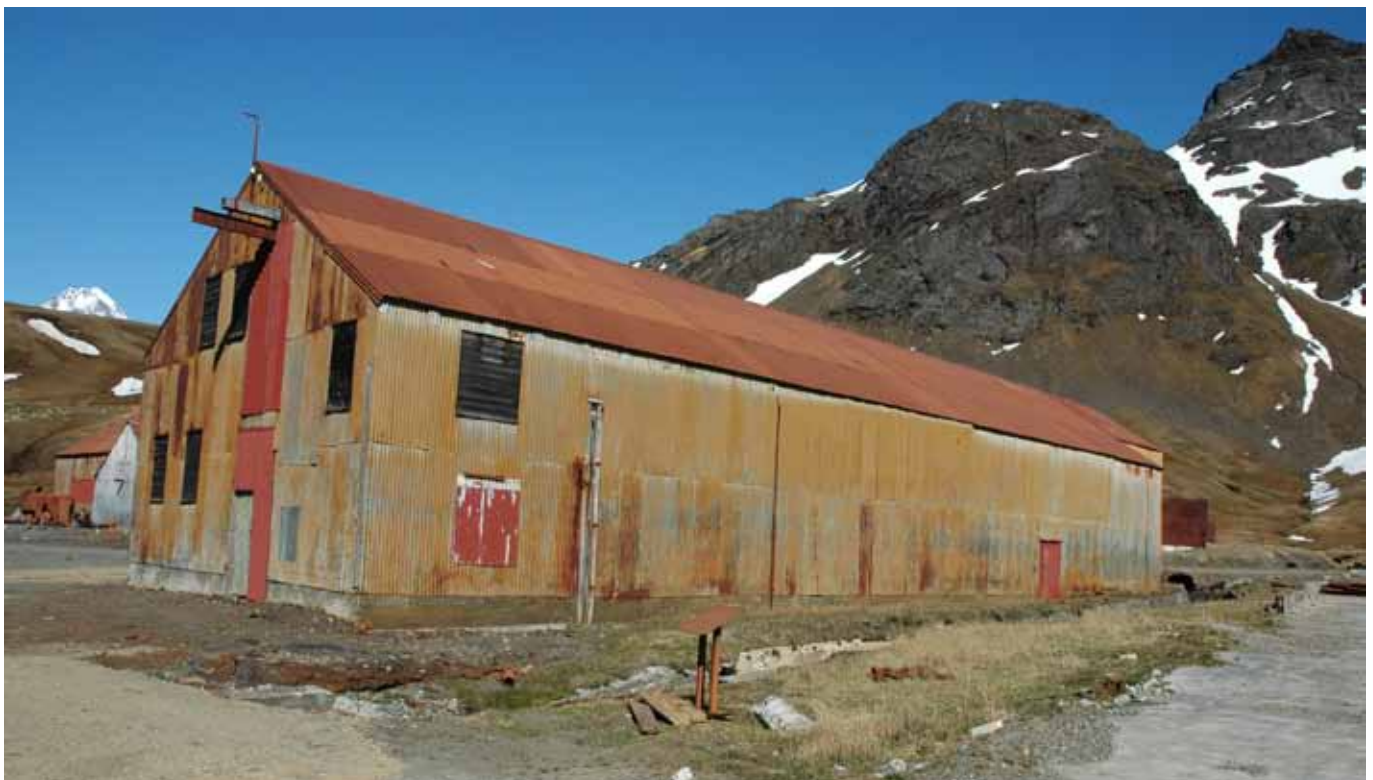
10.3 North and east elevations

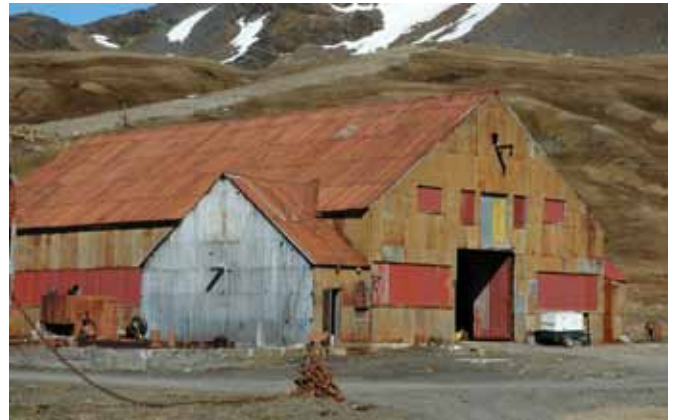
The corrugated iron of the roofs has a significant number of holes in it. There are many more that are apparent in the north end wall. These are generally regular punctured holes and it seems likely that this is the result of the army firing at the building. The holes in the roof may also be from this.

11.1 North and east elevations

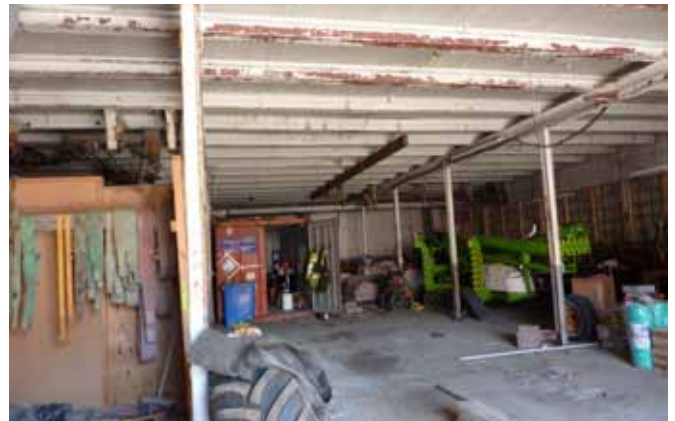
11.2 Interior ground floor of the main space now used for garaging

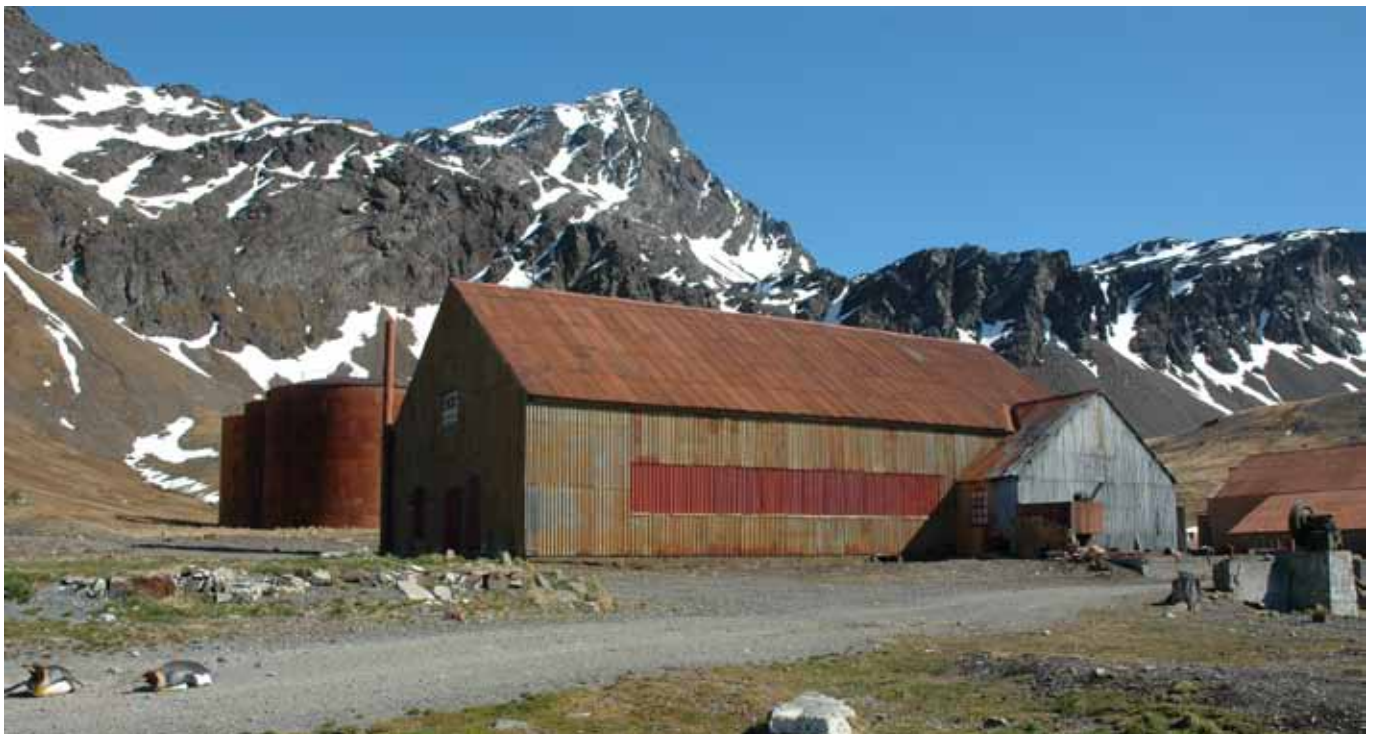
11.3 South and east elevations

Apart from the minor holes in the corrugated iron and some minor corrosion on the steelwork this building appears solid and no cause for concern. In the longer term removing some of the weight from the upper floor would be desirable.

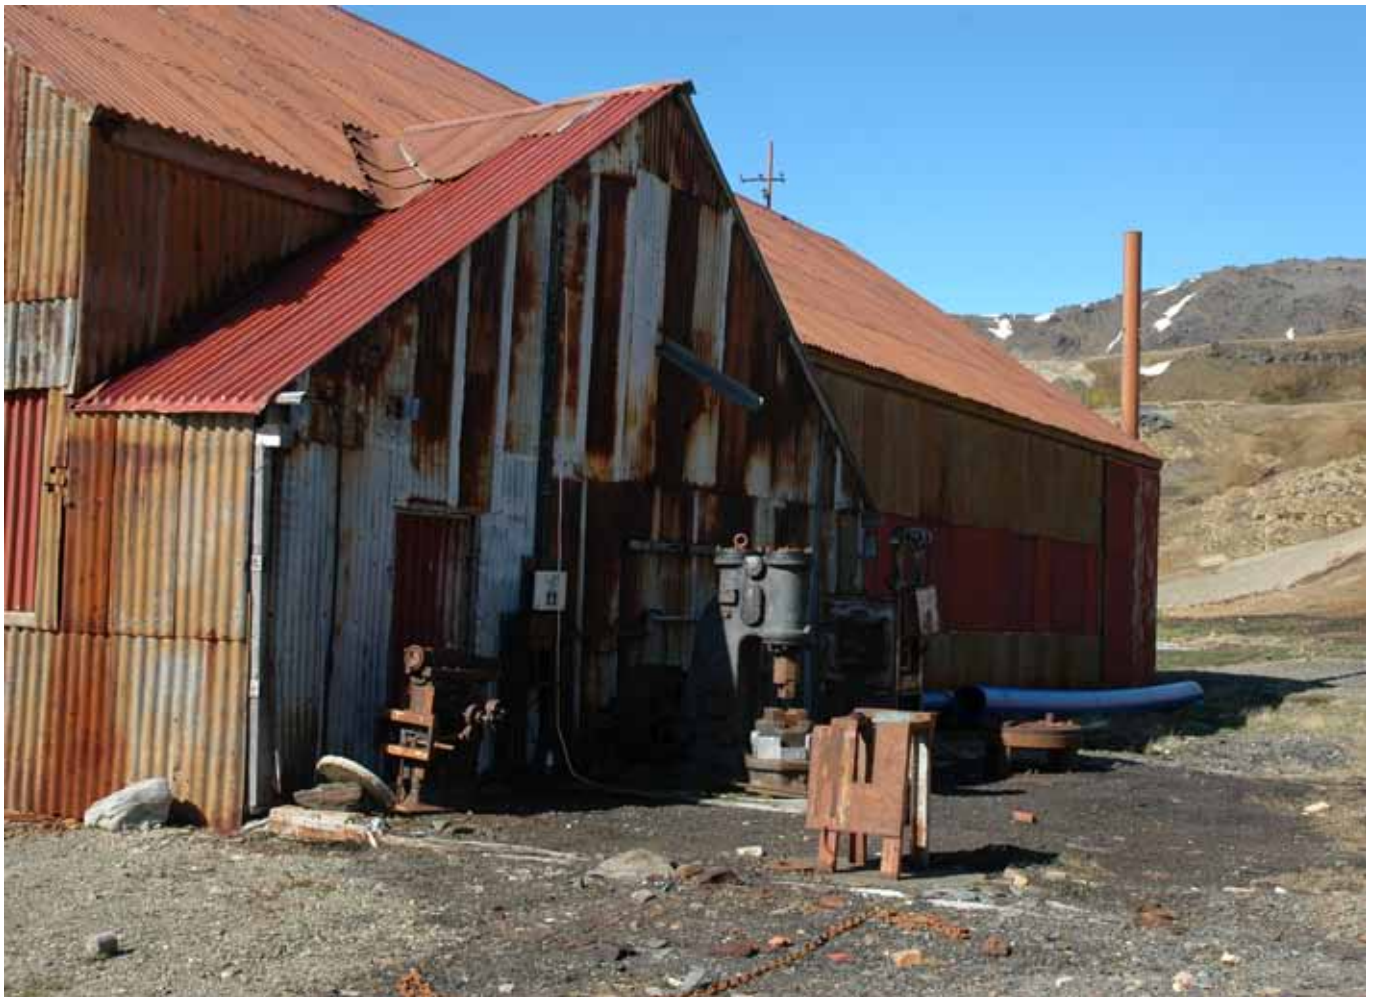
11.4 West elevation showing the location of the demolished Workshop

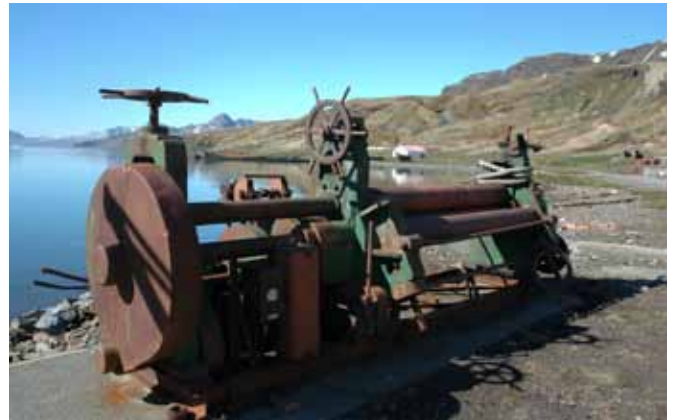
A rough concrete outline remains to show the location of the Plating Shop. The rolling machine, large press, forge and blower all still remain in position, but little else remains. It would appear that this building was probably dropping into the sea, before it was taken down. A good deal of old metal used as fill, harpoons, metal off-cuts, old chains, etc is exposed on the seaward side.

13.1 Rolling machine

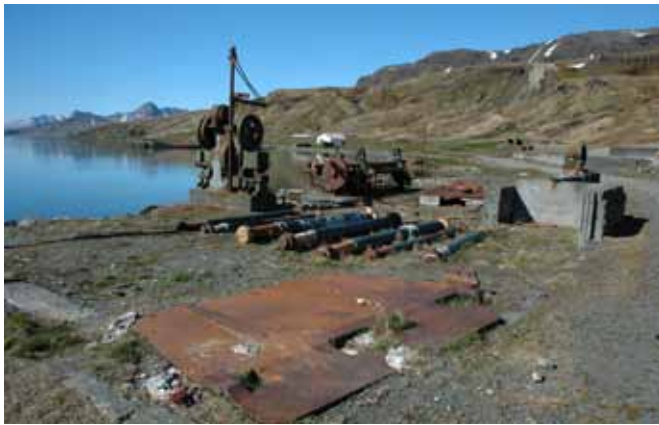
13.2 The site of the Plating Shop looking southeast

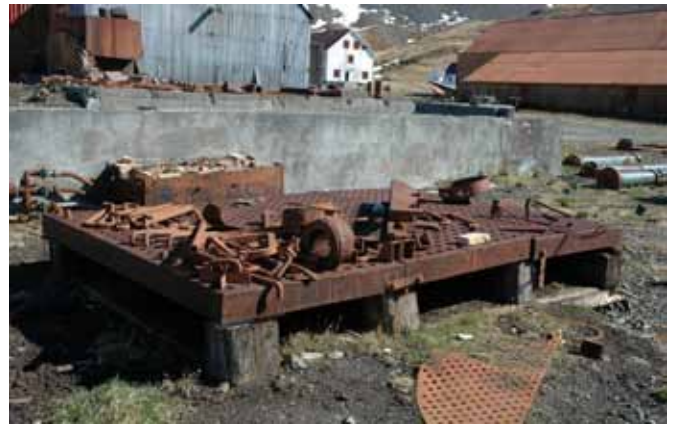
13.3 Anvil

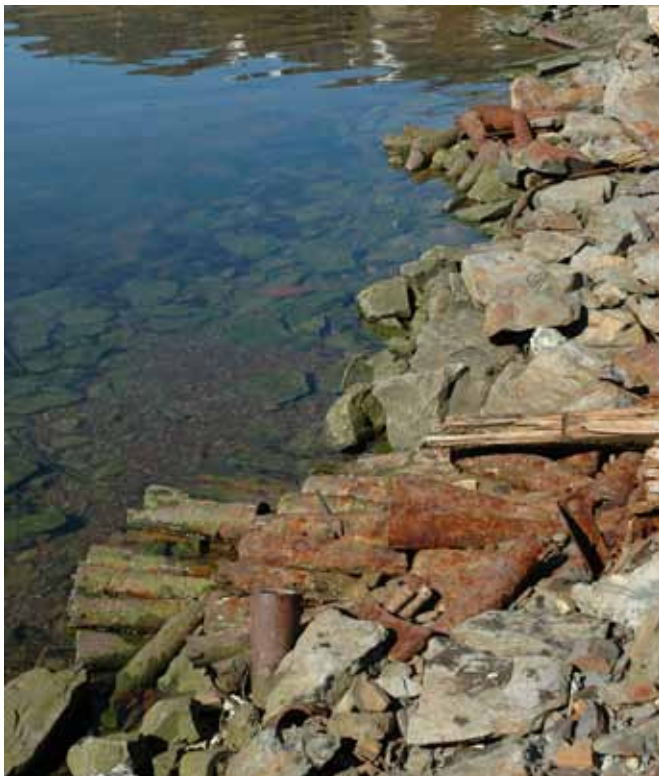
13.4 The ground made up with harpoon heads and other scrap metal

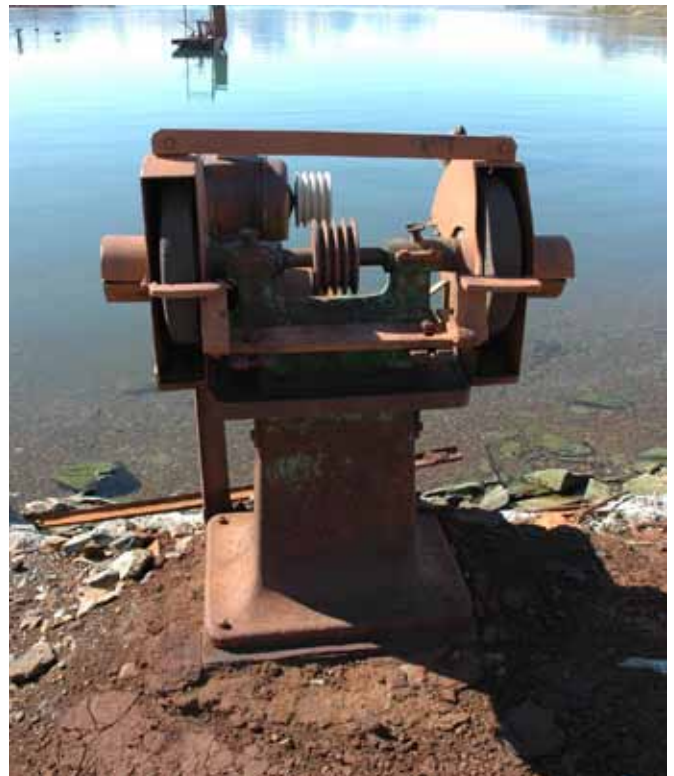
13.5 Grindstone

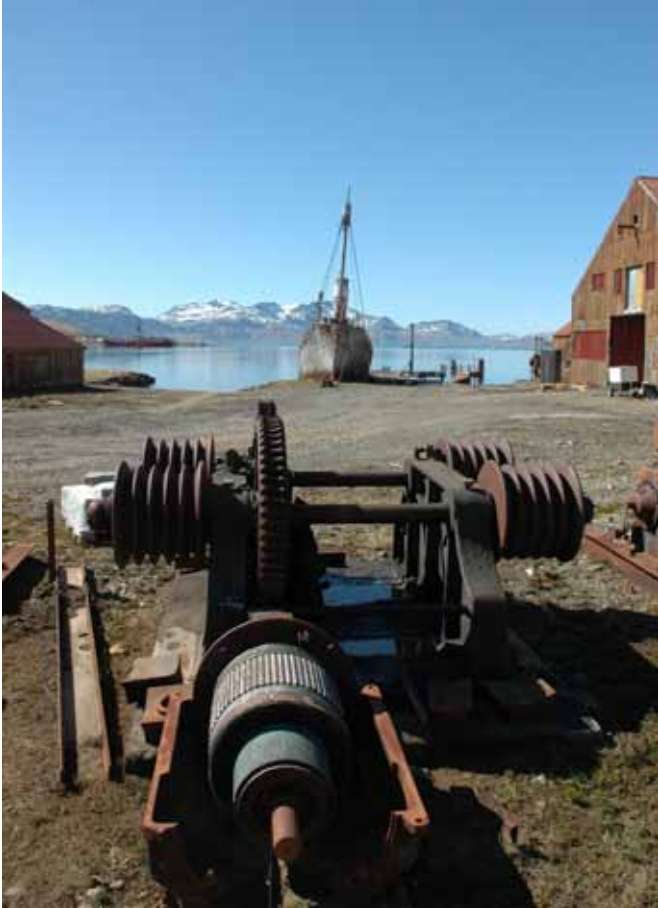
This building has been entirely removed although a large winch and an electric motor remain in position.

14.1 Detail of the remaining winch and engine

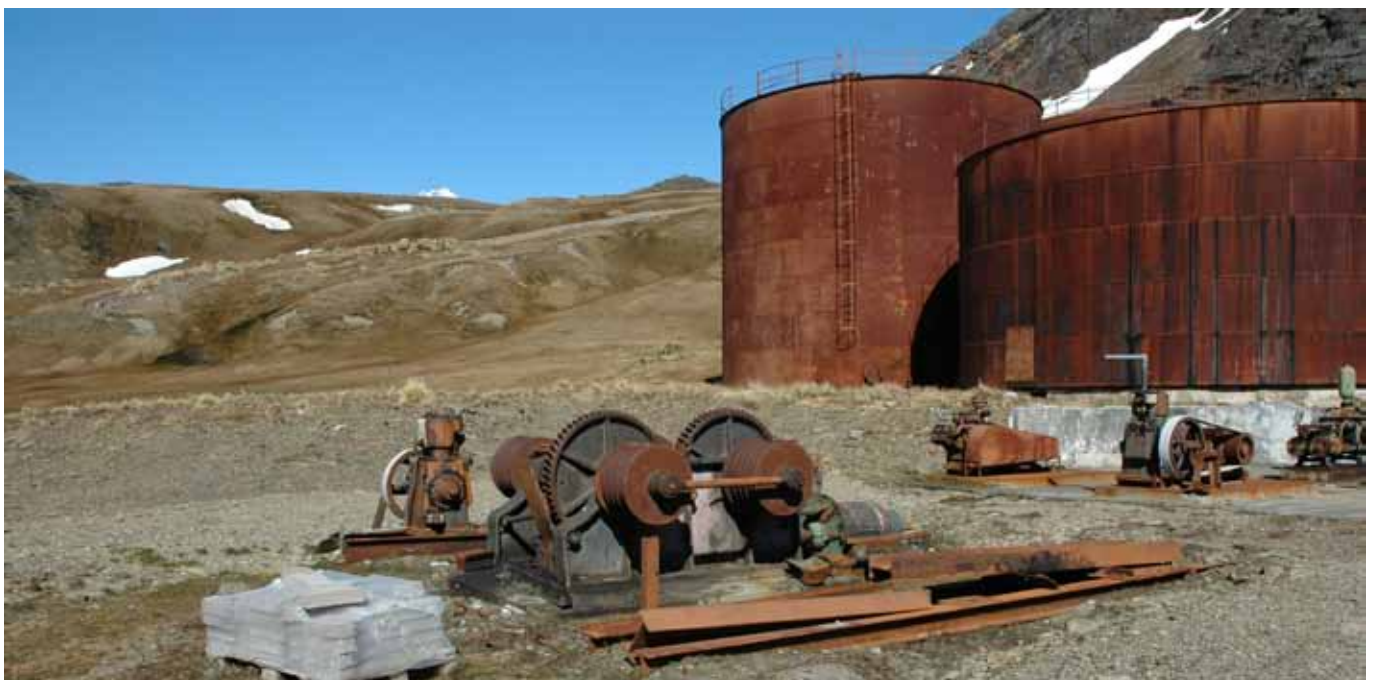
14.2 The site of the Winch House looking southwest with the Pump House behind

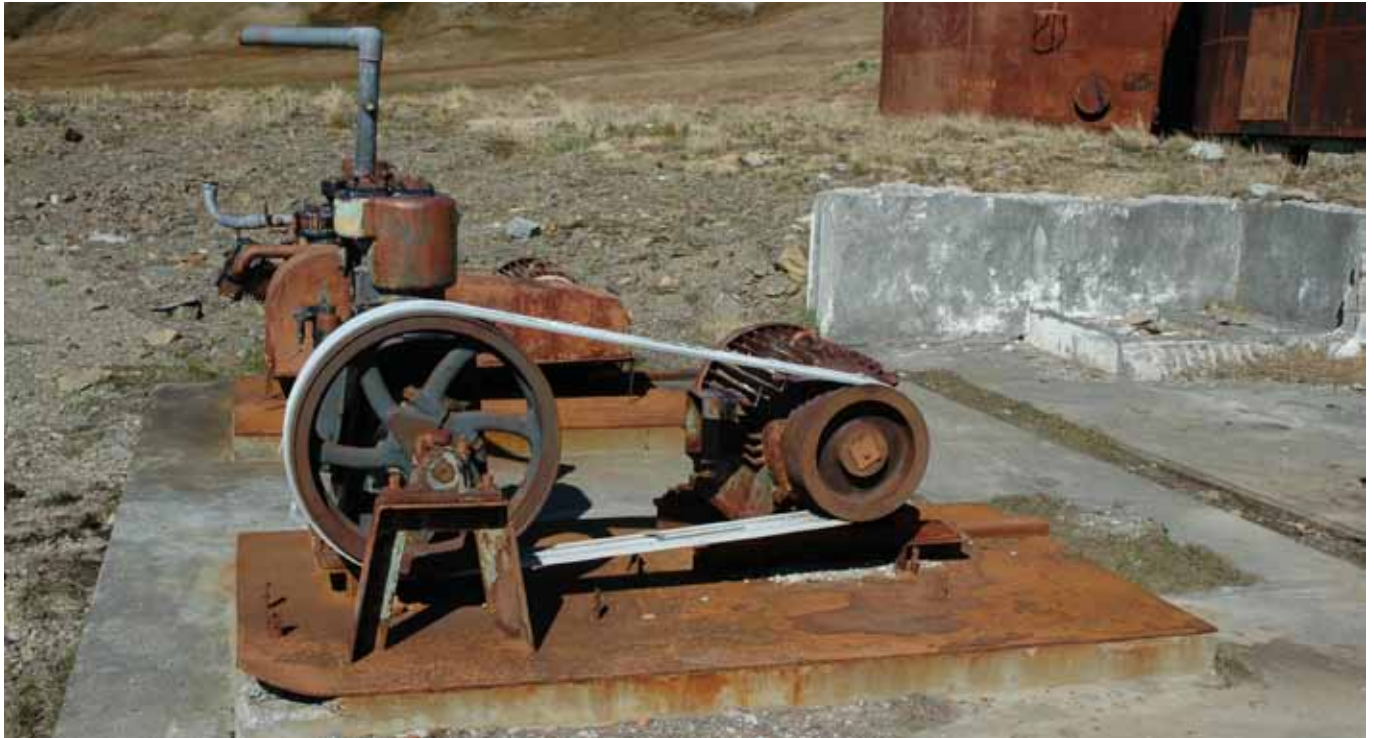
This building also has been taken down with only the concrete floor and the west wall and a short south return wall remaining. Six pumps remain in position, together with two electric motors and a large cylindrical tank at the north end of the building.

15.1 Remaining pump and motor

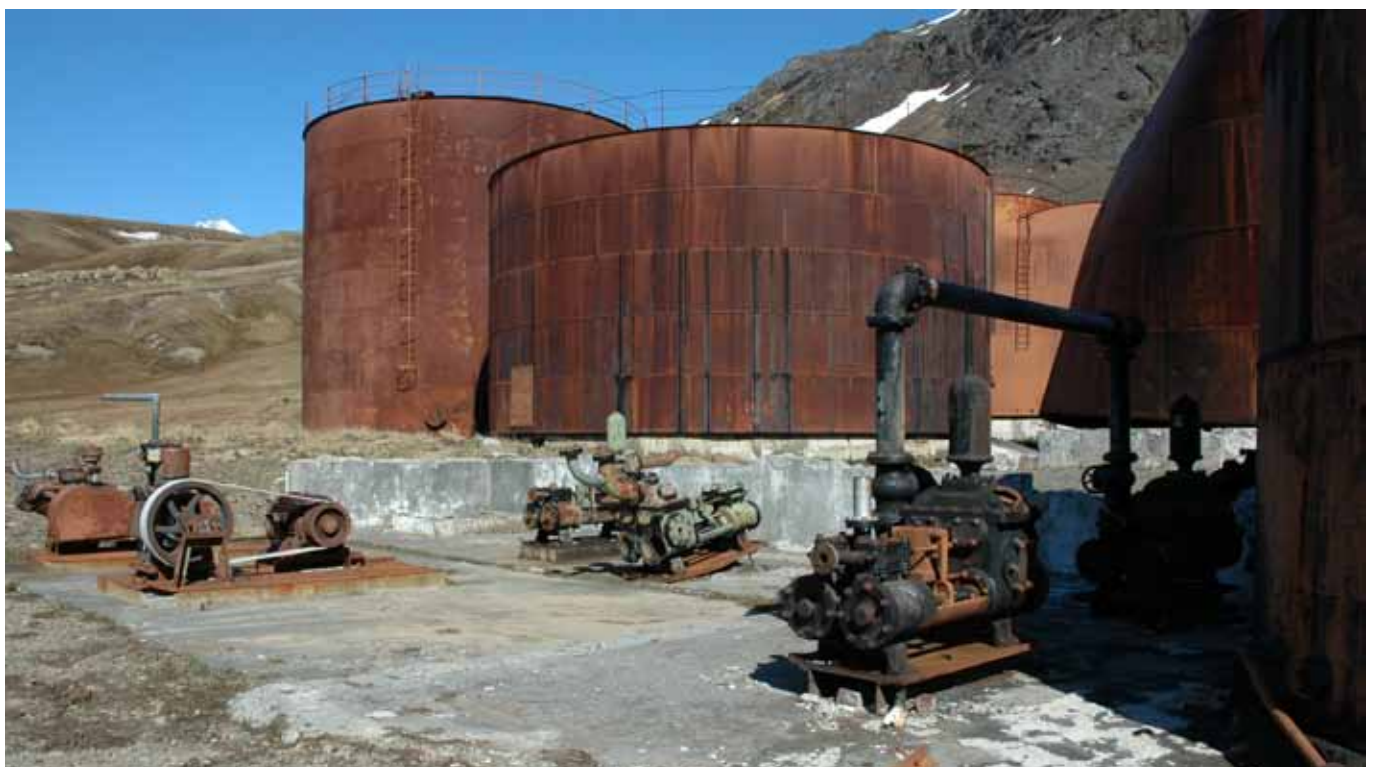
15.2 Site of the Pump House looking southwest with storage tanks behind

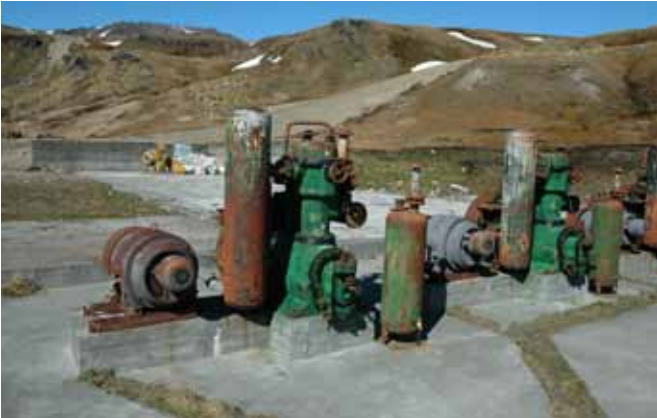
The Freezer House has disappeared. The concrete base remains for this building and some small sections of wall on the west side, together with four compressors and four electric motors and five cylinders.

21.1 General view of the floor of the Freezer House looking down from the hill to the southwest

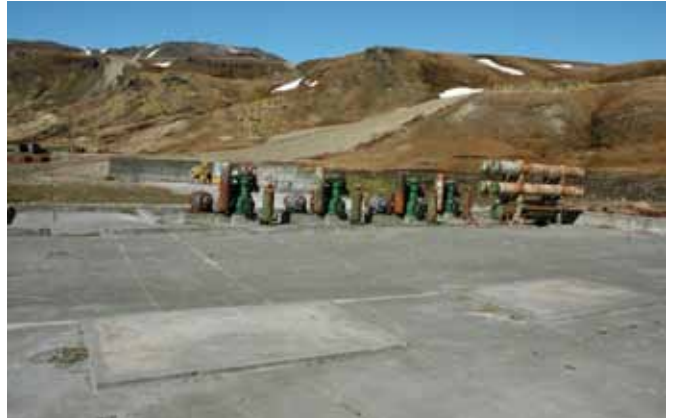
21.2 Remains of the Freezer House looking south

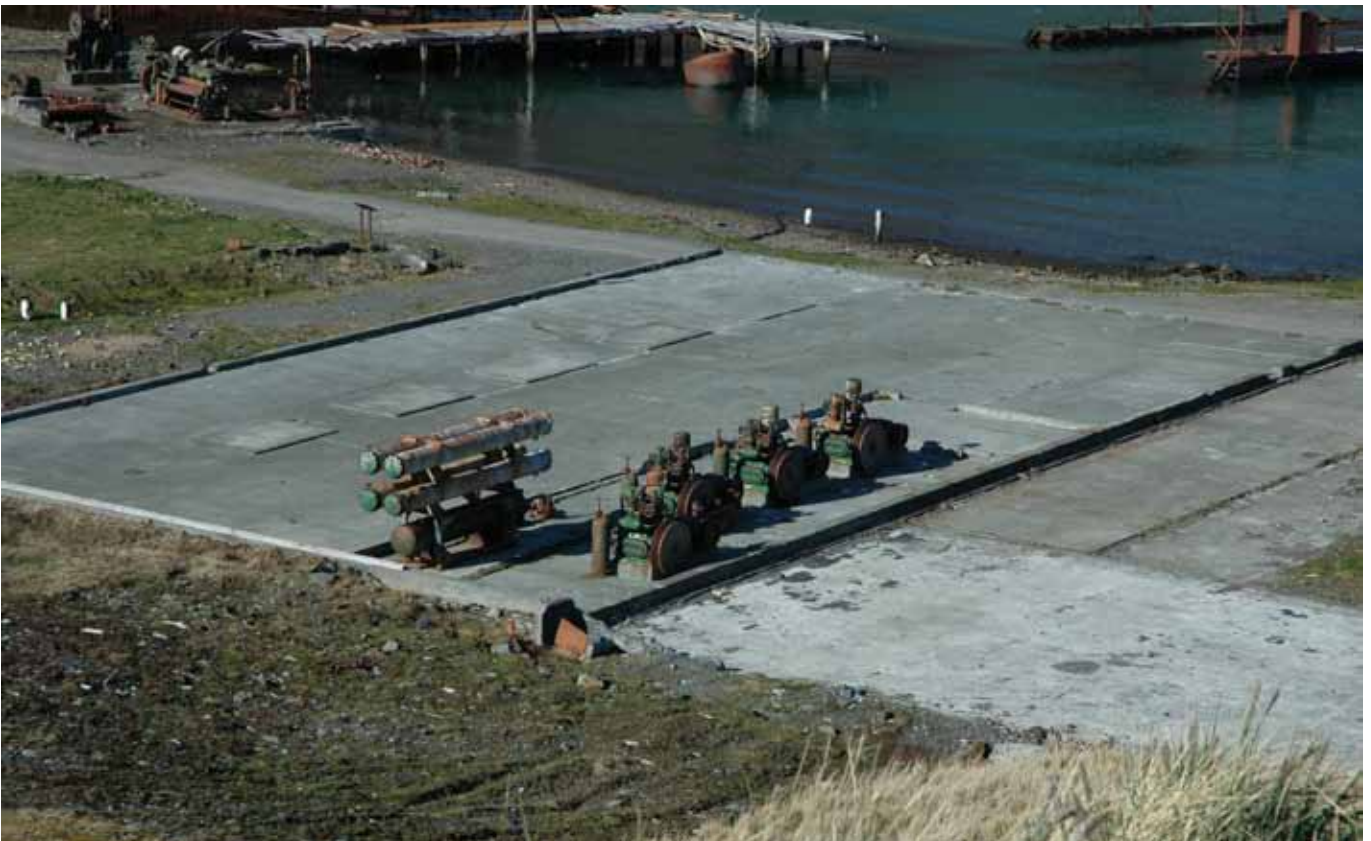
21.3 Detail of remaining Chiller Plant
