DISUSED WHALING STATIONS

Grytviken Harbour Gazetteer

Purcell Miller Tritton LLP, 3 Colegate, Norwich, Norfolk NR3 1BN
norwich@purcellmillertriton.com www.purcellmillertriton.com
July 2011

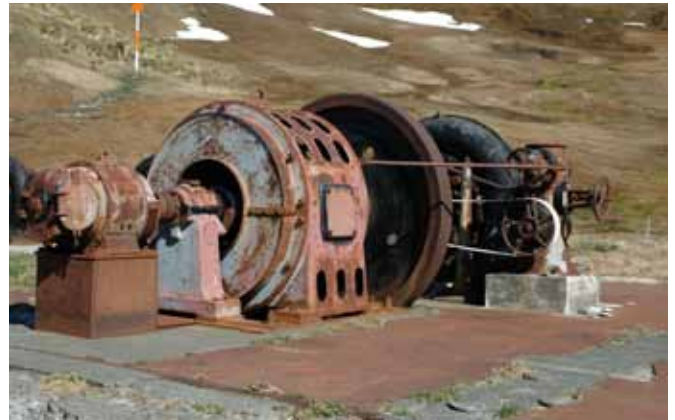
The base of this remains although the building has entirely disappeared. There are three turbines, all with the name 'Ing.A.Riva & Co Milano' on them. These are generator sets with the turbines, all of which remain in position, although two of them lost their outer coverings. One set would appear to be of an earlier date than the other two, with a much more substantial casing. The name plate from this set has been removed, although it appears very similar to the other two adjacent to this. Immediately to the west are two large diesel electric generators. Both diesel engines have 'Mirrlees' name plates on them. Instructions cast into the castings are in English, suggesting an English manufactured machine. The generator sets are by 'Brush'.

23.1 Hydro electric set with covering still in place on the generator

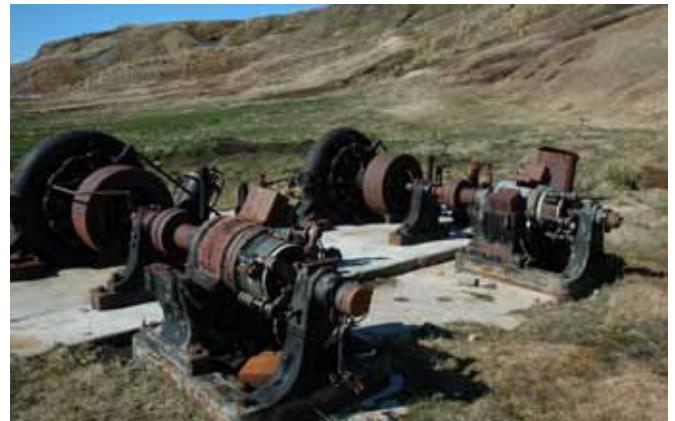
23.2 Hydro electric sets

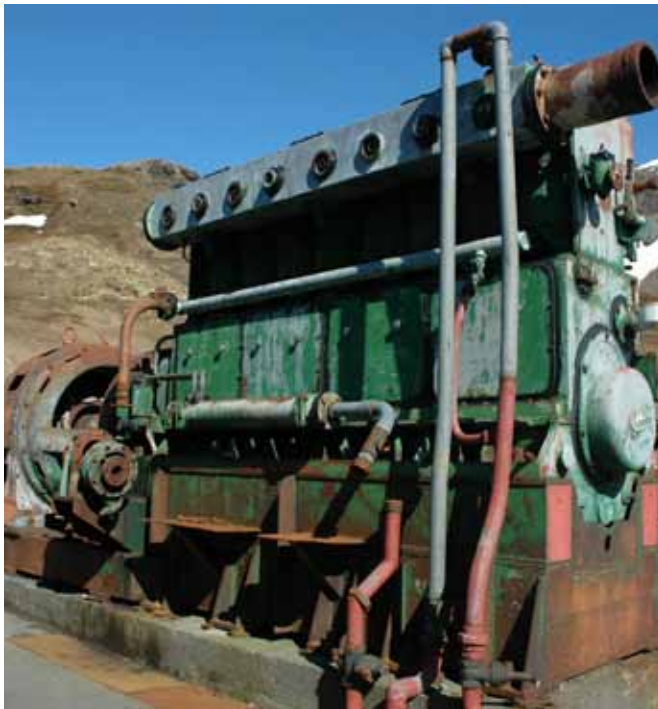
23.3 Diesel electric generator set

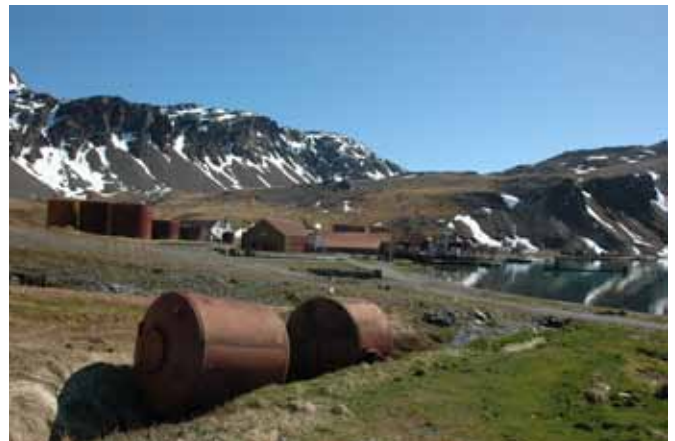
Immediately south of the building and outside it, there is a cylindrical tank held on two brackets, presumably a fuel tank. Two larger cylindrical tanks have been tumbled in the stream bed below the position of the building. They probably stood in the empty space to the north of the older of the turbines sets.

23.4 Fuel tanks tumbled into the stream bed below the site of the generator plant

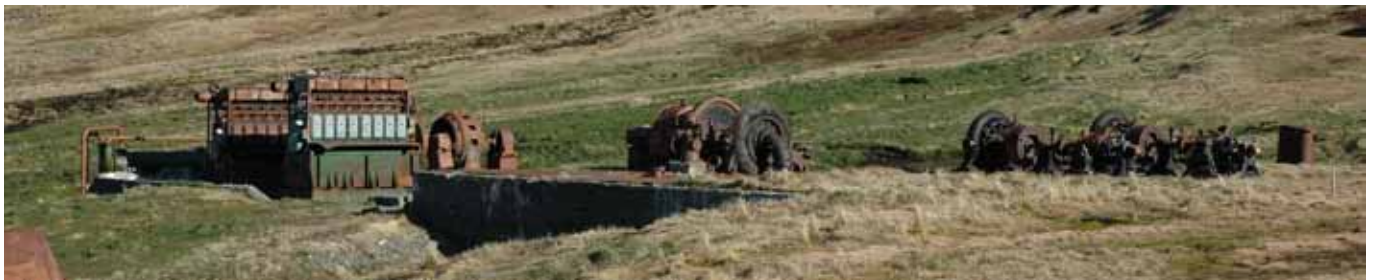
23.5 Remaining concrete floor of the hydro power plant looking south

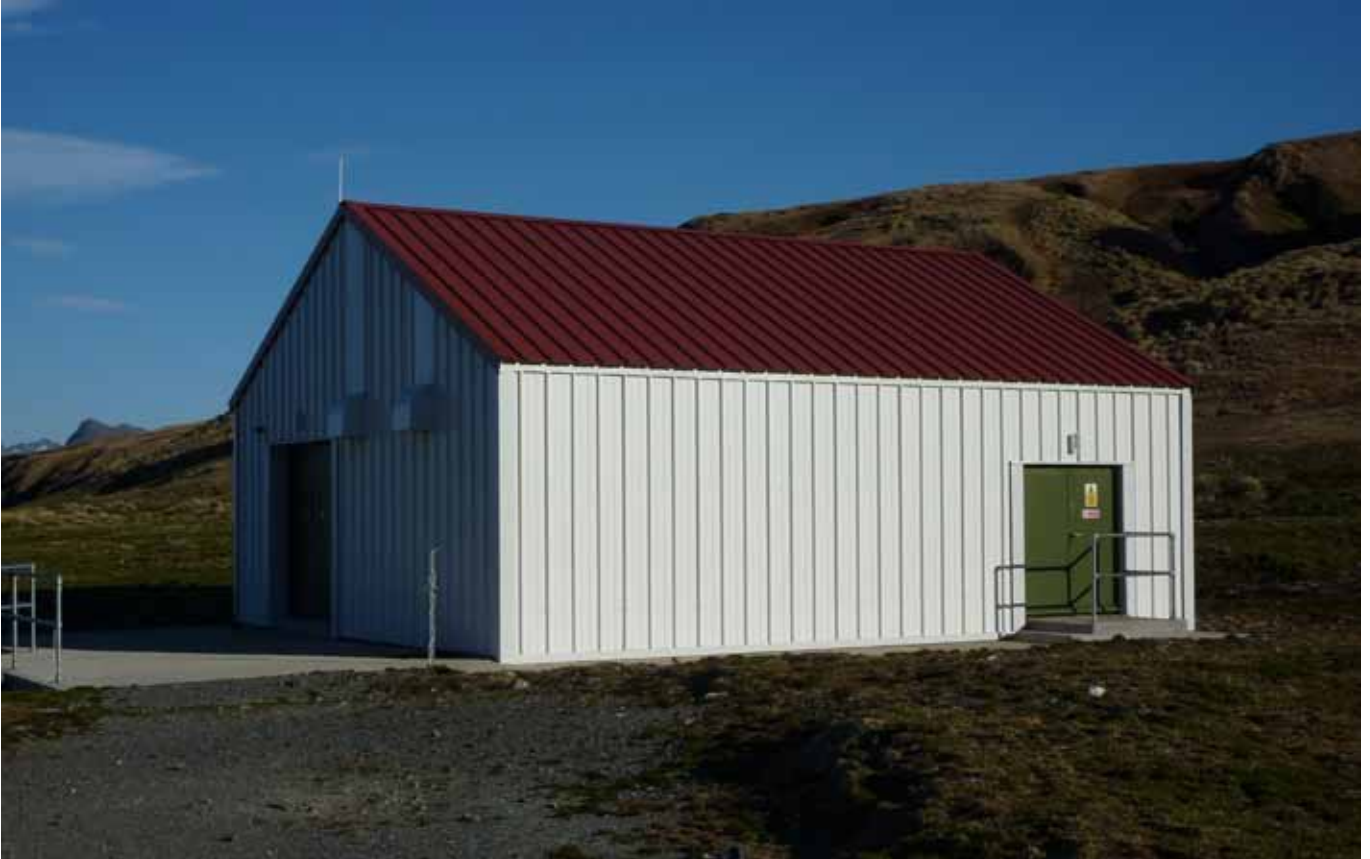
This is the modern hydro electricity generator house. This building was opened in 2009 and it is clad in plastic coated pressed metal, both for the walls and the roof. It was not accessed but all appears to be in good order.

24.1 North and west elevations

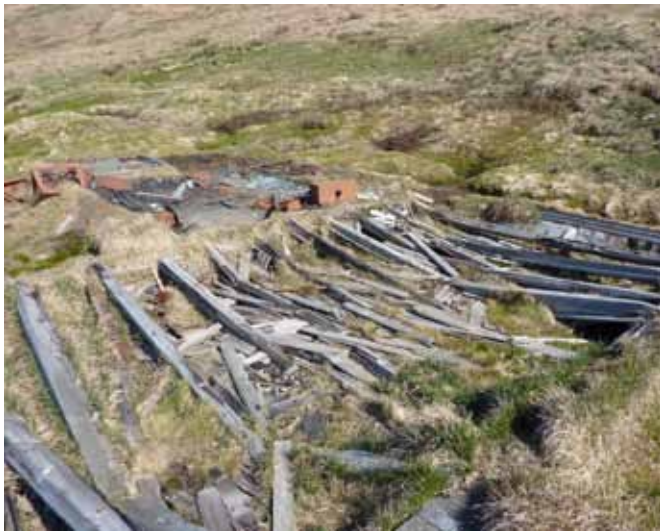
Little remains of this building. The concrete base is still visible, together with some rotted timbers, which were once the floor of the building.

25.1 The remnants of the Radio Station

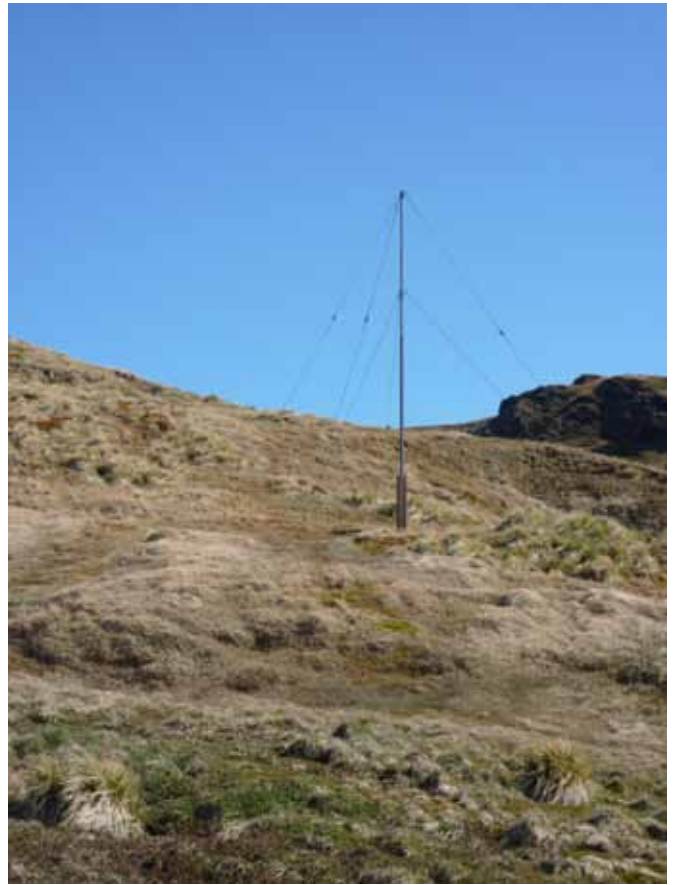
One small radio mast remains in position on the hillside to the southeast of the radio station. Two much larger masts are now lying on the floor. These are both steel, approximately 250mm diameter and 25m tall. Some of the staying wires are also still lying in the Tussock grass.

25.2 The remaining standing smaller mast on the hill above the station

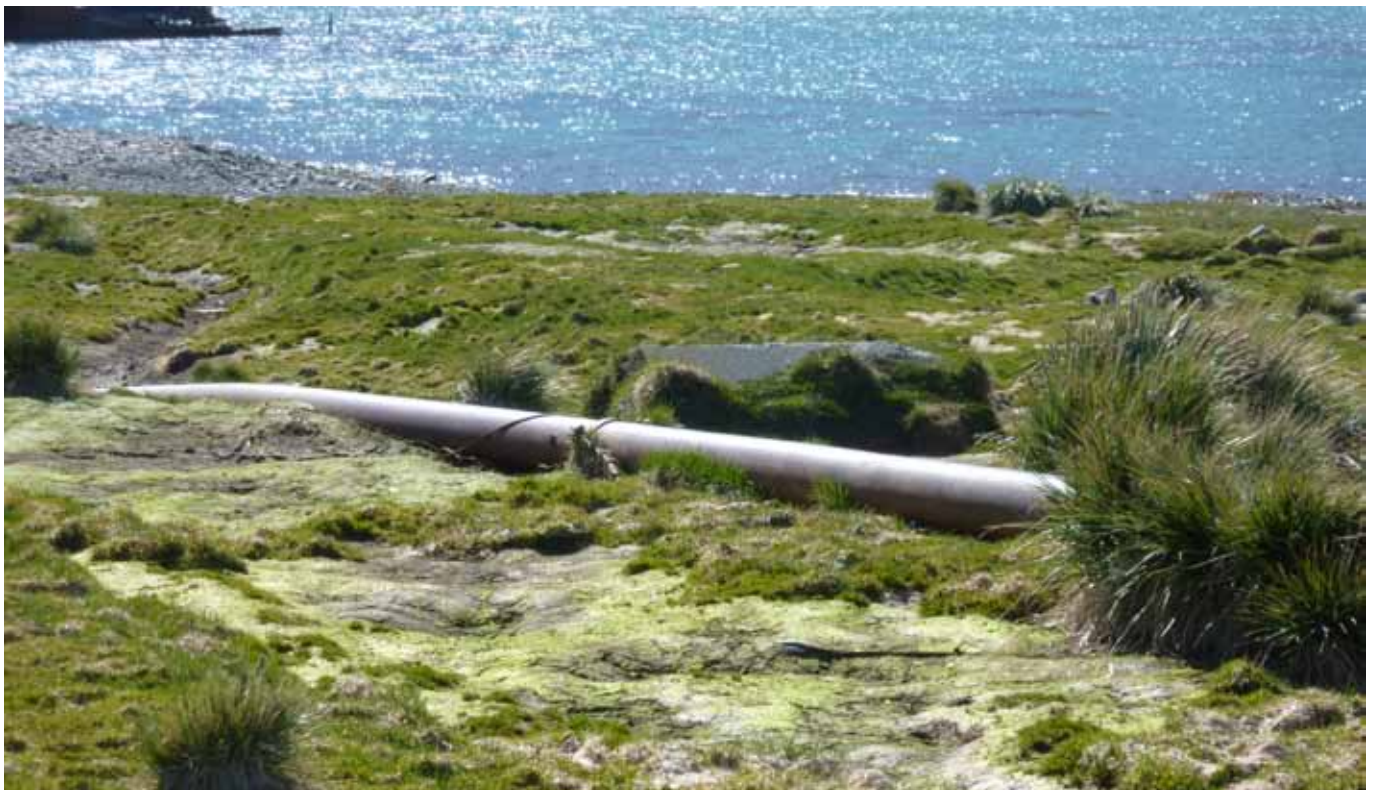
25.3 One of the two steel masts lying on the ground

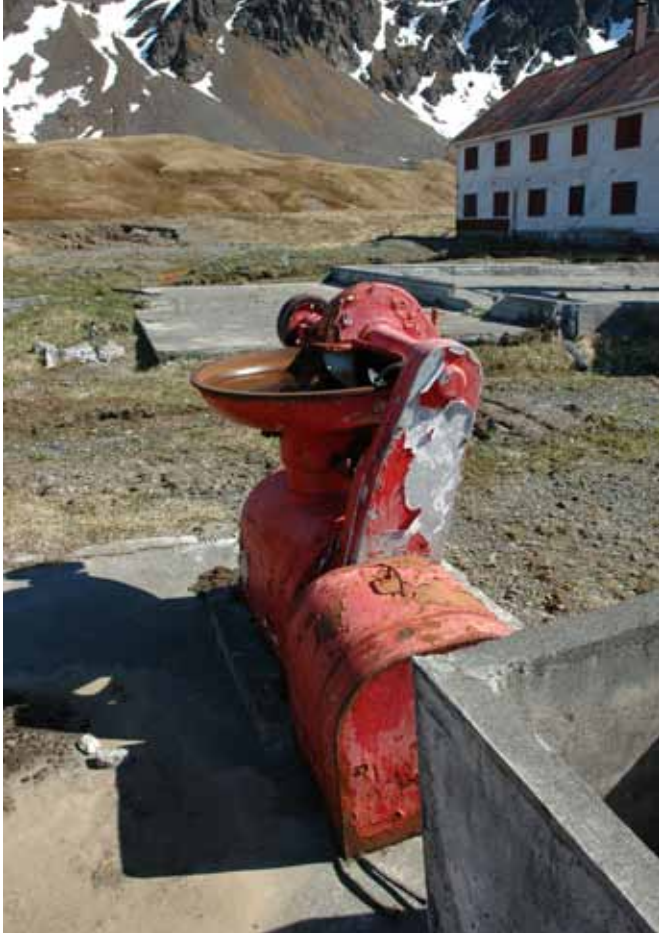
Only the concrete base remains together with a row of five concrete wash tubs and two pieces of machinery.

26.1 A corner of the concrete tub and one of the pieces of machinery

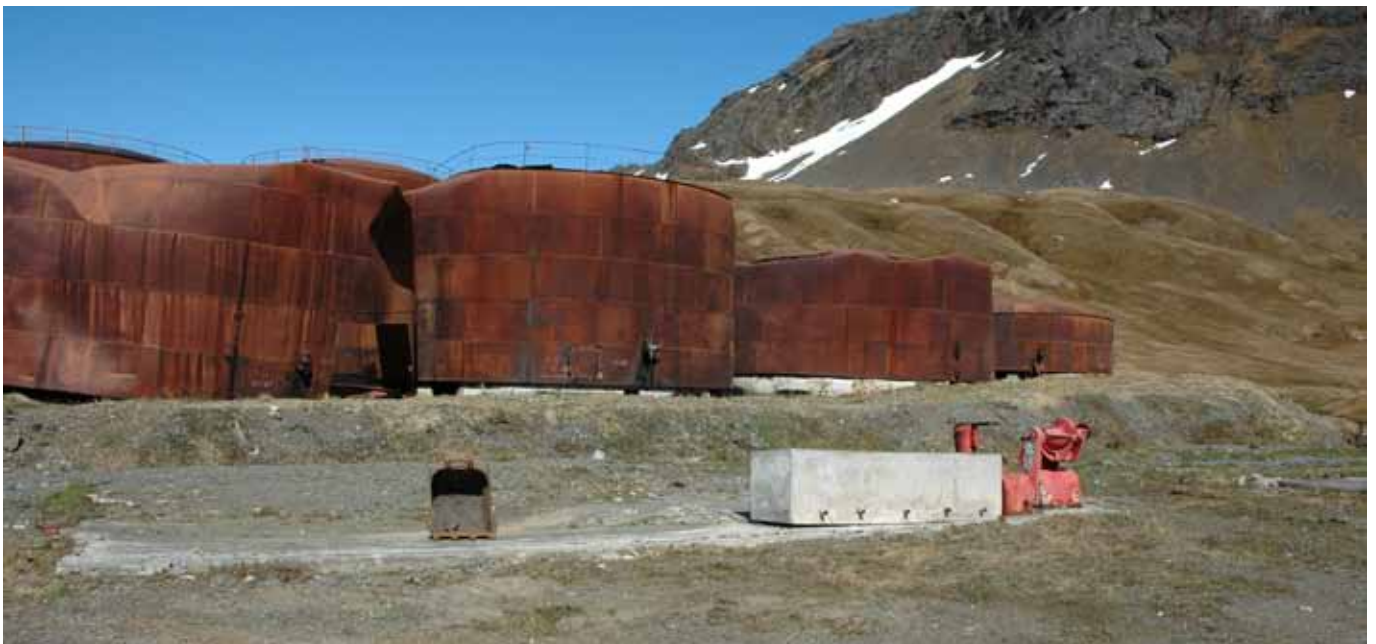
26.2 The remaining base of the Slaughter House with the storage tanks to the south of them

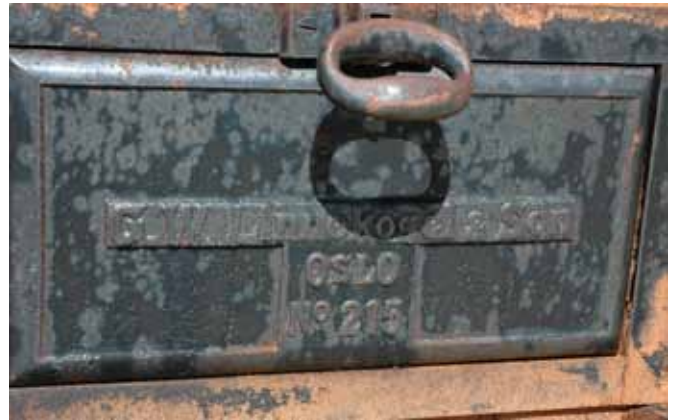
The Mess Building has been demolished completely with only a concrete base and the concrete foundation wall remaining. The kitchen has also been taken down, and only some base walls, the quarry tiled floor and the large stove remain in place. The stove has GW Linnekogel & Son, Oslo, No.215 cast into the oven front.

27.1 Oven front 'GW Linnekogel & Son, Oslo, No. 215'

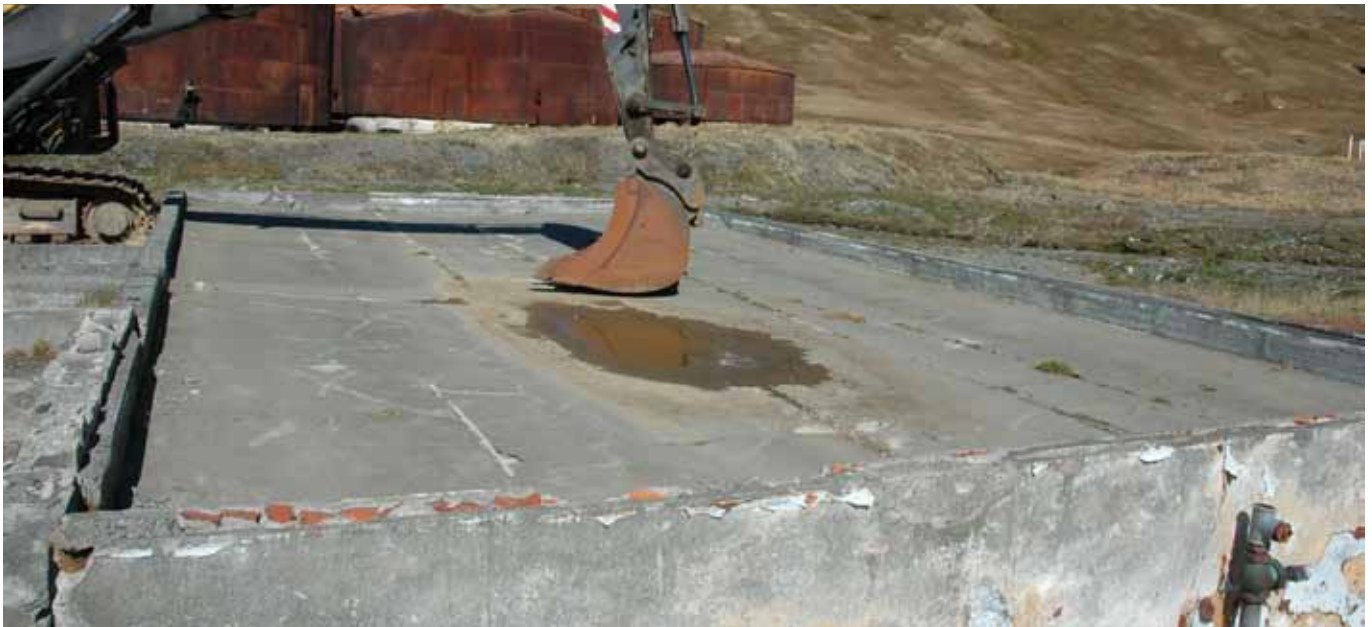
27.2 Base of the refectory area looking southwards

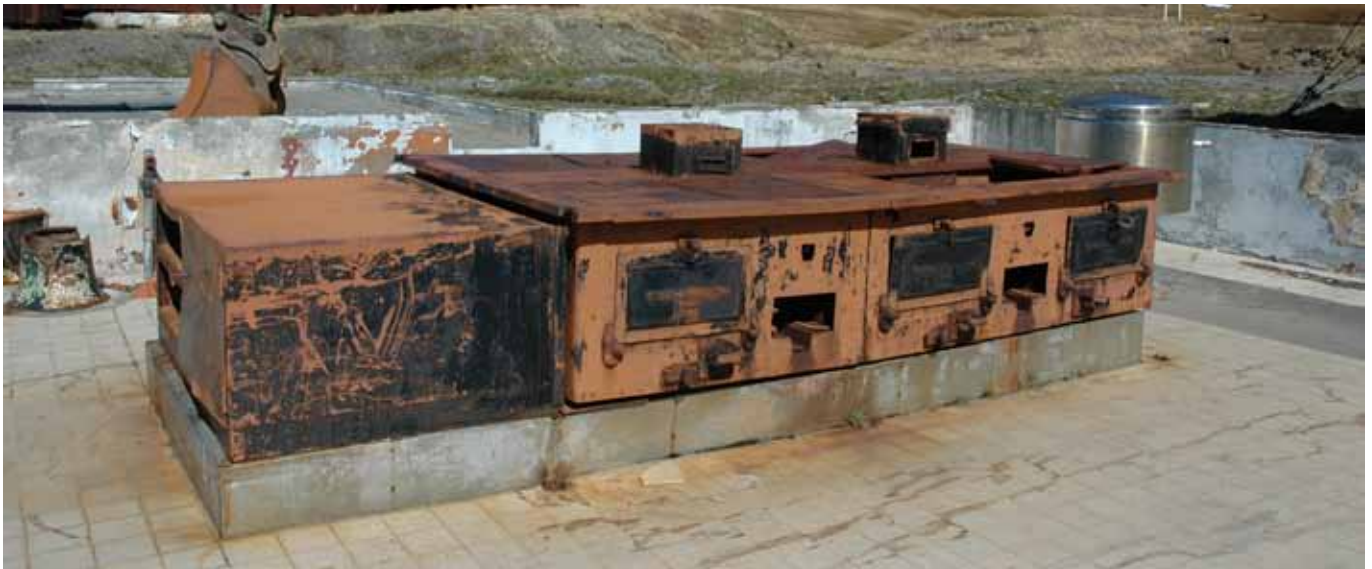
27.3 The stove remains in position

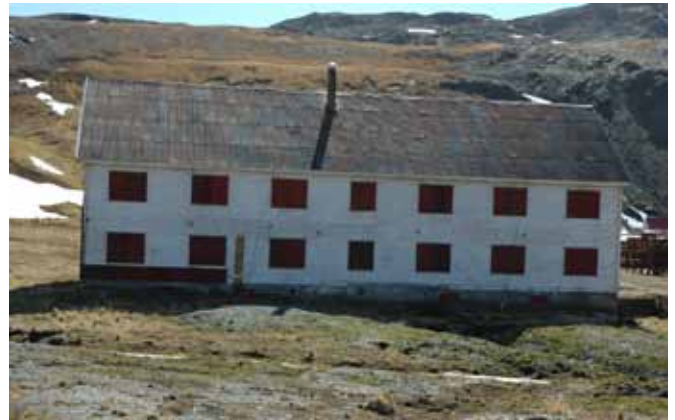
27.1 South elevation

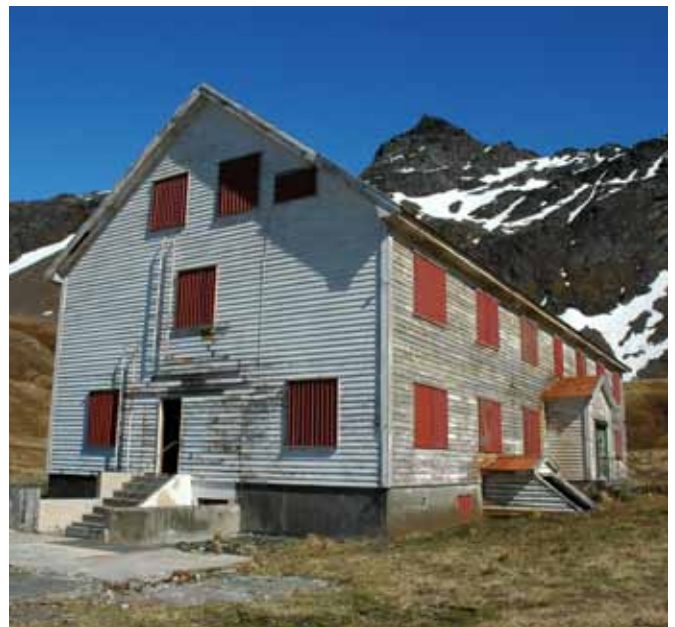
27.2 North and east elevations

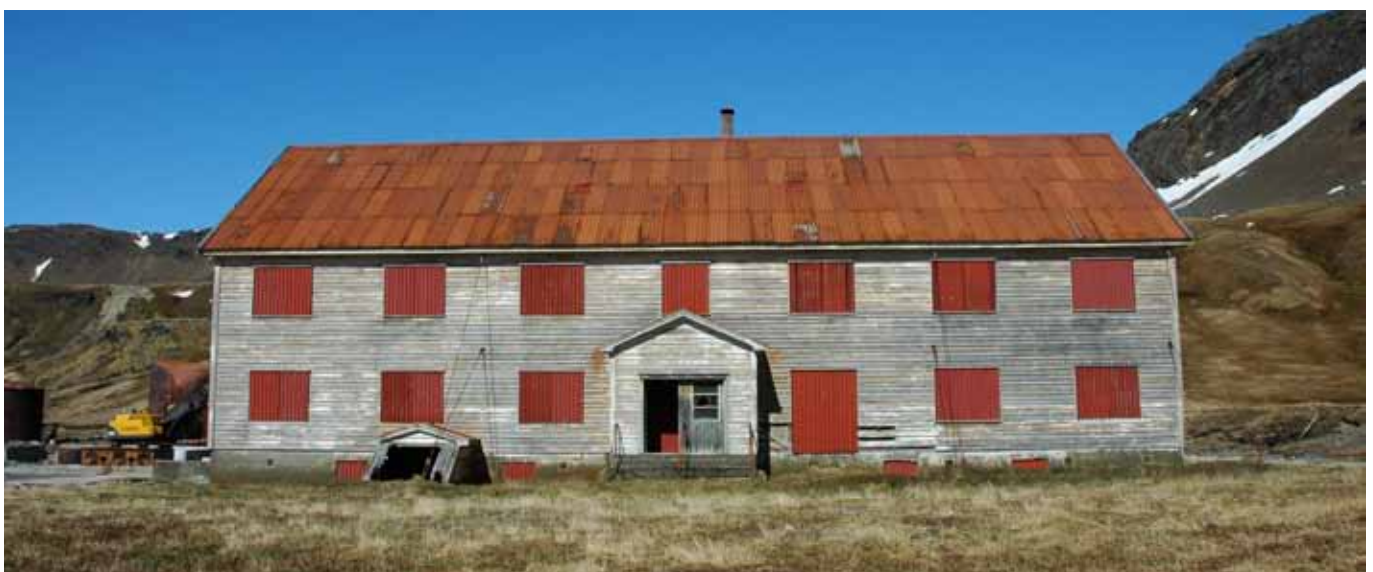
Externally, the boarding being fixed directly to the main elements to the frame, over a building paper. The internal surface of the walls is all made up of wood wool slabs. Generally, the feather edge boarding is in reasonable condition, except for a small damaged area on the north side, immediately west of the porch. To the east of porch is a stairway down into the basement which currently has around 250mm of water standing in it. The door was previously covered by a hatch but this has now fallen away. There is a further stair at the east end, going down to give access to the basement and up to give access to the ground floor. This would have been covered and the outline of the roof can be made out where boarding has been replaced, all that remains of this are the concrete walls, everything else having been removed. There are escape ladders from the attic floor, a continuous one at the west end and a split one at the east end, presumably there was previously a platform on the roof of the link building.

27.3 North elevation

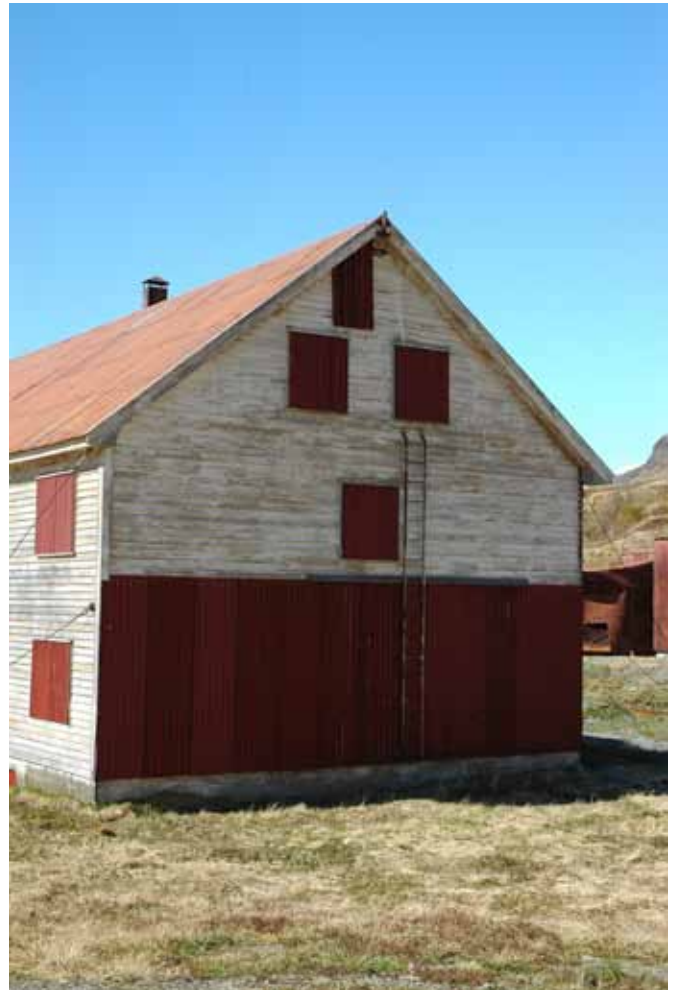
West elevation

At the lower level of the west end wall the featheredge boarding is missing and has been replaced with pressed metal sheeting. The featheredge boarding above this is in reasonable order, although the corner capping piece is missing from the southwest corner and should be replaced.

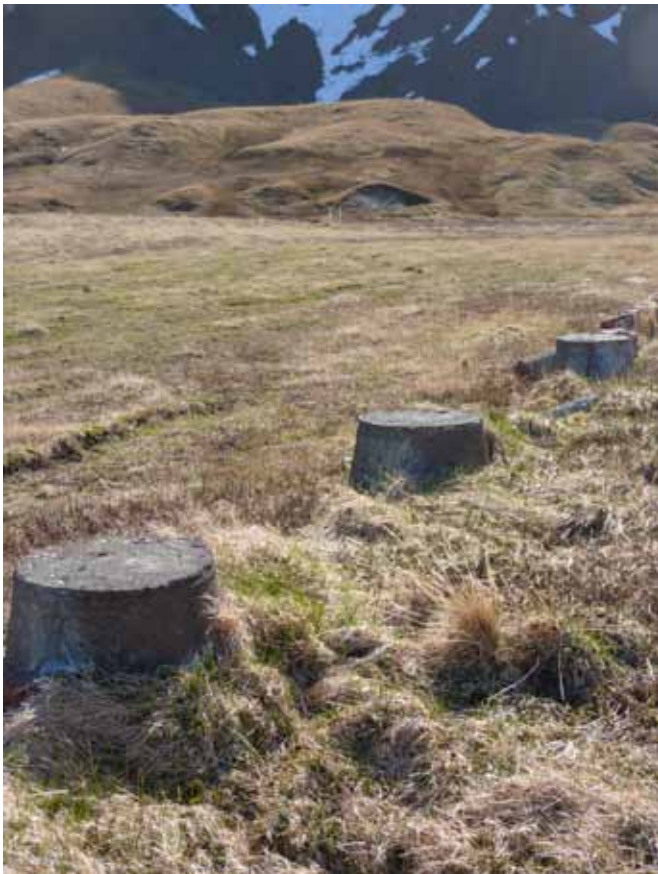
The concrete bases, presumably cast in barrels, remain in place but that is the only trace of the building.

29.1 Concrete bases

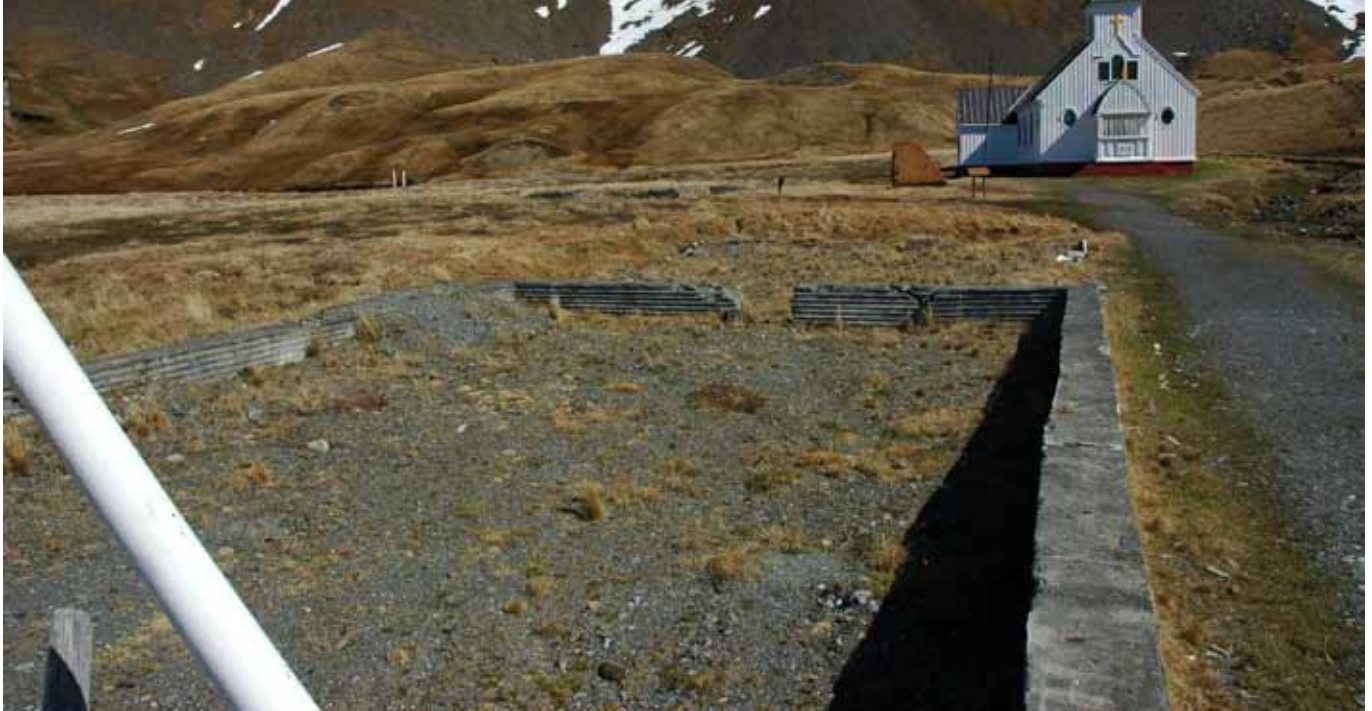
Only the concrete footings and spine walls still remain and all the superstructure has been removed.

30.1 Remnants of the Barracks footings

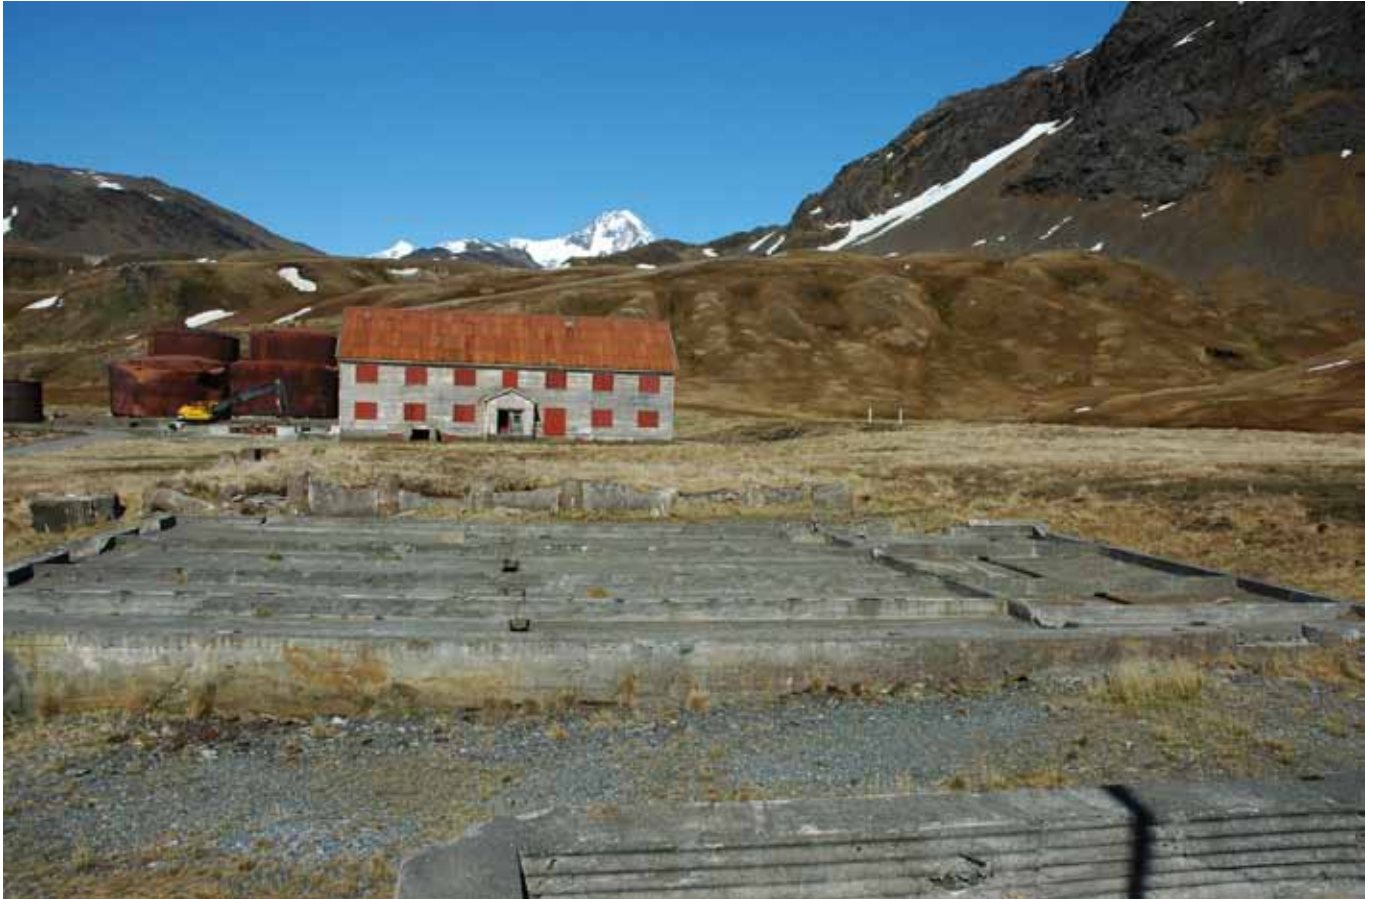
Only the concrete base remains.

32.1 The concrete base of the Bath House in the foreground looking south to the Nybrakka

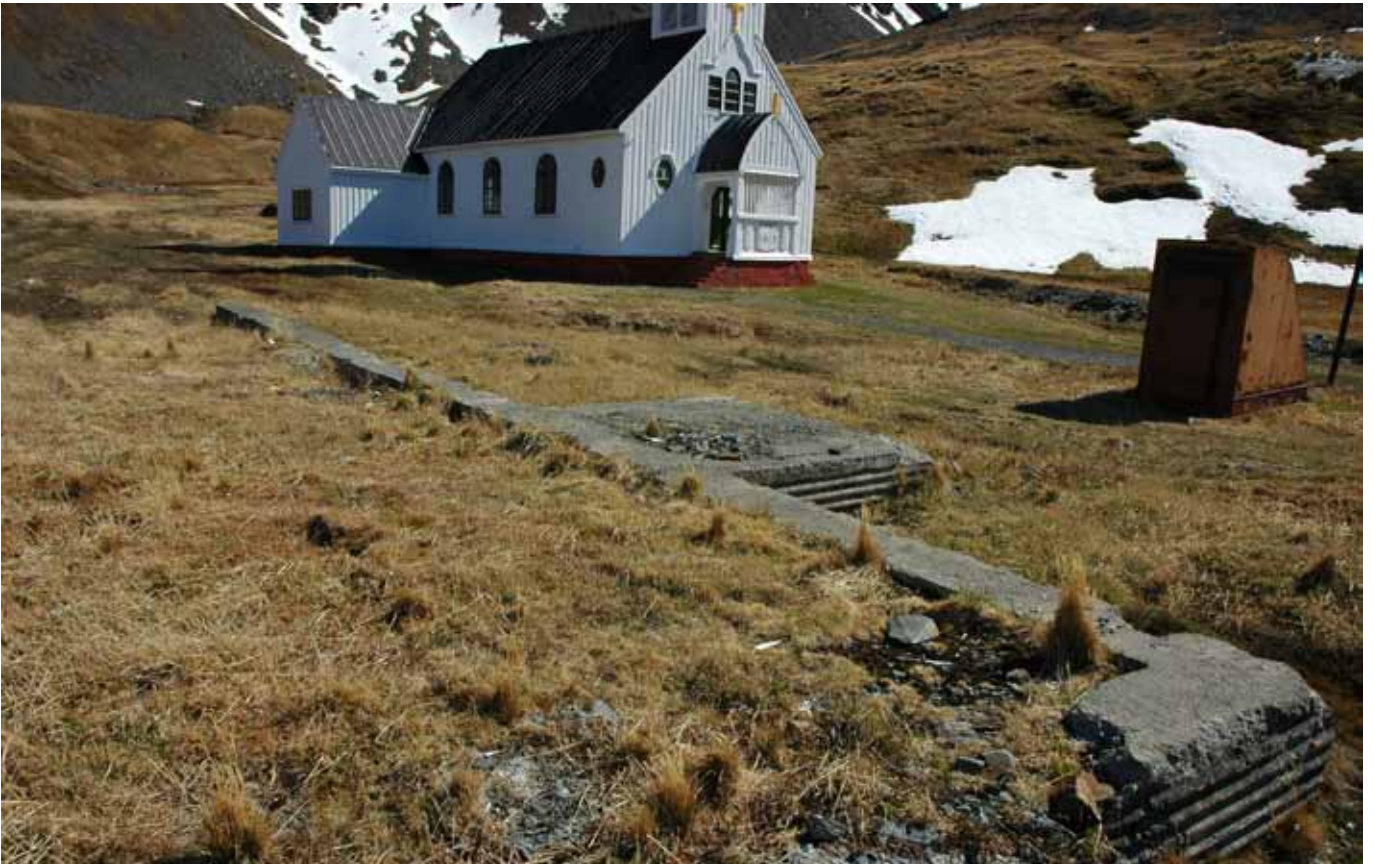
Only the concrete base remains.

33.2 The remaining concrete base of the Cinema looking northwest

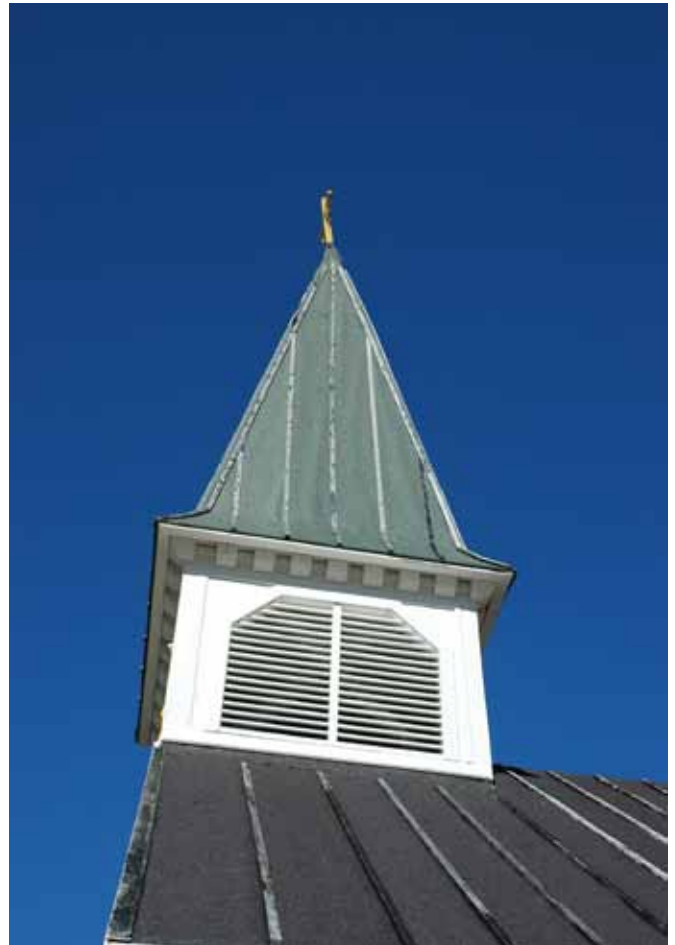
34.4 The north side of the spire

The tower has two bells hanging in the belfry, immediately above the ridge level of the main roof. This has louvres on the north and south sides; above this curved corbels fitted underneath the eaves of the spire. The spire structure takes straight off from the top of the belfry but the corbels allow the bottom to be flared out to give a more interesting shape. The spire felt is held on by timber battens, which run up the corners, matching the slope of the spire and vertically in between the corners. At the top of the spire is a metal cross, also painted a yellow. The only area of disturbed roofing felt on the building is on the west face of the spire. There are five metal rungs up near the top of the spire, probably put there originally as climbing rungs to allow access to the cross. The battening has been stopped short at the bottom rung and the felt beneath the climbing rungs looks satisfactory but there is a patch of felt immediately below this area which now looks loose. This should be kept under observation.

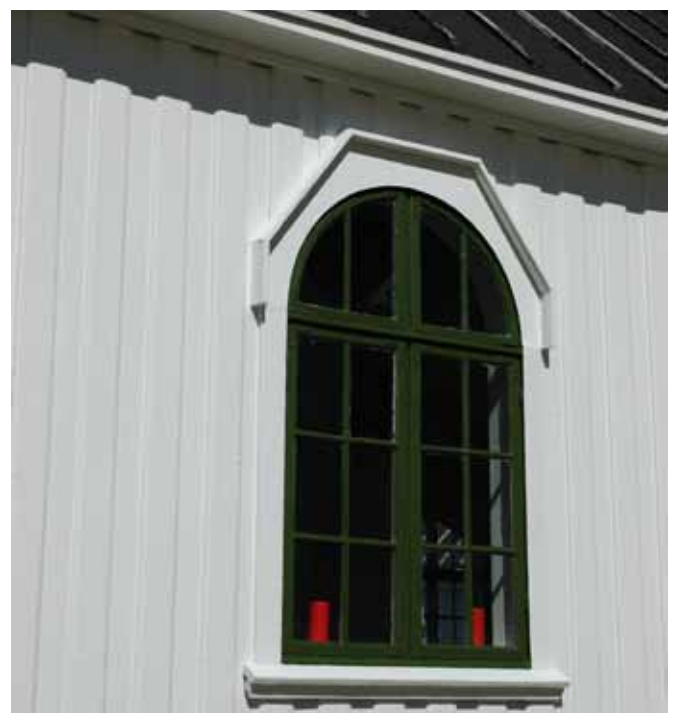
Externally, the walls are clad in timber vertical boarding, set on in a 'hit and miss' pattern, with a double timber sill at the bottom of the wall. There are three double side hung casement windows on the north and south sides of the nave with bullseye windows at either end; all five windows having hood moulds over the casements. All the windows have been repaired with metal corner plates and none would be capable of being opened. They look as though they have been painted shut for a long time. The bullseyes appear to have been fixed from the outset. In the east end, there is a 'Venetian window' lighting the gallery space, each being three-light with a curved head of the centre piece being filled in a single piece of glass. There is a decorated head piece over the Venetian window, with an applied timber cross on top of it, now painted yellow (possibly originally gilded). Either side of the porch are further oculus windows with hood mouldings. On the south side, the west end oculus is missing as the library is attached at this point. The library has a three-light side hinged casement window on the south side, again plated and fixed shut, with a two-light side hung casement window, two over three, on the north side. One of the frames appears to be a later replacement and the other is the original frame and hinges, again

34.5 Typical window

with reinforcing plates of three different vintages in the corner. The north door has canted corners at the head, a lower panel and three over three glazed lights. One corner of the hood moulding to the door is damaged. The concrete slab step to this north door appears to be a replacement.

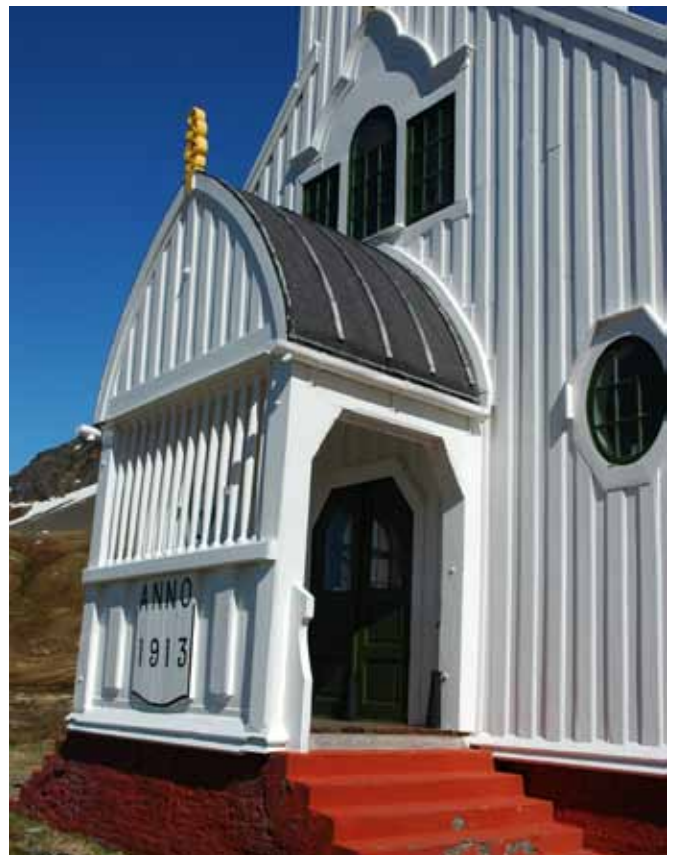
The porch at the east end can be approached from either side up seven steps, the bottom six being concrete and the top being part of the timber deck outside the double doors into the church. The porch has a boat hull shaped roof, covered in felt fixed with timber battens. There are gutters at either side of the porch roof, but no downpipes. There would appear to have been downpipes in the past, given the scooped out pieces of timber. The water falling from here makes the bottom of the timber columns and the cill piece vulnerable to rot. This has been substantially filled in the past and needs to be kept well painted if it is not to start wet rot. The timber steps have been repaired in concrete and some further repair is going to be needed in the near future. The steps are painted in red lino paint as is the brick plinth right around the church. There is some minor rusting from the tie rods across the top of the two openings into the porch; again, this needs repainting on a regular basis.

34.7 The porch and steps

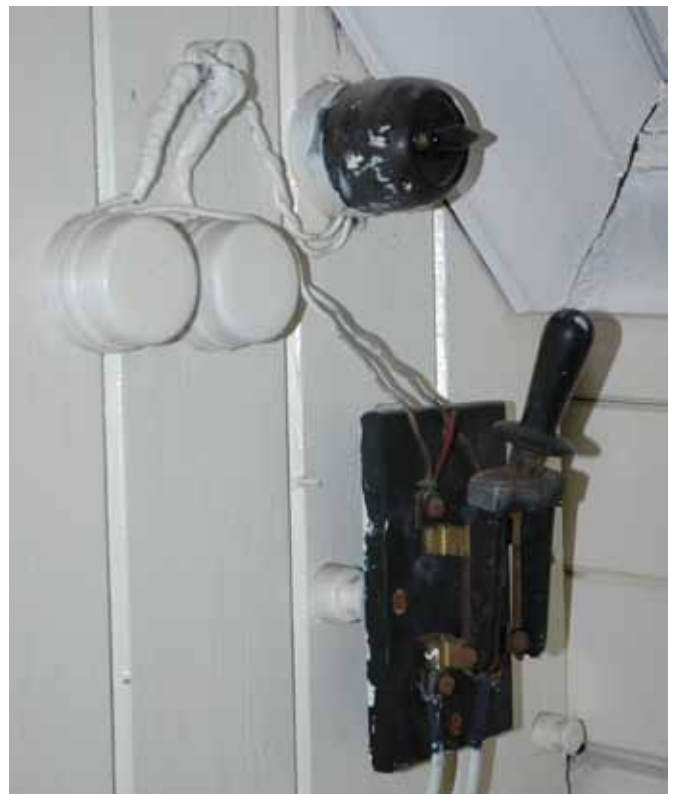
34.11 Remnants of the old electrical system (now disconnected)

The church has been wired for electricity at some point in the past. Some of the coiled wire and switches remain in position. There is currently no electricity in this space and no heating. There are signs that electricity is used on occasions, presumably from a temporary generator.

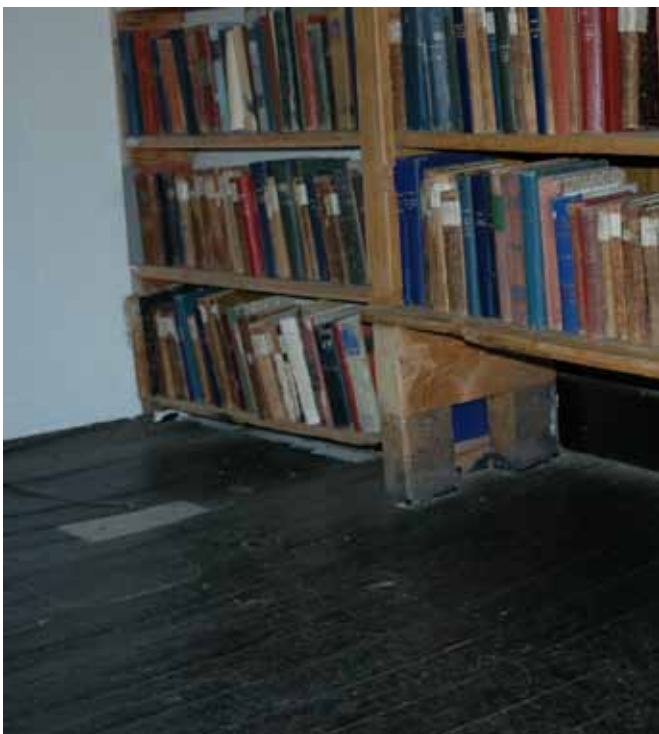
A door in the southwest corner of the nave leads to a small porch lined out with the same vertical boarded dado with horizontal boarding all round and above. The porch has a small cornice and a timber boarded ceiling. The walls are lined with various tributes to Shackleton. To the south is the library, a rectangular room panelled out with a low oak dado with painted horizontal boarding above. This room is fitted out with a counter of painted timber and book shelves on the walls. Other than in the northwest corner, the timber book cases are fitted to the walls. The earliest ones are those on the east wall. There has been a stove in the northeast corner of the room, and metal plates to the ceiling and floor remain in position. The floor, at this point, has sunk and the failure of the floor joists has allowed the timber shelving to tip out slightly. The floor here should be taken up and repaired.

34.14 Bookshelves on the east wall tipping where the floor is sinking

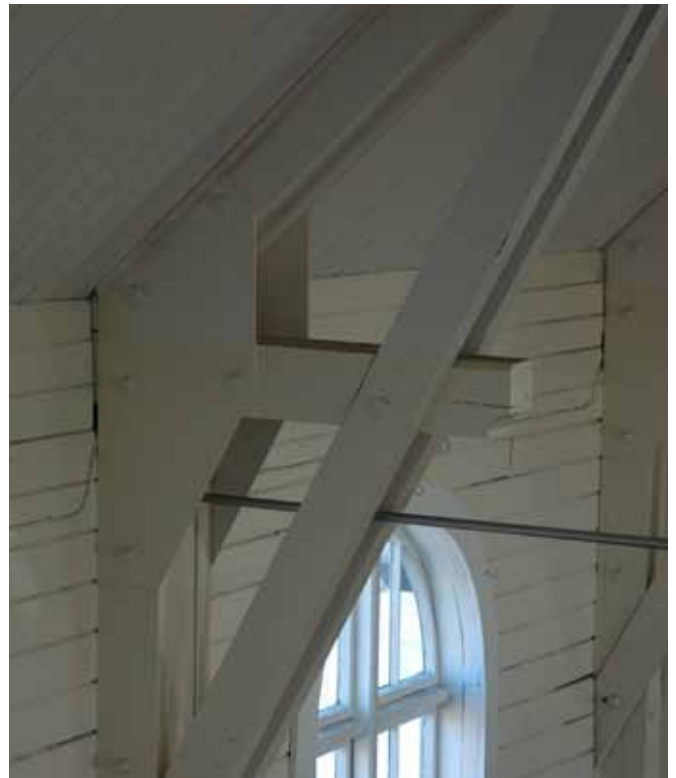
The roof is boarded out with boards running horizontally up to the ridge between the principal rafters. Four of the principal rafters have been further stiffened with timbers bolted on either side at high level and this is the pair of timbers over the gallery, one on the north side, one truss away from the gallery and one on the south side, two trusses away from the gallery. There are certainly some substantial shakes in the original timbers. Many of the open joints can now be seen between the replacement timbers and the original work. This probably is simply the way these timbers were fitted which must have been a difficult job. There is some movement in the boarding of the roof itself. Open joints are apparent and one or two boards appear to have dropped slightly. Keeping an eye on these joints for any further signs of movement would clearly be sensible and the boards may act as something of a tell tale. The general impression, however, is that this building is solid and in no immediate danger.

34.19 Steel plates installed to strengthen the roof trusses

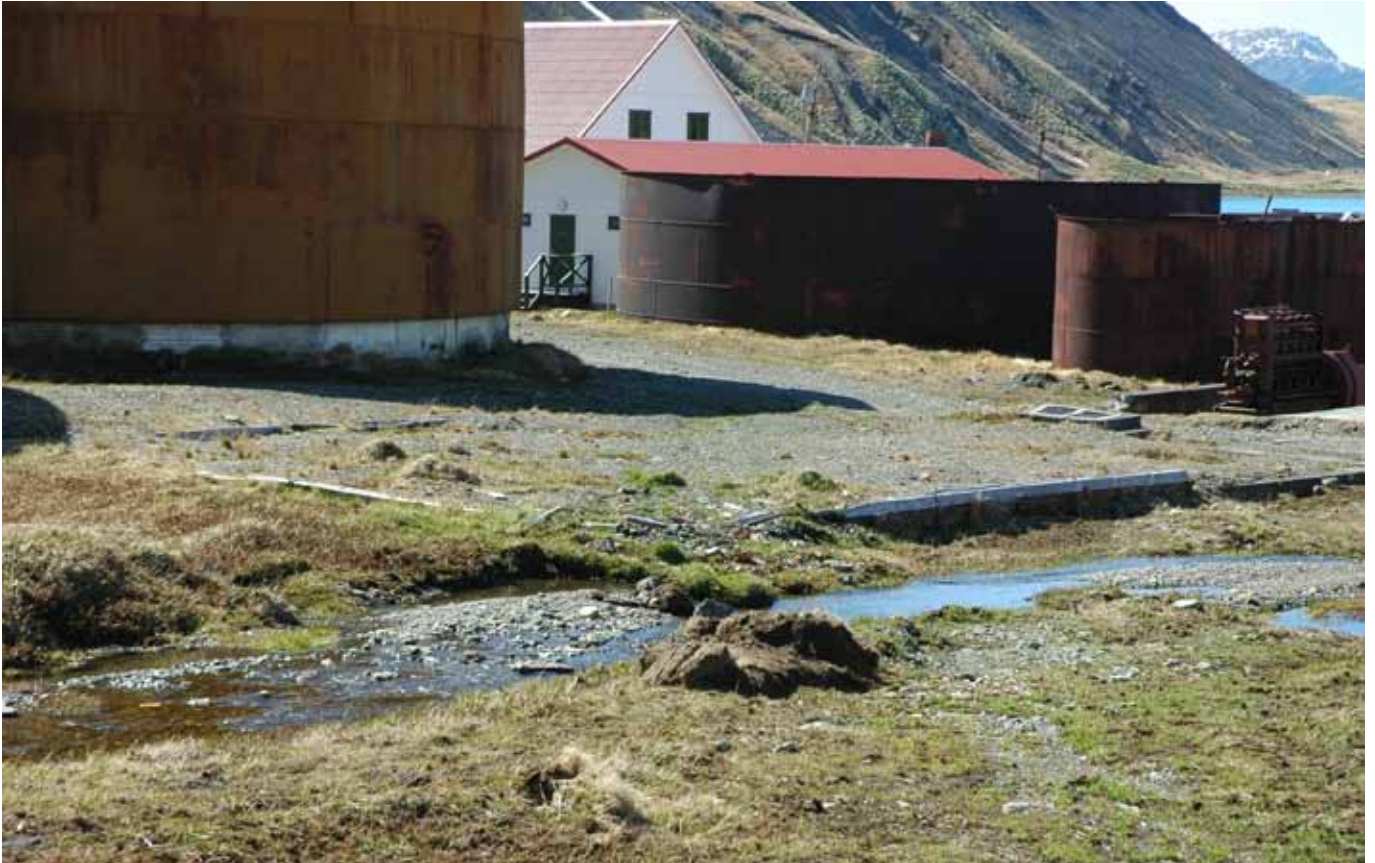
Only the base remains.

35.1 The remaining base of the Hospital looking northeast
