DISUSED WHALING STATIONS

Grytviken Harbour Gazetteer

Purcell Miller Tritton LLP, 3 Colegate, Norwich, Norfolk NR3 1BN
norwich@purcellmillertriton.com www.purcellmillertriton.com
July 2011

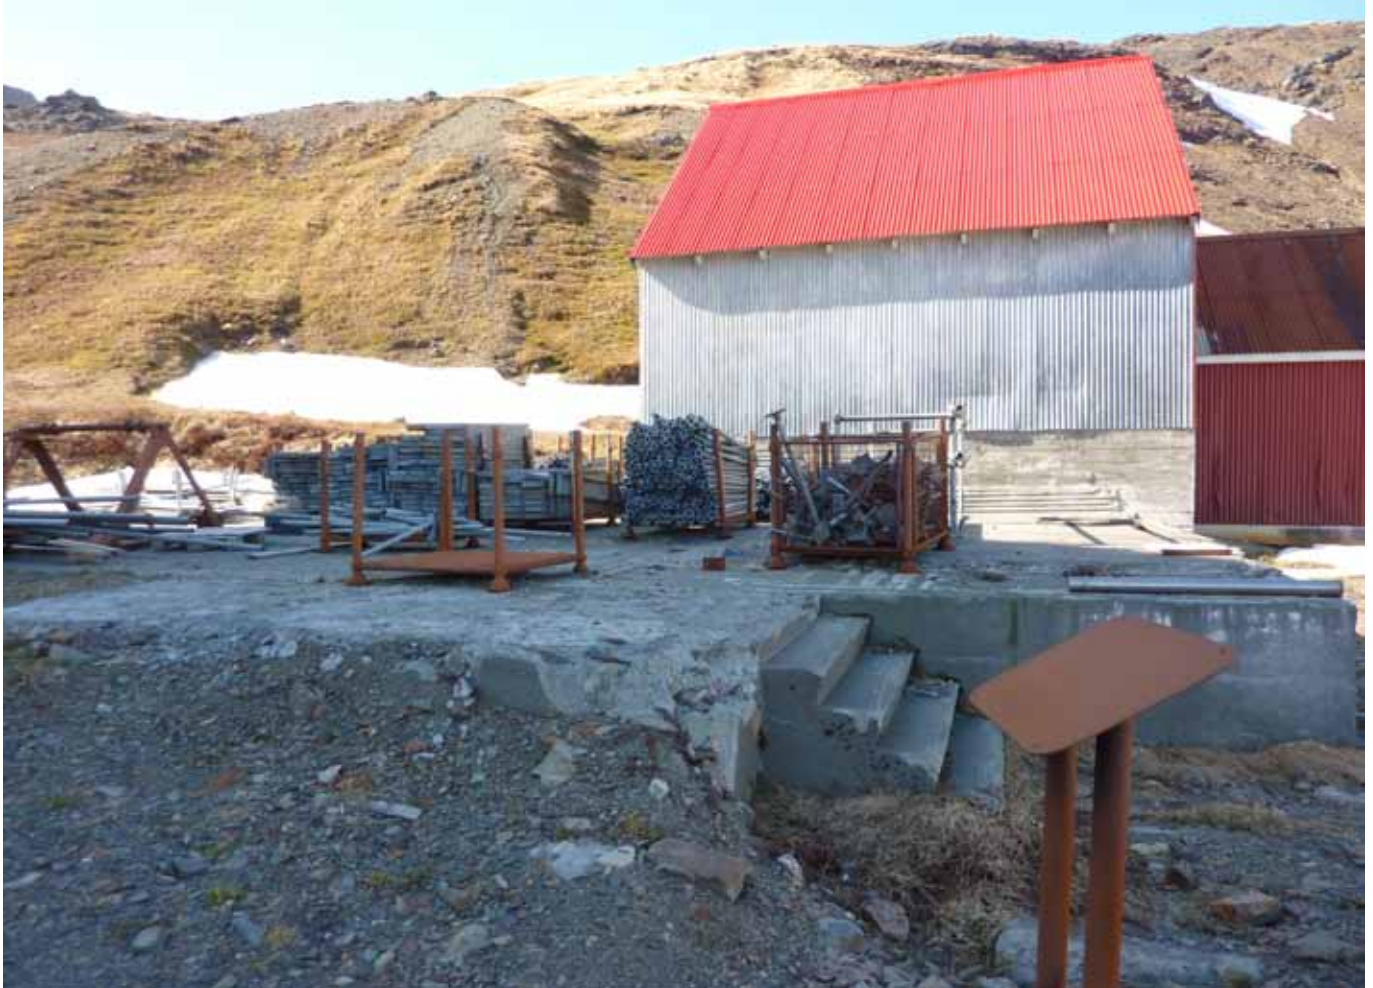
This has been demolished and the base is now being used for storing scaffolding.

40.1 The base of the Provisions Store in the foreground with the Slop Chest (Building No. 46) in the background

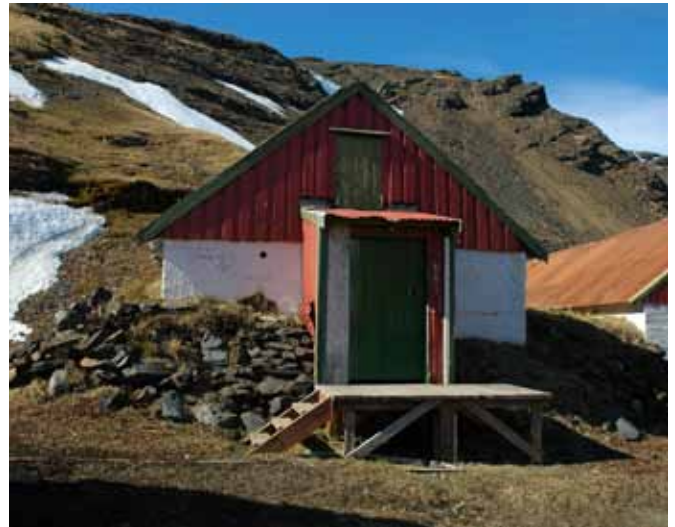
41.1 The entrance in the south elevation

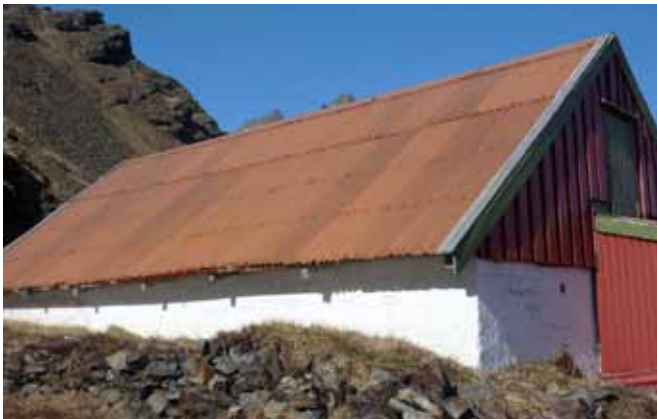
42.1 The west elevation partially below ground

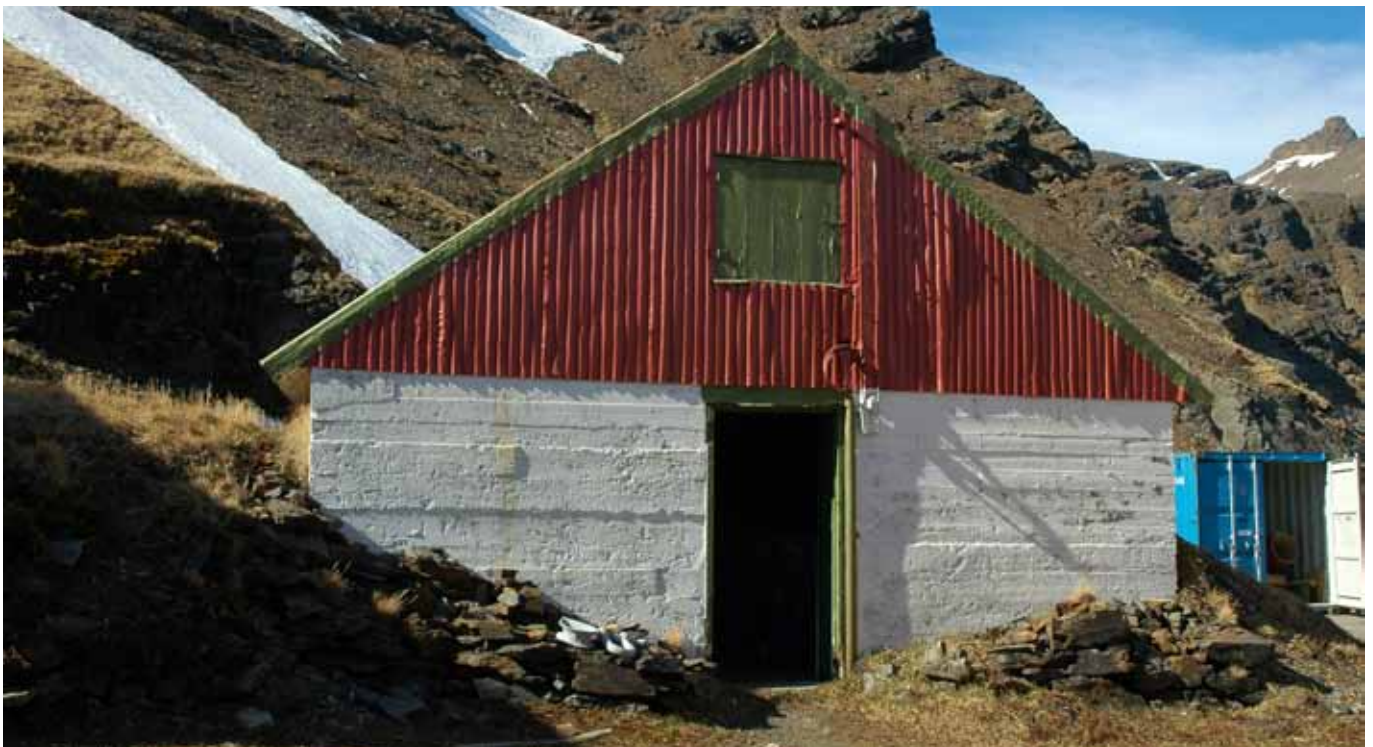
42.3 The south elevation with the entrance door

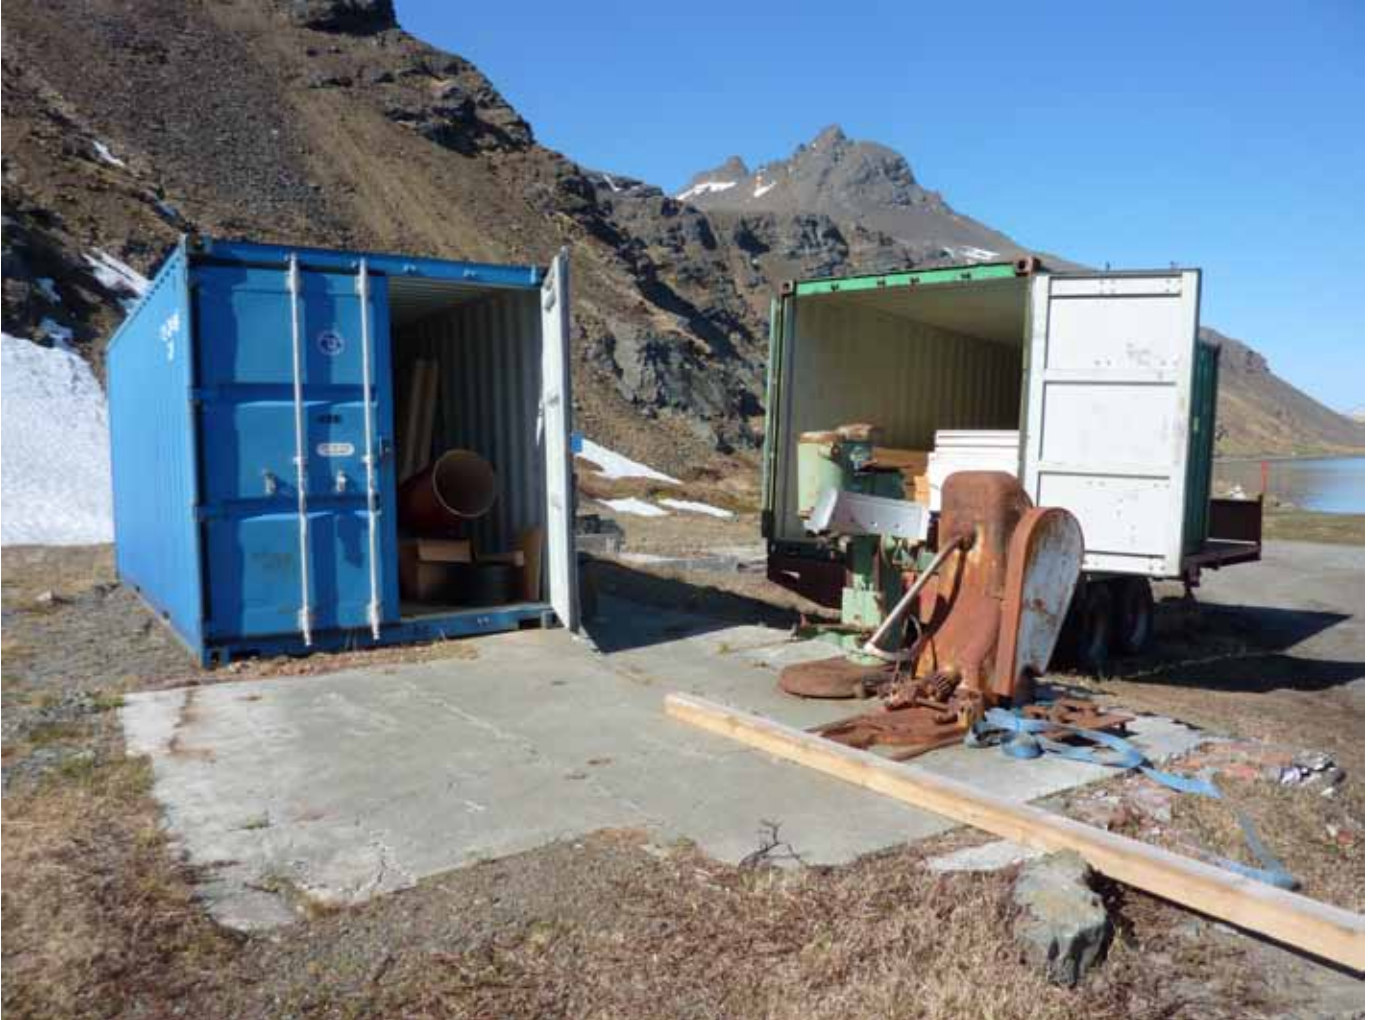
This building has disappeared with only the concrete base remaining.

43.1 The base of the Bakery

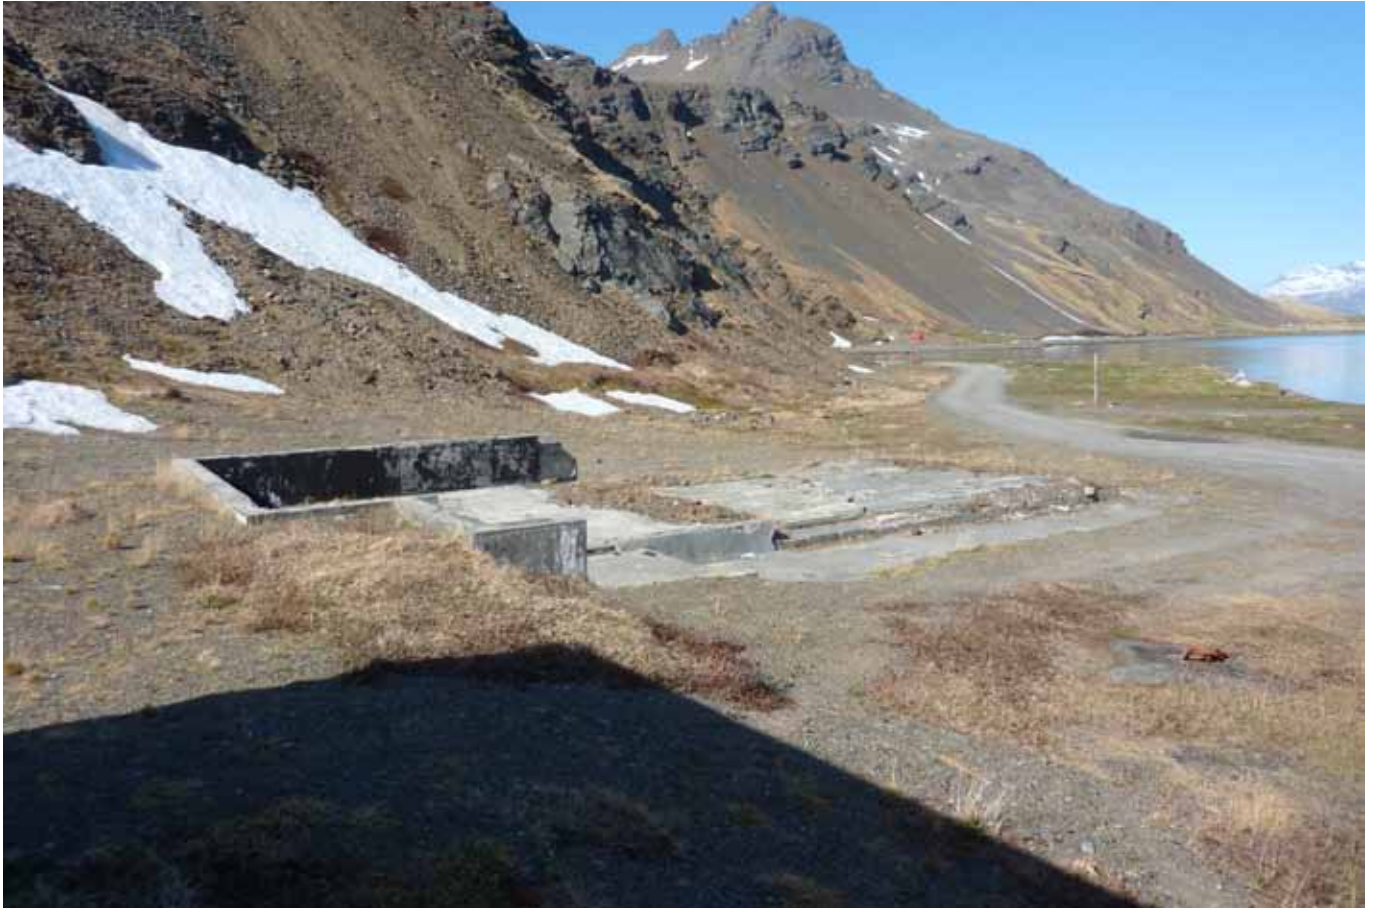
This building has been demolished with only a small amount of concrete wall remaining in position.

44.1 The remaining base of the Cold Store

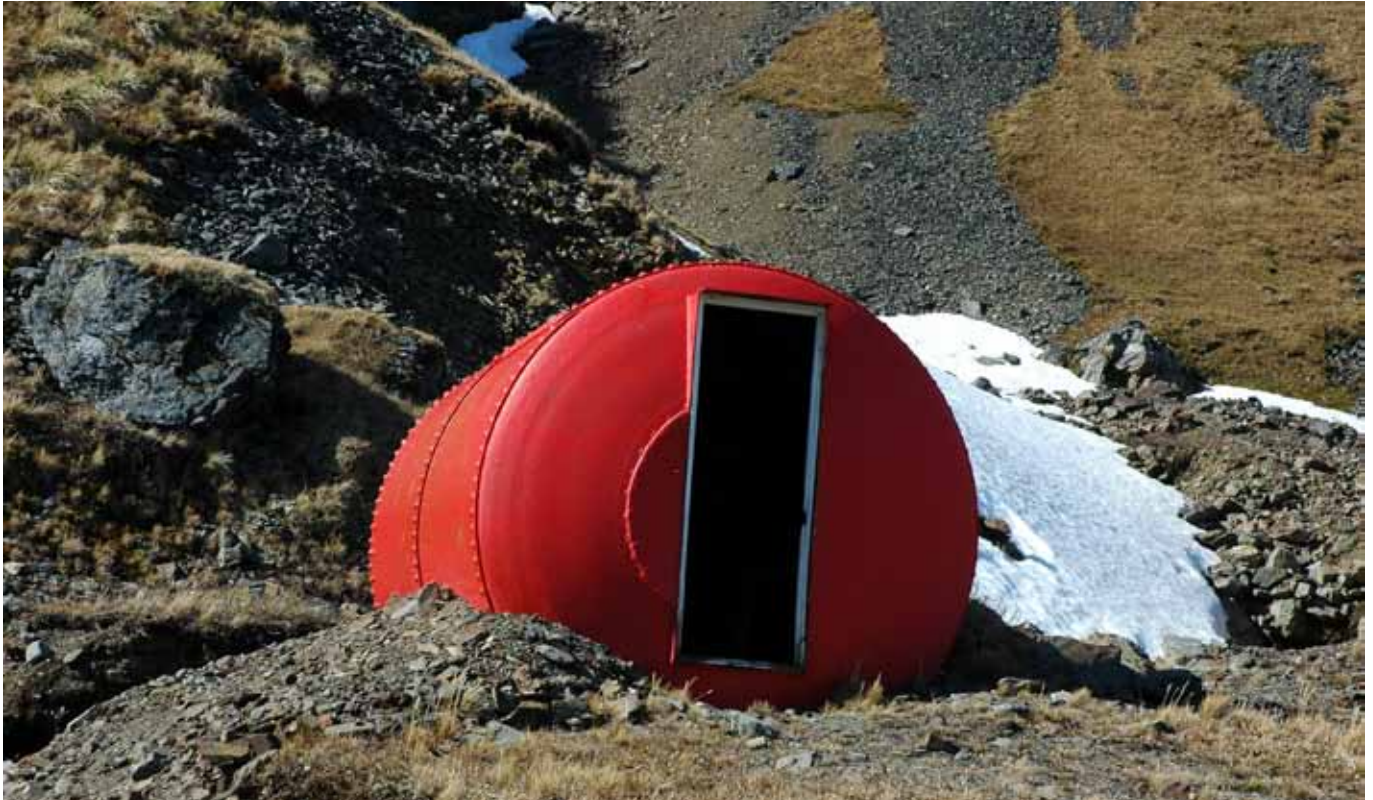
49.1 The store made from an old boiler

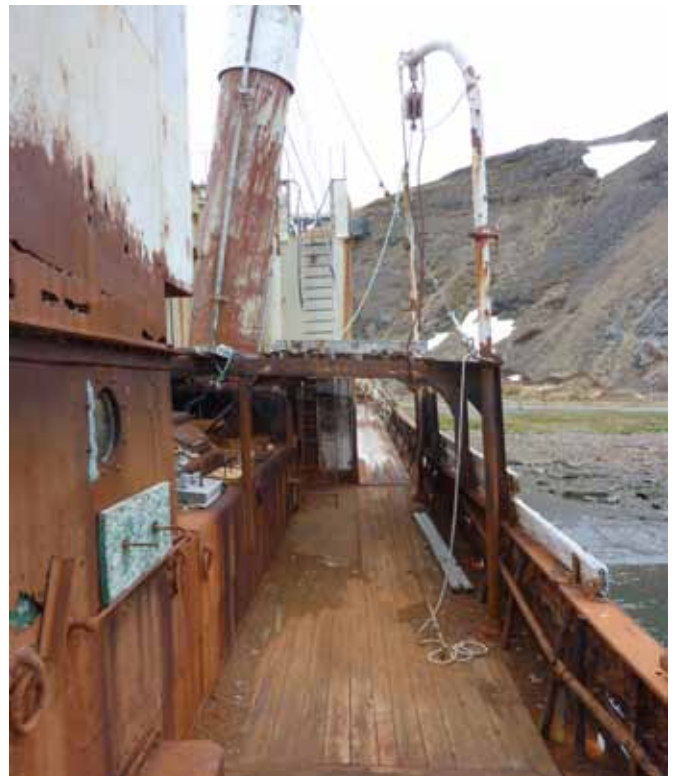
The base of the funnel had corroded to the point where it has started to collapse in on itself. The steel sheet of the surrounding deck was also seriously corroded. The conclusion of the inspection was that there was not sufficient sound material left to enable a temporary repair solution and that the funnel should be removed as a safety measure – hopefully with the possibility of it being replaced at some point in the future.

One obvious reason for the removal is the unlikely chance that the falling funnel could injure someone. The rather more likely concern, however, is that in falling the funnel would most probably tear a good sized hole in the deck and expose the asbestos in the engine compartment.

52.2 The starboard deck of the Dias showing the lean on the funnel

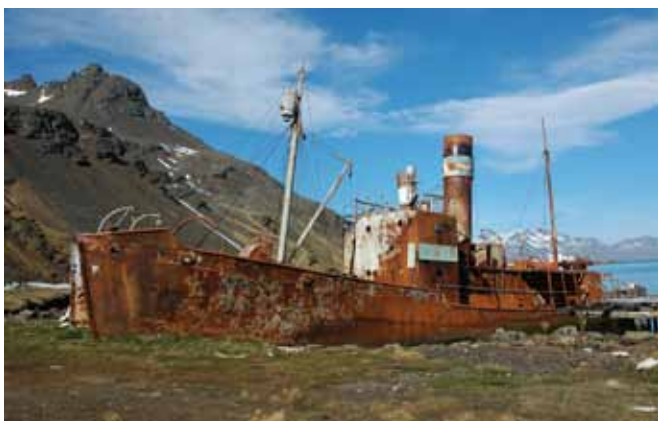
The two boats make a very evocative part of the general scene at Grytviken even if access is not available. Both boats are in poor condition with much corrosion on the exposed surfaces that are visible. One presumes that a good deal of corrosion is going on inside the hulls as the water is flooding in and out of here.

53.1 The Albatros

Apart from considering the problem of the funnel neither boat was closely inspected; however it was apparent that some decisions will be needed about these vessels in the immediate future. The engine compartments were sealed to encapsulate the asbestos (presumably when the general asbestos clearance was done). This sealing is now damaged in places and needs redoing.

If these two boats are to have a long-term future then some much more major work is going to be needed. Asbestos clearance is one obvious requirement so that access to the interior is possible. Significant repairs and a repainting programme are needed to all external services. Whilst the beaching of these two vessels secures them in the short-term, this is not a satisfactory long-term solution.

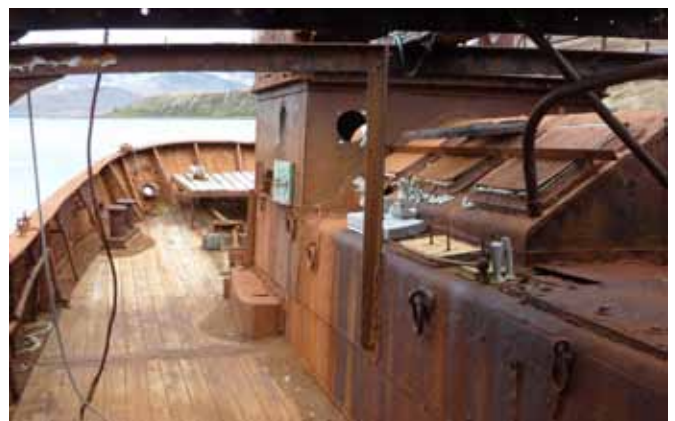
Corrosion is affecting the decks, the bulwarks and the side and top of the wheelhouse and engine compartments. Dias was accessed (in the company of Dave Peck) specifically to look at the chimney stack. This funnel had been stayed in the past with wire rope; however it had begun to lean to the northeast. There was some urgency about making a decision as to what to do with the funnel – if it needed to be lifted down the big Volvo Caterpillar tractor was only available for a few weeks until it was removed.

52.3 The starboard deck of the Dias looking towards the stern

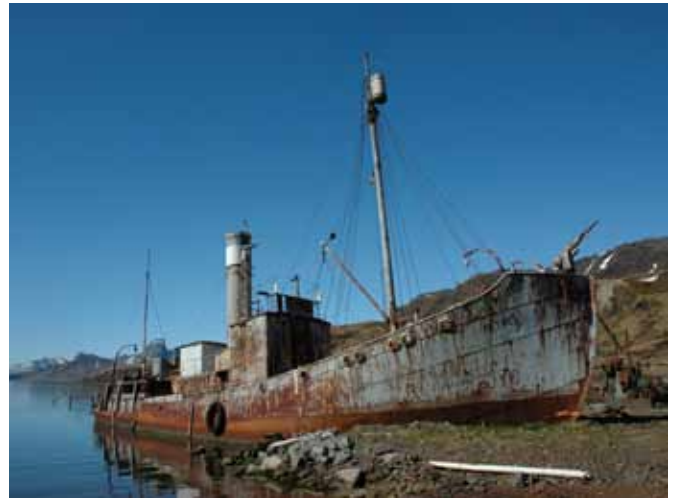
This old catcher boat is now completely beached. The boat genuinely looks reasonably secure. The whole of the hull and the superstructure is corroding quite badly but it would not appear to be in any immediate danger of collapse. The main funnel has been stayed with wire rope although these stays are relatively loose. The top of the funnel has been capped off with plastic sheet. A small mast to the rear also reasonably well stayed.

54.1 Petrel north side

The Petrel (along with Dias and Albatros) is a significant feature of Grytviken and an important way of setting the scene for visitors. Whilst there may be no immediate threat to the boat, in the medium term this is going to need a good deal of expensive conservation work if it is to be retained.

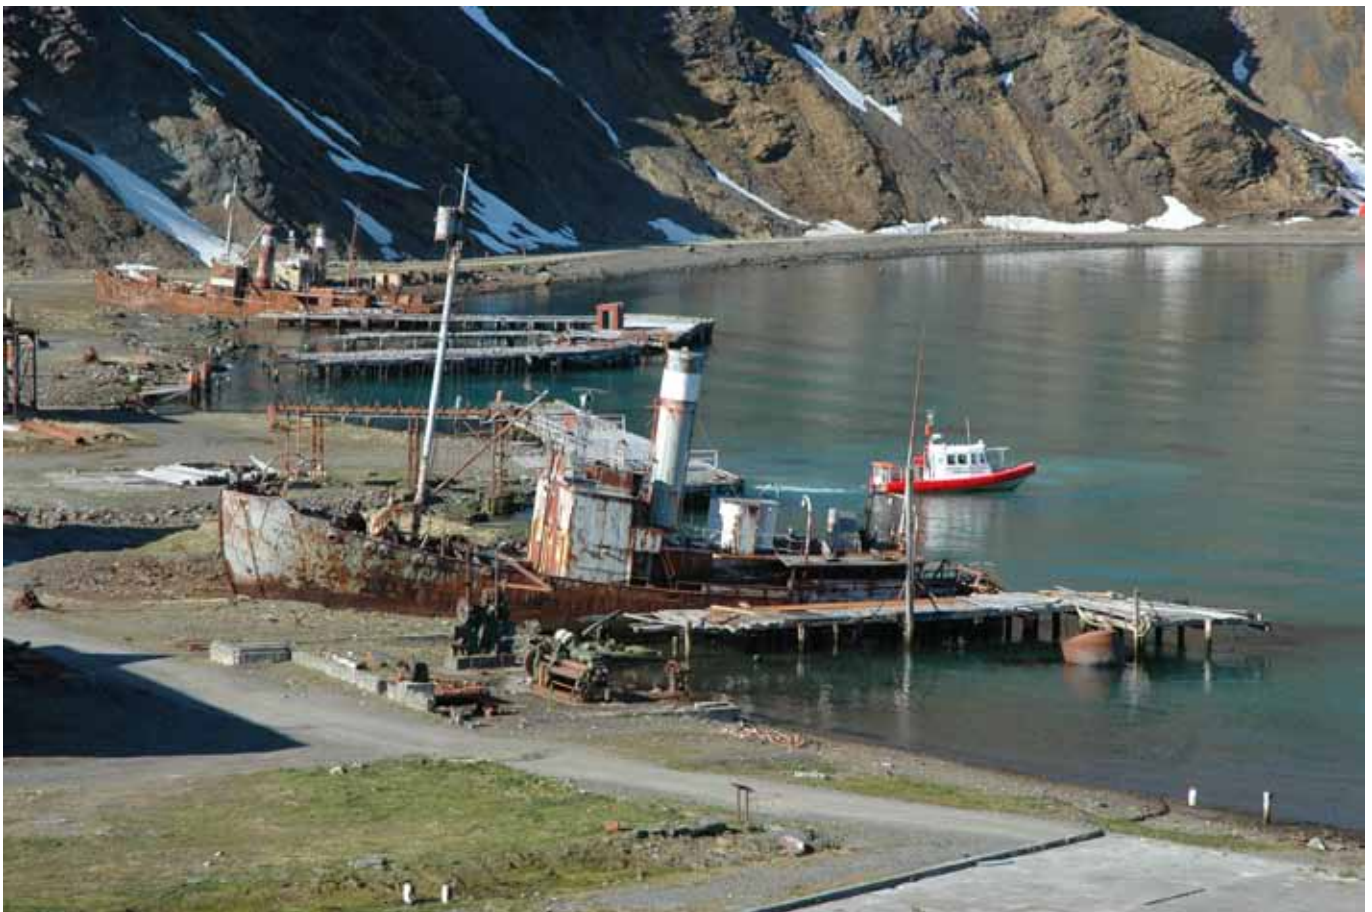
54.2 Petrel south side

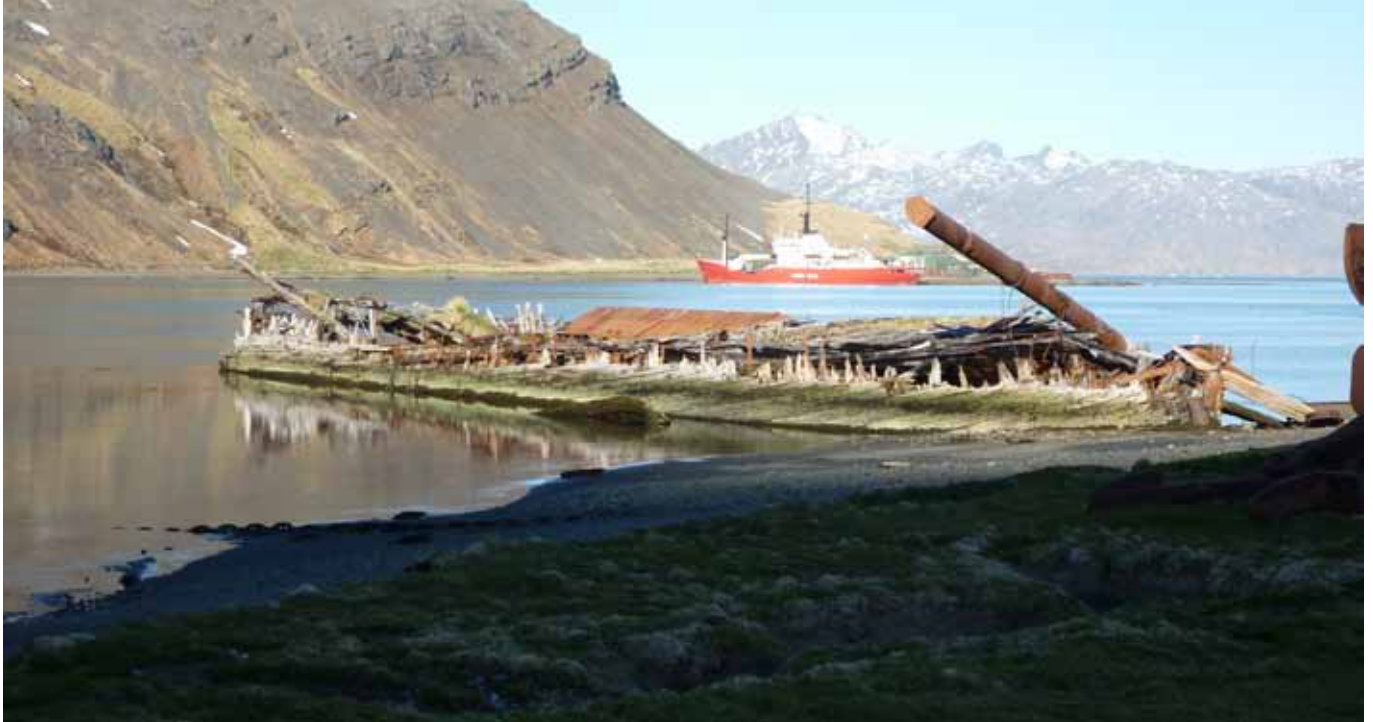
The Louise is burnt out pretty much down to the waterline. What little remains is beyond any sensible repair. One iron mast lies propped up against the side of the vessel with its top in the water. There is an iron barge lying on its side against the east side of the Louise. On the shoreward side there are two old steel barges lying upside down, both much rusted.

55.1 West side of the Barque Louise

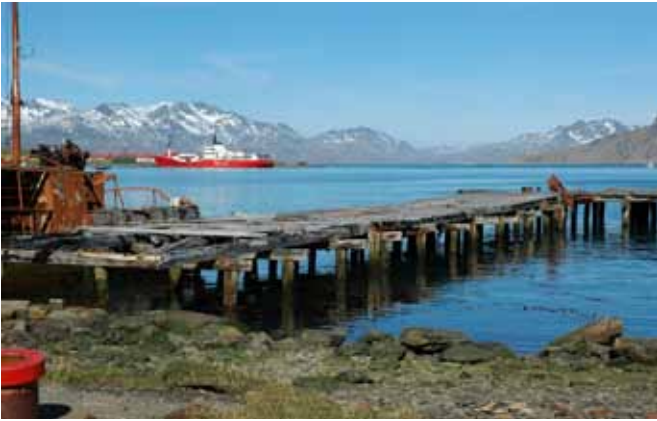
Three sections of this jetty remain but all are in poor order. The jetty is not attached to the shore in any position, although this may have been deliberately dismantled. It would require a great deal of work to repair it. A small hut sits on the outer section of the jetty, built in corrugated iron. There are various iron bollards and other fittings which are now in danger of falling through and into the water.

58.1 The north side adjacent to the Albatros

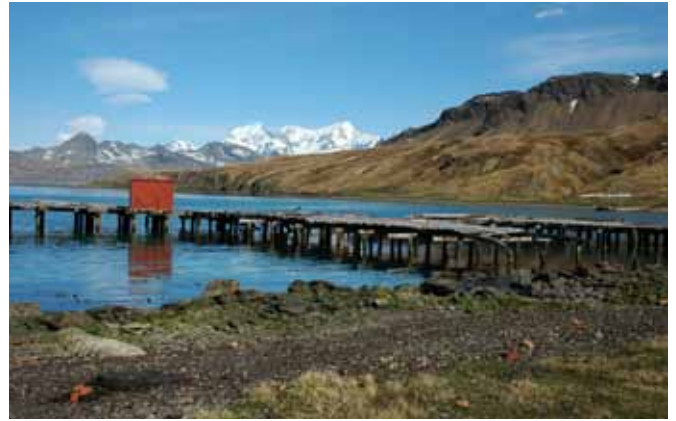
58.2 The south side - no longer attached to land

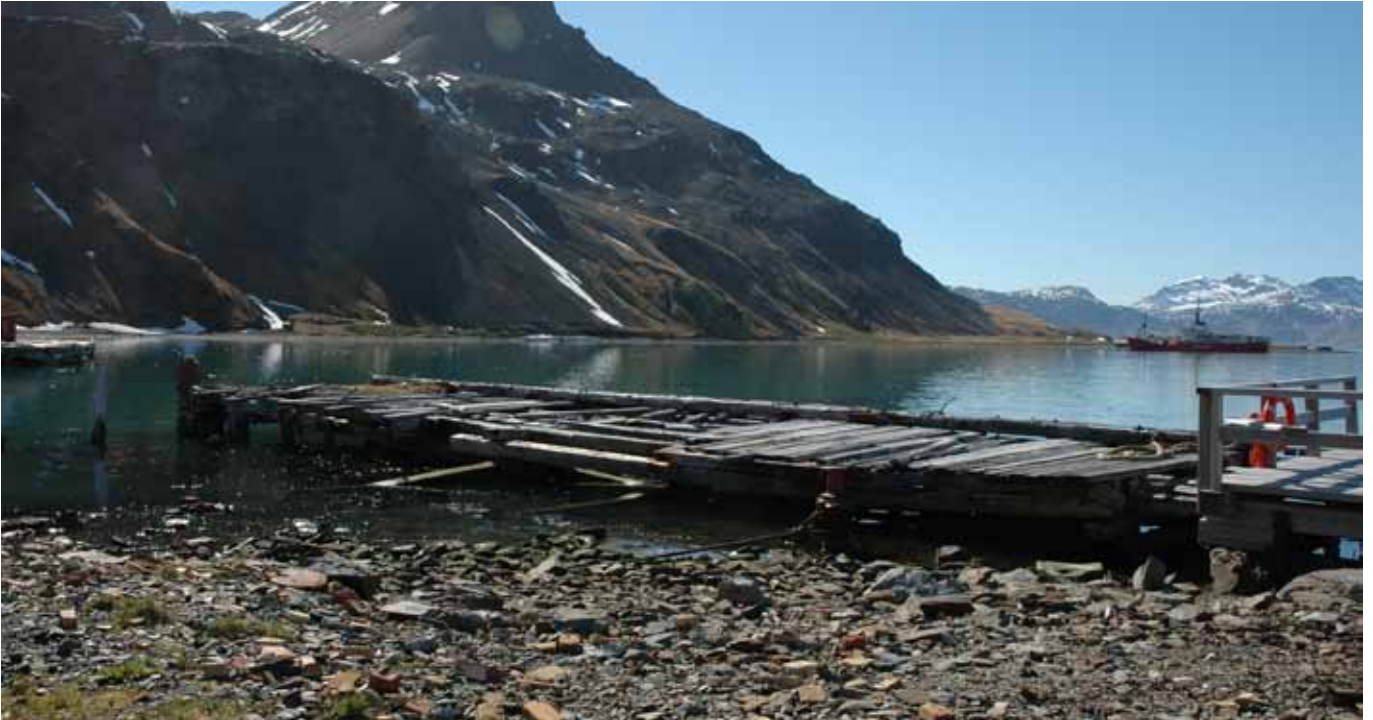
Only a small section of the original jetty remains. Part of it has been rebuilt to provide a modern jetty for landings, the remainder has disintegrated.

59.1 The south end of the Jetty where it abuts the modern landing platform

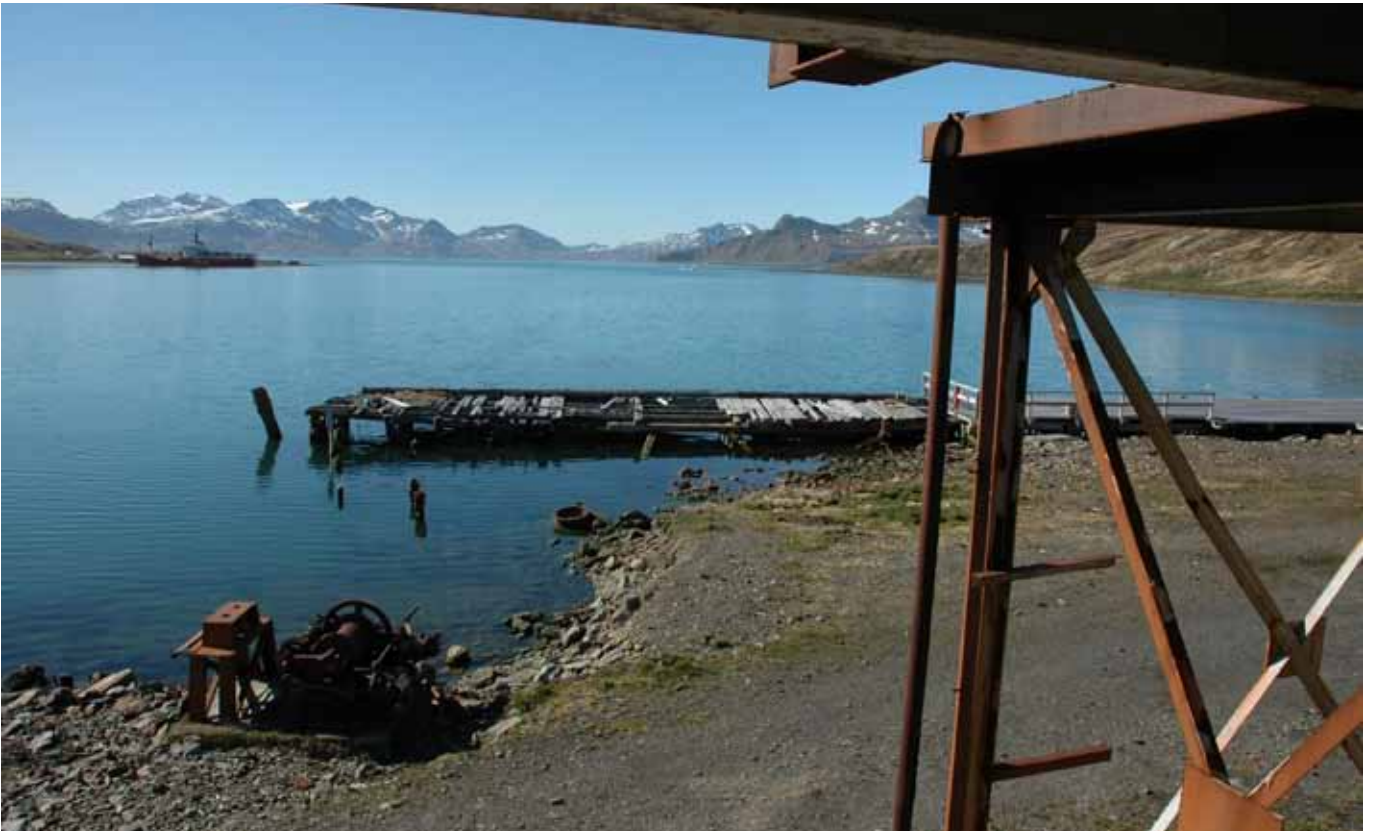
59.2 The north end of the Jetty

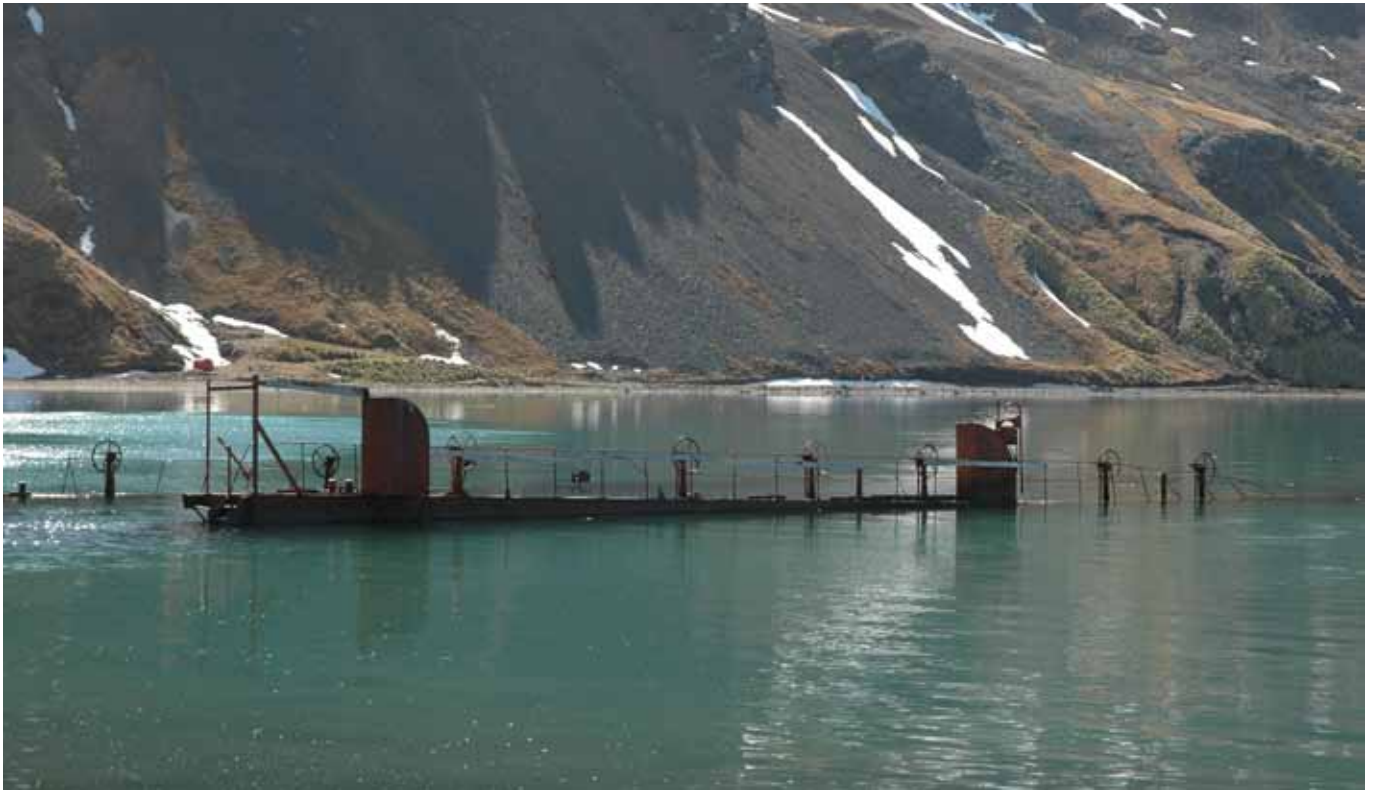
This is off the end of the catcher jetty with its upper part still visible. The floating dock would appear to have sunk and is currently sitting on the bottom.

60.1 The floating dock

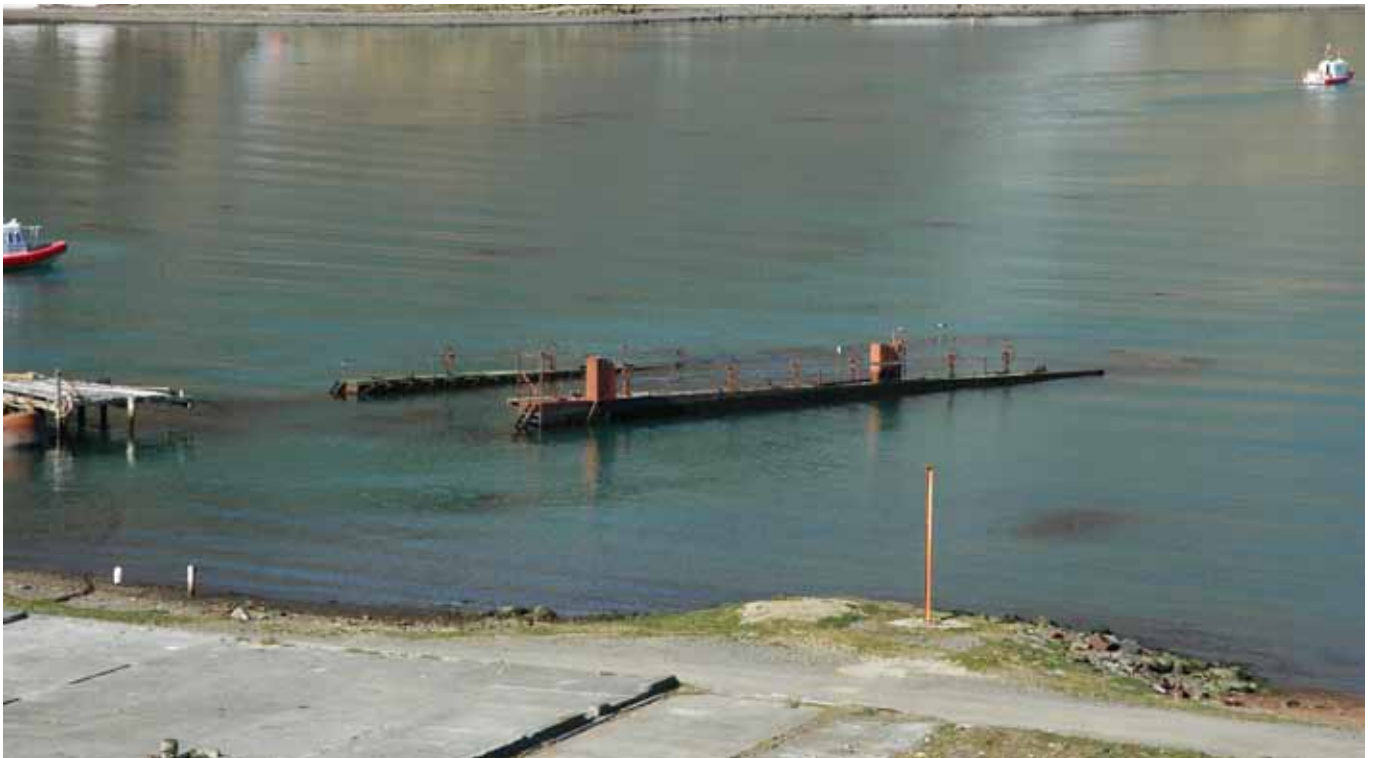
60.2 Showing the extent to which it is submerged

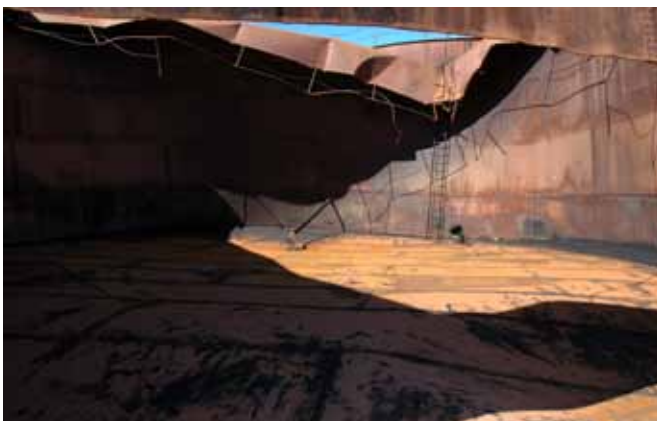
The bases generally are in poor order with supporting walls collapsing. There is also a good deal of corrosion around the edge of the roof where standing water can collect. It is likely that more roofs will collapse in the next few years.

78.2 The typical way a Tank collapses once the roof falls in

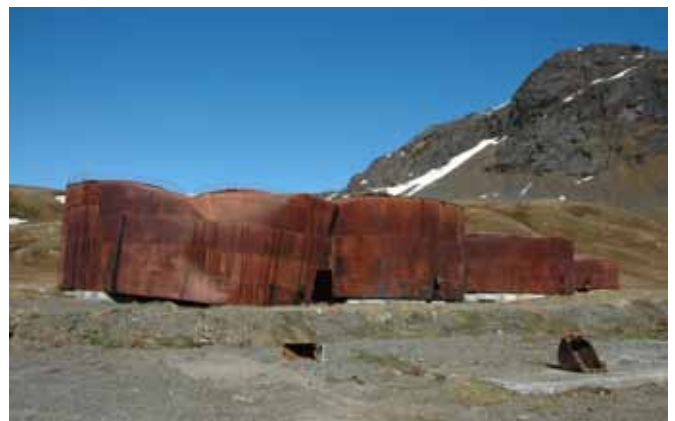
78.3 General view of the north side of the Tanks

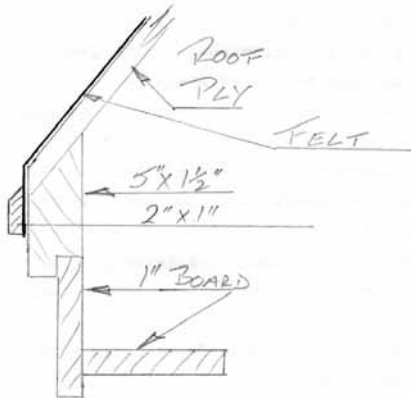
Section showing the fascia

The fascias and soffits were in a very poor state and were completely replaced. New bargeboards and weatherproofing around the base of the steeple completed the nave roof. The new fascia used 5 x 1½ inch boards for the top section and 6 x 1 inch for the lower. This enabled the felt to be well fixed where it turned down to the fascia. A 2 x 1 inch batten, with a sloped top edge, was also nailed along the edge of the felt. Due to the shortage of timber the soffit was replaced with timber on the south side but ¾ inch plywood on the north.

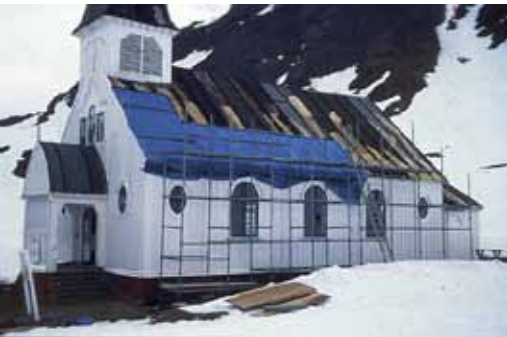
Temporary repairs after the 1994 storm.

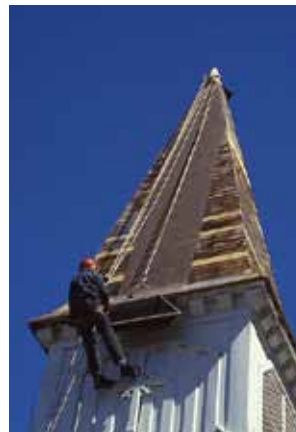
Tim repairs the steeple. New timbers and the plywood apex are in place and felt is being laid.

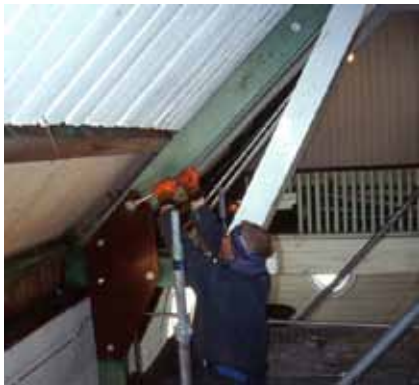
Tim bolts a plate to a roof truss.

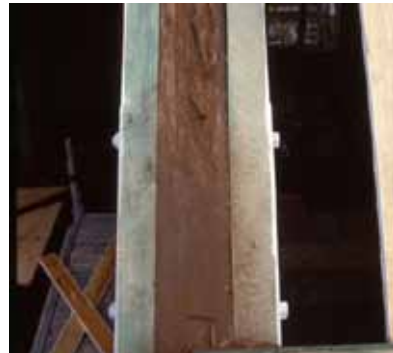
Original truss sandwiched between new timbers.

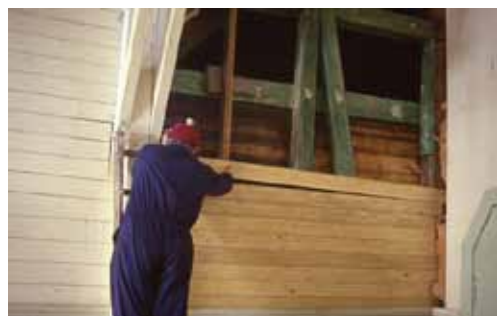
Dennis rebuilds the badly-rotten corner.

Progress had been rapid enough to give time to reroof the chancel and the west side (back) of the library. (The east side had been done at the same time as the valley.). As with the nave, the lower three purlins were rotten and had to be replaced. Extra pieces were put in to strengthen hip areas. New plywood had been used up, so sheets from the army's repairs of the north side of the nave were used. Waterproofing the join of the nave to the gable end of the nave proved a major problem because the old metal flashing had rusted away. The vertical boards of the gable had to be carefully eased off. (There was no material to replace them so this was achieved with a sigh of relief!) A weatherproof membrane was placed under the gable boarding, both layers of felt on the chancel roof turned up the gable and new flashing fixed over it. Rotten fascias and soffits were replaced.

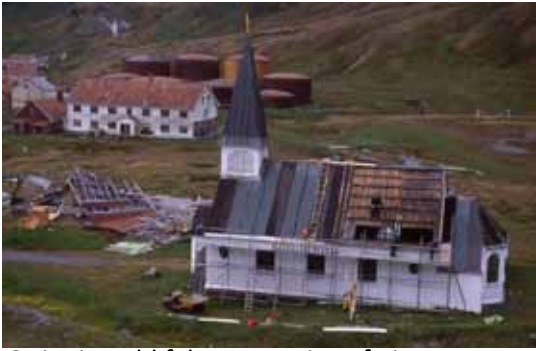
Stripping old felt. Note ruins of Kino.

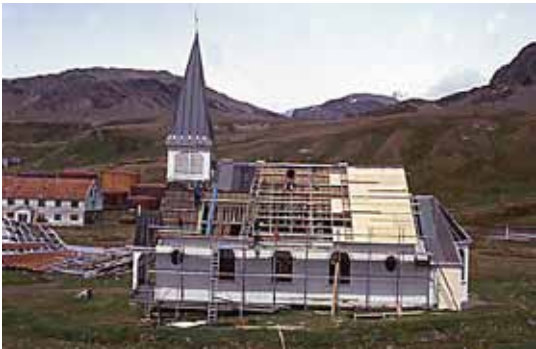
Laying plywood.

Repair of the nave roof, the main objective of the summer's work, had taken 50 working days from 22 November to 15 January. The plywood sheets had been laid by 9 January, the underfelt by 11 January and the roof completed except for the soffits by 15 January. On 16 February the last nail was hammered in and the roof teams's job was complete on 19 February.

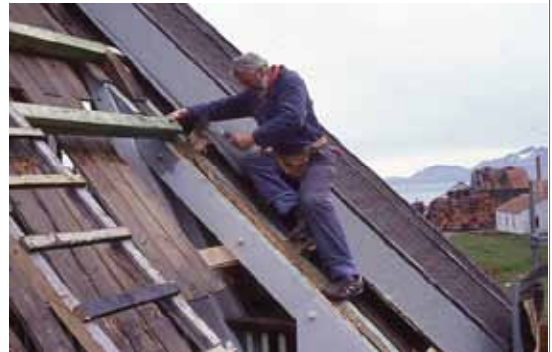
Or it was retained with a strut under it.

Once the south side of the nave had been made watertight, the building team was able to work inside on wet days, which became more frequent in this period. When the purlins had been removed, the internal tongue-and-groove ceiling boards nailed to their undersides had to be released. This was done as carefully as possible to minimise damage and, where possible, boards were left fixed to the top purlins and supported by temporary beams at the bottom. Rotten and damaged boards on the south side were replaced by boards taken from the north side, which were replaced with new boarding. The job was completed apart from a few sections that were left to give Tim access to the main trusses. It had been a close-run thing with timber running out. Existing material had to be carefully saved and recycled and other timbers scrounged from the whaling station.

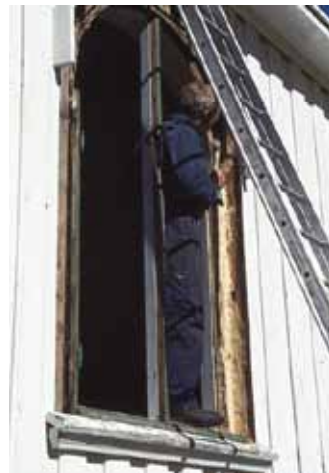
Tim cuts out rot from a window frame.

While the building team was working on the roof, Tim had continued to prepare timber for their use and then turned to repairing the windows. These were in a very poor condition with obvious signs of rot caused by rainwater leaking in. When the windows were removed, it was found that the rot had spread to the adjacent frame of the walls. Repairs proved very time-consuming as both windows and their frames required major 'surgery'. The intricate joinery had to be replaced either with new timber or epoxy filler. Rotten parts of the wall frame were chiselled out and replaced with timber and filler.

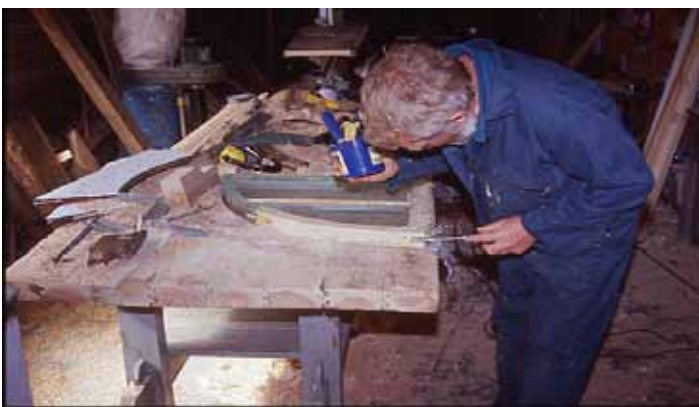
Tim rebuilds a rotten window frame.

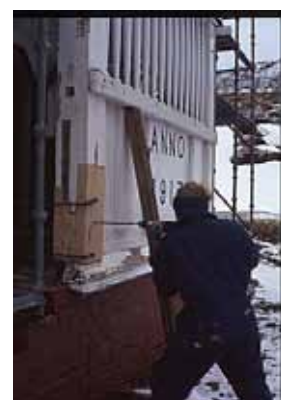
Tim repairs the porch

Summer 1997-98 Tim Carr bolted the porch to the main body of the church with tie-rods and completed repairs to one rotten pillar of the porch by replacing it with new wood. He built up the two steeple support pillars within the church with new timber and doubled the roof rafters in this area. During this job Tim had to go below the floor of the church and he found that all the floor bearers and supports were in sound condition.

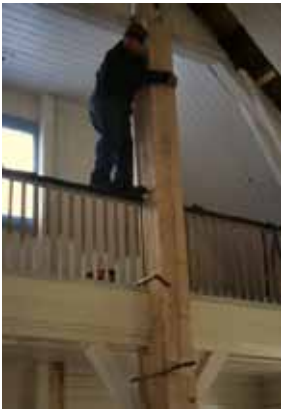
Tim strengthens the steeple pillars.
