DISUSED WHALING STATIONS

Husvik Harbour Gazetteer

Gazetteer, July 2011

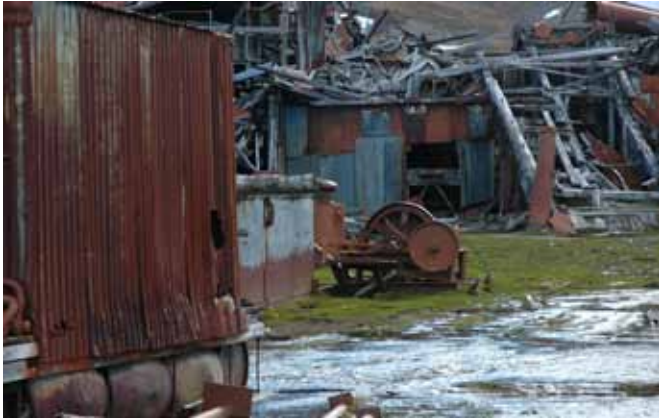
1.1 Detail of the Plan deck showing vegetation growth

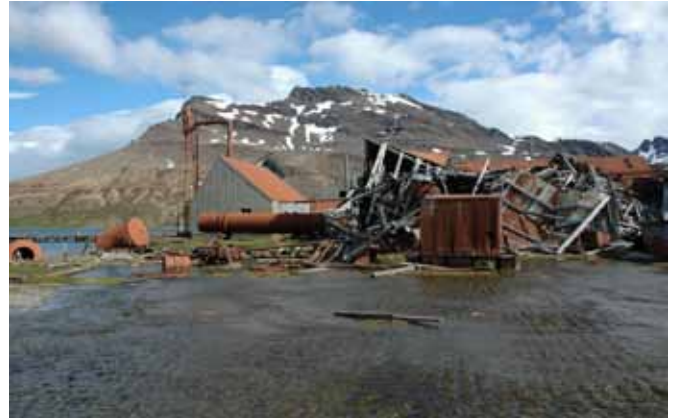
The Plan still exists and is defined by the three cookery buildings despite their collapsed state. Some of the timber boarding, possibly a good deal of it, survives but the majority of the area is now under water. The stream which was contained to the north of the blubber cookery has burst its banks and now runs diagonally across the Plan, the majority of the water running through and around the blubber cookery, but with some running through the bone cookery area. The water has deposited a good deal of gravel on the Plan. There is also some vegetation growing between the boards. A number of winches and one small winch shed remain in position.

1.2 General views of the Plan looking towards the Meat Cookery

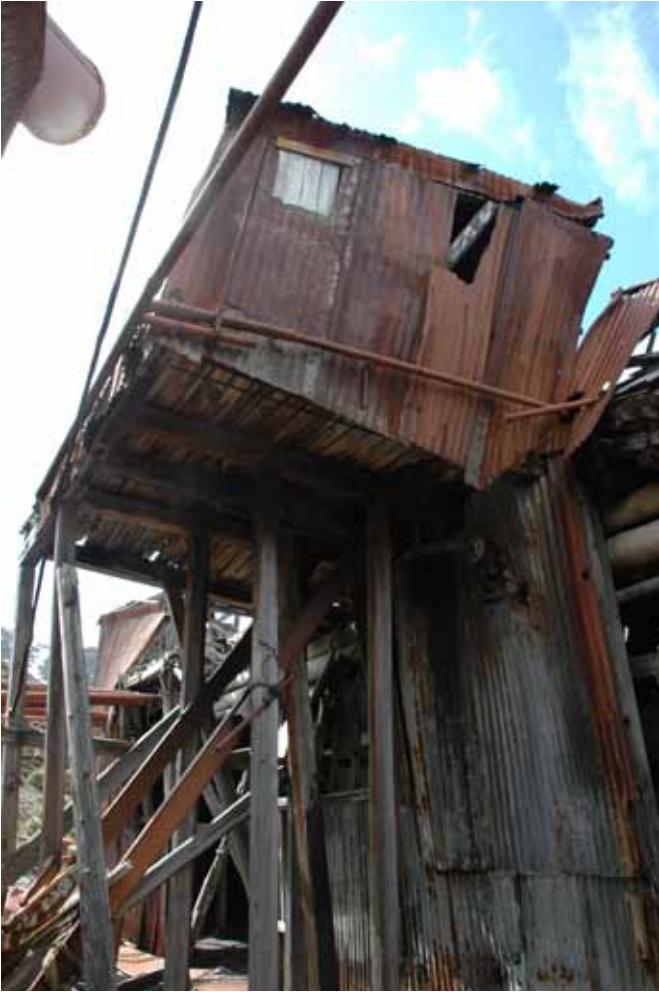
At the north end of Building No.2 is the bone cookery area. This is probably the most derelict area of the whole plant. Again it was not inspected in any detail as there were some concerns about asbestos and considerably more concern about the actual structural condition of the area. The structure around the bone cookers and supporting the bone loft were all of timber. The whole of the loft above the cookers has collapsed and the winch houses which were on the west side of the loft are on the point of collapse. These structures are supported on long poles and relied for stability on the floor of the bone loft. They are now on the point of collapse.

207.2 Collapsing winch house next to the bone loft

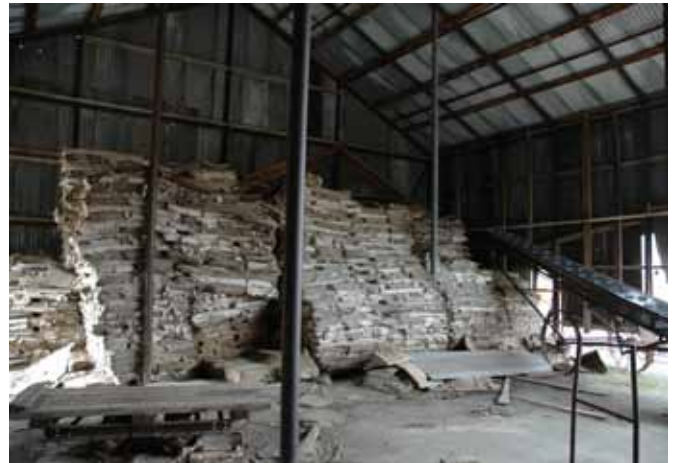
211.2 General view of the interior of the main store looking northwest

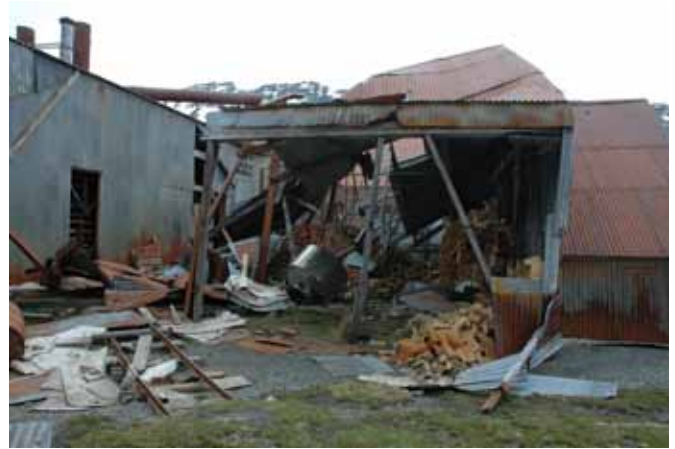
Off the east side of the guano store there is a wing that has been used as a brick store. This has now almost entirely collapsed. The only section remaining in position is the east gable, the rest of the building being a tangled heap of timber and corrugated iron. The store still has a substantial number of refractory brick and some commons inside it. On the east side of the brick store is an extension to the building which appears to be a general store. This has a pitched roof and is timber framed and corrugated iron clad with a timber boarded ceiling which is sagging ominously. The building has had a timber floor but only sections of this remain in place. The east wall of the building is leaning outwards. This is really an integral part of the brick store structure and is likely to collapse when the east gable of the brick store finally comes down.

203.1 South side of the Brick Store

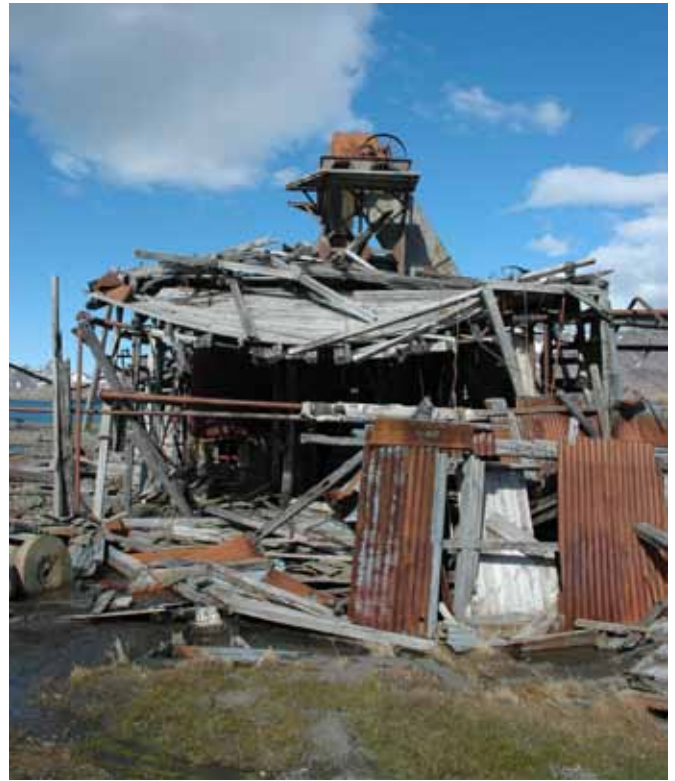
3.1 The west end

To hasten the collapse of the building (which cannot now be far off) the stream is now running alongside the north face of the building and across the east end. A fair amount of water is no doubt now finding its way through the centre of the building.

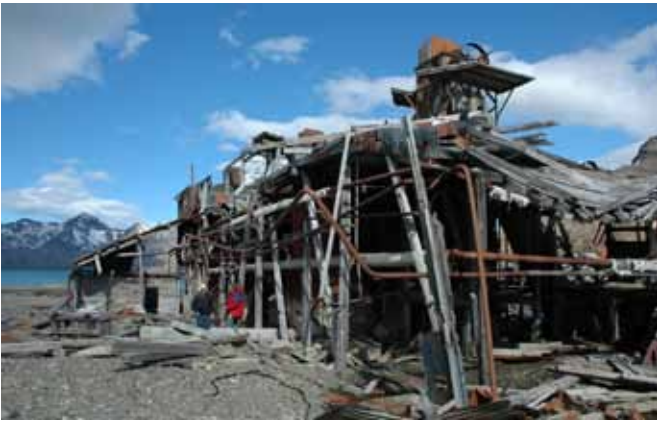
3.3 The north wall of the building

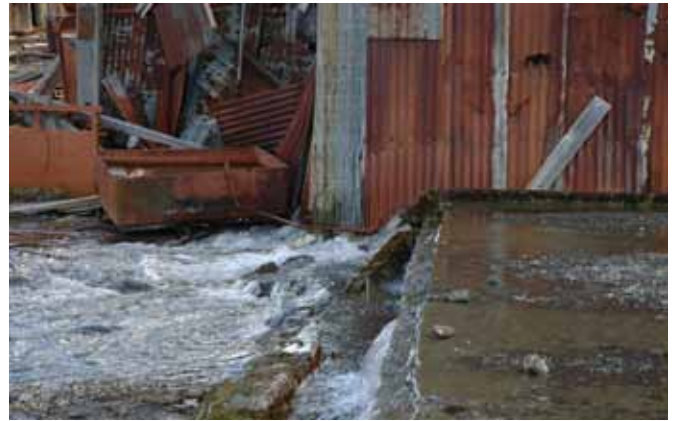
3.4 The stream running across the east end of the building meeting water which has run through the building

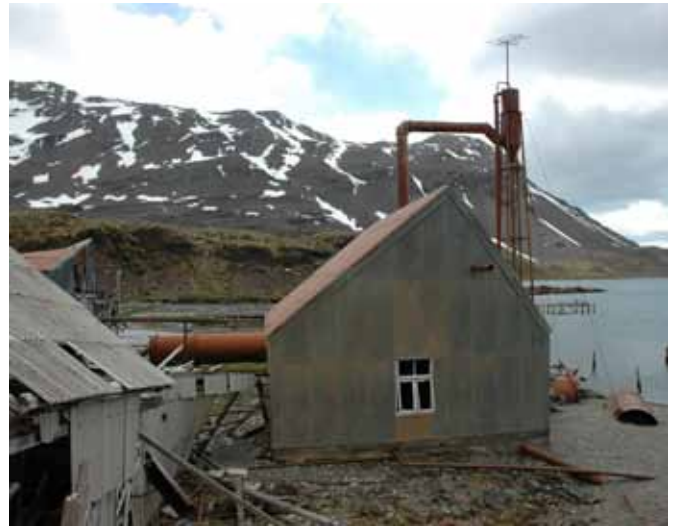
4.1 The south elevation

This appears to be a later building than most of the others on the site. The building has a raised solid concrete floor and a support wall under the wall framing. The building is steel framed with columns out of 65x65mm doubled-up angle iron supporting an I-beam wall plate and principal rafters. Angle iron is used for purlins and bracing. The whole building is clad in corrugated iron that remains in good order. There are windows on the north/south and east sides of the buildings with top hung casements below and fixed lights above - the frames remain but no glass. The entrance door is in the northwest corner and again the frame remains but the door is now lying on the floor. The meat extraction plant remains in the building and appears to be in good condition and is supported by a substantial steel frame with a raised gantry to the east.

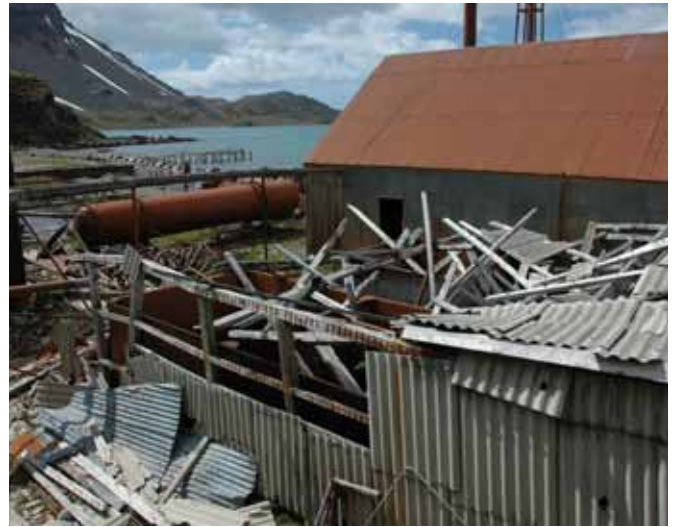
This building has collapsed more or less completely with only a small section still standing at the south end. The majority is a heap of timbers and asbestos cement sheets which both walls and roof were clad in. The extractor plant, as far as one can see, appears to be still under the debris.

There is a large amount of asbestos cement fragments lying all around the area. There are also a large number of old pipes lying to the north and east of the building many still with asbestos lagging on them. They may have been pulled from the debris of the fallen building.

5.1 Collapsed north end

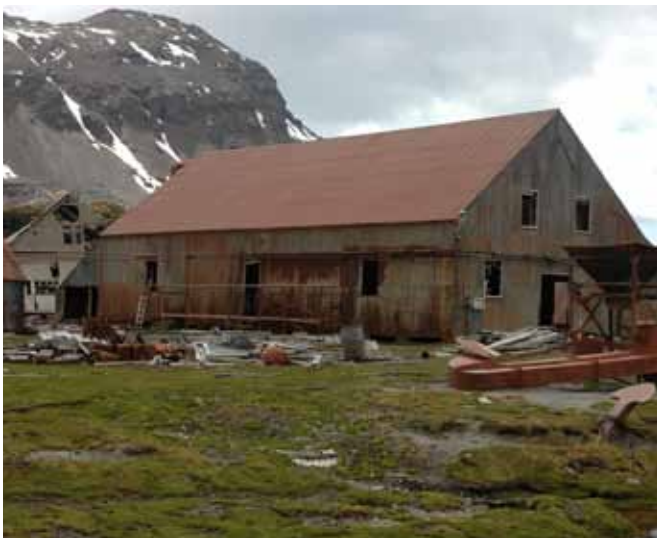
7.4 South and west elevations

The window openings remain but the frames have gone from the gable end windows and the floor is also in poor condition by the north gable end. There are three windows on the west side of the building at ground level, again with no casements remaining. A door and window on the south side both missing. There are three lean-tos against this building: that to the north is still in solid condition but those to the east and south have both partially collapsed.

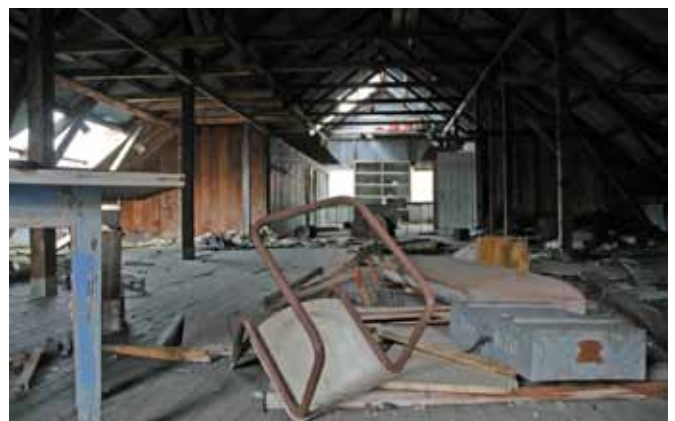
7.3 Interior of the first floor space looking south

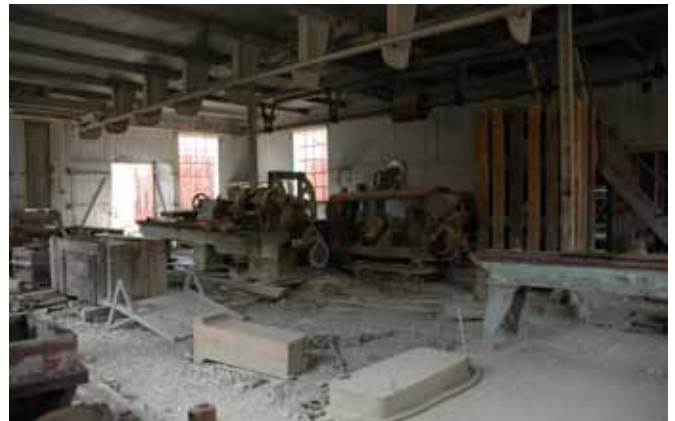
The Workshops are effectively two separate buildings. The eastern arm with a ridge running east/west houses the Foundry and Blacksmith's Shop. The much more substantial western arm, with a ridge running north/south, houses an engineering workshop. The eastern arm has two forges in it, both still present complete with hoods and flues, but it is in very poor condition with three of the principal rafters split and the roof partially collapsed. The north wall has been pushed out by the falling timbers and is leaning northwards. The rotation has also kicked out the south wall which has cracked. The roof is in imminent danger of complete collapse. At present the roof further west is in better condition but it is difficult to imagine that this can survive the collapse of the adjacent section of roof.

8.2 Interior of main Workshop looking north

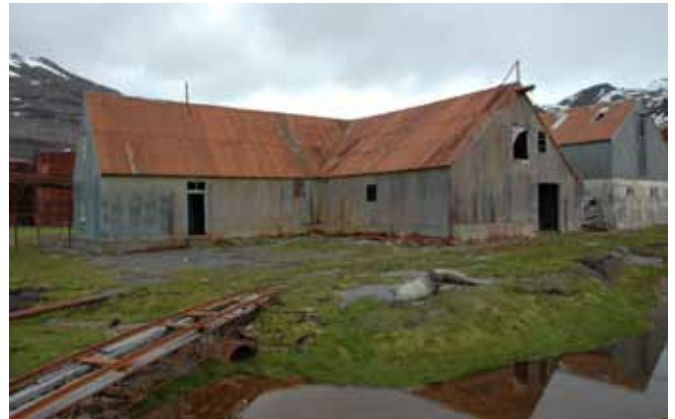
10.2 North and east elevations

There is a timber framed lean-to running the full length of the south side of the building with a low timber framed wall supporting the rafters of a mono-pitch roof with a wall plate roughly at the level of the first floor in the main building. Rafters are propped at mid span by timber posts. The main building has a continuous loft space over both store and workshop, accessed by a stair at the east end of the building; this is also racked out with shelving. Main doors were on the north side of the building but these are now missing. This building remains in reasonable shape.

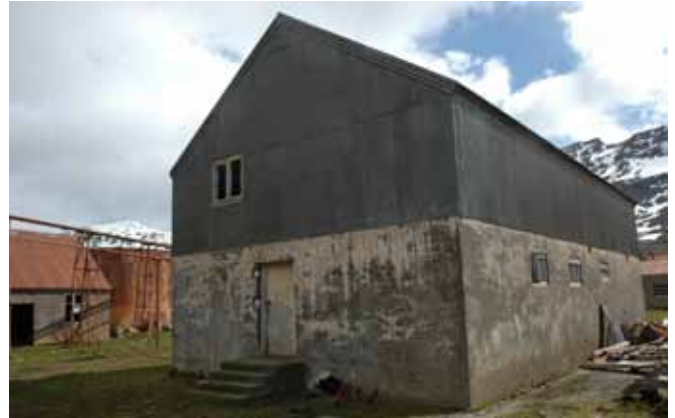
11.1 South and east elevations

This rectangular building contains the Slop Chest on the south end of the ground floor with first floor storage. The centre of the ground floor is the laundry with the north end being a drying room. The construction is of mass concrete walls up to first floor level, with ground and first floors of concrete, the ground floor being raised four steps above the ground level. The concrete upper floor is supported centrally on a concrete beam and columns. The first floor walls and the roof are timber framed with corrugated iron covering with no internal lining. The ground floor has an entrance door on the south end and timber casement windows, though some of these are missing and all are damaged. On the first floor there are only windows in the gable ends, otherwise the space is lit by plastic roof lights. The general condition of the exterior cladding is reasonable at present.

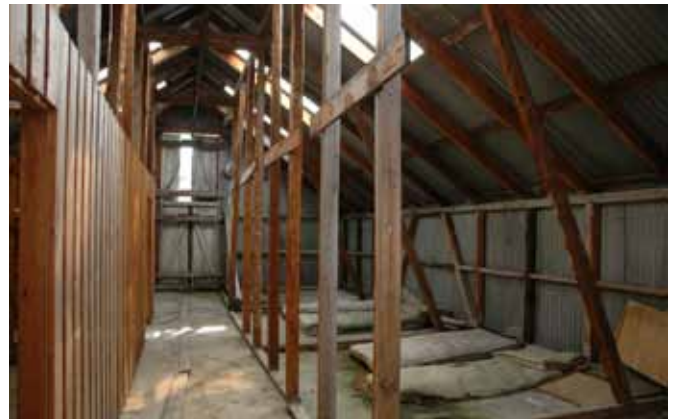
11.2 The Laundry on the ground floor

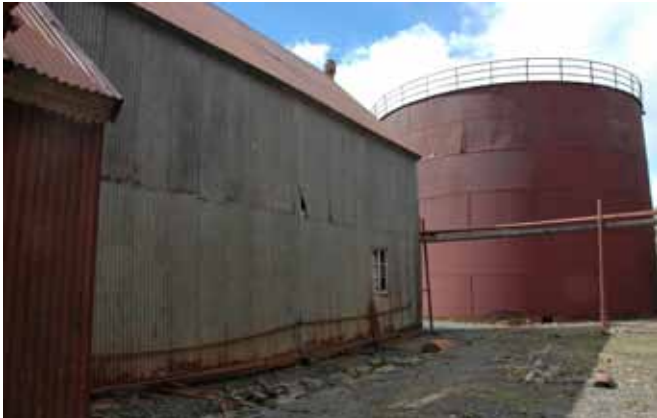
12.1 The west elevation

A two storey high rectangular building (though with no upper floor other than access gantry), built to house large tanks that run through to eaves level. Walls and roof are timber framed with principal rafters of the roof at 2m centres. The rafters have ties and collars and support purlins that in turn support the corrugated iron sheeting. The roof sheeting is all still present on the building though some are working loose. There is a missing sheet of corrugated iron to the west wall, two sheets are missing on the south side and sheets at the southeast corner need to be refixed. There are also some loose sheets to the south side of the roof.

The entrance door is on the northeast corner with only four small timber windows, two to the east, one to the west and one high in the south gable. There is a small lean-to building on the northwest corner of the main building which is now in a state of collapse. The main building looks solid enough at present - but the fact that sheets are starting to pull away from the walls suggest that deterioration is likely to accelerate.

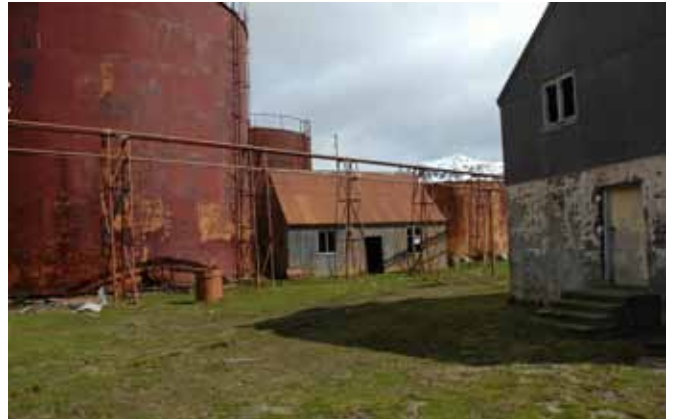
13.1 East elevation

A rectangular timber framed building with a pitched roof running north/south; walls and roof all being covered in corrugated iron. The walls are generally unlined except in the southeast corner where some office space has been created with a suspended timber floor and walls lined out in hardboard. This space is now used as a dump for old radios parts. There is a first floor and an attic space; the first floor being strengthened by a timber beam mid span which is itself propped on a timber post. The upper floor has a bedroom in either end, each with a timber casement window in the gable, the bedrooms being lined out. In the central area there is a urinal fixed to the wall, but no traces of any other bathroom fittings. The first floor is reached by a steep timber companion stairway immediately inside the entrance door in the east wall - the door being missing. There are two timber casement windows to the ground floor, both in the east wall. The corrugated iron is rusty and there are some holes in the sheet to the walls - but other than this the building is still reasonably solid.

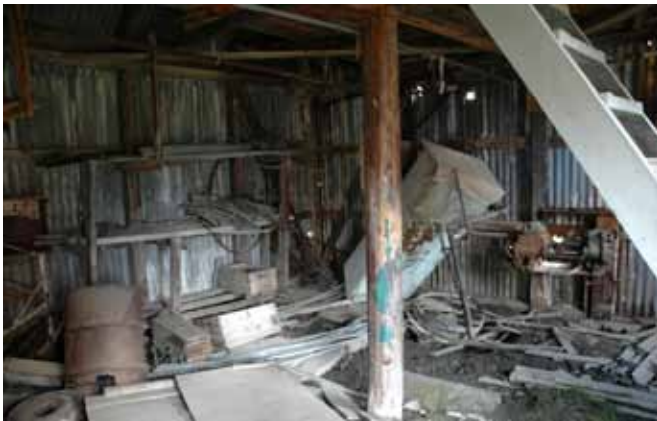
13.3 Interior ground floor main space

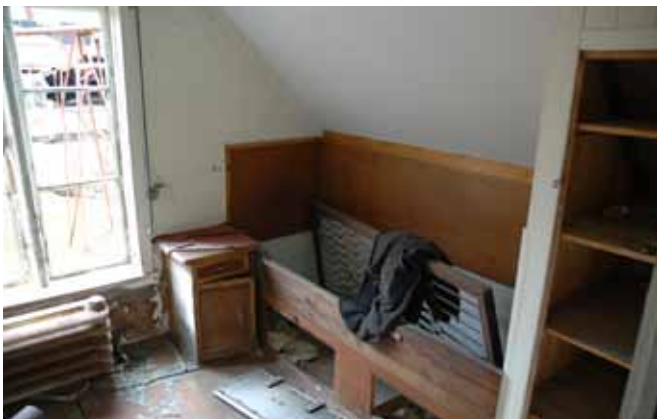
13.4 One of the first floor bedrooms

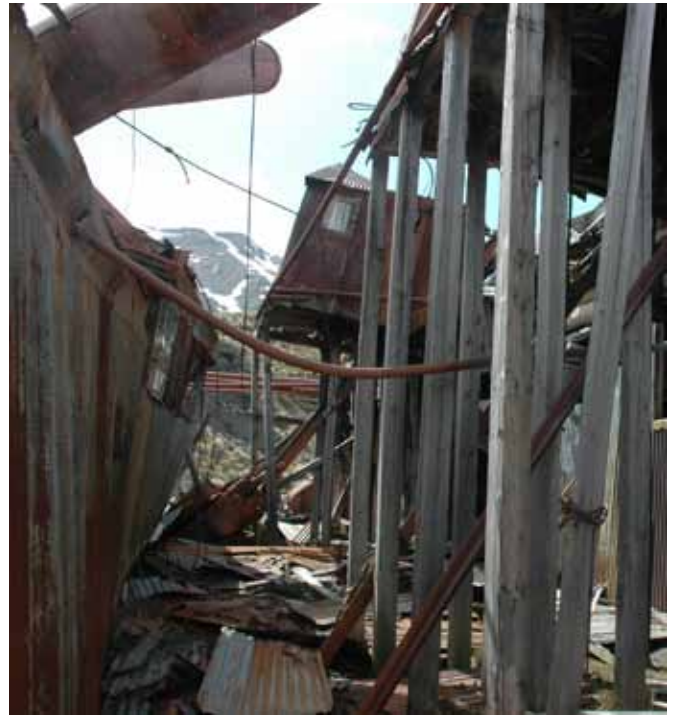
The Boiler House stood immediately to the west of the Bone Cookery. A tall single storey building constructed with a timber frame and timber pitched roof, all clad externally in corrugated iron. This building was not looked at very closely as it is in a state of collapse with its seven tall steel chimneys all having fallen across the roof. Only the south end of the building retains some of its roof though, even here, sheets are missing and the walls are bulging.

14.2 The east wall of the Boiler House (left of the picture) looking northwards

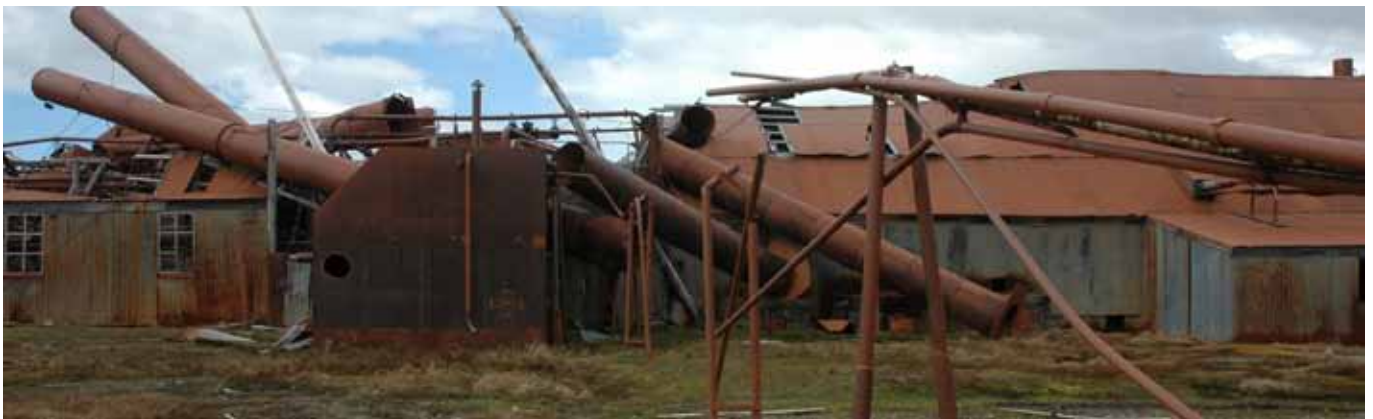
14.4 General view of the south end of the west face of the Boiler House

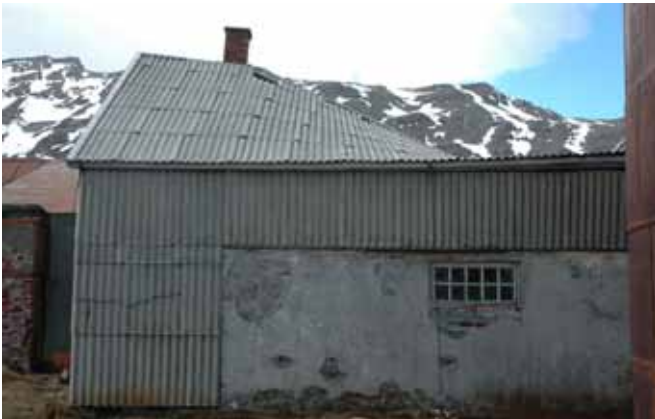
15.2 The north elevation

The walls up to the top of the windows are constructed in brickwork rendered externally; above this the walls are timber framed with a timber roof. The roof and upper sections of the walls are covered in corrugated asbestos cement sheeting. The building appears to have had a first floor in the roof space. The building was not entered as it is now in a state of collapse with the majority of the roof fallen in. A chimney stack remains at the west end but this is likely to be brought down as the roof collapses.

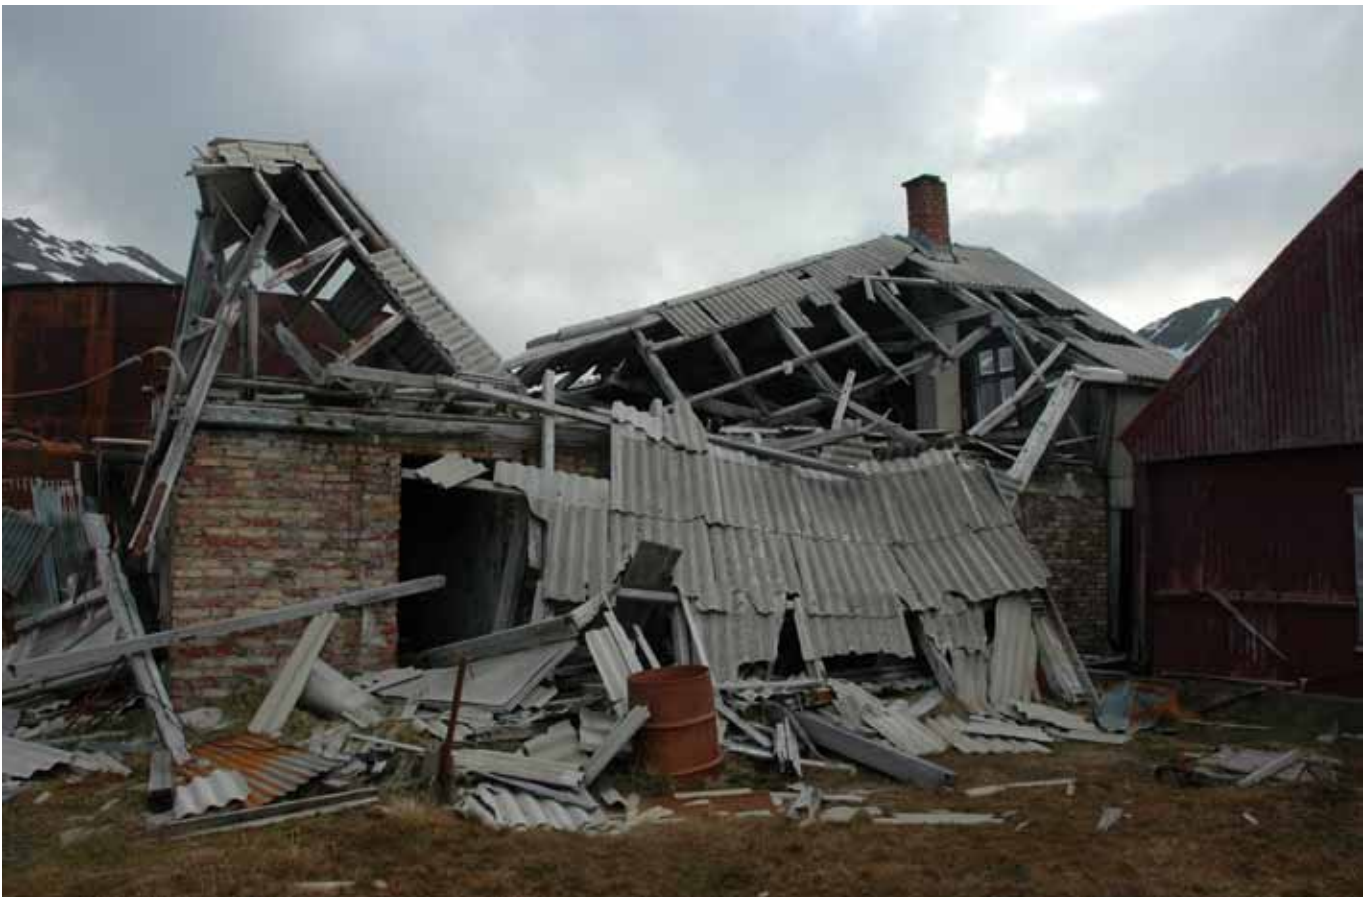
15.1 South elevation - the extension to the west can be clearly seen

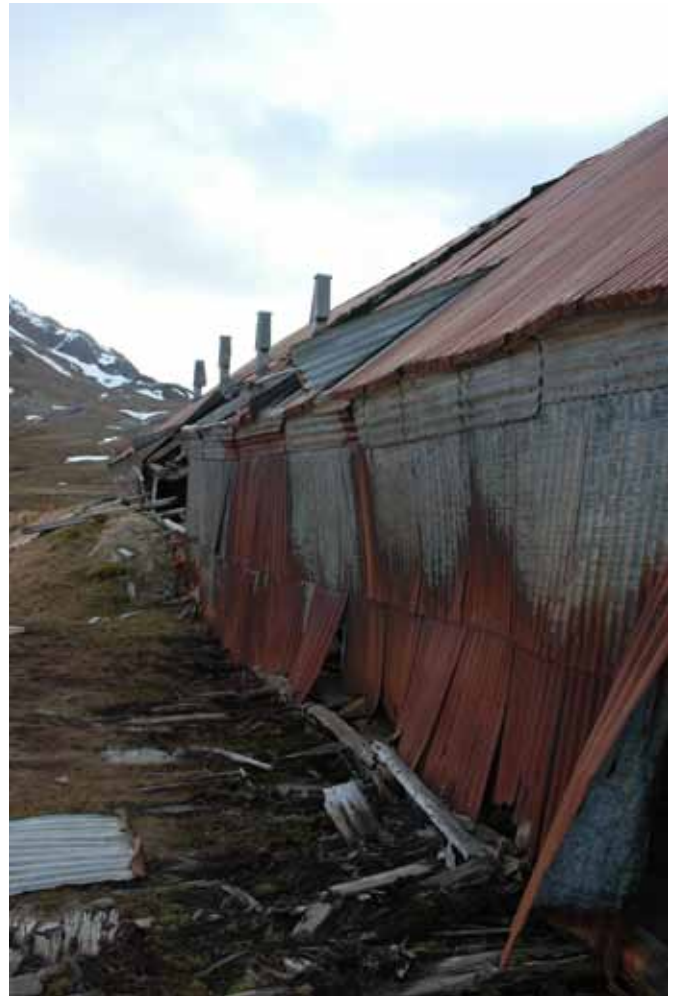
A single storey building although there has been some use of the loft space. The provision store at the north end has a floor at wall plate level which is heavily propped with iron posts to the south and timber posts to the north. The upper floor here has been used for storage. The ground floor has been in concrete, but is now completely broken up. This area has probably had water flowing through it at some time. The south wall in corrugated iron is buckled and several of the timbers are cracked. The western section of the provision store has earth banked up around a masonry wall. The floor above this area is of heavy timber construction with cinders between the joists for insulation, the floor being propped with two rows of timber posts. The section of the wall on the north side has fallen in and there is plenty of loose corrugated iron here.

16.1 Exterior of south wall looking west

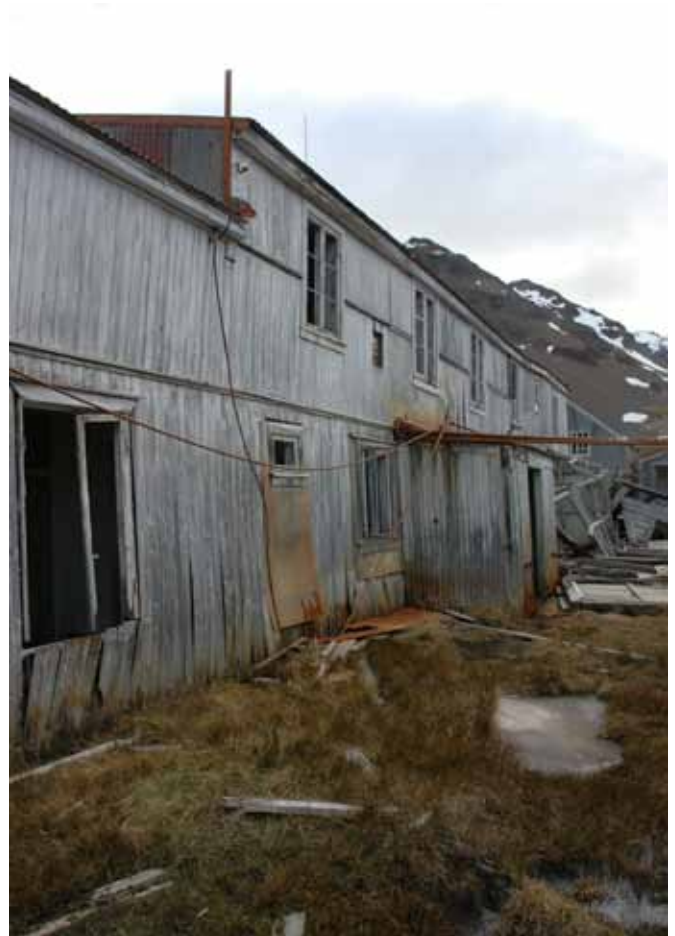
18.1 The north elevation

This building has been altered and extended on more than one occasion. It is a two storey building, timber framed and clad externally in vertical timber boarding with a corrugated iron roof. Windows are timber casements and the building was entered by porches on the north side. The building has been severely affected by water with the concrete ground floor broken up, much of the lower timberwork of the walls rotted away, particularly on the north side. The walls are now bulging and the collapse of this building must now be imminent.

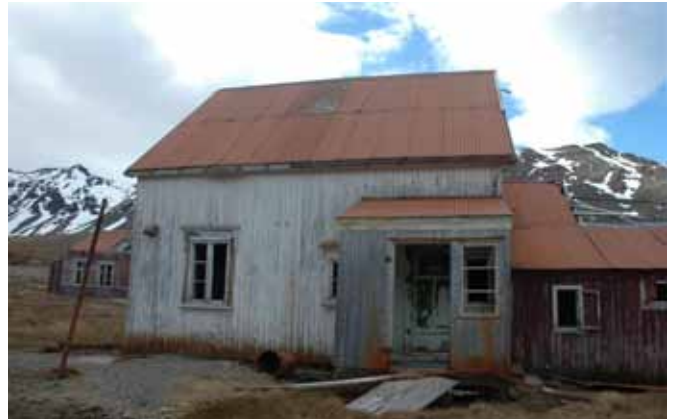
The majority of this building has collapsed with only the two storey west end remaining substantially standing. This is built from vertical timber boarding over thick horizontal boarding as the primary structure. There has been a first floor partially in the roof space with windows in the gable ends. The ground floor has windows on the north, west and south sides with timber side hung casement windows, with both internal and external sashes. The entrance door is on the south side through a small porch. There has clearly been a good deal of water running through this building and the whole of the suspended ground floor timbers have rotted away and fallen into the void beneath which now has standing water in it. The corrugated iron roof is in reasonable order but the capping pieces to the bargeboards need attention. Unusually this building has had a gutter fitted though only a small section of this still remains.

19.1 The south elevation of the west end of the building

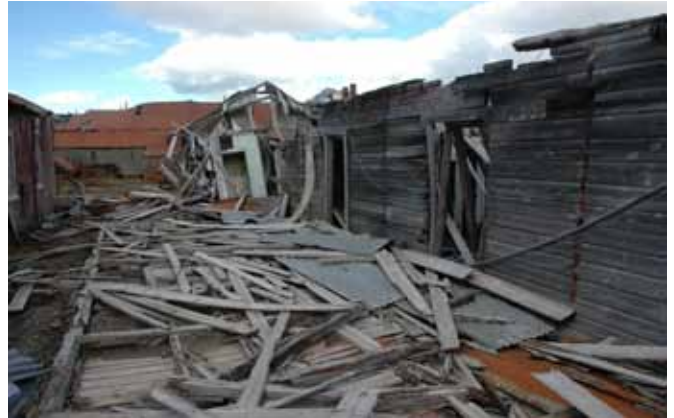
20.1 The east and north elevations

The whole of the roof of this block has collapsed. The building has been built in at least three phases with distinctly different builds and claddings. To the west there is a corrugated clad section. Next to this a section clad in vertical boarding with sprockets showing at the top of the wall and some early top hung casement windows. The east end is of thick horizontal tongued and grooved boards. The building is well beyond the point where it can be saved.

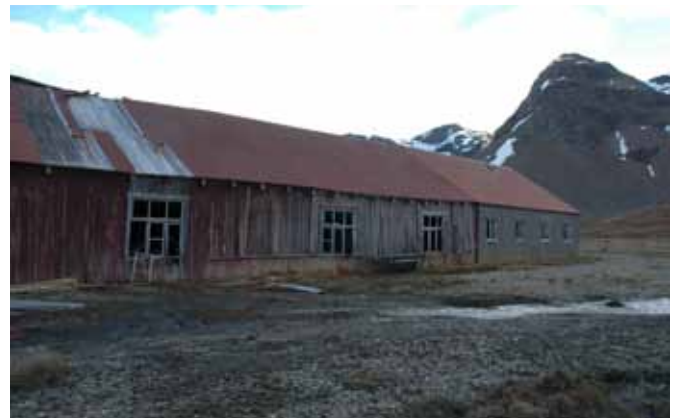
22.2 The north face of the building west end

The newest section of the building at the west end is in the best condition, this is fully clad in corrugated iron which remains in reasonable order - but this section of the building has also been affected by water running adjacent to the wall. There does not seem to be any realistic prospect of saving this building.

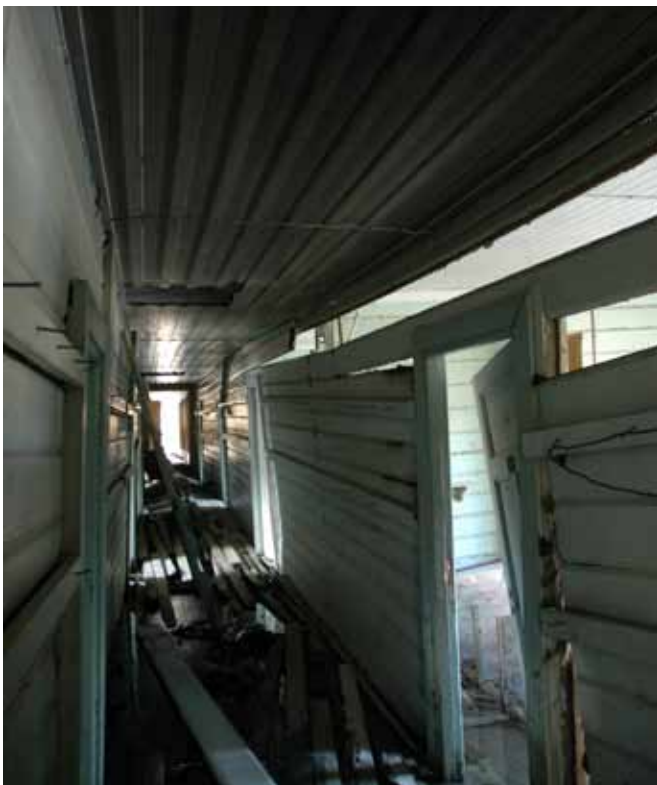
The central section of the building has walls covered with vertical timber boarding and is in slightly better shape but it is suffering from some subsidence and there are missing sheets of corrugated iron from the roof and the later addition of the south passage wall is leaning outwards.

22.3 The passage along to the south side of the building

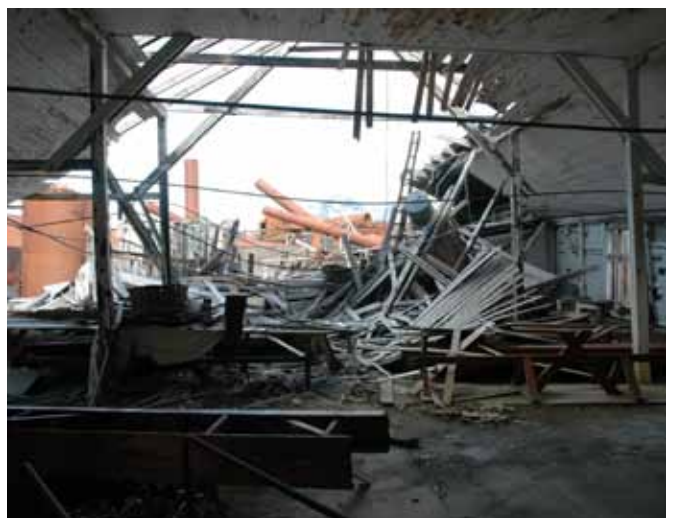
22.4 The collapsed kitchen seen from the remnants of the mess room

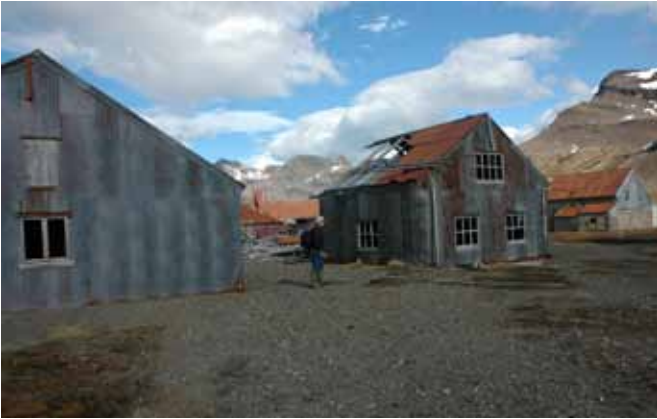
This building has been collapsed for a long time. Only the north end remains standing - the upper floor here may have been the library and reading room. The rest of the building is a heap of timber and corrugated iron.

24.1 The standing two storey section at the west end, seen from the northwest

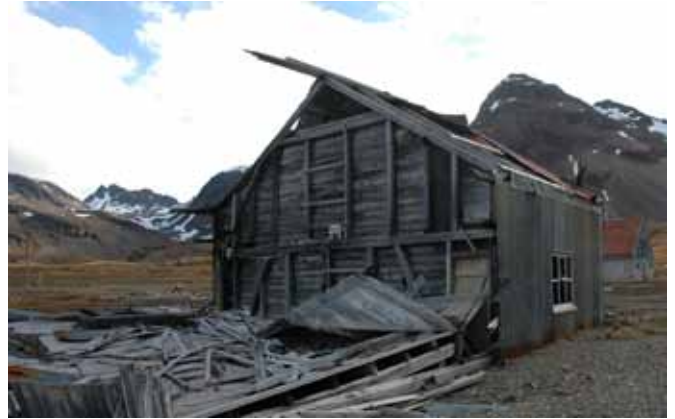
24.2 The north and east faces of the west end

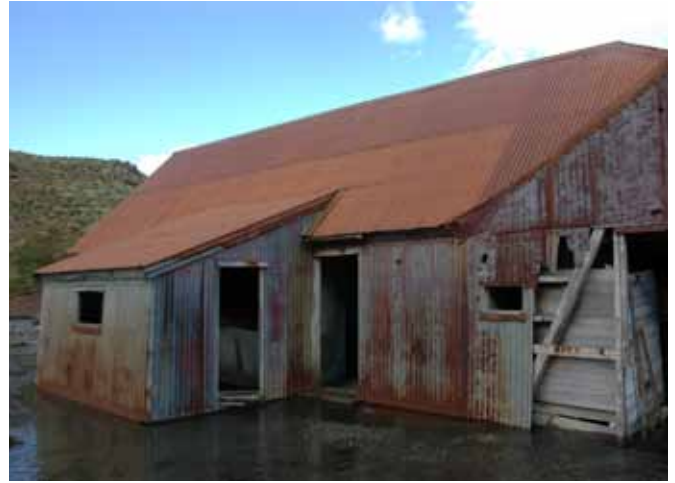
This is an 'L' shaped building with the Carpenter's Shop in the east wing. The building has timber framed walls and roof clad in corrugated iron. It has had a timber floor but at present the stream is running through the centre of the building both damaging the timber and undermining the footings. This has caused the south wall to start to fail and lean outwards and the roof slope is now distorted. This building is likely to collapse soon unless the stream course is altered.

28.1 The west side of the building

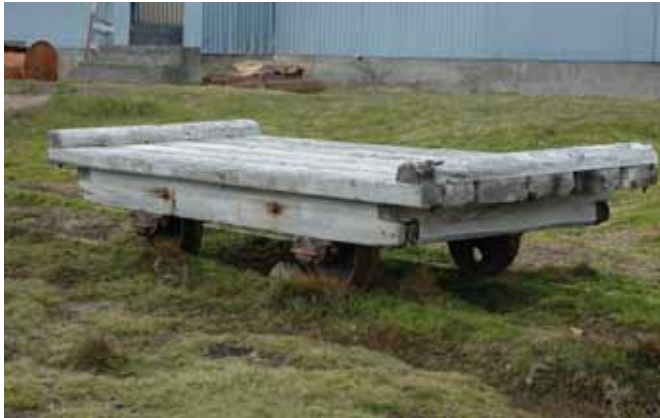
The remnants of the railway system were not inspected in any detail. A considerable amount of the track remains in place as well as some of the bridges and old railway cars.

33.1 One of the few remaining railway trucks

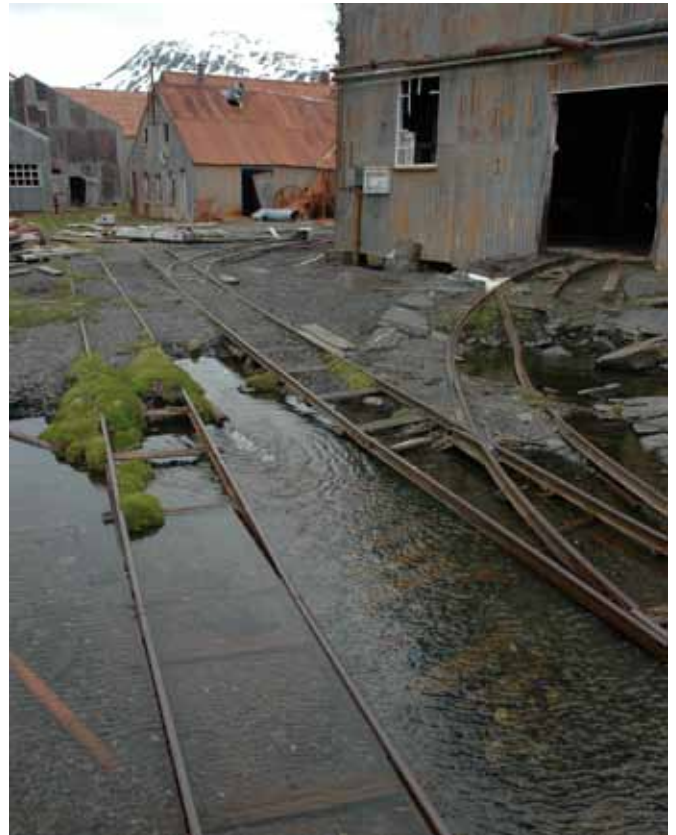
33.2 Railway track from the main jetty part of the south end and into the catcher store (No. 7)

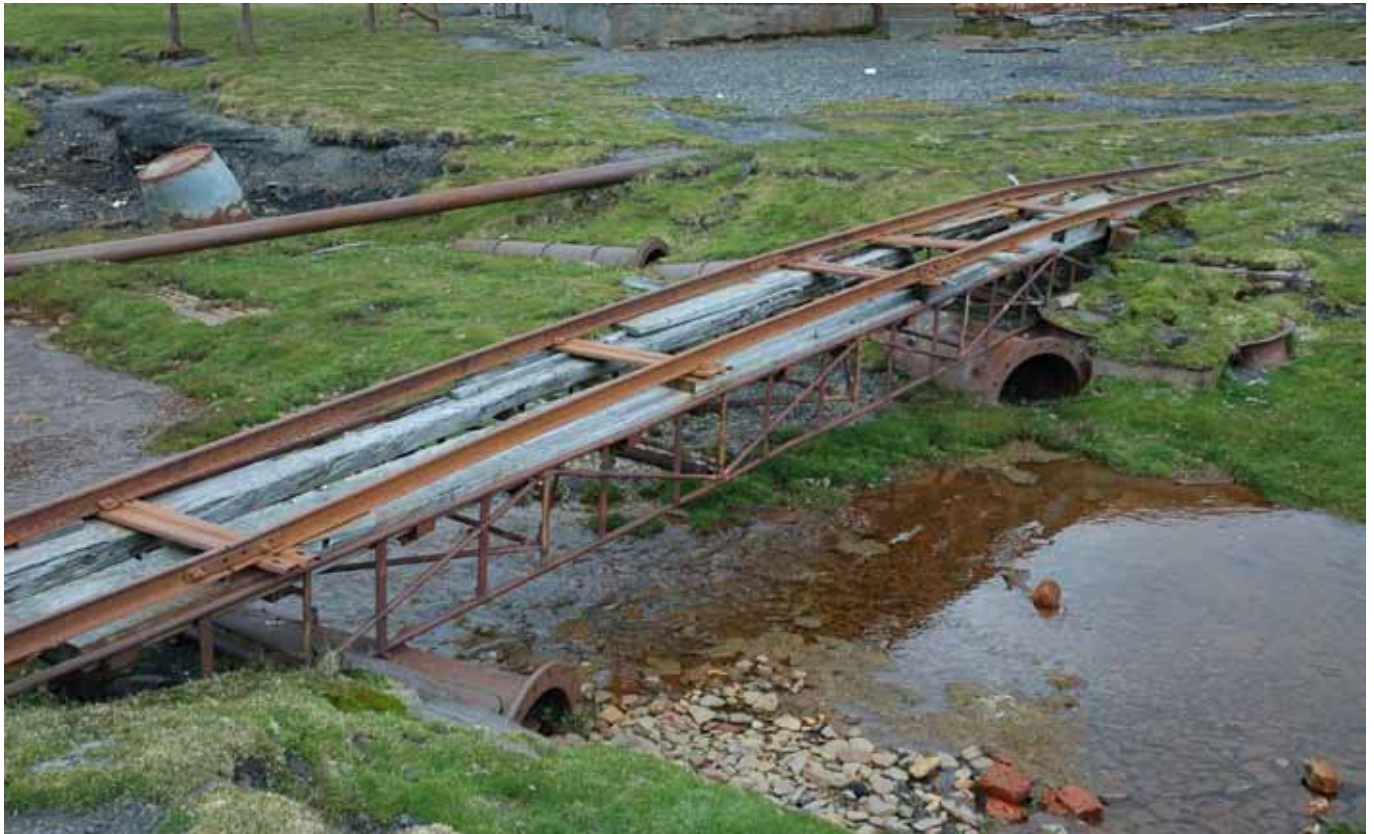
33.3 Bridge over the stream between Buildings No. 10 and 7

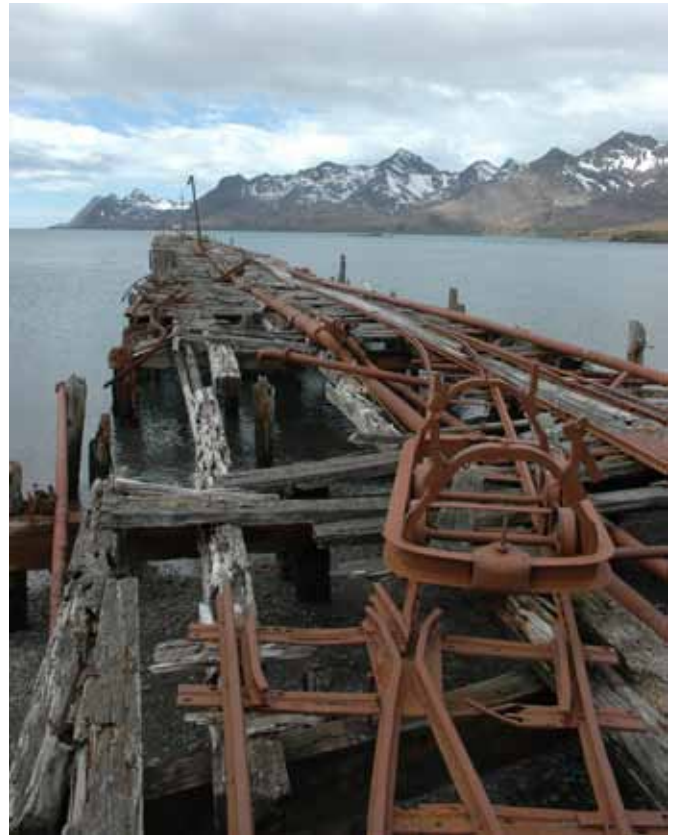
This is a very long jetty as the sea bed here is shallow. The jetty is still attached to the land but most of the decking has now fallen in to the sea. There are a series of large iron buckets lining the land side of the jetty - possibly put in to reinforce the ground. The railway line still runs out the full length of the jetty as do the oil pipes. There are two modestly sized derricks on the end of the jetty.

This structure is not safe to be used without a great deal of rebuilding work.

34.1 The railway track remains in place

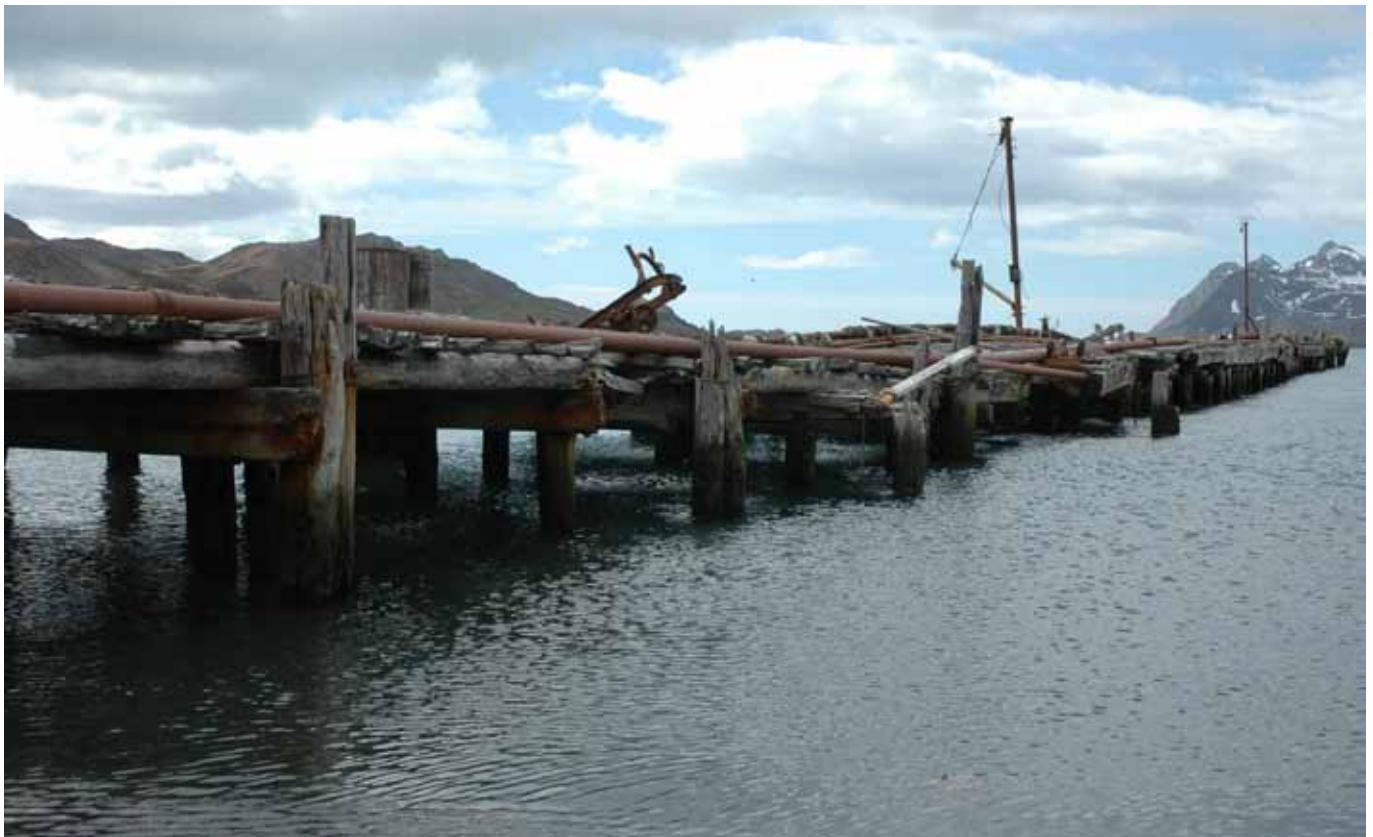
34.2 The south side of the jetty

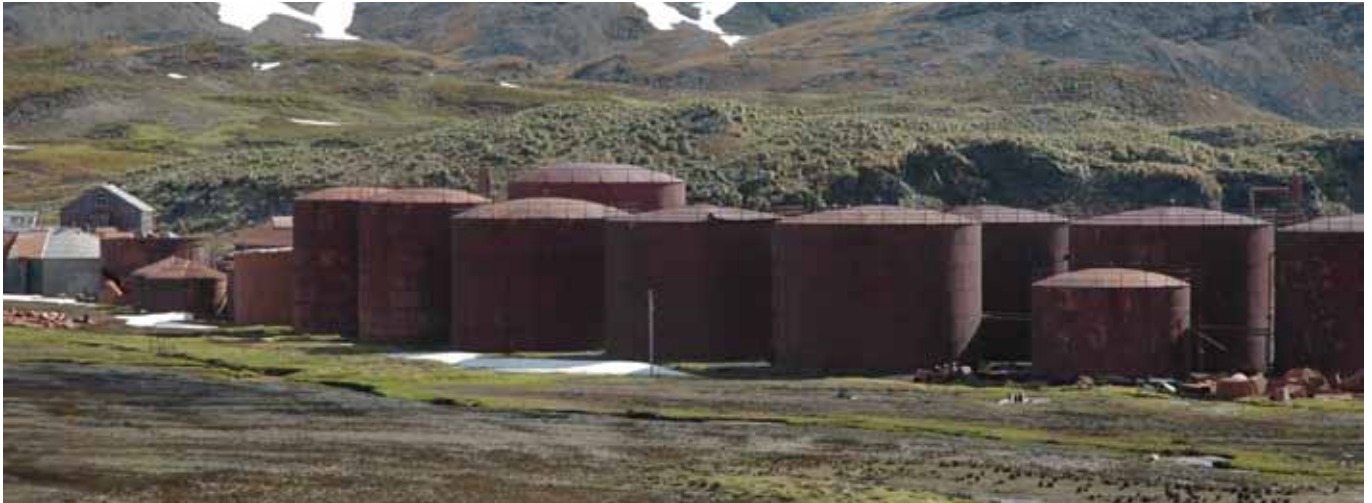
The tanks were not looked at in any detail. Generally the tanks are in fair condition with no signs of major disturbance or any signs of imminent collapse. Specific problems were noted on a number of tanks.

38.1 General view of the Tanks taken from the high ground behind the Manager's Villa

There is a good deal of standing water around the tanks which is likely to accelerate their corrosion.

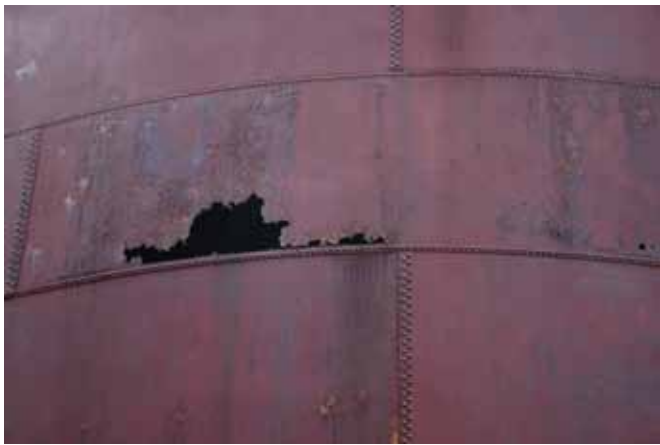
Tank No.42 has one plate which is severely corroded and its neighbour above has corrosion starting. Above this, at the junction between the roof and the side walls, there is a line of corrosion showing as small holes which is introducing a significant weakness into this tank. Plates are also corroded on the south side at the same level. Possibly this was the level the tank was left filled.

38.3 Detail of Tank 42
