DISUSED WHALING STATIONS

Husvik Harbour Gazetteer

Gazetteer, July 2011

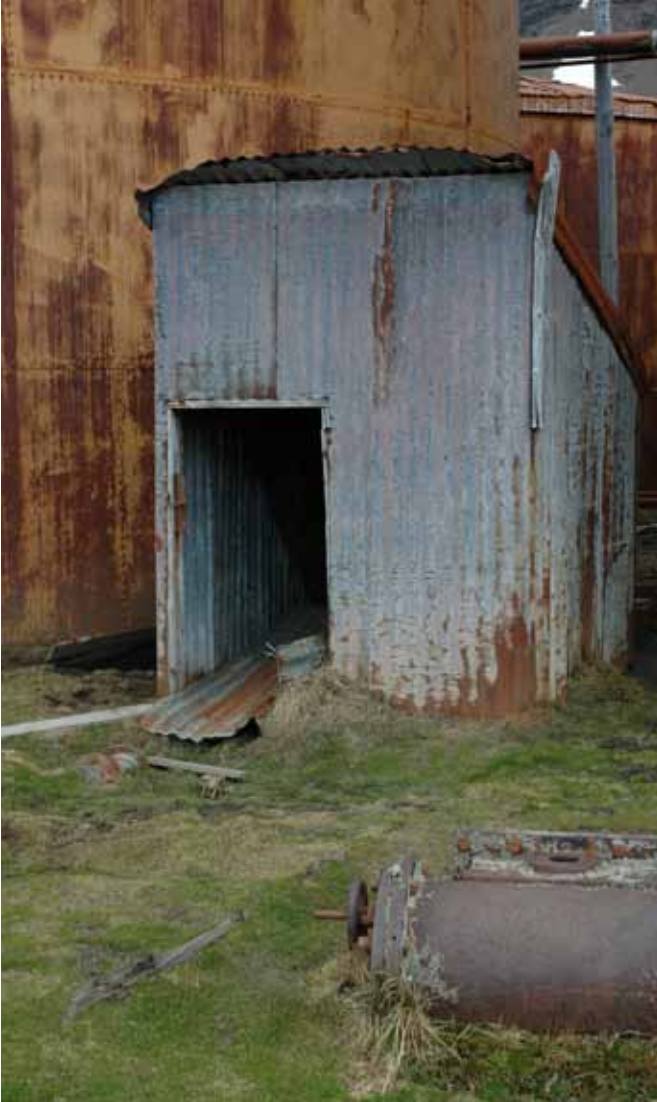
A small corrugated iron lean-to shed clad externally and internally in corrugated iron. The door is missing.

60.1 The east front of the Store

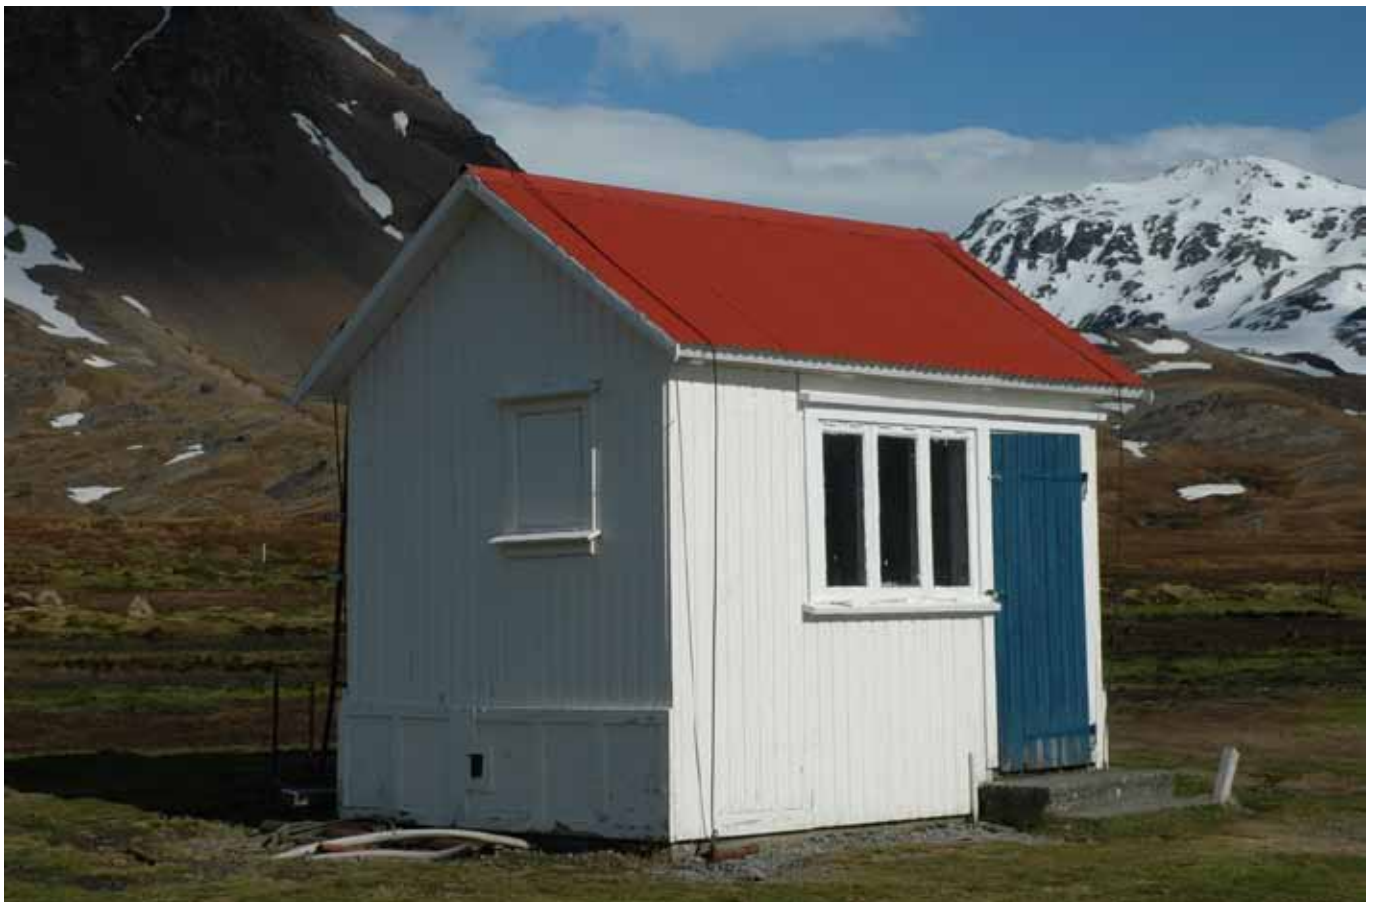
Outhouse to the manager's villa. Rectangular building approx 4x2.5m with a pitched roof running north/south. External timber boarding on a timber frame. Ledged and braced door (later replacement) and top hung casement window. Earlier door located in southeast corner and a small window now blocked on south wall. There have been two wire tie-downs over the roof but both are now loose. This building appears to be in reasonable order.

63.1 South and east elevations

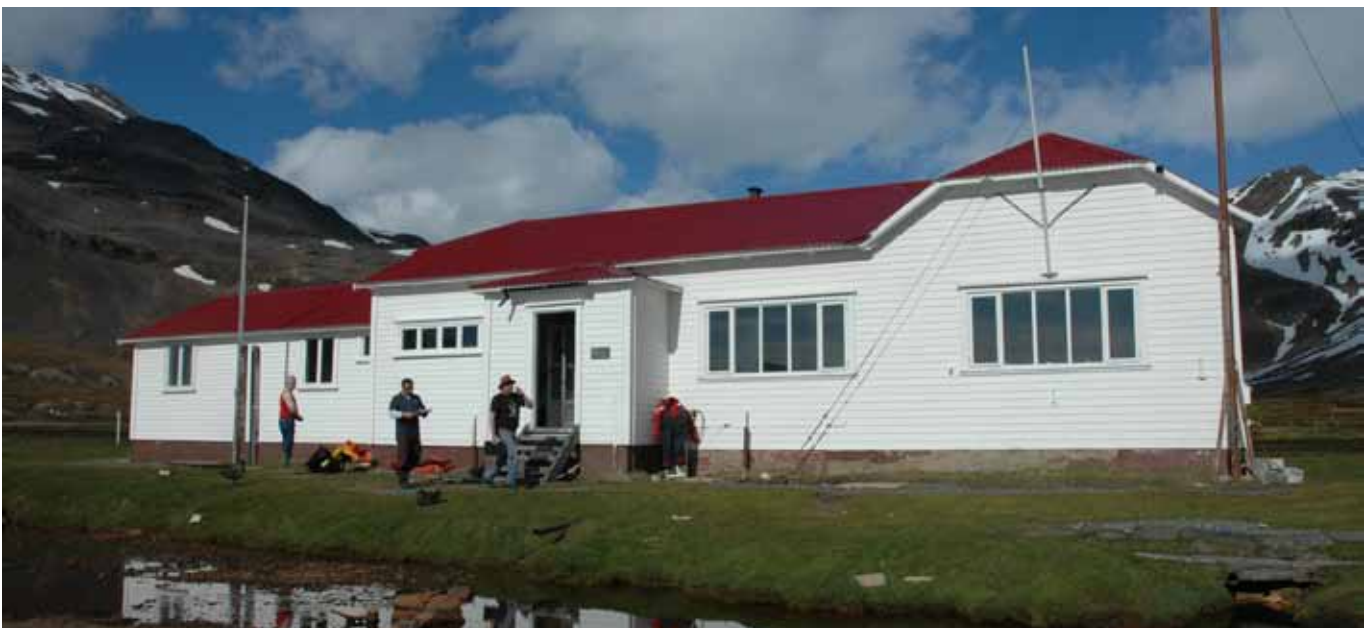
Built from a 100mm thick timber frame with a pitched roof running north/south with gables and hip at either end. There is a wing at the northwest end of the house which is probably original and then two extensions that are later, one at the south end that carries on the main block of the house though narrower and a lean-to on the west side. The house is raised on a rendered brickwork base with the main entrance on the east side through a small porch, with the floor raised five steps above the ground level. The walls are clad externally with feather edged boarding which is painted white on the seaward side and blue on the west side where it faces inland. Internally the walls are lined with vertical boarding though this is covered with hardboard in several rooms. The house has been extensively refurbished recently with a completely new pressed metal roof. Generally the timber windows remain but two on the east side have been replaced with UPVC. This building is in reasonably good order.

64.2 The main front - east elevation

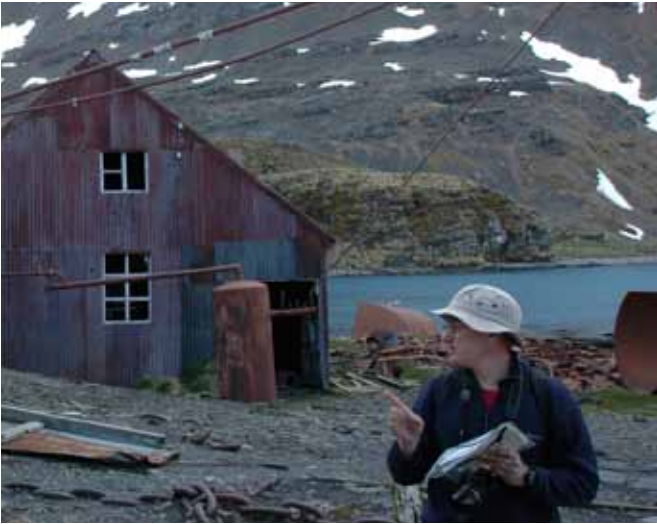
The Catcher Barracks is a small timber framed two storey building on the scale of a small domestic house. It is built off a plinth of roughly laid rock picked off the adjacent area set in mortar - suggesting that this is one of the earlier buildings on the site. The building is clad in corrugated iron which is in reasonable order. There have been two hold down ties on the building but neither is now functional. Original timber windows and ledged and braced timber doors remain though in poor order. Internally there are series of small rooms with walls and ceilings lined out with tongued and grooved timber boarding. This building is in a condition where it could still be repaired.

70.1 The Catcher Barracks in the distance with the Mechanical Workshop in the foreground

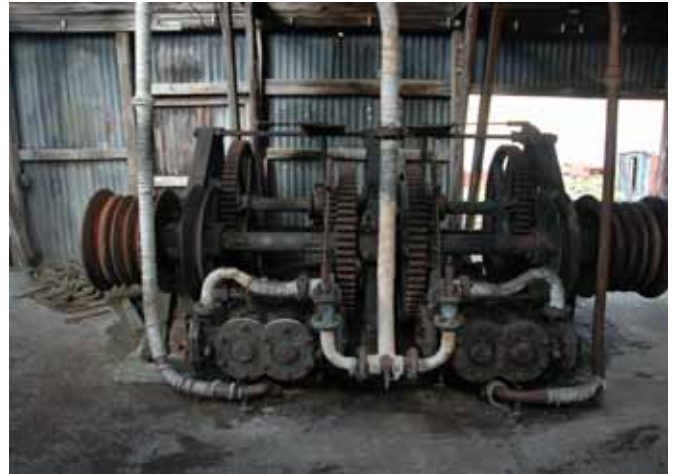
The back wall of the building has been built tight up against the bank behind it. The wall is now in very poor order and part of the west roof has collapsed. The east (front) wall of the building is moving away from the structure and the collapse of this building now looks to be imminent. The building is quite strongly framed which is the reason it has survived so long. There are still two large winches in this building.

74.1 The winches remain in position

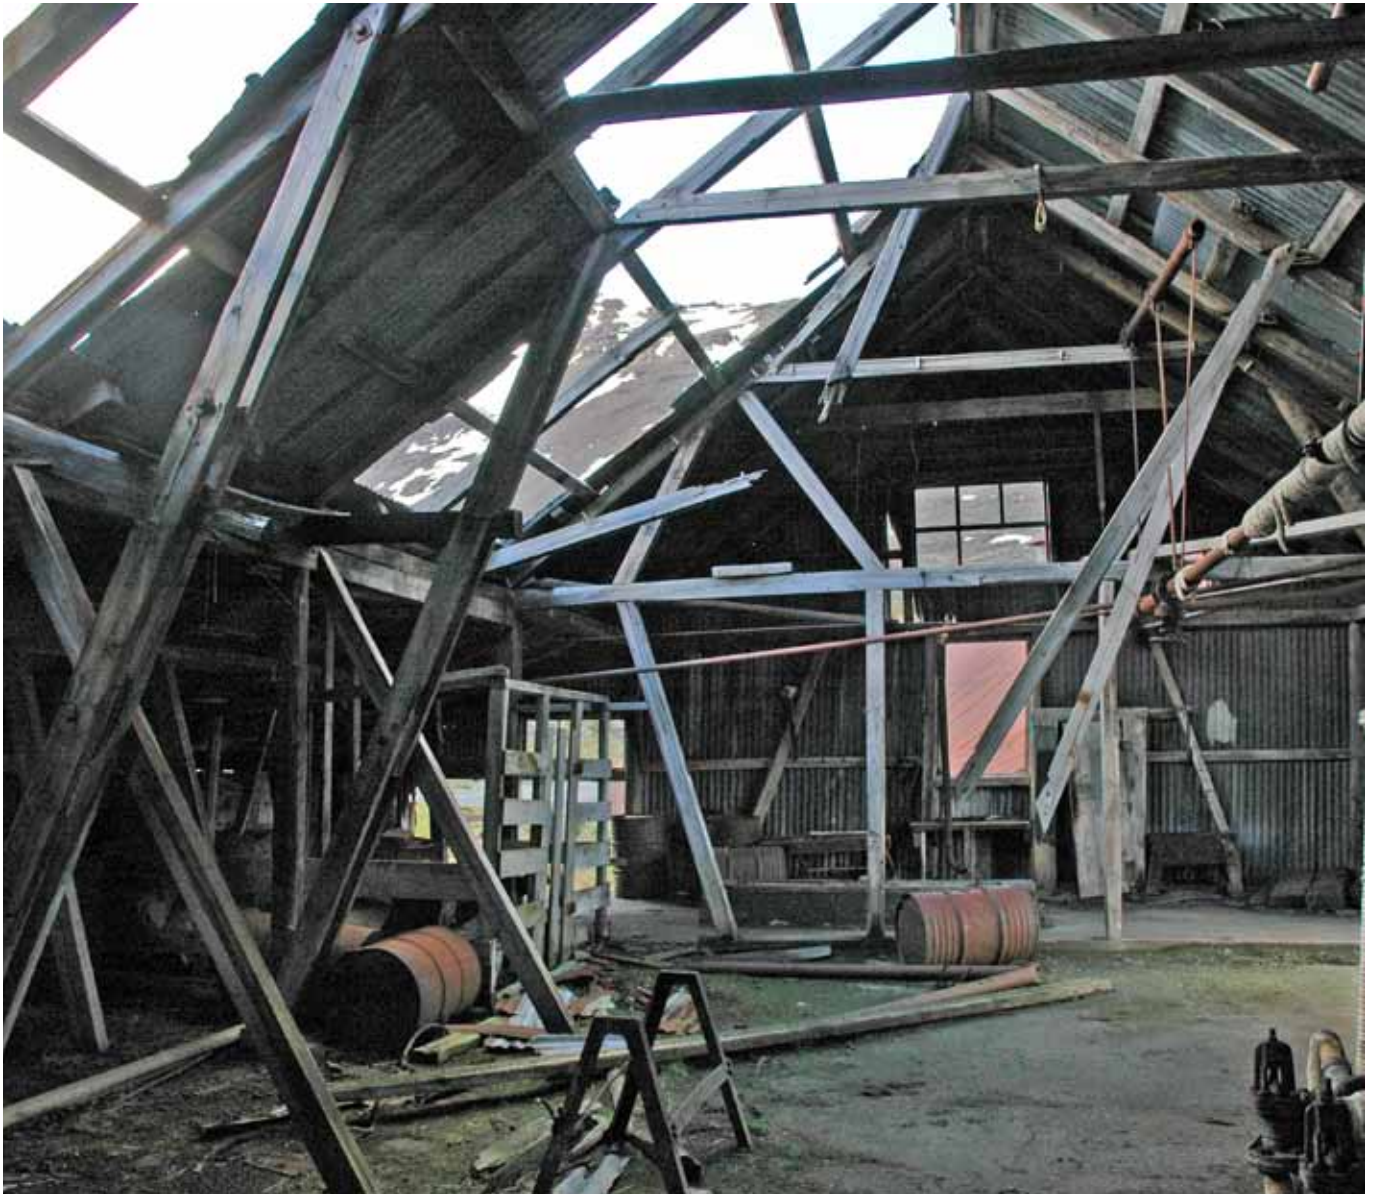
74.2 The Winch House looking southwards

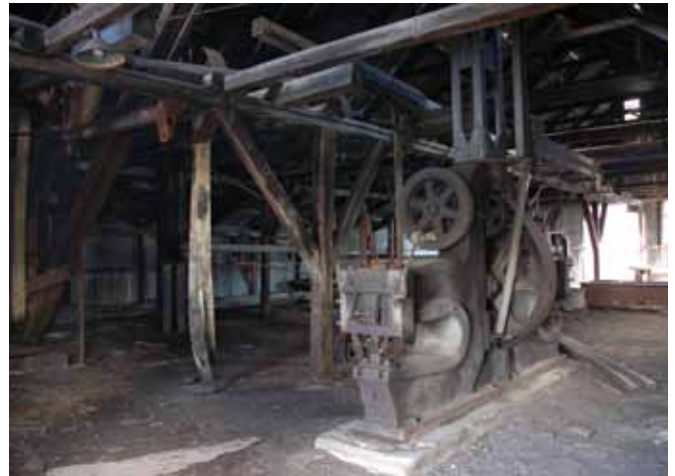
A simple timber framed workshop with a large opening on the east side facing the sea, at times the whole of the east front appears to have been open but currently over half is blocked. There are two forges in the building, one large and one small, with their flues still in place. Various bits of machinery are still in place, anvil (or perhaps more properly a forging floor - a heavy cast iron raised flat floor with regular holes), bending machine, drill and hole punch. There are the remains of a pulley and axle system in the roof for driving the machinery. The timber framed and corrugated iron clad walls are built off a rough local stone plinth. The building has been widened with a lean-to along the whole line of the west wall. The framing of the building seems to be slender for a building of this size - but it remains serviceable and could be repaired.

75.1 The interior looking northwards

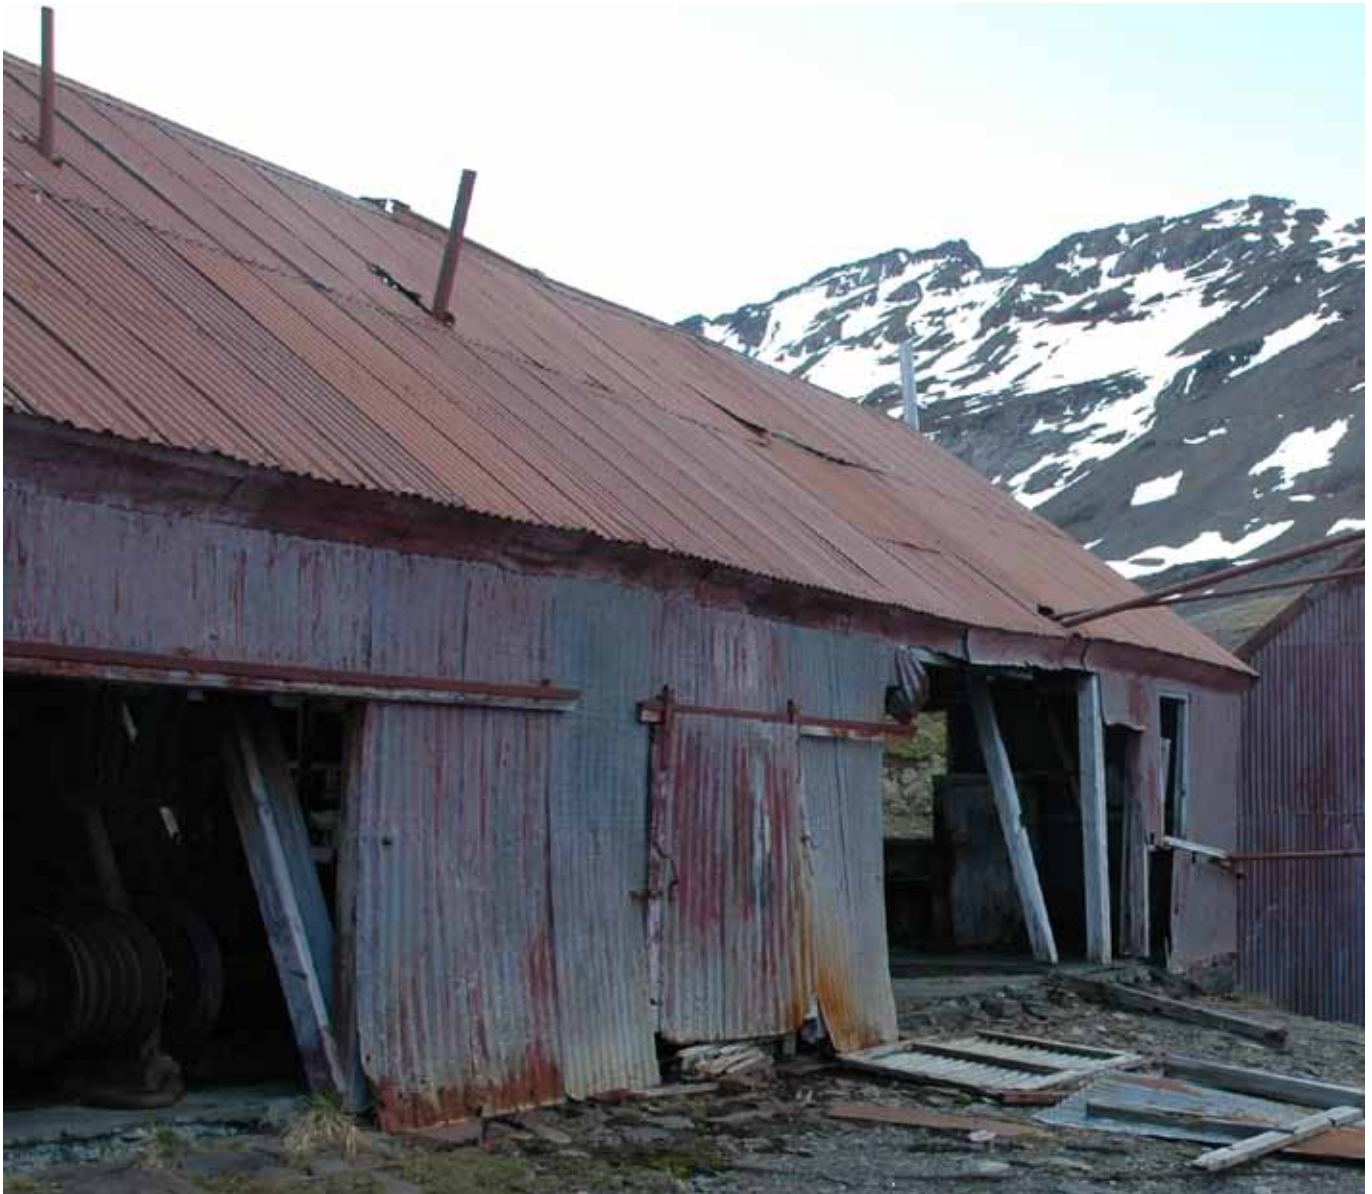
75.2 The east face of the Workshop
