DISUSED WHALING STATIONS

Leith Harbour Gazetteer

Gazetteer, July 2011

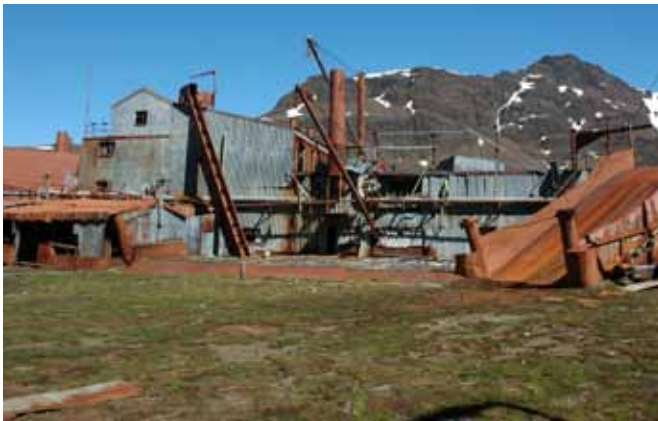
1.1 Looking southwest with the ramp to the bone loft on the right and the Rose Down Plant centre

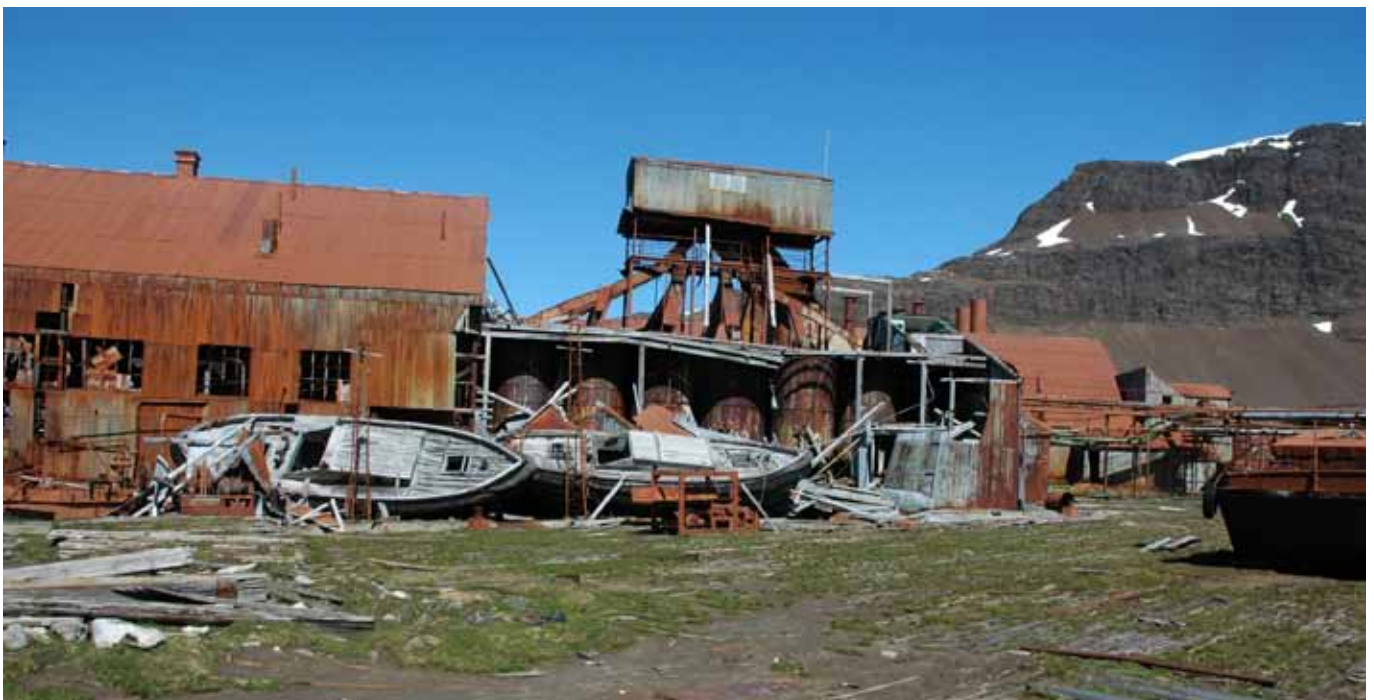
1.3 General view looking south towards the Blubber Cookery

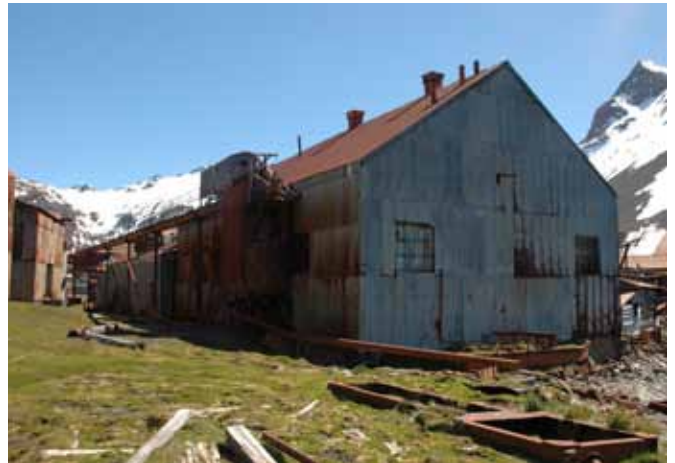
This building still looks reasonably solid although there is a fair amount of corrosion at the base of some of the stanchions.

2.2 The south and east elevations

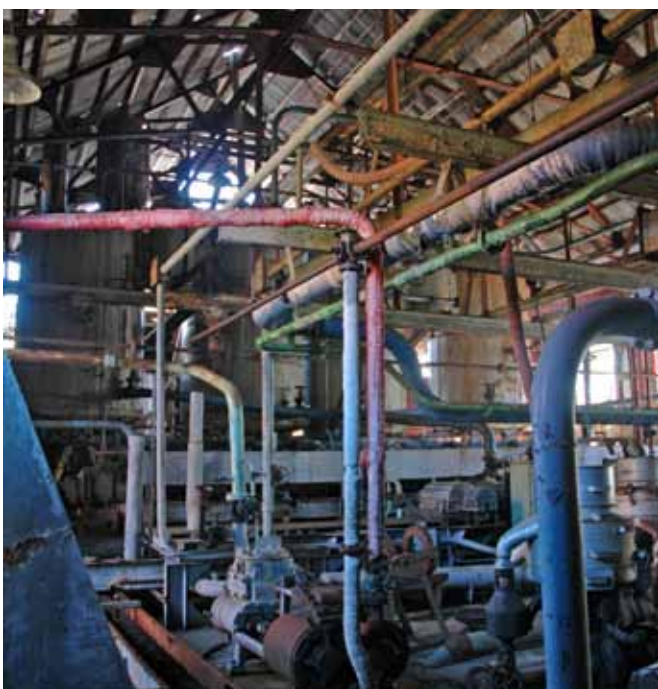
2.3 The interior of the east end of the building

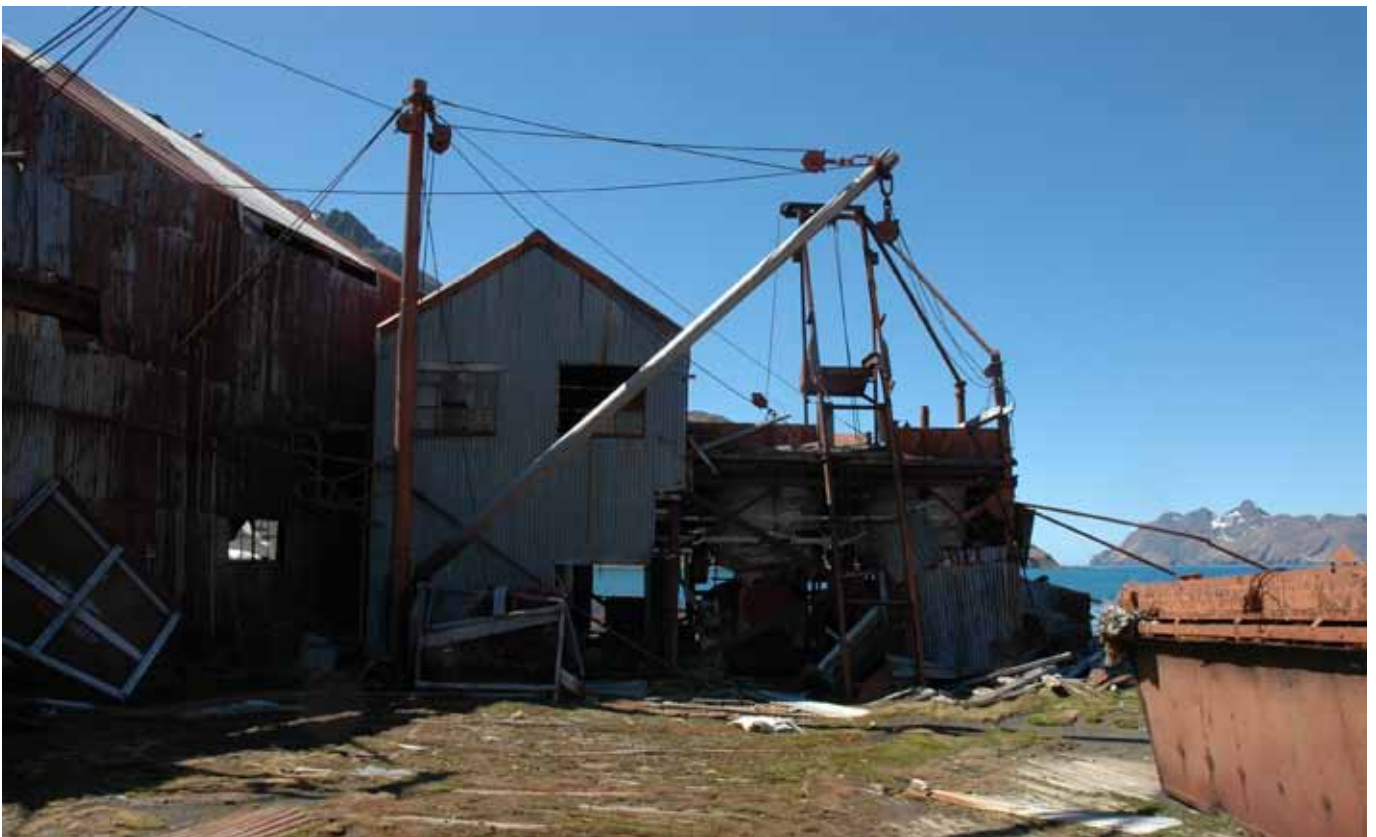
3.3 The west elevation. The large building to the right is No. 4 the Hartmann Plant.

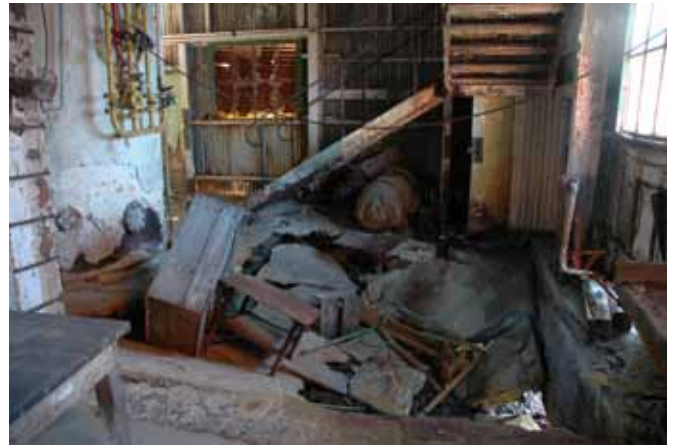
There are two rows of nine meat cookers in the eastern section of the building; these are mounted on timber beams on brick piers. The timber beams are now much decayed and two of the cookers on the south side have fallen and the rest will follow shortly. The haulage slip up to this area is still in position although a part of the bottom is missing and looks as though it has been cut away at some point.

4.1 The interior of the east end of the building

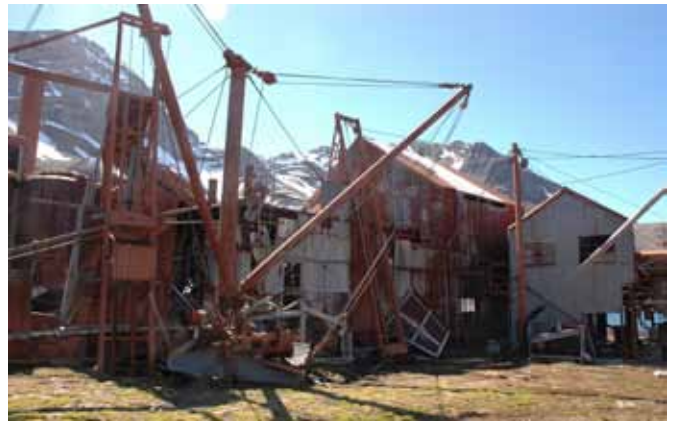
4.2 The south elevation of the building

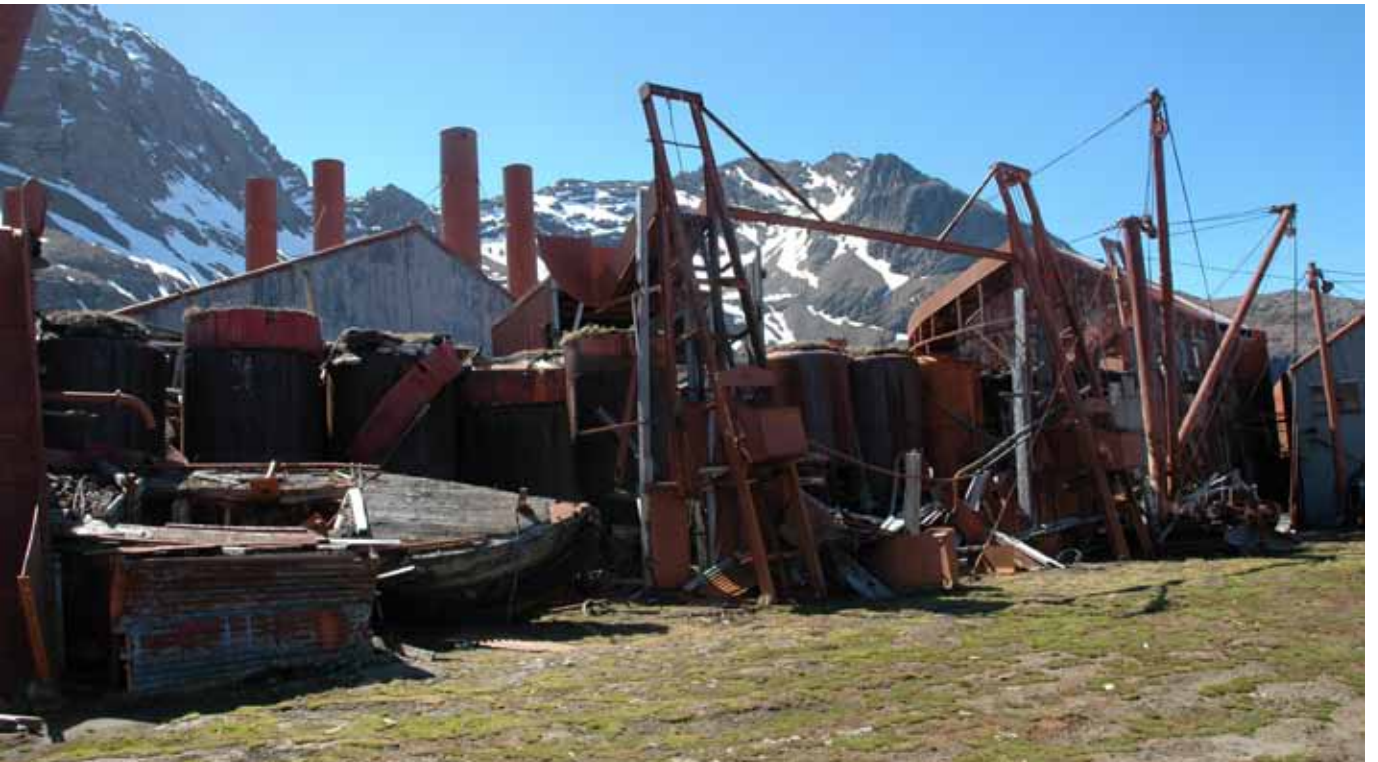
4.5 The west end of the south side of the building with the Boiler House in the background

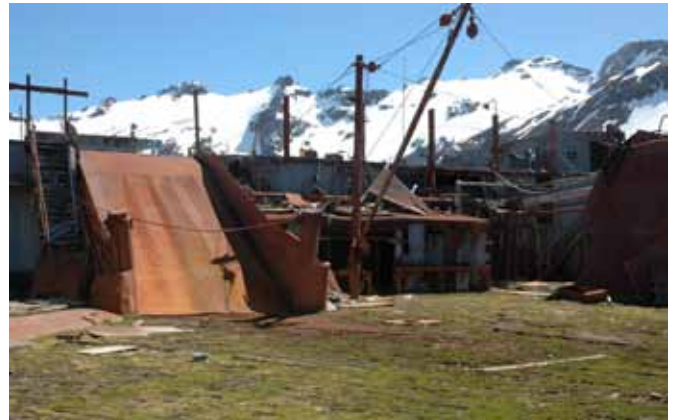
6.1 The ramp to the base lost at the north end of the east side

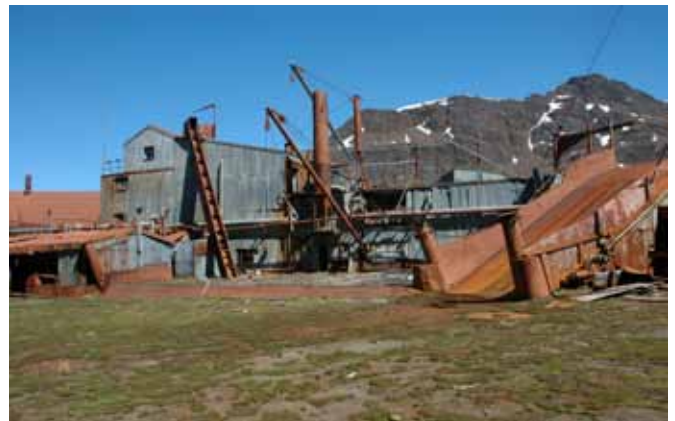
6.2 The east side of the Bone Cookery (to the right) and the Rose Down Plant (taller building to the left)

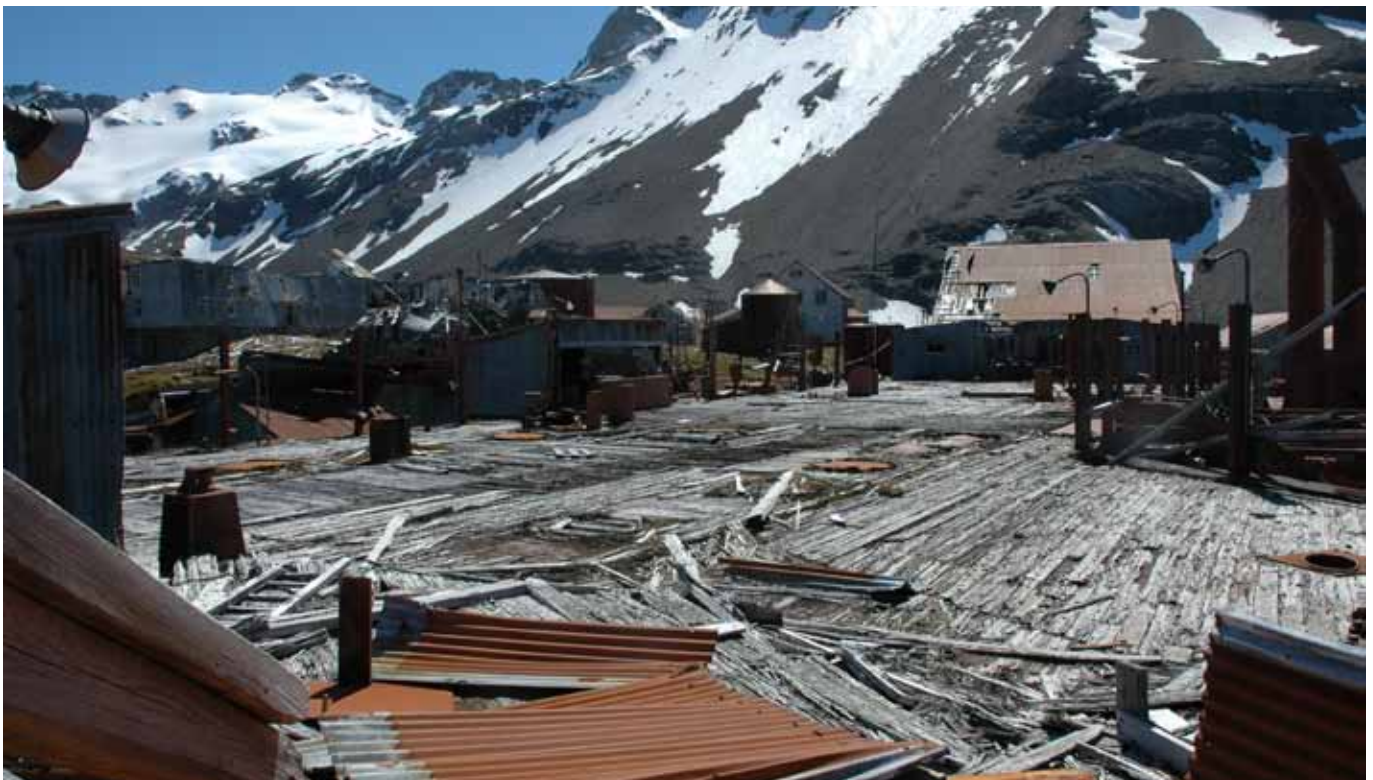
6.3 The loft over the Bone Cookery seen from the Rose Down building

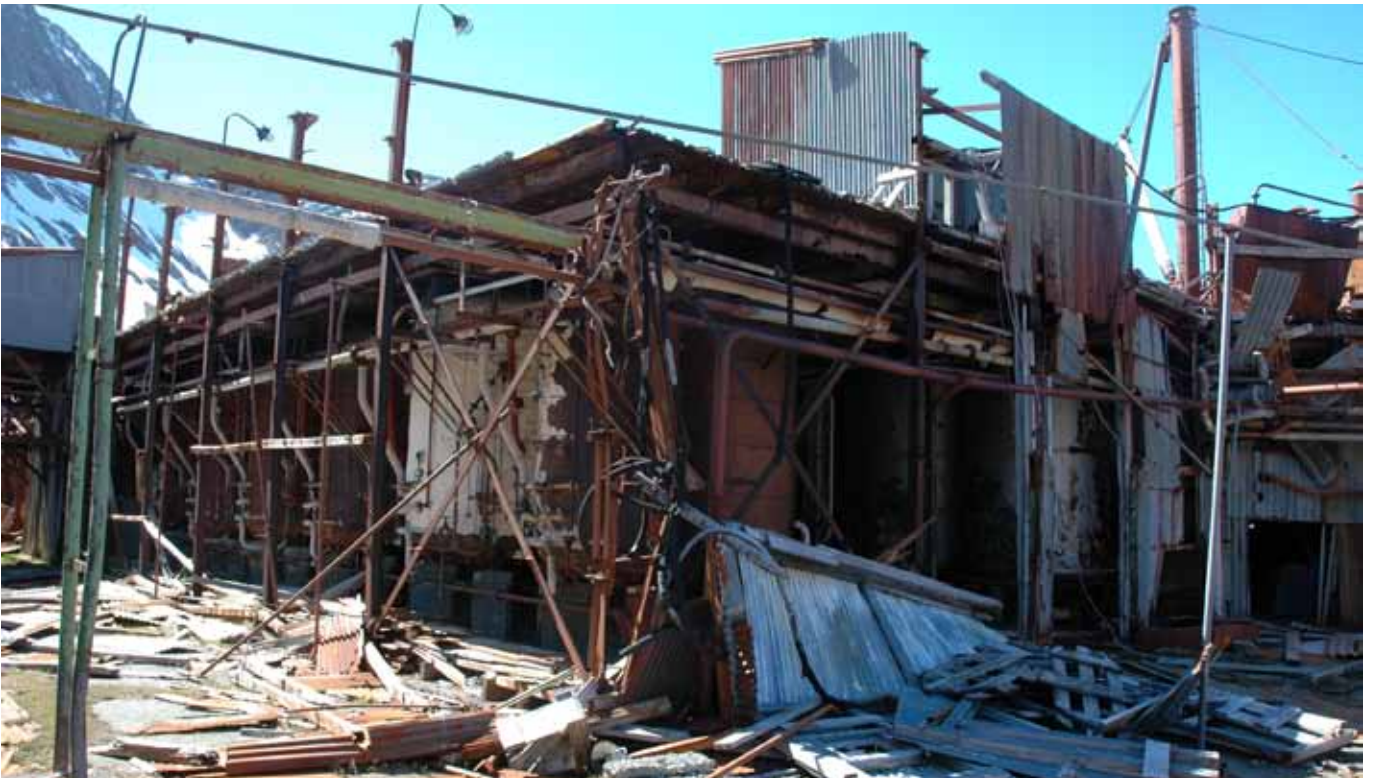
6.5 The southwest corner of the building

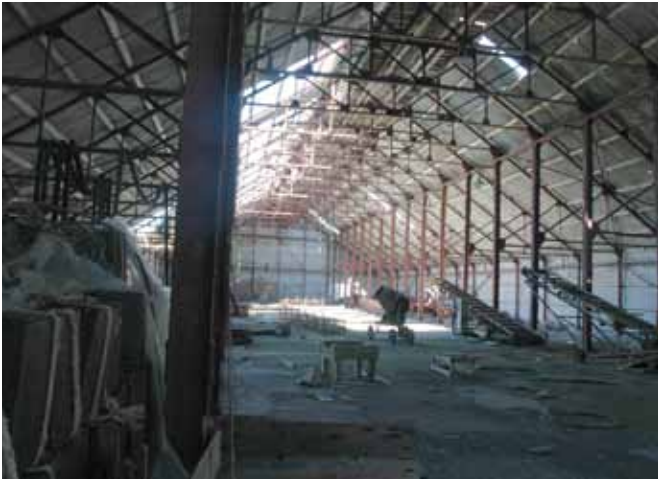
10.3 Interior of the main store shed looking eastwards

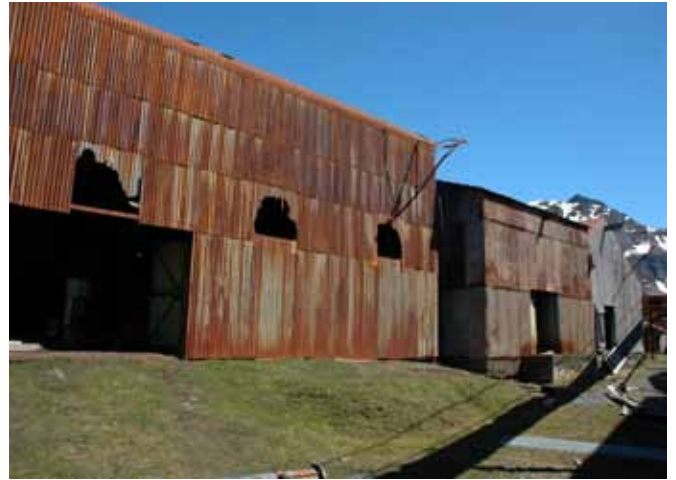
10.4 The west end of the north elevation showing the two big outshots

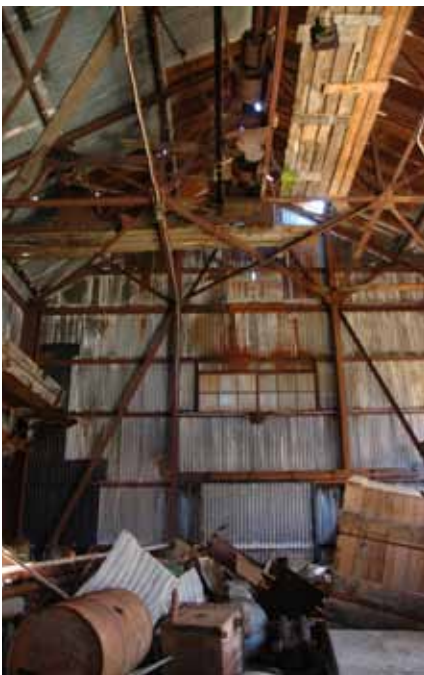
10.5 The interior of the west end of the two northern side outshot buildings

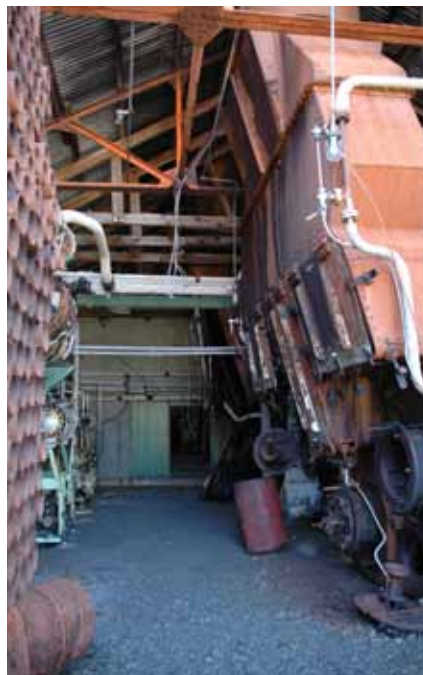
10.6 The boilers in the Boiler House in the South West Wing

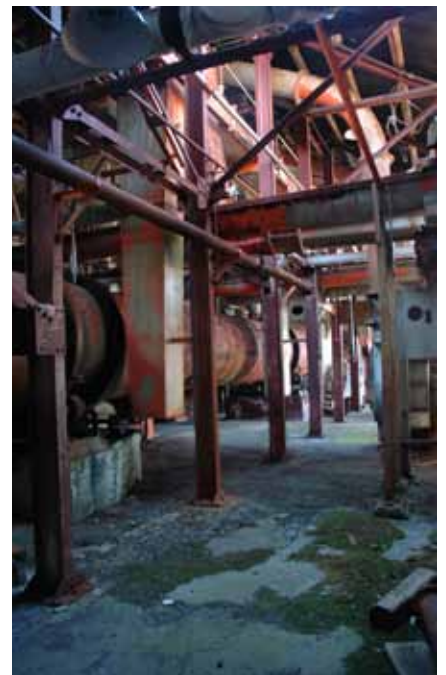
10.7 The west end of the main shed looking east and showing one of the rotary cookers

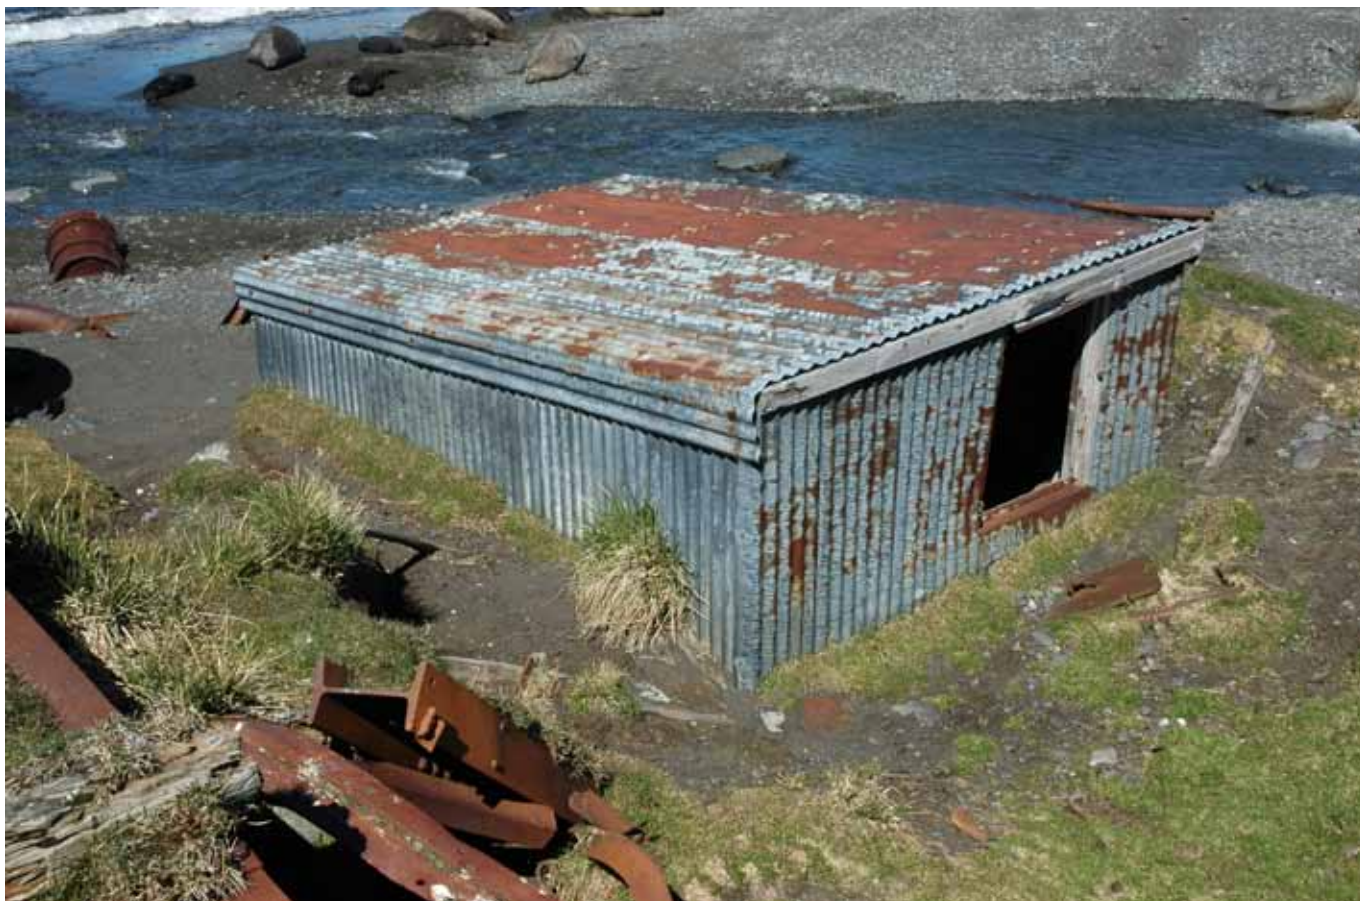
11.1 The Valve House looking southeast (ie., north and west elevations)

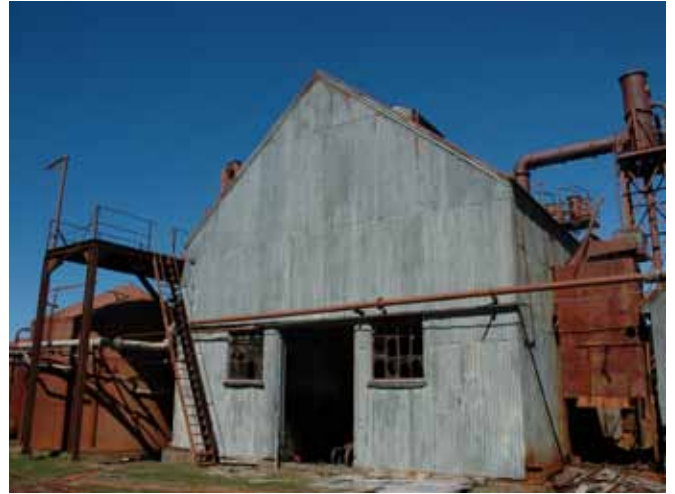
12.1 The north side of the building

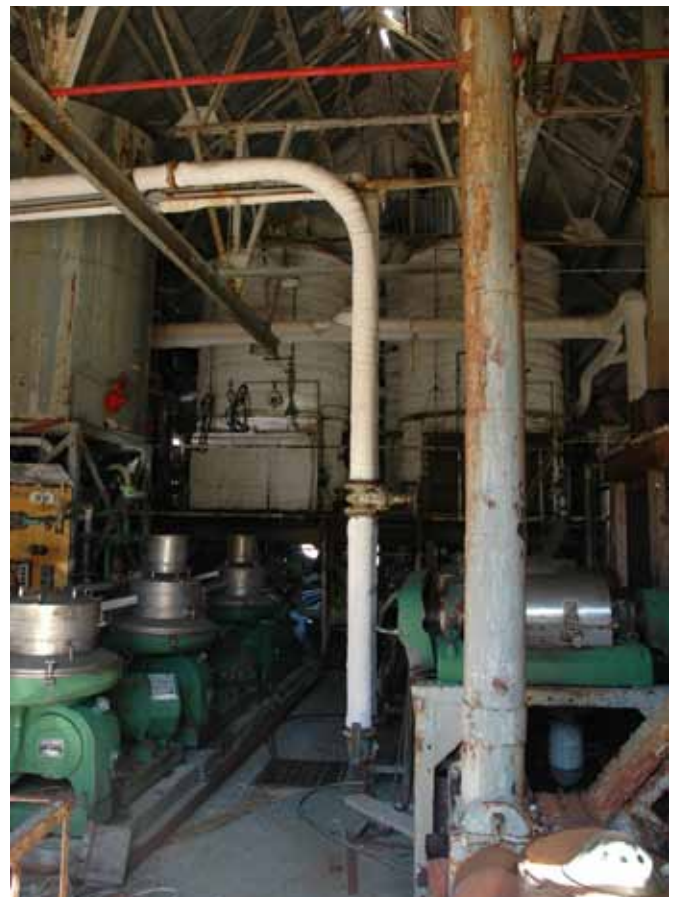
12.3 Interior of the building

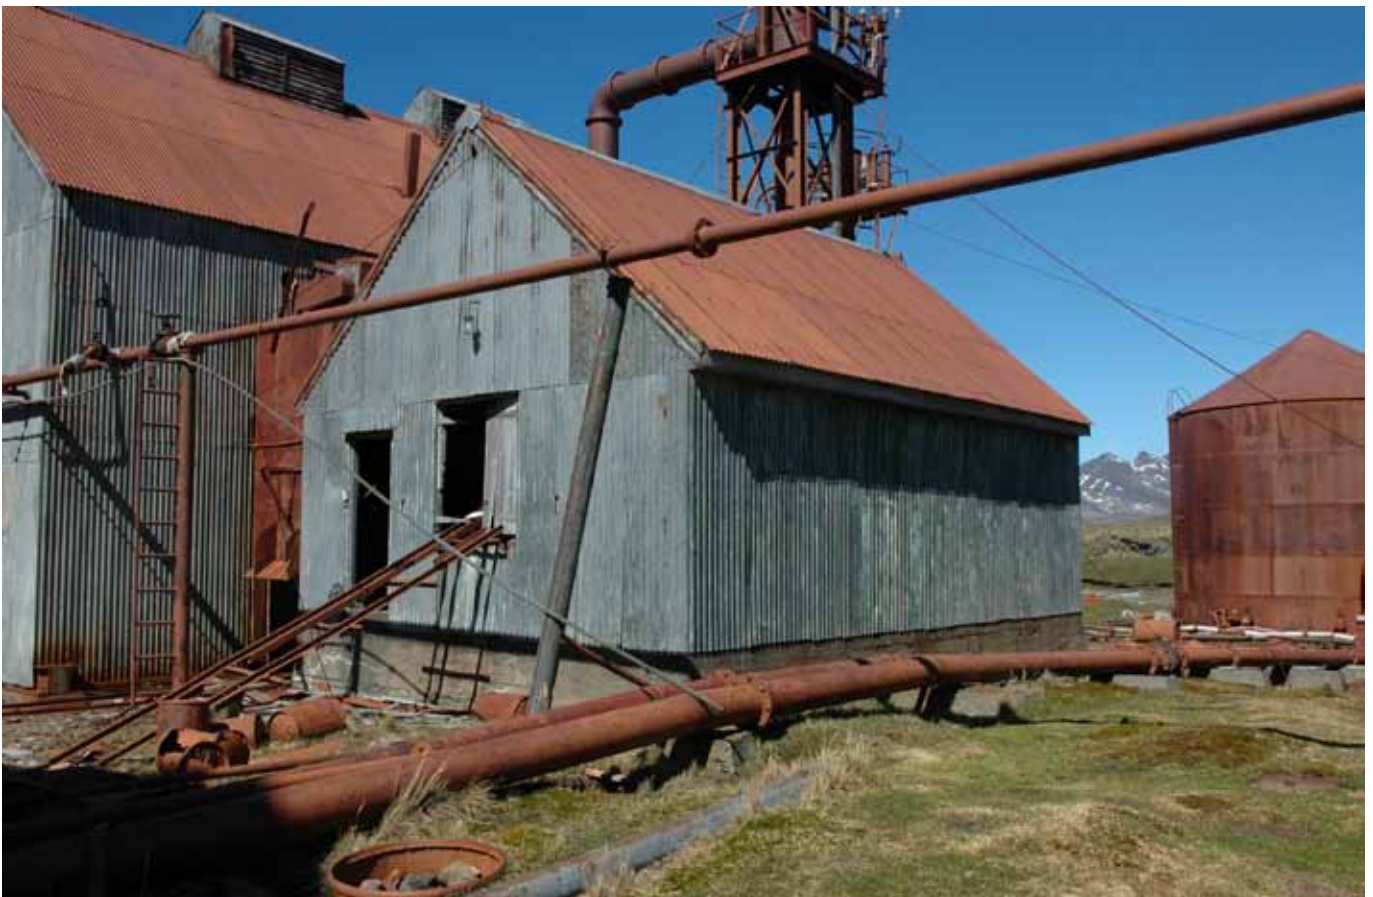
This building has a shuttered concrete base like most of the buildings, with a timber frame with corrugated iron cladding above. The wall sheeting is all present but 30 percent of the roof sheeting is missing on the east side.

13.2 The north and west elevations

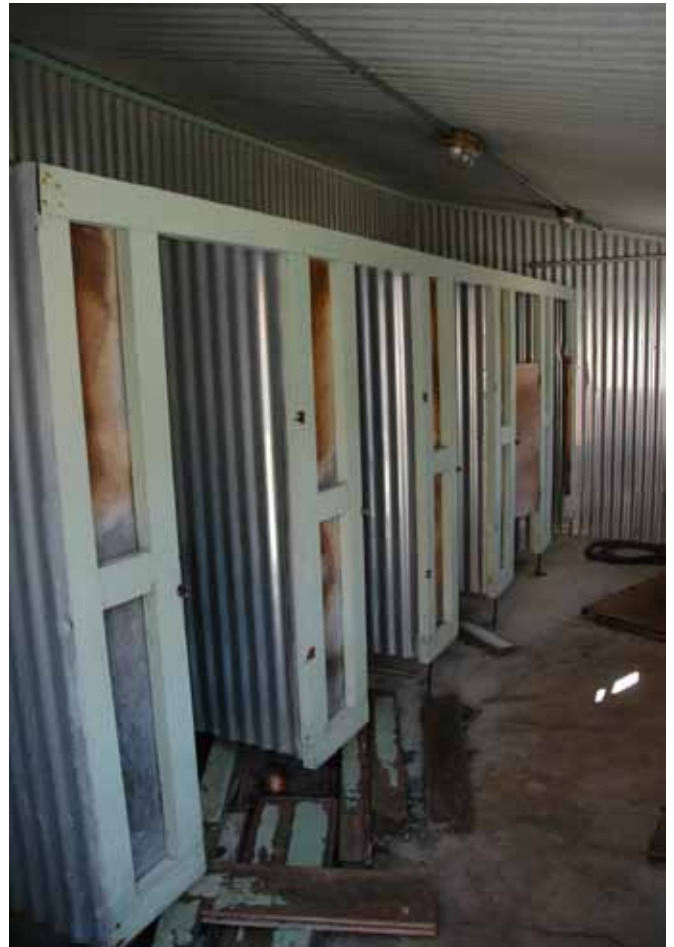
15.2 The interior of the WC Block (the northern part of the building)

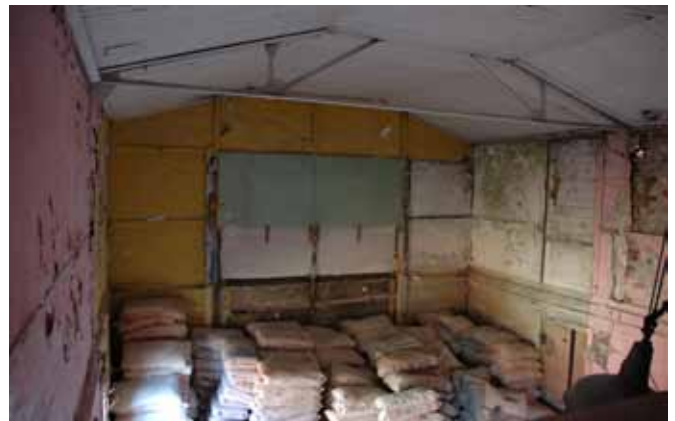
Nothing remains inside the cinema other than some remnants of the screen on the west wall. There is no rake left in the balcony although from the disturbance on the wall it would appear there has been a rake at some time.

19.2 The interior of the store (Old Cinema) looking west with the old screen still invisible on the end wall

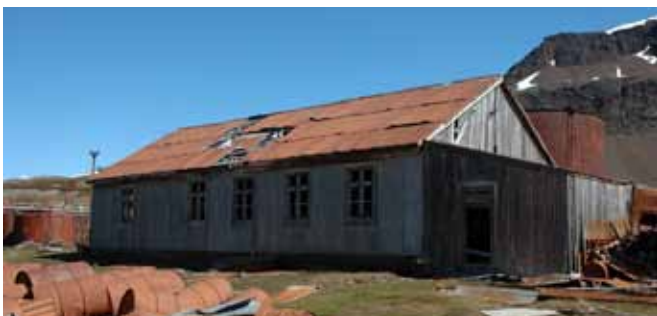
20.4 The east elevation with the northern lean-to from the switch room

There is no obvious access to any roof void from the interior but a door in the south gable gives access to a roof void where substantial king post timber trusses are visible with purlins between the trusses supporting the corrugated iron. The corrugated iron to the walls is generally in fair order but a good deal of the sheeting is missing to the roof, particularly on the east side. The sheeting on the west side is generally all present but it is considerably disturbed at the north end and one sheet is lifting and cracking at the south end. At the north end of the building is a lean-to. On the east side this contains switchgear and on the west side it has been a store room, although the roof of this and the north wall have now completely collapsed.

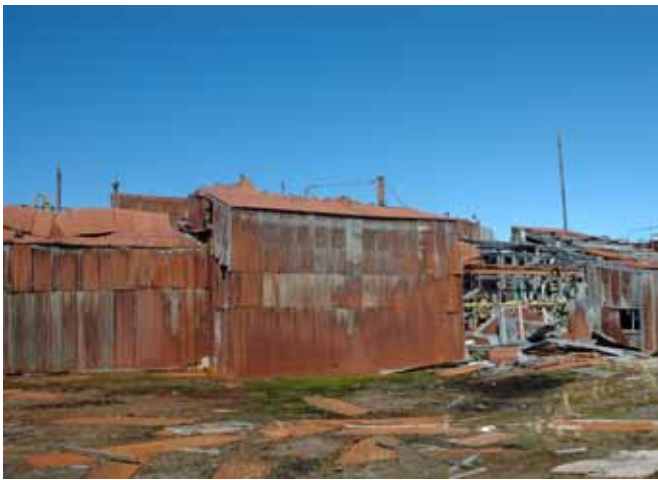
22.2 The west side of the Separator House looking southwest

This building is in a state of near complete collapse. The walls and roof at the south end have collapsed entirely. At the north end the building appears to have suffered from a fire at some point and the first four or five bays of the roof have fallen in and the upper section of the timber frame on the east side has burnt away and the sheets have fallen in. The roof over the central section appears to have collapsed. The building was never a substantial one with timber posts, some of which are not squared up, supporting sheeting rails and corrugated iron. What is left of the building appears to be propped largely by the internal plant. The fabric of this building would have to be removed if an attempt was made to clear the asbestos from this area.

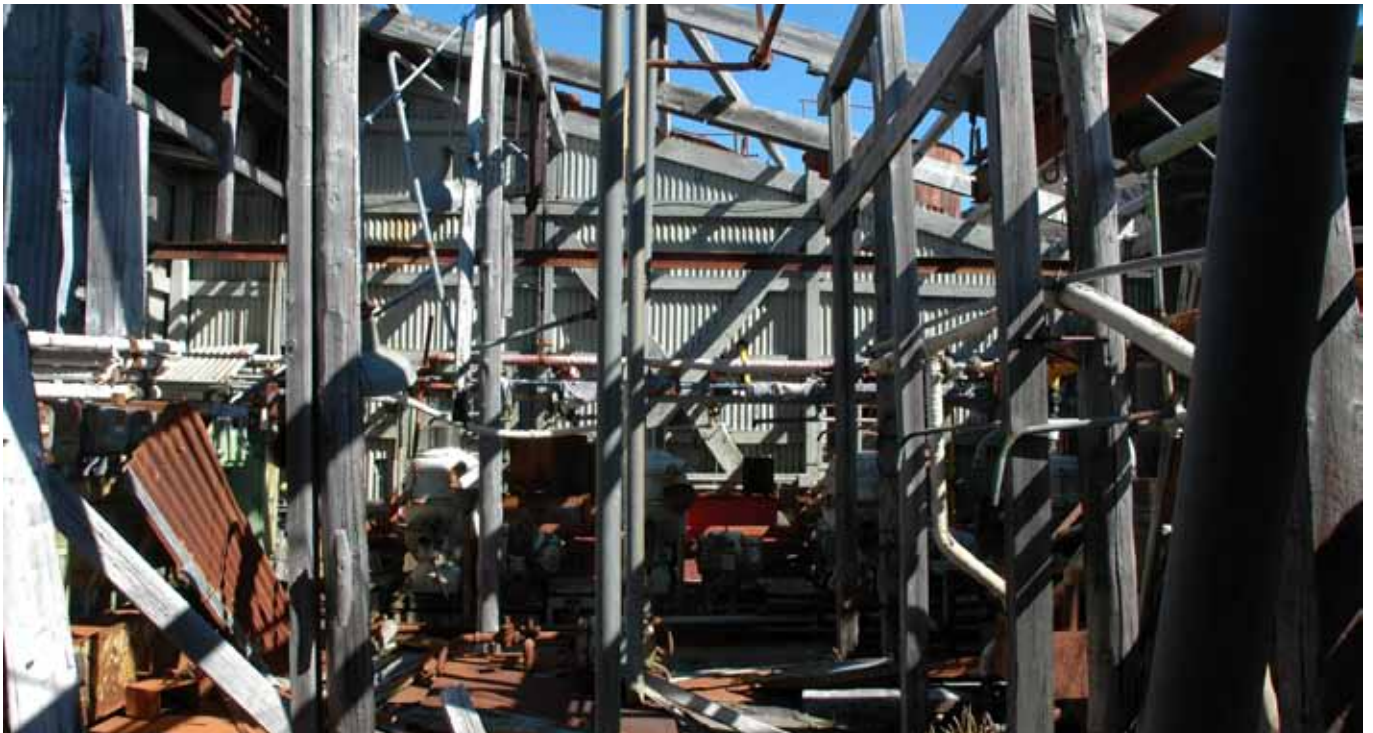
22.3 The collapsed central area

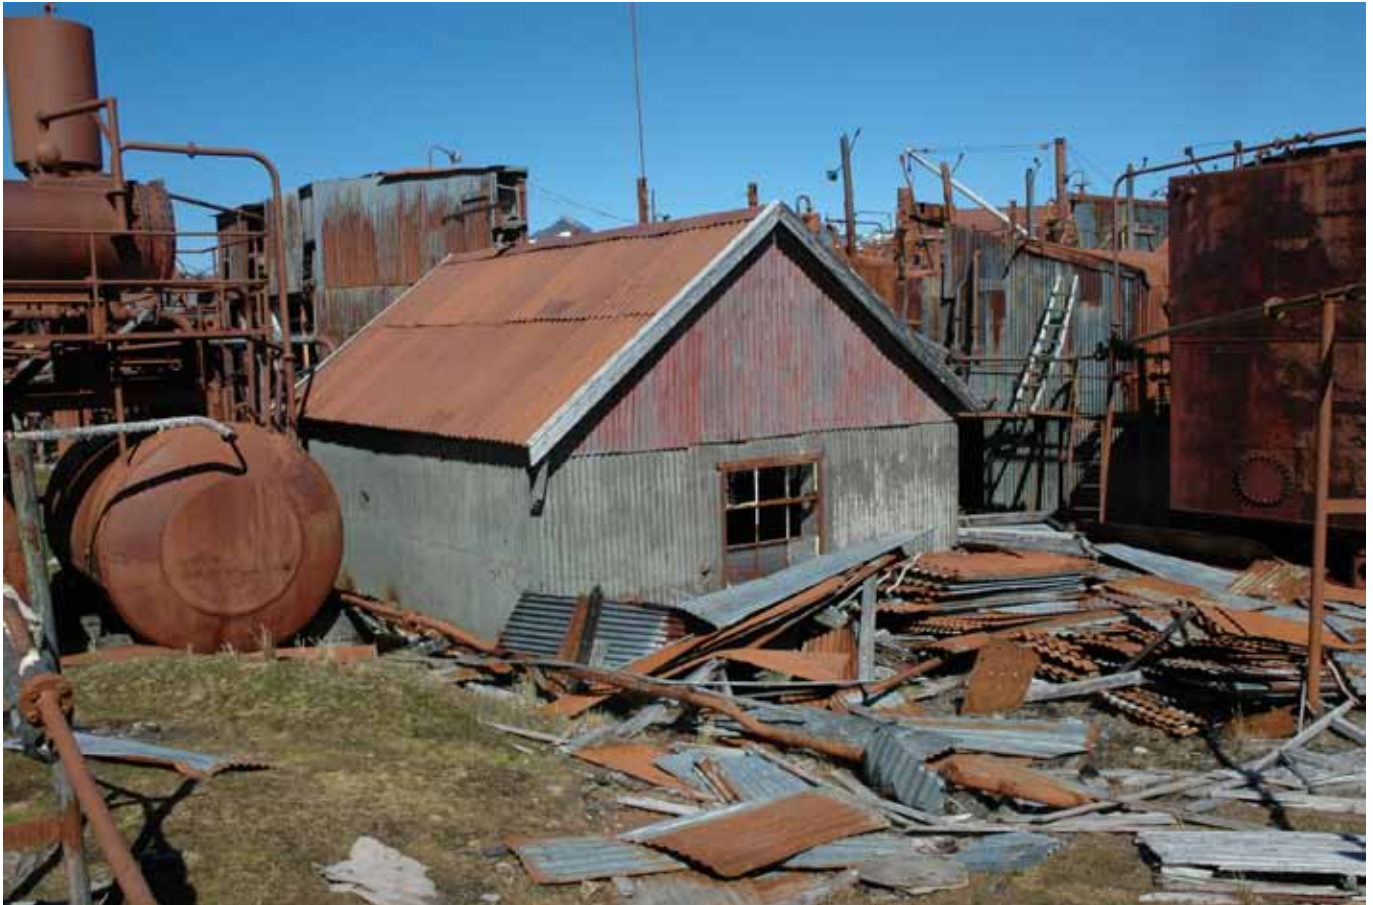
23.2 North and west sides of the building

A small pump house immediately north of the separator plant. The building has concrete walls up to wall plate level. These have been cast against corrugated iron sheeting which has then been removed. No floor is visible though there may be a concrete floor under the silt covering it. This is probably the result of water washing through here. The actual floor level would appear to be 400 or 500mm below the present level of the silt judging by the location of the plant. The roof consists of four steel trusses supporting timber purlins and corrugated iron sheeting and also in the gable end the roof sheeting is heavy gauged, that to the gable ends much lighter.

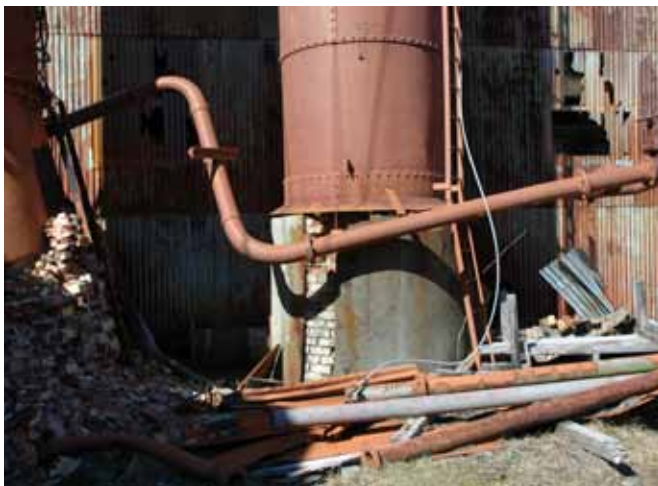
25.5 The chimney bases

The render is failing and the brickwork starting to fall away. The southernmost flue has cracked and dropped approximately 750mm. It is now wedged on the remains of the flue and leaning against the adjacent northern flue. It is unlikely to remain like this for long and in coming down may well bring more of the flue with it. These two main flues have been stayed, the stays to the broken flue are now ineffective but three ties remain in position and reasonably taut on the northern flue.

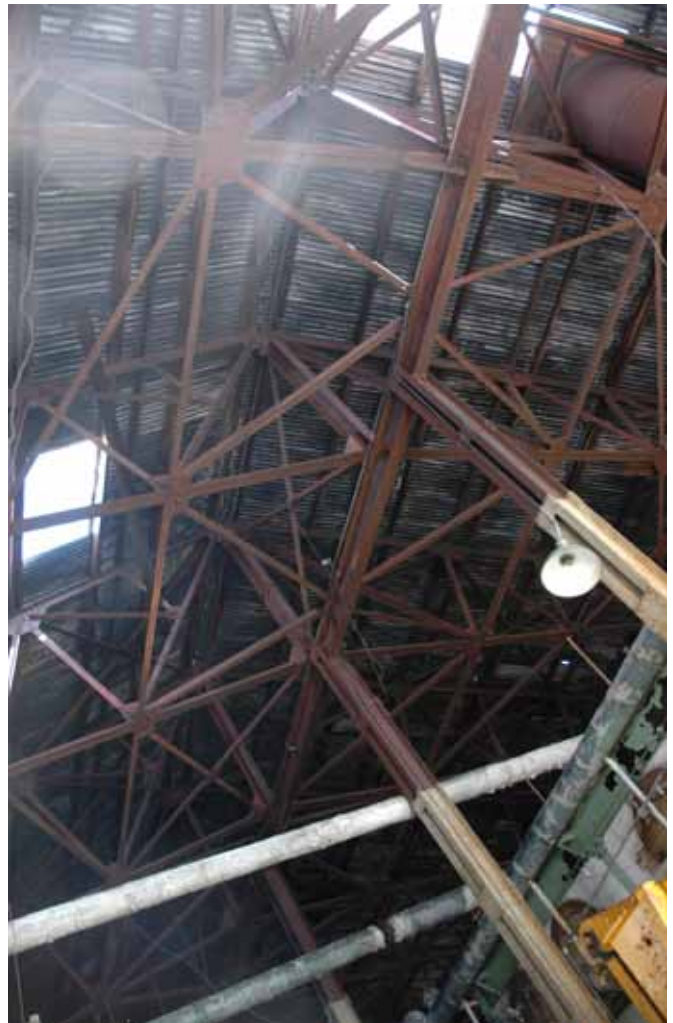
25.6 The roof structure

The Boiler House is a substantial rectangular steel framed building with heavy RSJs as columns and as a wall plate. Trussed roof with a central line of columns propping the ridge which is trussed in the opposite direction. This is a substantial steel frame which is likely to survive for some considerable time. The sheeting to the roof is generally in reasonable condition. There is one hole on the east slope where the plastic rooflight has failed and a partial failure of a rooflight on the west slope.

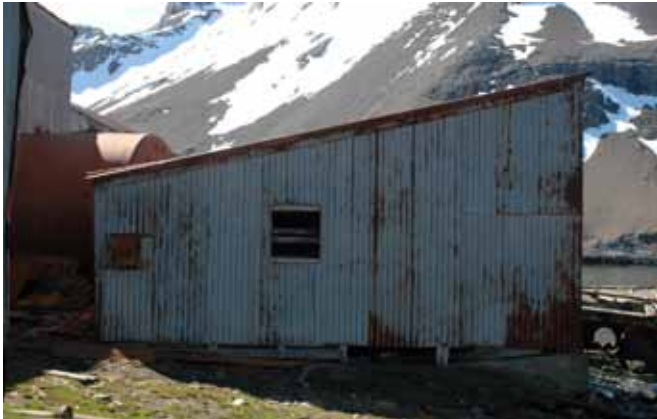
26.1 The south elevation of No. 26, the Battery Store

Two small huts between the boiler house and jetty 82. Building No. 26 is the larger of the two, this has no obvious access to the seaward side. Timber framed with a simple mono-pitched roof of propped timber. The northeastern section of roof, approximately 20 percent of the total roof, is now missing. Building No. 27 contains a generator for electrical welding. The hut is a simple timber framed building with simple 'A' framed truss roof. There is some internal timber boarding for mounting switchgear but otherwise it is unlined. The western part of the floor is concrete. The southern part of where the generator sits is timber. The building is in reasonable order.

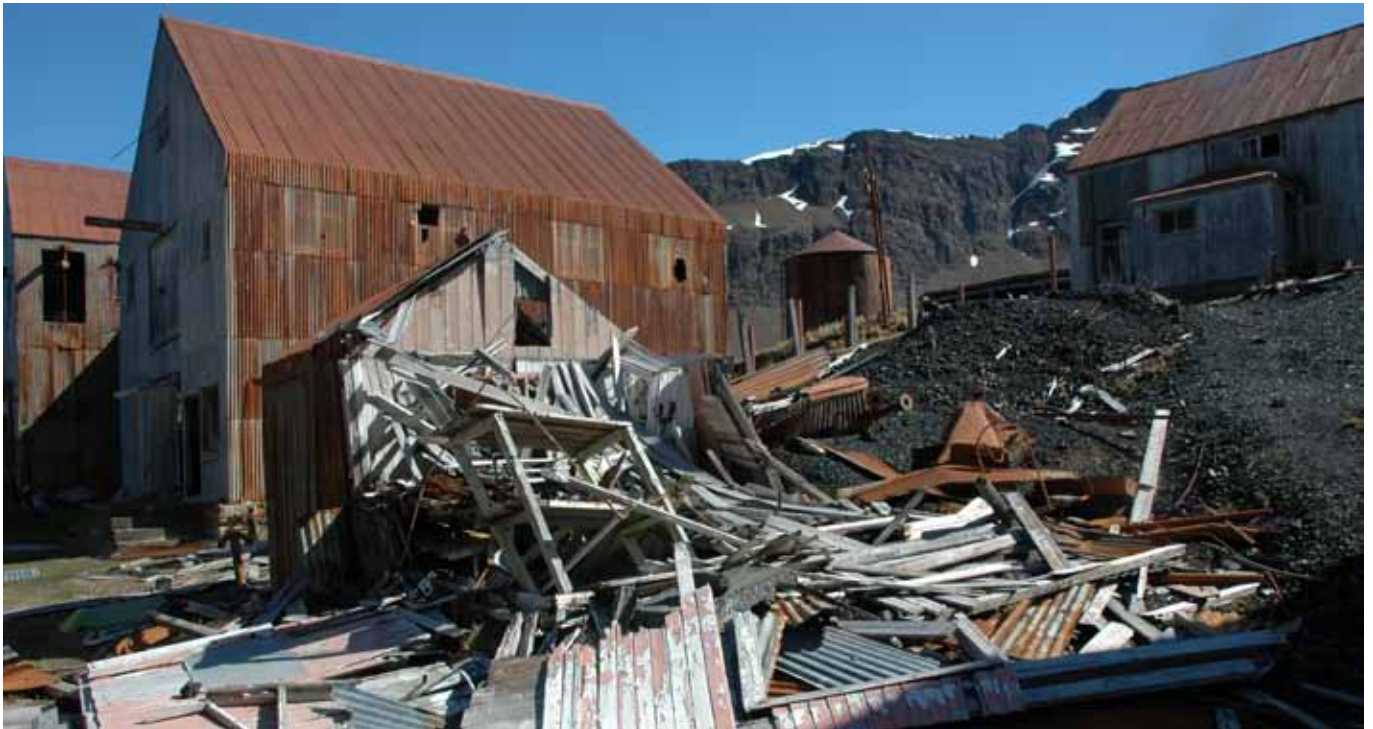
29.1 Looking southwards with the Catcher Store (No. 28) in the background

The building stands on the edge of the slope with a good sized coal heap behind it. The building is small timber framed with a pitched roof and has a small amount standing at the south end but most of the building has collapsed entirely.

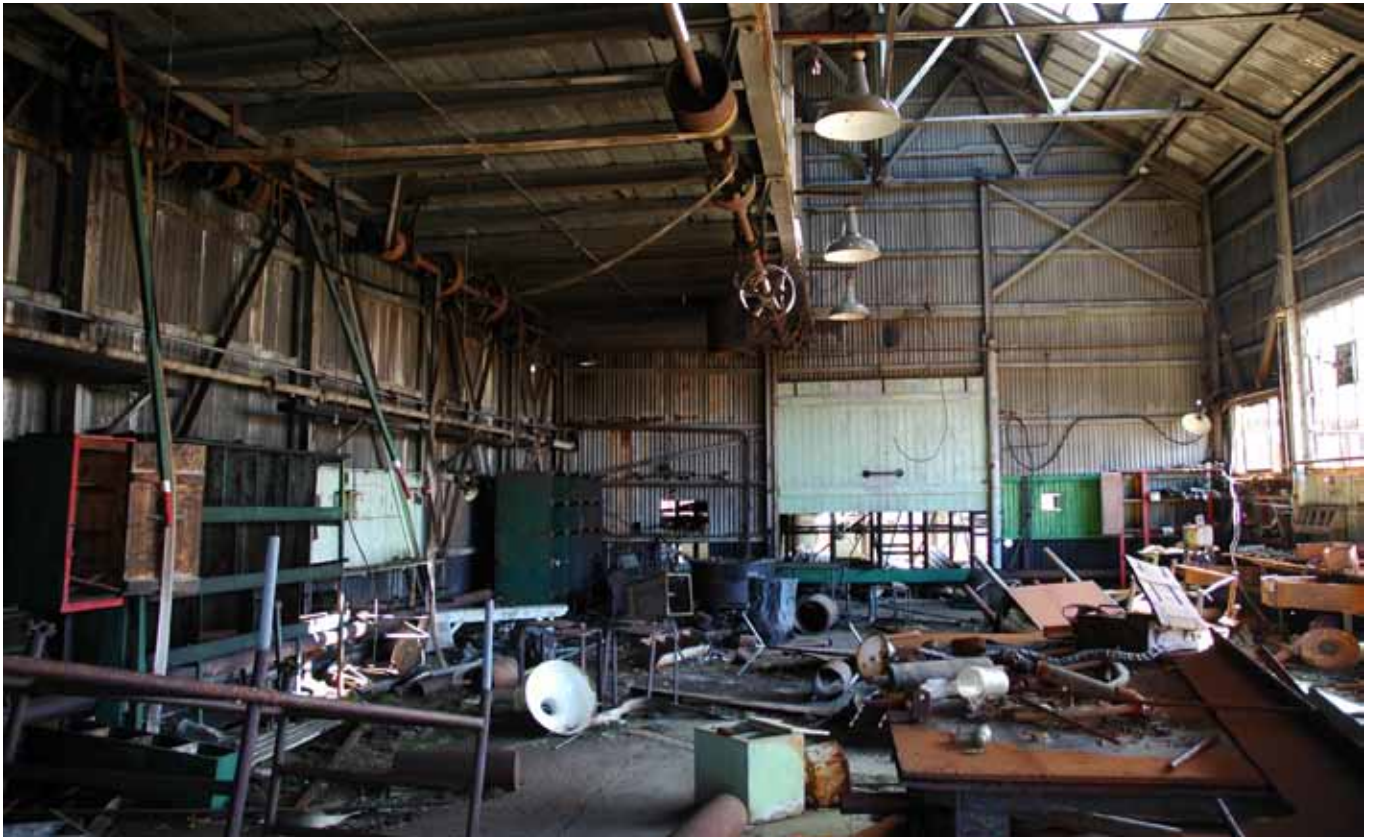
30.3 The interior looking northwards

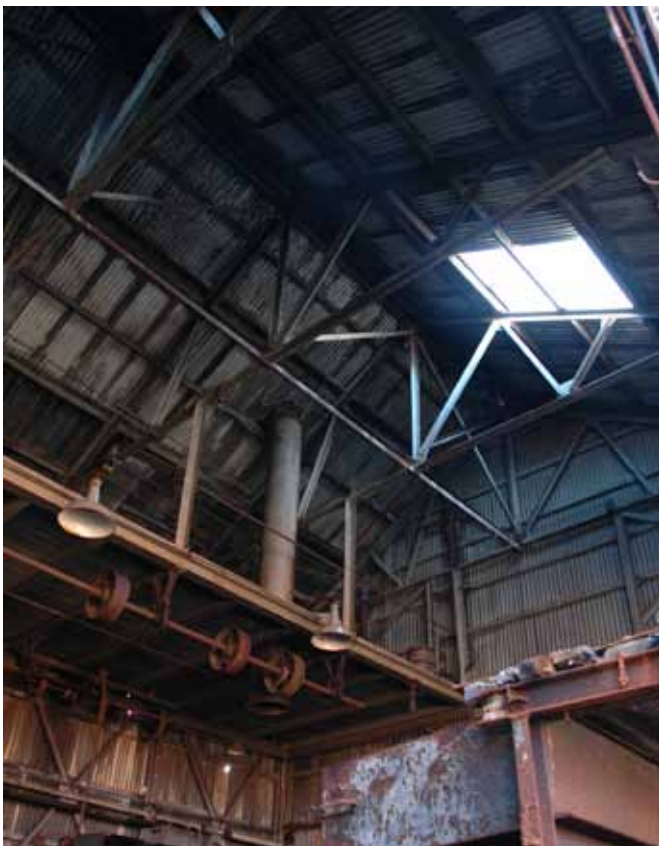
30.4 The roof structure
