DISUSED WHALING STATIONS

Leith Harbour Gazetteer

Gazetteer, July 2011

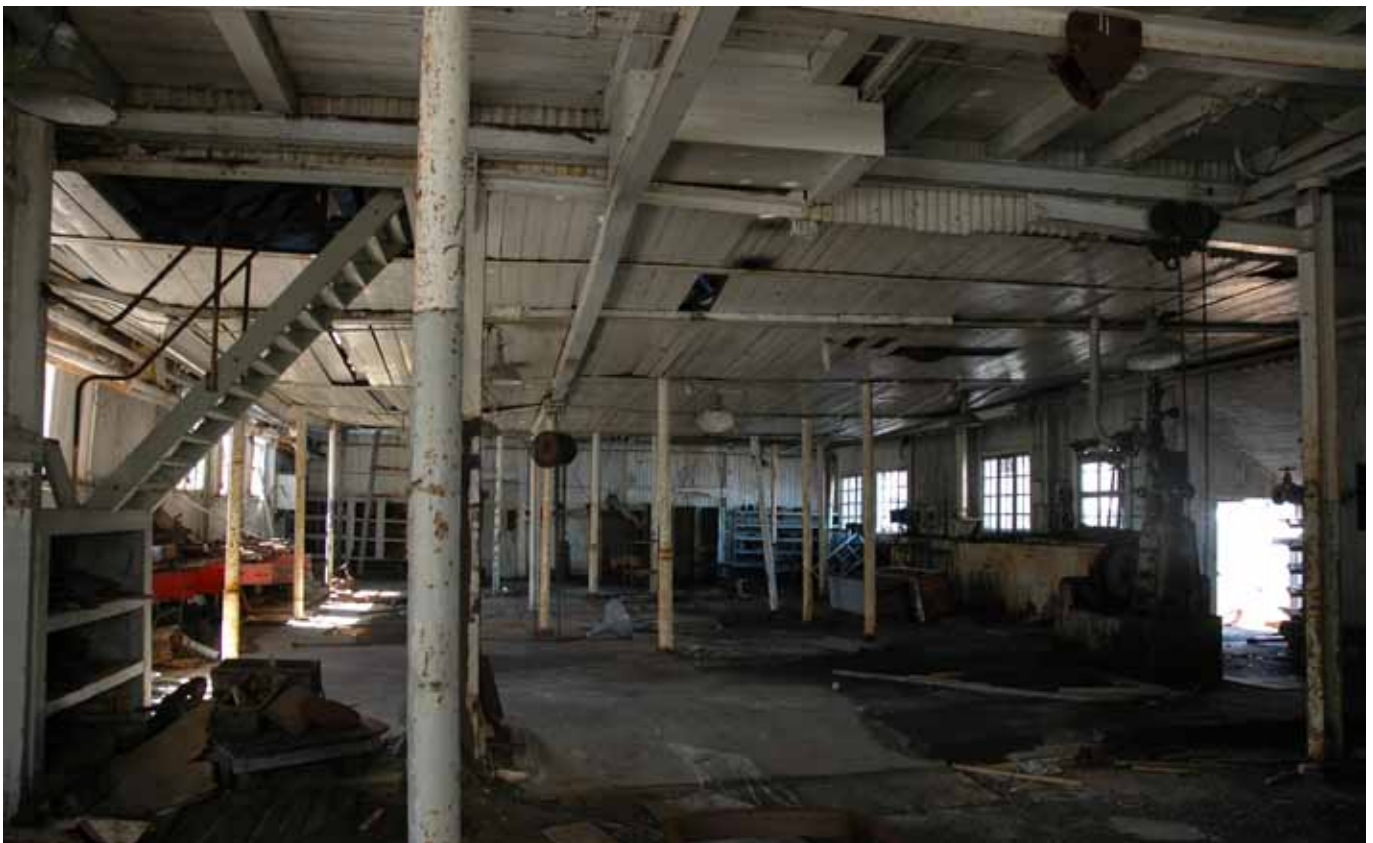
The adjacent building to the west would appear to have been built earlier judging by the way the corrugated iron protrudes through into the southern building. This is effectively a single storey building but with a large accessible loft space. The concrete floor in this section is raised approximately 150mm above the floor level of the south end and has concrete machine bases. The first floor is supported on steels with intermediate propping columns and these are now in poor condition and the floor is considerably distorted having dropped 400–500mm in places. The attic space is now too dangerous to access. This building, like its southern neighbour, has a steel frame with timber boarding inside and a trussed steel roof. The corrugated iron external sheeting is beginning to come away from this area with several sheets missing on the east side of the roof and the remaining sheets loose.

31.2 The interior of the south end of the building looking northwards

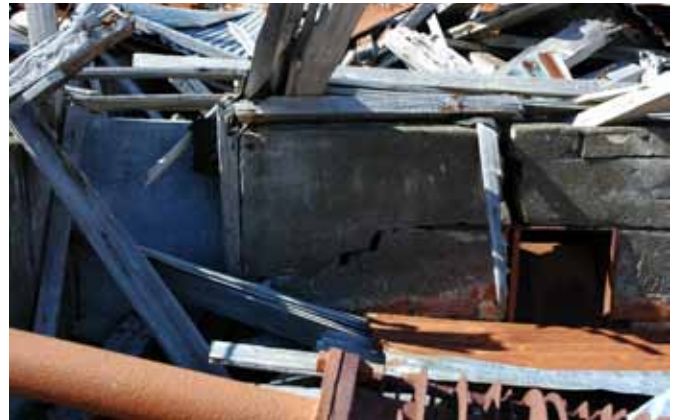
This building had a brick base which was built from rendered brick, half brick thick pens for the pigs with timber doors faced with sheet steel and metal feeding hoppers in the wall to the central passage. The building was constructed of 75mm thick tongued and grooved boarding for the walls with a plate top and bottom and with timber principals propped on posts and purlins. The building has more or less entirely collapsed except for one small section remaining at the west end which may have been used for storage although it still has the chutes into the pens.

33.1 The pig pens inside the collapsed building

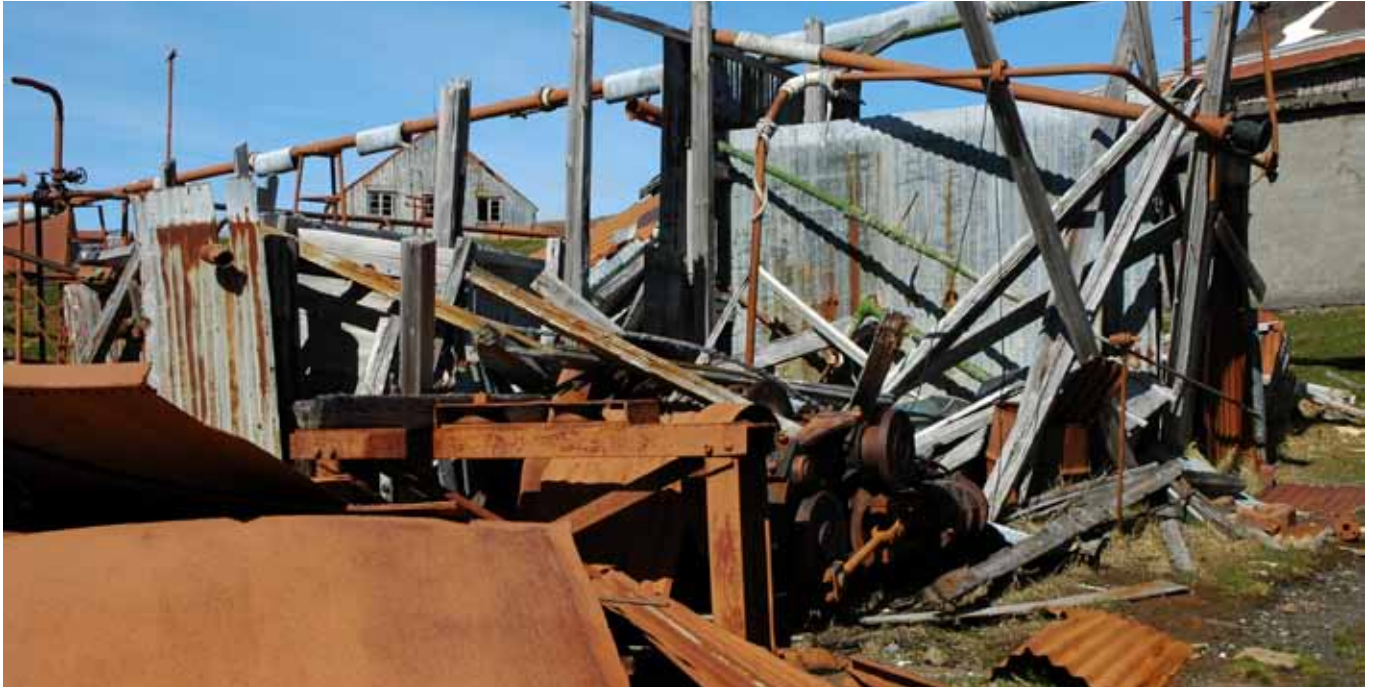
A small timber framed building, the northernmost bit probably having a pitched roof with a lean-to on the south side. This building has more or less entirely collapsed. In addition to being a store and garage there is a substantial winch in the northeast corner, probably relating to the principal jetty below this area.

34.1 The east side of the building

34.2 The west side of the building

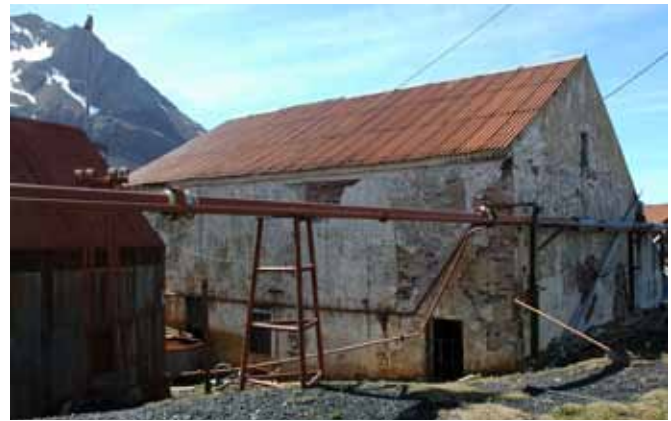
The building appears to have been altered on more than one occasion with two concrete 'columns' on the north side and some irregular bonding suggesting possible blocked windows. The building is dug into the ground so that the ground floor level is some 1800mm below the ground to the west. The roof sheeting is generally sound, although a section of the ridge capping has blown off and some timber windows remain though none have any glass. The section of the building to the south of the main blocks, containing the present slaughterhouse, would appear to be a later addition to the original building judging by the brick bonding. This is one of the more substantial buildings on the site.

35.2 The north and west elevations

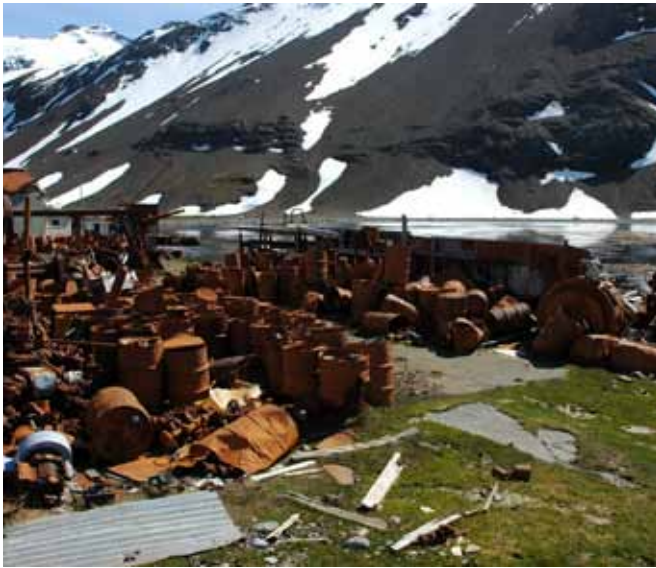
This building has pretty much completely disappeared; its location only being apparent from the concrete retaining walls to the west and the line of the original wall to the south which still has a lean-to metal bar store behind it. The concrete floor is still present though this is generally difficult to see as this area was used for assembling the scrap for loading in 1982.

37.1 The whole building and adjacent area is covered in the scrap metal assembled in 1982

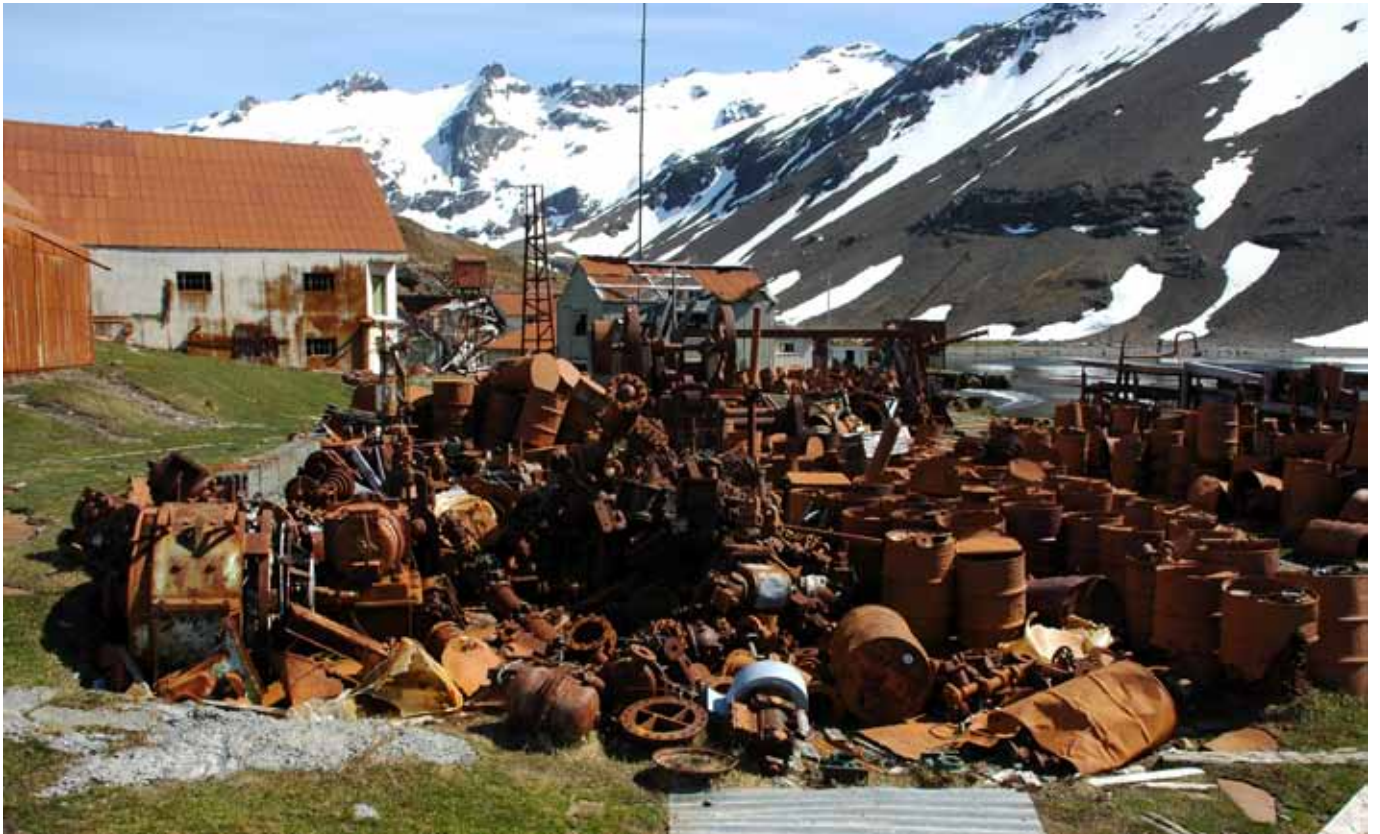
37.2 The outline of the building is just visible as is the floor

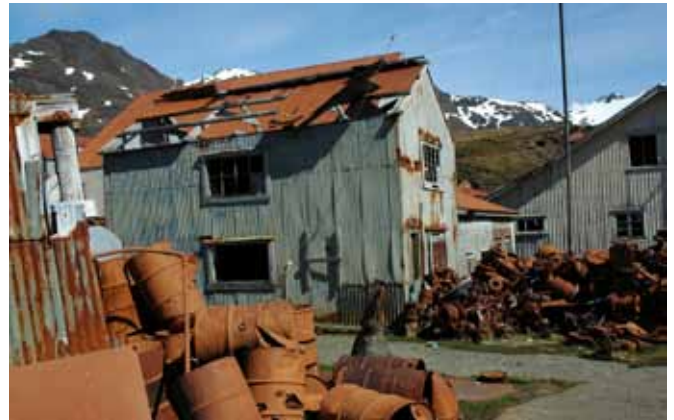
The southern part of the building is timber framed and the south block is two storey. This is a timber framed building with cladding of the much smaller gauge corrugated iron. It seems likely that this building was erected prior to the single storey building to the north. The first floor of this building was not accessed but it had timber windows which seem unnecessary in a hen house. The small gauge cladding is now rusting through around the windows and doors. The whole of the north side of the roof of the upper section has no covering and the purlins are missing. There is also a substantial hole in the north roof slope and loose sheets.

38.1 The two storey block on the southeast end of the building

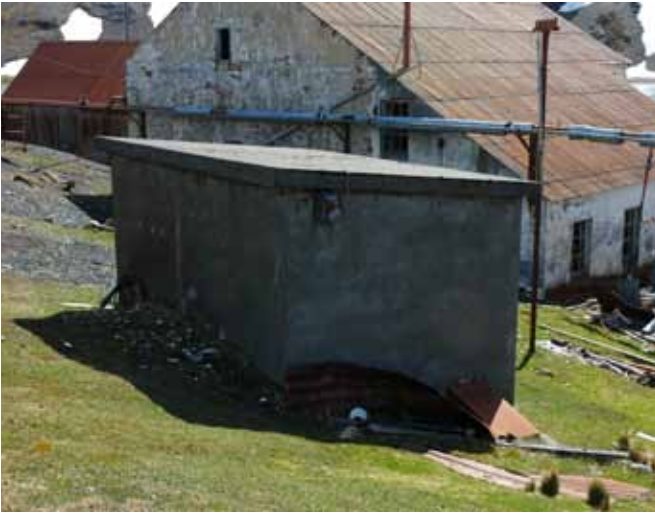
A small rectangular single storey building of rendered brickwork with a concrete floor and concrete slab mono-pitch roof. The entrance door on the north side of the building is missing. Some of the switchgear remains in this building.

14.1 The northwest elevation

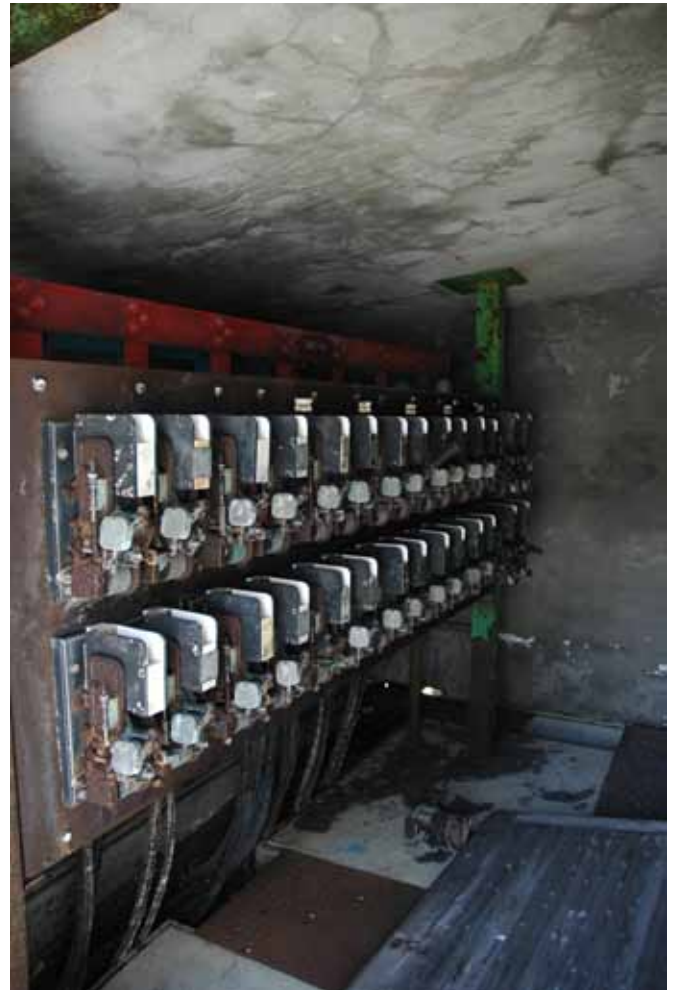
41.2 The remaining switchgear

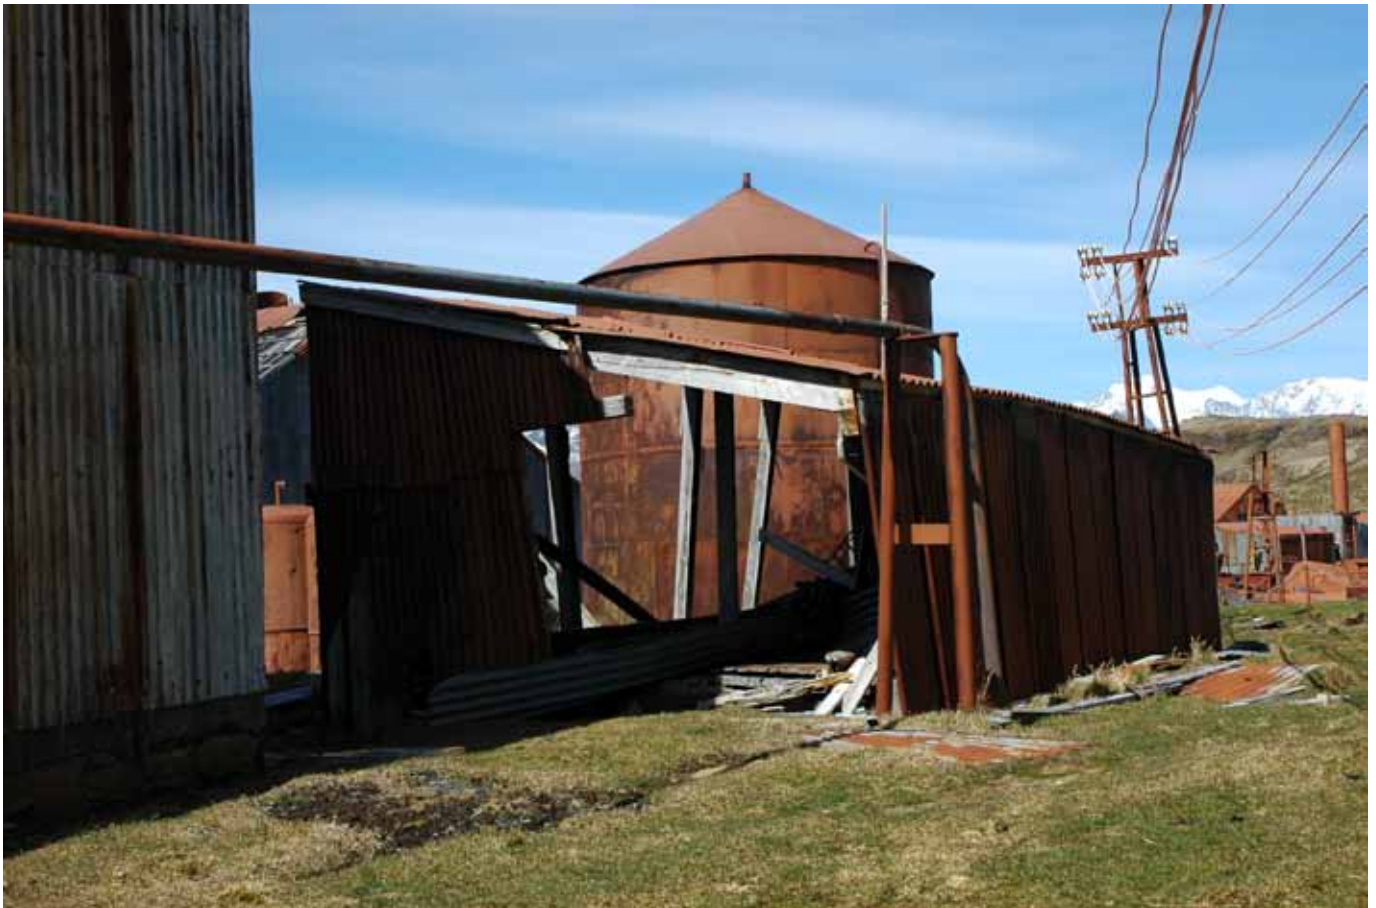
42.2 The north and west elevations

A small timber framed building clad in the large gauge corrugated sheet. The roof is a mono-pitch falling from east to west. Part of the north wall has fallen away and the whole of the south wall has fallen out. This building will not remain here for much longer.

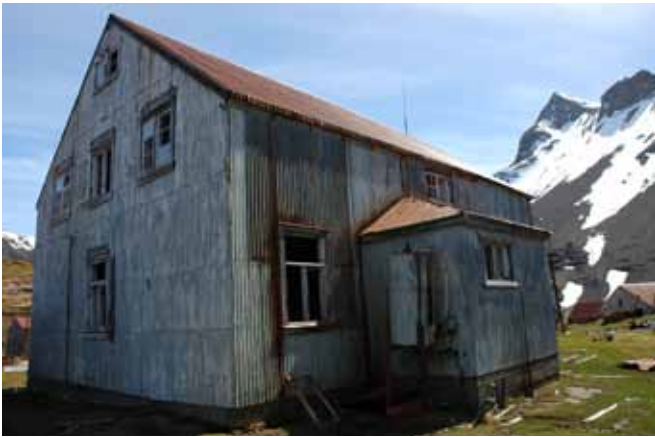
43.3 South and east elevations

The roof is intact on the east slope but there is a substantial hole on the west slope with perhaps some 10 percent of the roof slope missing. The timber roof structure can be seen here. Timber trusses with timber purlins. There would appear to be storage accommodation or possibly further bedrooms in the attic although this area is unlit apart from one small window in the south end gable.

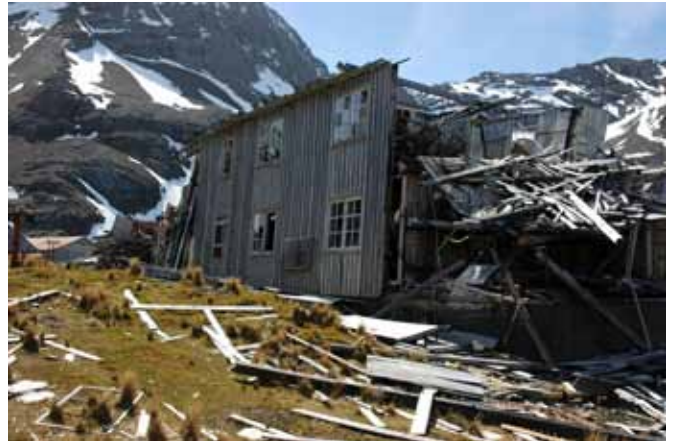
Both have collapsed in a comprehensive manner. The buildings appear to be very similar in their construction; both have concrete basements with a concrete ground floor slab and then timber stud framing above of two storeys, with further accommodation in the roof space.

44.2 The remaining section of wall on the west side of the building

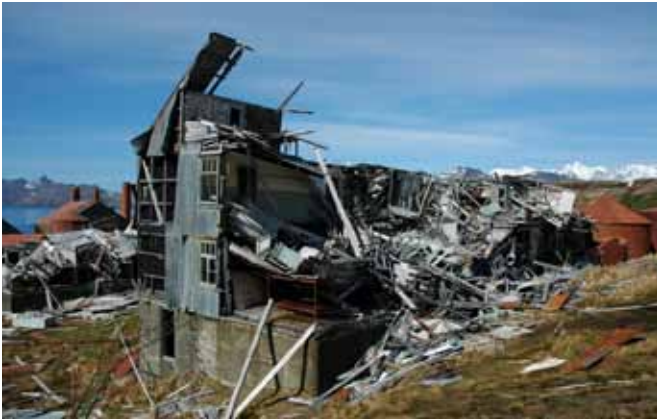
45.1 The north end and west side of Hillside Barracks

Building No.45 has a porch more or less in the centre of the east side with three large windows and one small window either side of the porch. On the first floor are seven bays of identical windows. This east wall of the upper barracks is the only significant amount of walling remaining with a very small section of roof at the north end and the remainder of the building has comprehensively collapsed in a tangle of partitions, beds, pipes, sanitary fittings etc. The construction appears to have been from 125x50mm timber framing with building paper and vertical boarding to the exterior which has then been sheeted in corrugated iron and vertical boarding to the interior, the void being filled with Kapok or some similar insulating material. It seems likely that these buildings will collapse completely in the next year or two.

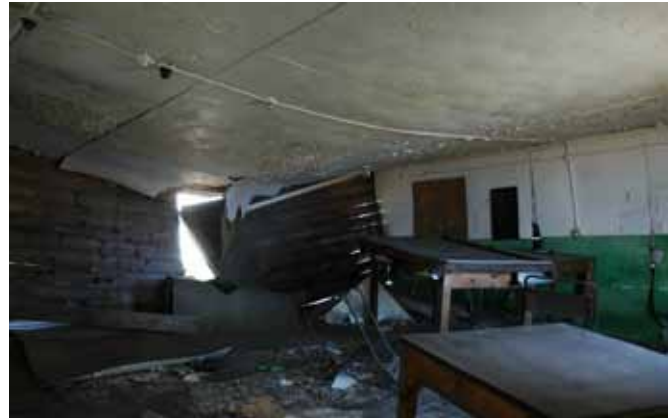
A small rectangular single storey building with a porch on the east side and the roof pitch running north/south. The building is constructed with continuous windows around the north and west sides of the main space, though these have been boarded in (and from the look of it were probably boarded in quite early in the hut's life). The hut is timber framed with vertical external boarding and horizontal internal boarding which has been covered over with hardboard to the walls. There is a softboard ceiling. The west wall of the hut has more or less collapsed with the floor subsiding at the northwest corner and the roof still in position but only just. A small amount of corrugated iron remains, though most of it has blown off. This building will collapse in the next year or two.

46.3 The interior of the main space showing the collapsing roof

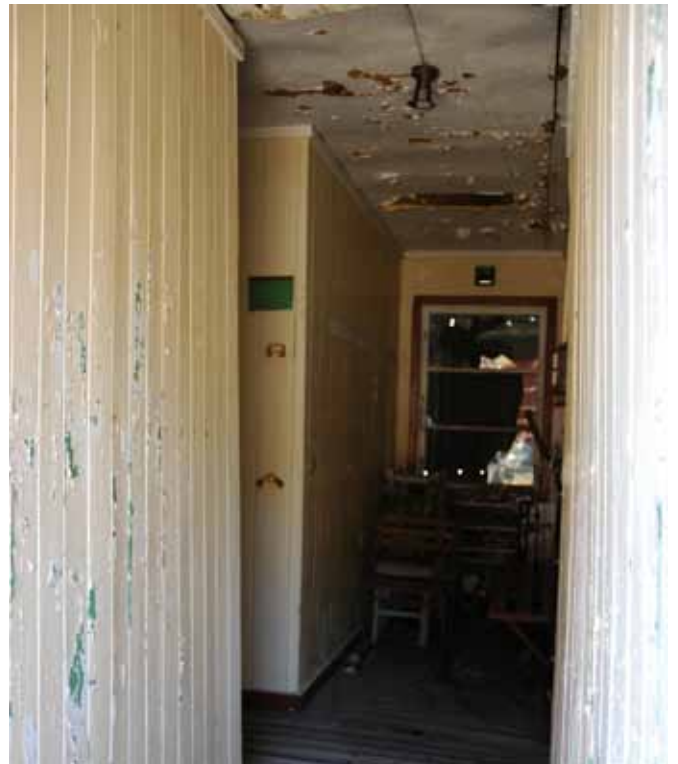
48.3 The entrance area looking east

Internally there is a suspended floor with timber boarded partitions and a ceiling probably of softboard. The floor has collapsed letting partitions drop with some sagging of the boarding on the centre of the west side and the boards are missing completely from the north end of the west side.

This hut is beyond sensible repair.

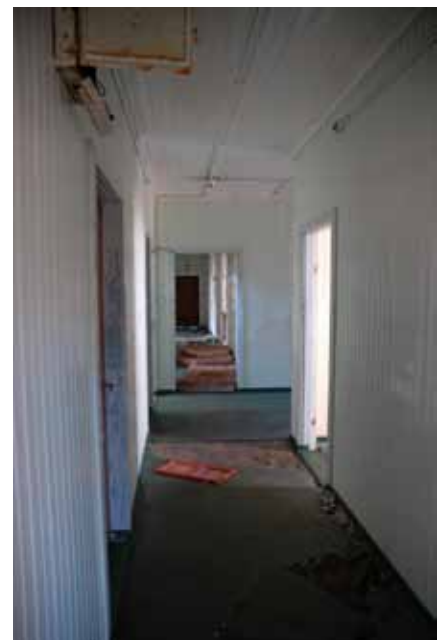
51.5 Ground floor central corridor looking northeast

Internally the building is lined with vertical timber boarding which in the rooms has been covered over with painted hardboard secured on with battens. The ceiling is also covered in hardboard. Internally the ground floor has suffered substantially from wet rot and has collapsed in several places. The staircase is in poor condition and the upper floor was not accessed.

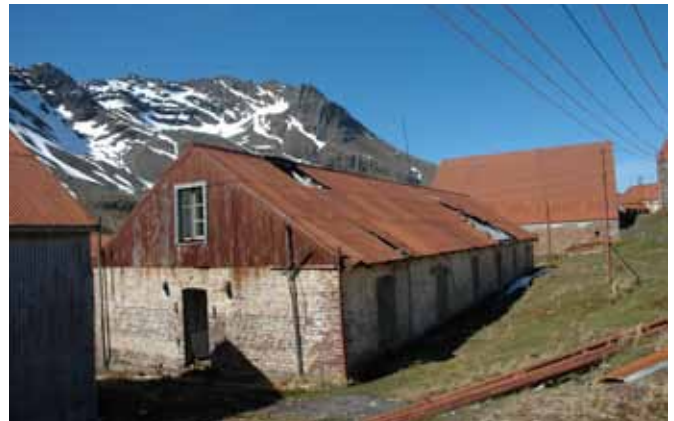
52.2 The northwest end of the D Barracks and southwest elevation

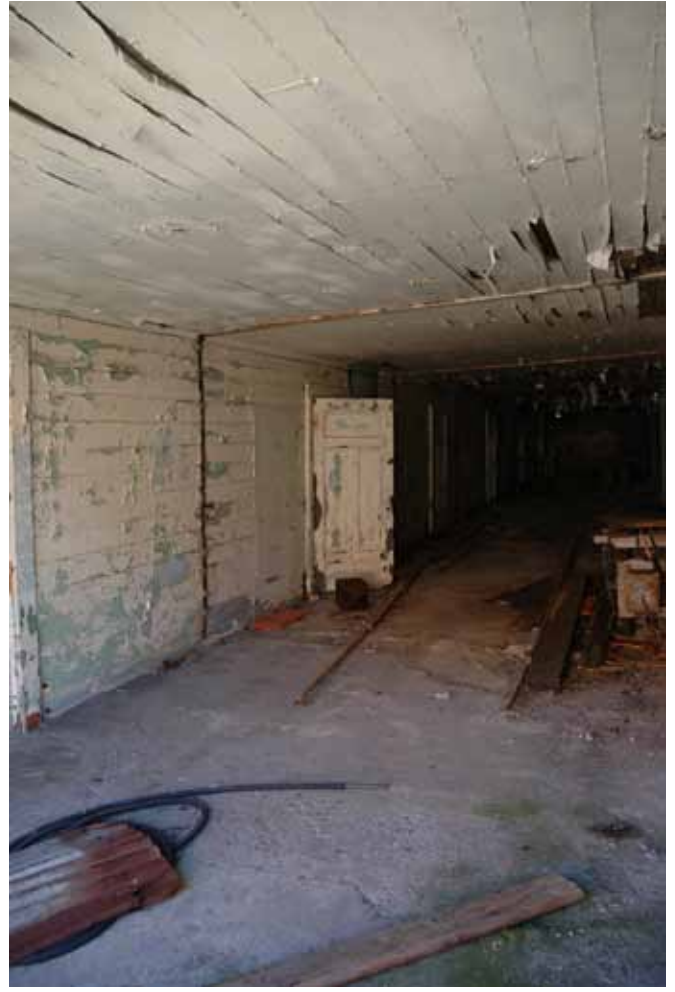
52.5 Ground floor storage area looking northwest

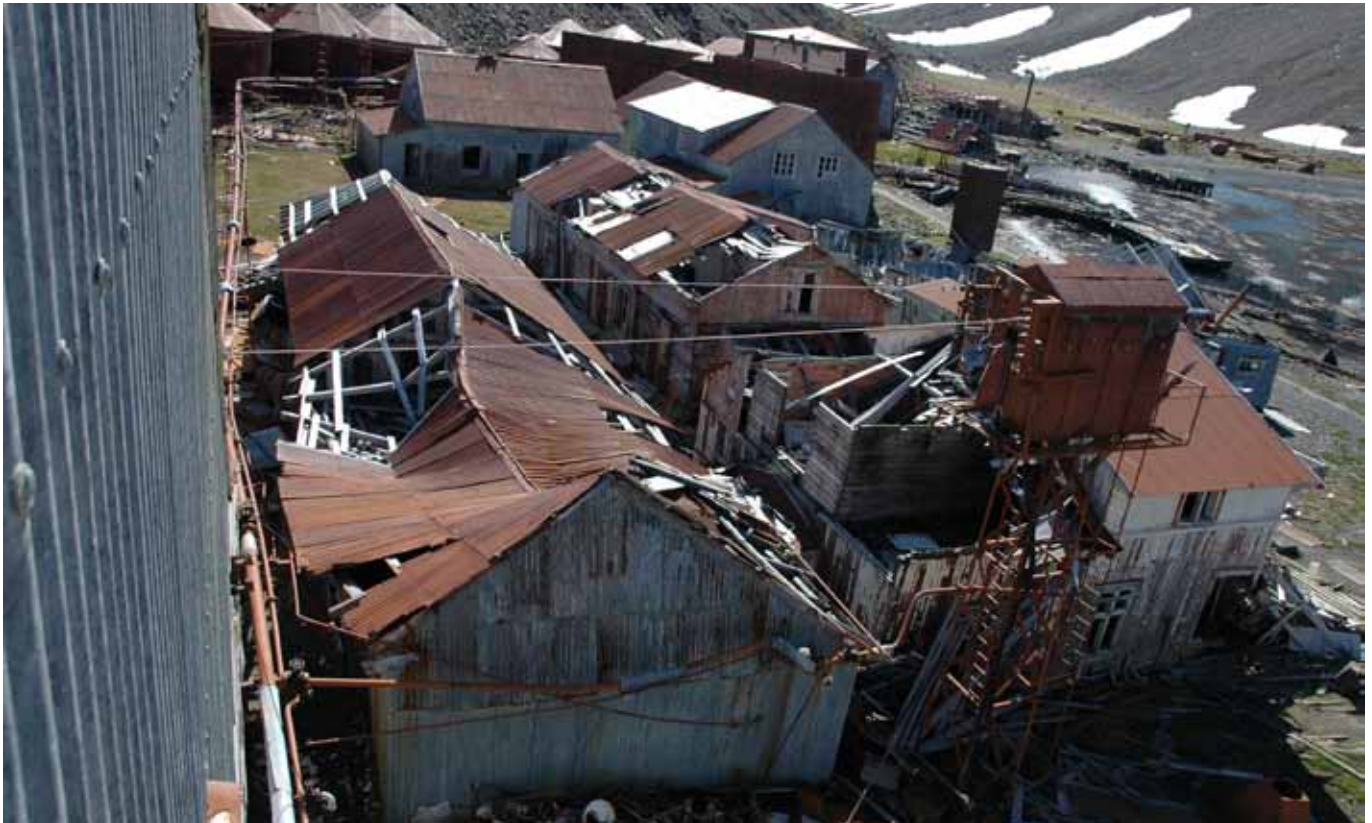
53.2 General view over the whole of the 'L' shaped building (taken from Stewards Store). The building contained by the 'L' is No. 64 the Provision Store.

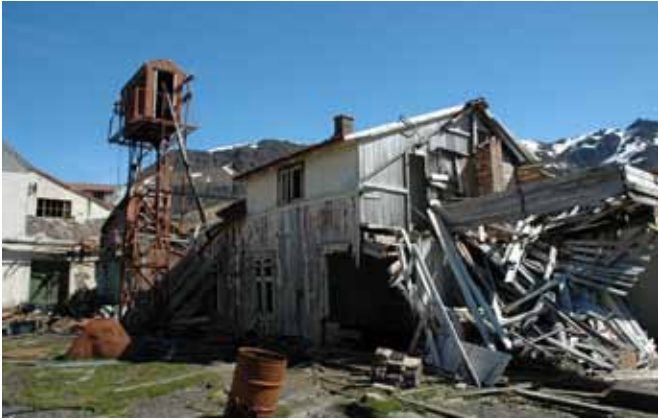
To the east of this is a long single storey which has a conventional timber frame and corrugated iron cladding to the walls and roof. The north end of this building has collapsed completely as has part of the southern end. The central section remains standing, just, but with walls leaning out and sheets missing from the roof. This building also appears to incorporate an earlier Norwegian style building which has been overlaid and had a passage added to give dry access to the various rooms, the passage being on the east side. This building is now in a state of near collapse.

53.3 The northeast wing showing the southeast and northeast elevations

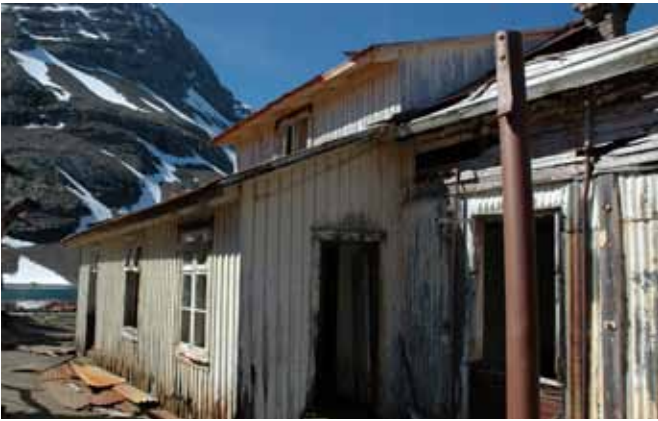
53.4 The northwest elevation of the northeast wing

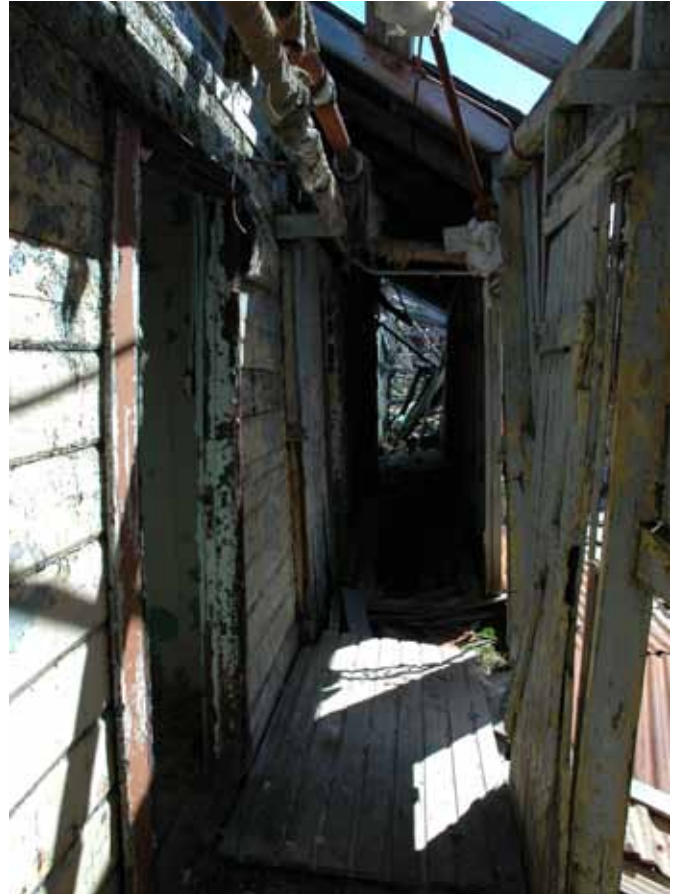
53.5 The added passage on the northeast side of the main wing

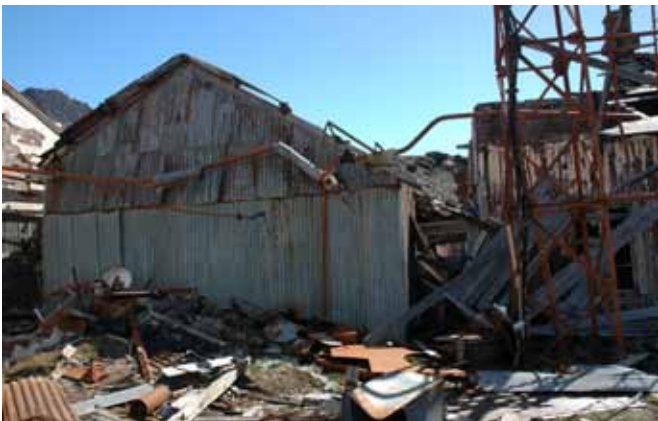
53.6 The southeast elevation of the main wing

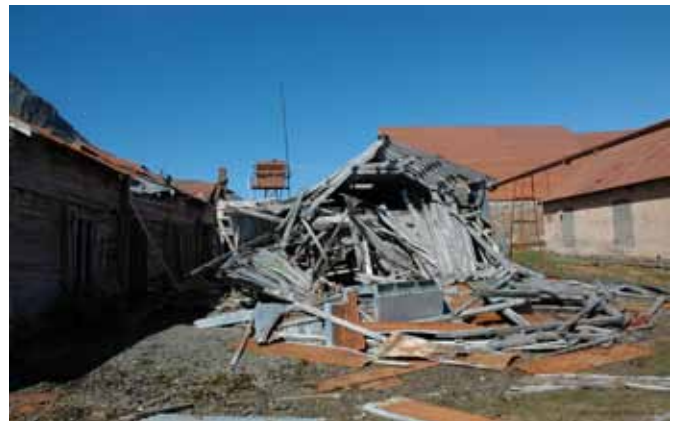
53.7 The collapsed northwest end of the main (northwest-southeast) wing

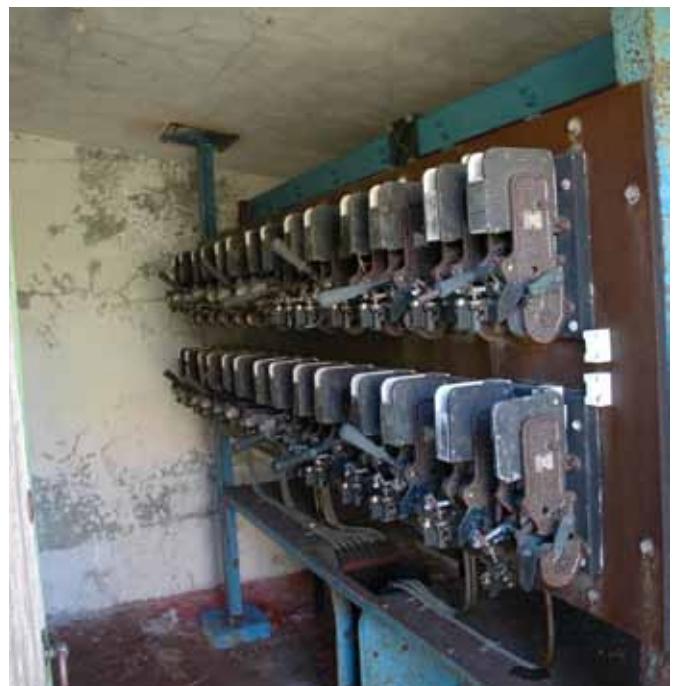
55.3 The remaining switchgear

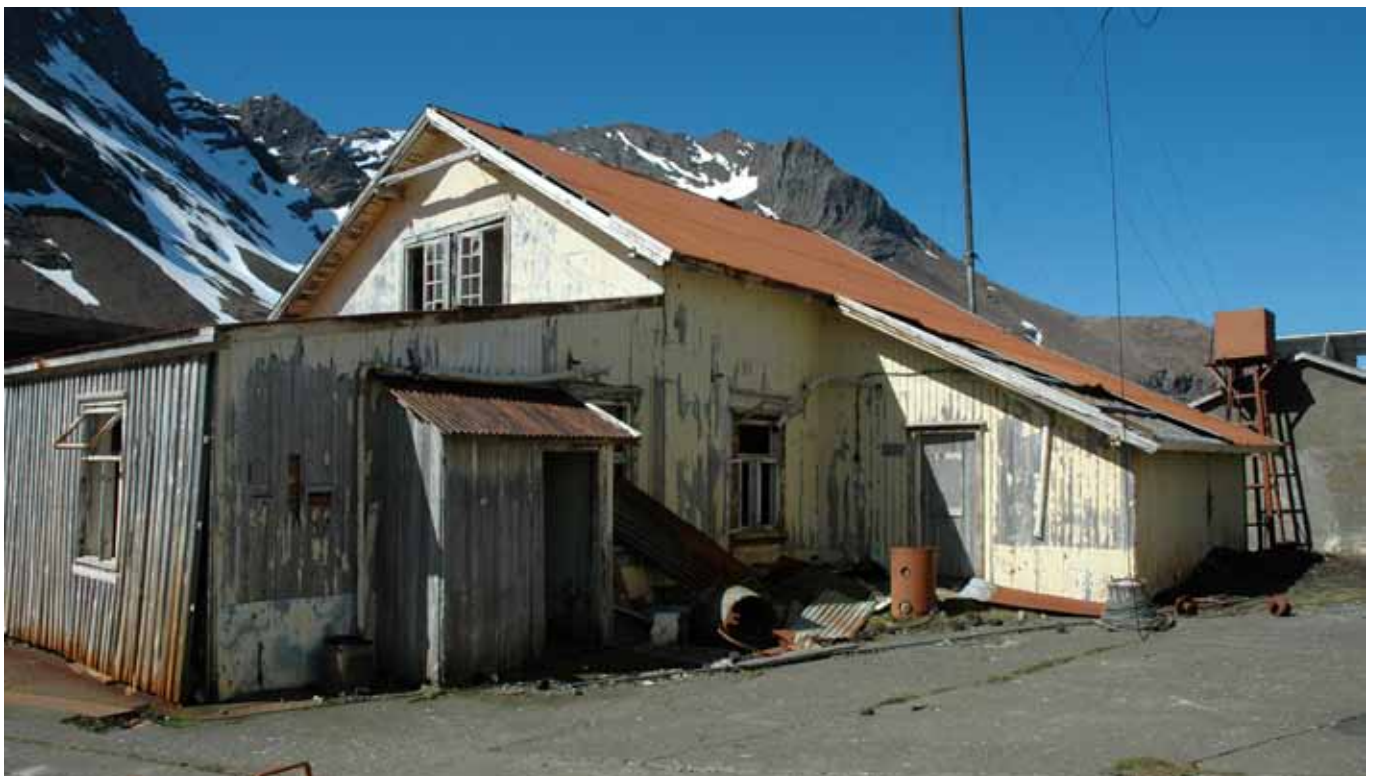
The construction, as far as can be seen, appears to be boarding on felt on a stud frame with boarding internally which has been lined out with hardboard. The low level roofs are generally in reasonable order although a section of corrugated sheet is tearing away on the east lower slope. The upper roof is in poorer condition. There are two dormers facing eastwards, which have lost their sheeting and boarding from the side and the casements have blown in.

59.3 The southwest corner of the Manager's House

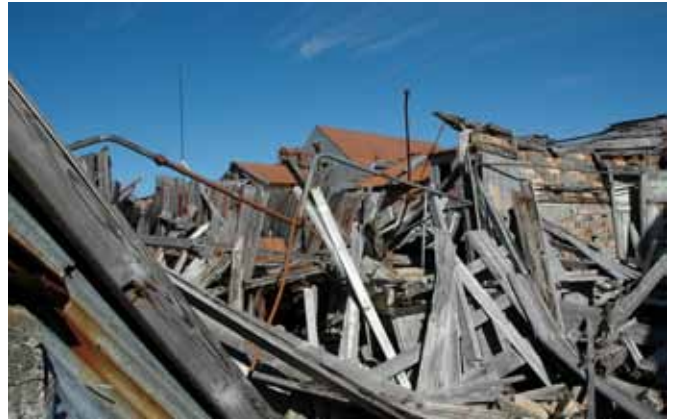
Again this is really two distinct buildings. The mess to the south is a timber framed building with timber roof all clad externally in corrugated iron. The ceiling has now collapsed completely. This southern section of the building is in very poor condition.

63.1 The central section where the fittings remain under the collapsed roof

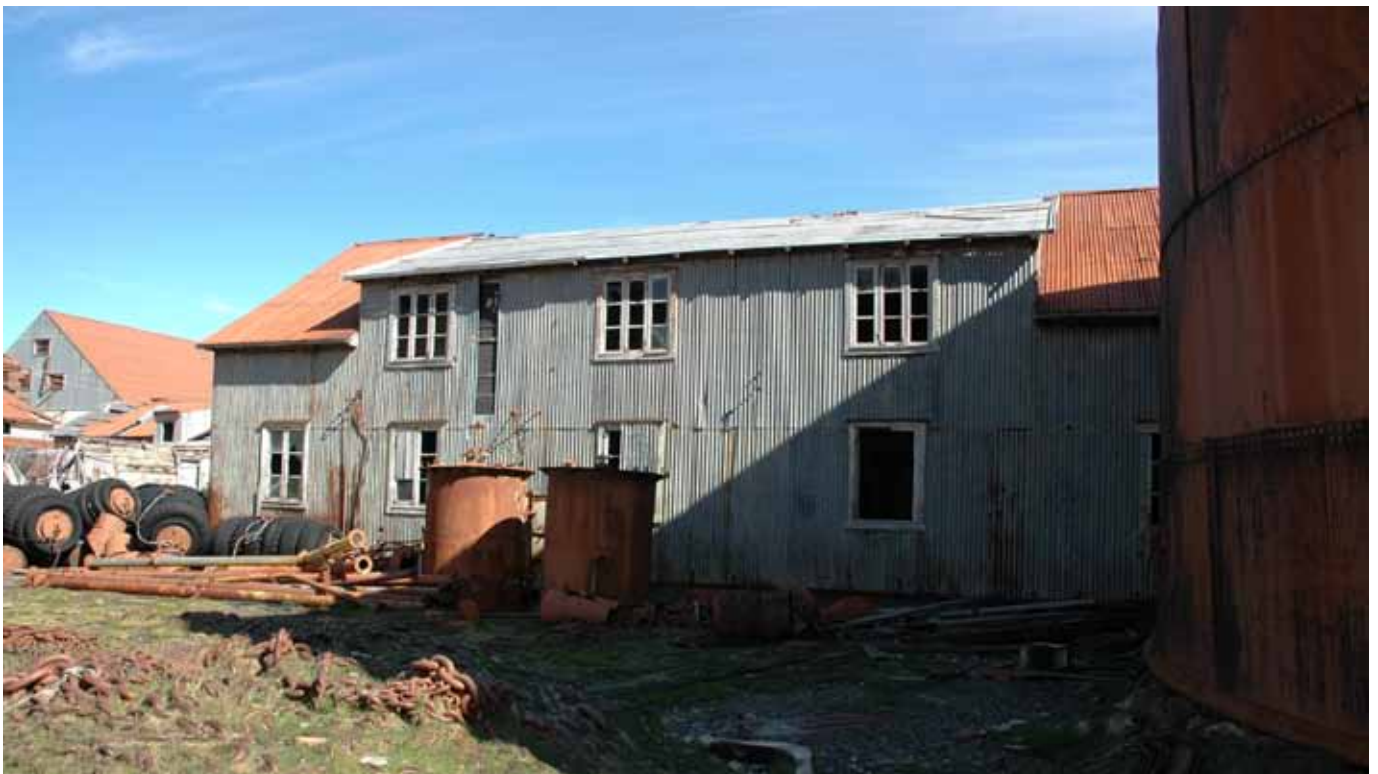
63.3 The east end of the north elevation

At the north end the mess has been extended by adding a lean-to and cutting out the end wall. Externally the wall cladding is in reasonable condition, timber windows remain though with no glass and some broken casements. The corrugated iron roof is missing over the dormer sections on both sides.

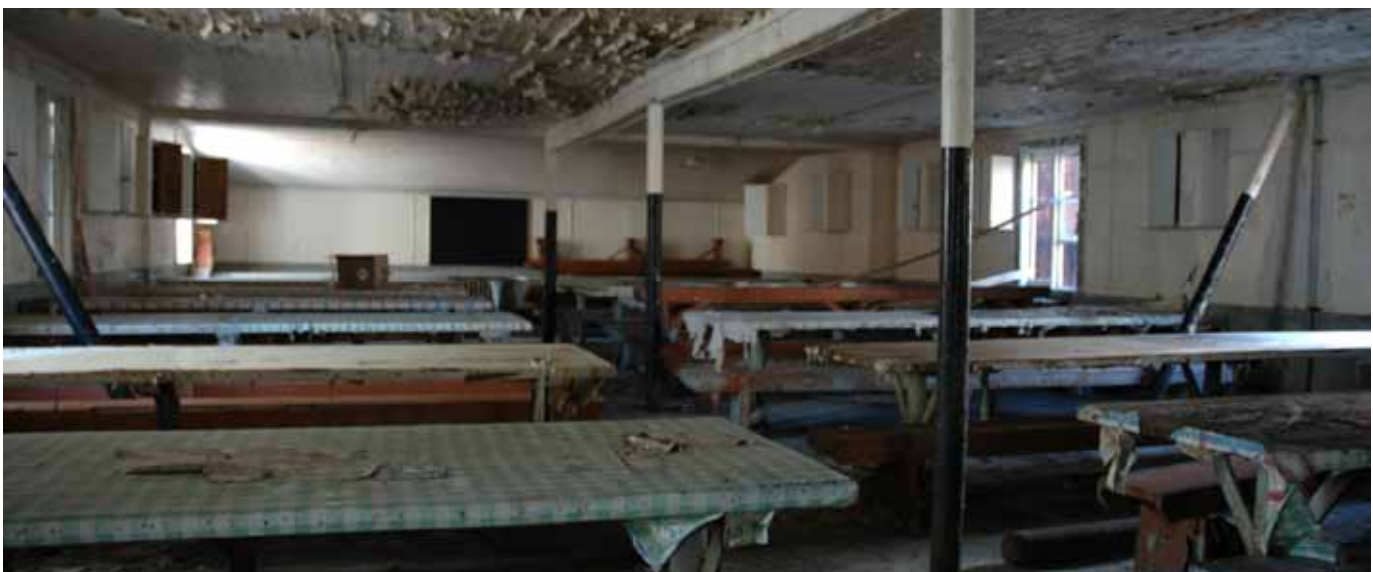
The lower floor mess room is still intact. There are curious diagonal stiffeners on the walls and a central beam on steel columns supports the first floor. This central beam is now sagging to a considerable extent. This may well be the result of converting individual units of accommodation with a central passage into open mess room.

63.6 The interior of the Main Mess in the west end of the building

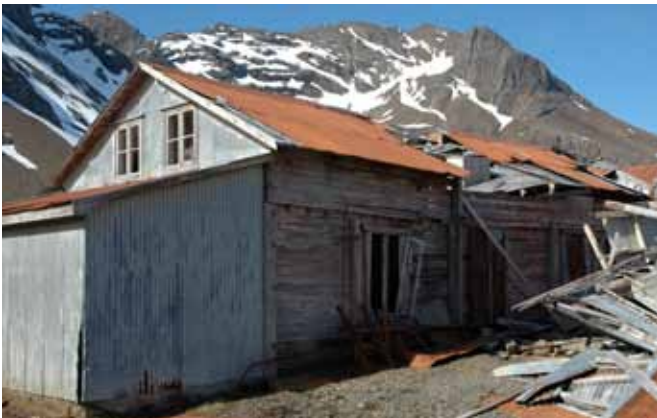
The building is now in a state of near collapse. The whole of the central section of the roof has collapsed and the standing section has a fractured main beam which is on the point of collapse and is starting to fall in at the south end. It seems likely that this building has been in a poor state for a long time as there is clear evidence of previous attempts to repair it, on at least two occasions, by adding external stiffeners bolted through the interior. This building is likely to collapse in the next few years.

64.1 The south side of the building looking east

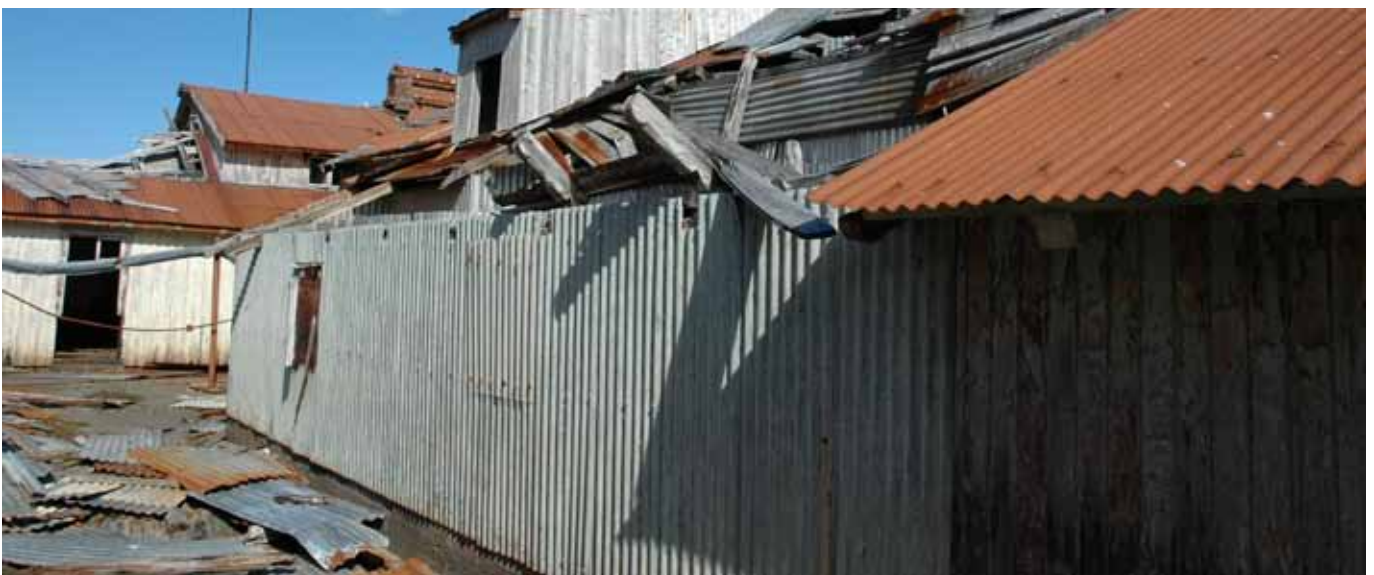
64.3 The north side of the building looking east

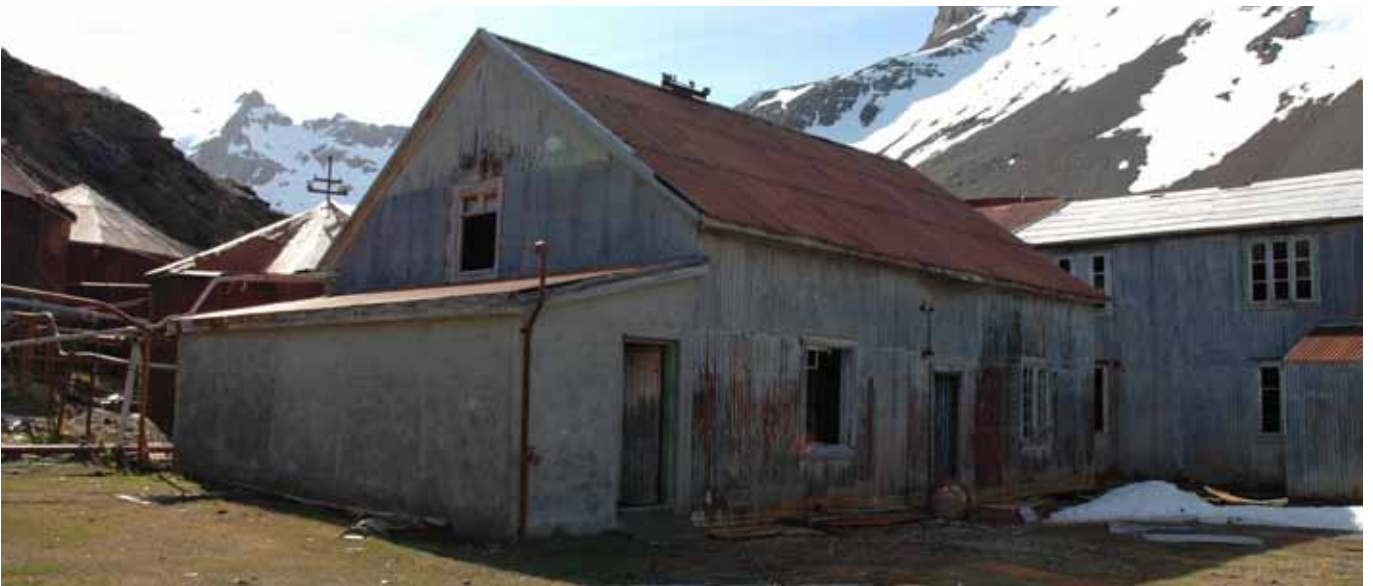
67.4 South and east elevations

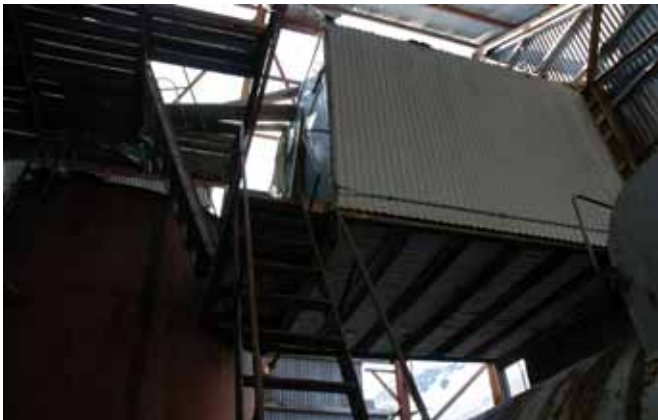
68.1 The steel stair and high level enclosed space

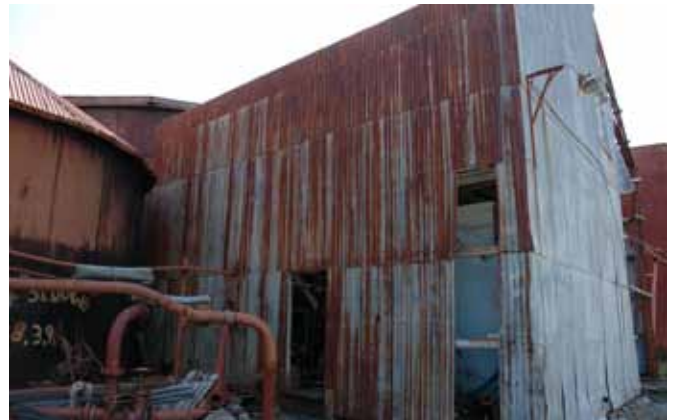
68.2 The southwest and southeast elevations

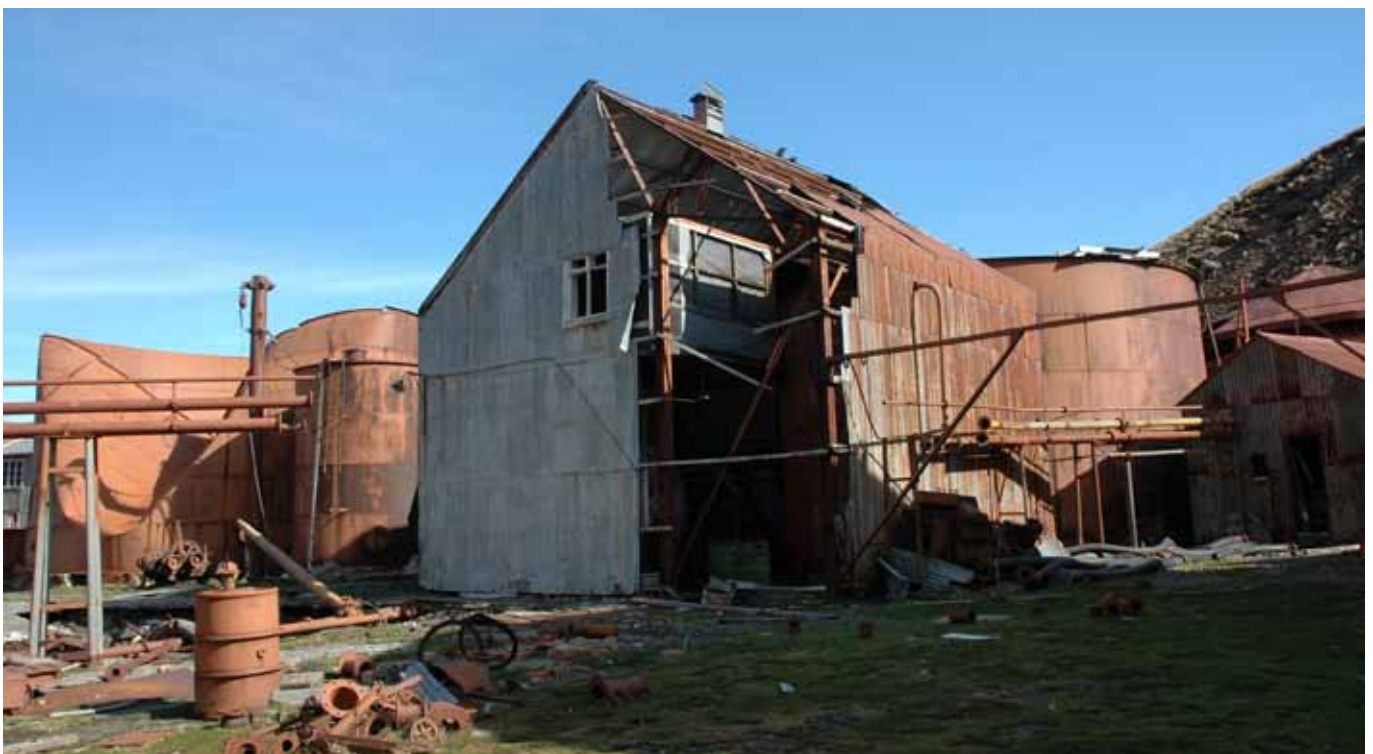
Two storey framed building has steel channels used as columns and trussed construction with steel angles used as purlins and timber sheeting rails to the walls. The building is clad externally in corrugated iron, the northeast corner of this has blown out completely. The corrugated remains on the south side of the roof but on the north side about 70 percent of the sheeting has disappeared. Internally there is a large vertical tank and one horizontal tank together with two remaining pumps. At first floor level there is an enclosed building reached by an iron companion stair. There is an access platform at the top level of the tank – presumably the building is an office or control room of some sort. The steel frame appears to be sound, but the remaining sheeting is likely to blow off in the next few years.

68.3 The northeast corner of the building
