DISUSED WHALING STATIONS

Leith Harbour Gazetteer

Gazetteer, July 2011

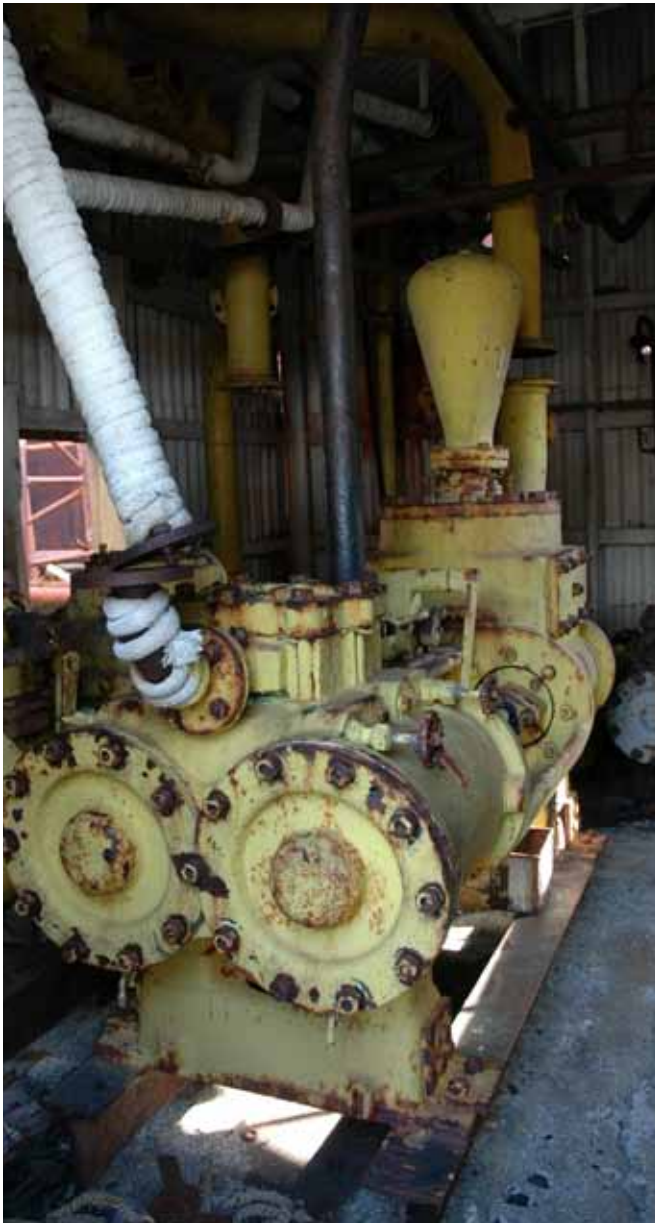
69.2 Detail of one of the pumps

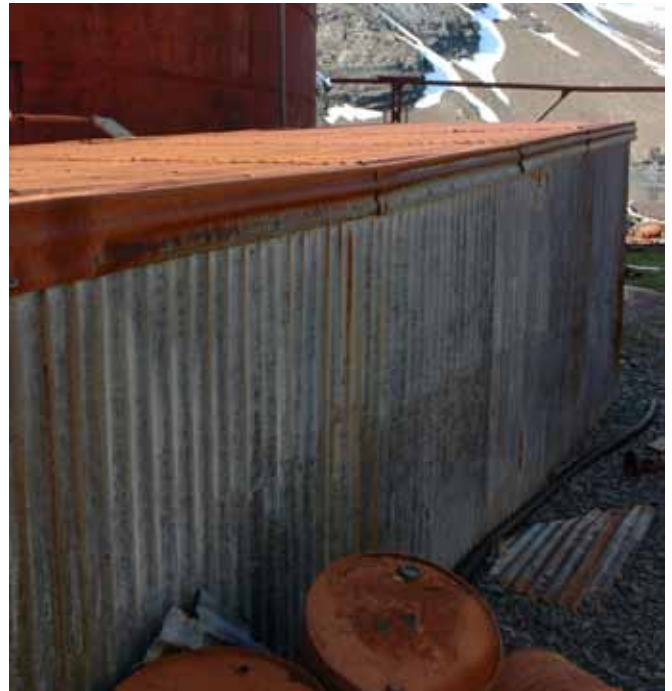
70.1 The south wall of the Hose Store looking eastwards

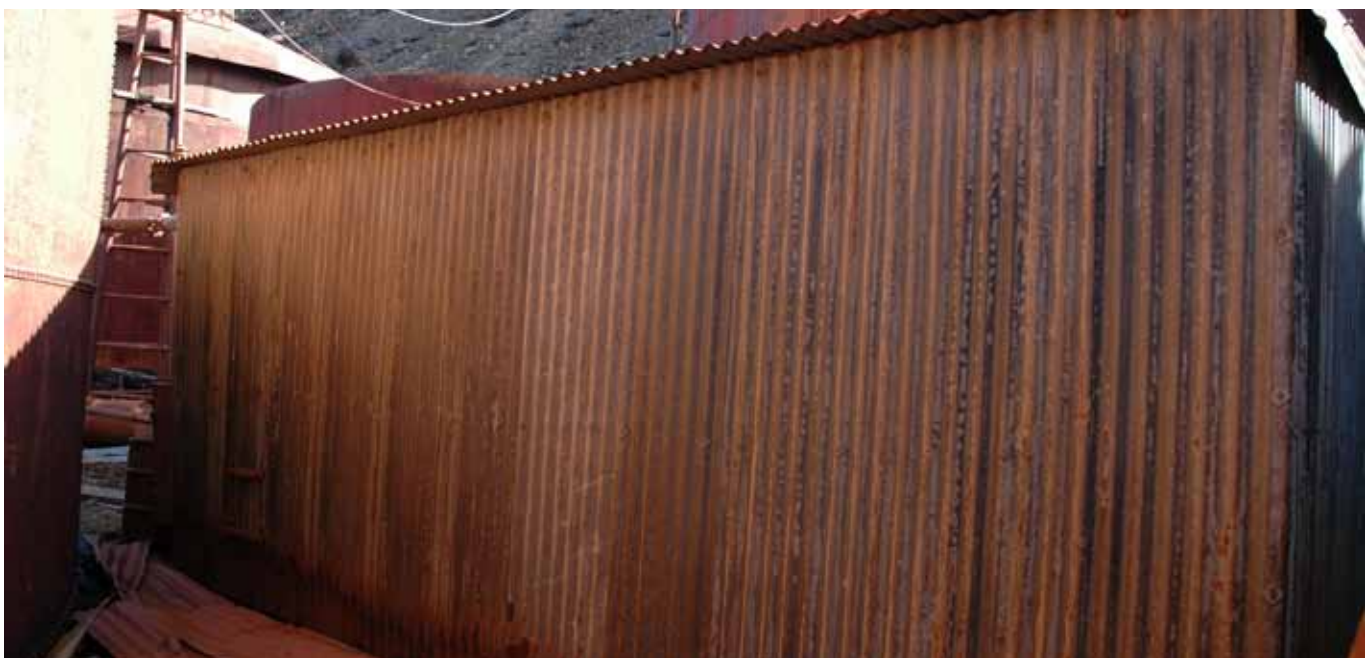
This appears to be the small building to the south of Store no. 1 (though the identification is not that clear). This is a small timber framed shed with a mono-pitched roof falling to the south. Access is on both the west and east sides. Access to this building is blocked by a tangle of fallen metal at present.

71.1 The south wall of the Butterworth Store

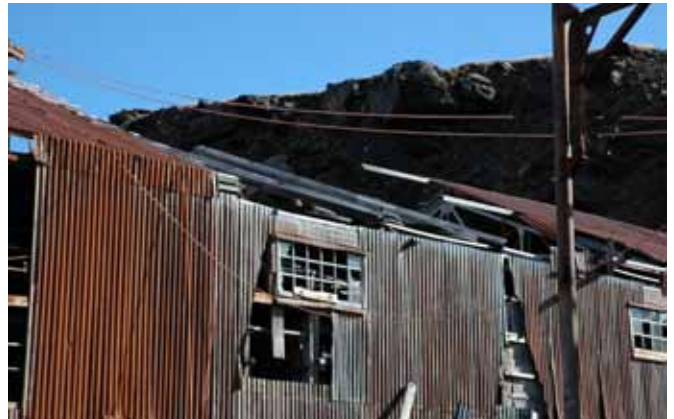
72.3 Detail of the north elevation

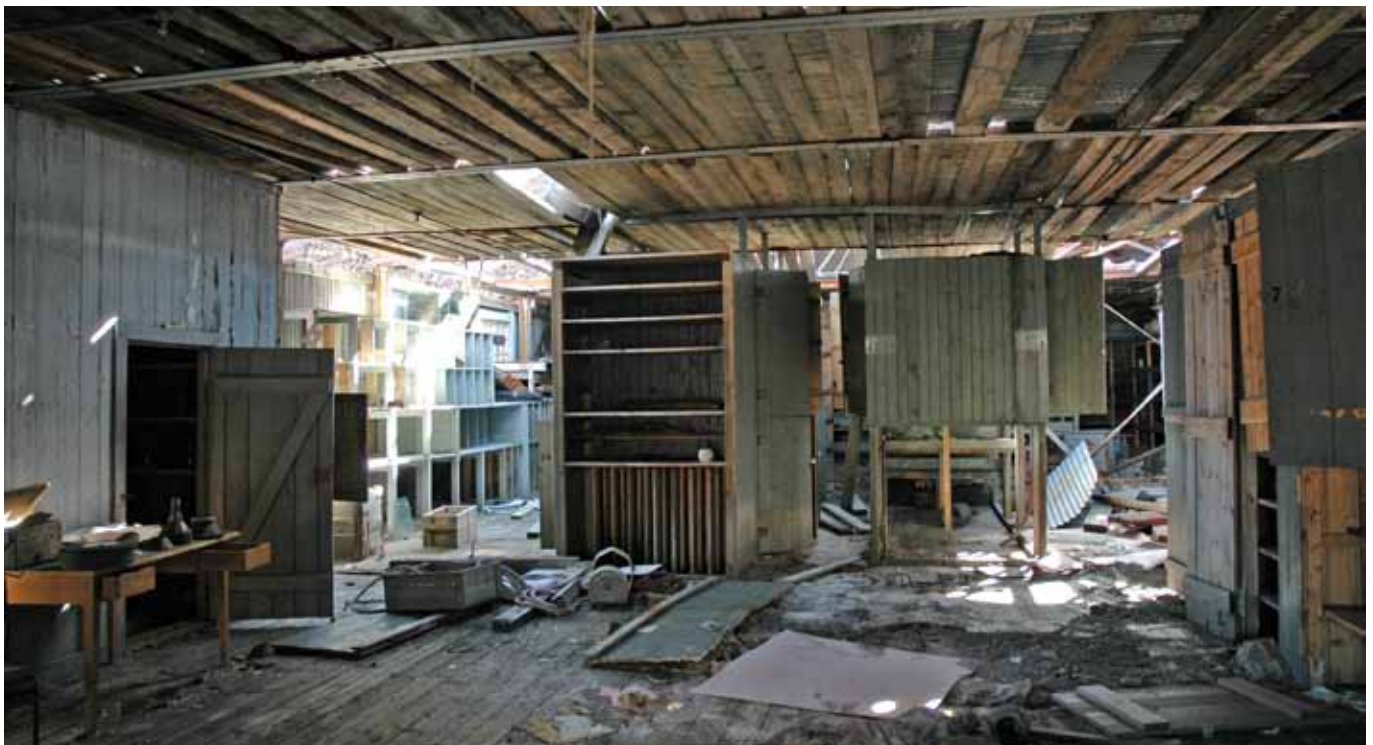
72.4 Ground floor storage area

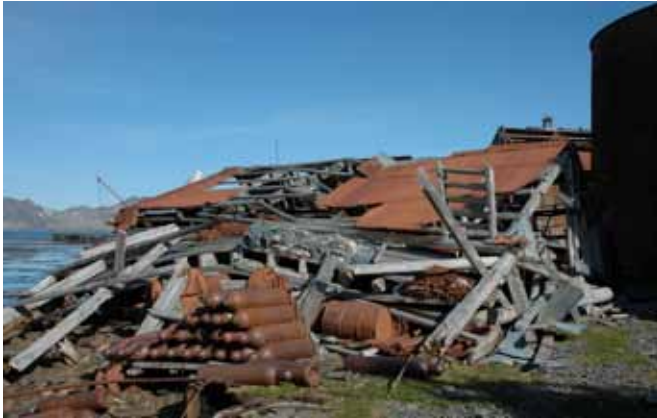
This building is right on the edge of the sea and has collapsed southwards with the south wall completely destroyed. The roof trusses are still there at present but the building is a muddle and likely to continue its collapse over the next few years.

73.1 The collapsed building seen from the north

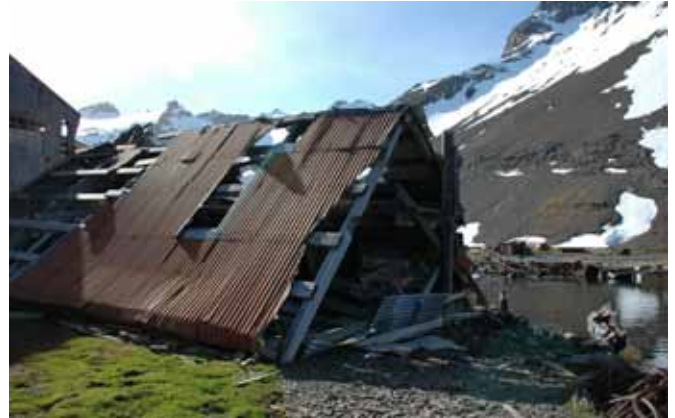
73.2 The east end of the roof

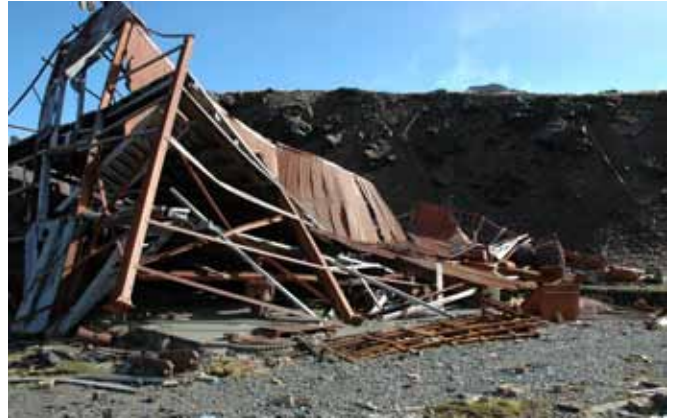
This was a substantial steel framed building but it has entirely collapsed with only the front gable remaining more or less upright. There does not appear to be a great deal wrong with the steel frame but the holding down bolts are very inadequate and appear simply to have pulled out of the concrete in which they were located allowing the whole building to turn over.

74.2 The northeast corner where the stanchions have ripped out of the concrete

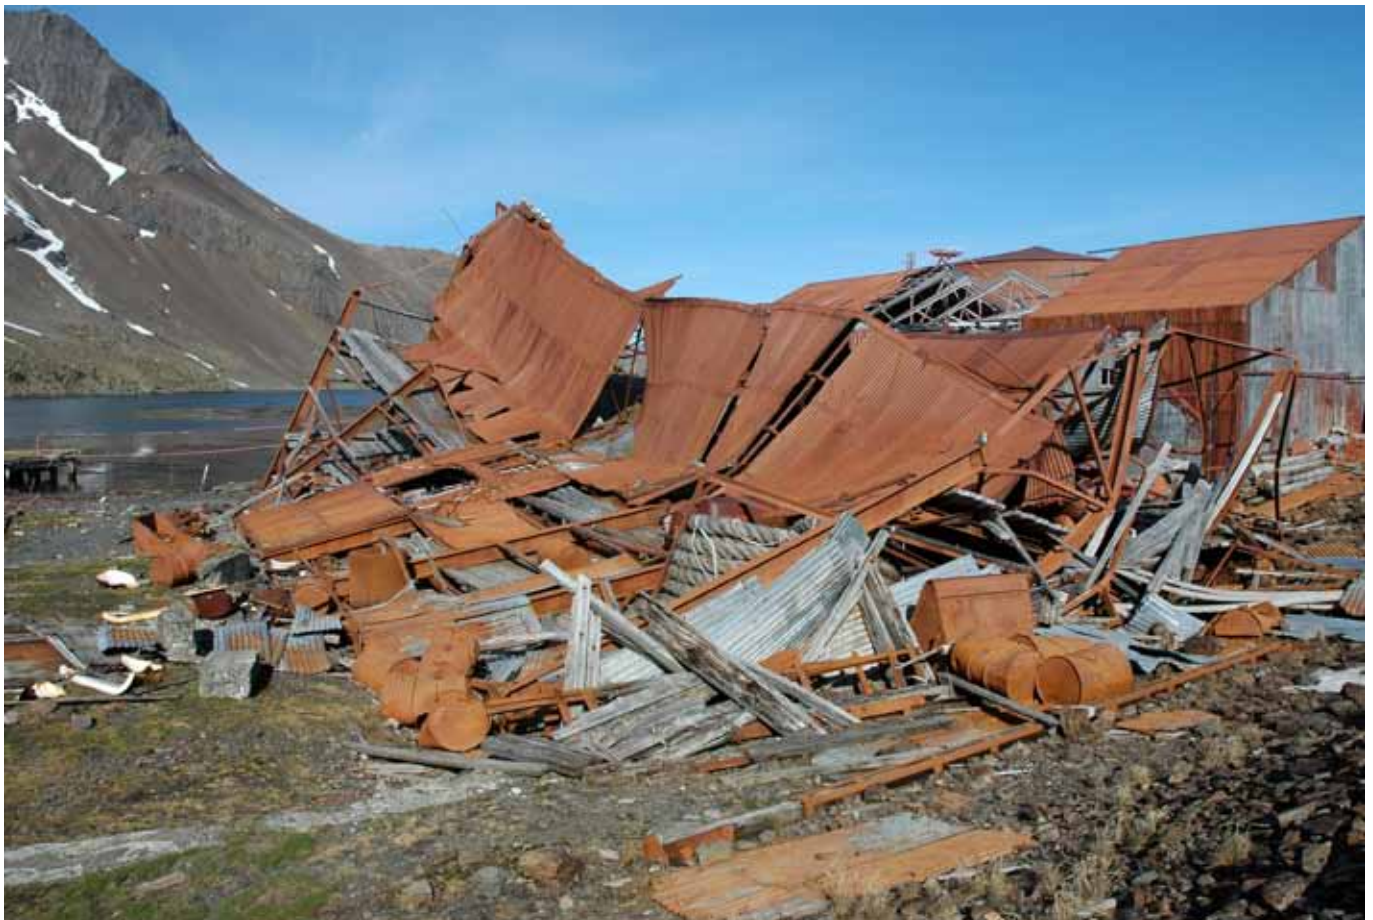
74.3 The west end of the building

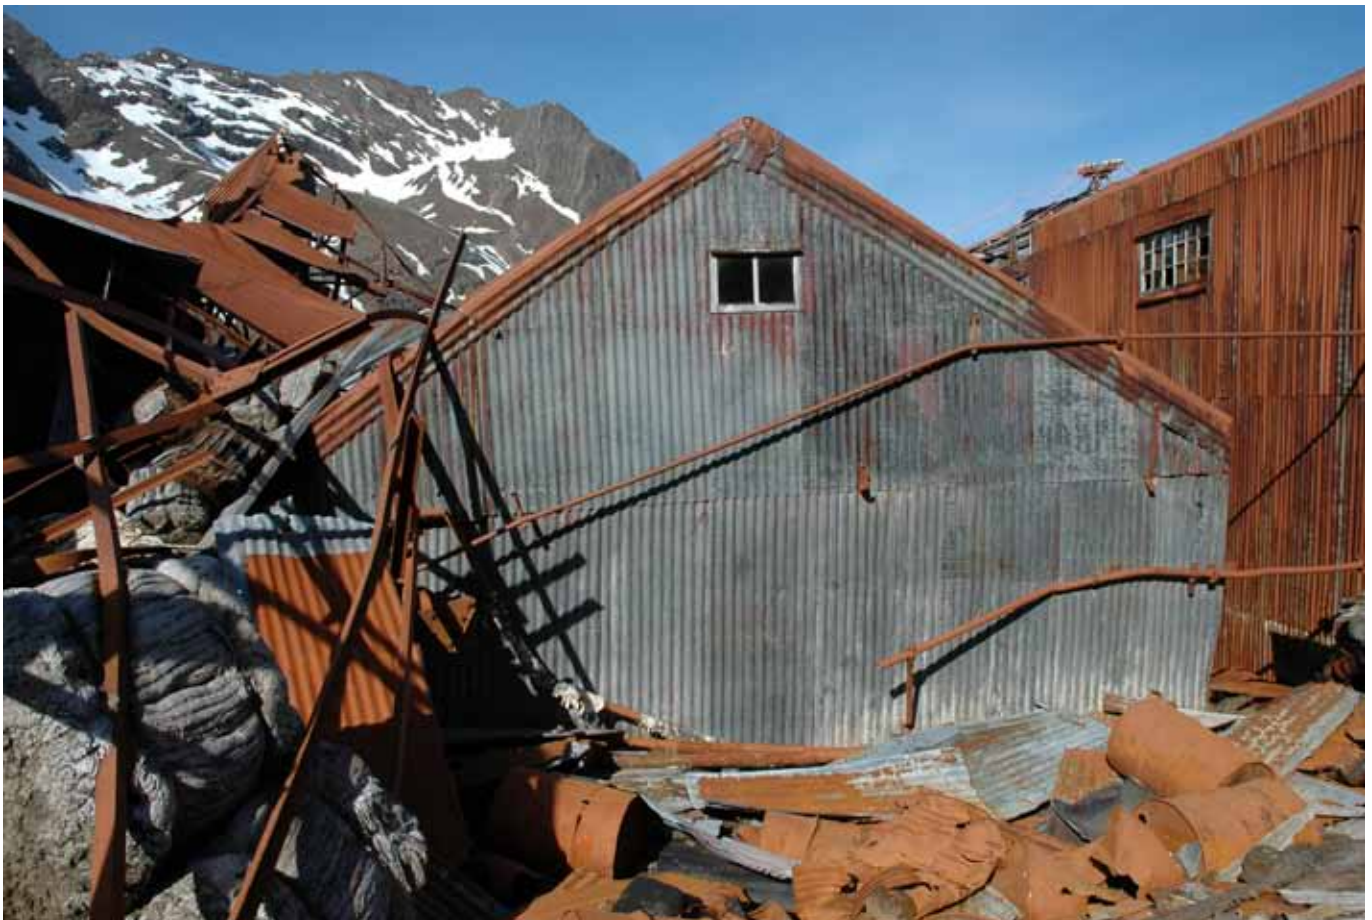
This is a single storey timber framed building clad in corrugated iron. The floor seems to have been fairly heavily propped and the upper area of the loft space has been used for storage with heavy 65mm thick timber boards between the floor joists. The building has more or less collapsed with only the west end wall and part of the west end roof remaining in position. At the east end of the building there is some collapsed reinforced concrete work, possibly part of an upper reinforced concrete floor or perhaps associated with the adjacent collapsed tanks supports.

75.1 The remaining west wall of the Paint Store

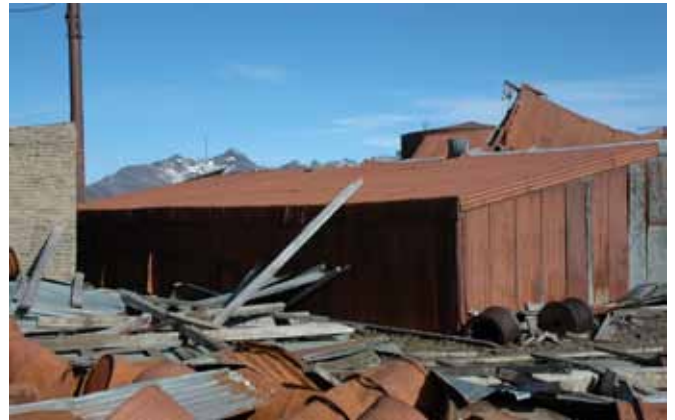
Only about 50 percent of this building remains and it is indeed still full of fire brick. The southernmost half has collapsed leaving only the timber floor and a jumble of timbers and corrugated sheet. The remaining section is a lean-to propped up on unsquared timbers with common rafters falling north which are propped in two rows. The corrugated iron of the end wall is still sound but the front edge is tearing up where the sheets of the opposing slope have been removed. These are likely to rip off in the not too distant future.

76.1 The north and west elevations

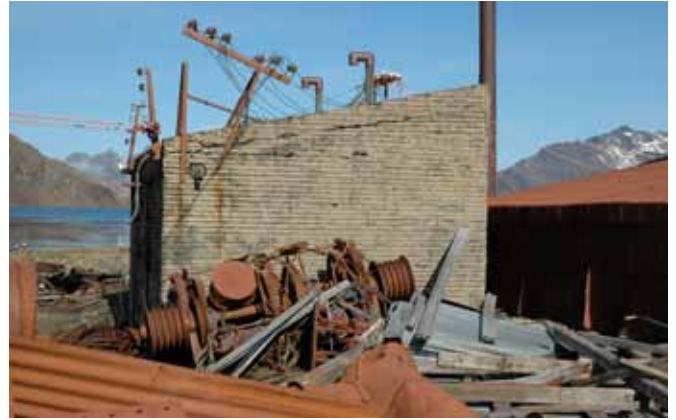
A concrete building with concrete slab roof with a generator. Internally the walls are of cast concrete with corrugated iron used for shuttering. The porch is made of brick and rendered and the doors are still on. The porch is tipping away from the main part of the building.

77.1 The west side of the Substation

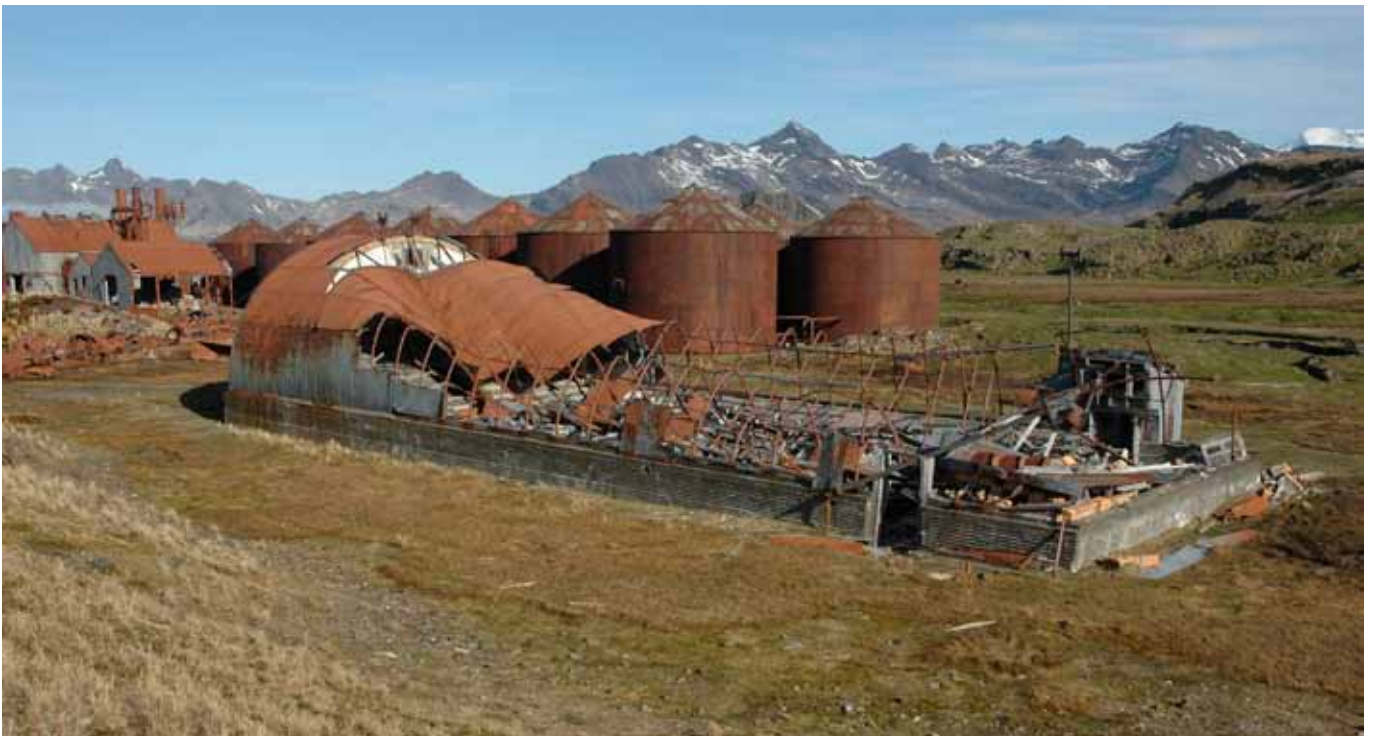
The Cinema has been in a state of collapse for many years. The building had a solid concrete floor and mass concrete walls approximately one metre high. Above this the construction is of curved corrugated iron sheets on a lightweight curved tubular steel frame. The appearance must have been that of a large Nissen hut but where a Nissen hut with its smaller space relies on the inherent strength of the curved corrugated sheeting, this would not have worked with a building of such a span. Given that the building seems to have collapsed inwards rather than to one side or the other the most likely explanation is excess loading by snow and ice.

80.2 General view of the remnant of the Cinema, the north and west sides

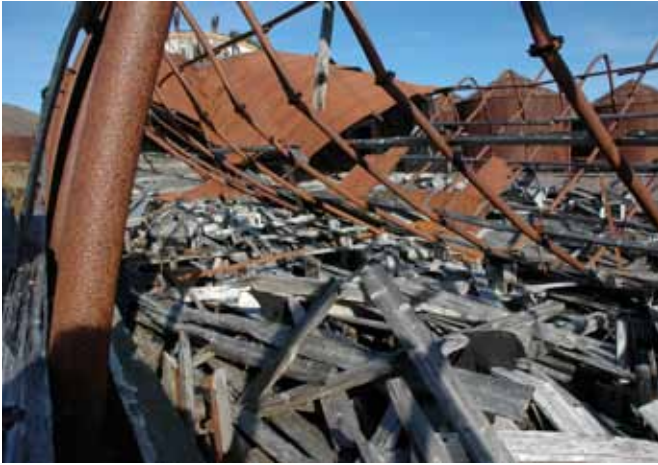
80.3 Looking eastwards along the north side of the building

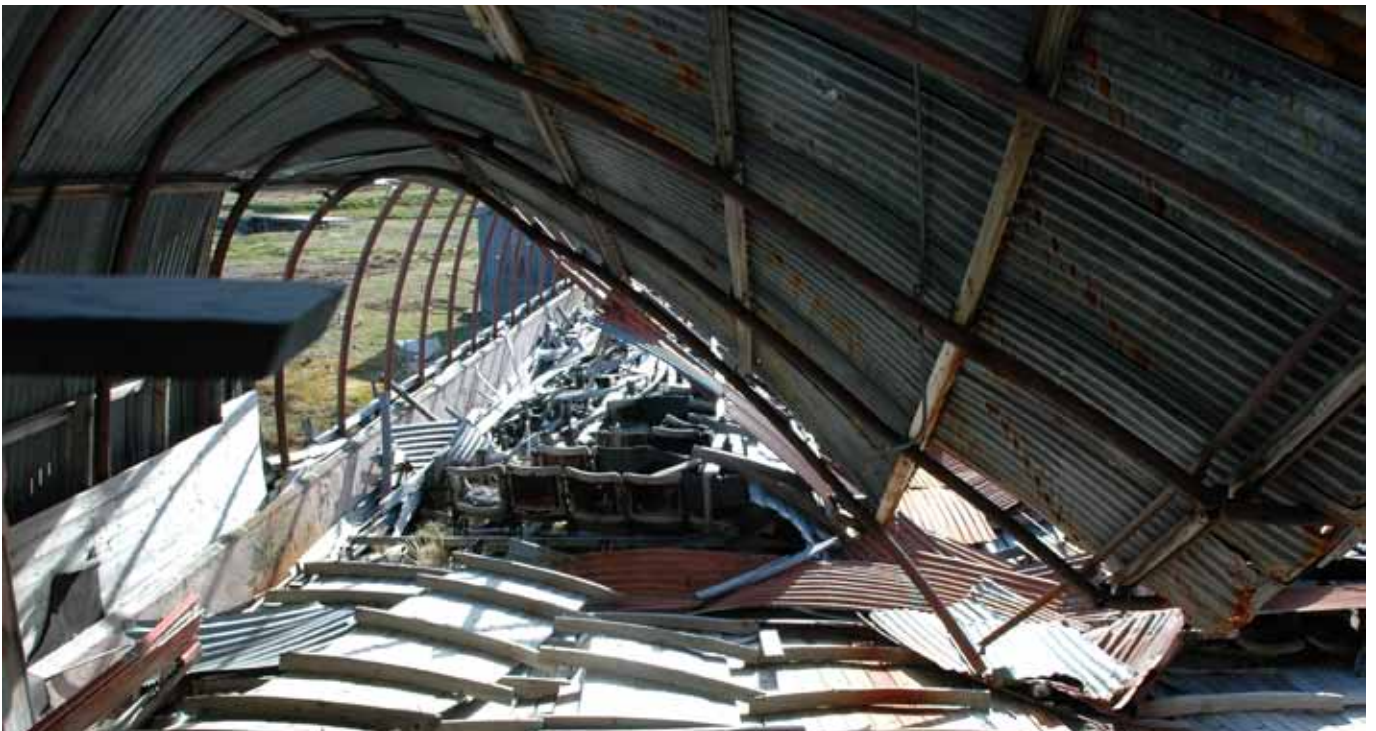
80.6 Looking west under the collapsed roof from the east end

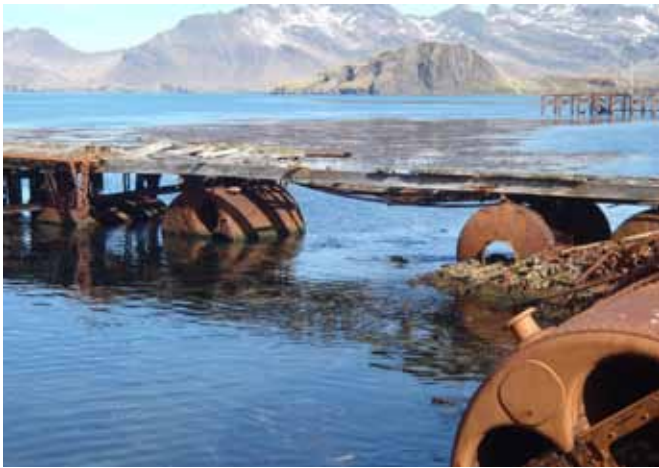
82.1 The connection to the shore at the west end of the Pier

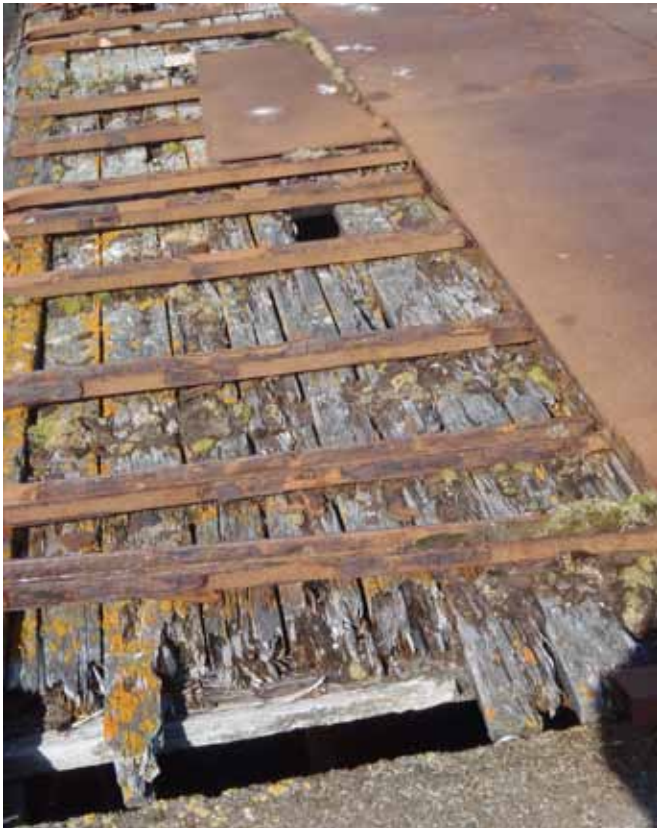
84.1 General condition of the deck

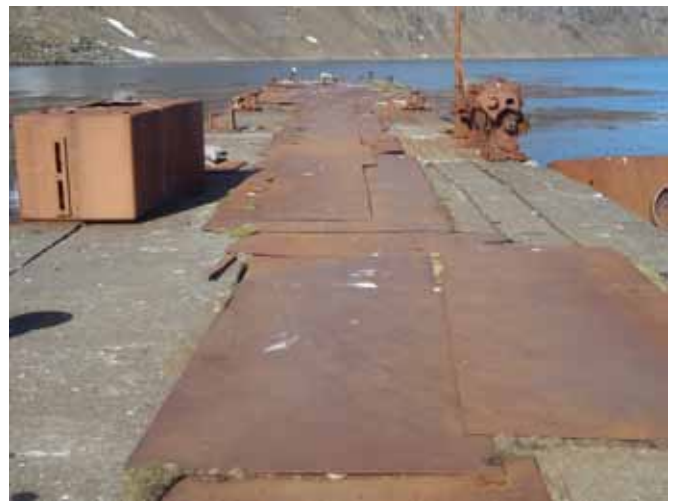
84.2 View along the Pier looking east
