# DISUSED WHALING STATIONS

**Prince Olav Harbour Gazetteer**

## Gazetteer, July 2011

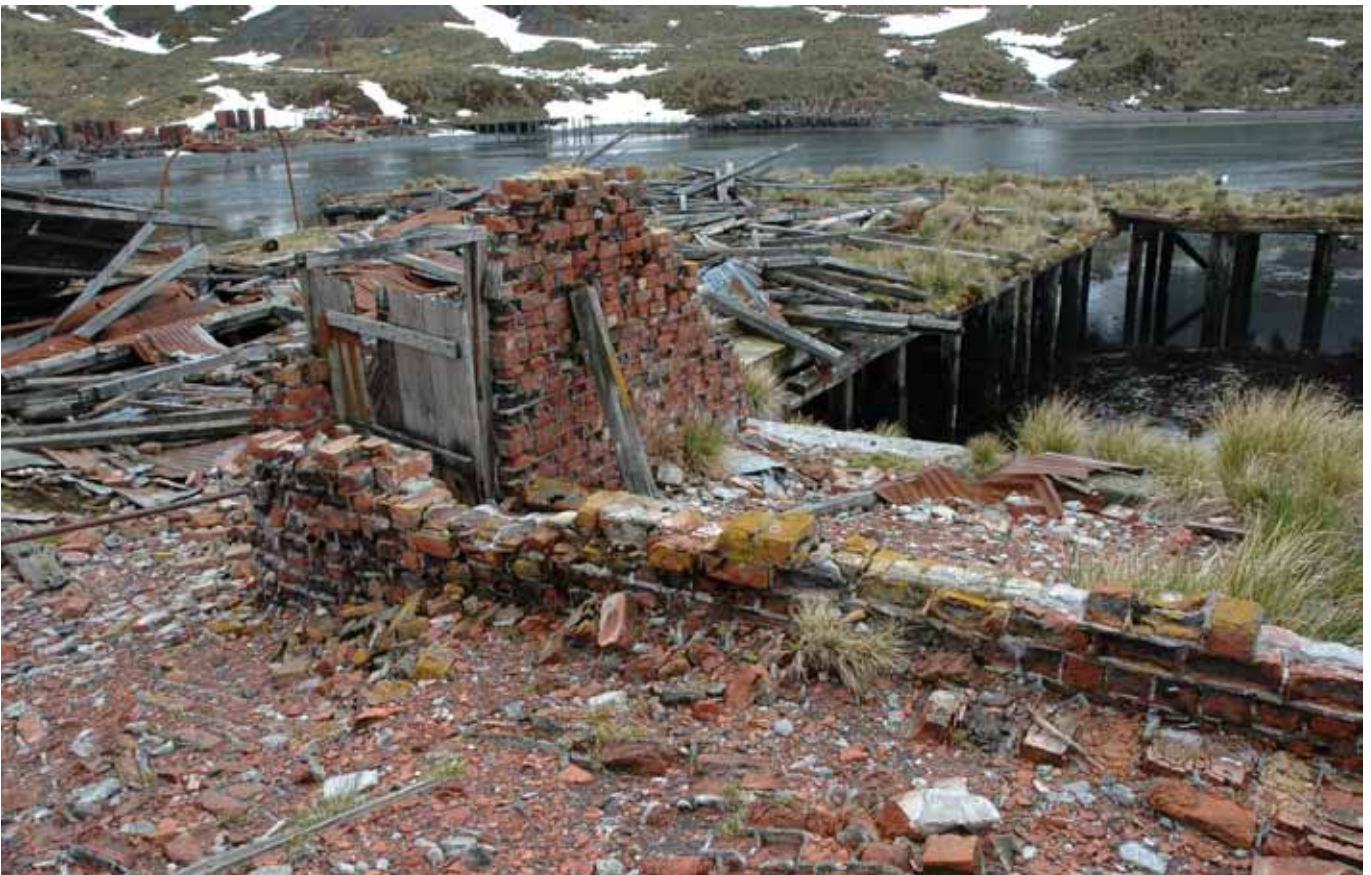
This has collapsed completely and only one small section of roof remains propped up, the remainder is a heap of timber and corrugated iron. Part of this was built on the jetty itself. The jetty is supported by substantial timber piles of approximately 250x250mm cross section. These are at roughly 2m centres with heavy cross timbers supporting secondary beams and then a timber deck of 75mm thick boards. The deck is now significantly decayed with grass growing out of it.

29.3 The Jetty can be seen beyond the Jetty Store. The brick remnant in the foreground may be part of the Boiler House (No. 30).
