DISUSED WHALING STATIONS

Stromness Harbour Gazetteer

Gazetteer, July 2011

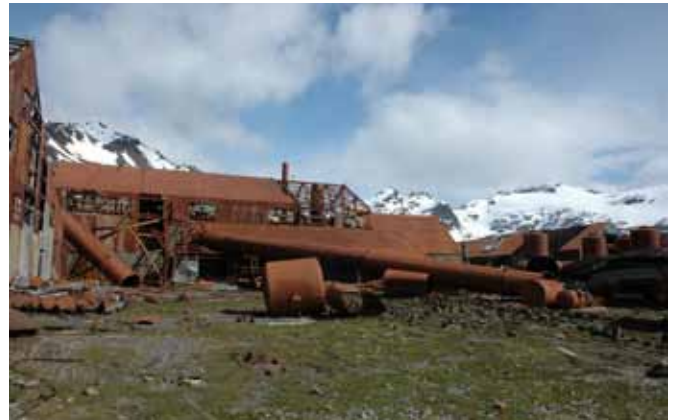
1.1 General view of the Plan looking west to the Boiler House

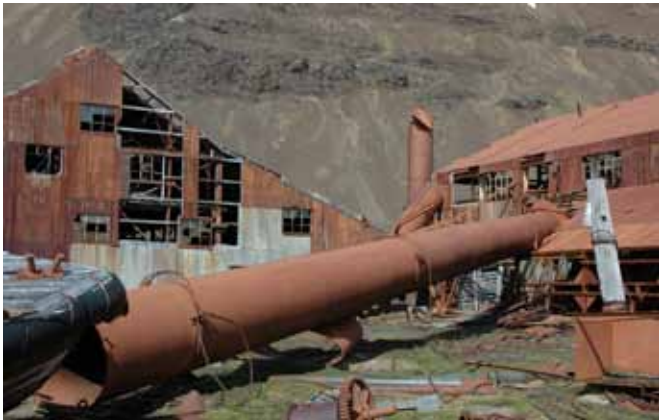
The winch house remains in position on the west side of the Plan with two winches still in place (although one of the boiler chimneys has fallen through the end of the building). There are several other winches in place around the Plan.

1.4 The fallen boiler chimney

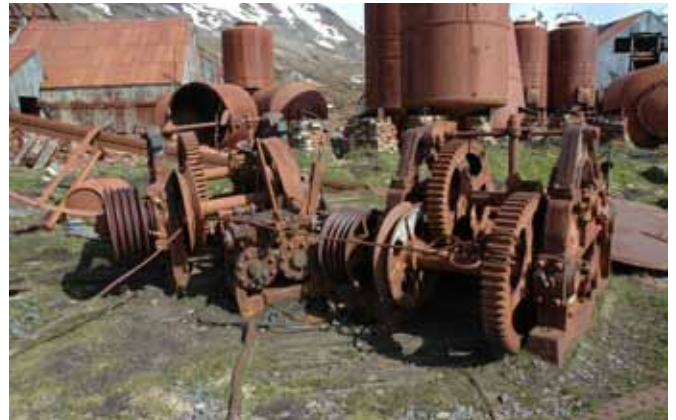
1.5 Winches on the north side of the Plan with the Meat Cookery in the background

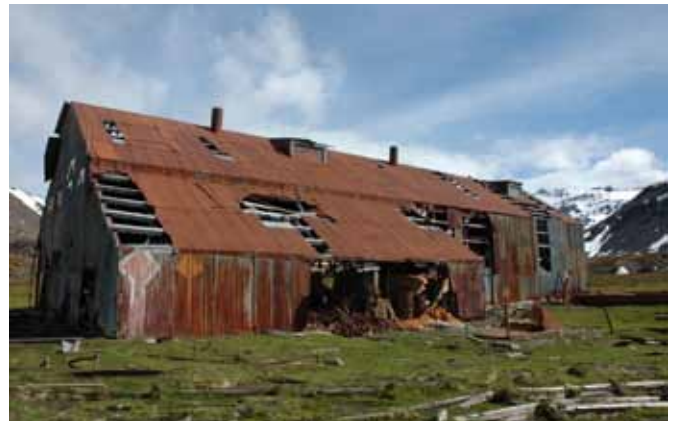
The steel frame looks to be solid enough but around 25% of the wall sheeting and 30% of the roof sheeting is now missing. The purlins and fixing rails are of timber and a good deal of the remaining sheeting is now at risk of wind damage.

4.1.2 The east elevation of the North Wing

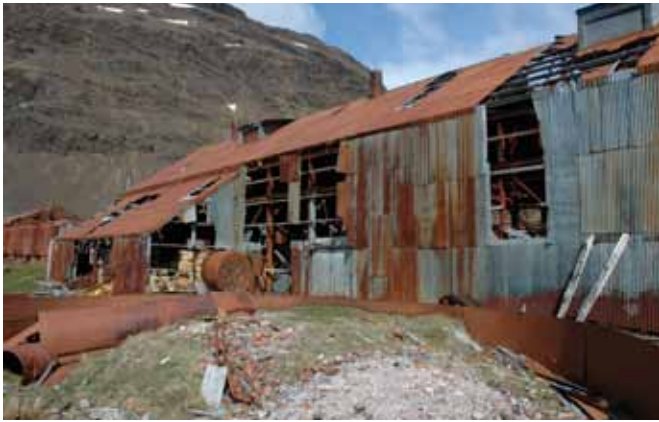
4.1.4 The east elevation of the North Wing

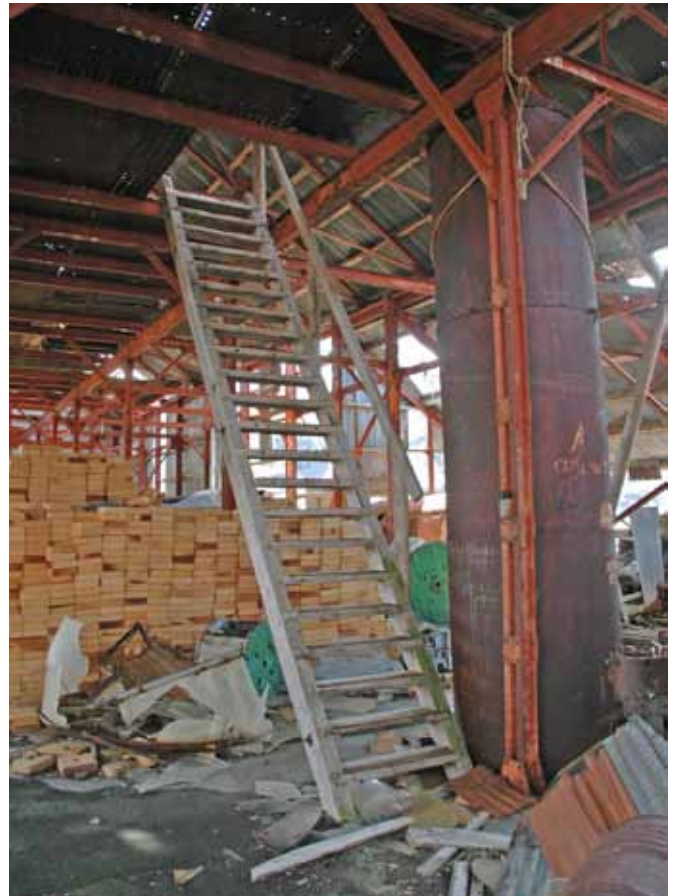
4.1.6 The stair to the upper deck

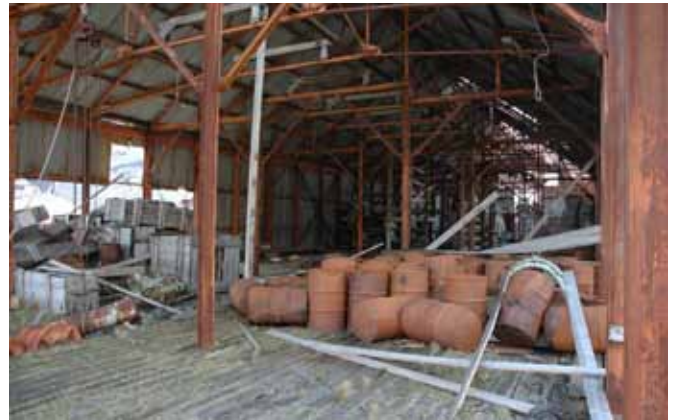
The building is constructed with a steel frame with columns to the walls at 2m centres and a trussed steel framed roof all covered in corrugated iron. Every third bay has a heavier column with a pair of props at quarter and three-quarters positions which support lifting beams and chain hoists. The sheeting rails and purlins are all steel and, at the time of inspection, approximately 40 percent of the wall sheeting had blown off and some 20 percent of the roof sheeting. The RSJs forming the columns have been cast into concrete footings set in old iron drums and there is a good deal of corrosion around some of the stanchions. The last use of this building was for storage.

4.3.1 Interior of the West Wing looking east from the west end

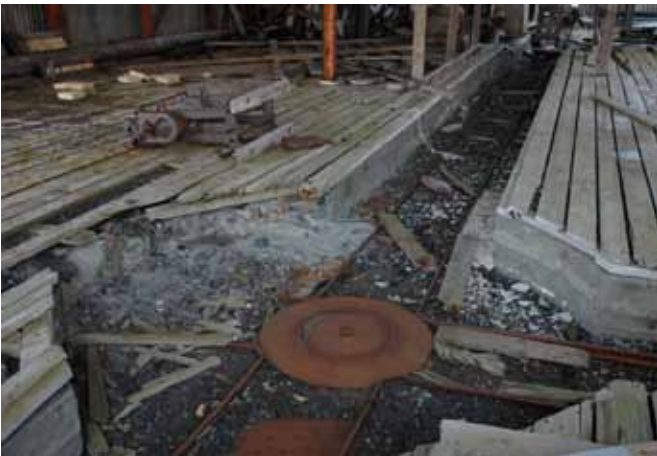
This would appear to be another large store. The building has a railway track running down the centre (east/west) set some 600mm below the general floor level with two north/south branches with turntables. This would be a convenient height for loading and unloading sacks.

4.3.4 The lowered railway track and turntable

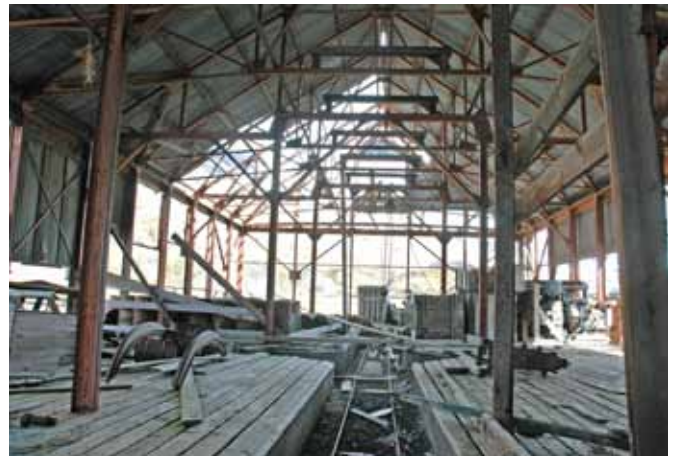
4.3.5 The interior looking west

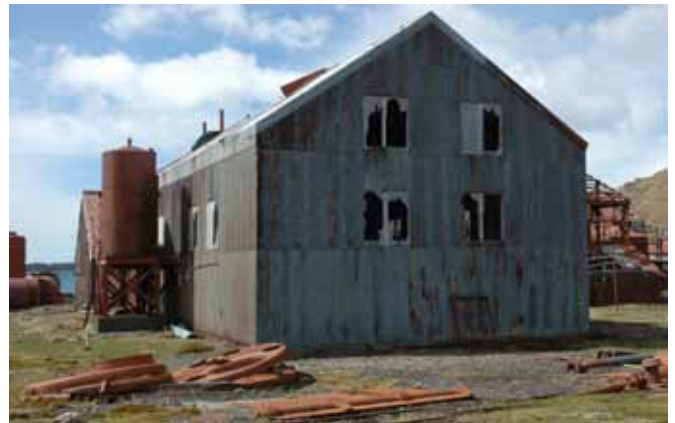
The north slope of the west wing roof has lost some 50 percent of its covering and sheets are now starting to come loose on the south slope.

5.1.2 West elevation of the West Wing

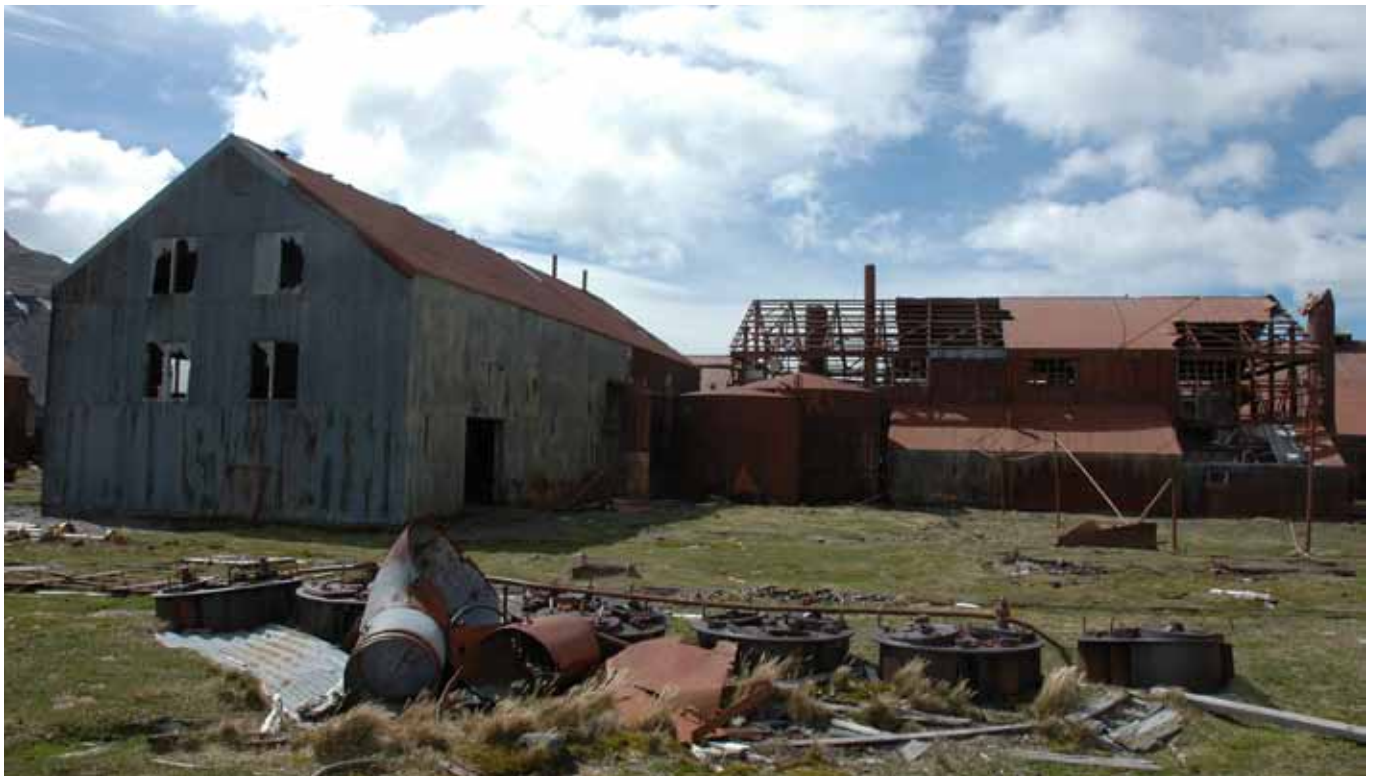
5.1.3 West and south elevations of the West Wing (the Power Station) with the Boiler House to the right

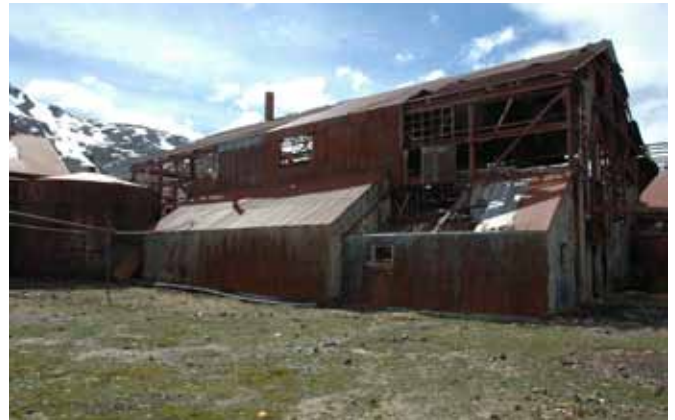
The boilers are in a building that has a steel frame and trussed steel roof. The walls have been filled in to approximately 4m high with brickwork with corrugated iron above. At high level there are some large cast iron windows – the frames remain but the glass has all disappeared. The corrugated iron cladding is missing entirely from the north wall and mostly from the south end of the building and around 80 percent of the roof sheeting is missing.

5.2.1 The west elevation of the Boiler House

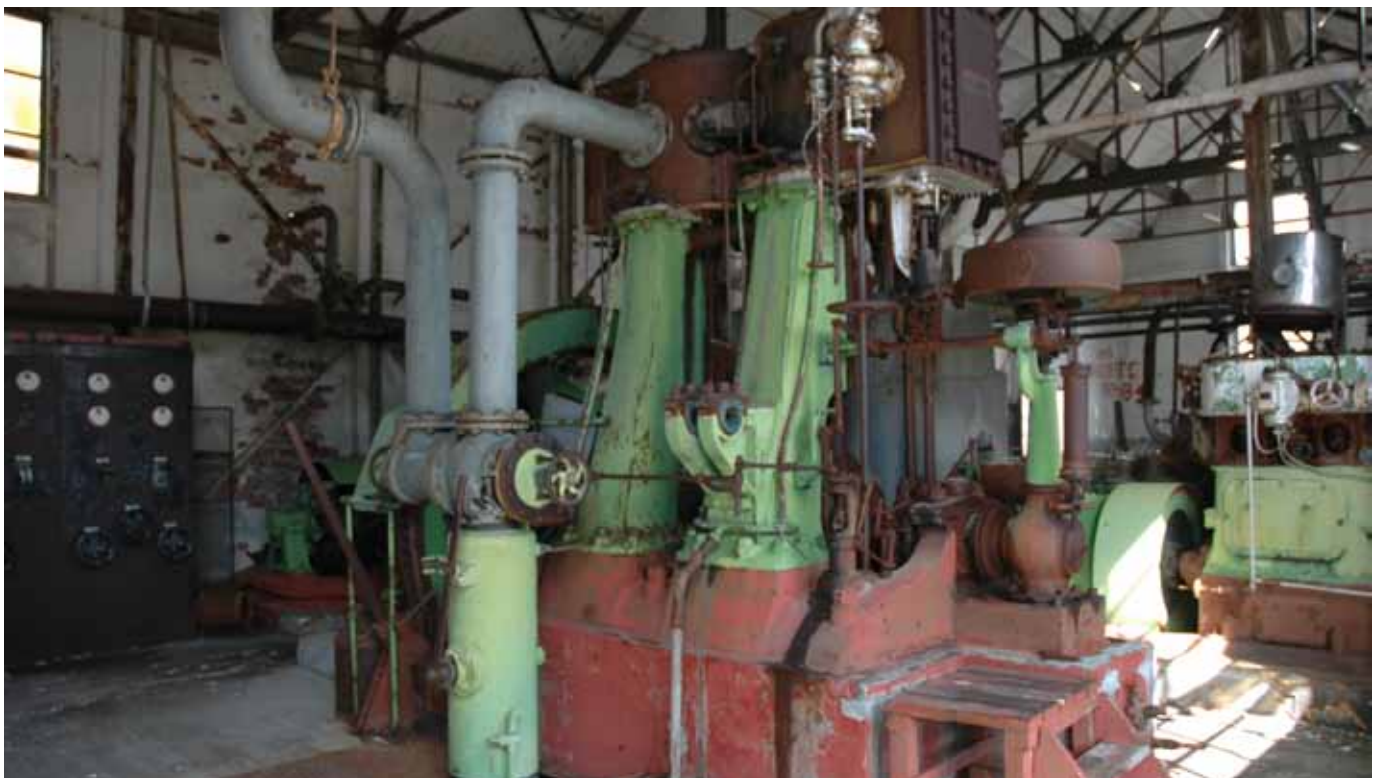
5.2.3 One of the two steam reciprocating dynamos originally made for the Bergen Tramway system

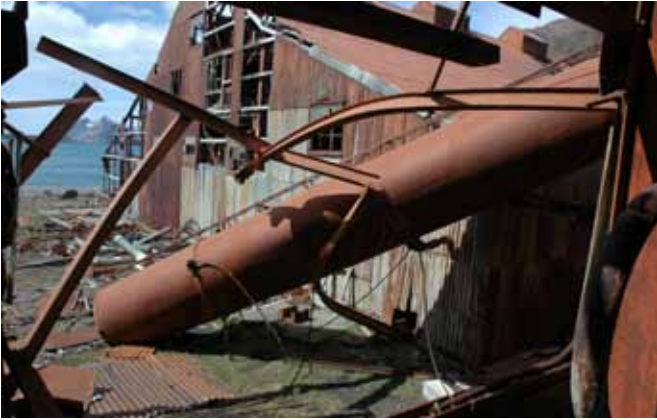
5.2.4 Collapsed boiler chimney seen from the Boiler House

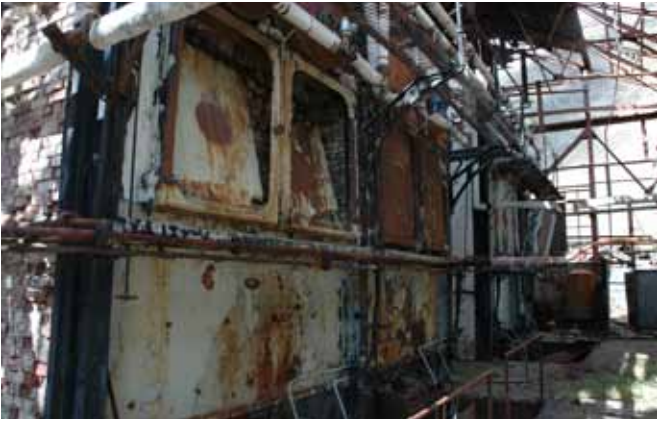
5.2.5 The main boilers

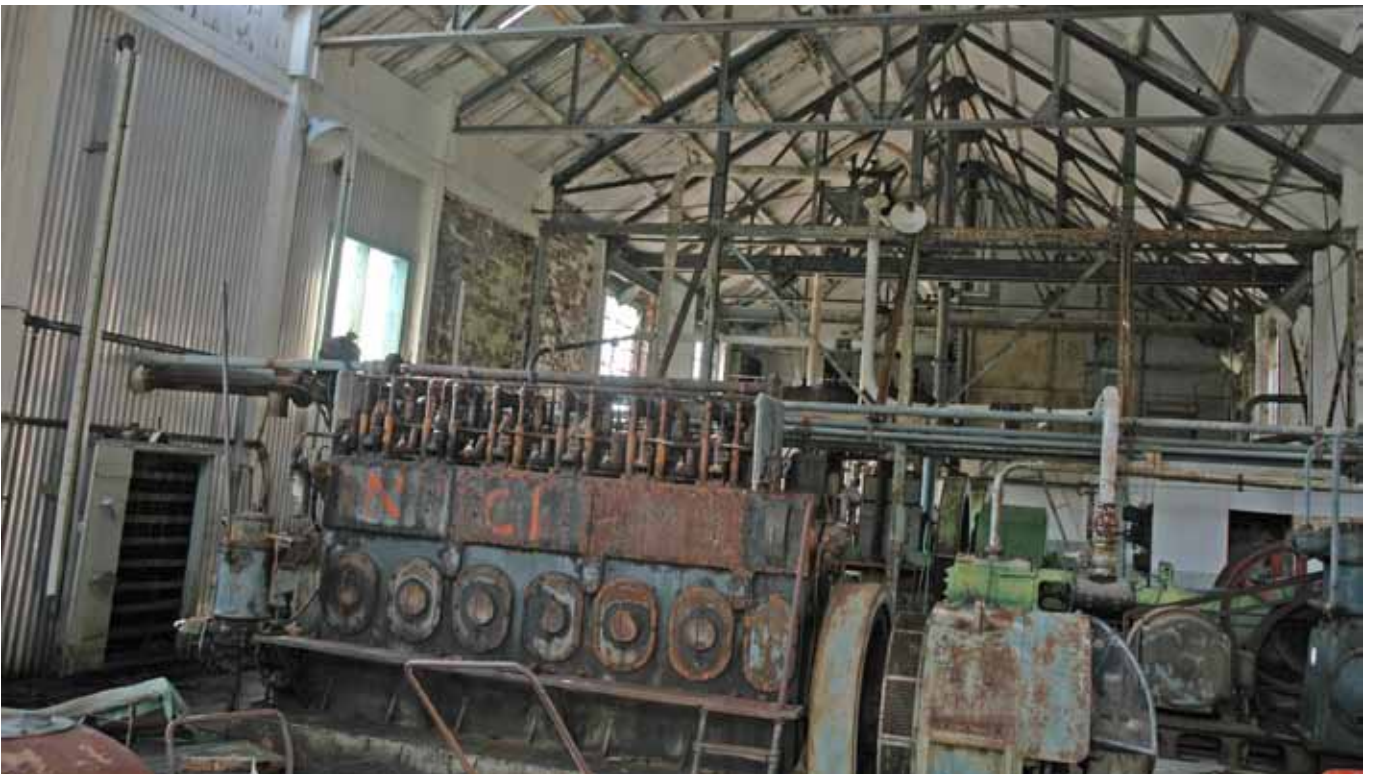
5.2.7 Diesel generators in the Power House

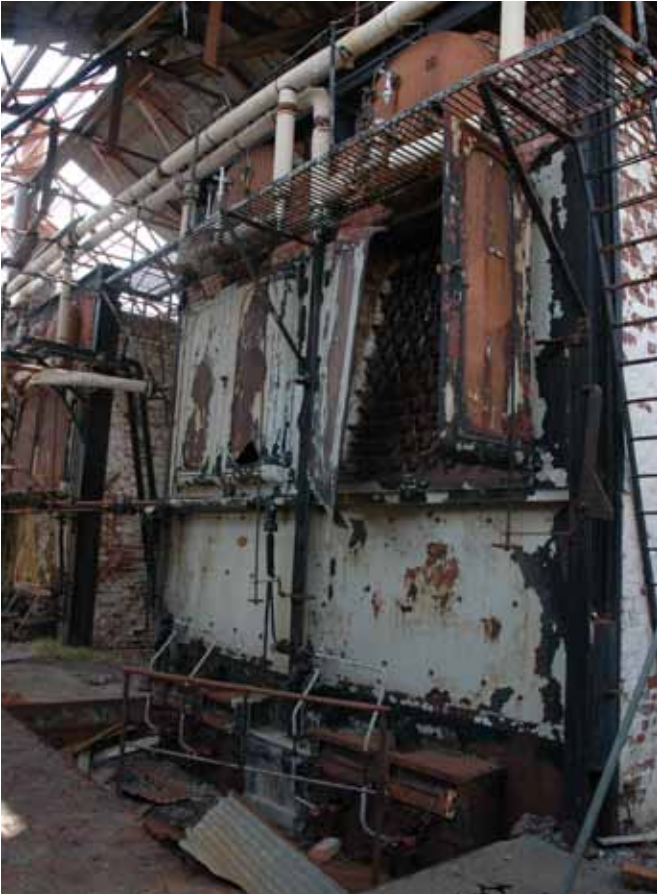
5.2.8 Detail of the Main Boiler

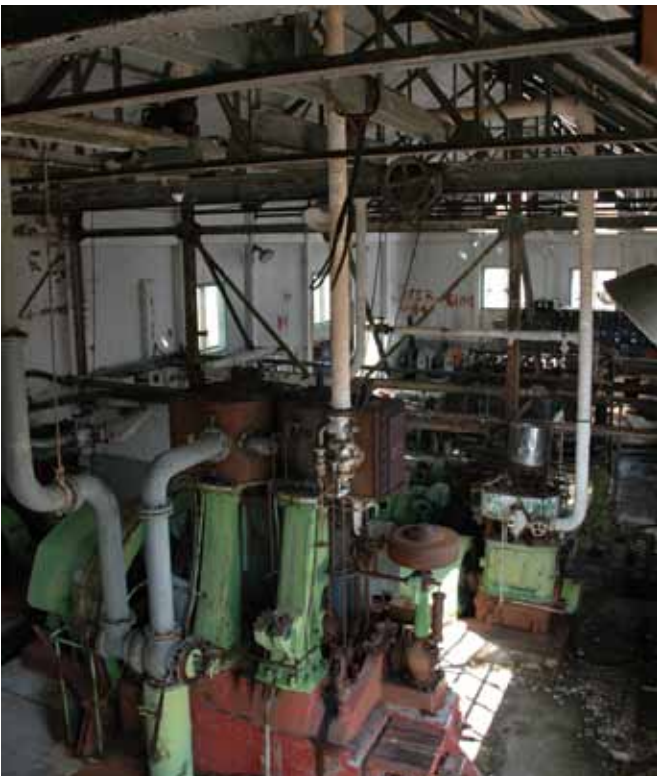
5.1.10 General view over the Power House looking west from the high level gallery

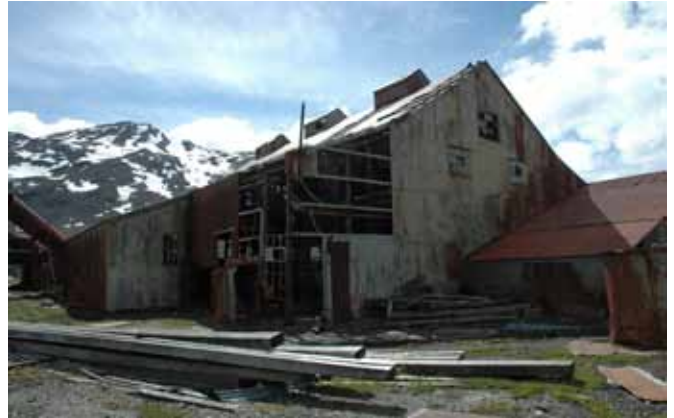
The large main space has a double row of columns propping the roof and supporting an upper deck on the east side. The timber stair to this deck was damaged and the area was not accessed. The steel frame generally looks reasonably solid but 25 percent of the sheeting

6.1 The southeast corner of the main building

is missing from the end walls and perhaps 10 percent of the sheeting missing from the roof.

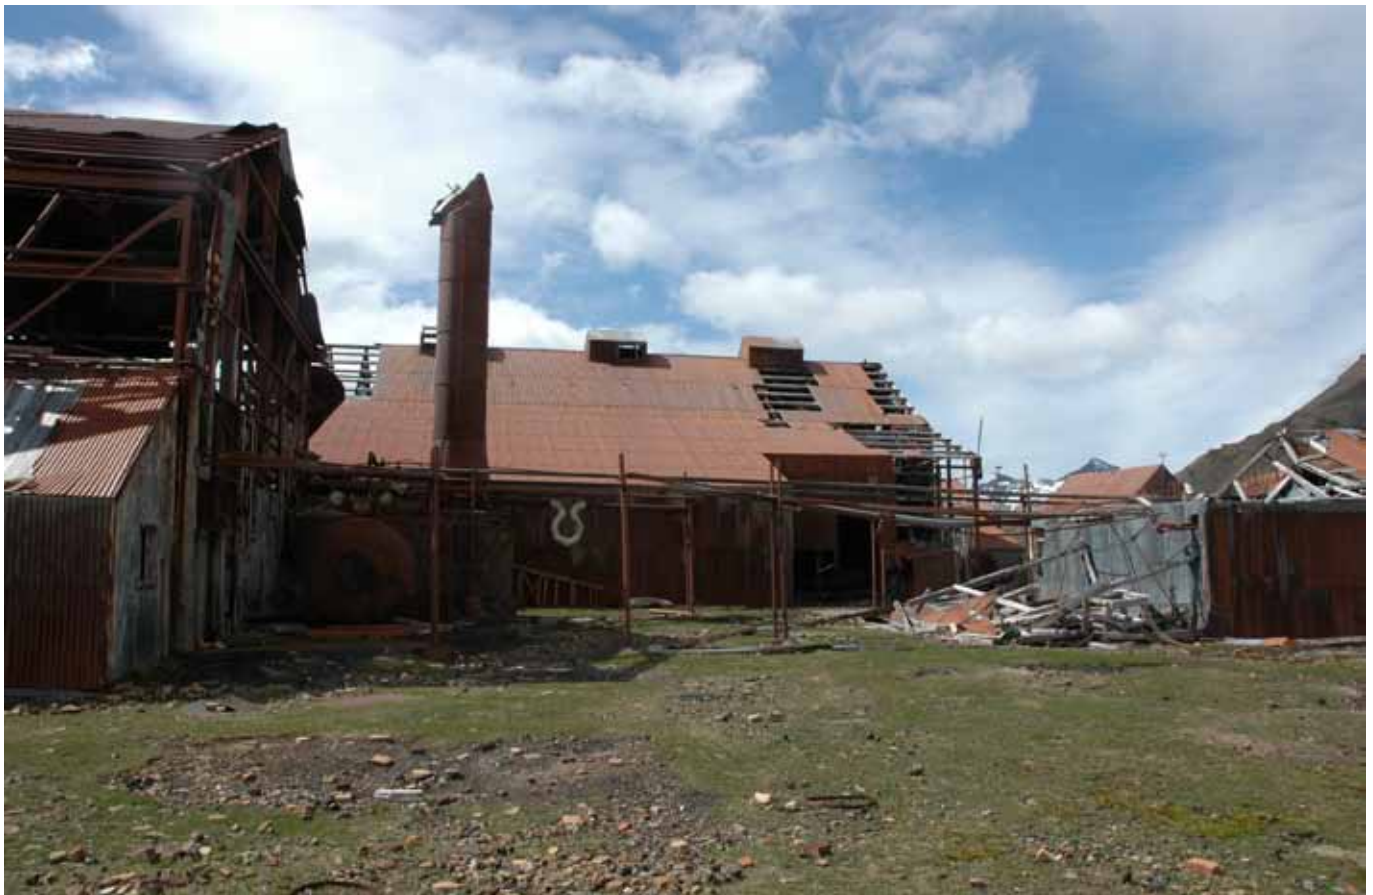
6.2 The west elevation of the South Wing which contains the Forge

The Blacksmith Shop (or Forge) in the building to the southeast appears to have been built at a different time to the main building, indeed it may well pre-date it. It is equipped with four forges, two of which remain in place with their hoods and two of which have partially collapsed. All four chimney flues have collapsed. The building is framed up with steel columns and a trussed angle iron roof clad externally in corrugated iron. The internal walls have brickwork behind the forges but are otherwise lined out with flat steel sheet. There are large steel framed windows on the south wall together with access doors. The sheeting to the roof is damaged where the flue has collapsed.

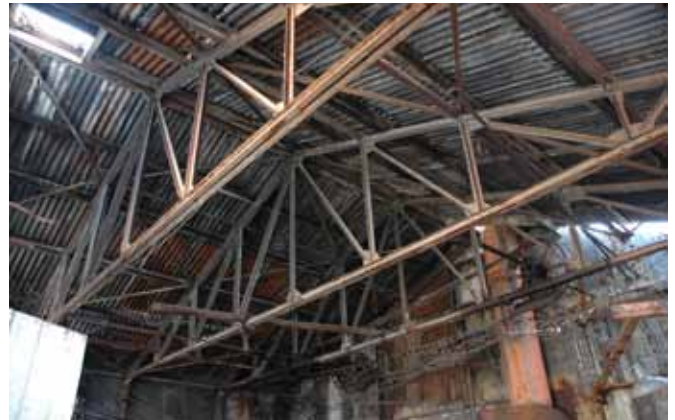
6.5 The roof of the Forge

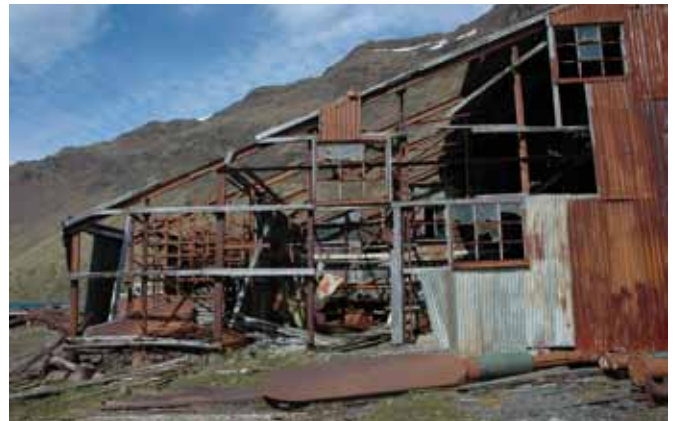
6.6 The northeast corner of the building

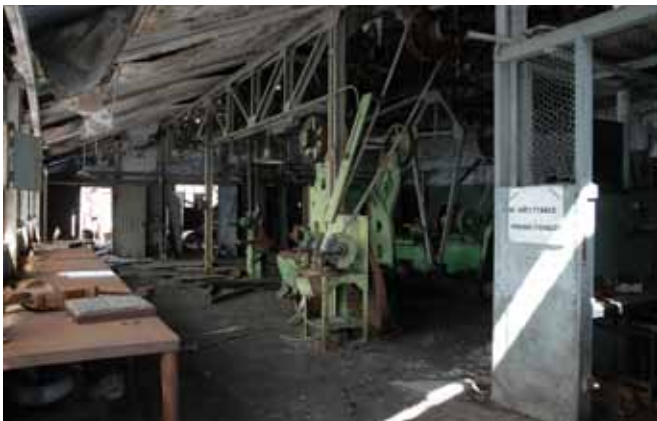
6.3 The Workshop on the east side of the building

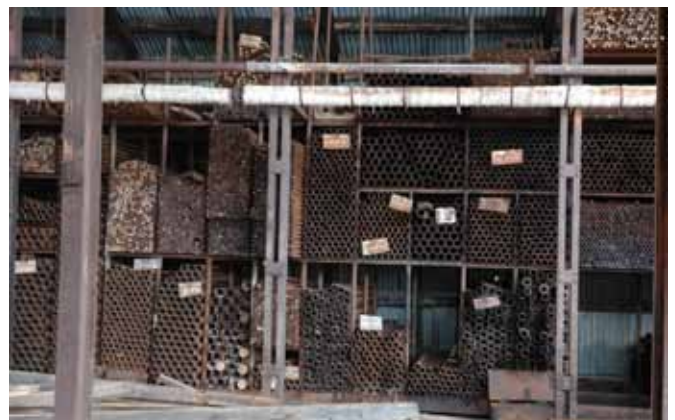
6.7 Pipes stored in the main building

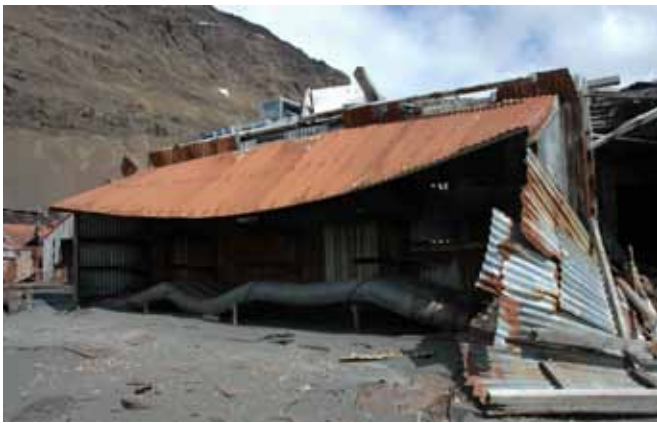
8.2 The lean-to on the south end of the east side

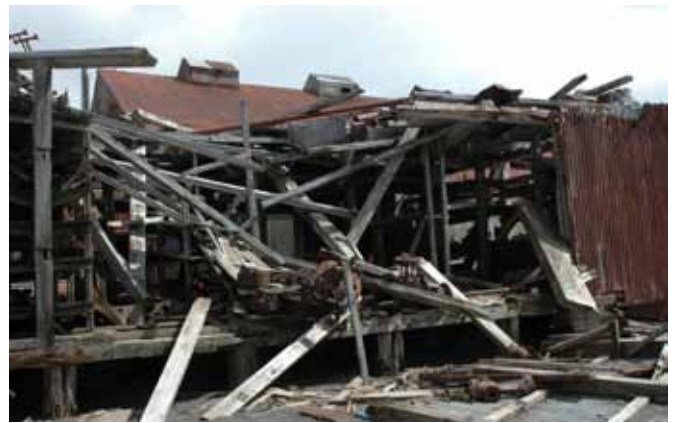
8.3 The central section of the building

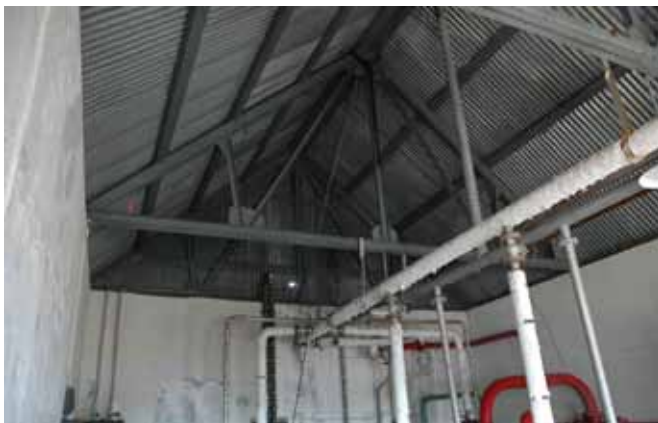
9.3 Interior of roof looking west

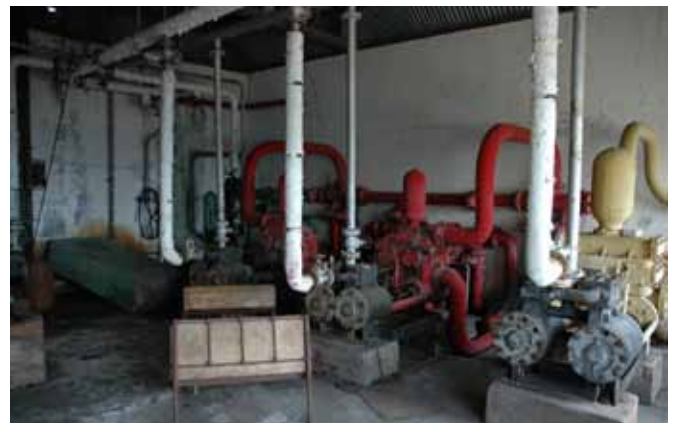
The space still contains pumps and pipework (with asbestos insulation). The brickwork is decaying around the penetrations of the pipes through the walls.

9.4 The remaining pumps

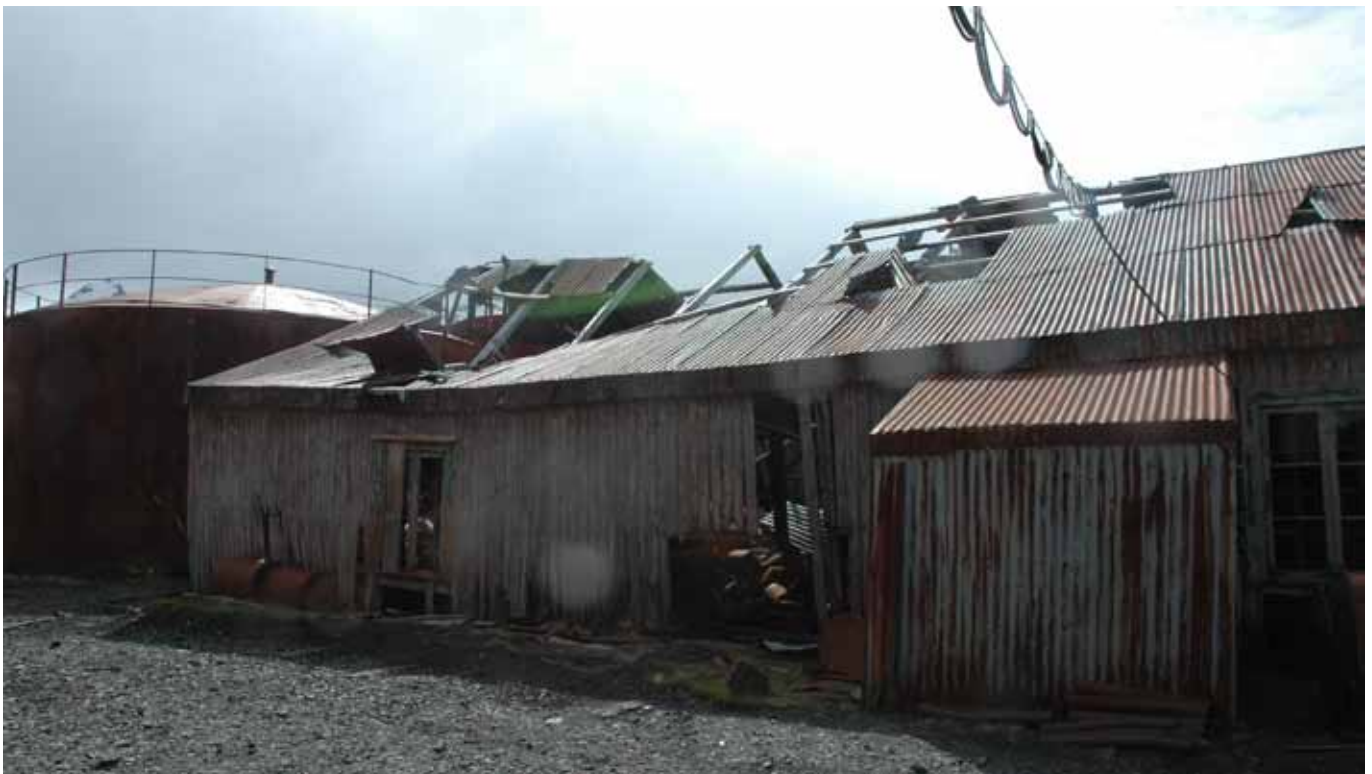
10.4 South elevation, west end with Tank 34 behind

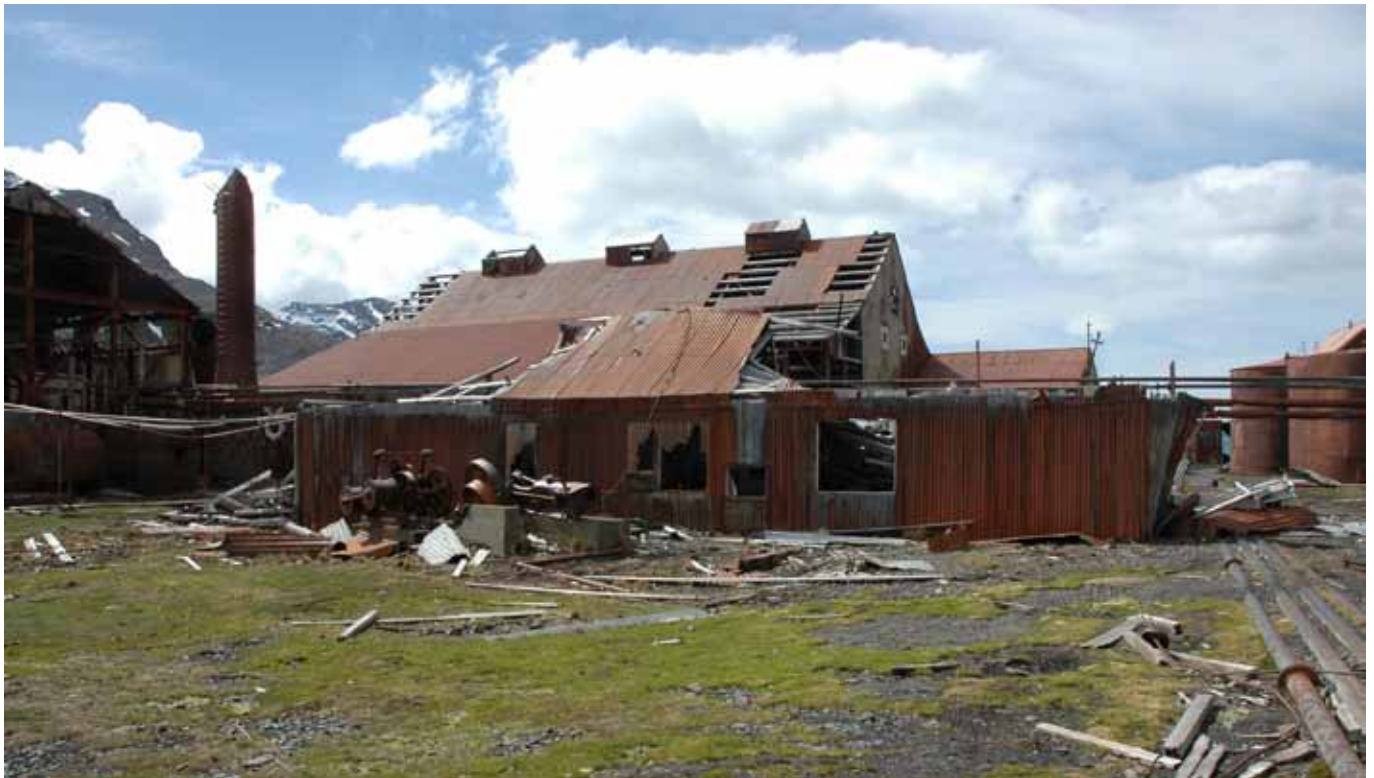
11.2 The west elevation with the Workshop (No. 6) in the background

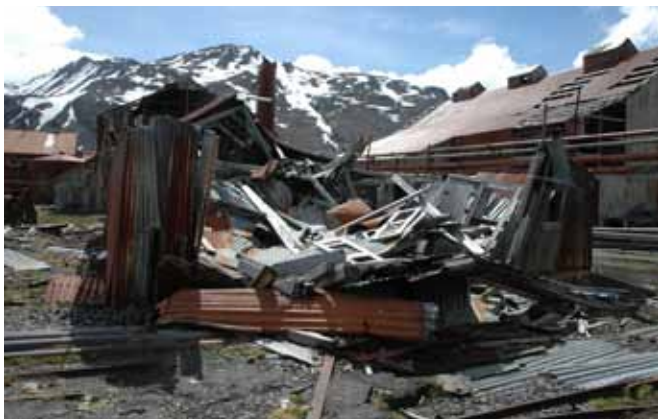
11.3 The south end of the building

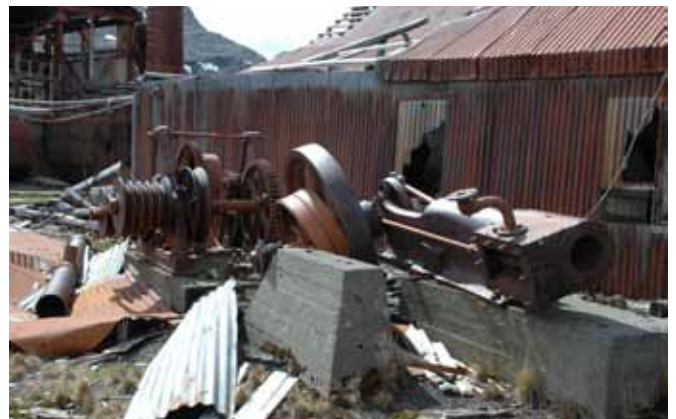
11.4 Detail of machinery, west of the building

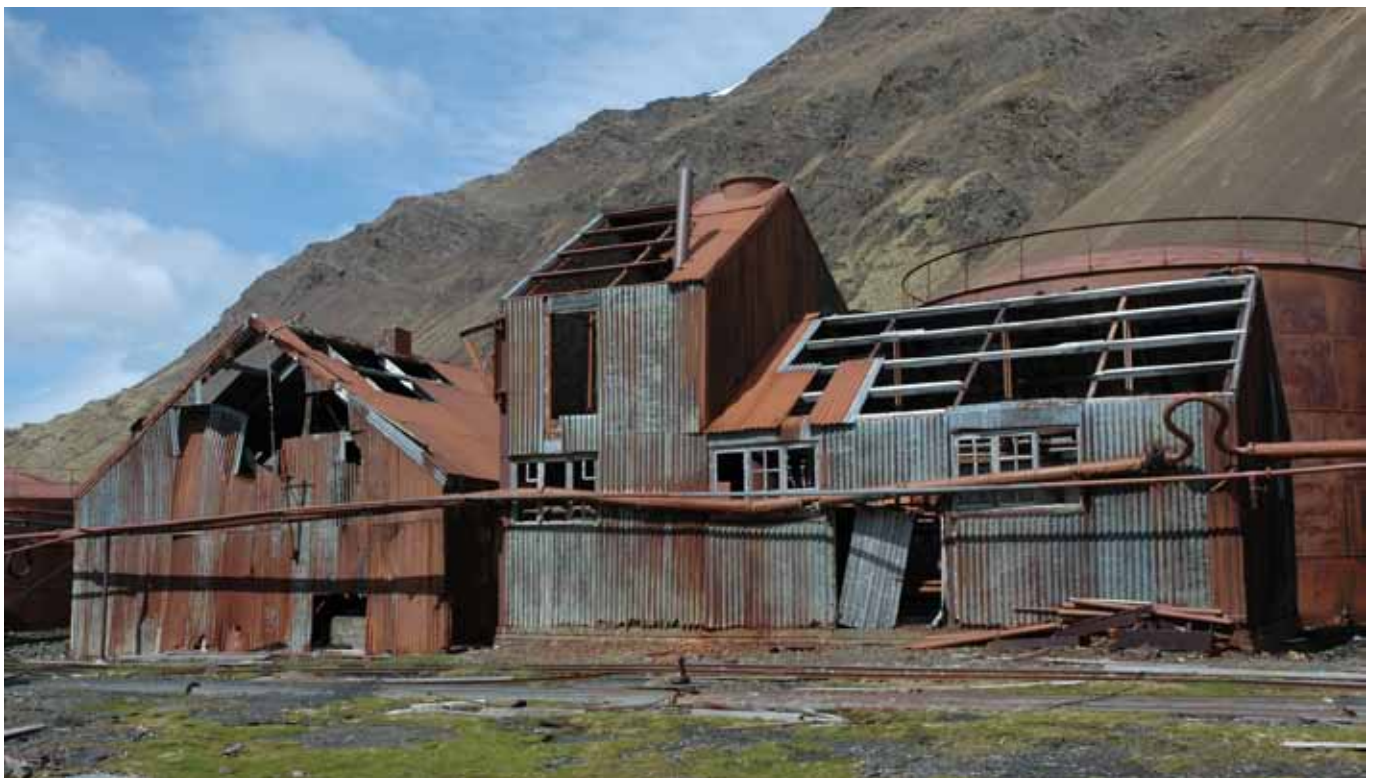
The larger part of the building running north-south is a larger single storey volume with timber framed walls and simple timber trusses. This part of the building (foundry?) has an earth floor and the walls are unclad internally. There were windows and doors on the east wall and windows in the south gable – the majority of them are missing. There is some 20 percent of the corrugated iron sheeting missing from the north gable and 10 percent of the sheeting missing from the north end of the roof.

12.3 The north elevation with the gable of the main wing to the left of the photograph, the northwest wing to the right and Tank 50 behind

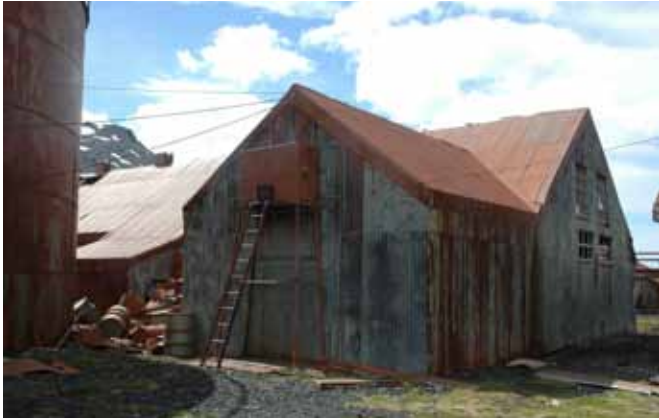
12.4 The south elevation of the main wing and the extension

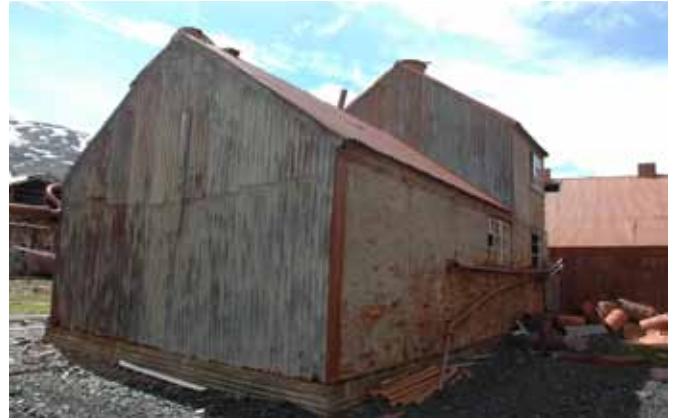
12.5 The west and south elevations of the northwest wing

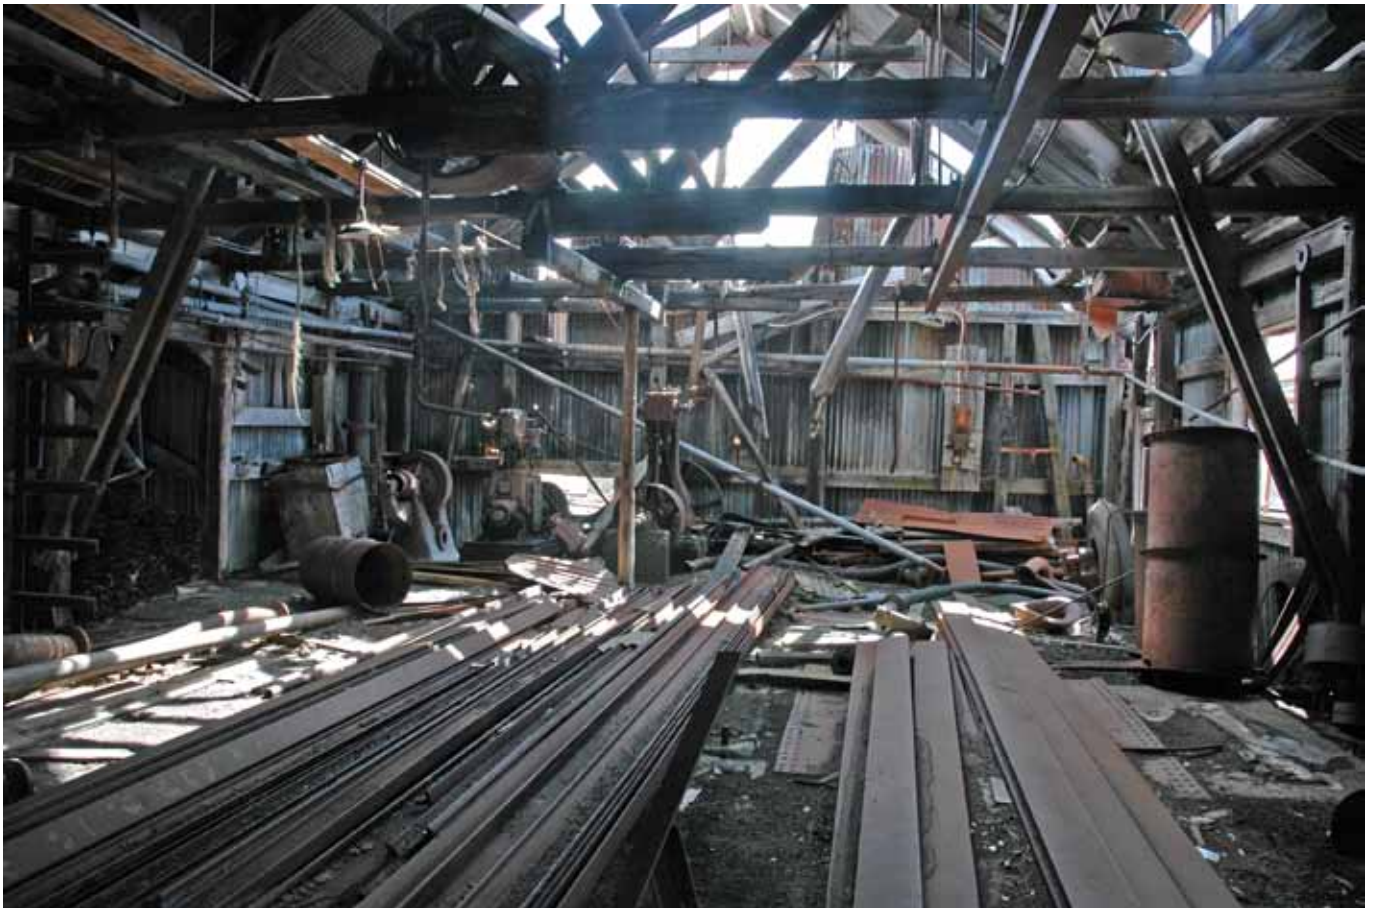
12.6 The interior of the main wing looking northwards

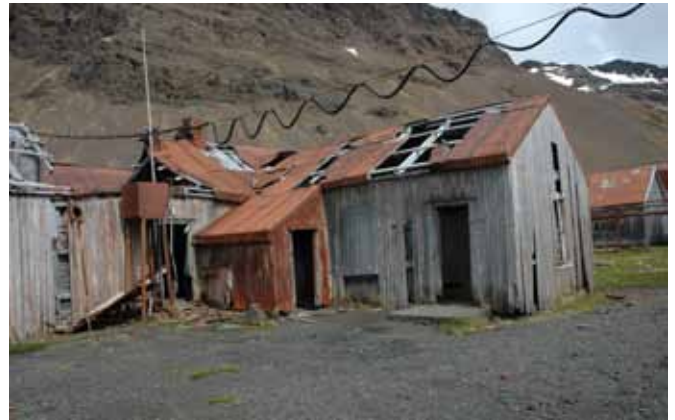
14.1 The extension to the north side of the building

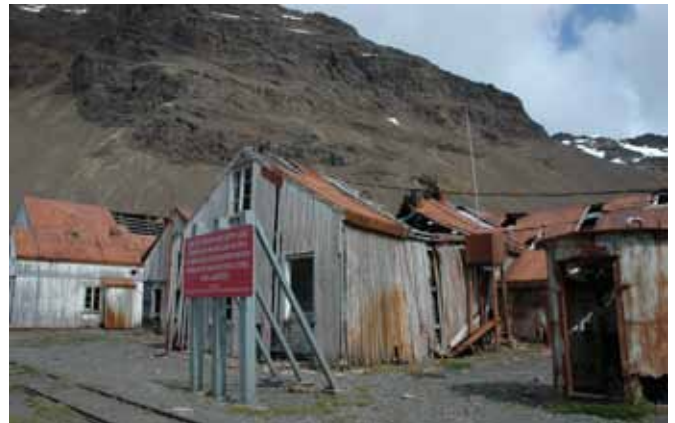
14.2 The east elevation and part of the north

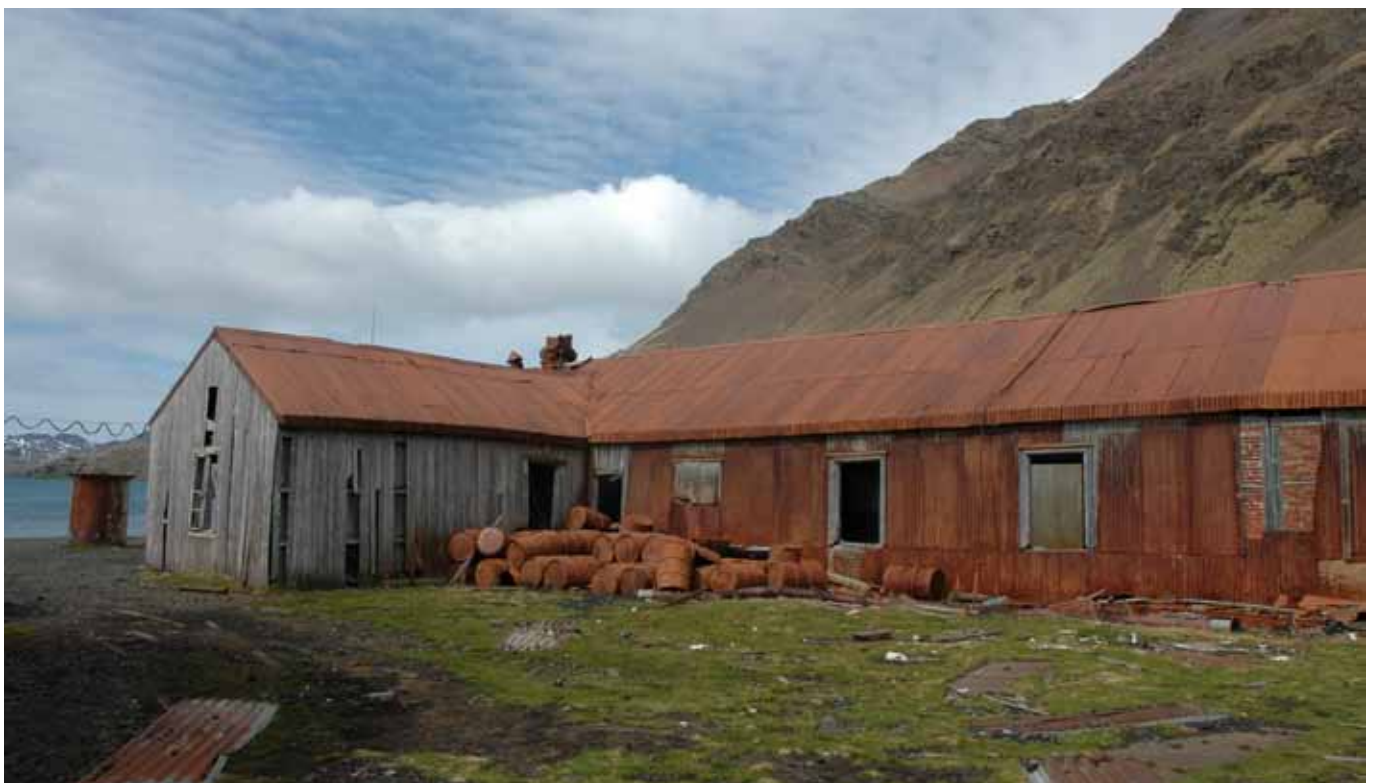
14.3 The north elevation of the main building and the north and west faces of the extension

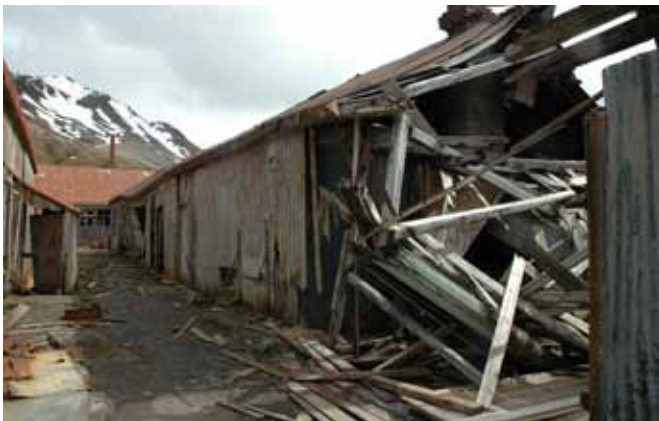
The floor appears to be subsiding as do the columns supporting the attic floor. The roof has a large sag in it and the south wall has partly fallen out.

This building is close to the point of collapse.

14.5 The collapse at the east end of the building

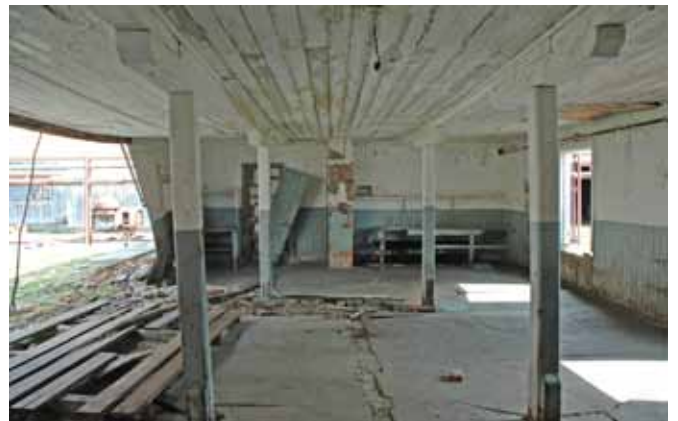
14.6 Interior of the Mess Room space

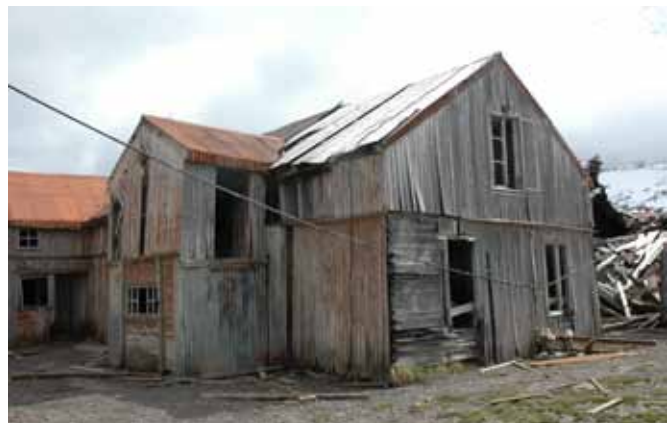
The general condition of the whole building is poor with the external cladding falling away and rotten elements of the structural frame. The roof covering is missing from the south sides of the west wing and the upper floor ceilings are coming down. The ground floor is also collapsing in places.

15.2 East elevation of the north wing

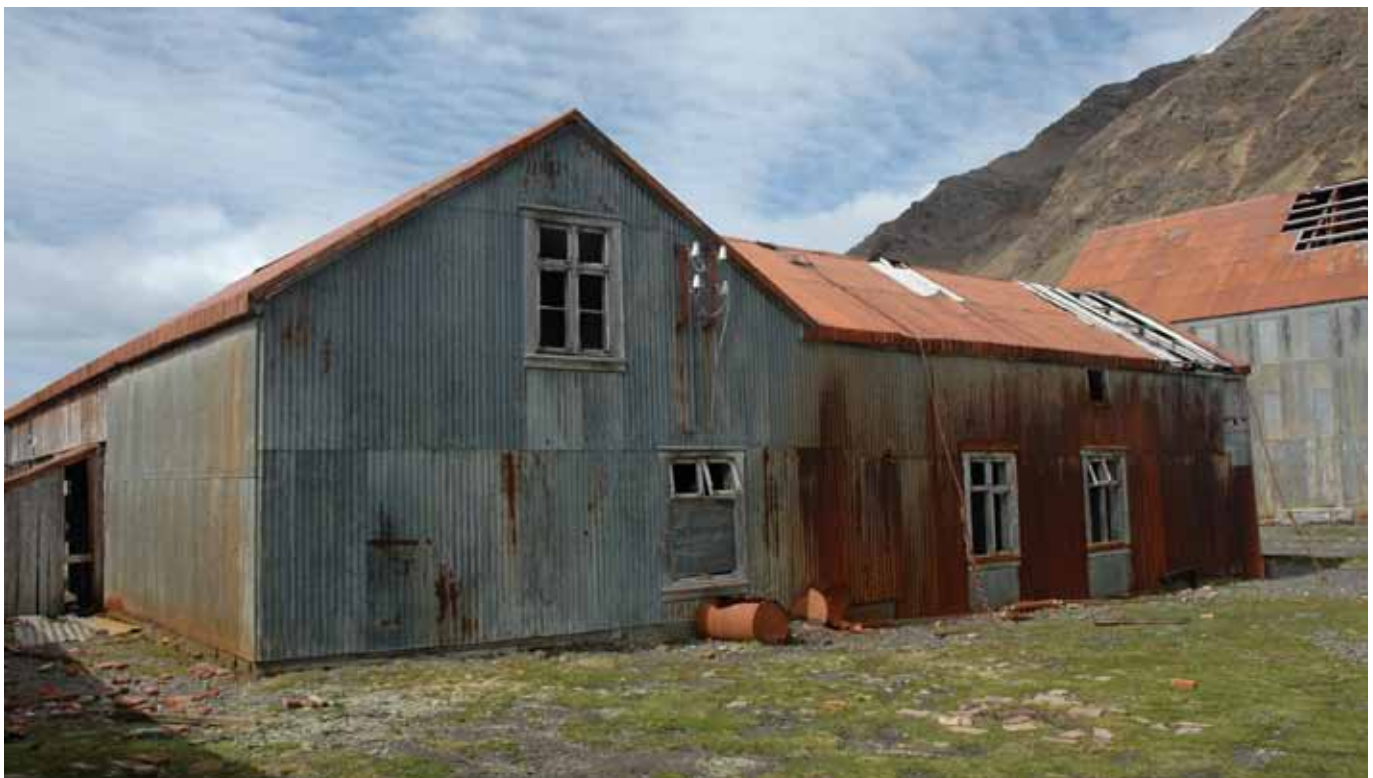
15.3 West elevation of the west wing and part of the north elevation and west gable of the north wing
