DISUSED WHALING STATIONS

Stromness Harbour Gazetteer

Gazetteer, July 2011

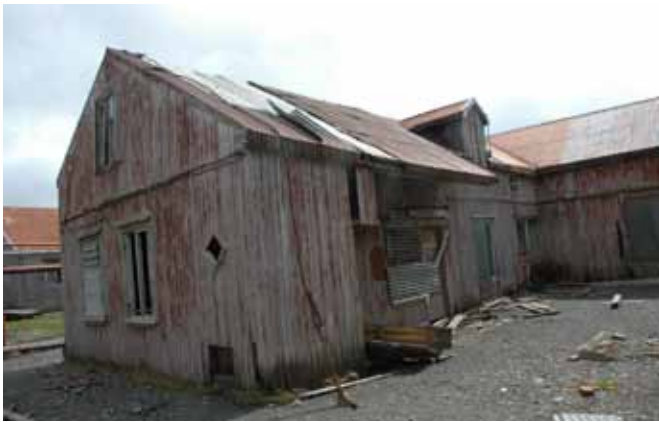
15.4 The south and east elevations of the west wing

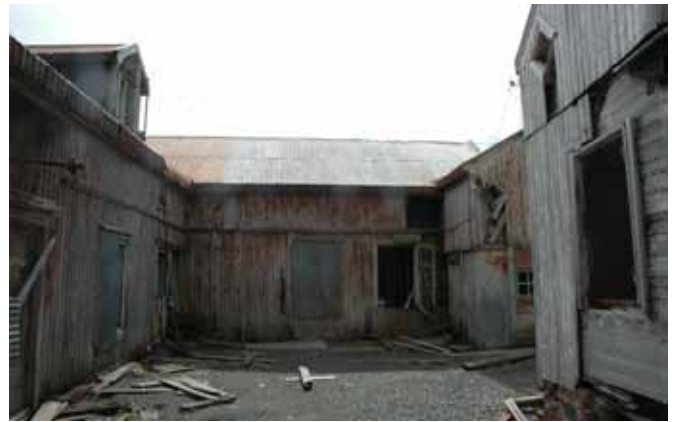
15.5 The south elevation of the north wing with the west wing to the left of the picture and Building No.16 to the right

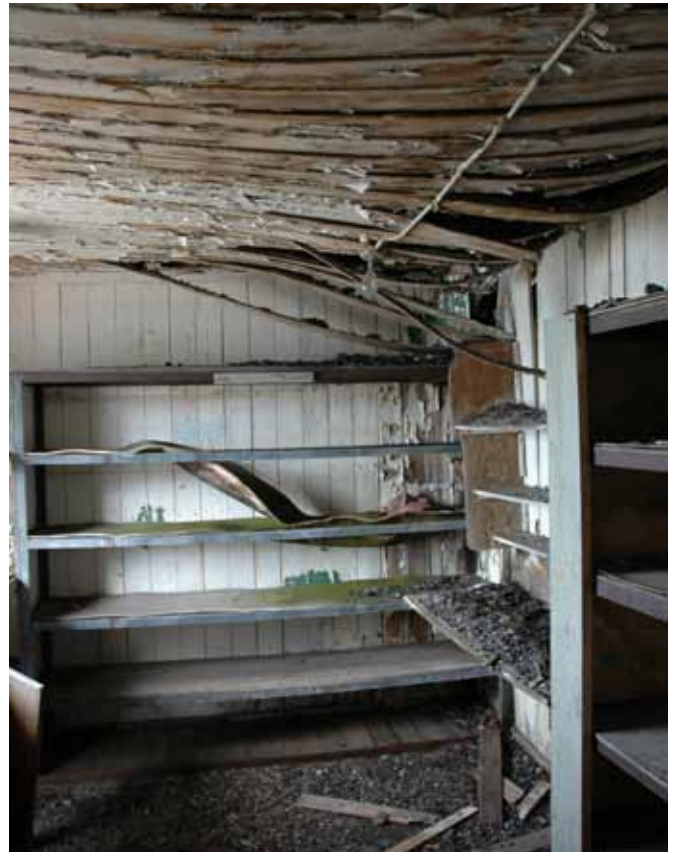
15.7 Ground floor Store Room

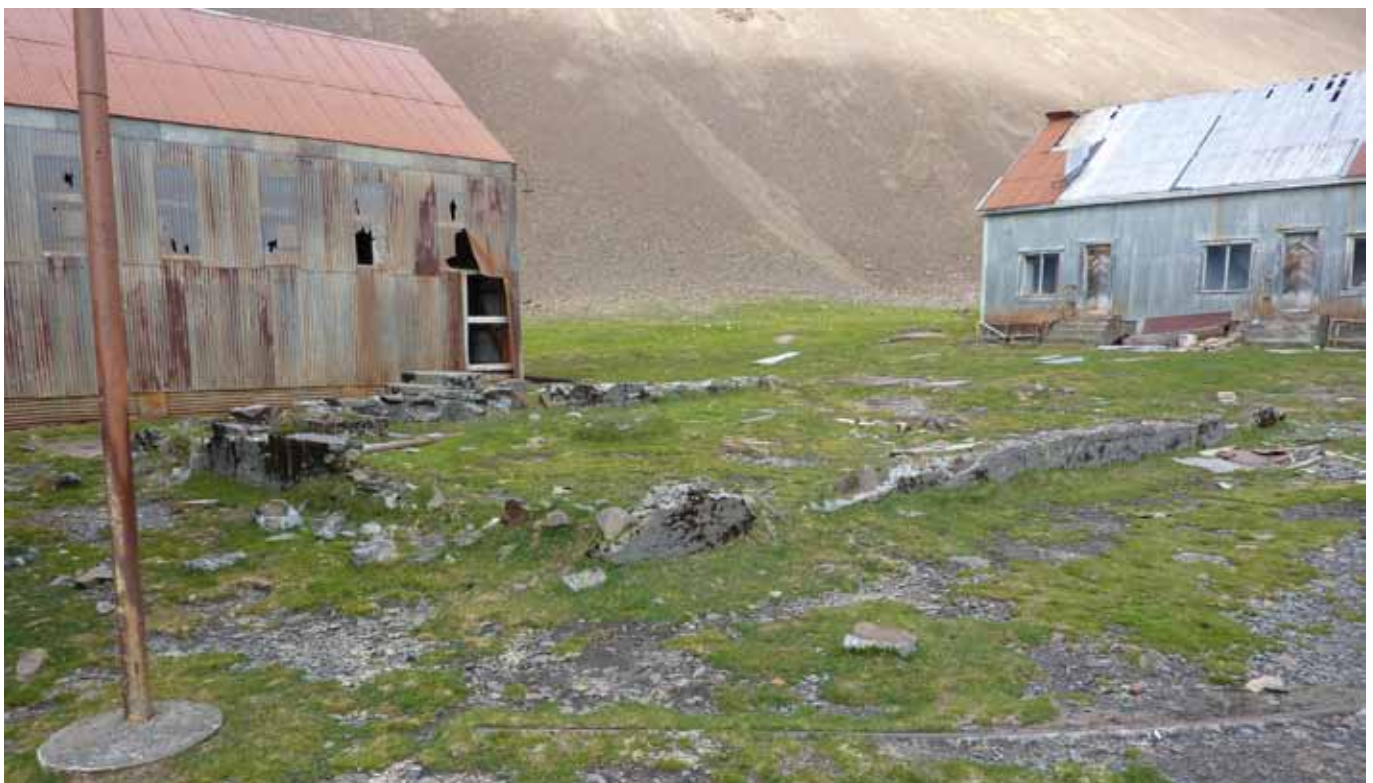
This building is roughly the same size as Barrack No. 1. It is marked as a ruin on the plan and all that remains of this is the concrete plinth and the entrance steps on the east side. It seems likely that it was identical to Building No. 1 from the location of the entrance steps and from its size.

18.2 Site of Barracks No. 2. Building No. 24 (Bath House) is in the background to the right.

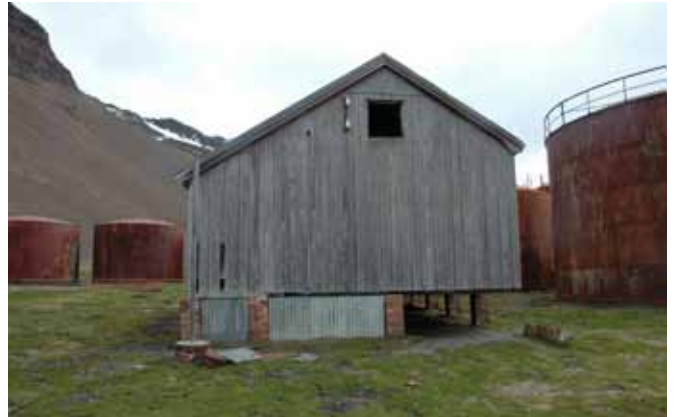
25.6 The east elevation. The passage extension to the south is easy to make out.

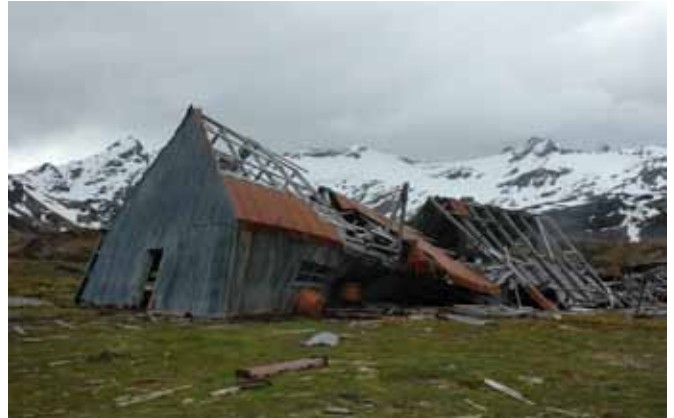
The walls of this building have collapsed with the east wall falling eastwards taking the roof with it. The roof at the north end of the building is now some five yards away from its original position. The west wall remains more or less intact leaning up against the pig pen. The walls here consisted of heavy timber frame 125x125mm timbers with internal tongued and grooved boarding. Externally tongued and grooved boarding is covered with substantial 87x65mm battens with vertical boarding which was then covered with corrugated iron. There is some remaining building felt behind the internal boards. There is a series of windows along the two main east and west fronts. The roof was composed of principals at 1.2m centres with timber purlins and corrugated iron sheet covering. The loft space appears to have a tie at floor beam level and to have been boarded out internally up the rafters and underneath the collars on the principals. This area was possibly used for storage as there does not appear to have been any daylight in this area and there are no signs of dormer windows and no window in the south gable end.

26.1 South and east elevations

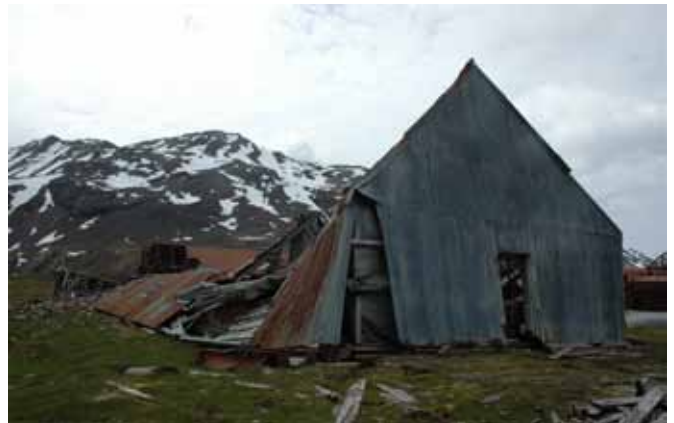
26.2 The south gable end

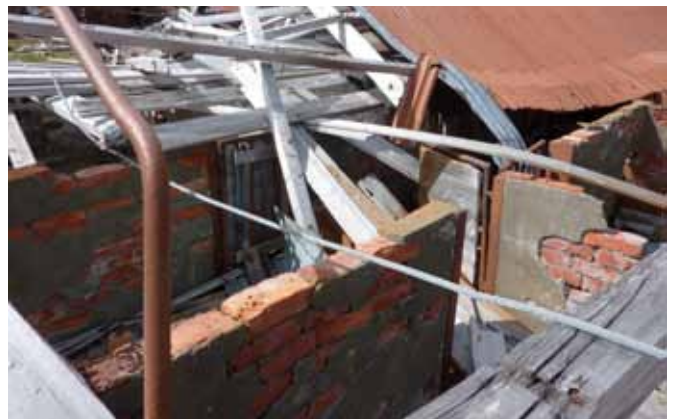
26.4 The rendered brick pens seen through the south door.

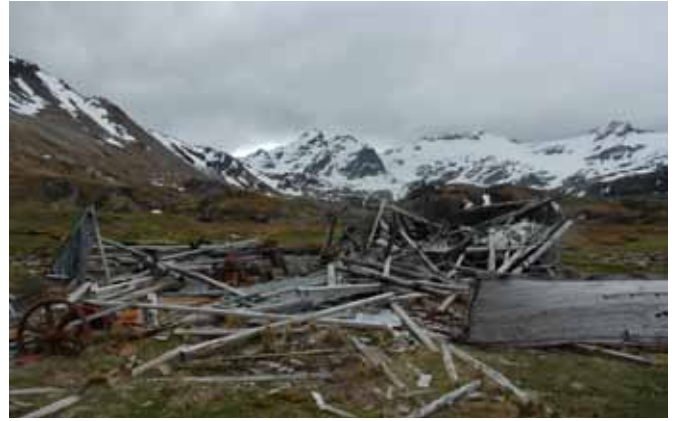
27.2 The centre of the building looking west

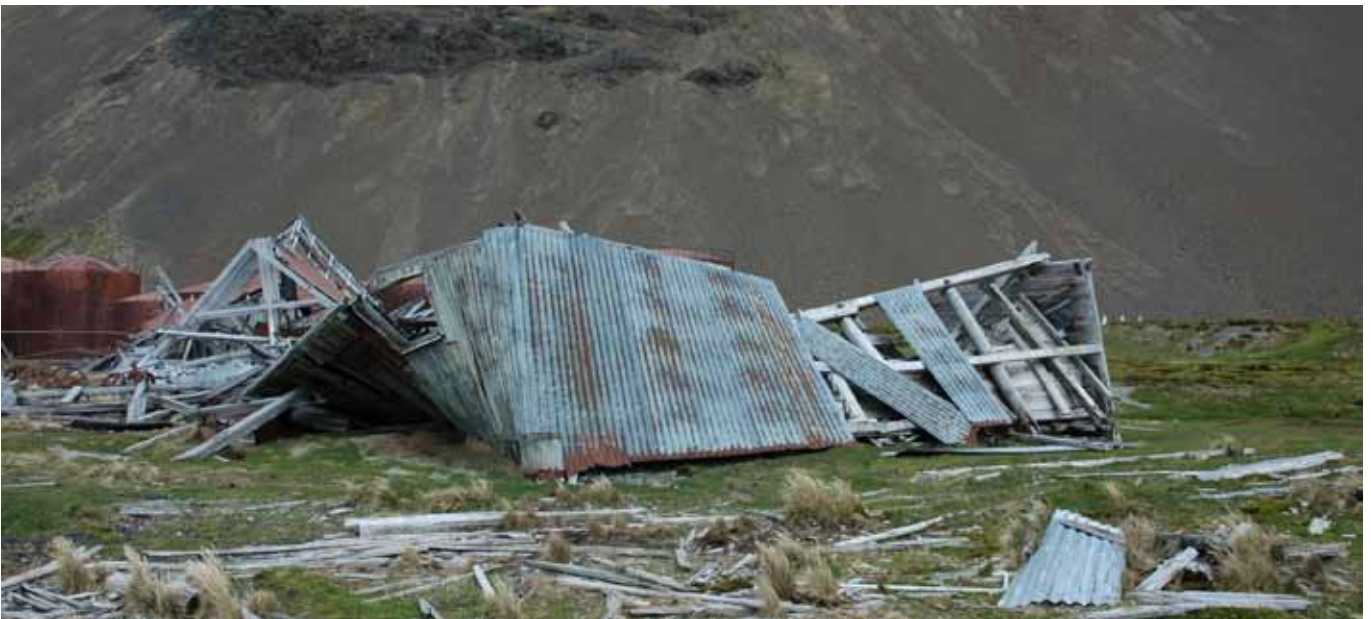
The Hen House was in the northeast corner where the brood boxes and lined out section of wall remain in position. There is a substantial iron window at this point and the remains of a cast iron heating coil, possibly there was some sort of office space at this point (or perhaps just keeping the hens warm?).

27.3 The northeast corner of the building

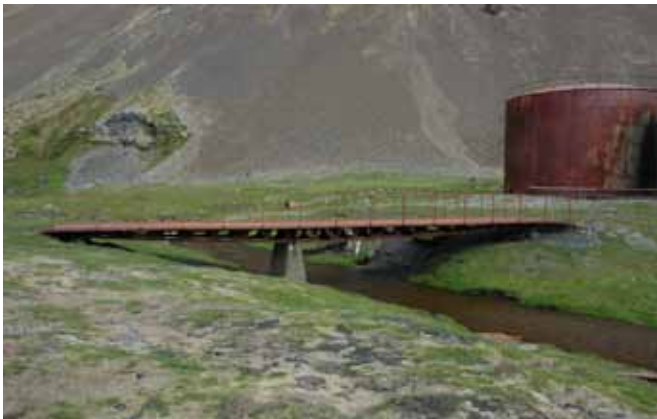
The steel bridge spans across the stream to the six main tanks. The bridge has three concrete abutments, the central one not being quite in the centre of the bridge but on the edge of the stream. The bridge appears to have been purpose-made with flat plate welded on to give top and bottom cords to the main web which has been cut away to reduce weight. The welds are still clearly visible and are not continuous. Handrail stanchions have been welded on as have the brackets supporting the perforated steel deck. The concrete supporting piers are beginning to crack presumably with the rusting of the embedded steelwork. However, generally the bridge remains serviceable with remarkably little corrosion given that it is entirely exposed. The main problem appears to be the undermining of the central support pillar by the stream. To the south of this bridge there was a railway bridge. Rail lines remain and some timber props can be seen where they have fallen into the stream but nothing of this bridge remains.

33.1 North side of bridge

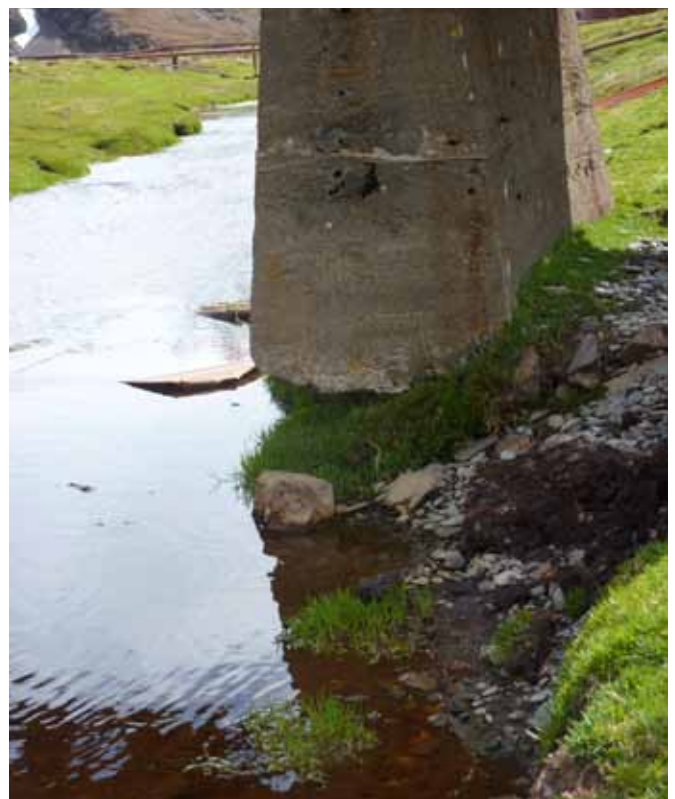
33.4 Concrete pier being undermined by the stream

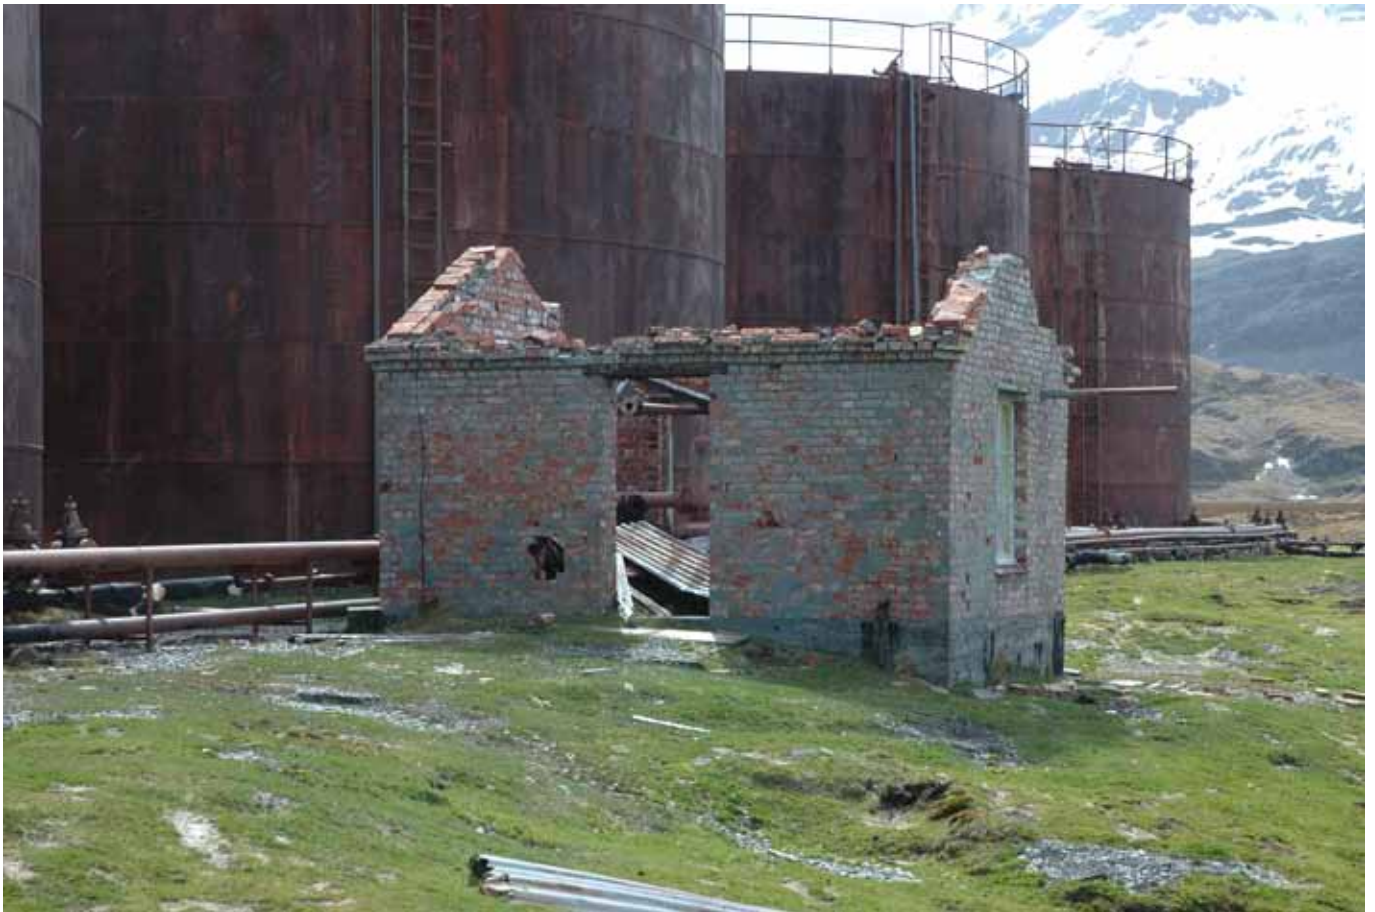
Small brick building with pitch roof running eastwards. The walls are a brick-and-a-half thick though built with an internal cavity with occasional headers providing the bond between the skin. There is a window in both the north and east walls and a door in the south. A steam driven pump remains in position. One window frame remains but the other door and window are missing. The roof has fallen in entirely and the exposed tops of the walls are now in poor condition with the top six courses with blown loose joints. The floor currently is covered with earth and what was originally on the floor is not apparent, probably concrete.

58.1 The south side of the building

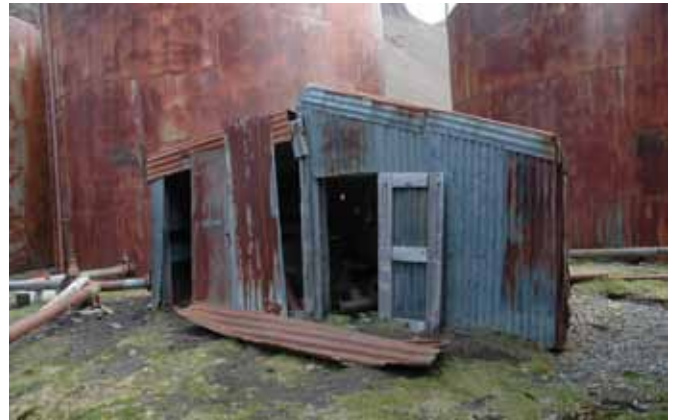
34.1 Pump House by Tank No. 48 (not on Bjorn Basberg's Plan)

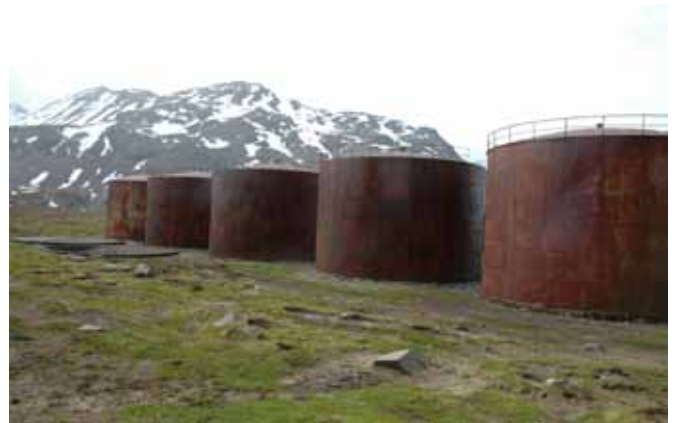
The six main tanks all appear to be identical in design and all appear to be in good order. There is some minor damage to the railings around the top of tank no. 55 (third from the south end) but generally all are in reasonable order and all are still sitting on their original bases. All have roofs that are intact and there are no immediate signs of any holes or leaking.

34.2 Tanks 52-57 east side

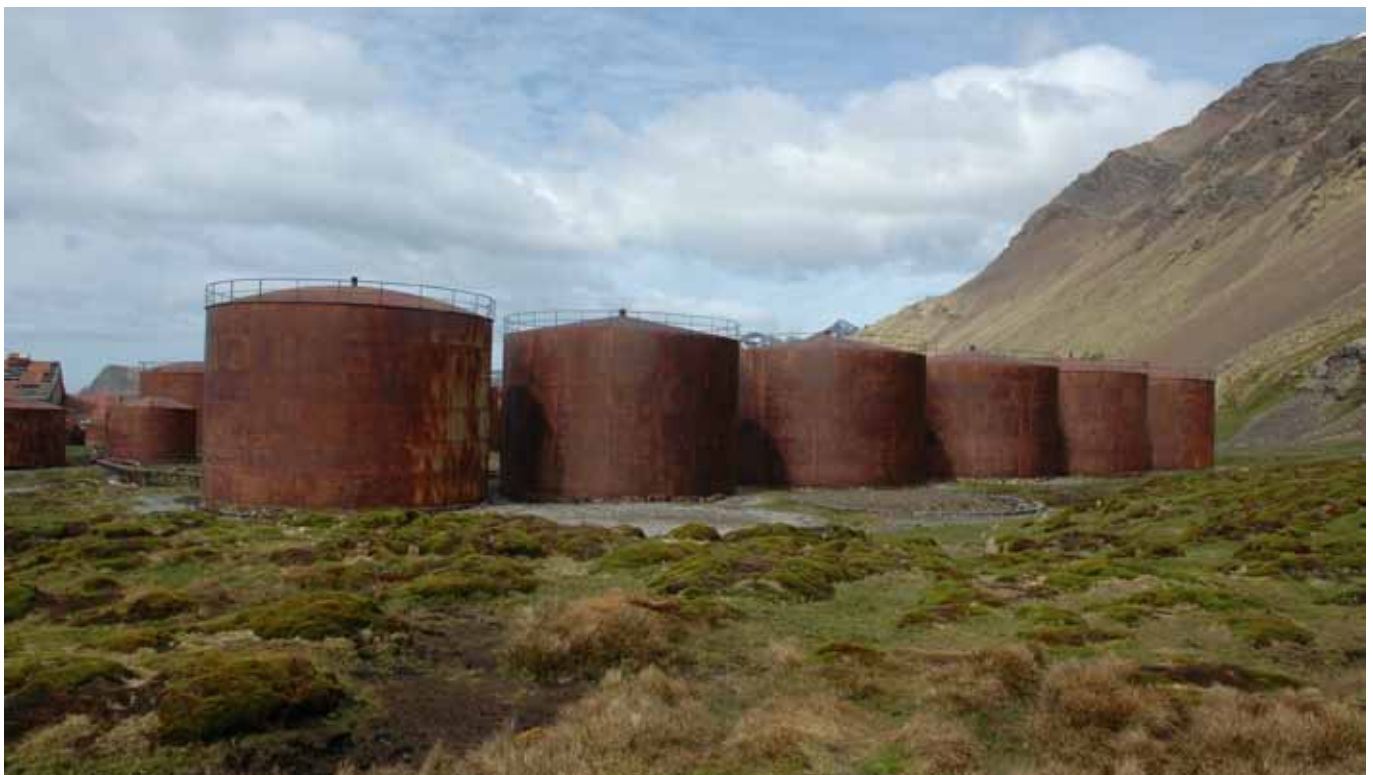
34.3 Tanks 52-57, west side of Tanks looking southeast

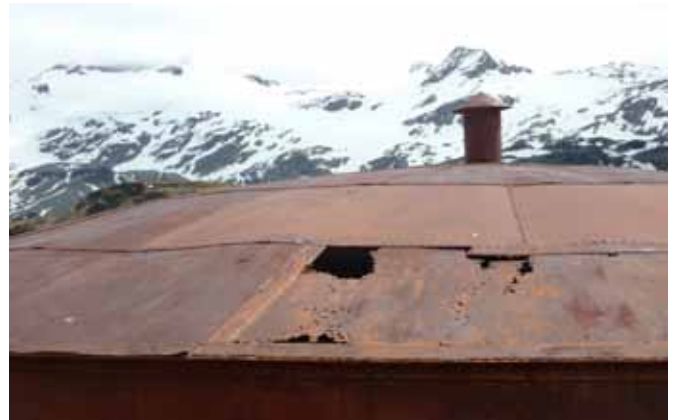
34.5 Roof of Tank No.47

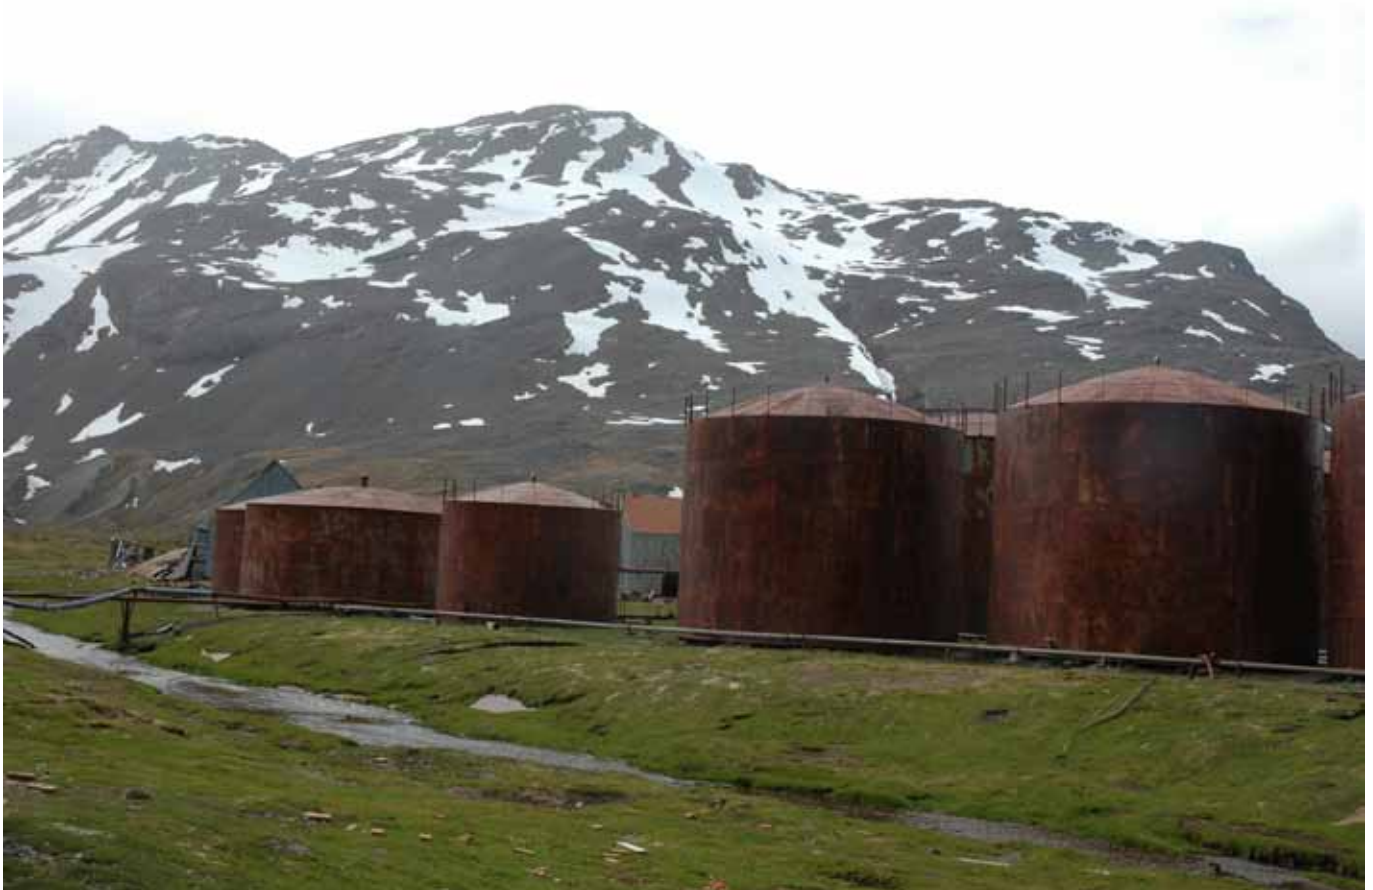
34.6 Tanks 43-47 looking northwards

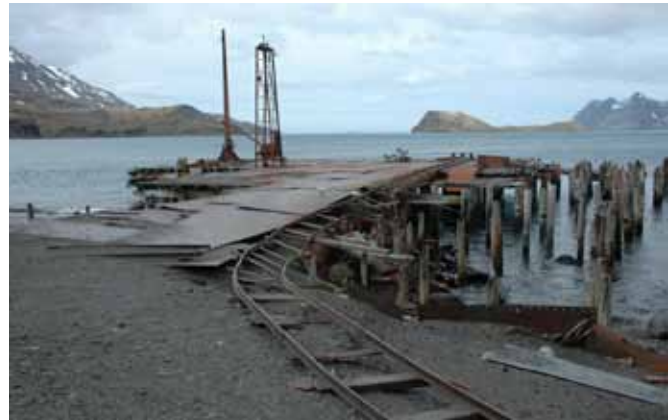
All three jetties remain in position, all are on timber piles and none is in good order. Jetty No. 30 is generally on round timbers more or less the size of a telegraph pole. These are at close centres, around 1.3m though the spacing varies with cross pieces and then principal beams above these and 50mm thick boarding to the top. Much of the jetty has now been covered with steel sheet presumably in an attempt to make it useable. Part of it on the south end of the jetty has now collapsed leaving a small section isolated. There is one remaining derrick and one pipe support remaining in position. The railway line ran out to the end of the jetty though this too has partly now fallen away.

30.1 Railway running onto the Jetty

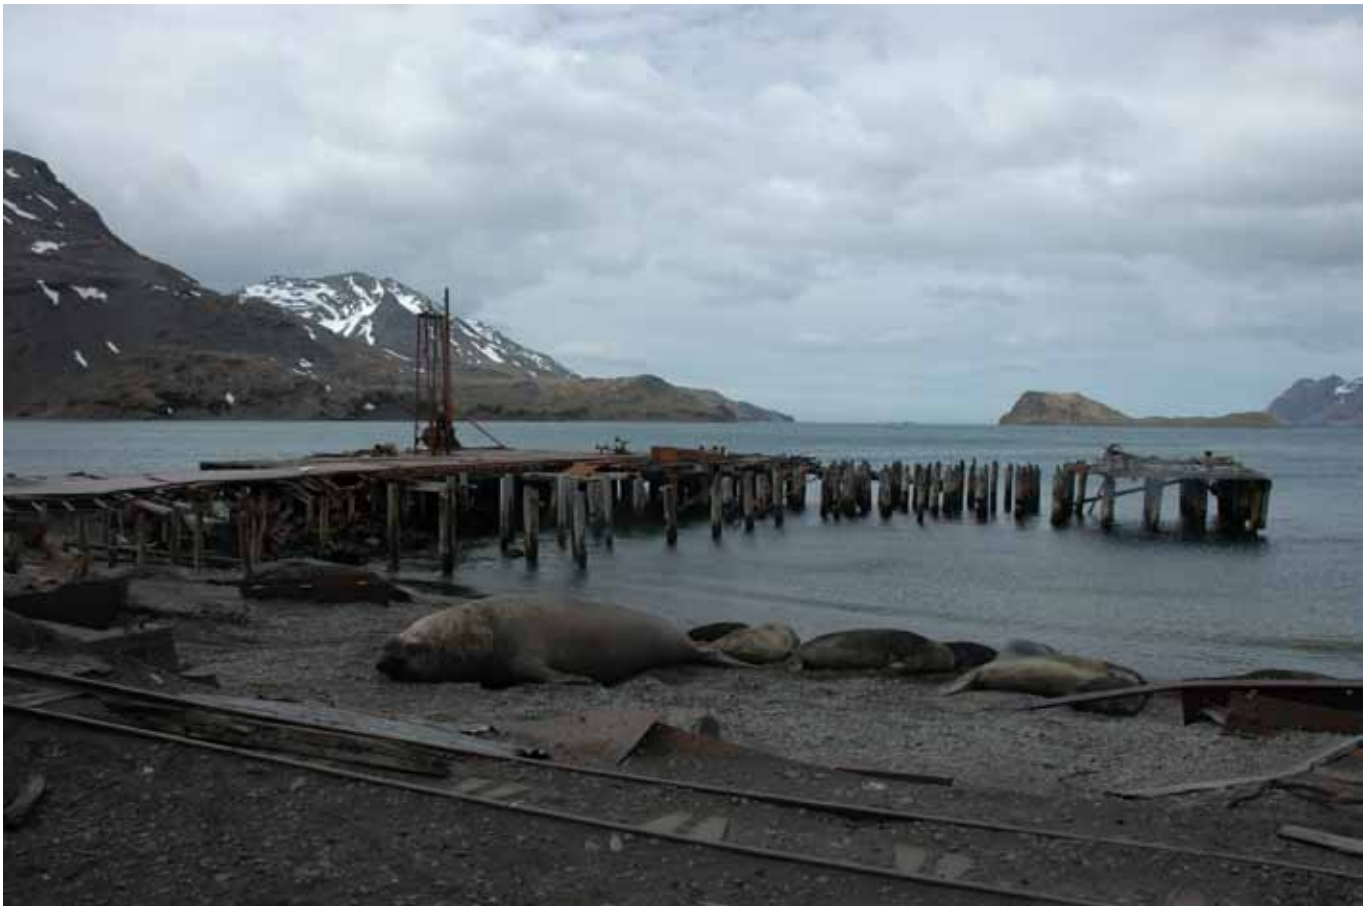
30.2 General view of the south side of the Jetty

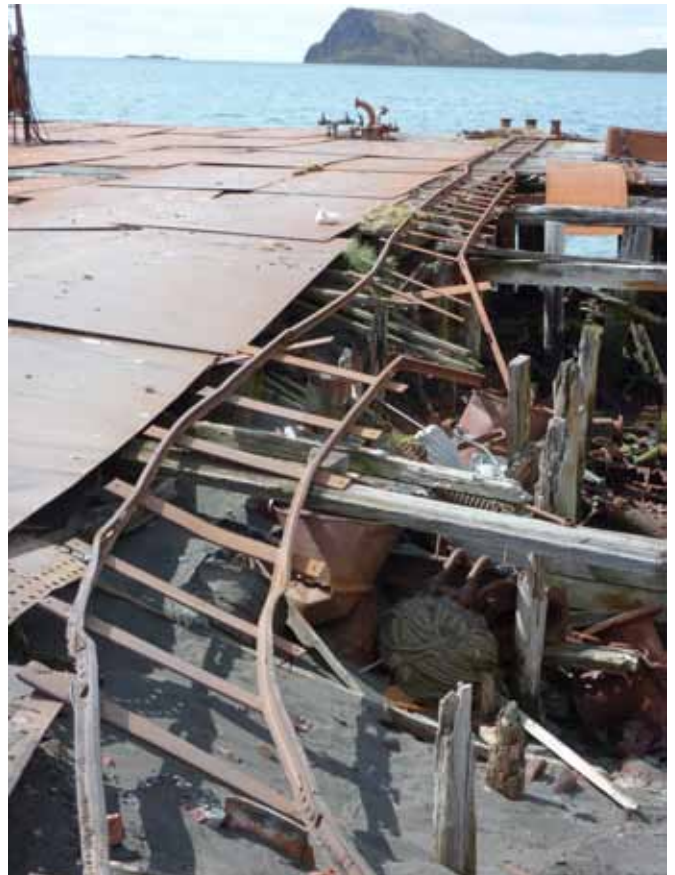
62.3 Tracks running out onto Jetty 30
