DISUSED WHALING STATIONS

Leith Harbour Gazetteer

Gazetteer, July 2011

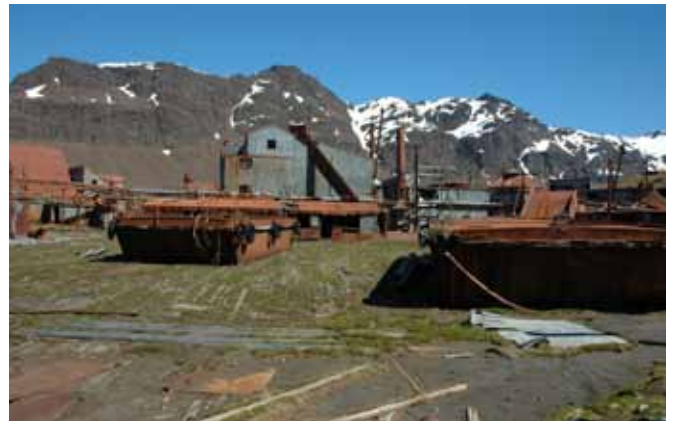
1.2 Looking west towards the Bone Cookery and Rose Down Plant

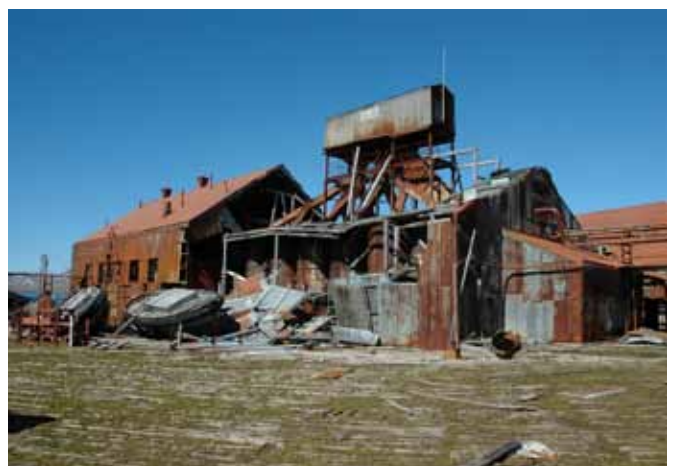
2.4 The north and west elevations of the Blubber Cookery

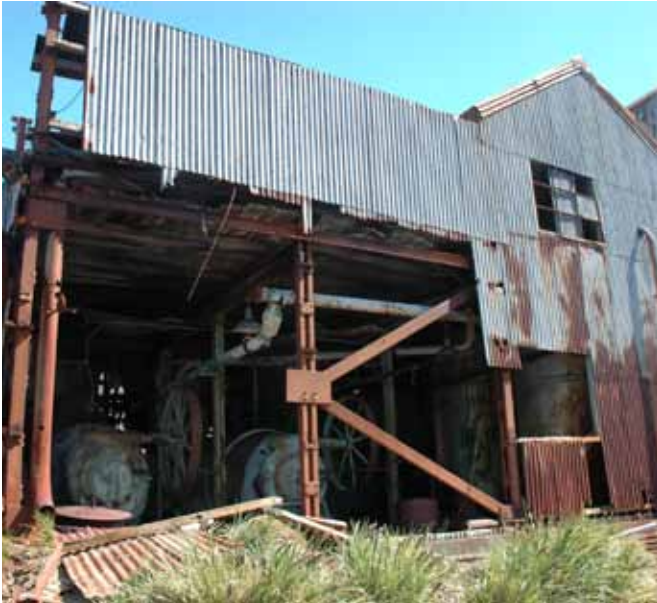
3.1 The east elevation

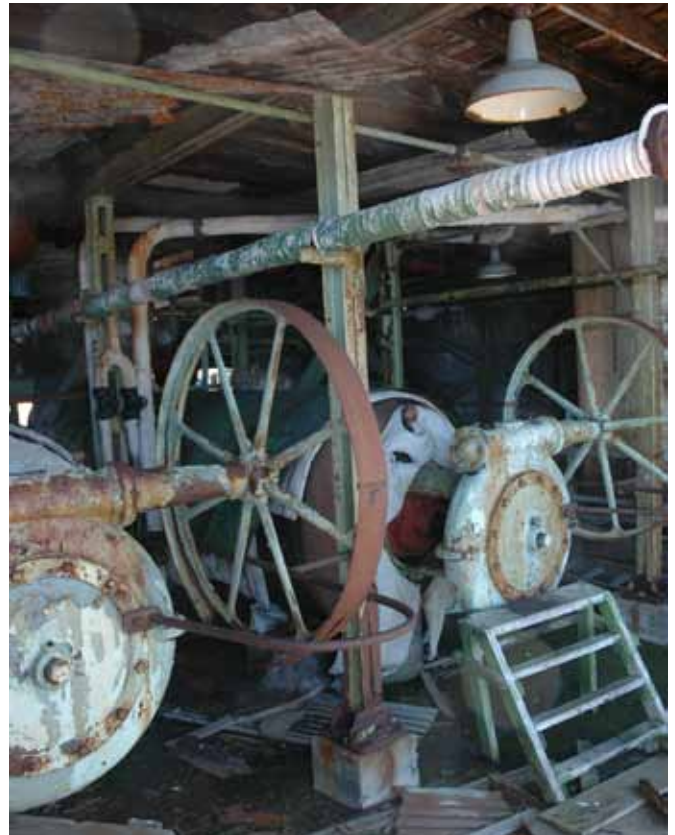
3.2 The cookers in the interior

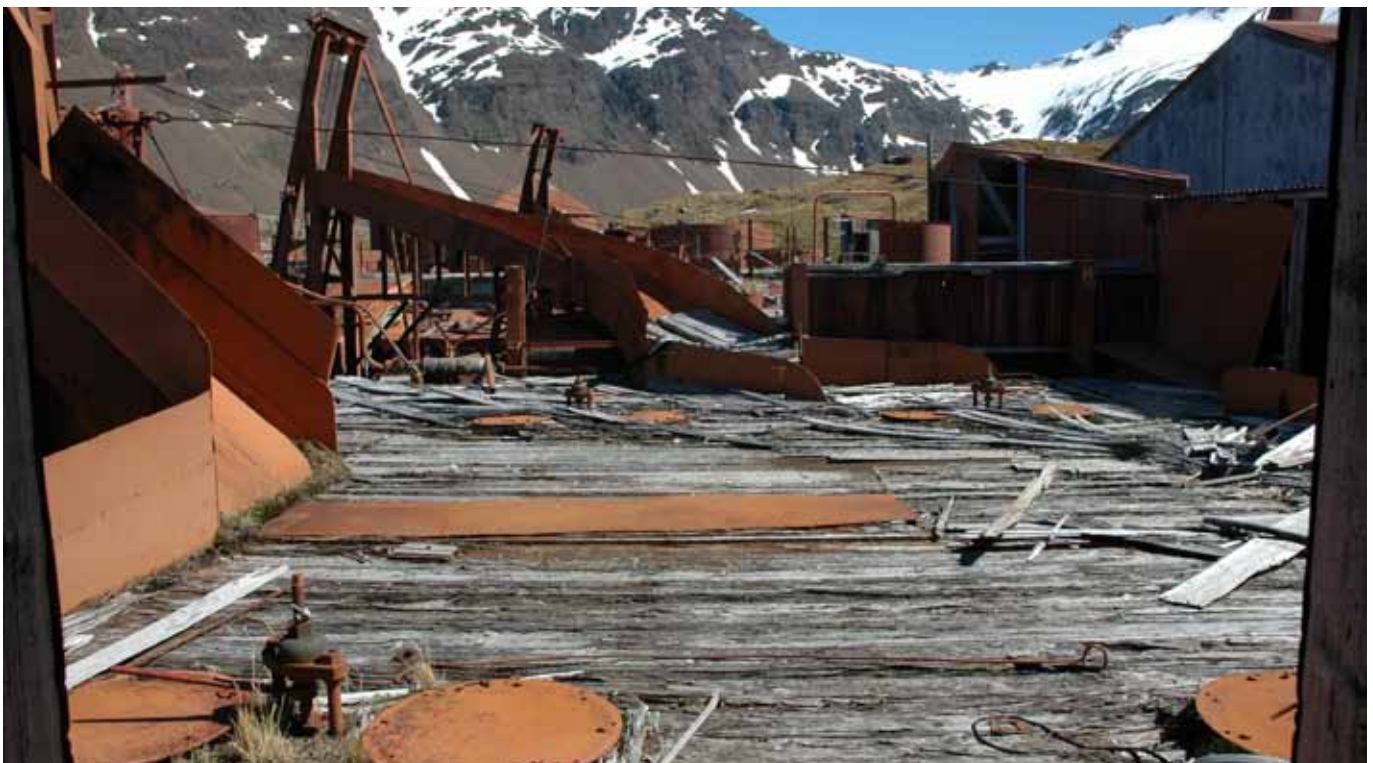
4.3 The platform over the Meat Cookery looking west

There are two bucket conveyors leading up to the platform level. The platform itself is still present but is in very poor condition, the walls around the meat cookery building are in timber and corrugated iron and have all fallen away leaving the metalwork of the platform at the south end exposed and the cookers themselves.

There is sufficient of the building left to be able to see how the processes operated but collapse here is likely to accelerate over the next few years.

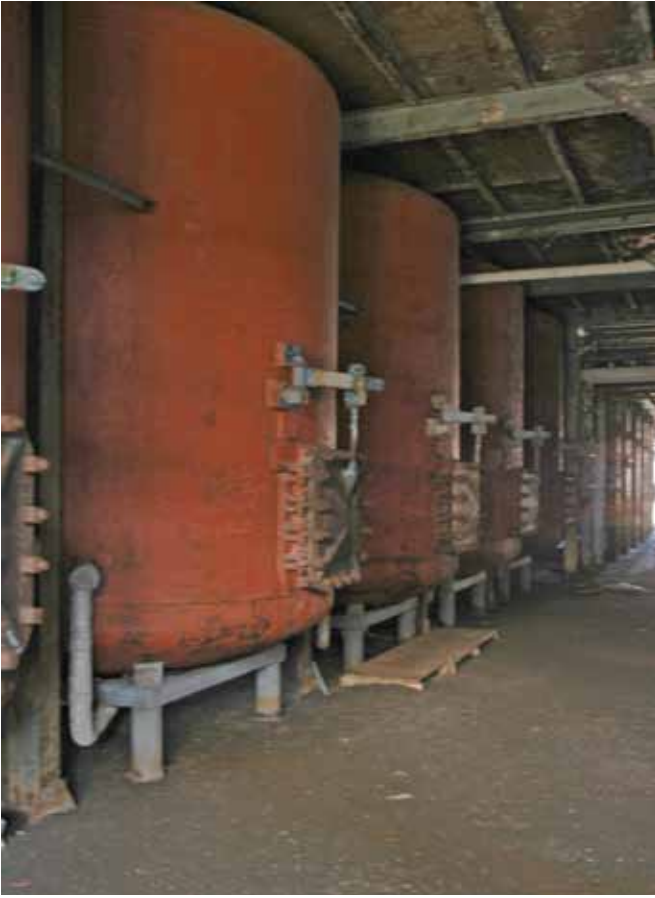
6.4 Bone cookers looking southwards

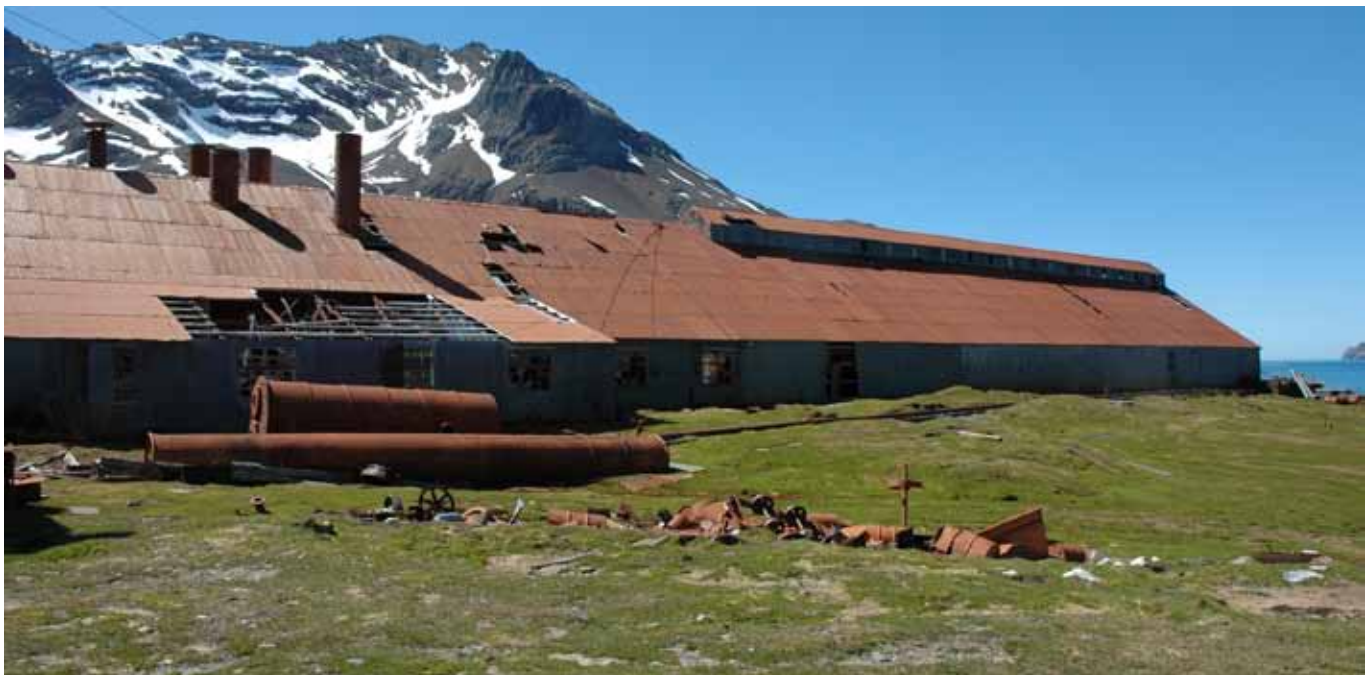
There is a significant amount of damage to this building. A small amount of wall sheeting is missing on both north and south sides. Ten bays have lost half or more of their sheeting. On the north side of the east end several of the columns are bent, though this looks as though it's where they have been hit by machinery. The structure is reinforced at the west end by the additional steel work to support the machinery above and around the plant. On the north side of the building are two outshots, both would appear to be earlier buildings which have been left in place when the new building was erected with doors cut through into them. The building to the northwest is timber framed and partially collapsed. That to the northeast is a bigger more substantial building with a heavier steel frame and trussed roof. The majority of the cladding sheets on this building are still intact although the roofing sheets are starting to go in the northeast corner.

10.2 The south side of the building

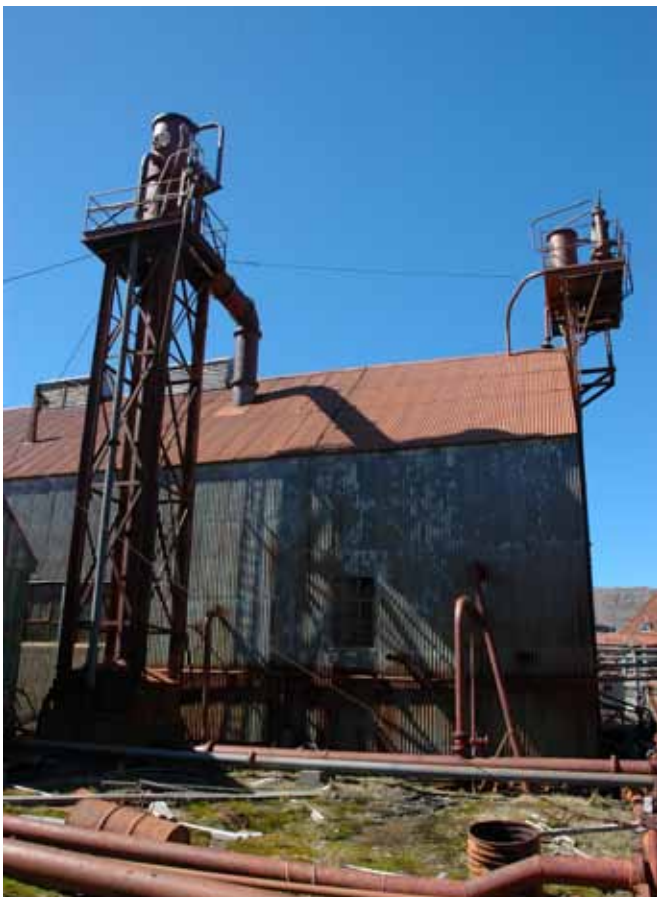
12.2 The west side of the building

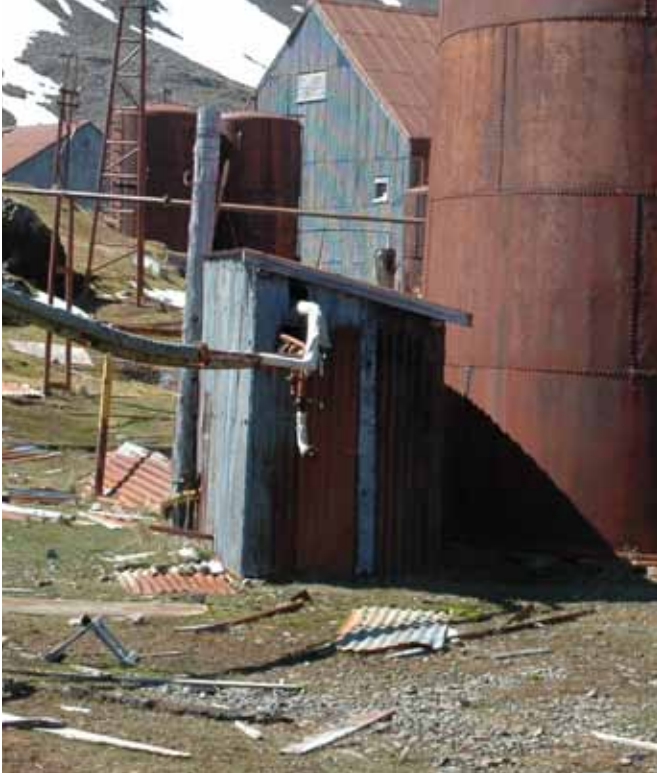
14.1 The south elevation

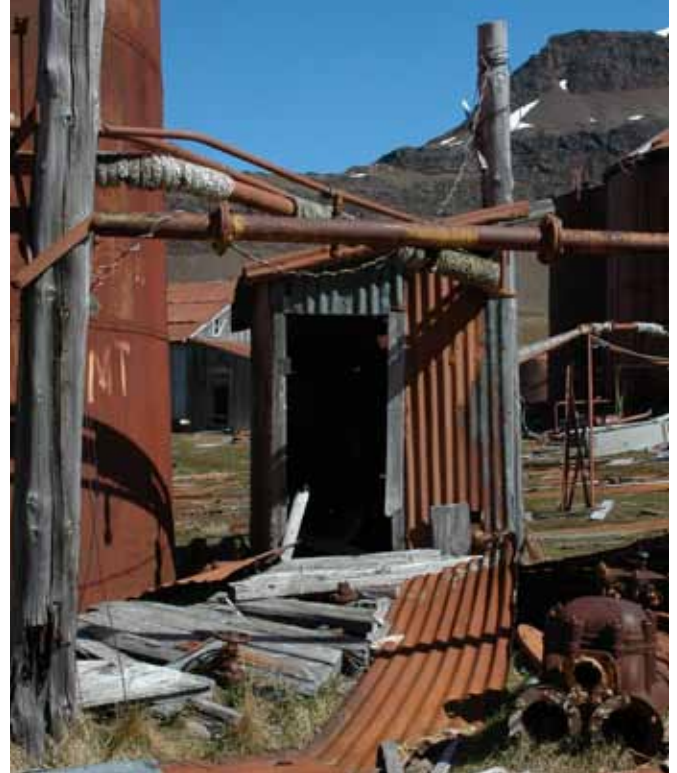
A small Pump House standing next to the tanks on the northwest end of the separator plant. This is a single storey timber framed building with a mono-pitched roof all covered in corrugated iron. The entrance door on the north side has fallen off. The pump remains in the building.

14.2 The north elevation

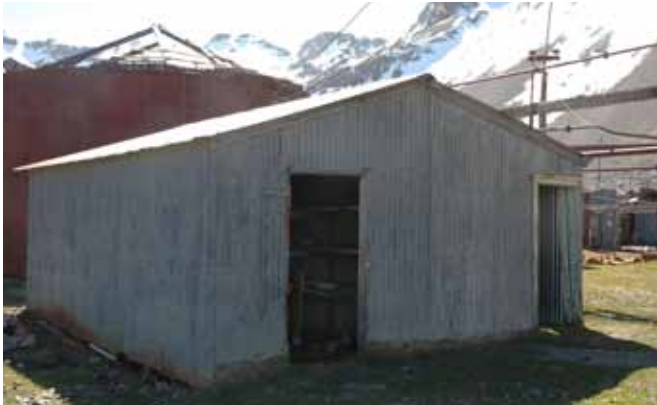
The store has been added later on the south side with a reverse mono-pitch giving the appearance now of a normal pitched roof. This is a simple timber lean-to with a wall plate fixed through the corrugated iron of the lavatory block and fitted out with shelving for storage. The sheeting towards the roof is in reasonable order. The east door is now missing.

15.1 Southeast elevation

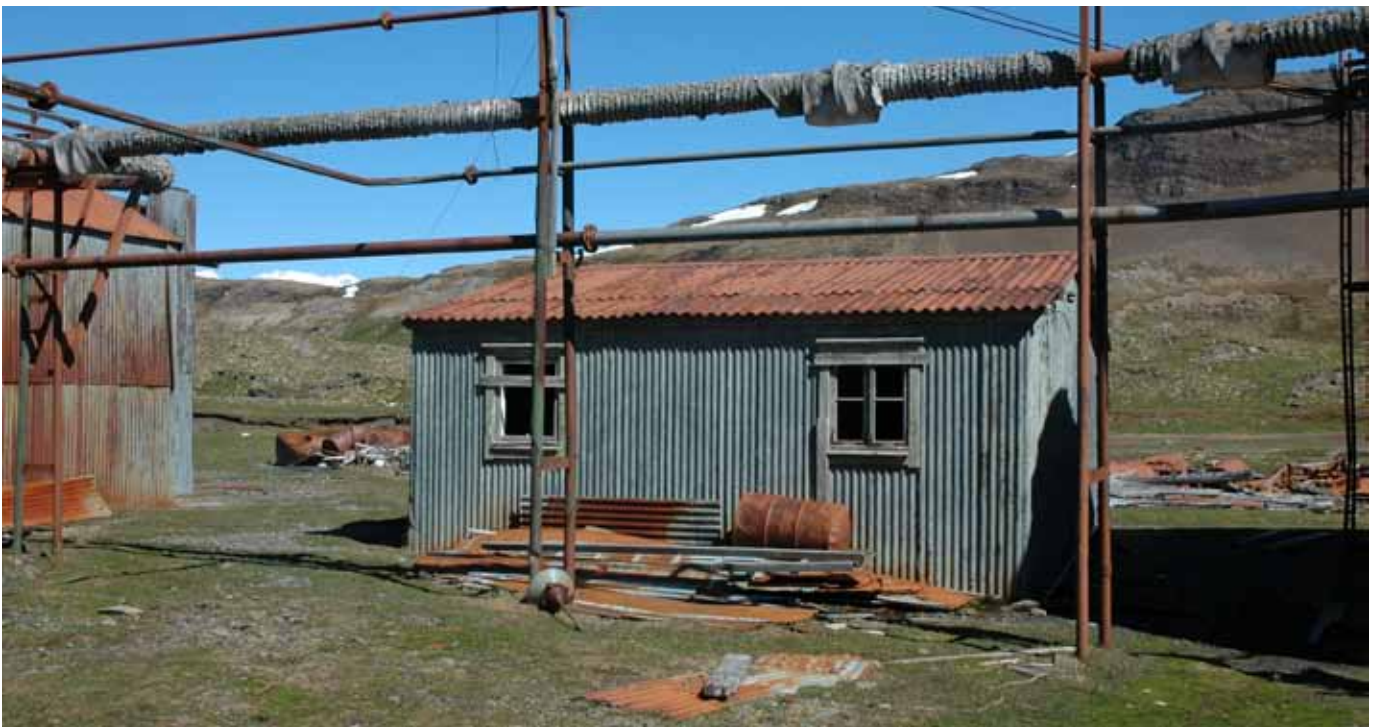
15.3 Northeast elevation

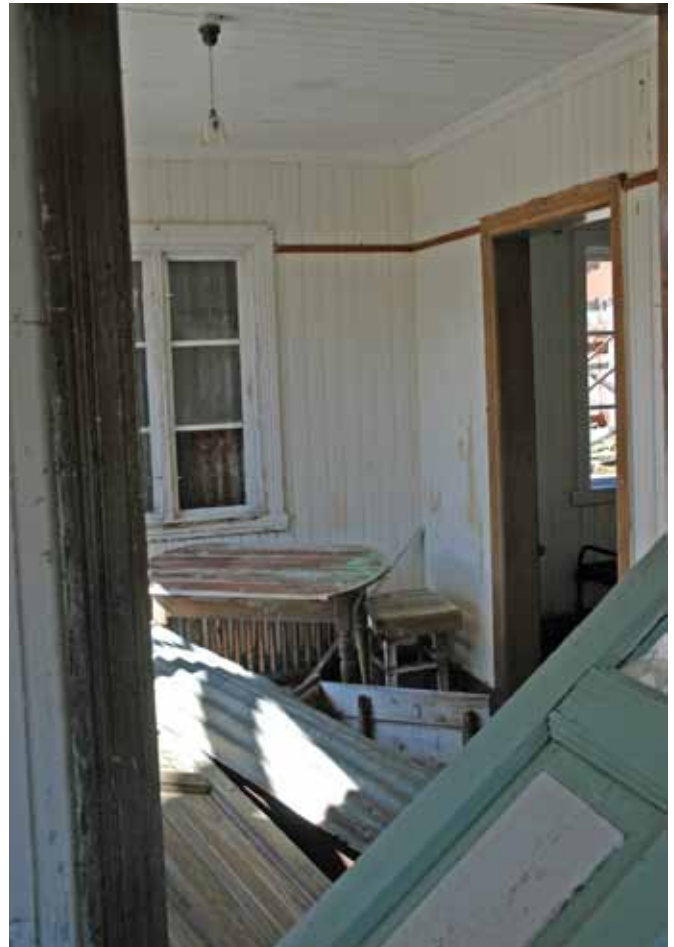
17.1 The north elevation

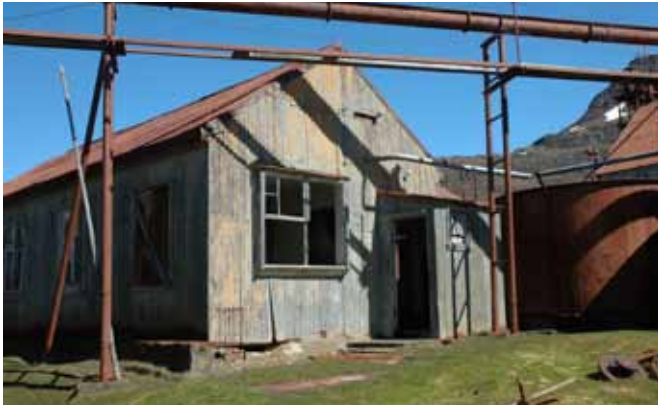
17.2 Typical interior space

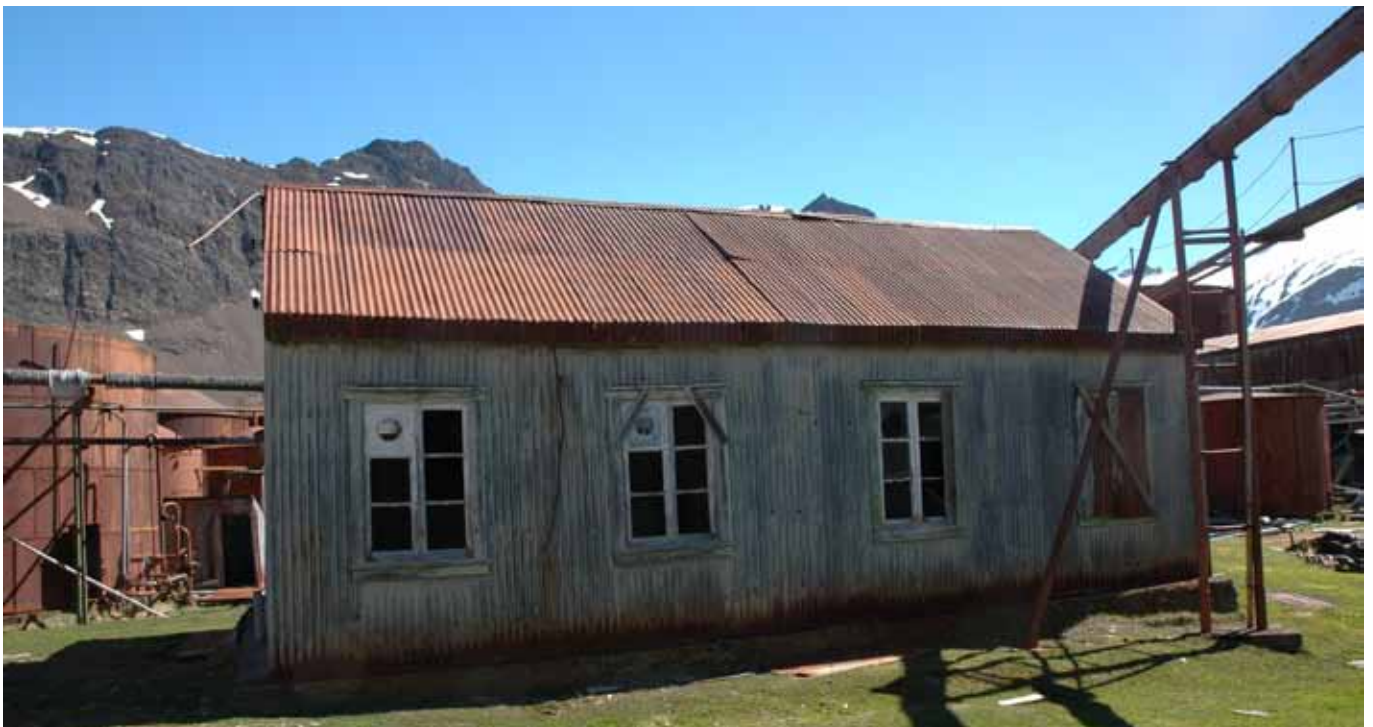
17.3 The east elevation

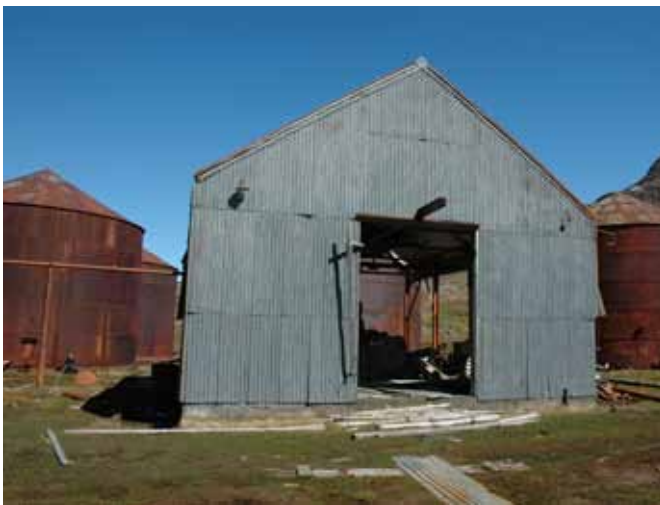
18.1 The north elevation

The Pump House stands on a concrete base with a concrete upstand, with a slatted suspended timber floor over the concrete internally. The building is steel framed with a trussed steel roof. The cladding is completely missing from the south end gable wall and from the west wall. The roof sheeting is missing at the southwest corner and northwest corner.

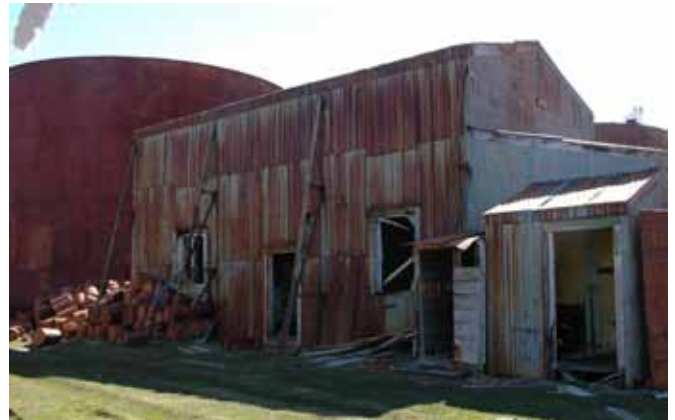
19.1 The south elevation

The original timber floor has rotted away and props have been added under the centre and either end of the balcony. The rather slender steel channels making up the walls are corroding and cracking the masonry away from them. Infill between the columns is in single skin brickwork which is damaged and falling away in several places, particularly on the south wall. This building is in poor condition and not likely to last a great deal longer.

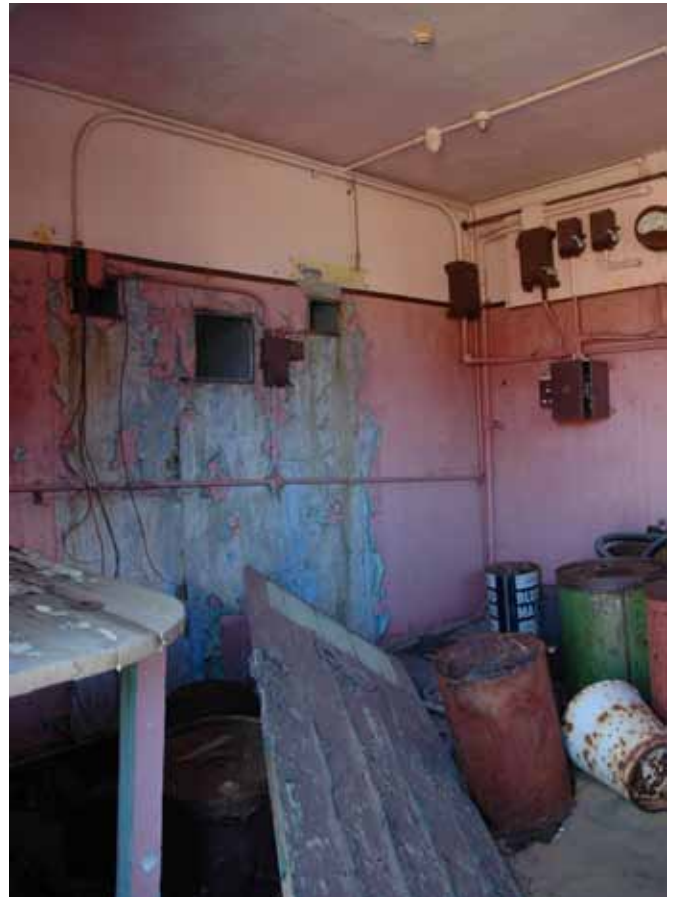
19.4 The projection room

The projection room is now in a separate small rectangular timber framed building; the floor being some 600 above the ground level, presumably to get the projector at the correct height.

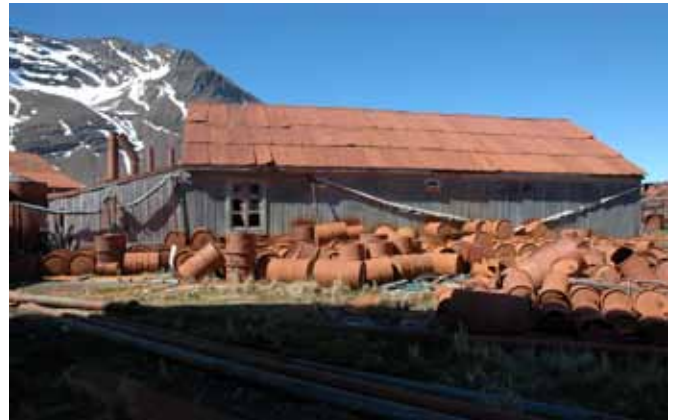
20.1 The west elevation

There is no obvious access to any roof void from the interior but a door in the south gable gives access to a roof void where substantial king post timber trusses are visible with purlins between the trusses supporting the corrugated iron. The corrugated iron to the walls is generally in fair order but a good deal of the sheeting is missing to the roof, particularly on the east side. The sheeting on the west side is generally all present but it is considerably disturbed at the north end and one sheet is lifting and cracking at the south end. At the north end of the building is a lean-to. On the east side this contains switchgear and on the west side it has been a store room, although the roof of this and the north wall have now completely collapsed.

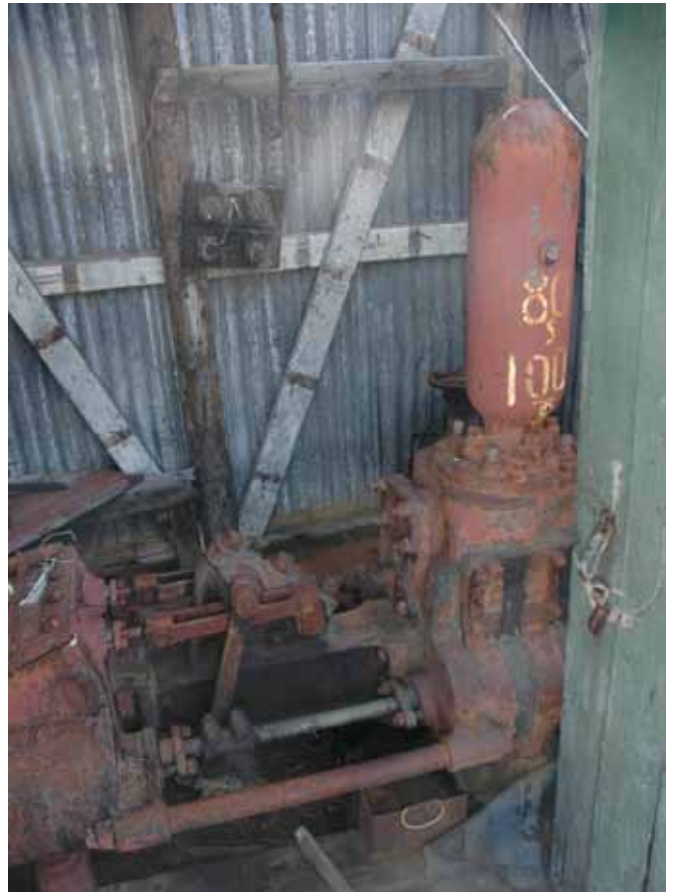
21.1 The interior

The original building to the north is a small rectangular building with a pitched roof built from corrugated iron on timber frame. The north side of the roof is now missing and the wall sheeting damaged on the north side. The southernmost part of the building is a later and simpler lean-to building, a mono-pitched roof with barely any fall and miscellaneous framing timber internally.

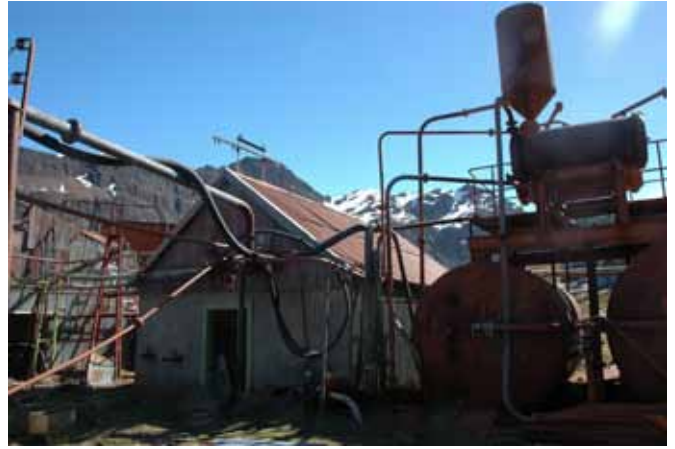
23.1 The south side of the building

A small pump house immediately north of the separator plant. The building has concrete walls up to wall plate level. These have been cast against corrugated iron sheeting which has then been removed. No floor is visible though there may be a concrete floor under the silt covering it. This is probably the result of water washing through here. The actual floor level would appear to be 400 or 500mm below the present level of the silt judging by the location of the plant. The roof consists of four steel trusses supporting timber purlins and corrugated iron sheeting and also in the gable end the roof sheeting is heavy gauged, that to the gable ends much lighter.

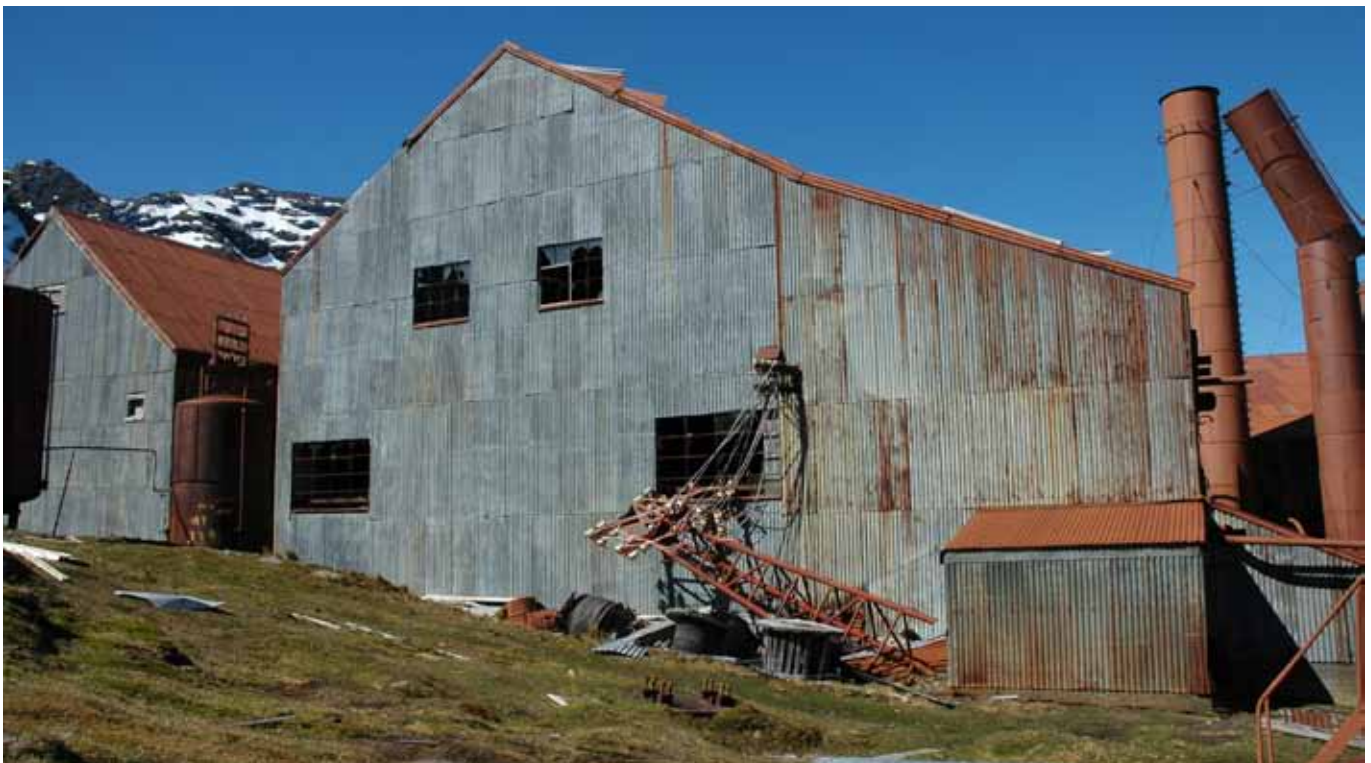
24.2 The west elevation

The roof, however, is in poor condition with approximately 30 percent of the sheeting missing from the south slope of the building and 30 to 35 percent of the sheeting missing from the north slope, in both cases on the west end of the roof slope. Some of the remaining sheeting is disturbed and loose.

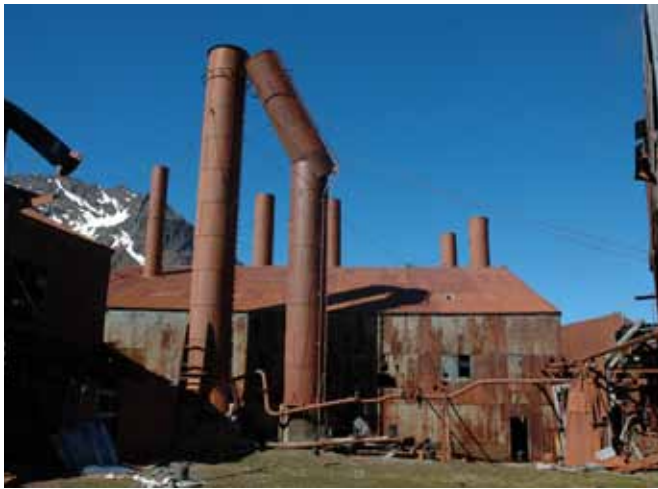
25.4 The west elevation

There are 'windows' on the walls, also in plastic sheeting, most of which has fallen away. There are one or two loose sheets of corrugated iron on the walls but generally the cladding is still reasonably sound.

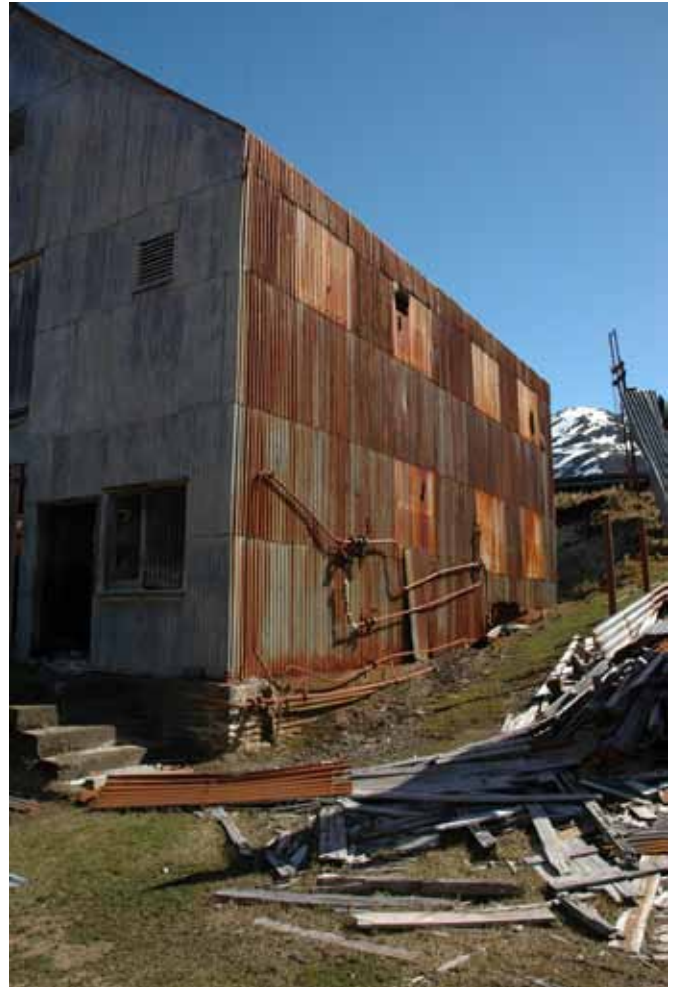
28.4 The north elevation

The wall sheeting is generally in reasonable condition other than the plastic which has been used in the ground and first floor to give daylight. This has failed on both north and south sides.

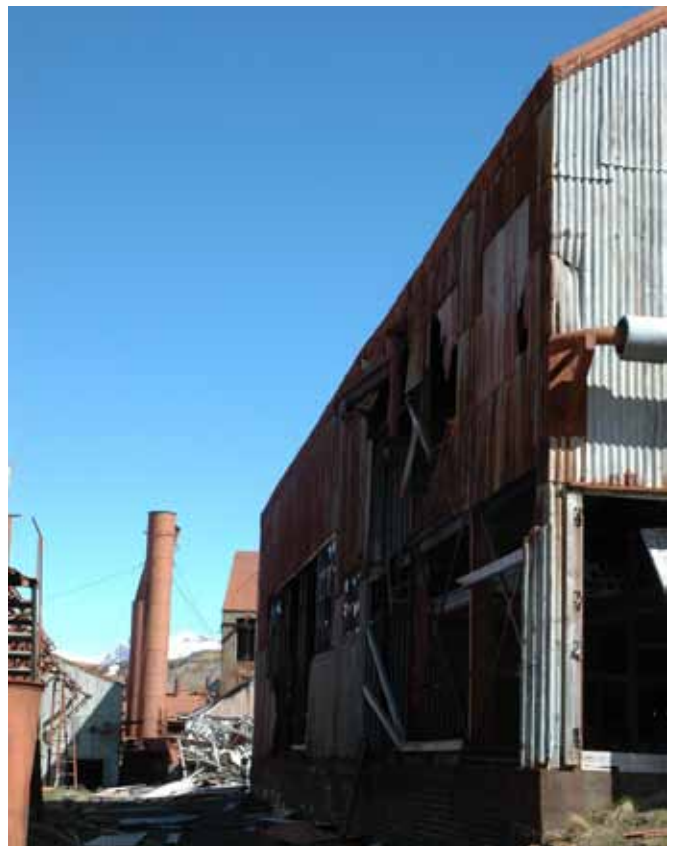
30.5 The east elevation

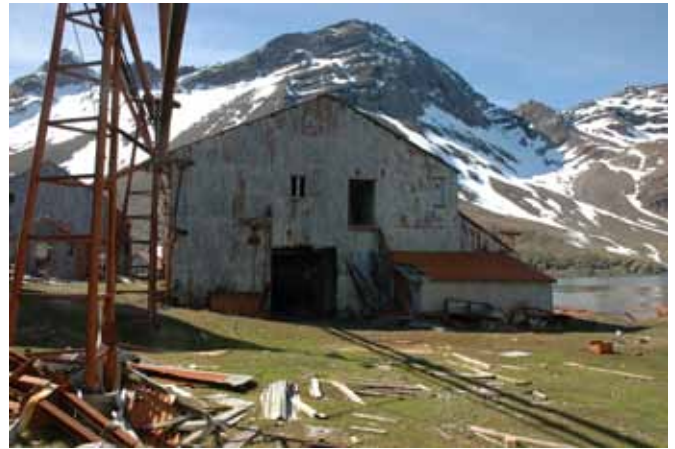
This is at least three, and possibly four, different phases of building. At the south end is a two-storey metal framed building clad internally with timber board and externally with corrugated iron. It has a heavy timber floor with 50mm thick boards which has some propped steel beams supporting the floor joists. The upper floor appears to have been used as additional workshop space and storage.

31.1 The south elevation

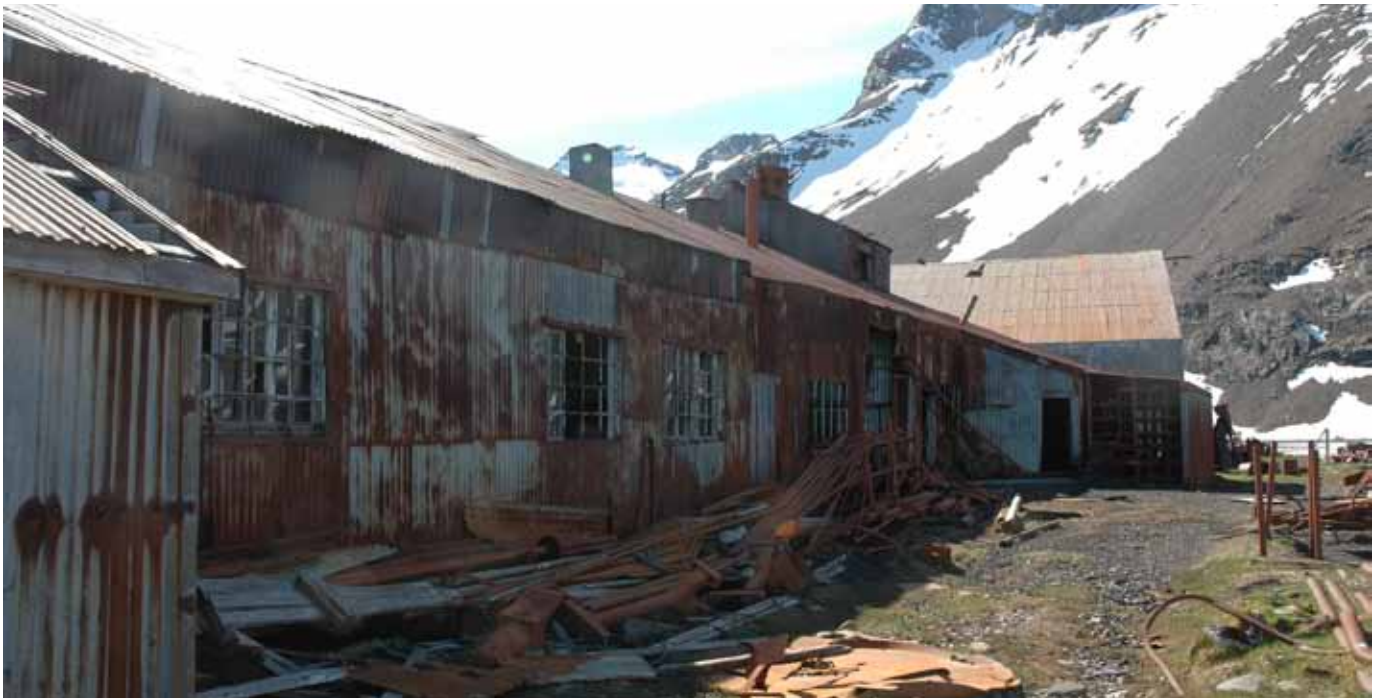
There is a pair of corrugated iron lean-tos on the east side. That to the south attached to the engineering shop is losing its corrugated sheeting and a section of the walling has fallen away. There is a good sized heap of coal outside the north wall of the forge area blocking the doors into this space.

On the west slope of the building some of the sheeting (around 10 percent) is missing from the north end of the building over the higher section of the forge and three or four sheets are missing from the lower level section of the workshop. The west slope at the higher level section has two sheets missing over the office/bedroom area.

31.3 The east elevation

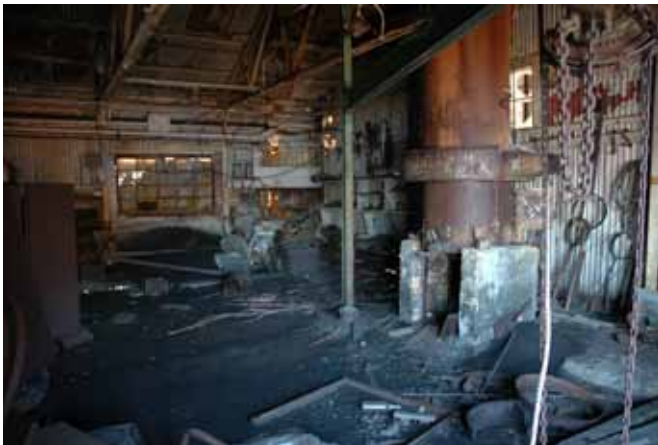
To the north of this section of the building is a blacksmiths shop with a forge to the north. This may all be one building but it is sub-divided by a corrugated full height wall. The roof does not meet exactly and the sheeting arrangement is slightly different suggesting that they may have been built on separate occasions. Both the Forge and Blacksmiths Shop have iron windows to east and west and the Blacksmiths Shop has a large pair of doors to the east which are now fallen in. The Forge door to the east remains in place but is unusable. Neither buildings are lined internally; both have steel frames with steel trusses. The Forge has a large flue over a central furnace and a smaller flue over a secondary furnace with some sort of kiln on the north wall. The flues protrude just above the roof. The smaller flue still has a cap but the larger flue's cap has fallen off.

31.4 The Blacksmiths Shop at the north end

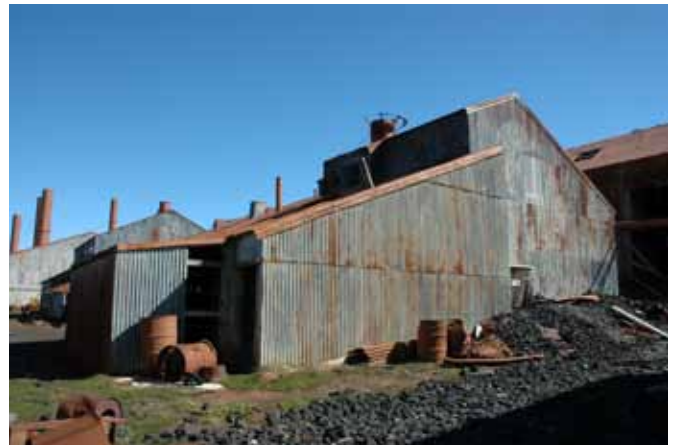
31.5 The north elevation

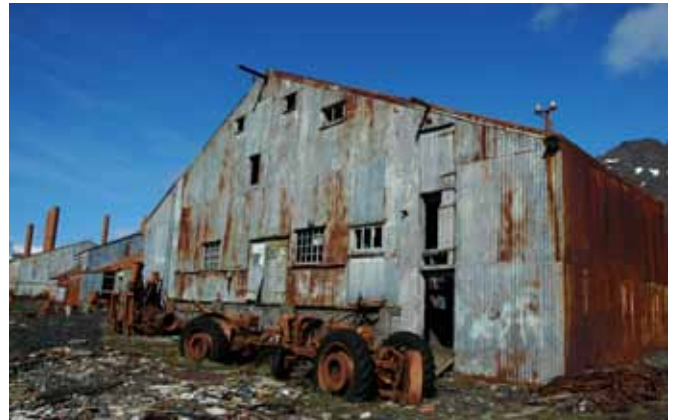
To the south side of the main building there is a simple lean-to with steel columns and steel principals with timber purlins and boarding over. There are windows on the east side which are still intact. The windows in the southern outshot, five in number, have clear plastic sheeting over them, three of which now have holes. To the north of the main part of the shop is a store for metal rods. Above this there appear to be two levels of timber storage though these were not accessed. The metal rod store had doors on it although these have all fallen away. There was also a timber framed outshot to the north side which appears also to have been used for storage of timber.

32.1 The east elevation

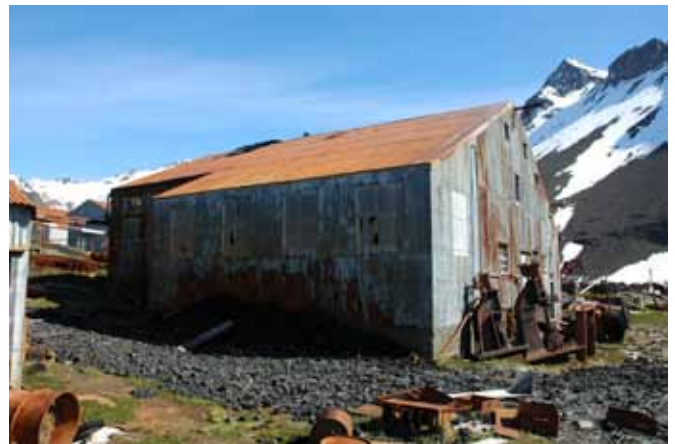
32.2 The south elevation

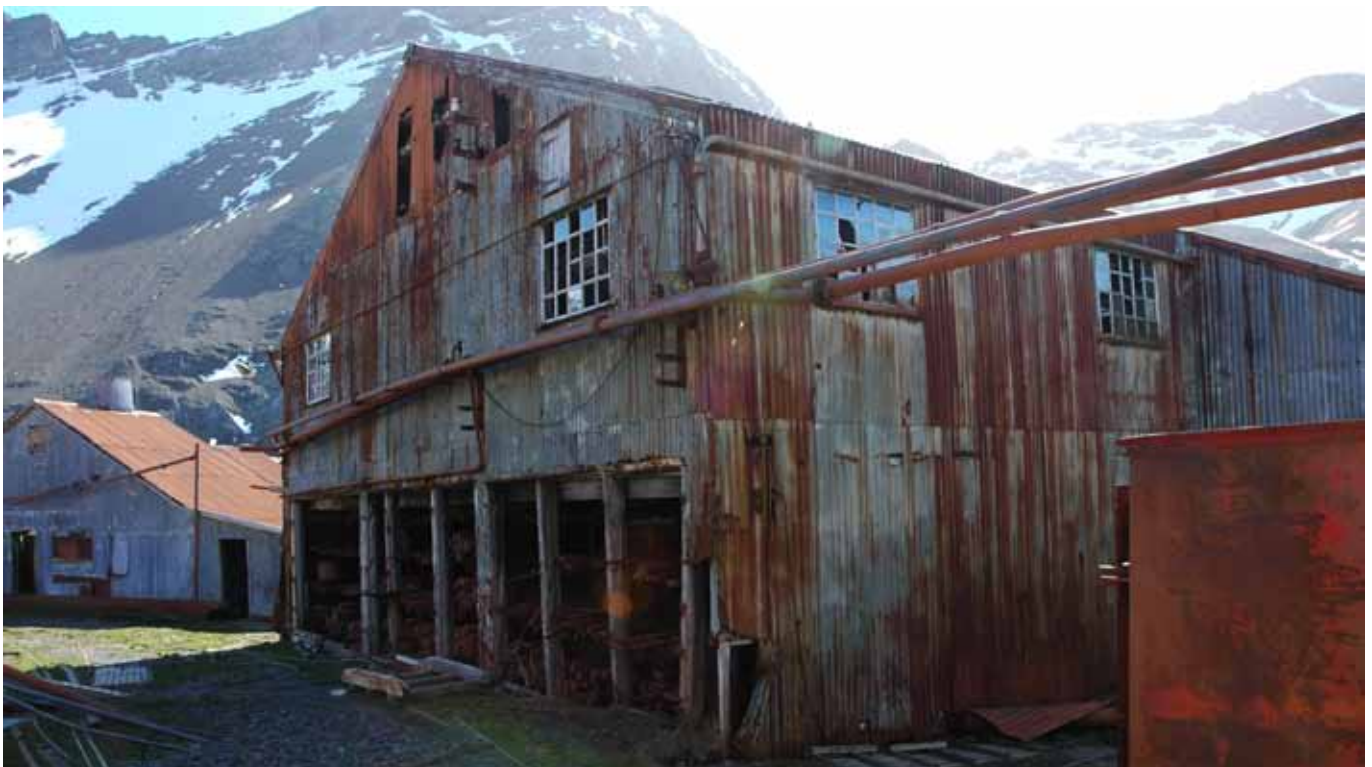
The corrugated iron external sheeting to the wall is damaged and partially missing on the north side and there are holes at high level on the west side. There are holes in the roof on both the north and south slopes, perhaps 5 percent of the roofing missing in total.

32.3 The west elevation

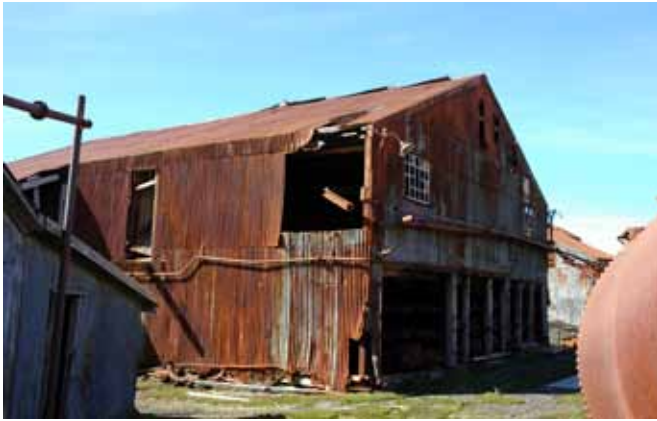
32.4 North and west elevations

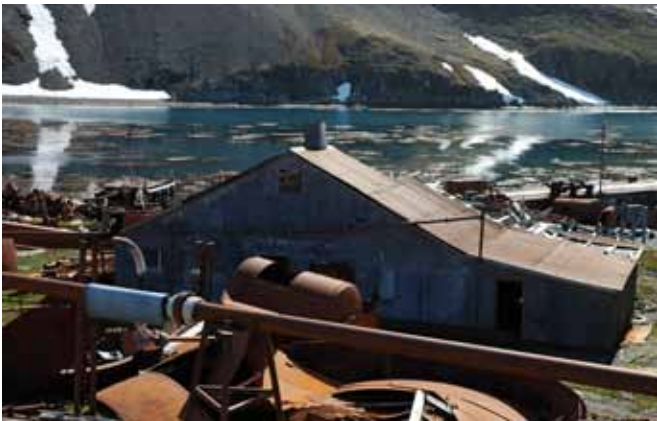
33.2 General view of the Pig Sty looking northeast

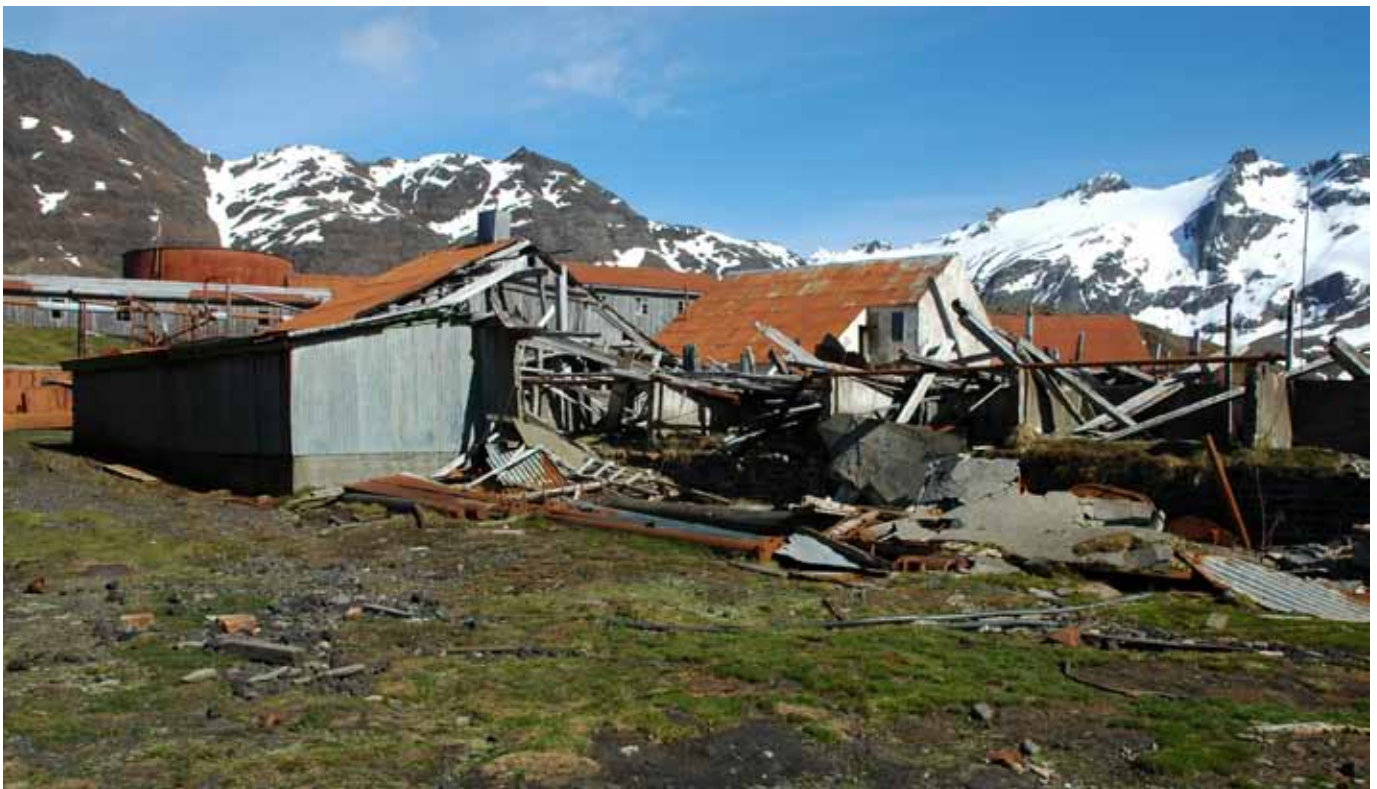
33.4 The remnants of the Pig Sty looking westwards

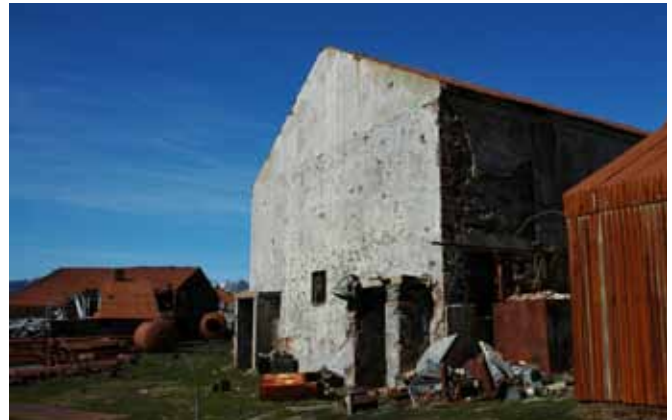
A substantial building built in brick rendered inside and out with concrete floors at both ground and first floor level. The Slaughterhouse appears to have been the southernmost chamber with a butchers shop behind it. The central area has a butchers shop and a substantial cold store on the ground floor to the south and then to the north is a plant room with a workshop behind it. The first floor appears to be a further cold storage accessed by a solid concrete stair. The walls are still in reasonably good order although the render is beginning to fall away and the northeast porch concrete roof is failing.

35.1 The east elevation
