DISUSED WHALING STATIONS

Leith Harbour Gazetteer

Gazetteer, July 2011

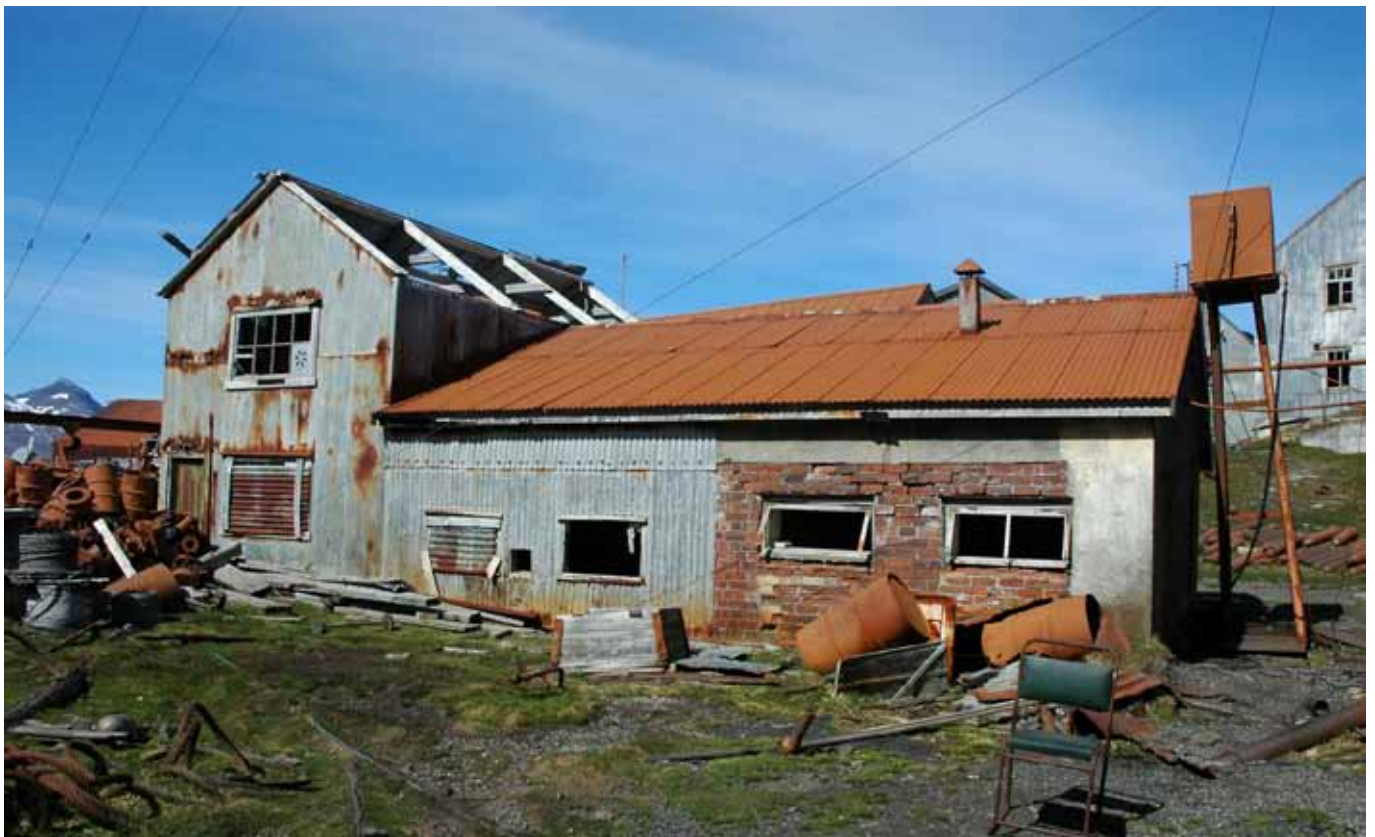
The single storey section to the north is in better condition. There has been some extension to the northeast corner judging by the lack of render on the brickwork and the roofing felt which remains attached to the eaves board. Possibly there was a greenhouse on this face of the building.

38.2 The northeast elevation

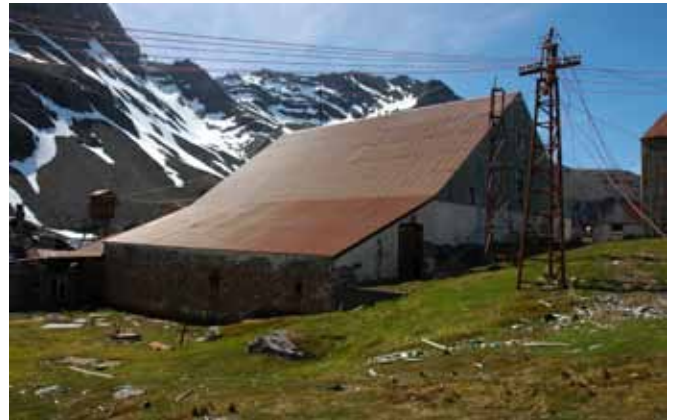
The lean-to on the north side appears to have been built as an issue store with first floor storage. The first floor is level with the ground at the rear of the building and the first floor sits on the very substantial steels that form the bottom chord of the half trusses in this area. The render has fallen away from the north wall (i.e. the wall of the lean-to) and there are several loose sheets of corrugated iron on the lean-to roof and some sheets becoming loose at the east top of the north roof slope, but generally this building is in fair condition.

40.1 Northwest and southwest elevations

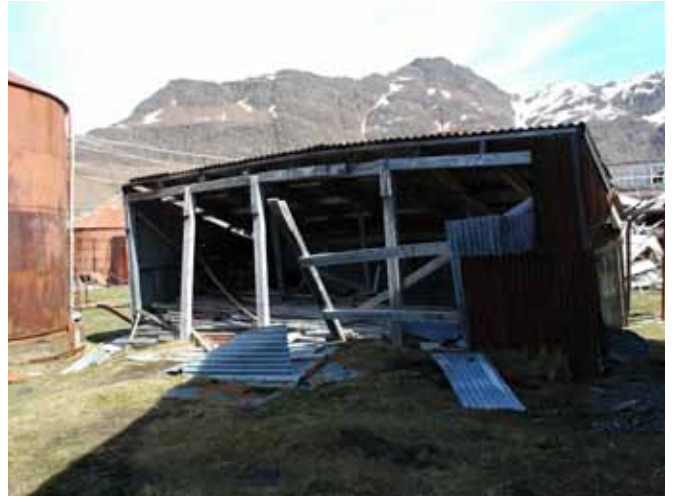
42.1 The east elevation

A small timber framed building clad in the large gauge corrugated sheet. The roof is a mono-pitch falling from east to west. Part of the north wall has fallen away and the whole of the south wall has fallen out. This building will not remain here for much longer.

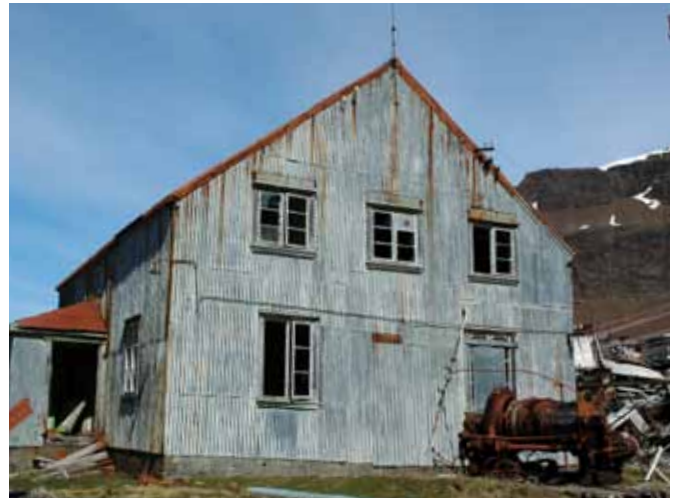
43.1 North and east elevations

A two storey accommodation building with unlit loft space. The building is mounted on a concrete plinth to level it up with the ground, raising the ground floor approximately a metre above the lowest point of the surrounding ground level. Windows on all sides appear to be the original side hung casements. One or two of these have been covered over with corrugated iron. The ground floor is of suspended timber which has collapsed in the area of the entrance. The centre of the building appears to have subsided with distortion to the floors. The first floor was not accessed.

The interior is boarded out and in some places covered with hardboard. There is generally a timber cornice under the boarded ceiling and moulded architraves to panelled doors. There is a timber porch on the east side which is covered in the small gauge corrugated iron. The steps up to the porch have collapsed and the external door has been removed from its hinges. The porch floor has collapsed. Several of the internal doors are off their hinges or otherwise damaged. This looks more like forced entry than wind damage.

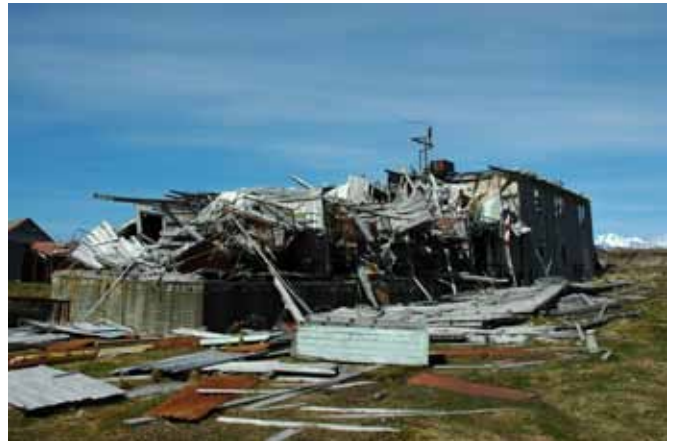
Both have collapsed in a comprehensive manner. The buildings appear to be very similar in their construction; both have concrete basements with a concrete ground floor slab and then timber stud framing above of two storeys, with further accommodation in the roof space.

44.1 The north and west sides

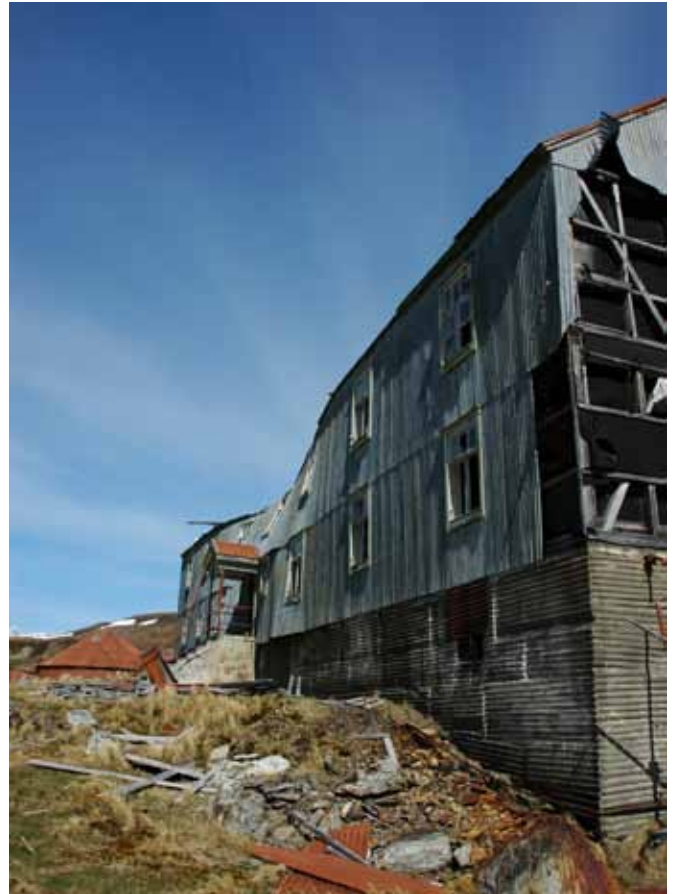
Building No.45 has a porch more or less in the centre of the east side with three large windows and one small window either side of the porch. On the first floor are seven bays of identical windows. This east wall of the upper barracks is the only significant amount of walling remaining with a very small section of roof at the north end and the remainder of the building has comprehensively collapsed in a tangle of partitions, beds, pipes, sanitary fittings etc. The construction appears to have been from 125x50mm timber framing with building paper and vertical boarding to the exterior which has then been sheeted in corrugated iron and vertical boarding to the interior, the void being filled with Kapok or some similar insulating material. It seems likely that these buildings will collapse completely in the next year or two.

45.3 The remains of the east front

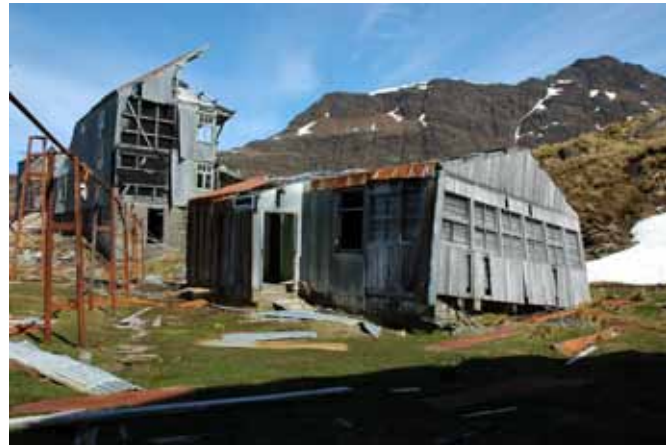
46.1 The north and east elevations with Hillside Barracks in the background

A small rectangular single storey building with a porch on the east side and the roof pitch running north/south. The building is constructed with continuous windows around the north and west sides of the main space, though these have been boarded in (and from the look of it were probably boarded in quite early in the hut's life). The hut is timber framed with vertical external boarding and horizontal internal boarding which has been covered over with hardboard to the walls. There is a softboard ceiling. The west wall of the hut has more or less collapsed with the floor subsiding at the northwest corner and the roof still in position but only just. A small amount of corrugated iron remains, though most of it has blown off. This building will collapse in the next year or two.

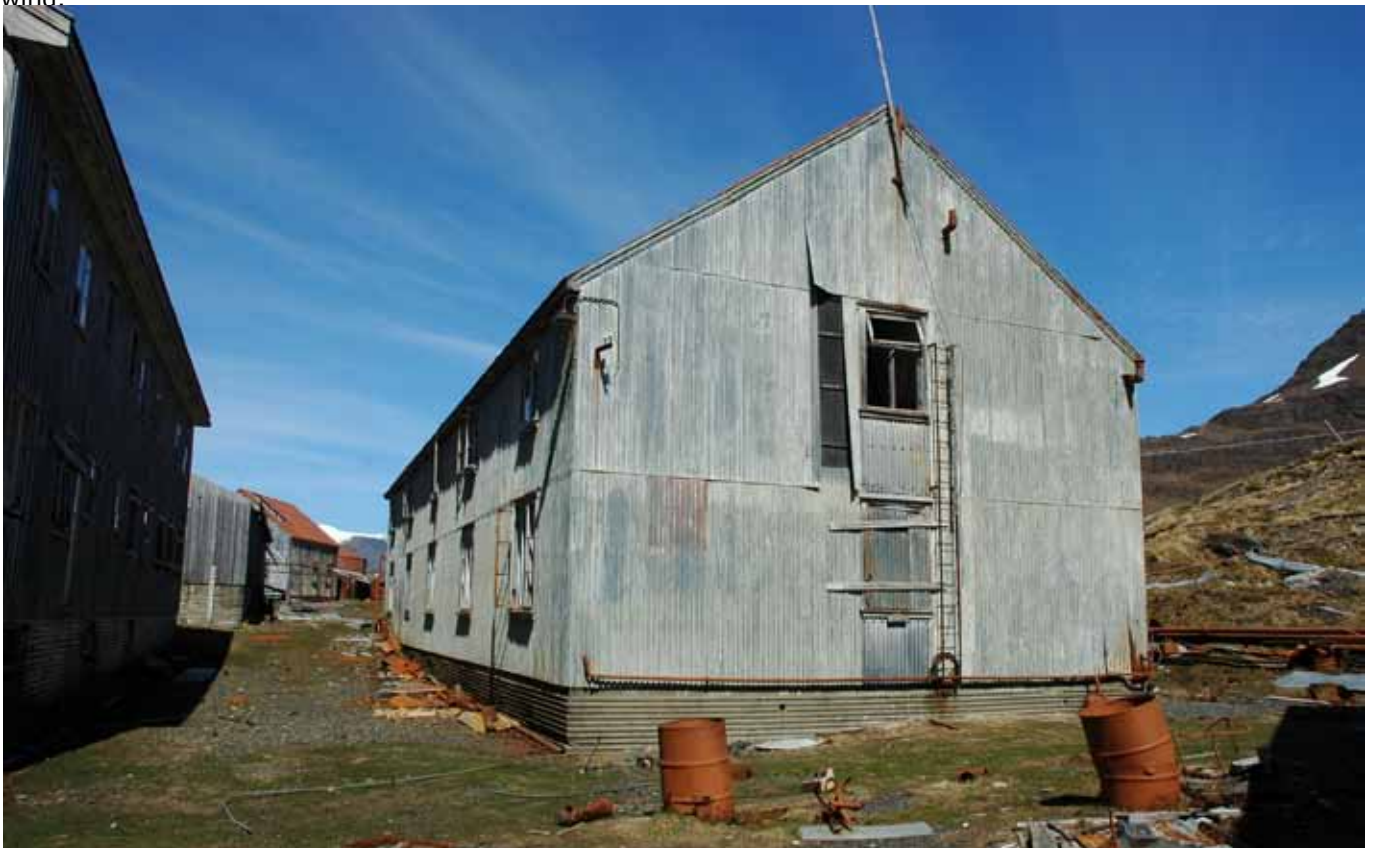
47.2 The north elevation

The metal cladding to the walls is in reasonable condition with some loose sheets at the northwest corner. The west slope of the roof has all sheets present but a number are clearly lifting and must be at risk. The sheeting on the east slope is also all there but, again, there are fourteen or fifteen sheets which are loose at one edge and must be at risk. Timber windows are generally all present; one or two have been boarded over but generally they remain with side-hung casements though no glazing and the casements are clearly blowing about in the wind.

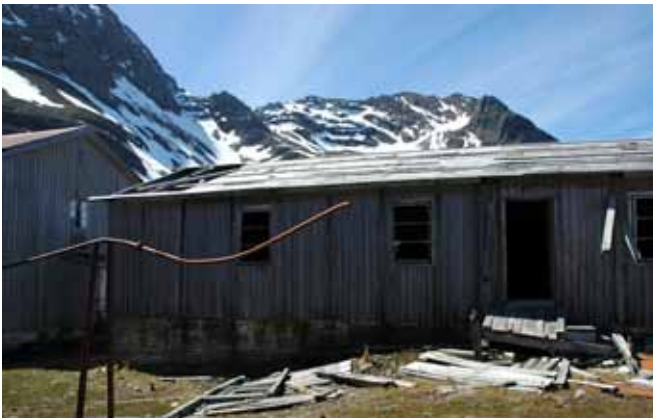
48.2 The west elevation

This hut is built on a higher concrete base to take account of the steeper ground level at this point. The ground floor is 1700mm above the lowest point of the external ground. A single storey rectangular building with a pitched roof running north/south. The building is in Bratiled timber boarding. There are four windows and an entrance door on the west side, two windows on the south side, five windows on the east side and two windows on the north side. The external timber cladding is generally in fair condition although there are some loose boards on the north side of the building. The roof is relatively shallow in pitch and is covered in timber boarding with some roofing felt held down by battens and then corrugated iron over this. The corrugated iron has gone completely from the west side of the building and a small amount remains on the east side.

This hut is beyond sensible repair.

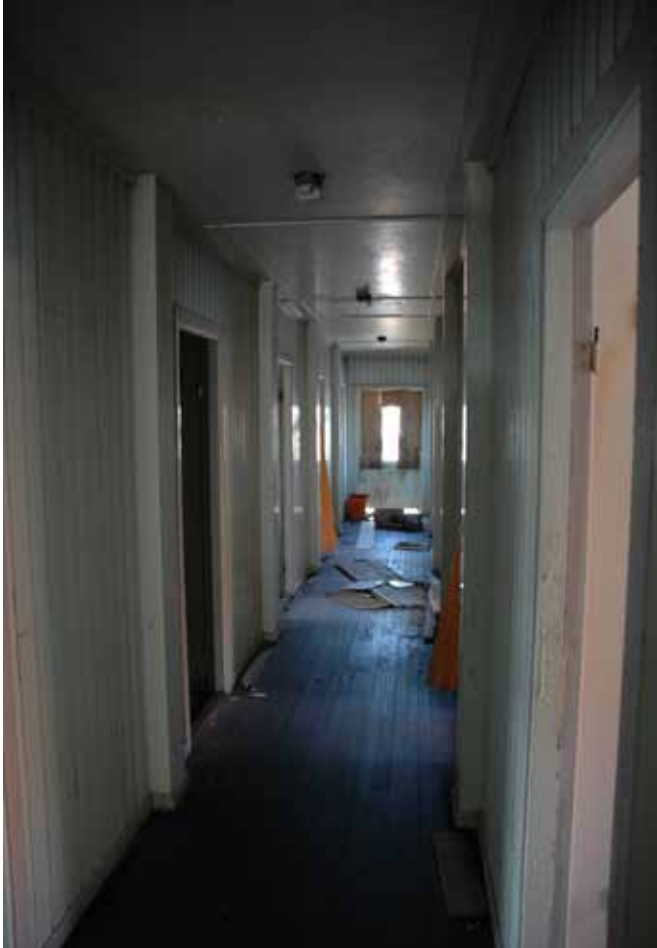
49.3 Central passage

The suspended timber floors are all made from narrow pine boarding and the internal walls are all boarded out and painted. Doors here are generally flush doors with an unpainted veneer finish. Either this is a later building or it has been refitted. There is a good deal of damage inside though most of this appears to be forced access and vandalism rather than any wind damage. The ceilings throughout are of softboard held up with narrow timber battens and there appears to be insulation between the ground and first floors of the loose Kapok type.

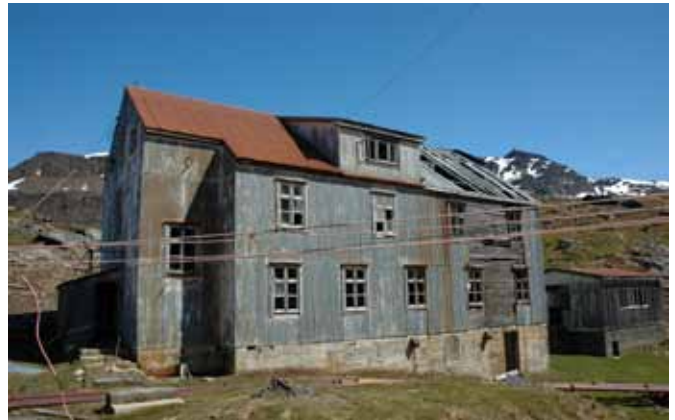
50.1 Northeast elevation

The building is timber framed, clad externally in corrugated iron over boarding. This external cladding is in reasonable order on all sides except the east side where a large section of the corrugated sheeting is missing and the timber boarding is exposed beneath. This is in poor shape and is now beginning to collapse.

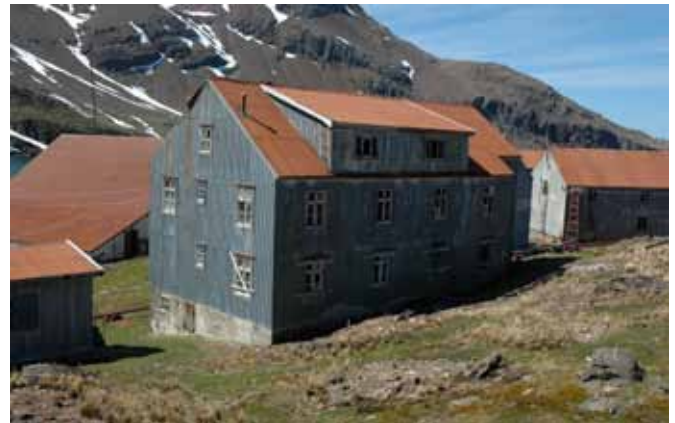
50.2 Northwest and southwest elevations

Whereas the roof is in reasonable condition on the west side, on the east side the whole of the north section is missing and a good deal of the boarding has also fallen in. Internally at first floor level the floor under this area now has a substantial amount of wet rot. It seems likely that this end of the building will collapse in the next few years.

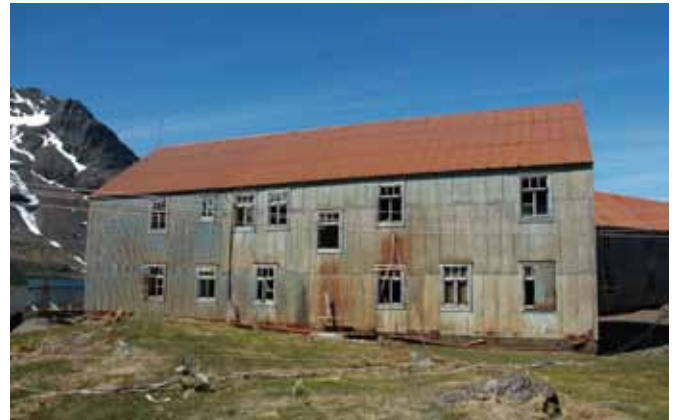
51.1 Northwest elevation

Externally this building looks reasonably solid but internally there are signs of some of the internal walls sinking.

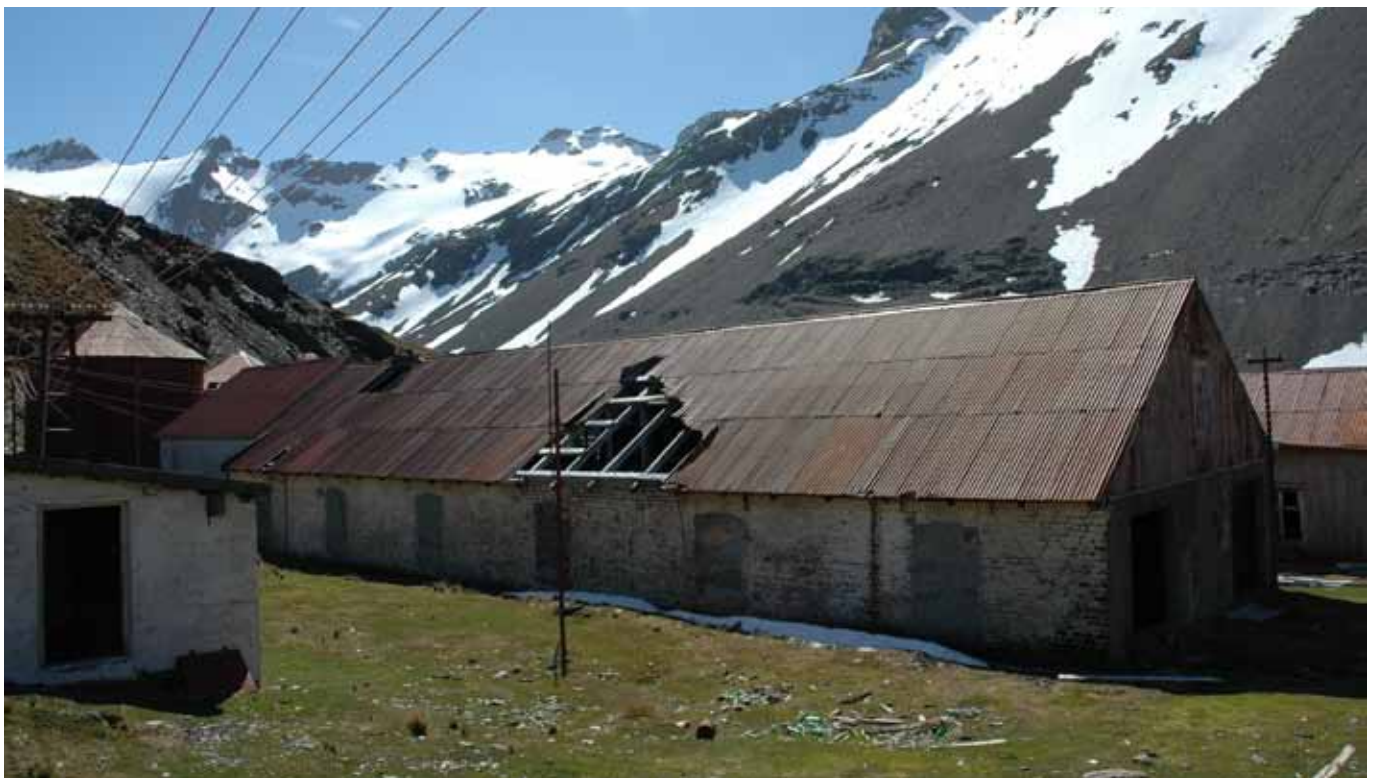
52.3 Southwest elevation

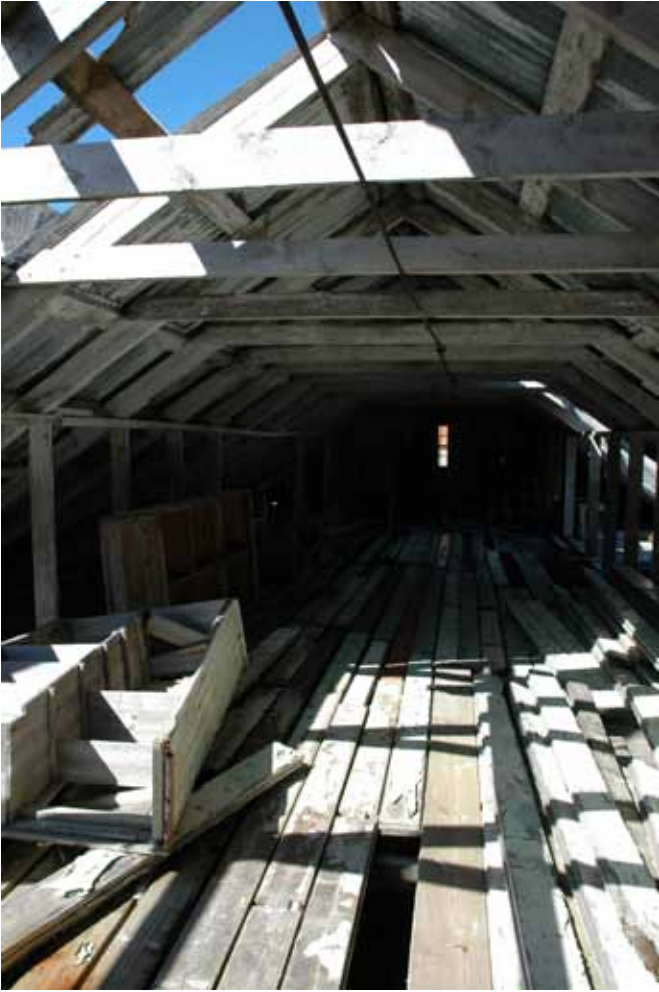
52.4 Interior of roof storage area looking southeast

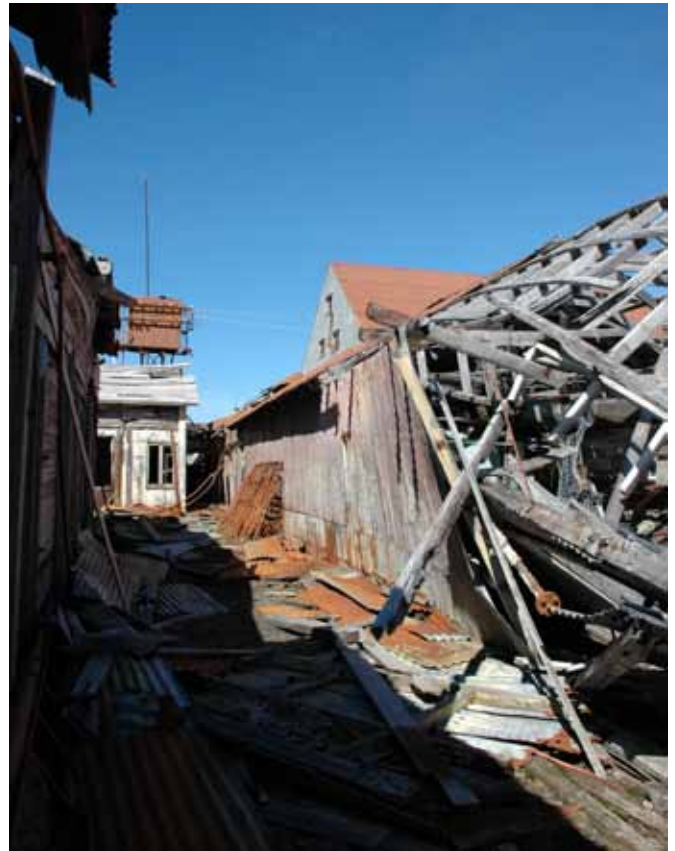
This is really two buildings though they are joined together. The most part is a two storey building, which seems to have been substantially altered over the years. The original part of the building was probably rectangular of the Norwegian type with thick boards with dovetail joints at the end. This appears to have been added to with lean-tos against both the north and south sides with an extension east (which has now completely disappeared). The building is generally collapsing with the southeast corner having entirely collapsed. The building had one, or possibly two, brick chimneys; one now remains in position. Some corrugated sheeting is still on the remaining section of roof. The suspended timber ground floors have all completely collapsed. This building is really only staying put because of the strength of the interlocking Norwegian building system.

53.1 The northeast elevation of the main wing

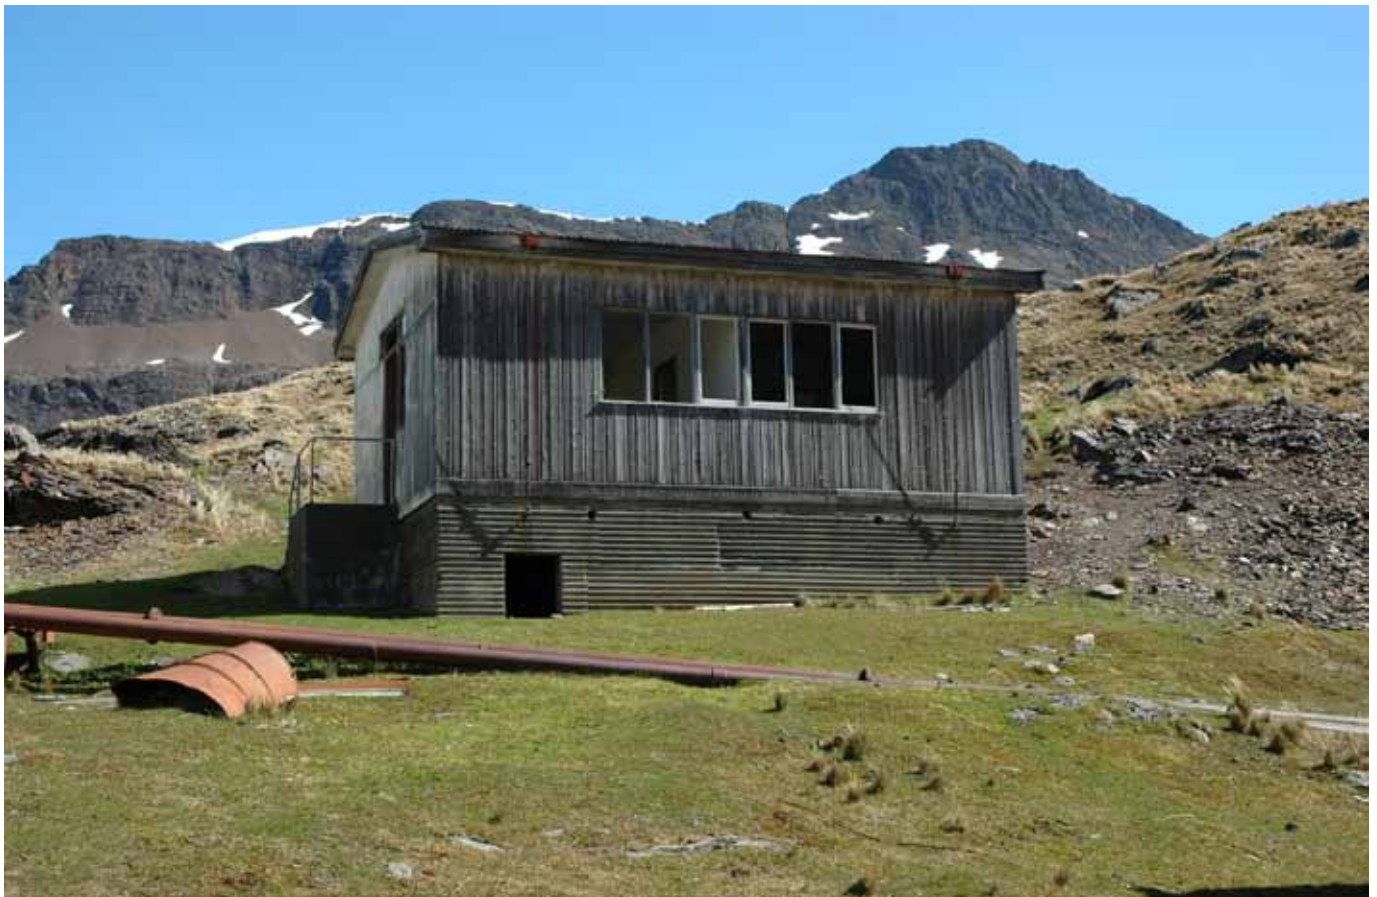
54.2 Northeast elevation

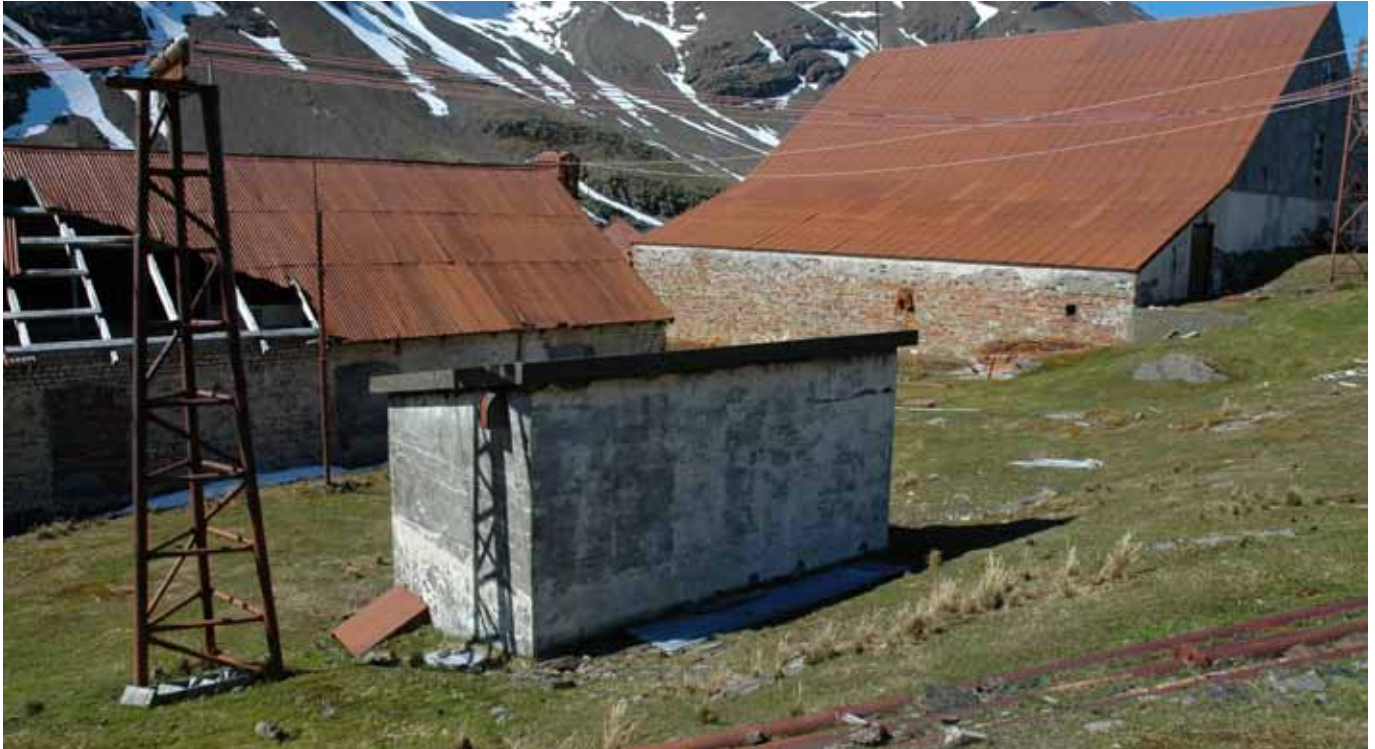
This building is built in solid one brick thick rendered externally with a solid concrete floor and a concrete slab roof. The entrance door is on the south side and still intact as is the internal switchgear. There is some cracking in the north walls possibly caused by corrosion of some internal reinforcement to the brickwork. Generally this building is reasonably solid.

55.1 West side of the building

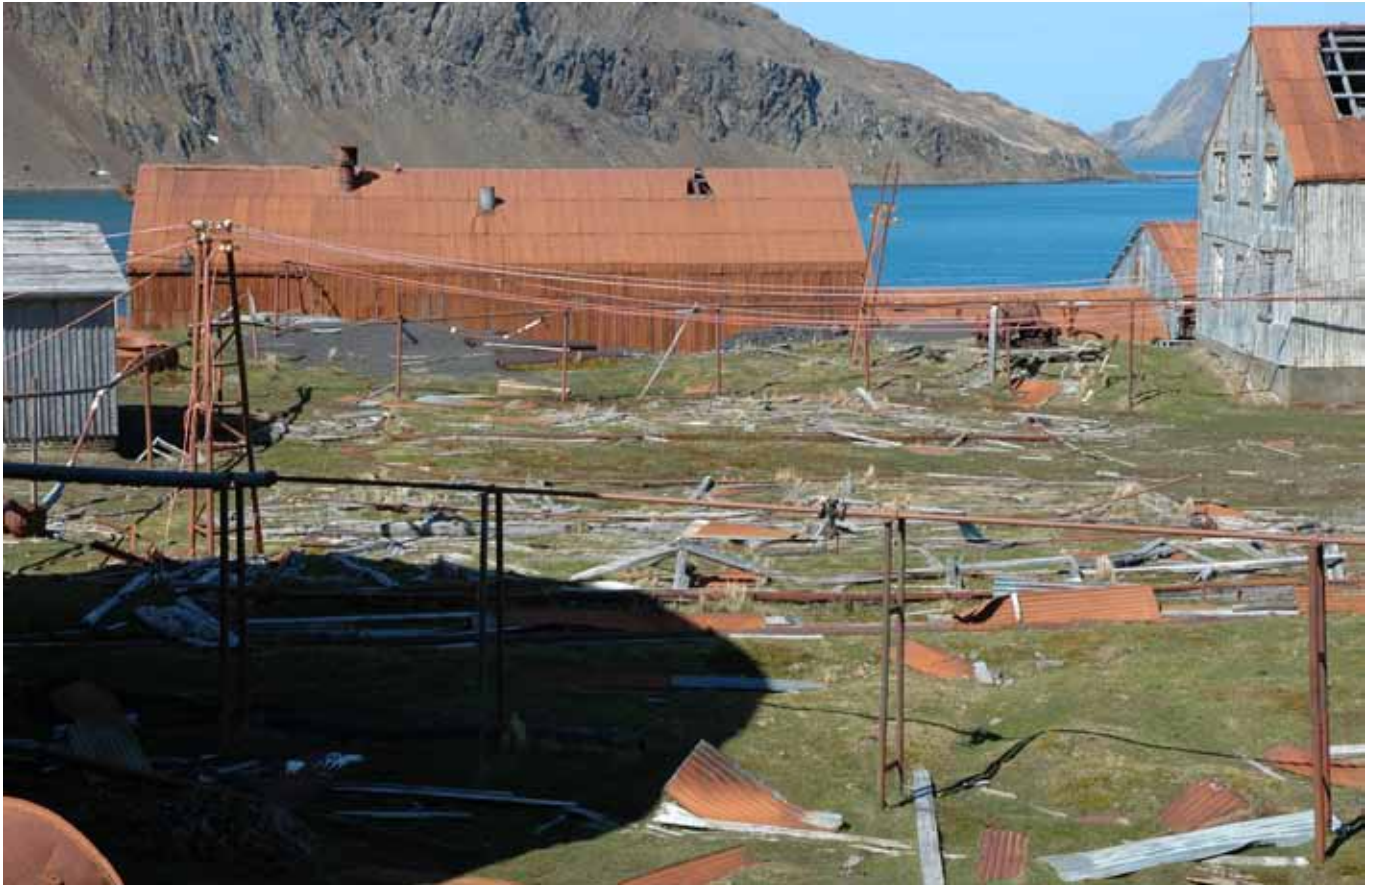
These have disappeared completely and only the bases remain in position.

56.1 The site of the Greenhouses

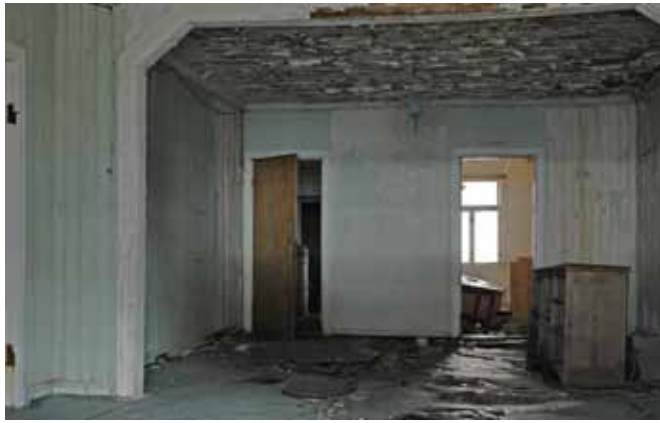
Internally the ground floors, which were suspended, have collapsed and the ceiling is coming down in places. The base of the north wall has moved outwards showing brickwork infill between the studwork. At the northwest corner this has moved, perhaps 200mm, and the brickwork has fallen out wedging it in this place.

59.4 Interior of the main space looking southwest

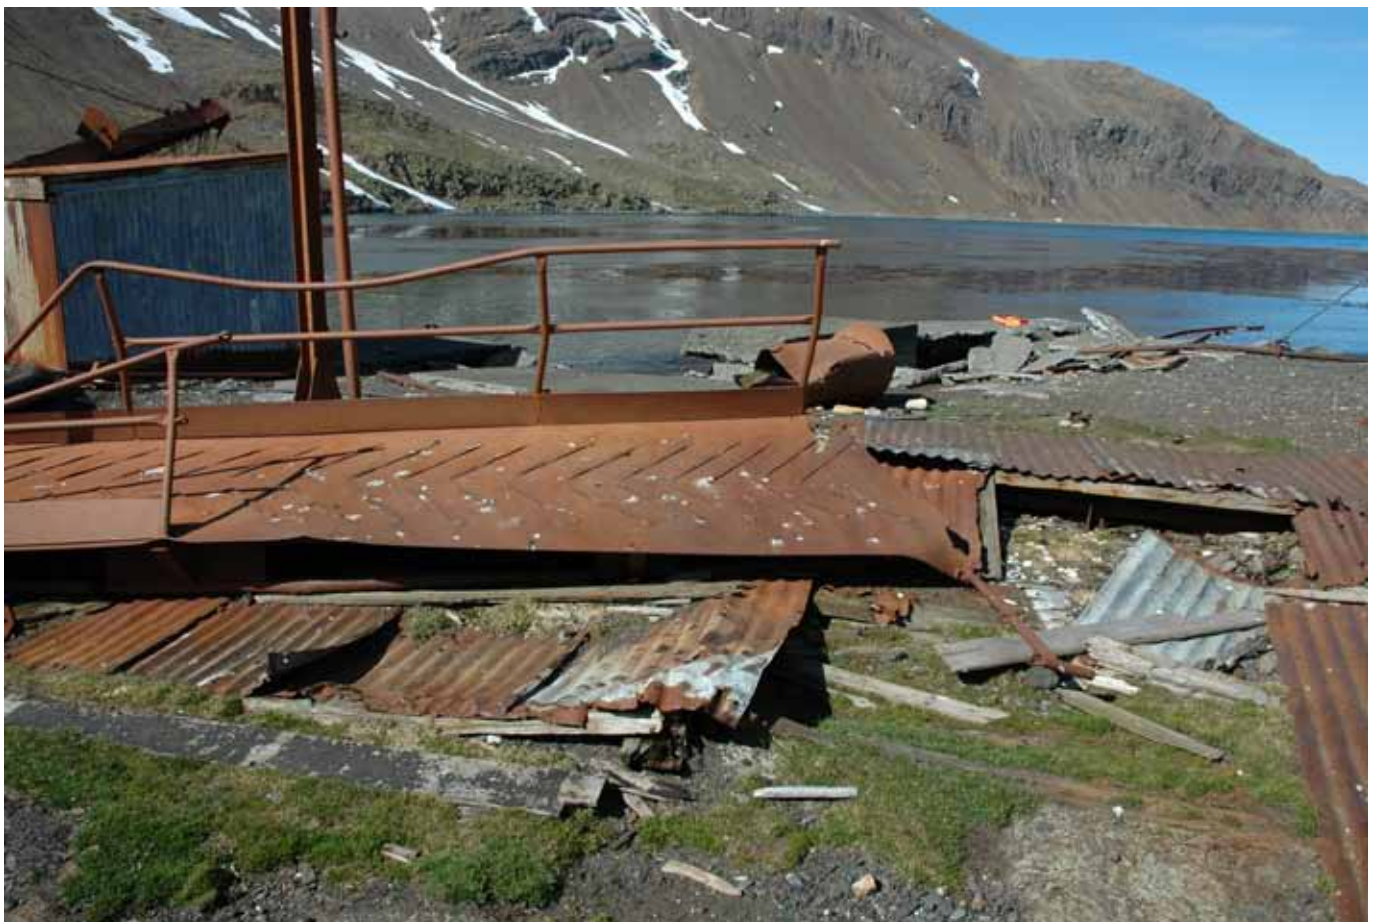
Some sections of corrugated iron and timber walling remain in place and there is the suggestion of the outline of the wall. There is a concrete base to the building though part of this has fallen into the sea. This is all that remains visible of the Catcher's Store.

61.1 The site of the Catcher Store

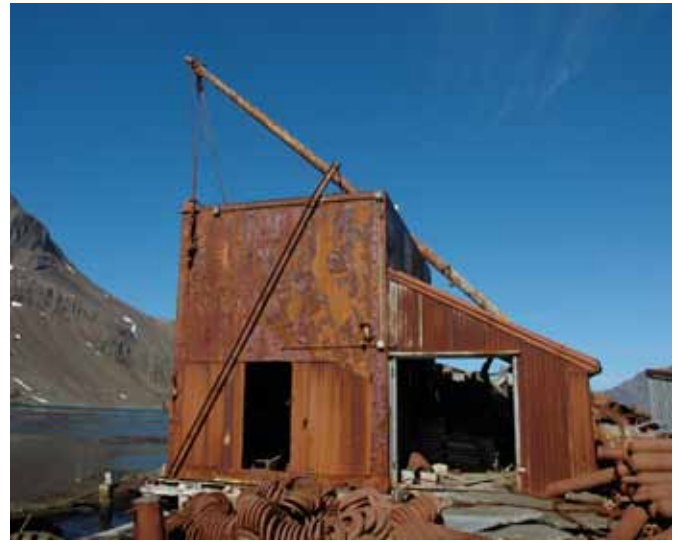
On the west side there is a lean-to building, timber framed and corrugated iron clad. This contains a large collection of extremely rusty harpoon heads and some timber boarding. The roof has partially fallen in of the timber shed and the derrick serving the store has the main arm collapsed on top of the roof. The crane arm through the side of the building also looks to be in fairly perilous condition.

62.1 Northwest elevation

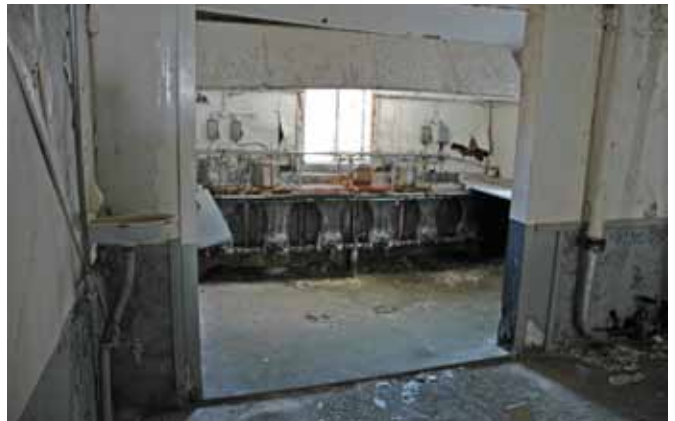
63.2 The scullery area off the south side of the Mess

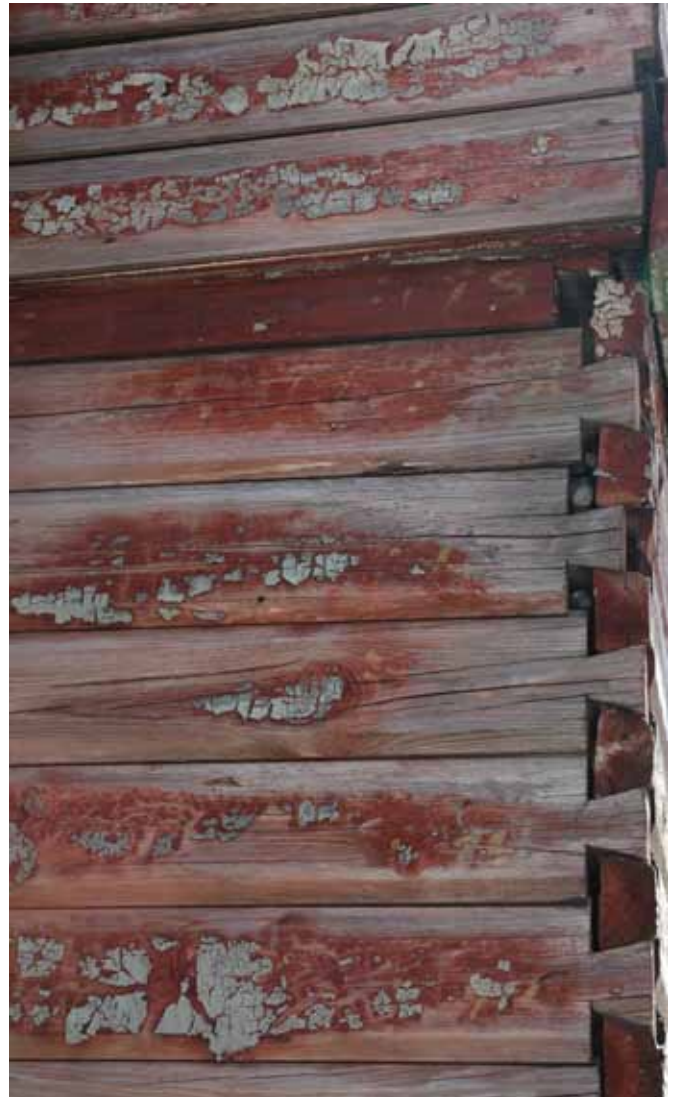
64.2 Typical corner detail of the original building

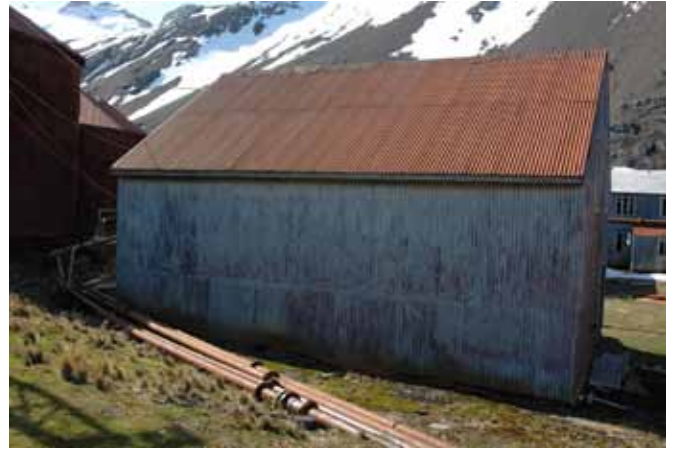
A timber framed building clad in corrugated iron internally and externally. There is an inserted steel prop in the centre of the building holding up the first floor. The ground floor is solid concrete raised on a concrete plinth. This has pieces of washing apparatuses together with shelving for storing laundry. The first floor contains drying room, small office and the Laundryman's bedroom. There are windows in the north and south elevations and two on the east elevation at ground floor level and windows into the bedrooms at first floor and over the staircase. Generally the condition of the corrugated cladding on the exterior and roof is good. The building feels reasonably solid, but the door on the building cannot be shut.

65.1 South elevation

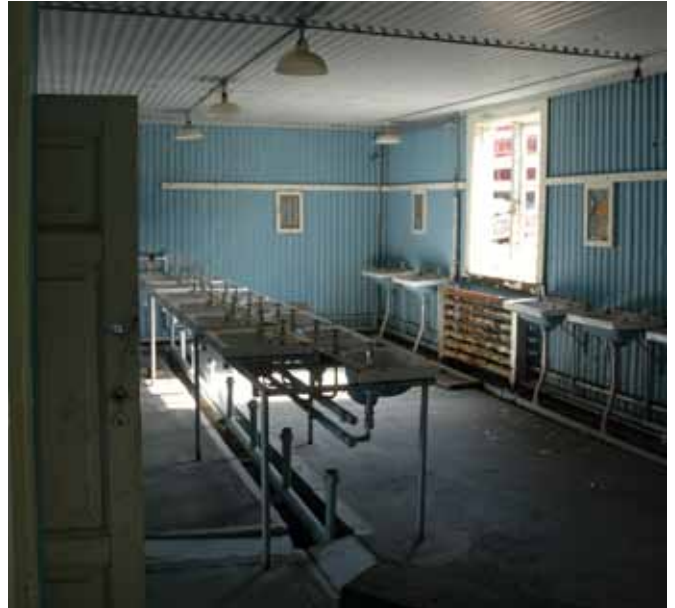
67.1 Central wash room

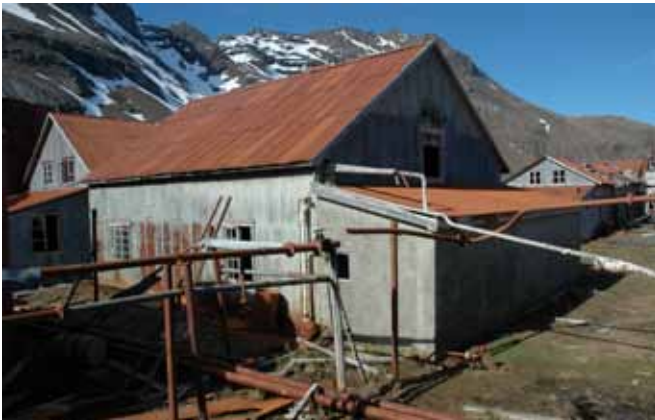
A framed rectangular building with a roof pitch running east/west. The external corrugated cladding and the roof, which is of the larger gauge corrugated iron, is reasonably secure. The windows have lost most of the casements. The timber roof is unlined and the upper floor appears to have been used for storage but there are three small cabins built on the east side and sitting accommodation. The ground floor contains eight showers, two washbasins and a sauna and an outer room which may have been used for washing boots etc. To the west there is a brick built rendered lean-to construction with a solid floor with roof pitching to the west. This contains nine lavatory cubicles. It is clad internally with corrugated iron and corrugated has also been used for ceilings.

67.2 South and west elevations

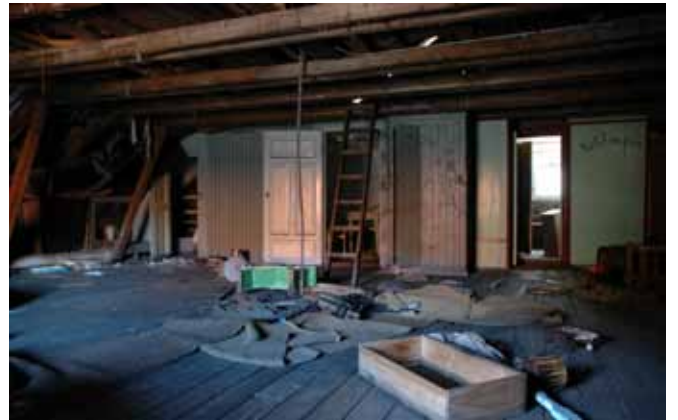
67.3 First floor common area with bedrooms off

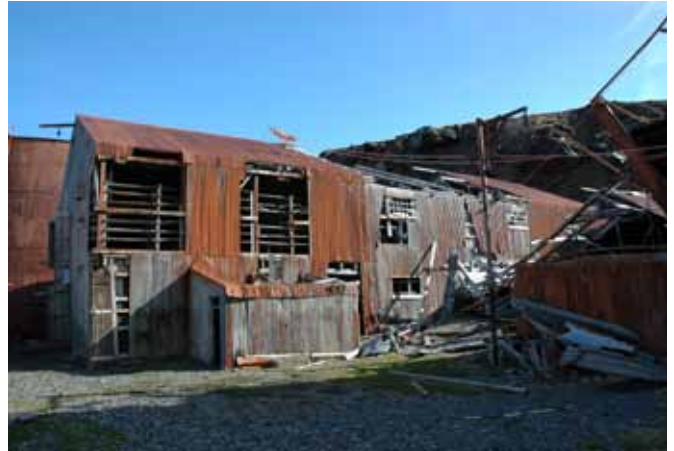
Building No.72 joins on to the collapsed Building No.75 next to it, the Paint Store. Building No.72 appears solid enough in the front but the whole of the rear of the roof has fallen away and the majority of the upper floor is now exposed to the weather. The sheeting is coming away from the side walls and generally this building is in a very poor condition.

72.1 The north elevation

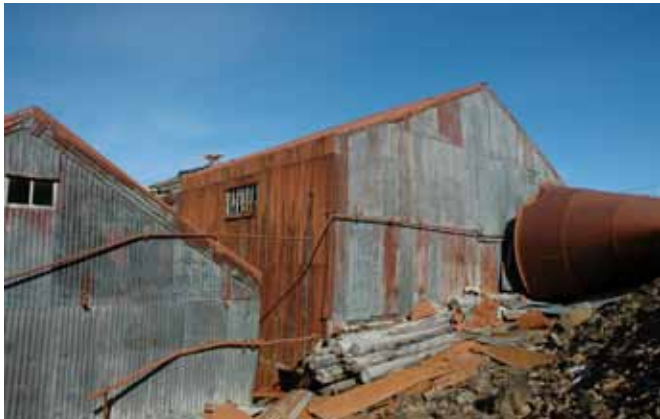
72.2 The west elevation

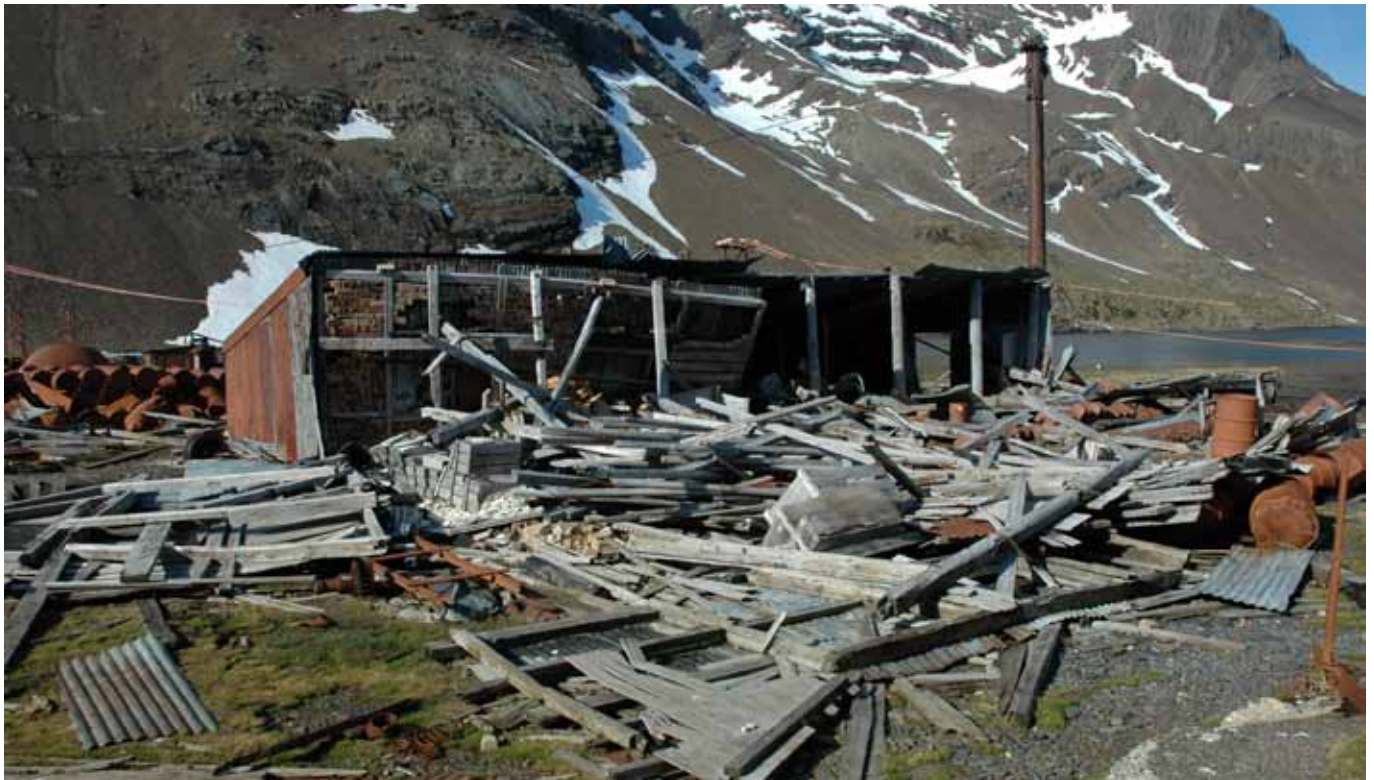
76.2 The south elevation

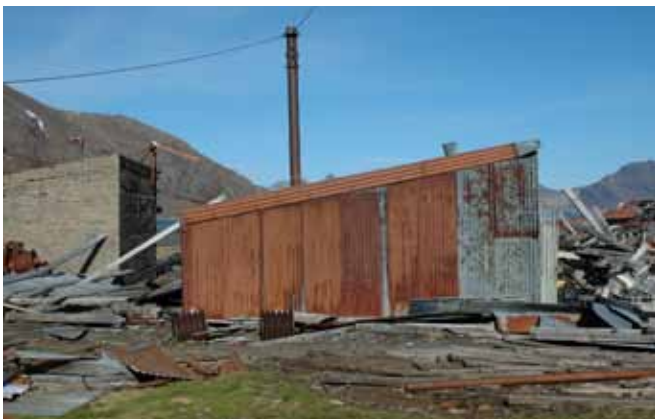
76.3 The west elevation

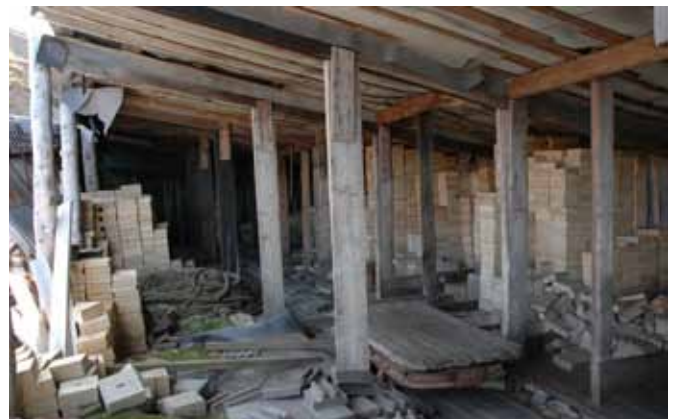
76.4 Interior of the main space
