DISUSED WHALING STATIONS

Leith Harbour Gazetteer

Gazetteer, July 2011

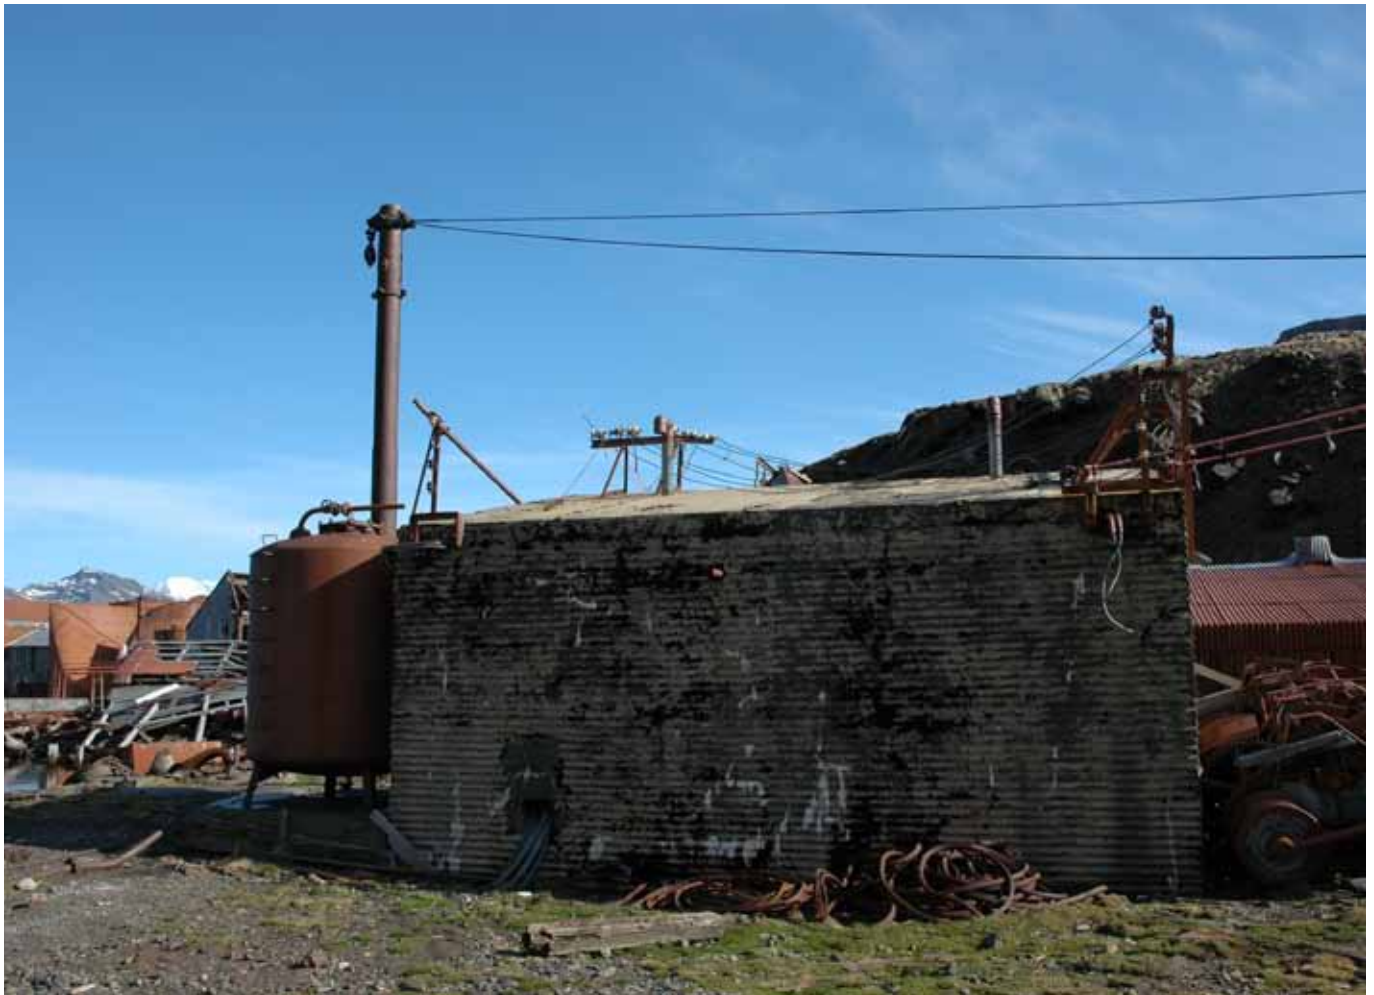
77.2 The north elevation

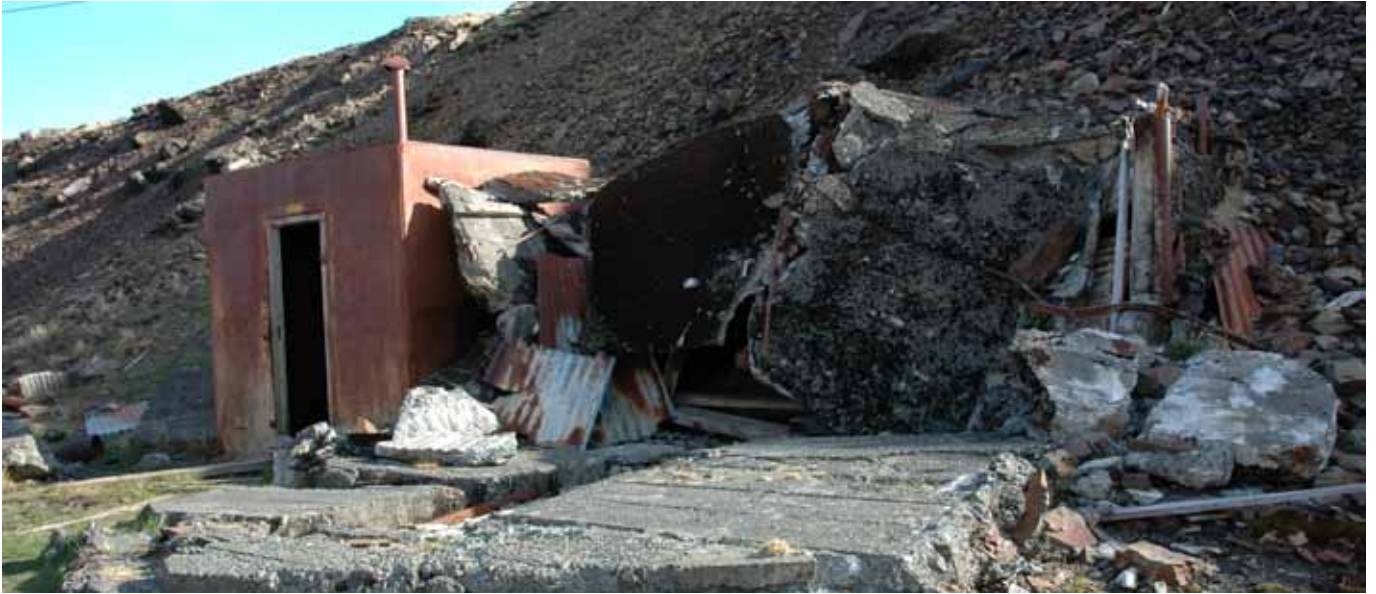
Both of these were substantial concrete buildings with mass concrete walls and concrete roof. Neither remain, No. 78 has been demolished and No. 79 has collapsed. Only the watchman's hut converted out of an old tank remains in position.

79.1 The remains of the Gunpowder House No. 79

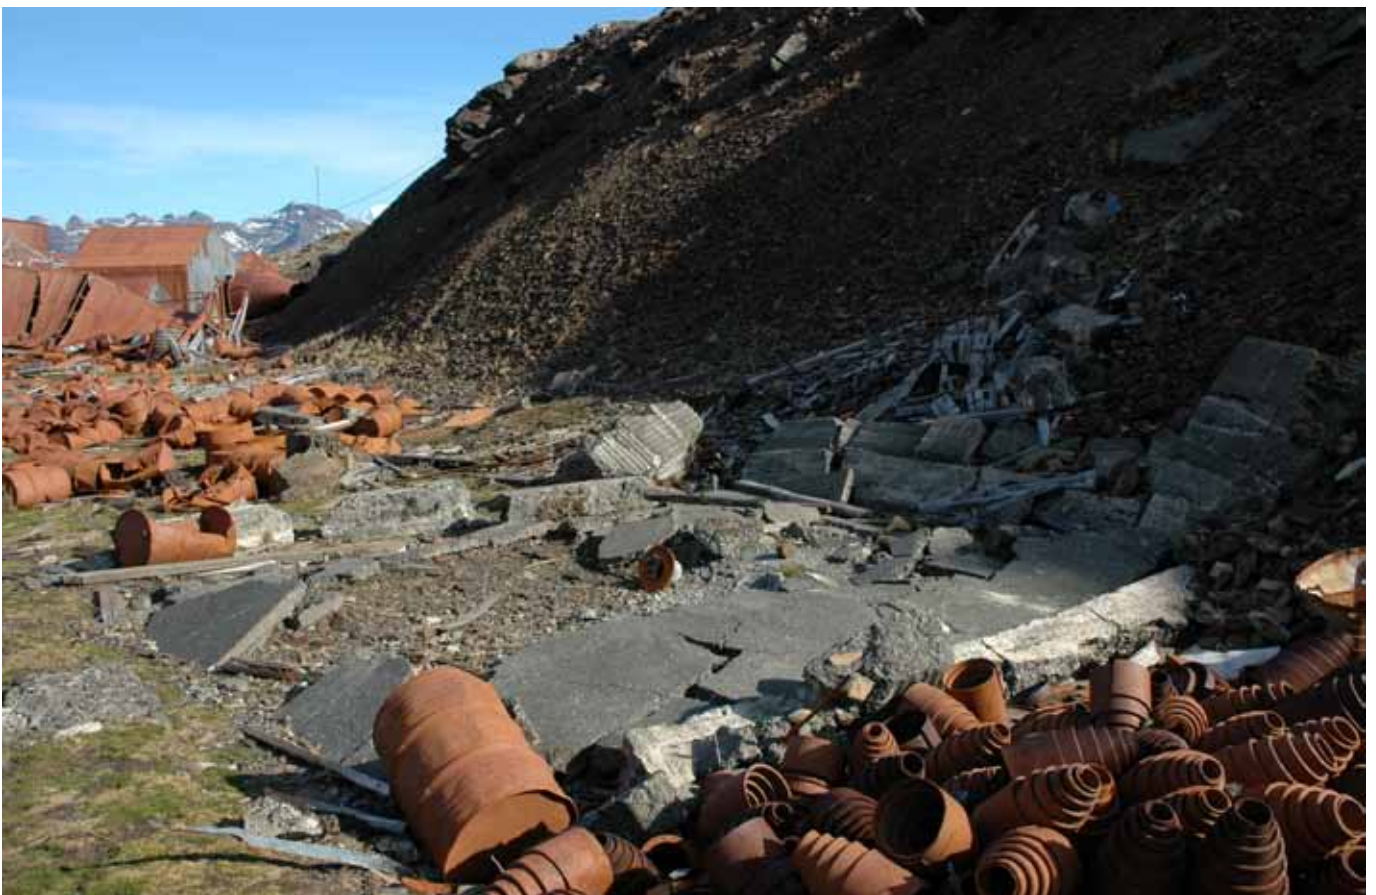
79.2 The site of the Gunpowder House No. 78

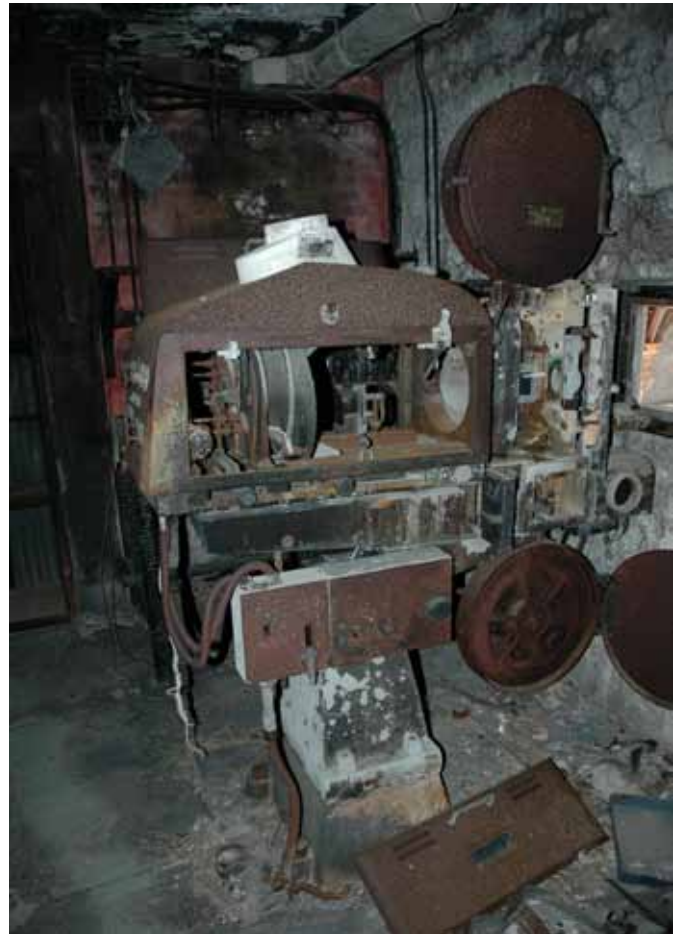
80.1 One of the projectors in the east end projection room

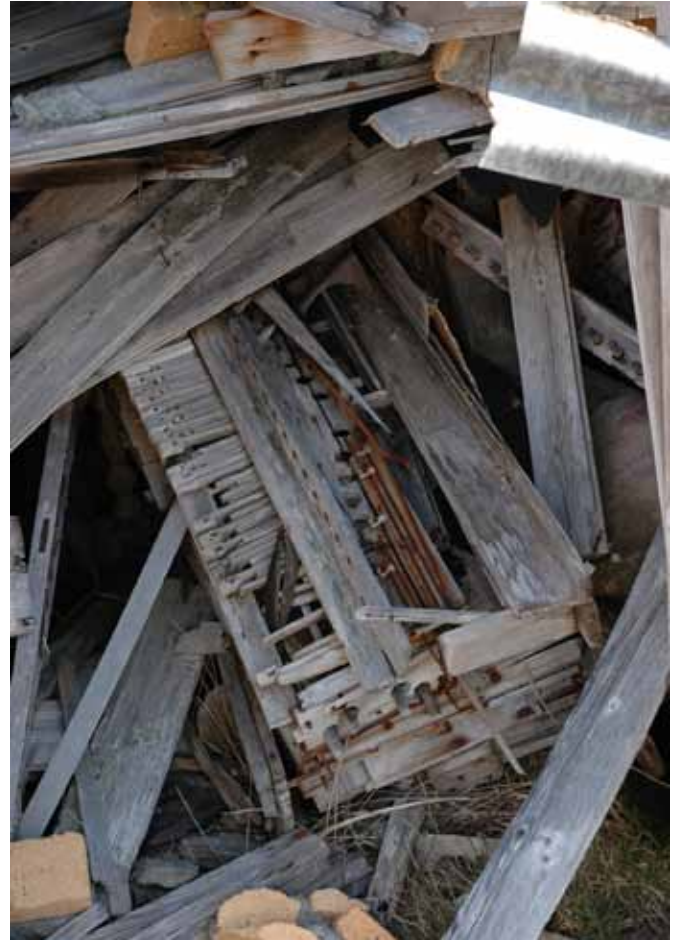
80.5 The remnants of the organ

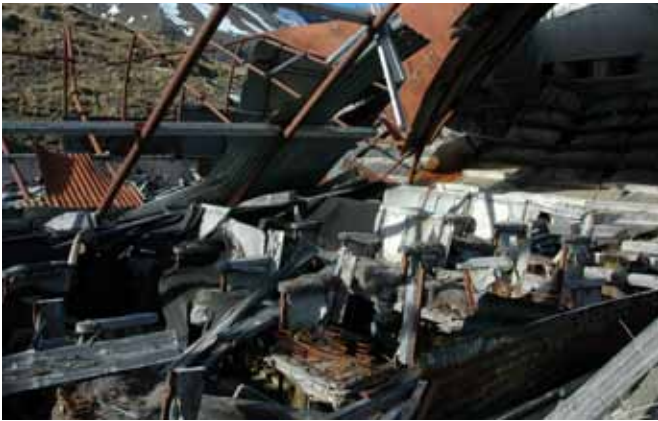
80.4 Seats remaining in position

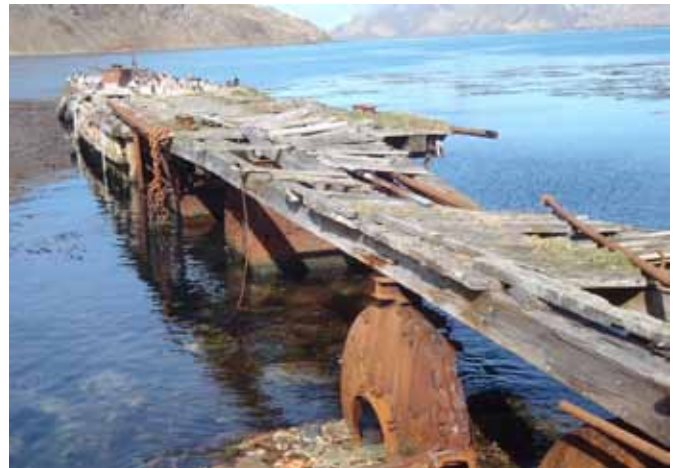
82.2 General view along the Pier looking eastwards

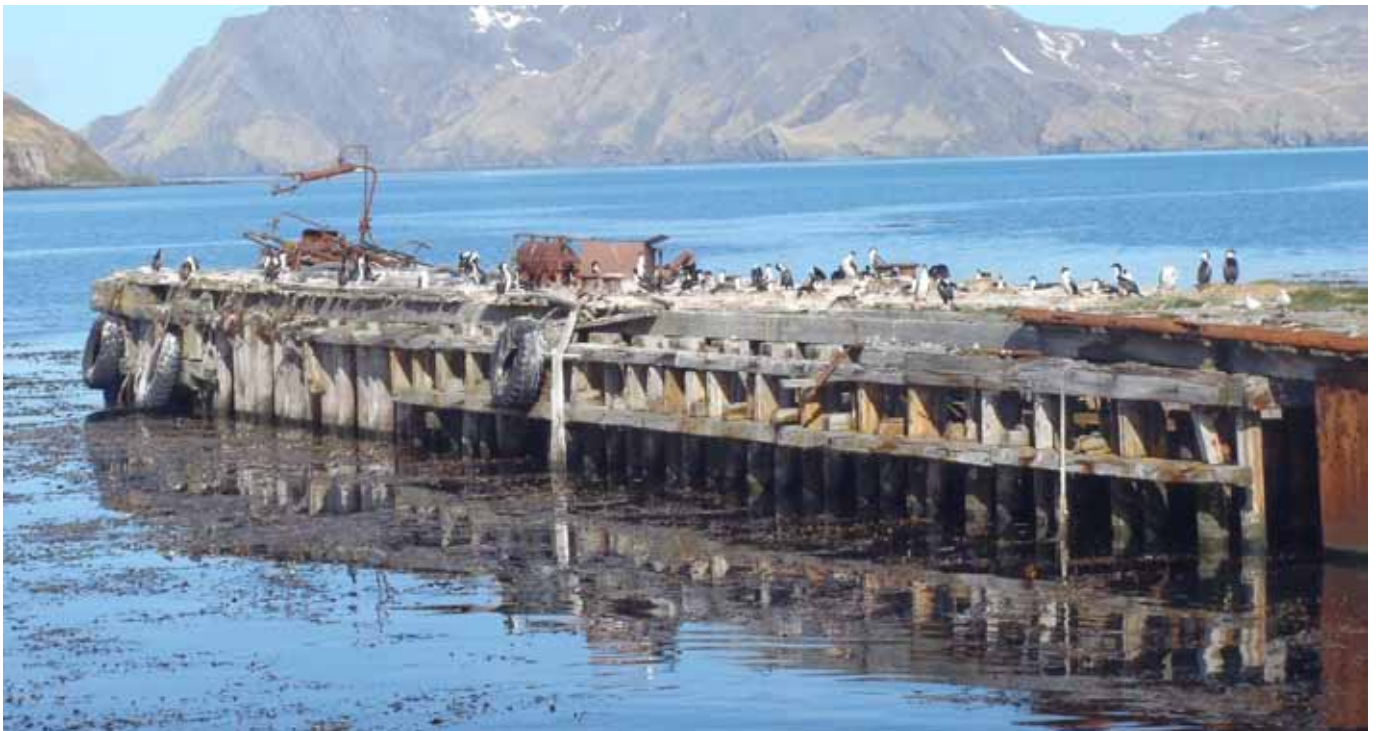
82.3 The east end of the Pier seen from the north side
