# DISUSED WHALING STATIONS

**Prince Olav Harbour Gazetteer**

## Gazetteer, July 2011

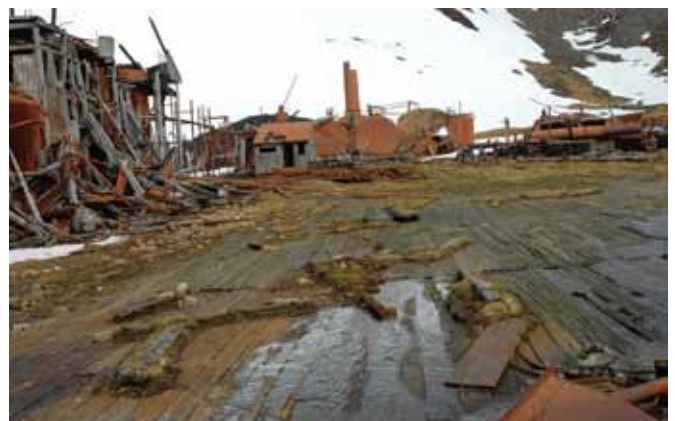
1.4 Looking west from the sea towards the Winch House

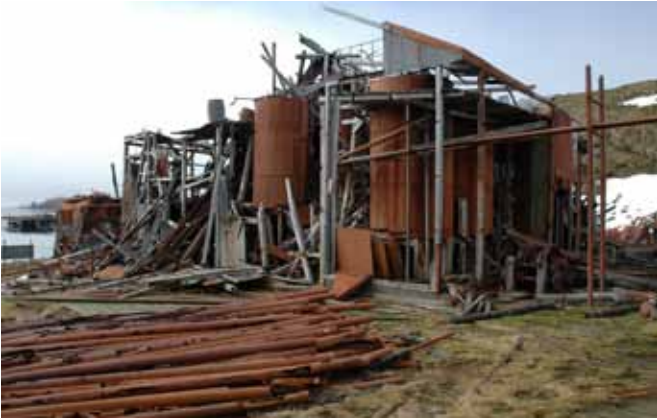
The whole of this building is in the state of collapse. The various boilers are still in position but they are now quite seriously corroded. They stand on timber bases and these are beginning to fail. It would seem that it is too late to save anything significant here.

2.3 The west end of the building

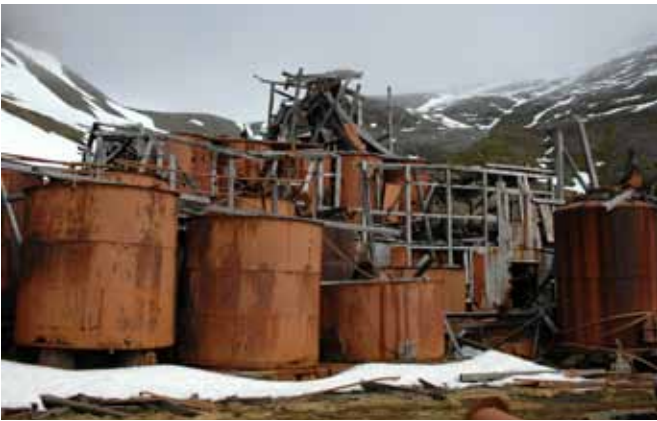
2.4 Cylindrical tanks at the east side of the building

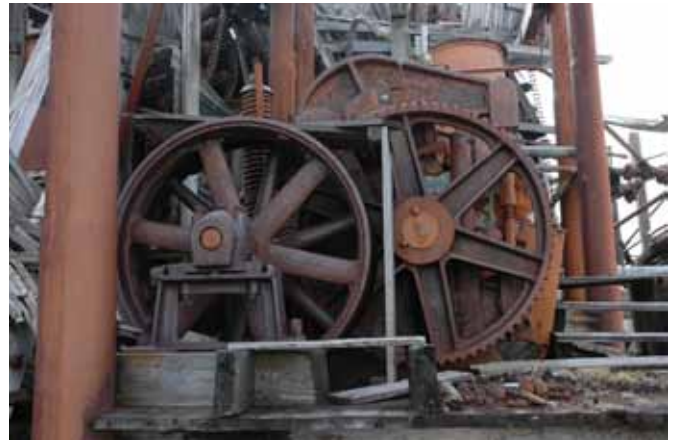
2.5 Detail of remaining machinery at the southwest corner

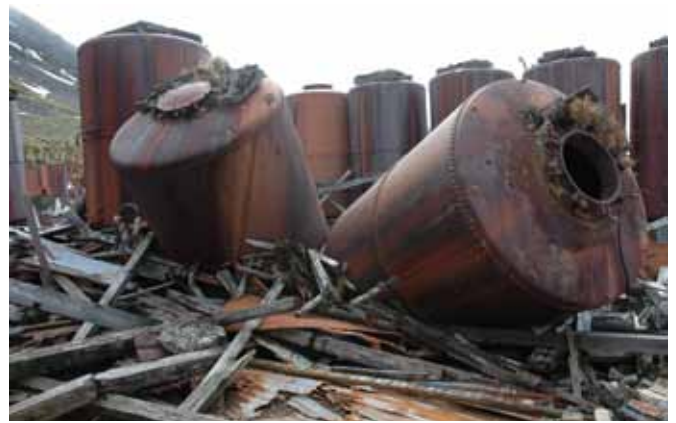
This was a timber framed building framed out of substantial timbers the main pieces measuring 159x159mm in a cross section. There are two rows of six cookers: the western row standing on timber bases, one cooker is missing and two have fallen and the others look insecure. The eastern row of cookers stands on iron legs on concrete bases but the concrete is spalling and in poor order. The boilers themselves are still reasonably sound although doors are missing in several cases. The building and the platform above the meat cookery has entirely collapsed and lies in a heap between and around the boilers.

3.2 The north and east sides of the building

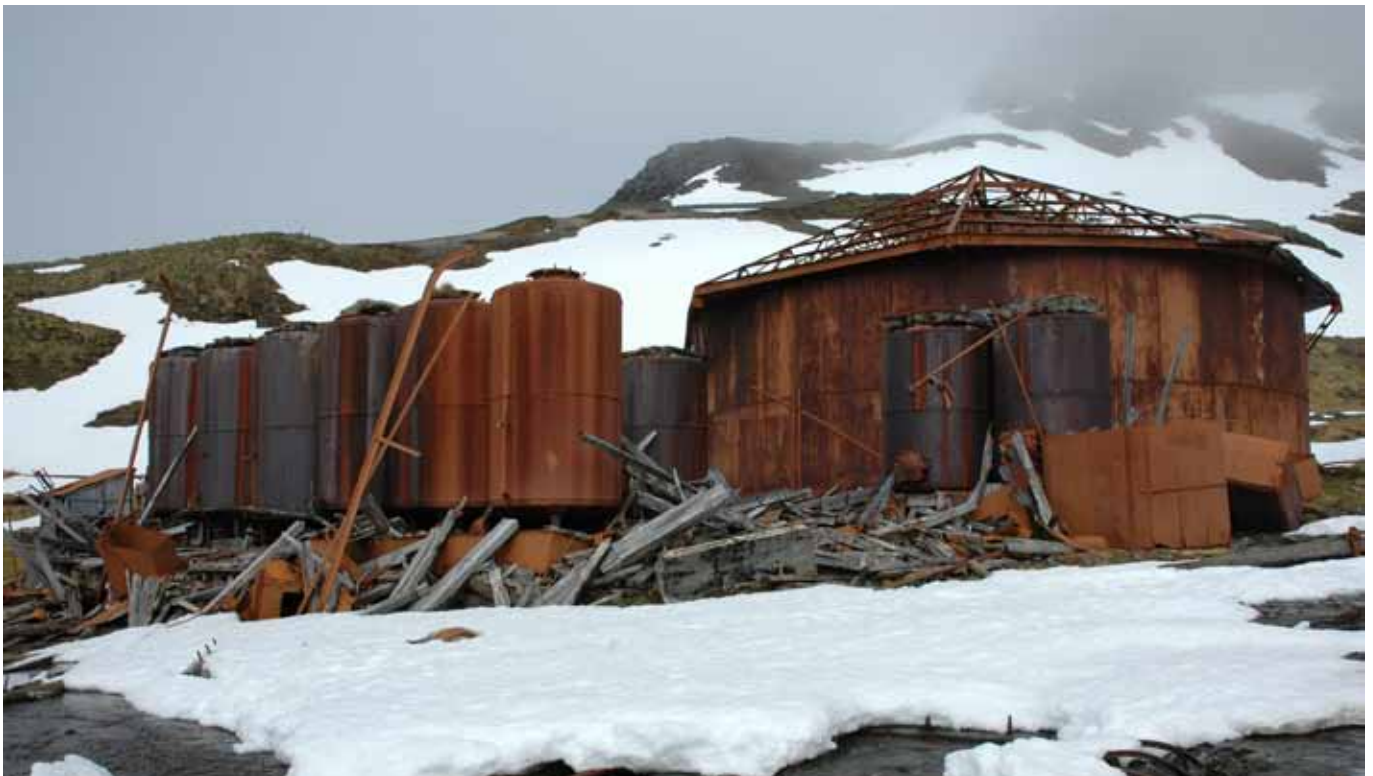
3.3 Detail of the cookers

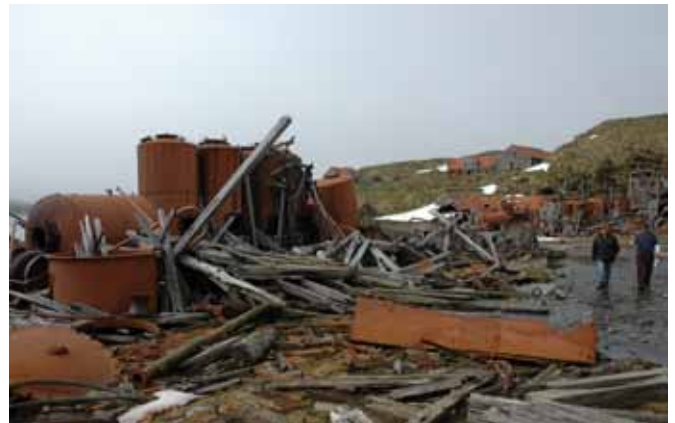
This too was a timber framed building and like Building No.3 it has collapsed entirely. Four boilers remain standing on timber bases which are failing. Two boilers are now leaning sideways against each other. A fifth boiler is in a semi-upright position having fallen through its frame to the floor. There were certainly six and possibly more boilers standing in one central row. There are four concrete bases and two timber bases for a second row of boilers to the west although the boilers themselves have disappeared. There may have been a northward extension to the plant, as there is a row of four boilers on bases cast out of concrete (using old oil drums for shuttering) immediately north of the original timber building through the remaining position, although the concrete bases have fallen away in many cases, one has fallen completely. As in Building No.3 this was built out of substantial timbers 150x150mm which appear to have been used for the posts and there are more substantial 300 square timbers possibly used at the corners, although the collapse is so complete it is extremely difficult to tell what belongs where.

4.2 The remnants of the building looking southwards

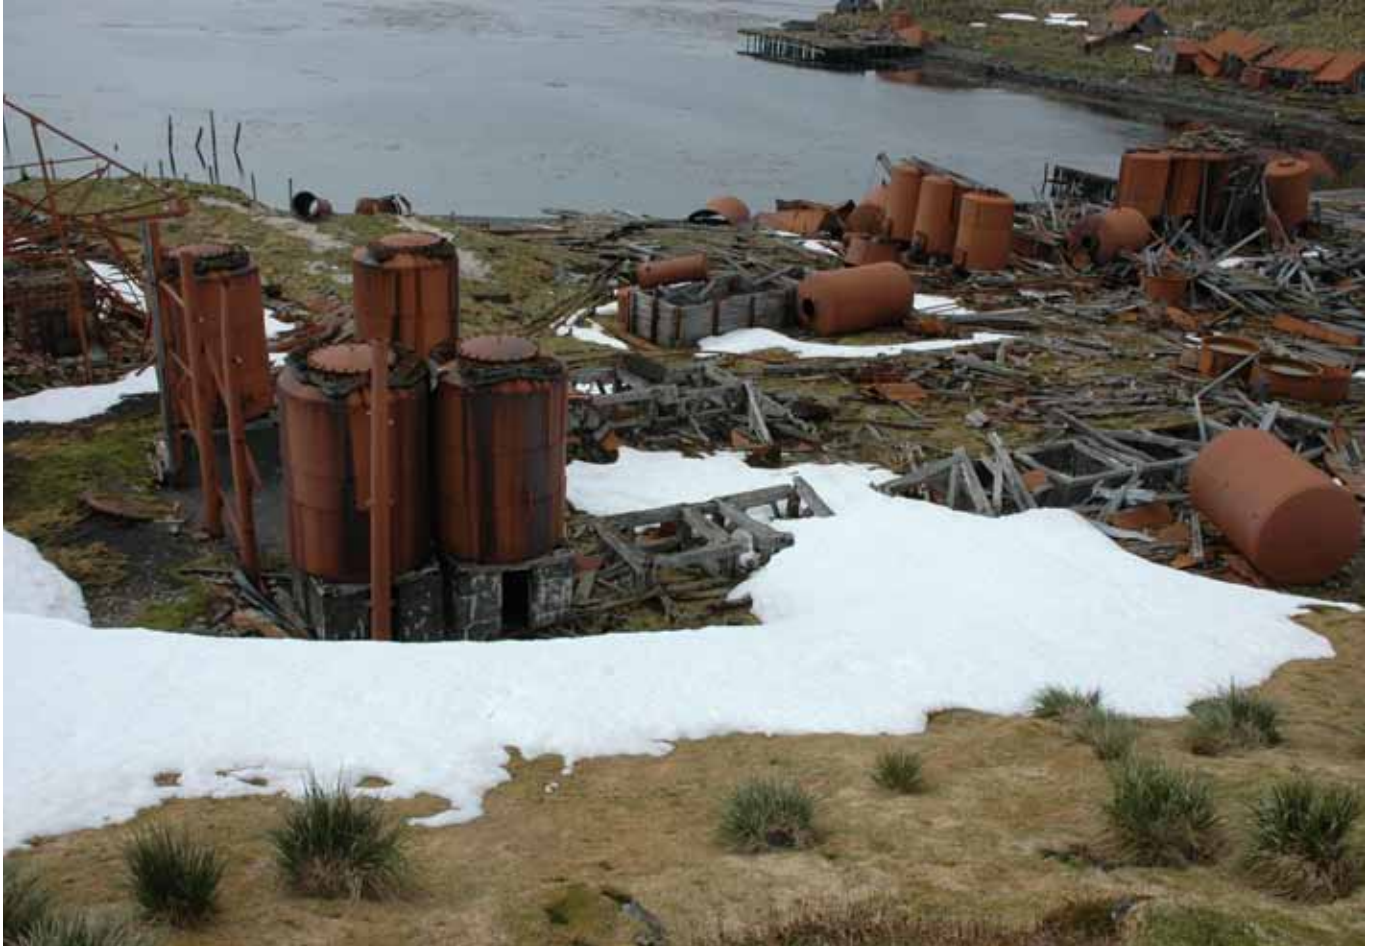
This has disappeared almost entirely. Timber wall plates and some small evidence of concrete footings is all that is left to indicate the outline of the building, various heavily rotted timbers lie in place. Four cookers remain in place on timber packers on concrete bases. Part of the timber is decaying but they still look reasonably solid. There are nine further bases which are on the west side of the building suggesting there were 11 cookers in rows on either side. The bases on the east side have very little fabric left. The floor appears to have been covered in heavy timber (around 100mm thick). There is a small section of steel framing at the north end of the building but none is evident elsewhere. It seems likely that this was a timber framed building.

5.2 General view over the Bone Cookery from the higher ground to the northwest

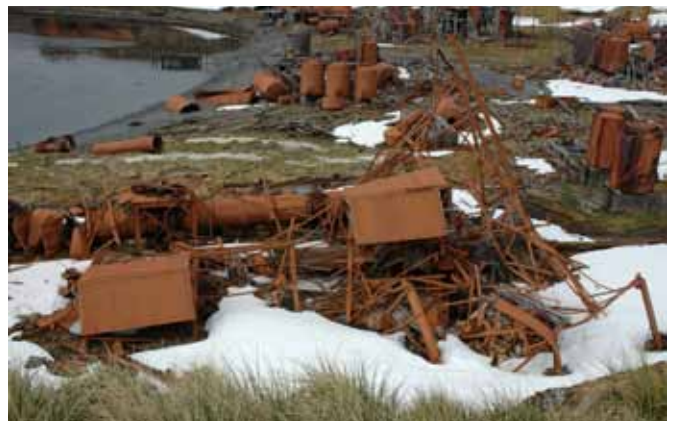
This was a steel framed building and a small amount of the steel frame remains standing at the west end. The rest of the building has completely collapsed. From the ovens that remain in place it would appear that there were three rotating cookers for processing the meal. One remains clearly visible, the other two are now buried in the wreckage. The brick boilers are all in poor condition and are beginning to collapse. At the southeast corner of the building there is a fine steam engine with a large fly wheel.

6.2 The west end of the building looking south

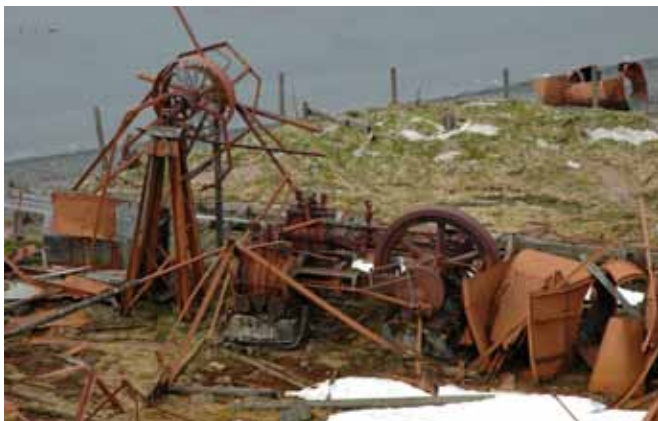
6.3 Detail of remaining machinery, centre of the south side

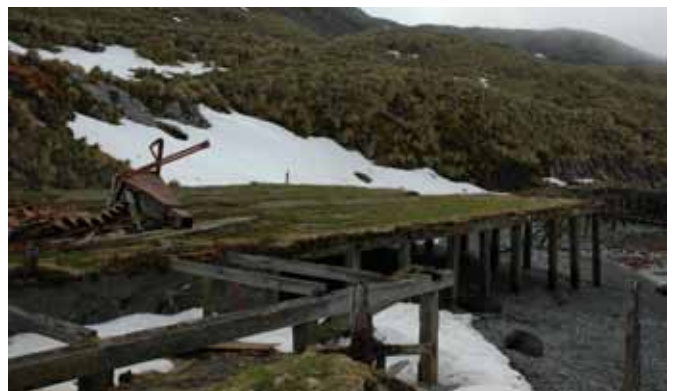
6.4 The platform at the east end of the building. It is not clear whether the building ever extended over this platform.

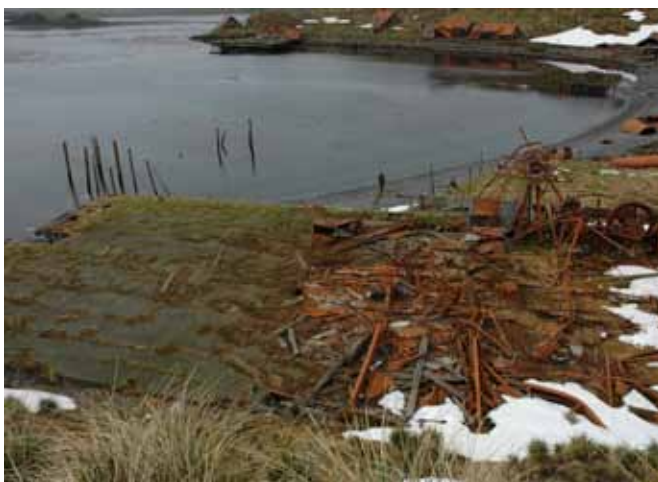
6.5 The east end of the building looking south

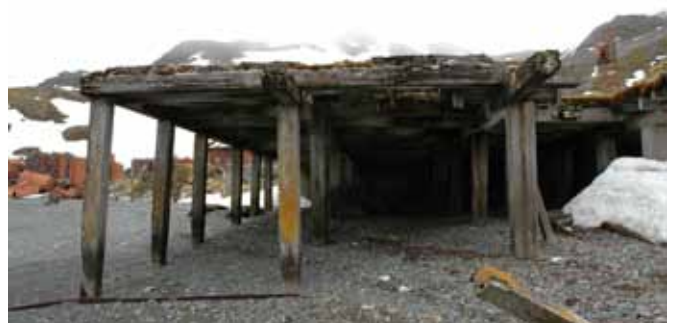
6.6 Below the platform looking west

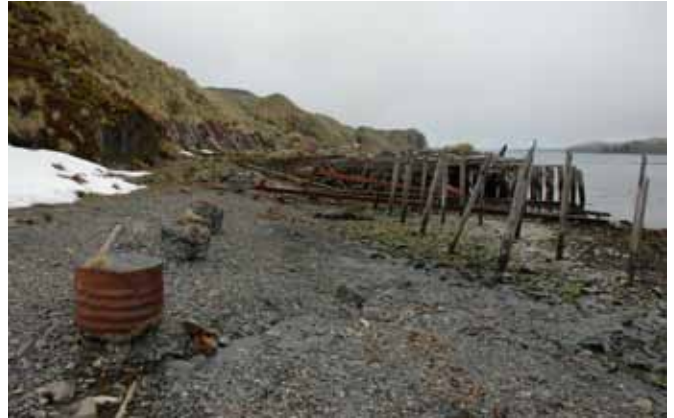
This appears to have been connected to Building No.6 by a railway and a raised walkway; possibly the elevated railway also served this area. There is a steel 'A' frame with an access ladder and a platform which might be part of this. Building No.7 appears to have been a timber frame building of some size, little or nothing remains other than the north wall which has fallen against the adjacent bank. This shows corrugated iron cladding and timber framing – the building was built up out of rock on the beach with a concrete platform cast over the top of it and the seaward, south side being supported by timber piles. This outer edge of deck has now partially collapsed and the inner deck of timber on concrete is in poor condition and falling away.

7.1 The line of the elevated walkway joining the Guano Factory to the Guano Store

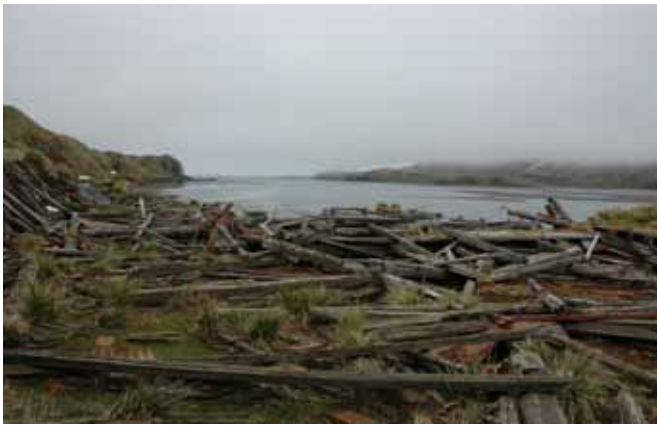
7.2 Detail of the remains of the building

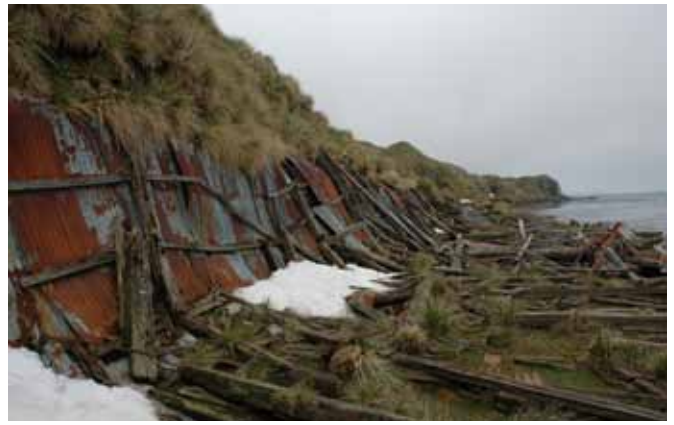
7.3 The north wall which remains leaning against the bank

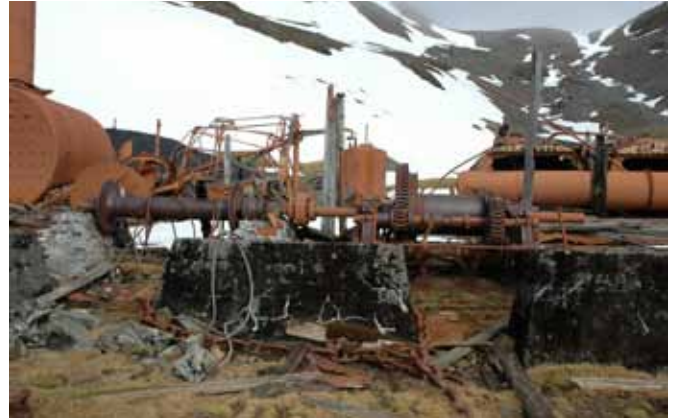
The Winch House stands at the top of the Plan. It was probably constructed as a lean-to against the adjacent boiler house. All that remains are two upright concrete posts on the west side and there are concrete blocks at the front (east side) with iron holding down bolts. A large timber beam fitted with pulley blocks sits alongside which would presumably have spanned between the concrete blocks and been bolted to them. One large steam driven winch remains in position with an extension to a drum for wire rope on the south side. At least two other winch bases remain but there are no signs of the winches themselves. There is a small timber framed mono-pitched shed immediately to the south of the site of the Winch House. Whether this was part of the Boiler House or of the Winch House is not clear.

9.1 The east side of the Winch House

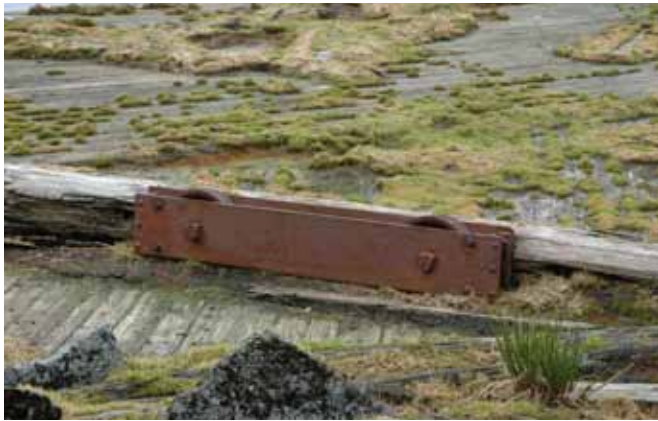
9.2 One set of blocks and the timber mounting beam

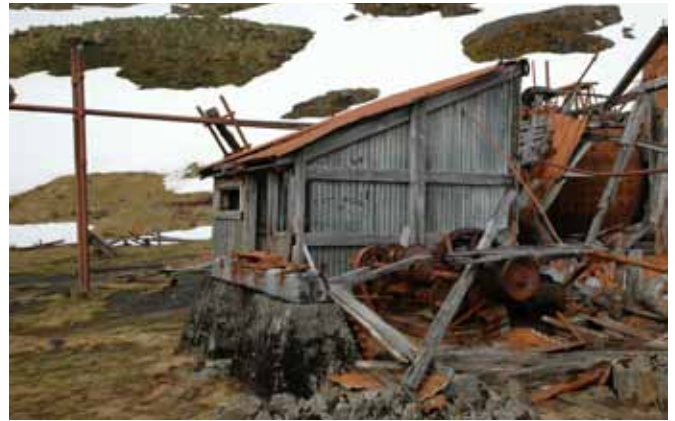
9.3 The remaining building on the south end of the Winch House

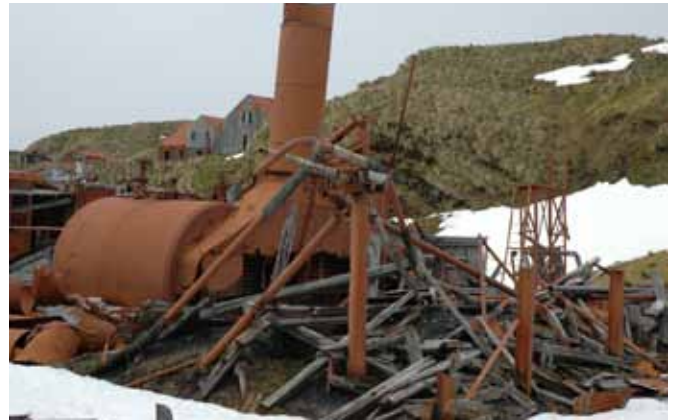
This too appears to have originally been a timber structure – very little of this remains at present. Five boilers remain in position with various sections of steel chimney scattered in the debris. The boilers appear to have been coal fired and there is a good deal of coal both within the boiler house itself and the large heap outside to the west. To the west of the boiler house is a later steel frame building which appears to be an extension to the original building. This western extension was a relatively lightweight construction with RSJ measuring 125x200mm and angle iron trusses in the roof. Some of the roof trusses remain partially attached to the remaining columns but little else remains of the building other than some concrete walls which define the perimeter of the building.

10.1 Boilers looking southeast

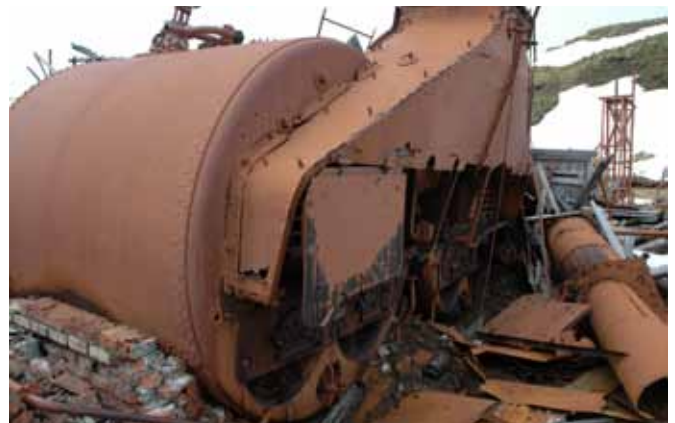
10.2 Detail of boiler

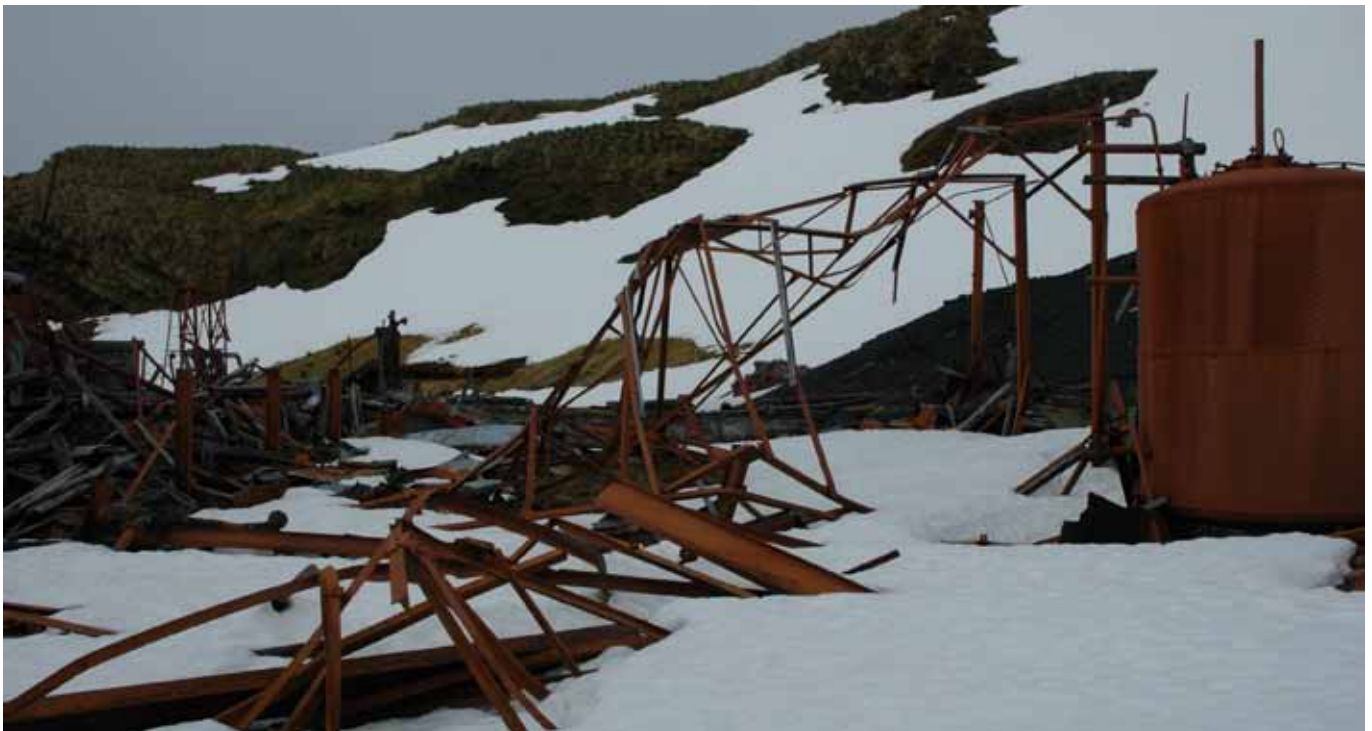
10.3 The remnant of the building west of the remaining boiler

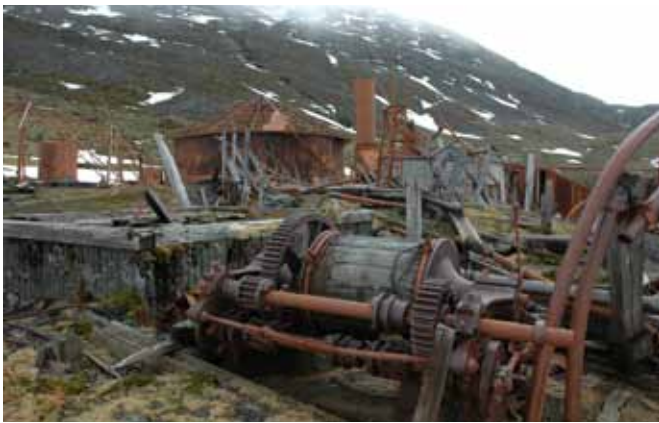
There is a timber and corrugated iron extension running out southwards from the west corner of the building ending in a concrete platform together with another steam winch but the purposes of this is not entirely clear, though it may have been to do with loading coal into the boiler and there is certainly plenty of coal lying about at this position.

10.5 Detail of the platform and winch at the south corner of the building

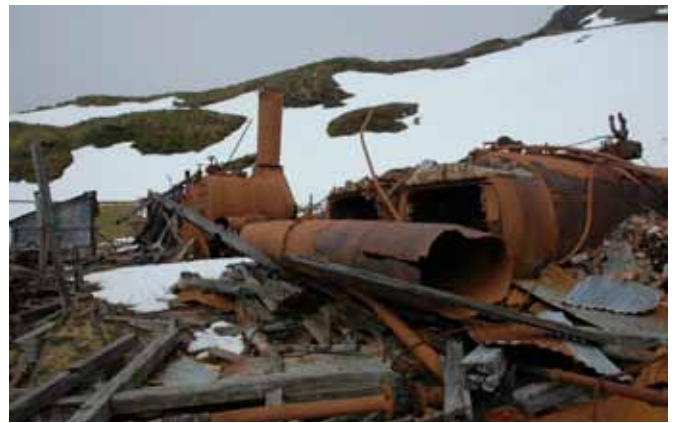
10.6 General view of the remains of the Boiler House looking southwards

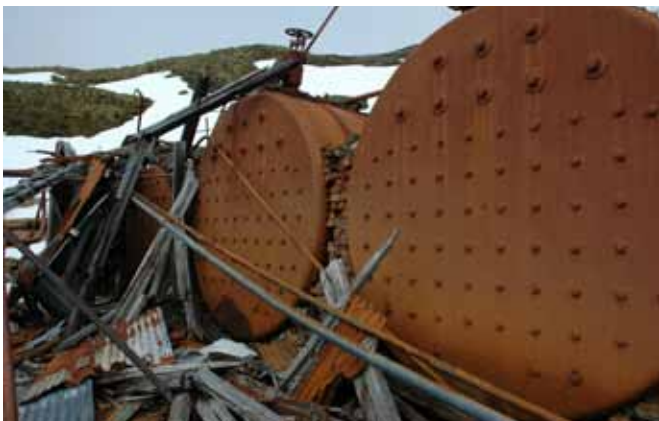
10.7 The east (back) of the boilers

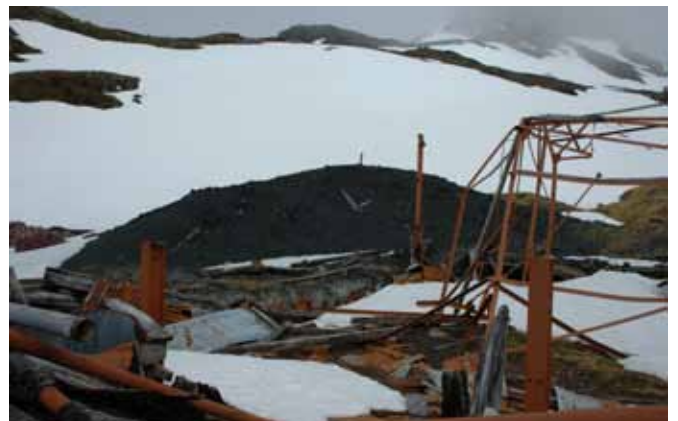
10.8 The coal heap to the southwest of the Boiler House

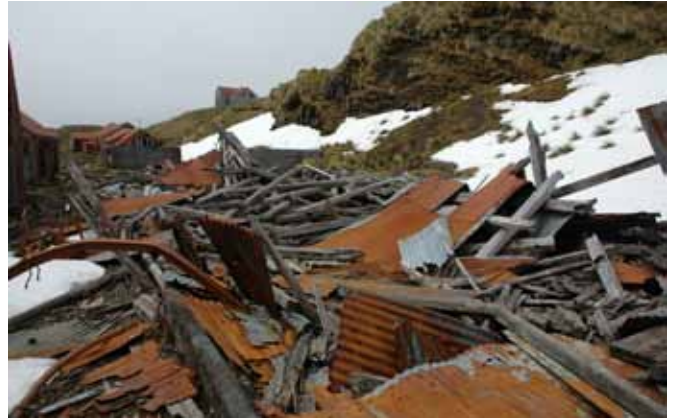
This building has entirely collapsed and is now simply a heap of timber and corrugated iron. It would appear to have been raised approximately 450mm off the ground level with the timber base plate being supported by heavy timber bearers and in some places a concrete pier. The floorboards generally appear to have been very thick at around 75mm. It is difficult to determine where building No.12 ends and Building No.15 starts. Building No.15 is also in a state of complete collapse, the most visible part being the west gable end which appears to have been built up above ground level with a suspended timber floor and the outer walls of heavy stud framing with corrugated cladding externally and horizontal boarding internally. The main timbers of the stud frame being roughly 125x125mm. The same timber appears to have been used for ties and for principal rafters of the roof. These two buildings are well beyond the point where any repair is possible.

12.1 The remains of the general store looking east

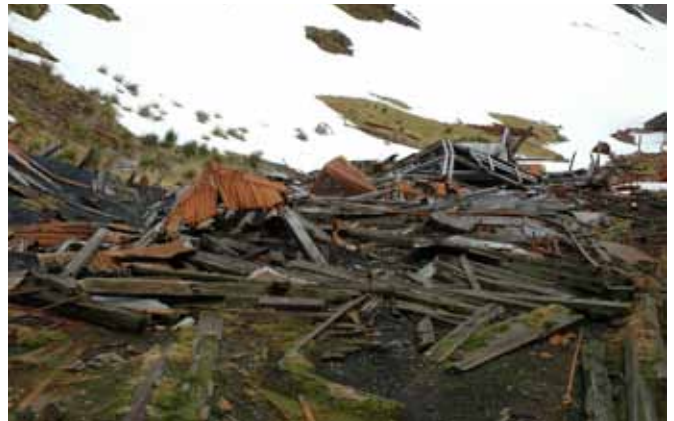
15.1 The remains of the Blacksmith's Shop looking west

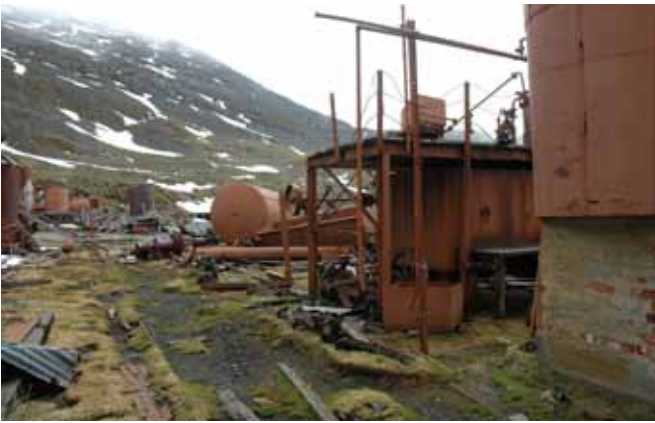
Nothing recognisable remains of the building other than a concrete floor. This floor has recently been used for storage of various bits of metal and pipes and presumably any building remnants were cleared away before the area was used for storage. There are a few elements of timber and corrugated iron lying underneath some of the stored material. At the south end there is a steel frame supporting three tanks and the remnants of a small steam engine and belt drive. Probably this is the 'refinery'. There are concrete bases adjacent to this area, one of which still has a tank on top of it, the other has a tank lying next to it.

13.1 The plant at the south end of the building

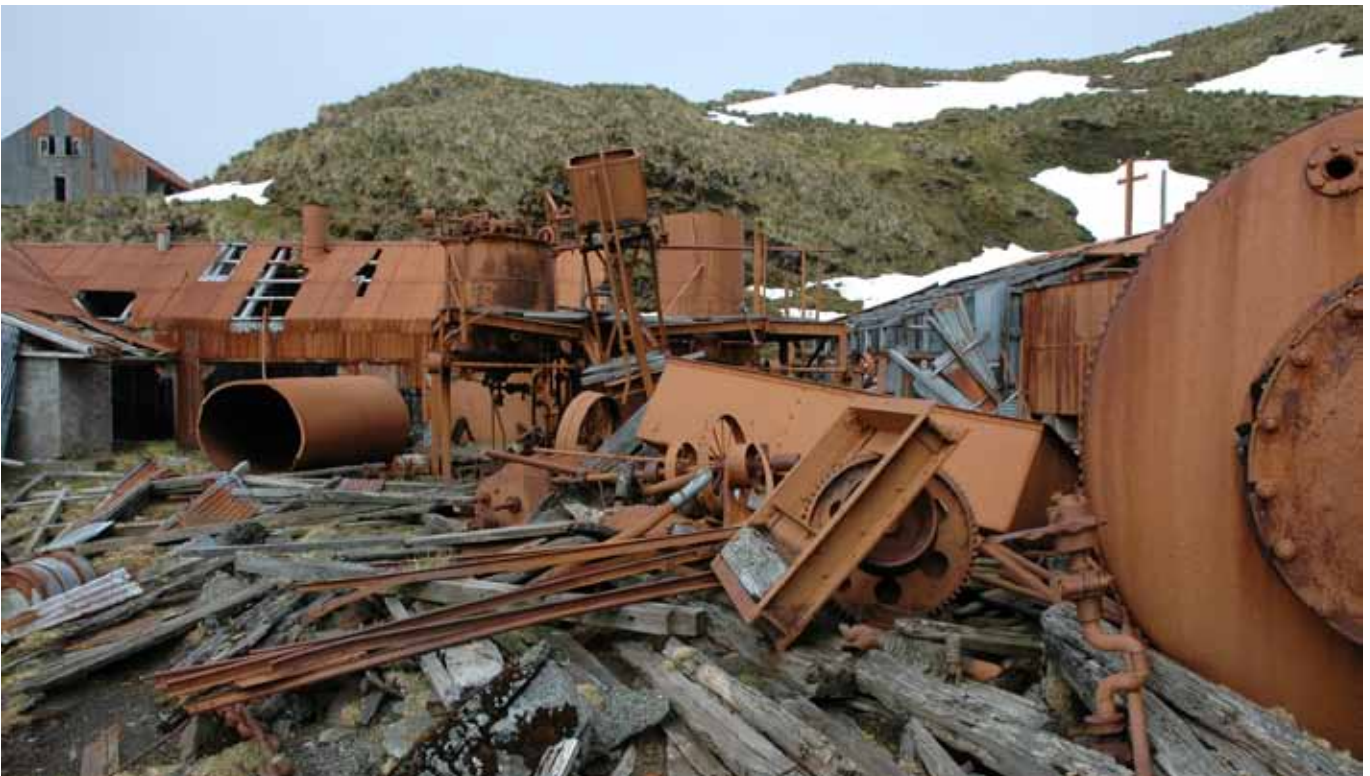
13.2 The remains of the Laboratory looking southwards and showing the material that has been stored on the Laboratory floor

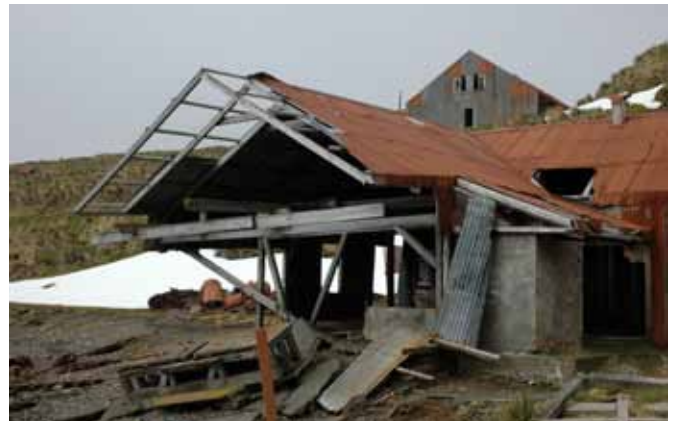
The carpenter's shop is similarly framed out of 125x125mm timbers clad externally with corrugated iron. The main roof was east/west with what appears a later addition running out northwards. This northern extension of the carpenter's shop was supported on concrete bases cast onto the beach. These have now fallen away leaving the timber plates supporting the floor exposed and allowing the corner of the building to drop. This section of the building is in very poor condition and is also being used by elephant seals as a moulting area which must give the remaining structure considerable battering. It seems likely that this will collapse in the fairly near future. The roof over the westward arm has holes in both sides with, perhaps, 15 percent of the sheeting missing and 50 percent of it damaged to some degree.

14.2 The north wing of the building

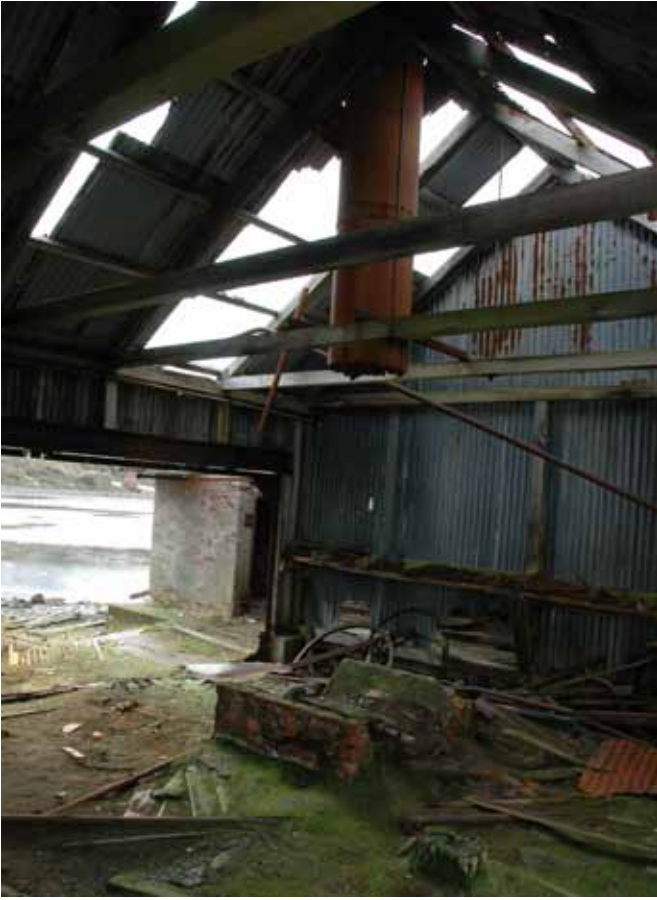
This building is still standing although in very poor condition. At the west end is a butchery and, adjacent to it, what appears to be a blacksmith's shop in that it has what looks like a forge in the centre of the building with part of the flue remaining in position and wide doors opening out to the adjacent waterside. This section of the building appears to have been built later than the adjacent eastern section – it is a simple timber frame with trusses consisting of a tie beam, two principals and a hanger.

14.4 Inside the Blacksmith's Shop in the centre of the main building looking northeast

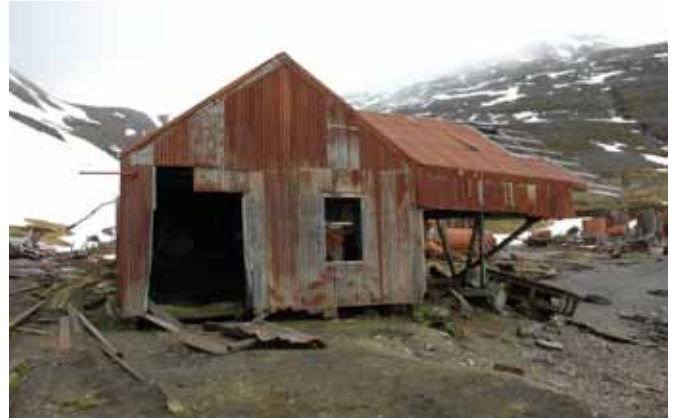
14.5 The east elevation

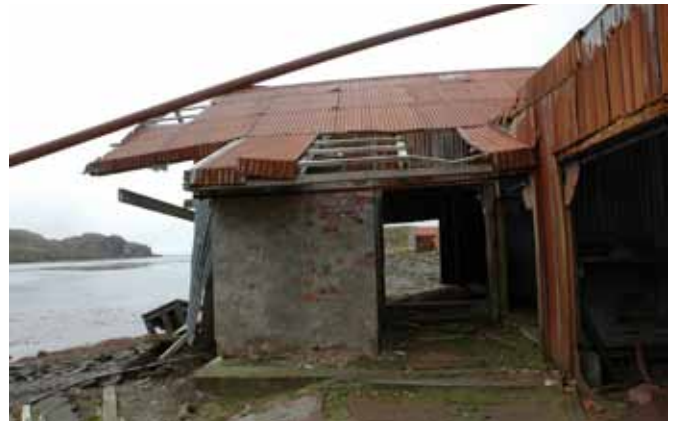
14.6 The west side of the North Wing

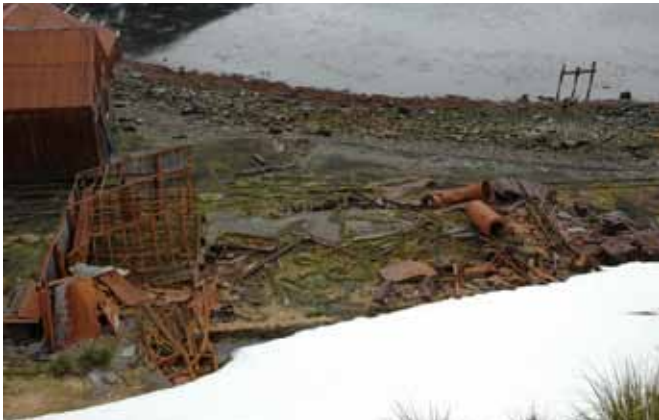
The concrete base remains at the foundry but apart from this the only surviving structure is the west wall. This appears to be an extension to the original building with a lean-to roof falling to the west. It is framed up in steel work with three heavy columns, no doubt adapted from something else supporting the north wall. These columns will be here for some years to come. The rest of the building was presumably of timber and corrugated iron.

16.1 General view of the Foundry

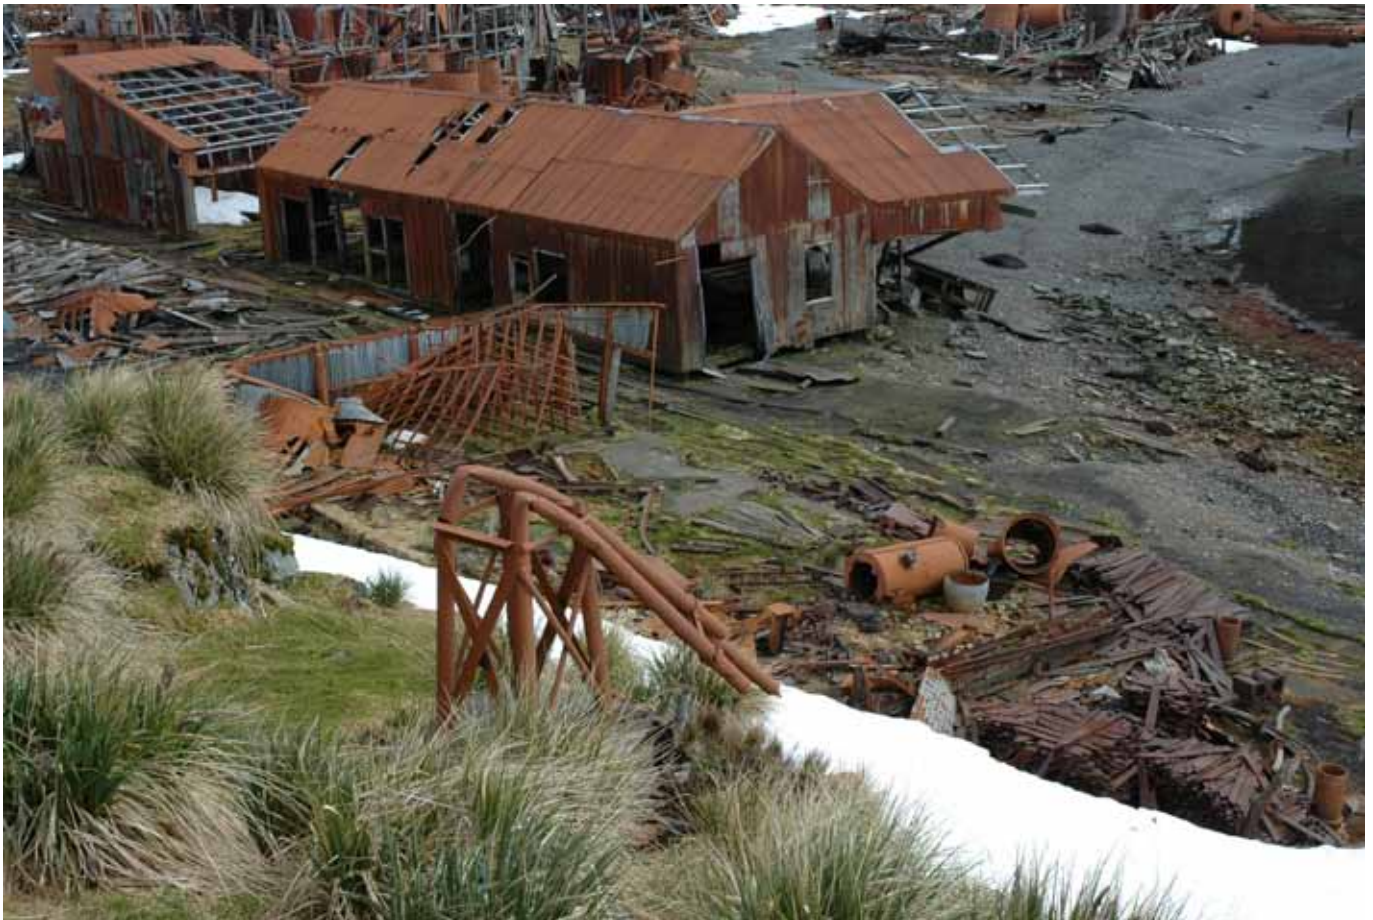
16.3 General view of the Foundry from the high ground to the south. One of the pylons for the Elevated Railway in the foreground.

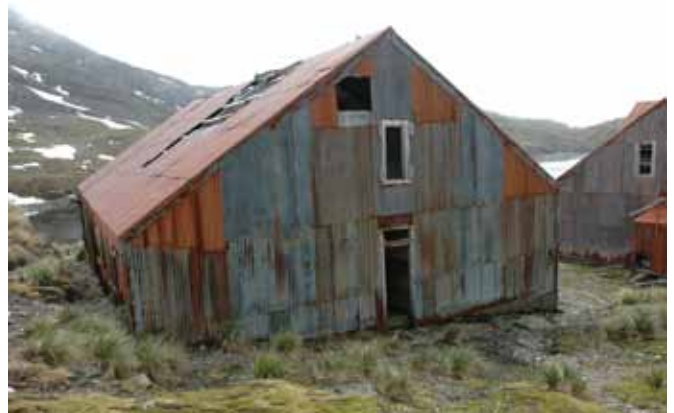
18.1 South elevation

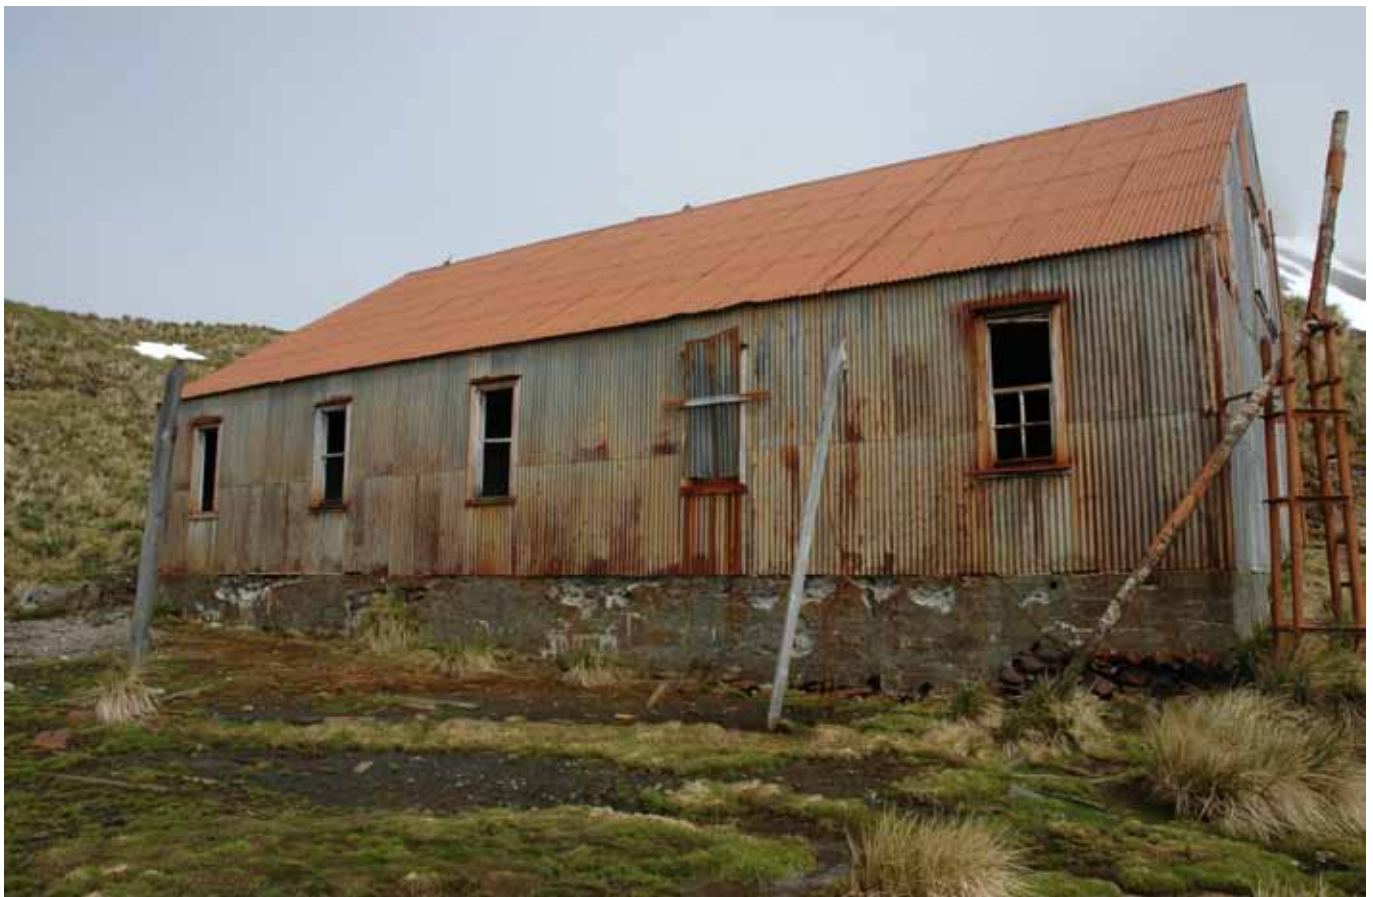
18.2 East elevation

The corrugated iron cladding is present on three sides of the building but the sheeting is coming away on the west side with the northwest corner of the wall having collapsed. The east roof slope is more or less intact but some 20 percent of the corrugated sheeting is missing from the west slope.

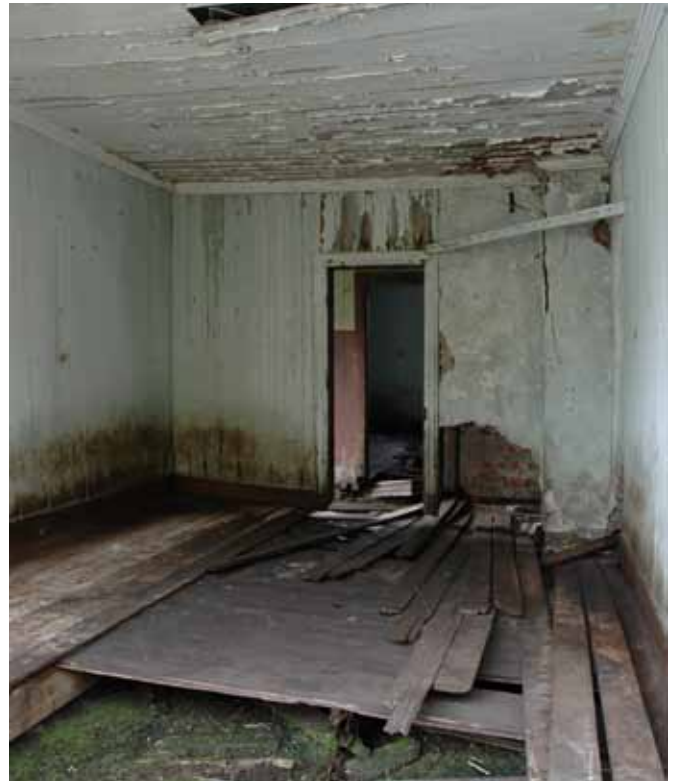
18.3 A typical bunk room

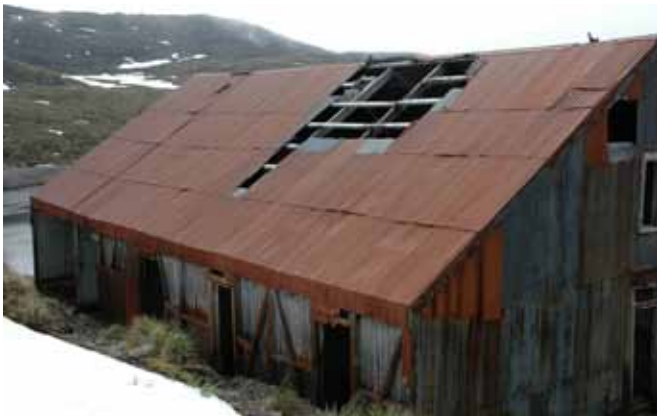
18.4 West elevation

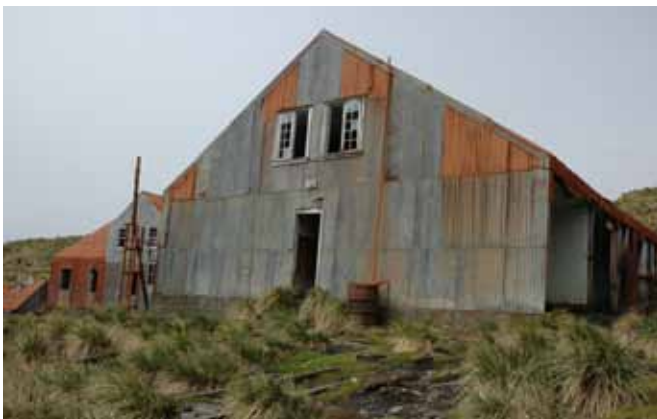
18.5 North elevation

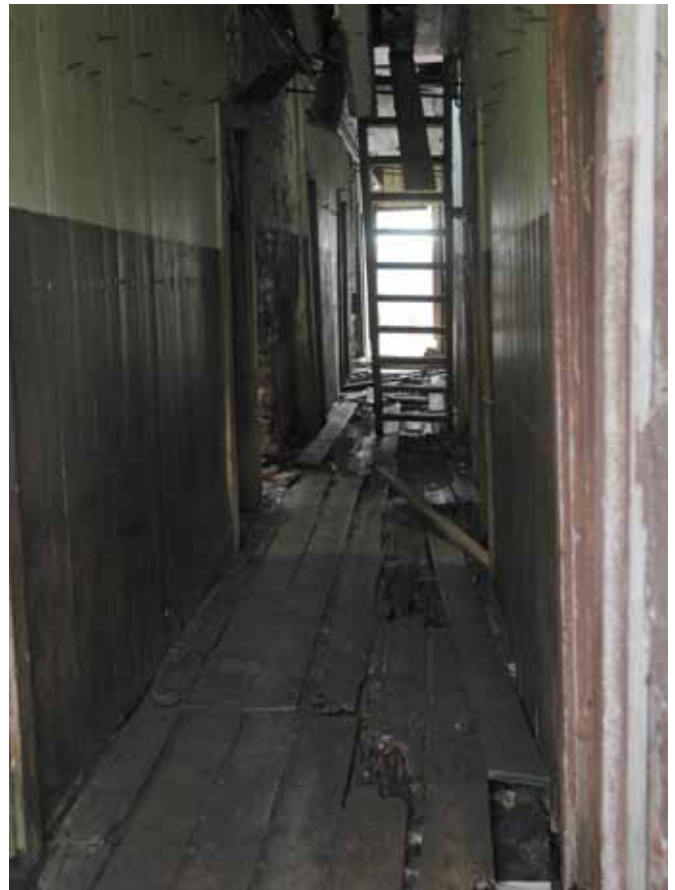
18.6 The central passage on the ground floor

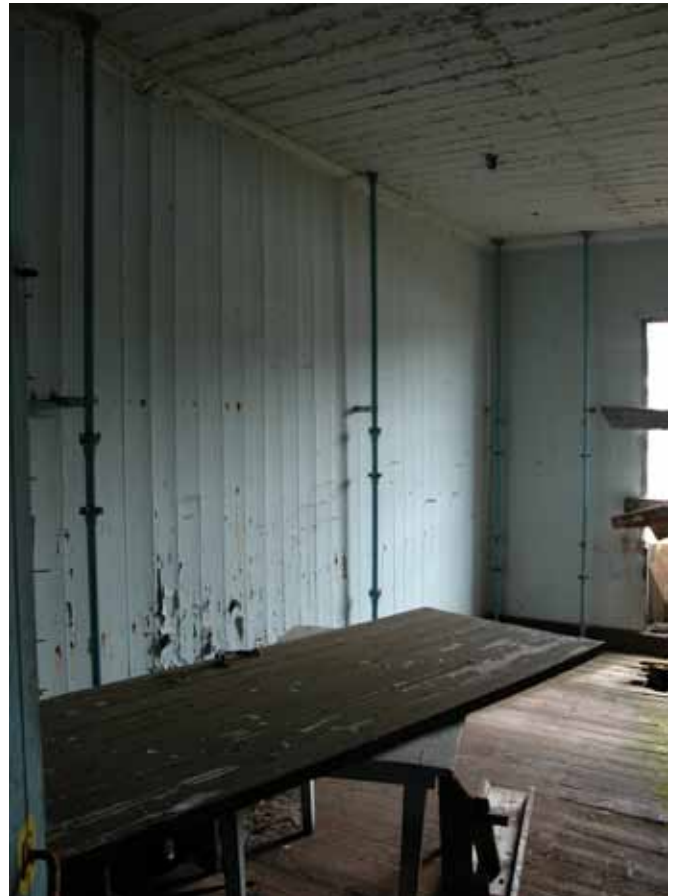
The building is in poor condition with the suspended floor on the ground floor collapsing and the ceiling coming down. The first floor was not accessed.

19.1 A typical bunk room

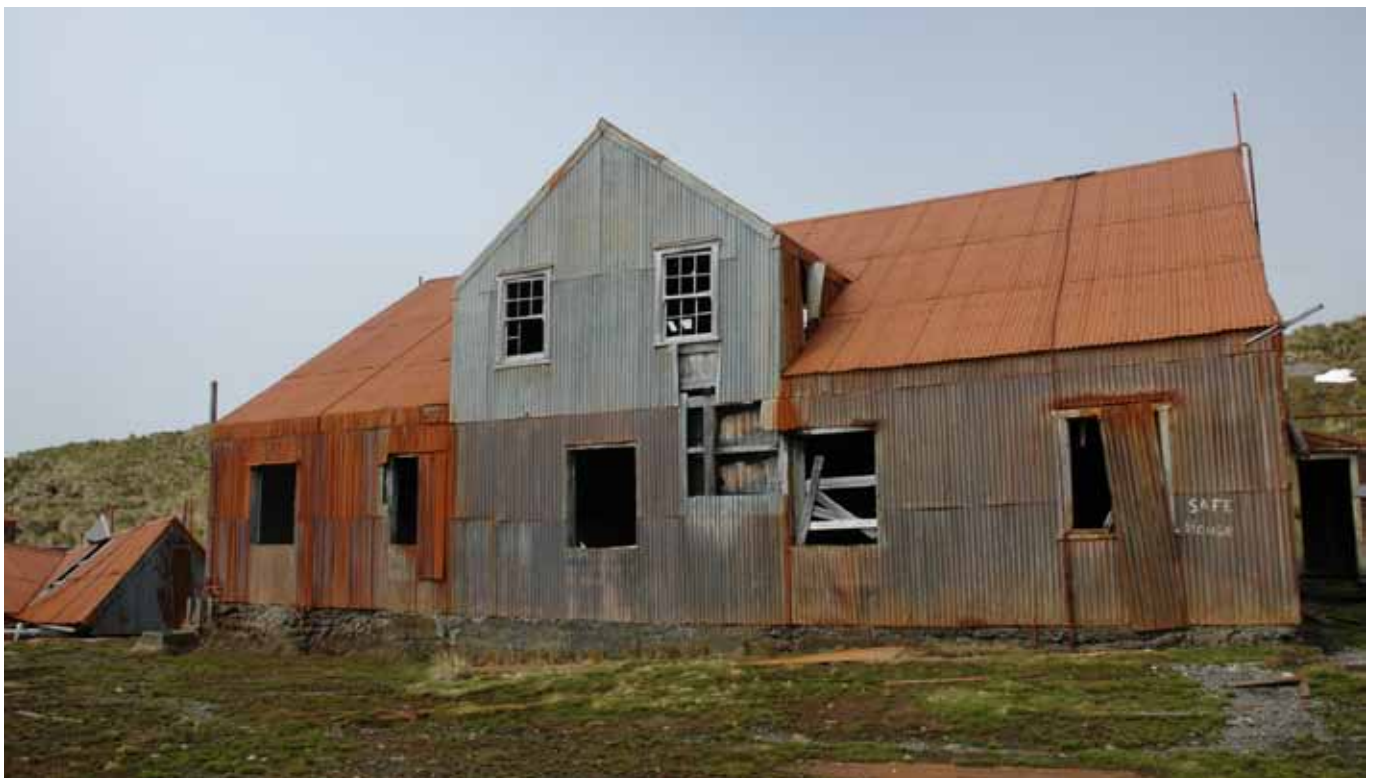
19.2 North elevation
