# DISUSED WHALING STATIONS

**Prince Olav Harbour Gazetteer**

## Gazetteer, July 2011

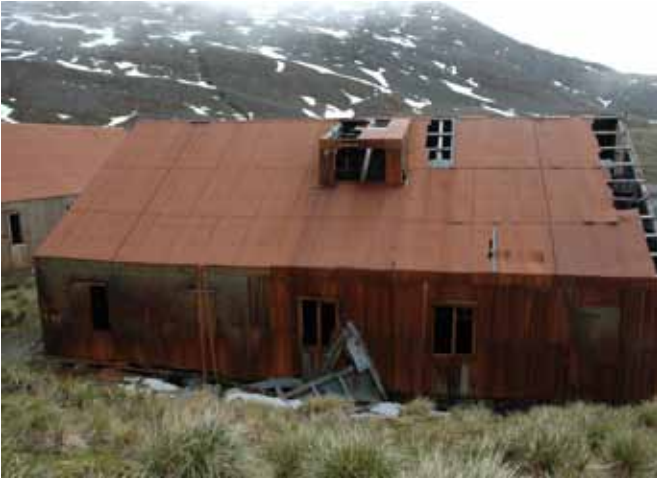
19.3 South elevation

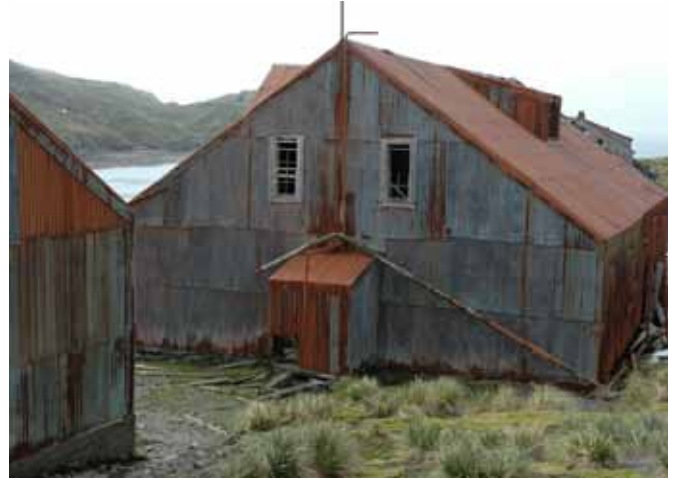
19.4 West elevation

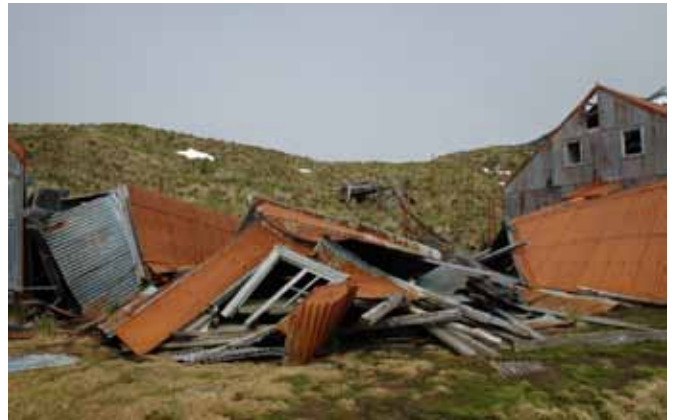
This building has collapsed completely and only the roof trusses and the corrugated cladding to the roof remain intact. The whole building has fallen northwards so the roof now sits some 6m forwards of the original building line. From the size of the walls this would appear to have been a single storey building with a loft which was accessible as a solid flight of stairs remains in the wreckage. The structure of the building seems to have been based on 60mm thick tongued and grooved vertical boarding as an internal skin with battening fixed to it externally and corrugated iron on the outside of that.

20.1 The remnants of the building from the north

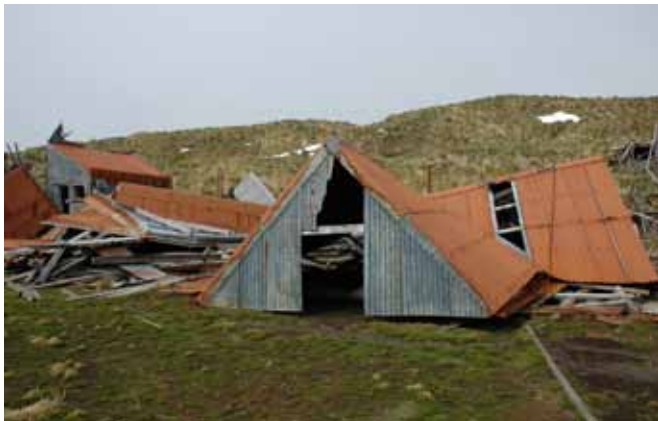
20.2 The remaining section of roof on the ground to the north of its original location

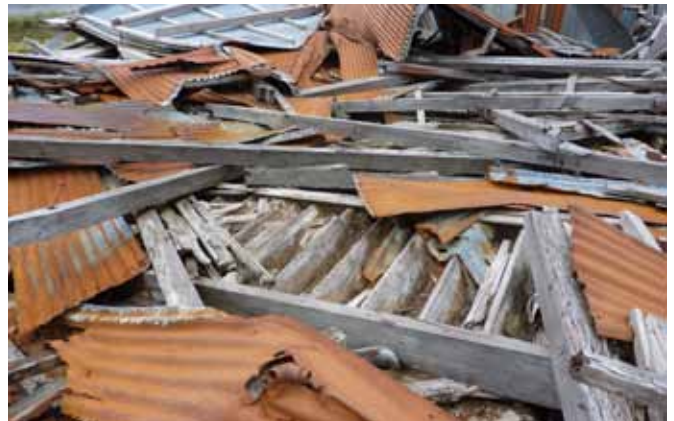
20.3 Detail of the remains of the building showing the staircase

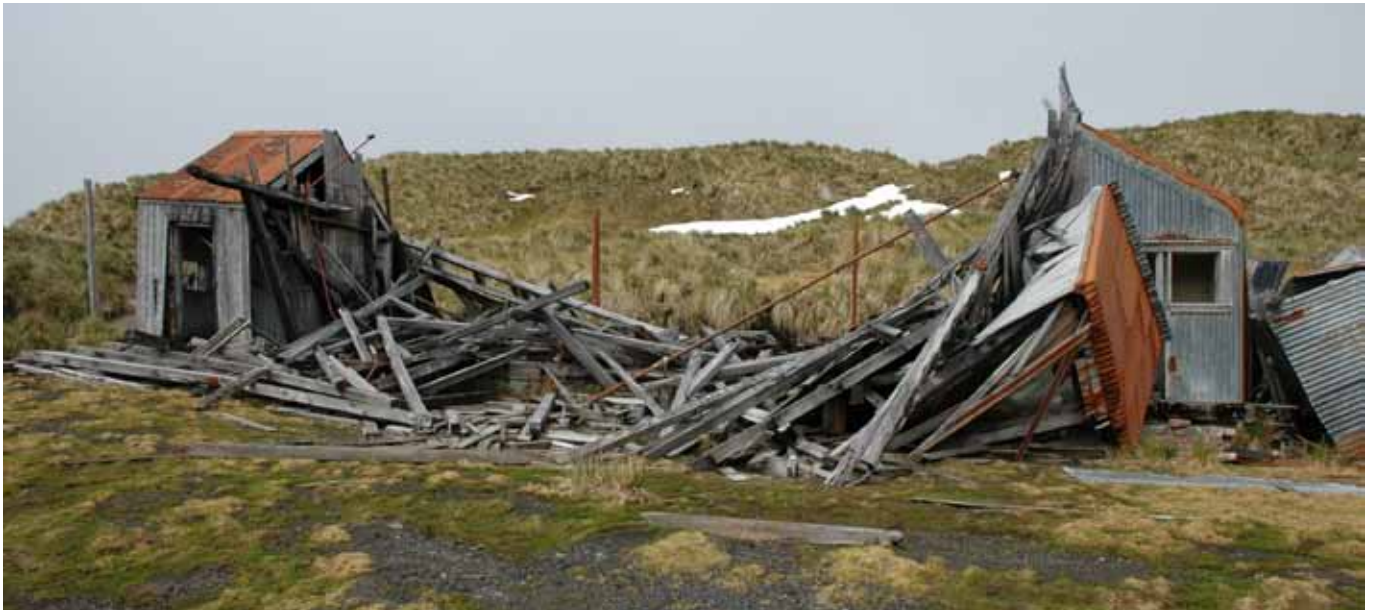
This building has entirely collapsed with the exception of small sections at either end, a lean-to on the west side and an entrance porch on the east side. It appears to have been a single storey building although the roof space was probably accessible as there appears to be a window in the gable end. The wall structure appears to be vertical boarding covered directly with corrugated iron on the exterior and with vertical boarding internally.

21.1 The north side of the building

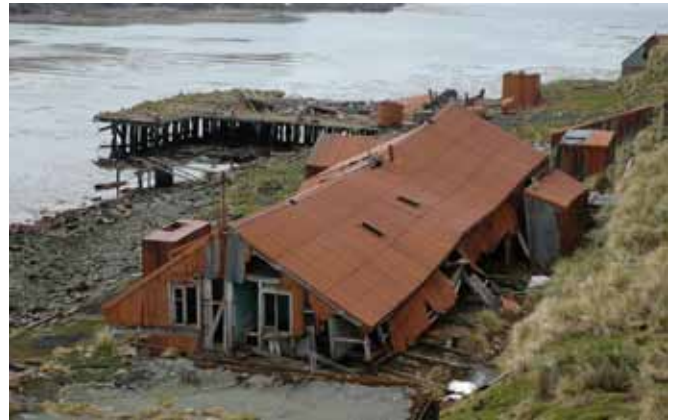
This building remains standing although only just. The whole building appears to have fallen northwards so the upper storey is now at ground floor level. The building was single storey with an accessible loft space with a continuous long dormer on the north side and possibly a pair of roof lights on the south side, although these may be vents for stoves. The roof covering miraculously remains more or less intact though with a substantial wave along it. At the east end of the building the southeast corner remains more or less full height. At the west end the upper floor is now at ground floor level. The concrete base remains and inside this is visible some remains of kitchen equipment and some tables of the old mess room.

22.1 General view of the building from higher ground to the southwest

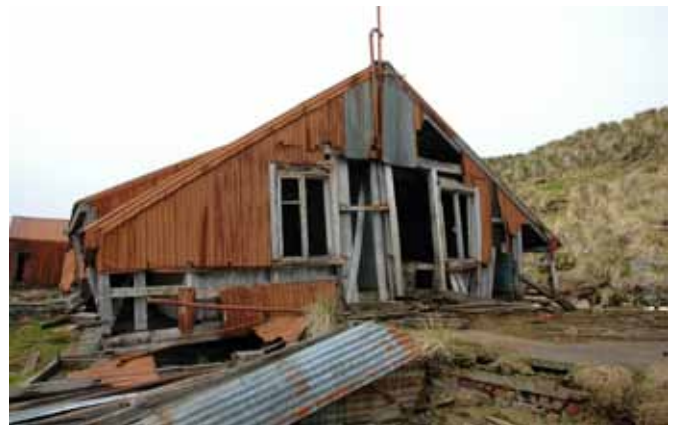
22.2 The remains of the west elevation

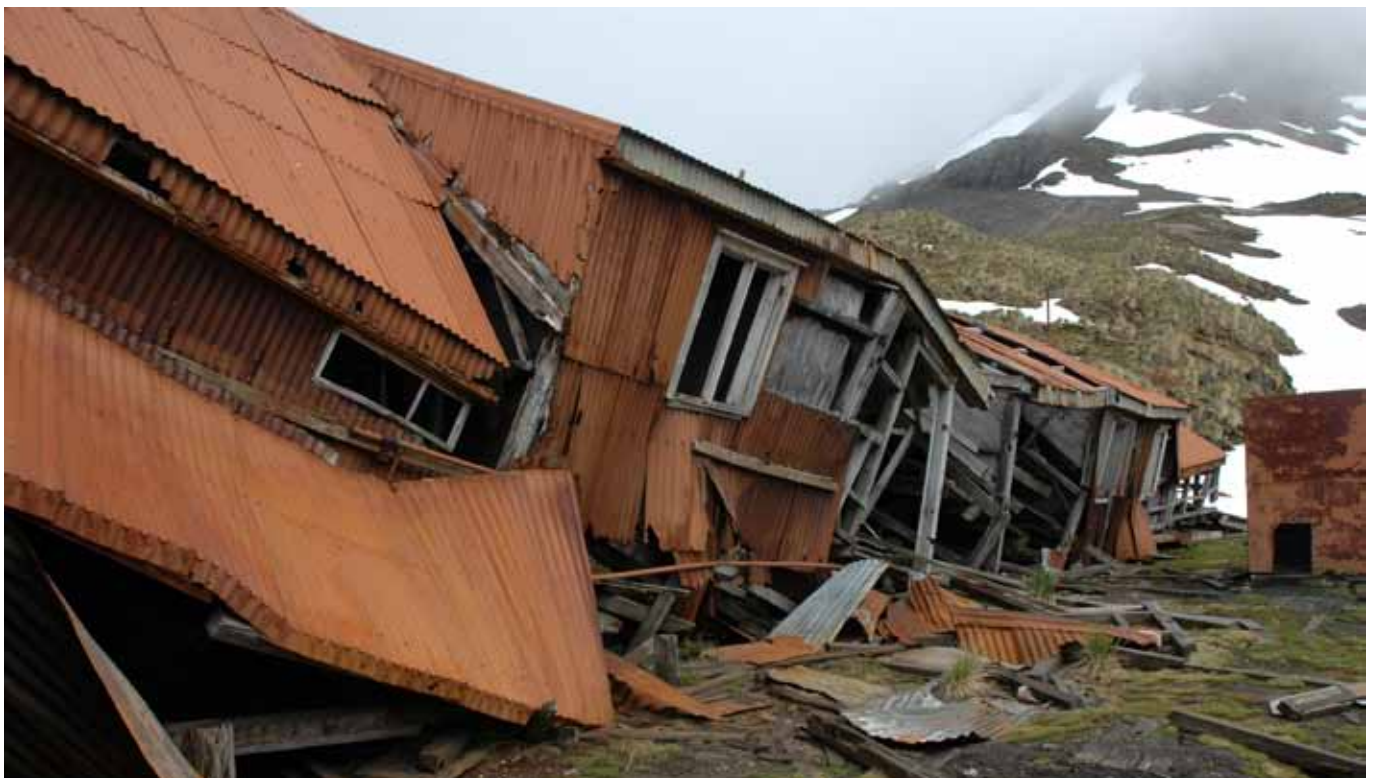
22.3 The north elevation

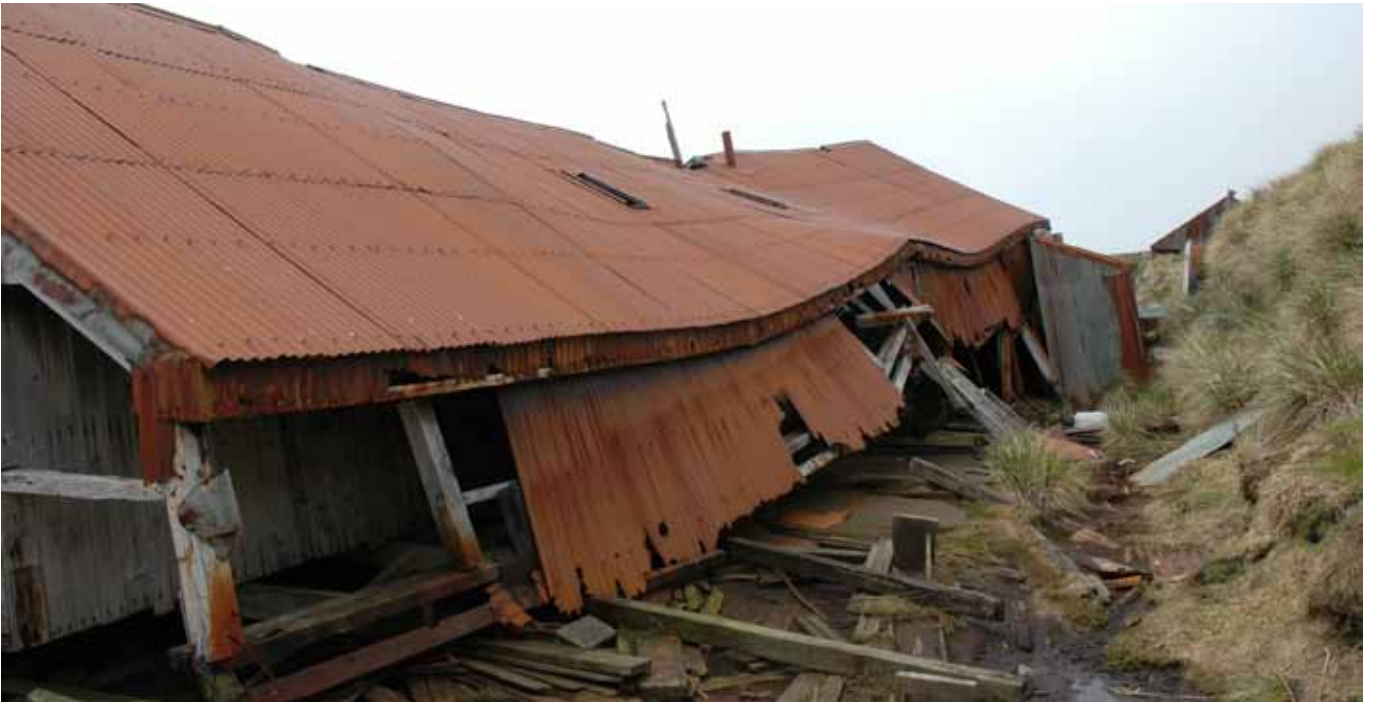
22.4 The south elevation

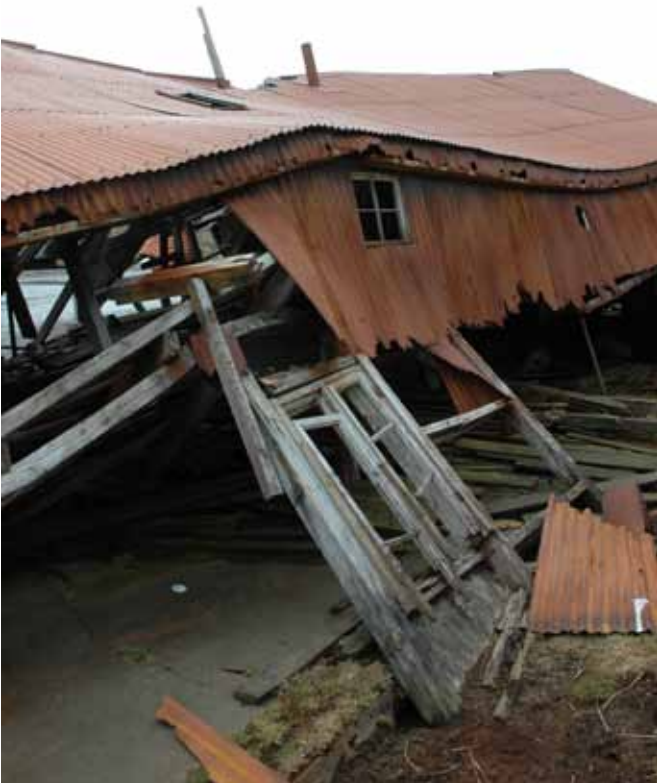
22.5 Detail of the centre of the south elevation

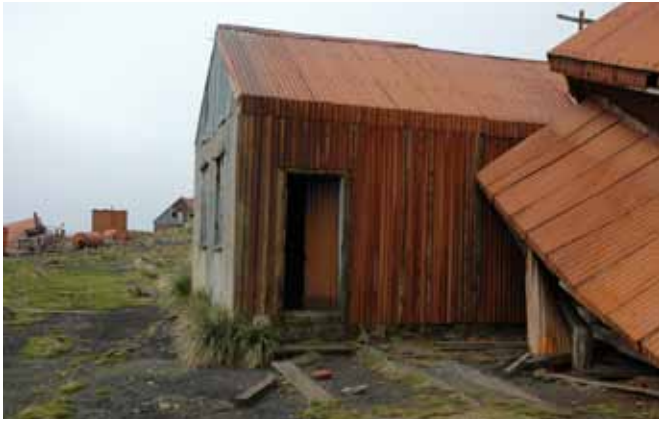
The north end of the bakery remains intact. This small building is single storey with a pitched roof running north/south and two side hung casement windows in the north gable end. The concrete floor and the stud frame is unclad internally. To the south is the remains of the oven built in brick. This is now in poor condition with much of the brickwork damaged and the iron fittings for the doors and reinforcing rusting and splitting off the brickwork. The south end of the building was built tight up against the adjacent bank and the brick end wall and corrugated iron gable remain in position. Other than this the southern section of the building has collapsed completely with only a pile of timber and the concrete base remaining.

23.1 The north end of the Bakery - west side with the collapsed end of the kitchen in the foreground

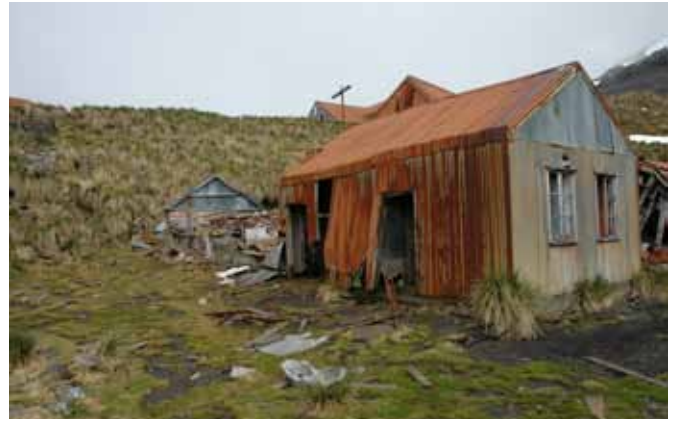
23.2 The north and east sides of the Bakery

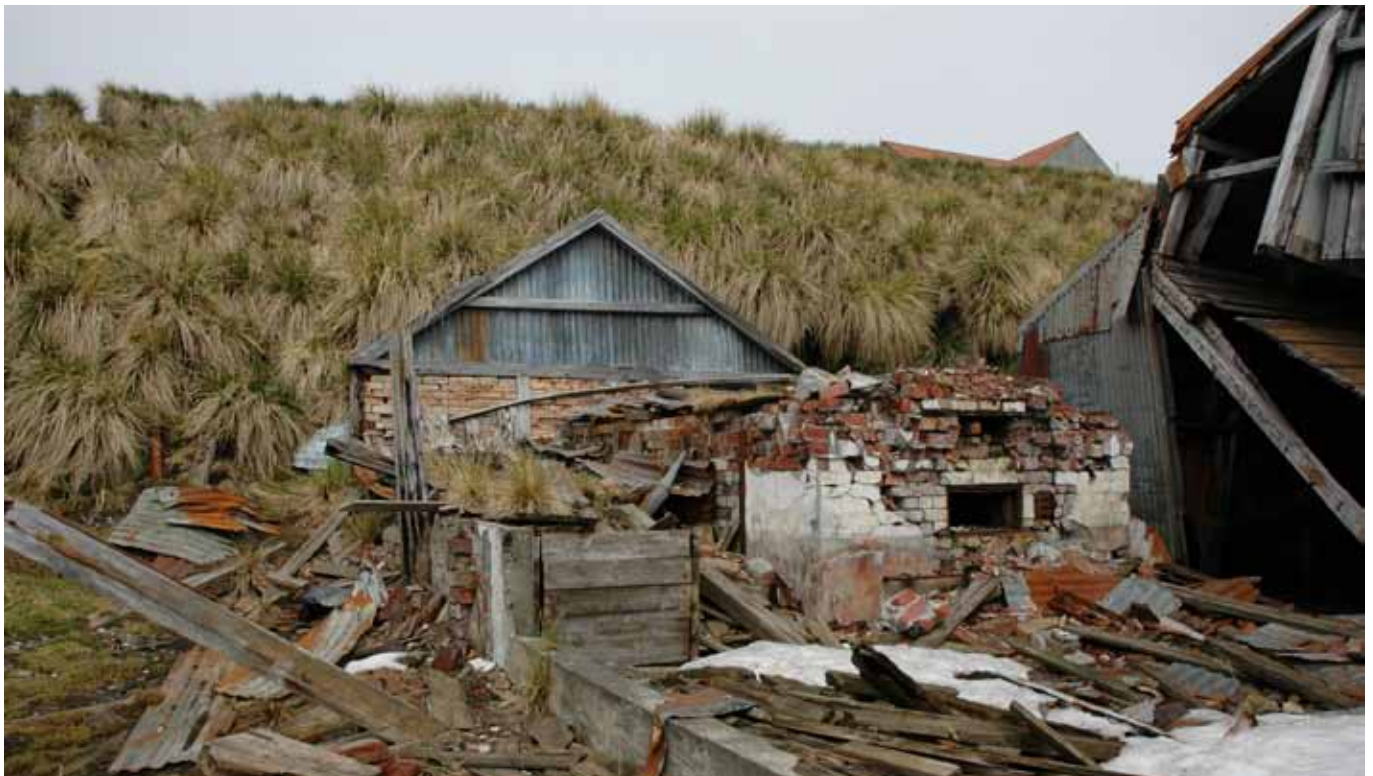
23.3 The remaining brick over the south end of the Bakery

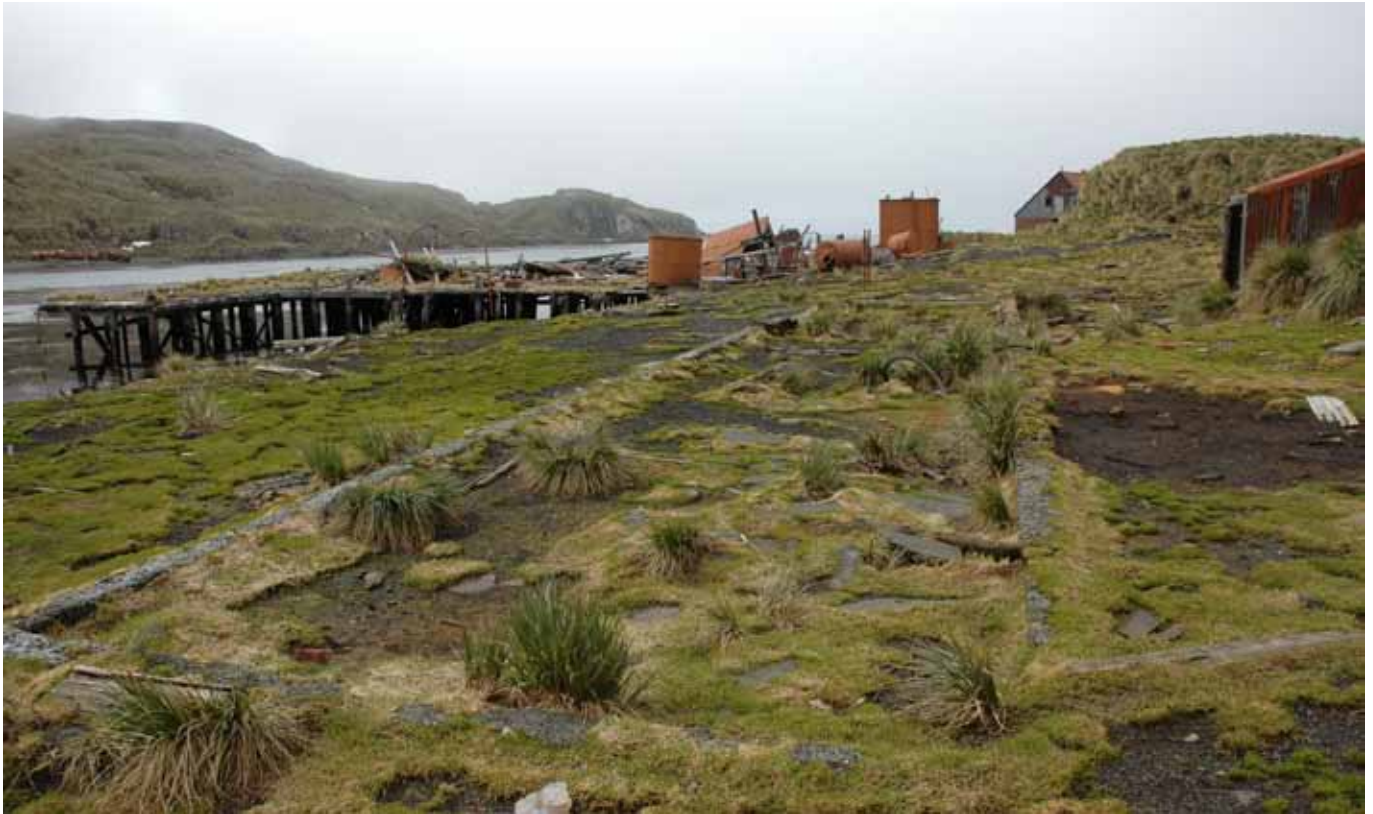
This building has disappeared entirely apart from its concrete base which just remains visible.

24.1 The remaining concrete base

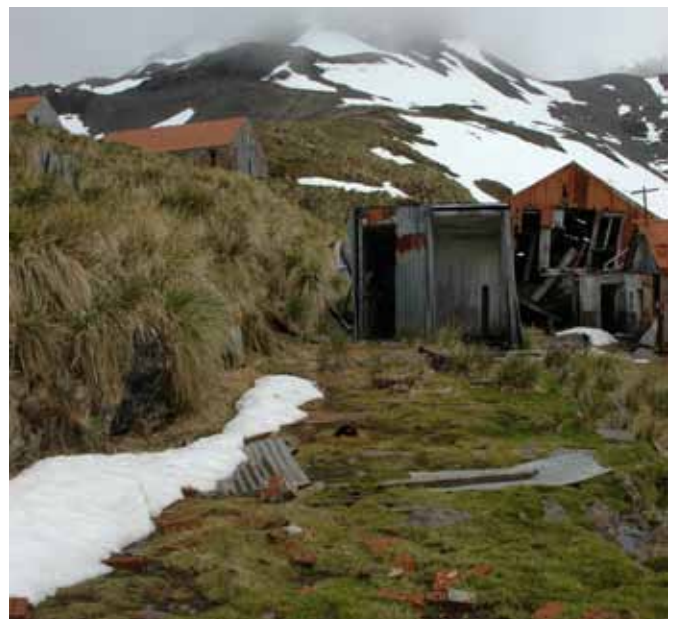
The corrugated iron entrance porch to the old barracks remains at its west end in poor condition. The remainder of the barracks has disappeared completely with only a few bricks showing where it had been.

25.1 Remnant of the old Foremen's Barracks

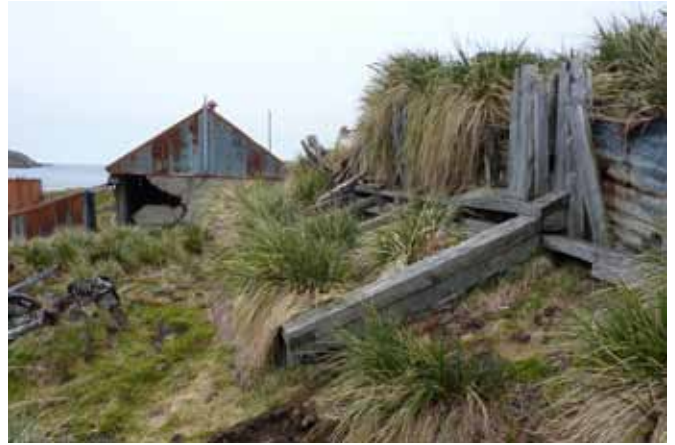
26.1 Remnants of the cold frame

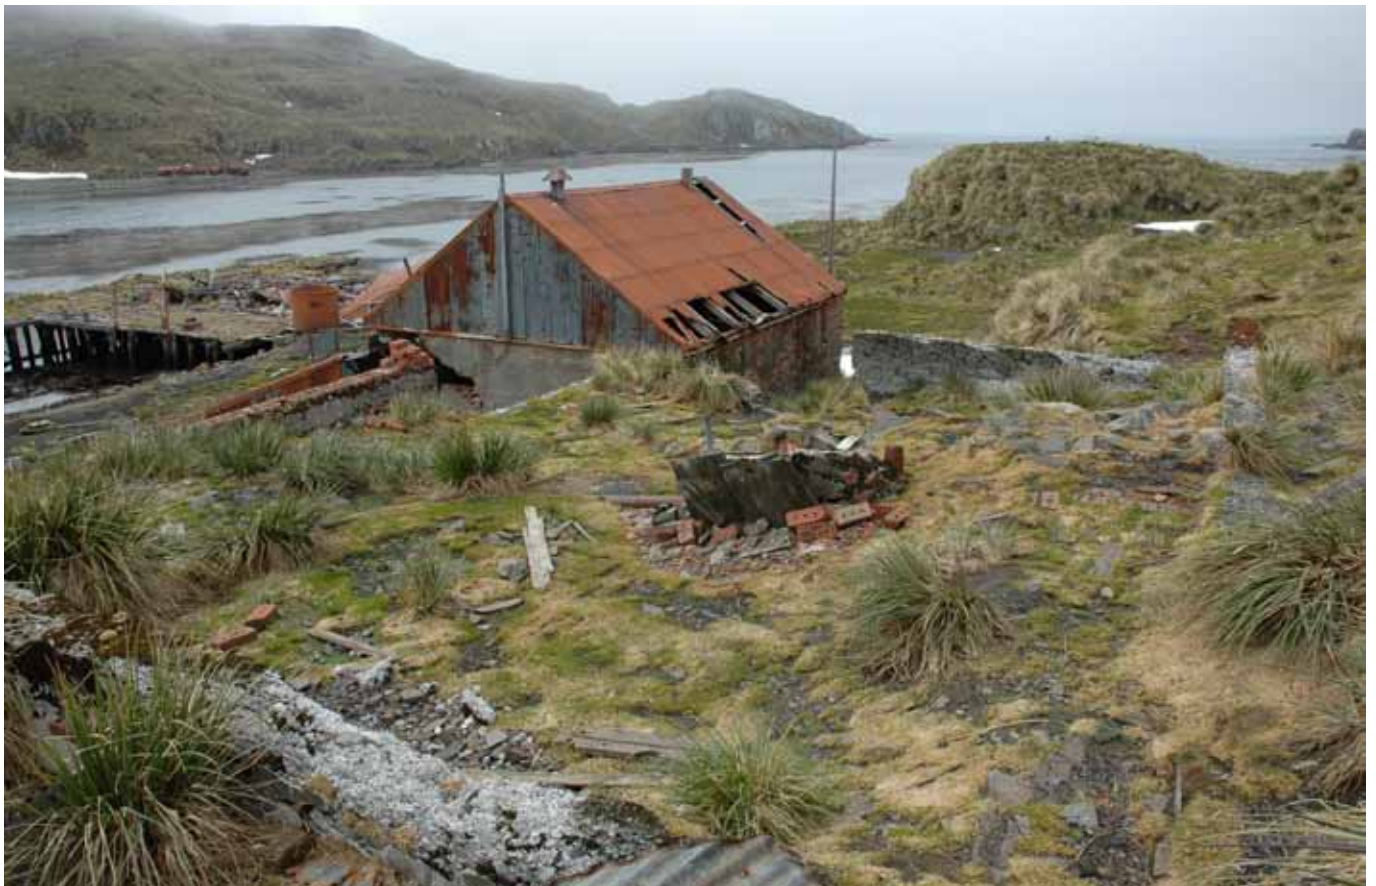
This too has disappeared in its entirety with only some concrete and brick walls showing where it has been in the past. There is a timber construction to its north side which may have been an entrance platform but at the west end this looks as though it may have been used as a cold frame.

26.2 Remains of the New Foremen's Barracks looking eastwards. The 'building with no number' is in the background.

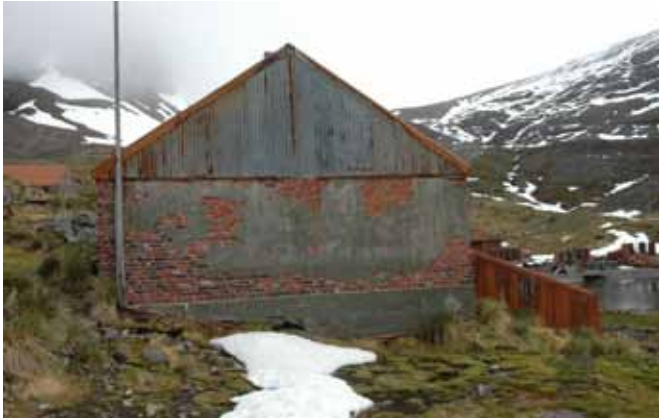
NN5 East elevation

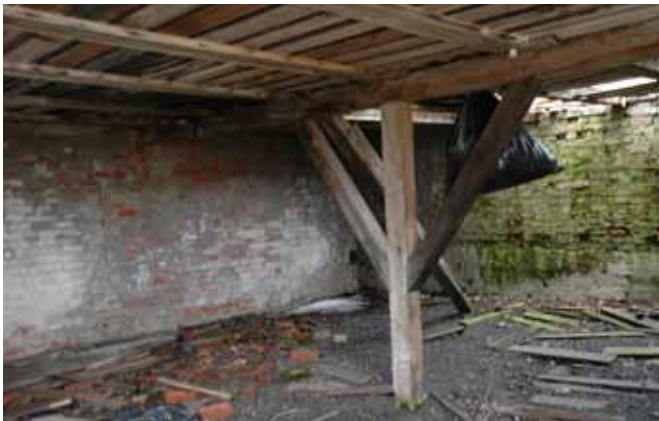
NN6 Interior of the store showing propping of the attic floor

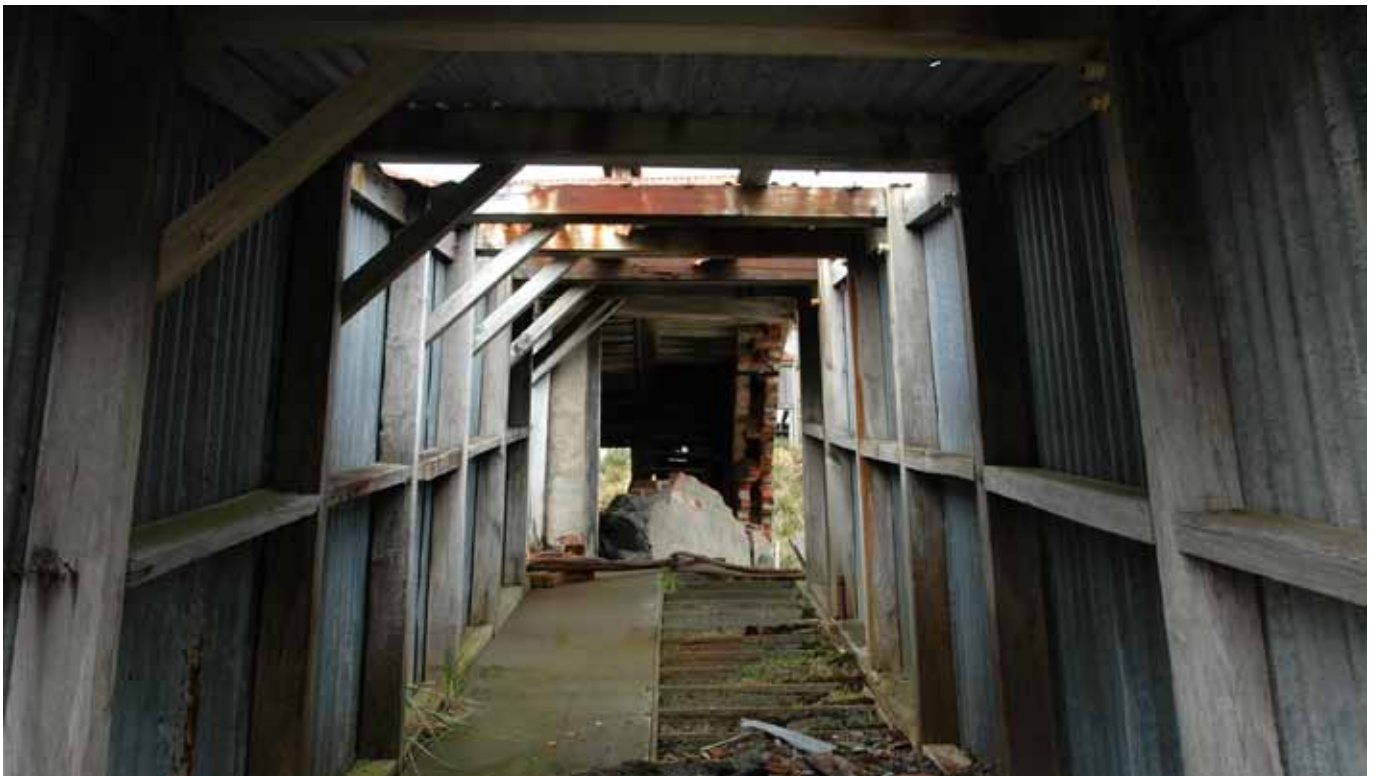
NN7 Interior of the stair and ramp looking south from the bottom

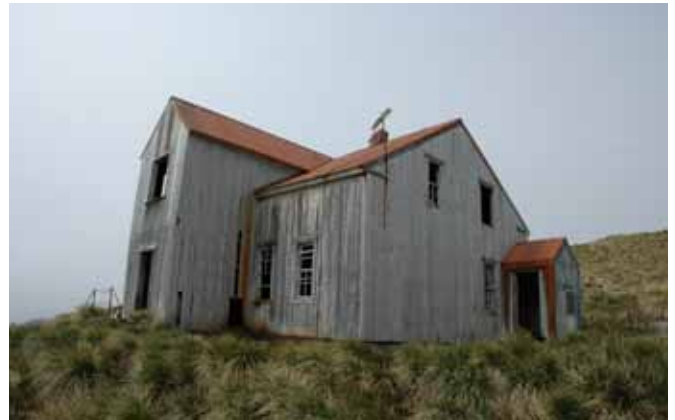
27.1 North and west elevations

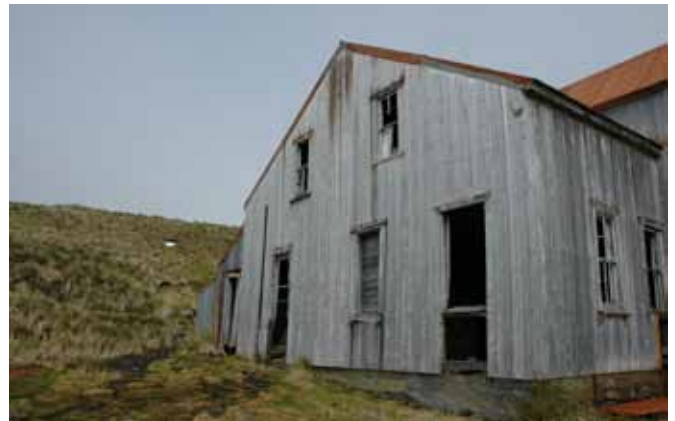
27.2 East elevation

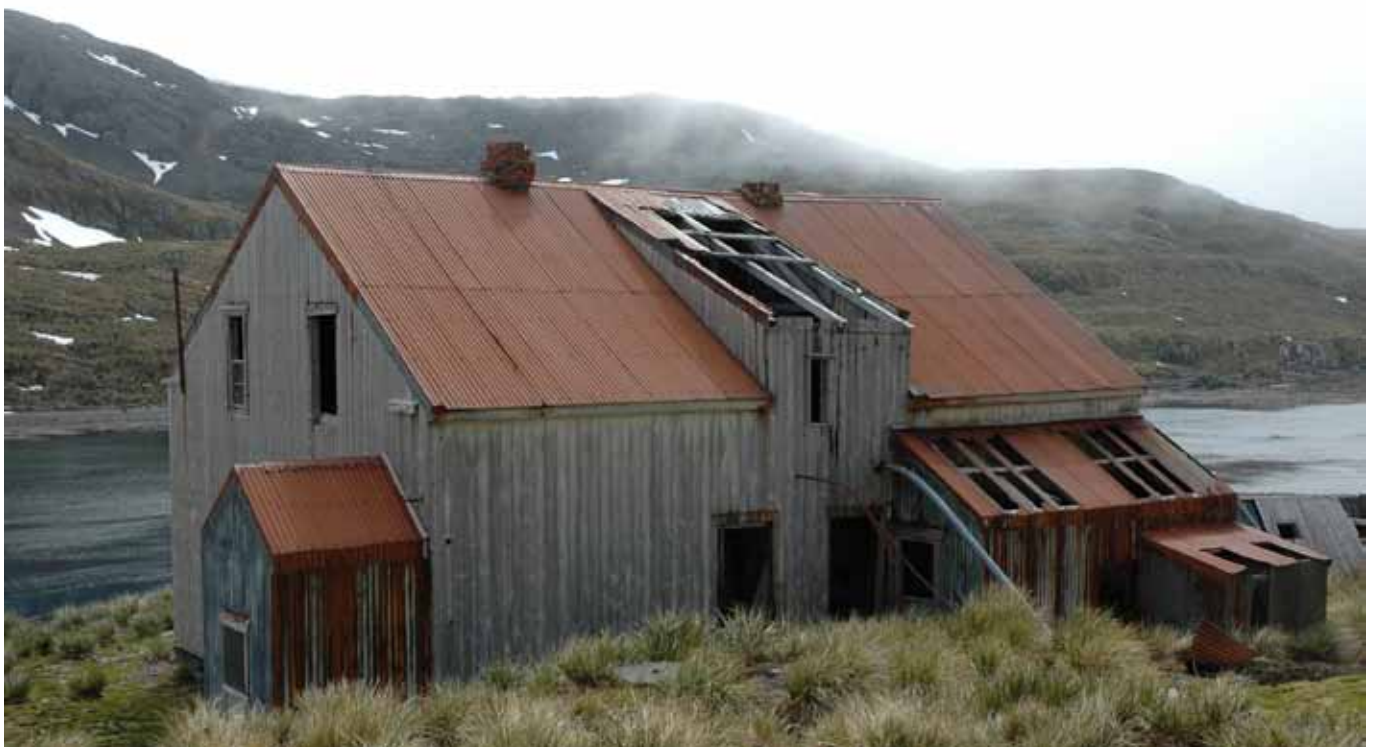
27.3 South elevation

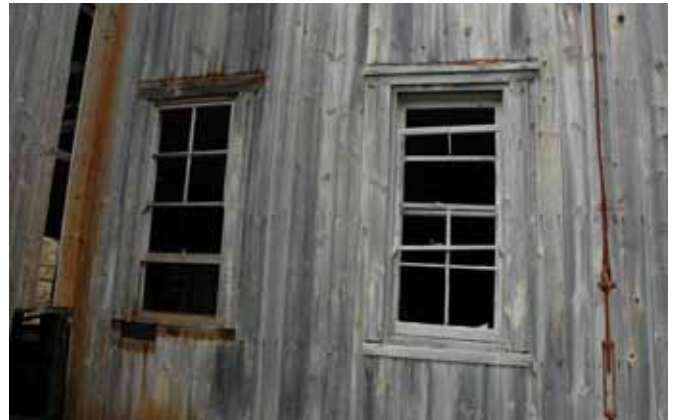
27.4 Typical sash windows

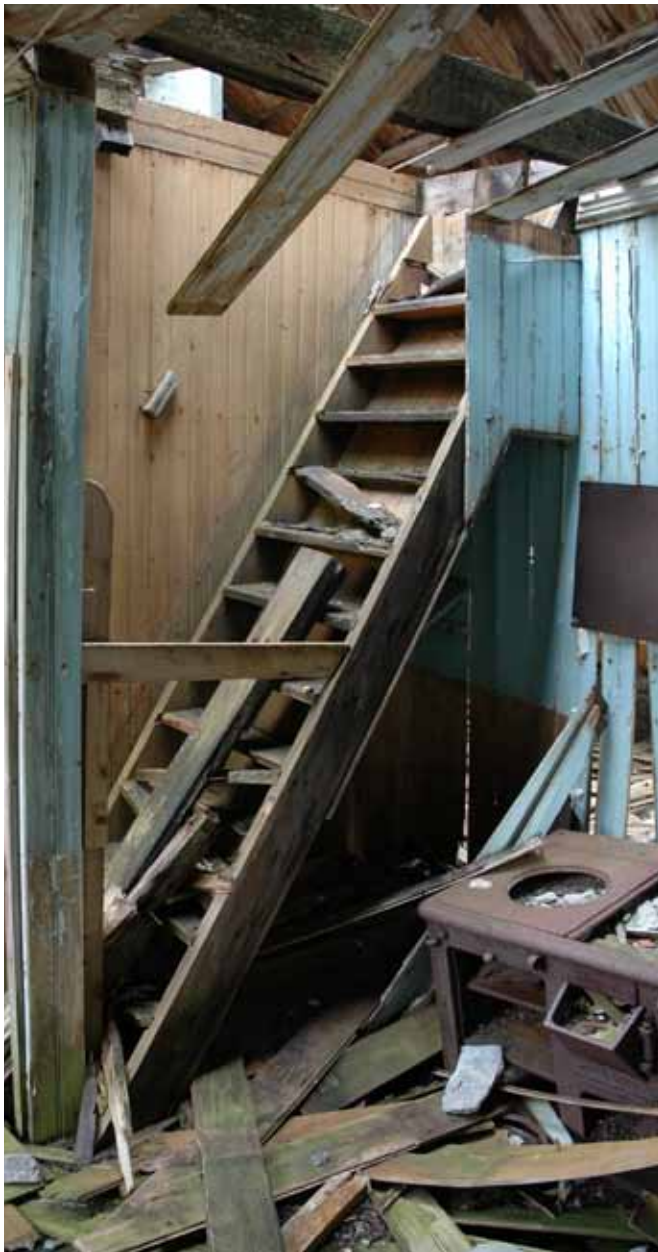
27.6 The staircase on the south side of the house

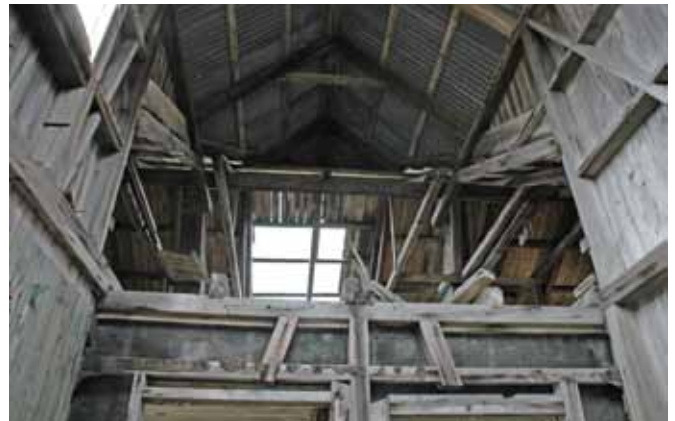
The whole of the ground floor, which was suspended, has fallen in and the ceiling has collapsed. Curiously there did not appear to be any remaining floorboards to the first floor – why they would have been removed is unclear. It would seem that partitions have been stripped out here as well leaving the upper floor as open – perhaps the building has been used as a 'quarry' for materials. The construction of the building is much the same as the others with a substantial timber frame, roughly 125x125mm principal members with vertical boarding internally and, in this case, vertical boarding externally with felt under both inner and outer boarding. The front entrance has four concrete steps and a wrought iron balustrade.

27.5 Inside the north entrance looking up into the main first floor space

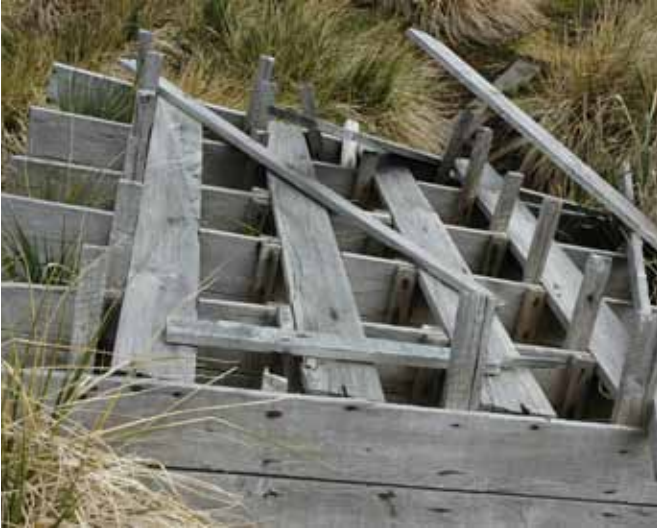
28.1 The nesting boxes

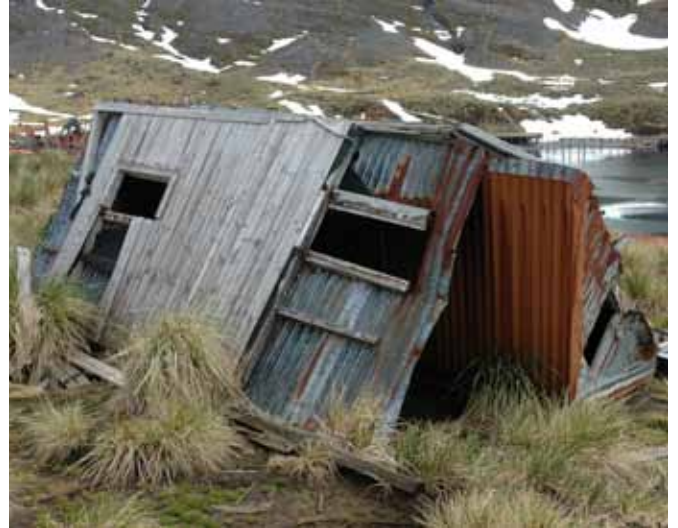
The Hen House has collapsed completely. The roof appears to have flipped over the north wall of the building, leaving the roof lying upside down and the south wall exposed having moved through 180°. The nest boxes for the hens remain on the south side of the building, the roof, remarkably, remains intact.

28.2 The remnants of the Hen House

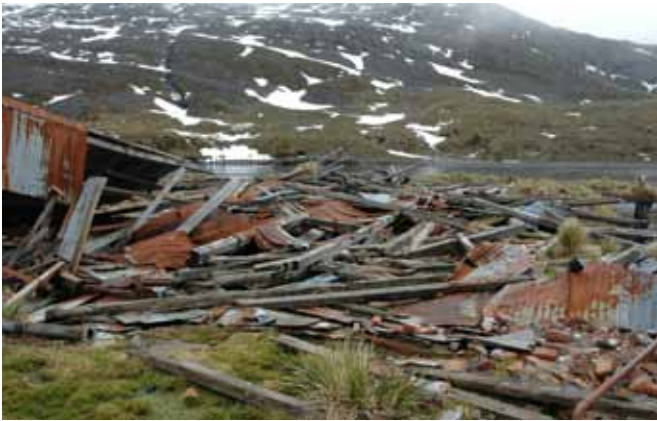
This has collapsed completely and only one small section of roof remains propped up, the remainder is a heap of timber and corrugated iron. Part of this was built on the jetty itself. The jetty is supported by substantial timber piles of approximately 250x250mm cross section. These are at roughly 2m centres with heavy cross timbers supporting secondary beams and then a timber deck of 75mm thick boards. The deck is now significantly decayed with grass growing out of it.

29.1 Jetty store looking northwards

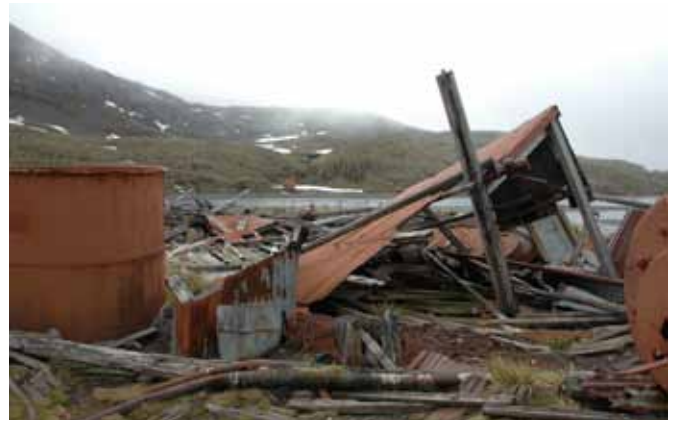
29.2 The remnants of the jetty store

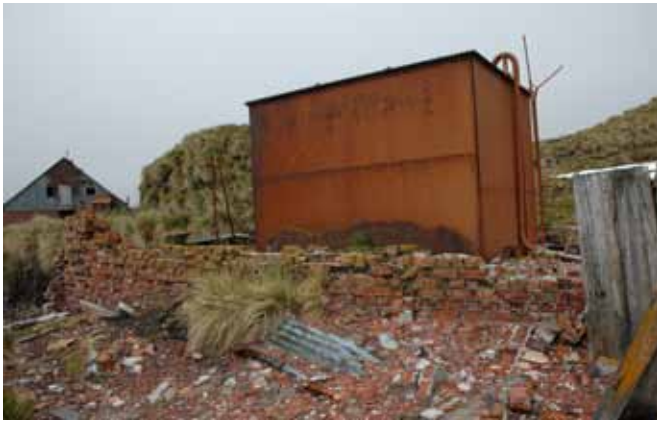
There are some remnants of standing walls and a door and frame and a good deal of brick rubble but not enough to distinguish what the buildings were at that part. One rectangular fuel tank remains in position, possibly a fuel tank for the boilers.

31.1 Tank and remaining wall looking southeast. The building in the background is the Pig Sty.

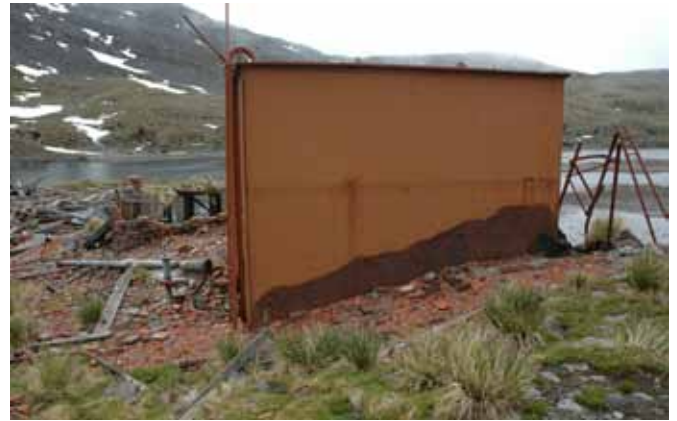
31.2 Tank looking northwards with Jetty 29 in the background

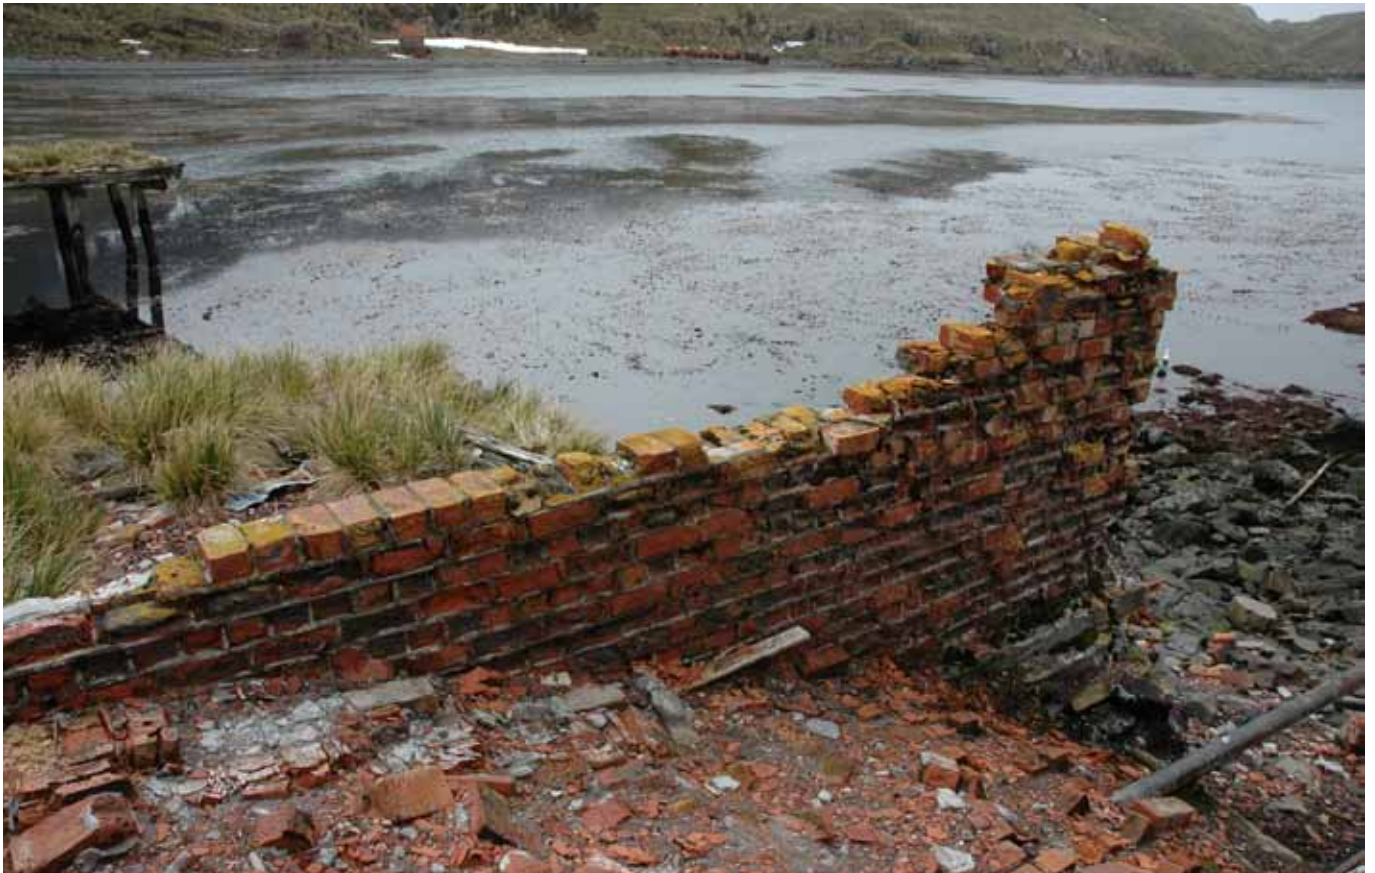
31.1 It is not clear whether this is a remnant of the Boiler House or part of the Pump House

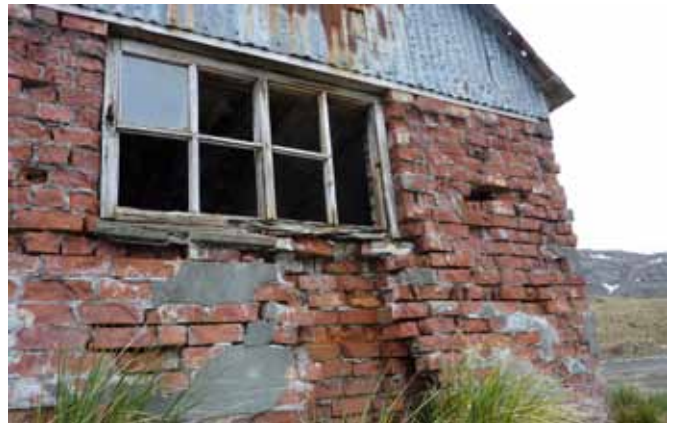
This building is in slightly better condition than the other brick buildings on the site. It is built in brick-and-a-half bond of the 'rat-trap' type with headers tying the inner and outer skins together. The wall has failed under the windows on the north side and in a substantial area of the east elevation. The east wall which is built on top of an escarpment is the most precarious of the building. The walls have been rendered externally but most of this has now fallen away.

32.2 Detail of very poor brickwork on the east elevation

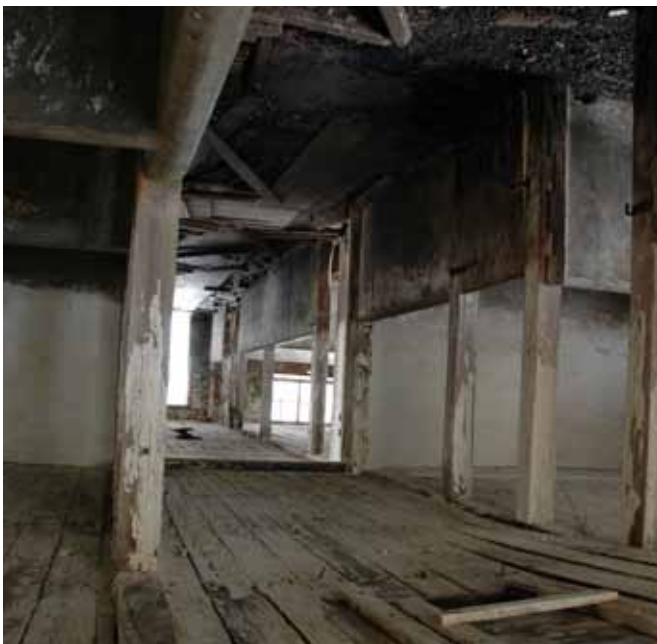
32.3 Detail of the interior

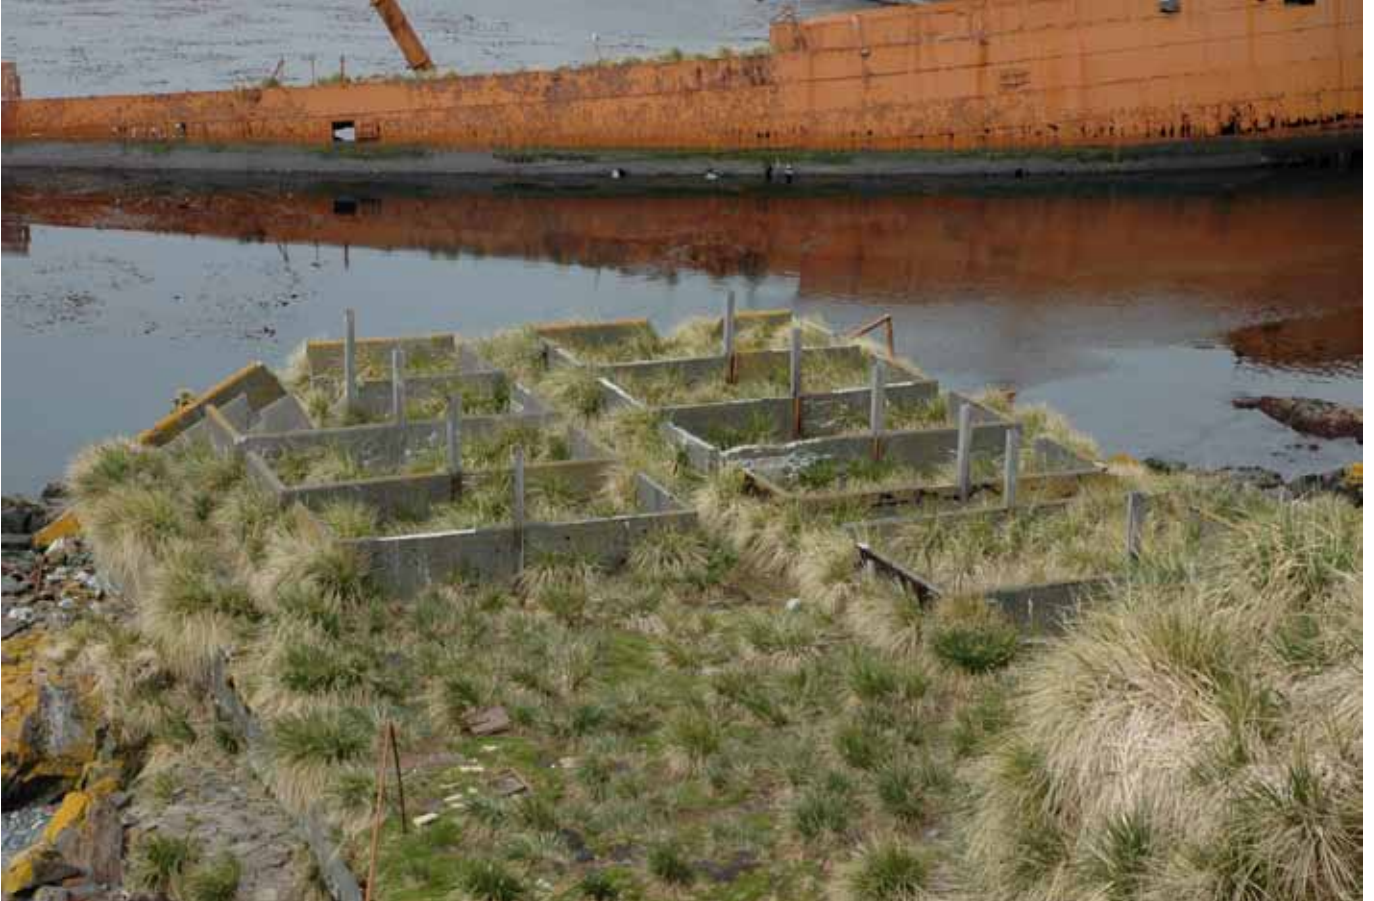
The structure of this building has disappeared entirely leaving only the concrete floor and the walls of the pig pens visible.

33.1 The remains of the Pig Sty with the hull of the Brutus in the background

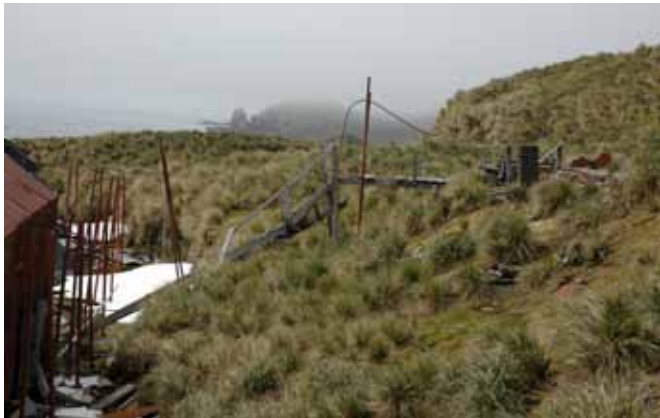
Little now remains of the cinema which stood on top of the bank to the south of the New Barracks and the Slop Chest. There is the remains of a timber stair leading to the cinema and the location and extent of the building is still apparent from the remaining concrete foundation and some remnants of brickwork. The main superstructure of the cinema no longer exists.

34.1 The access stair seen from the west

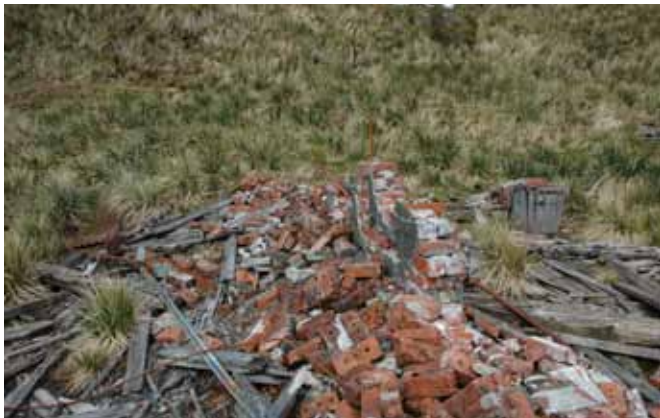
34.2 Remnant of the east wall
