# DISUSED WHALING STATIONS

**Prince Olav Harbour Gazetteer**

## Gazetteer, July 2011

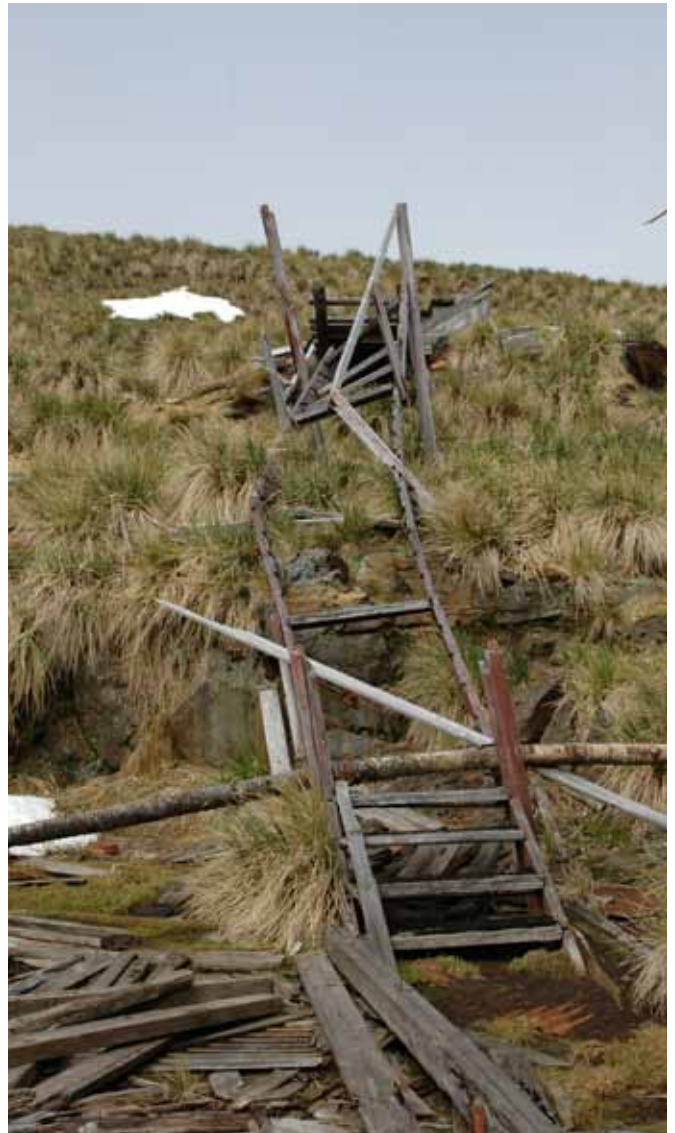
34.3 Detail of the access stair seen from the north

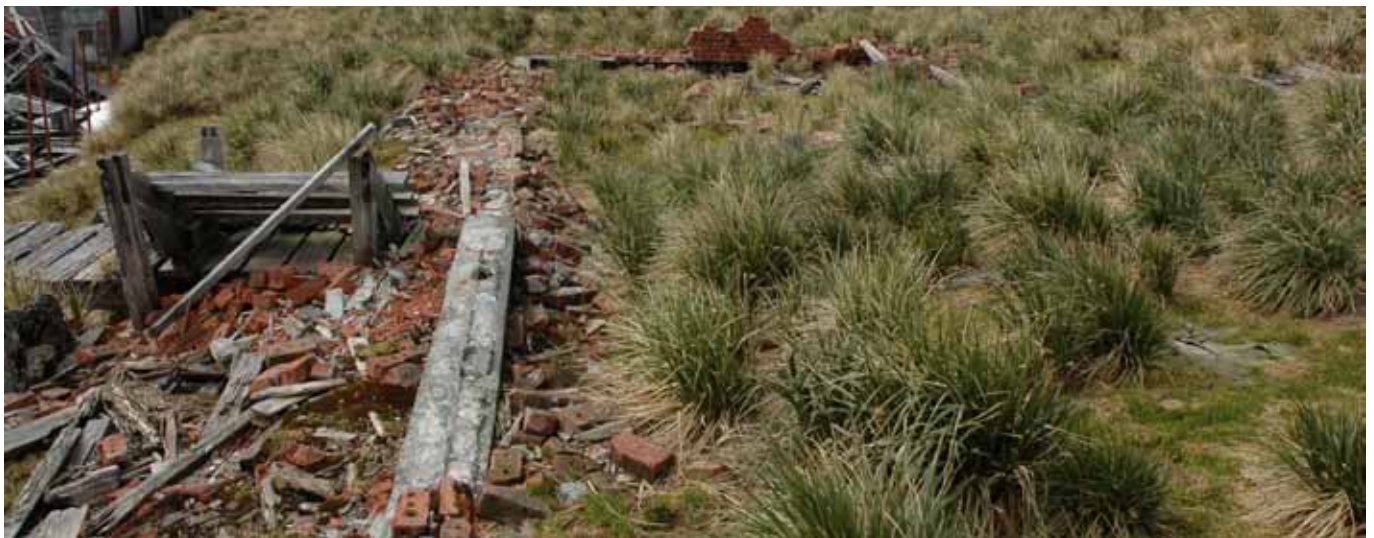
Little now remains of the cinema which stood on top of the bank to the south of the New Barracks and the Slop Chest. There is the remains of a timber stair leading to the cinema and the location and extent of the building is still apparent from the remaining concrete foundation and some remnants of brickwork. The main superstructure of the cinema no longer exists.

34.4 General view of the site of the Cinema looking eastwards

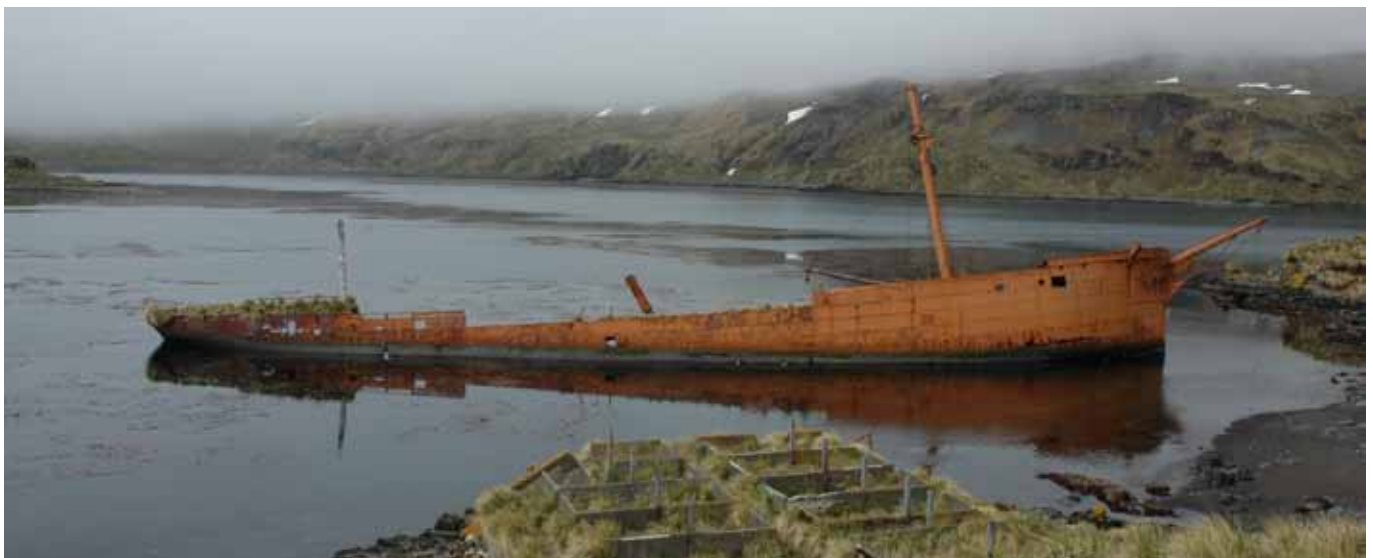
37.1 General view of the west side of the Brutus

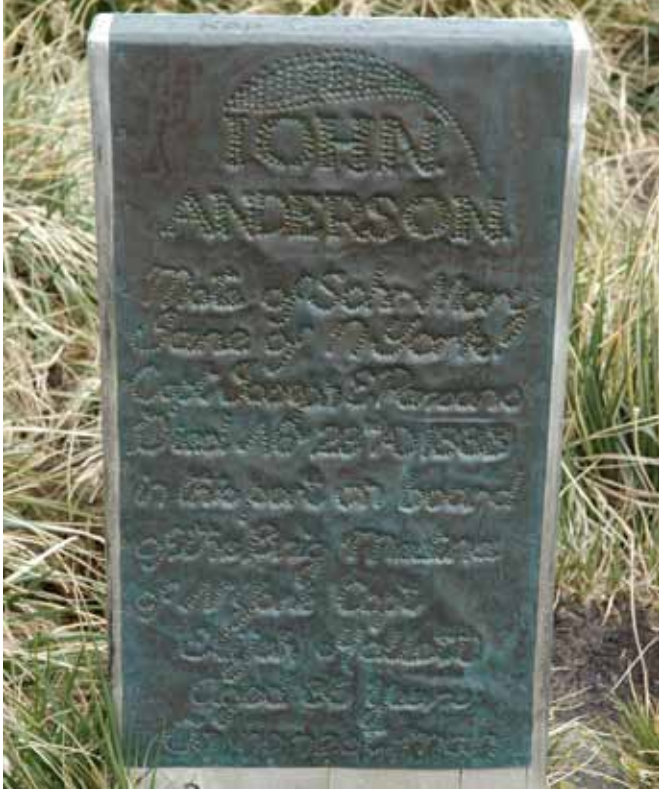
38.1 The replica headstone of John Anderson

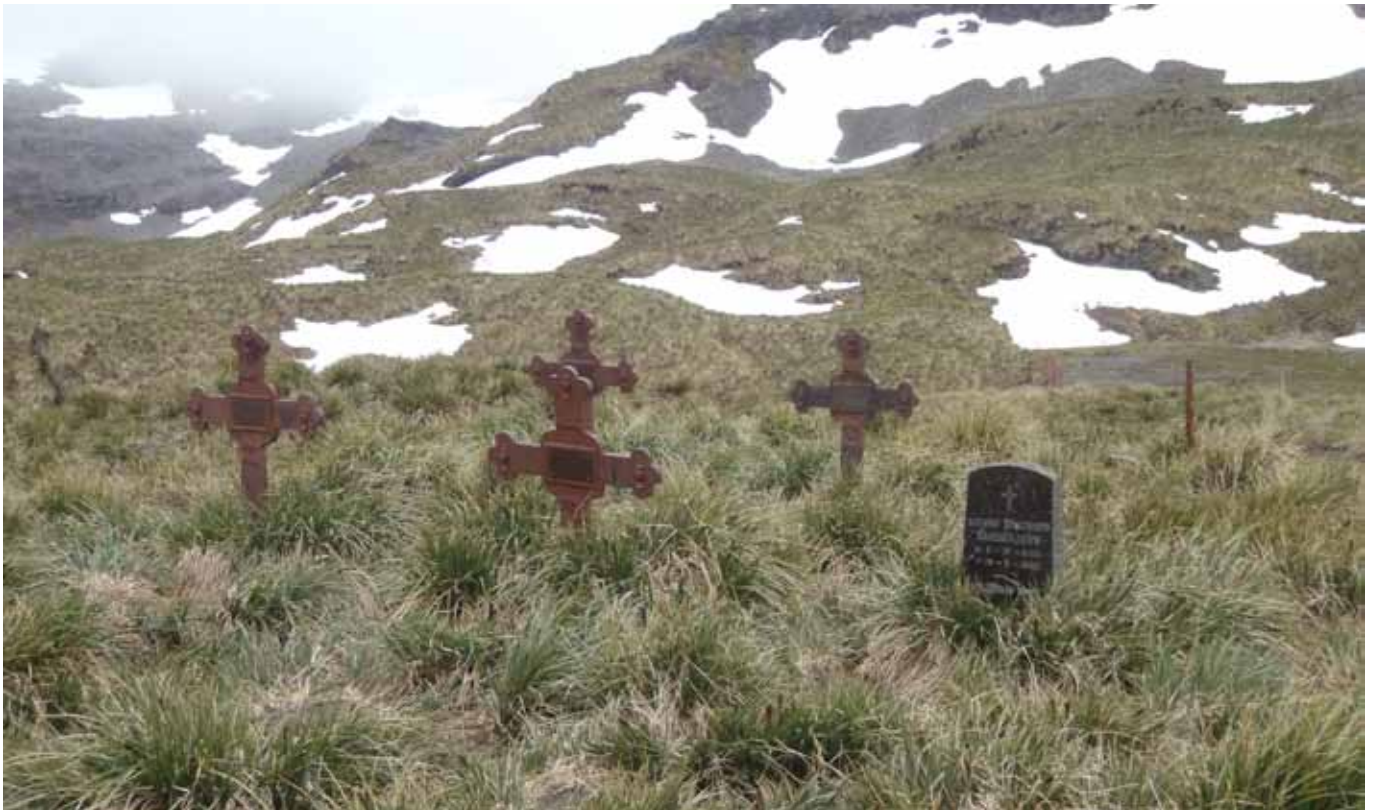
38.2 General view of the Cemetery
