DISUSED WHALING STATIONS

Stromness Harbour Gazetteer

Gazetteer, July 2011

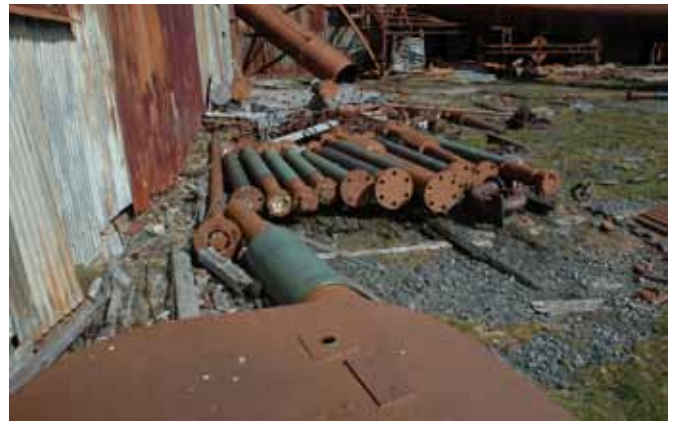
1.2 Spare prop shafts by the side of Building No. 6

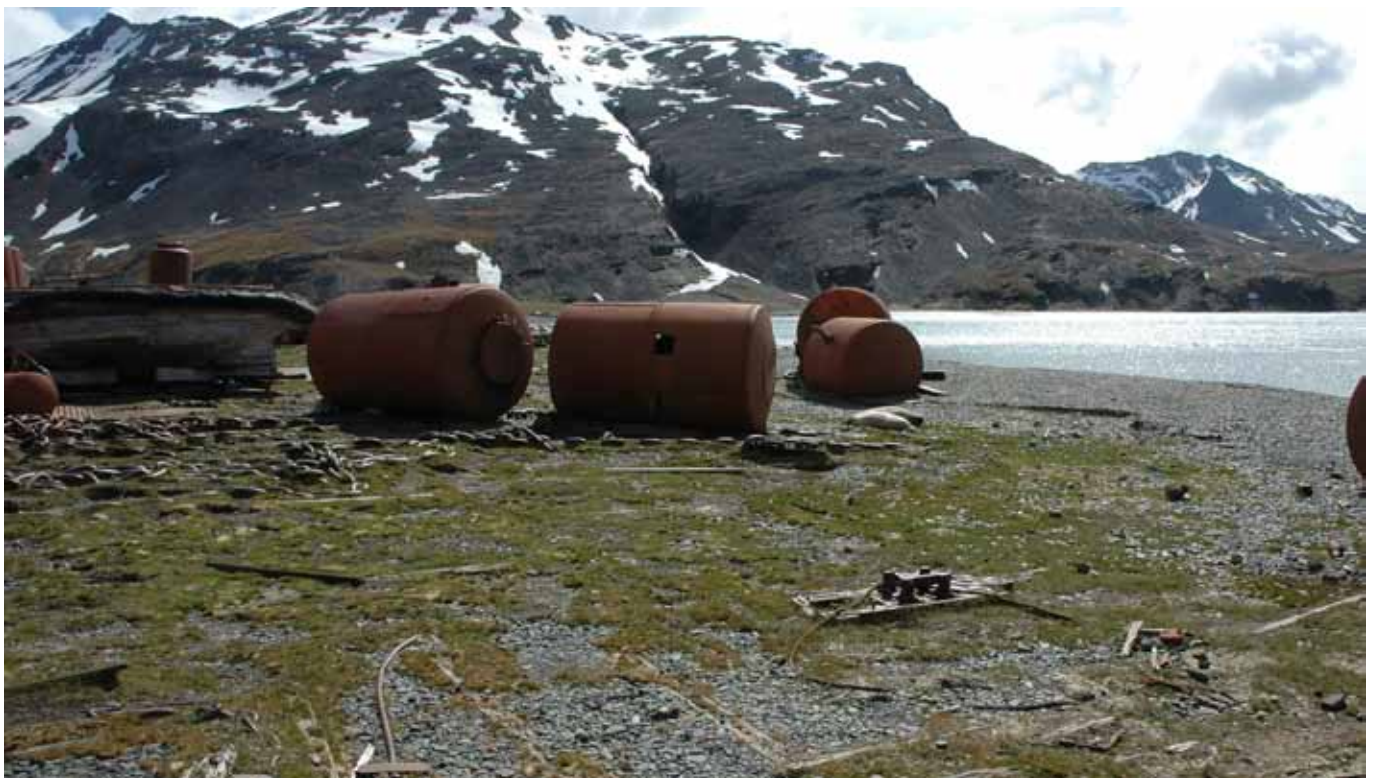
1.3 Looking north across the Plan

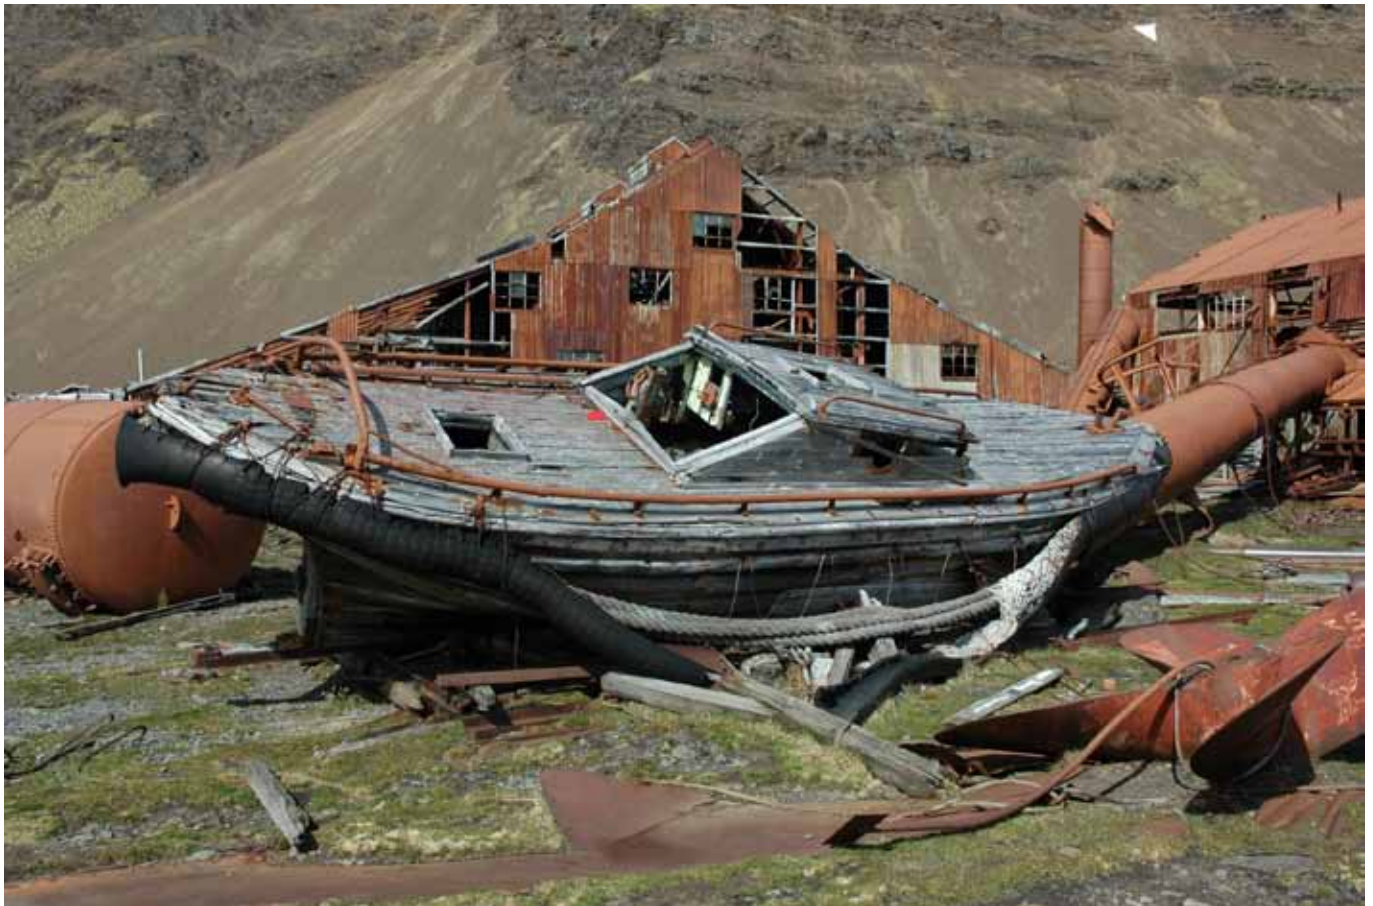
1.6 The motor boat with Building No. 6 Workshop in the background

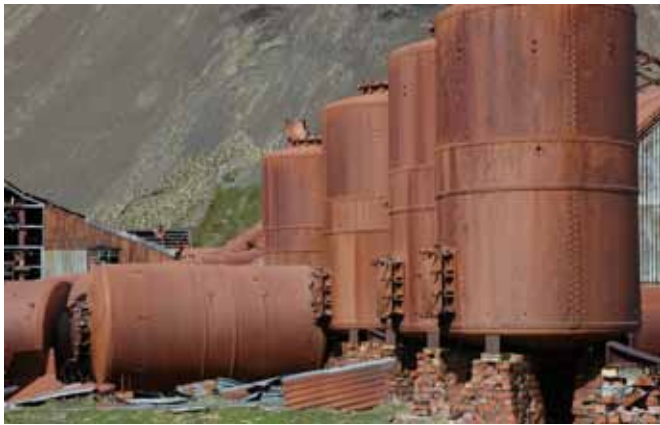
Eleven cookers remain standing off brick bases but the brickwork is in very poor condition and the majority of these are likely to collapse in the next few years.

3.1 The remaining standing west row of cookers

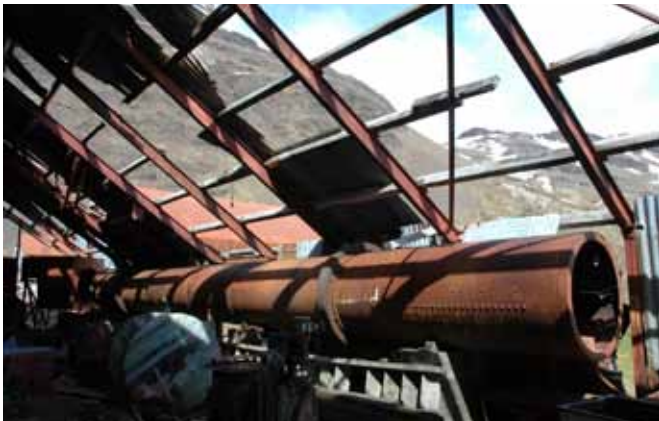
4.1.5 One of the guano cookers

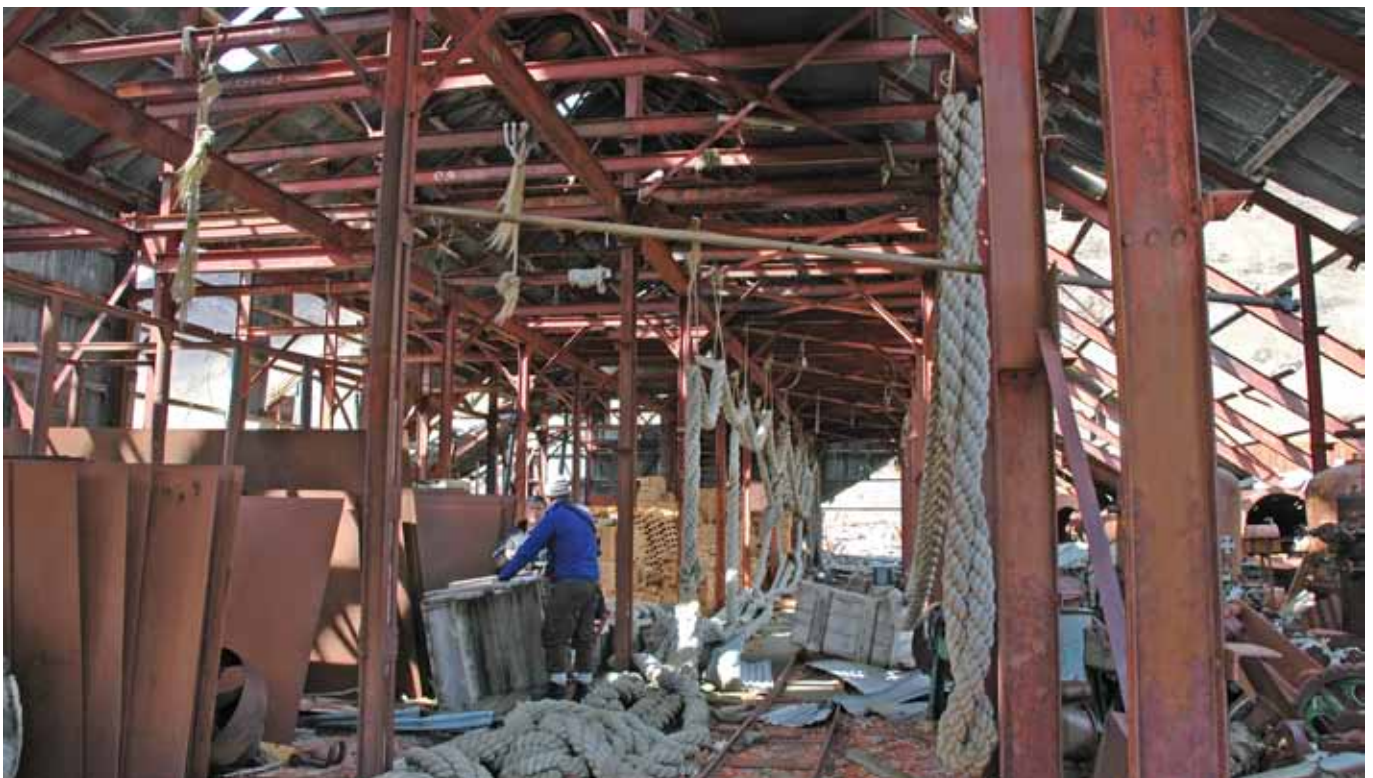
The steel frame looks to be solid enough but around 25% of the wall sheeting and 30% of the roof sheeting is now missing. The purlins and fixing rails are of timber and a good deal of the remaining sheeting is now at risk of wind damage.

4.1.7 The interior of the North Wing looking southwards

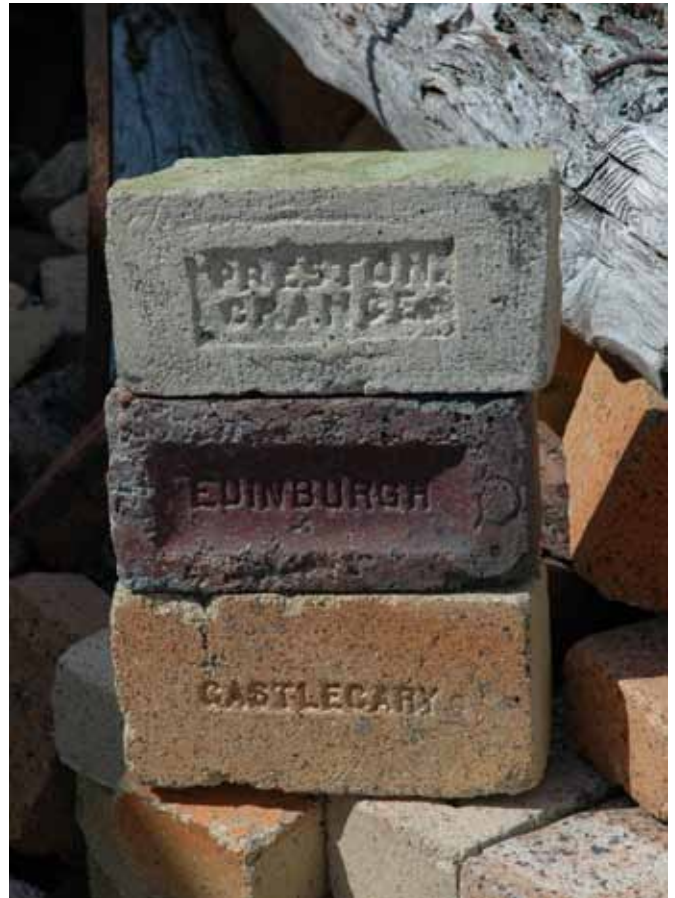
The most recent use of this area has been for the storage of bricks. Three different Scottish bricks were identified 'Preston Grange', 'Edinburgh' and 'Castlecary'. The Castlecary Company (Castlecary Fireclay Co Ltd) was incorporated in 1919 and dissolved in 1937 after the company had been taken over by General Refractories of Sheffield – which suggests that these bricks have been here, unused, since the 1930s.

4.2.1 Bricks from the store

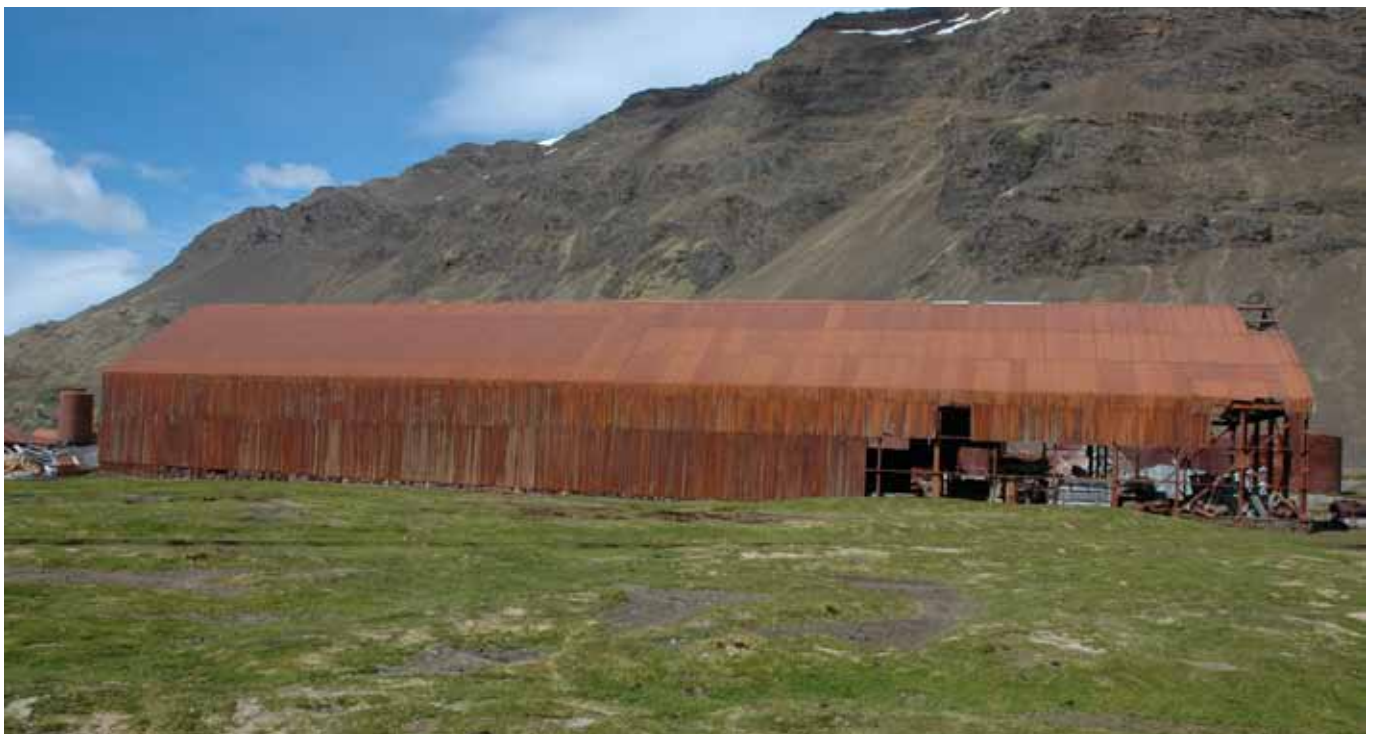
4.3.2 The north elevation

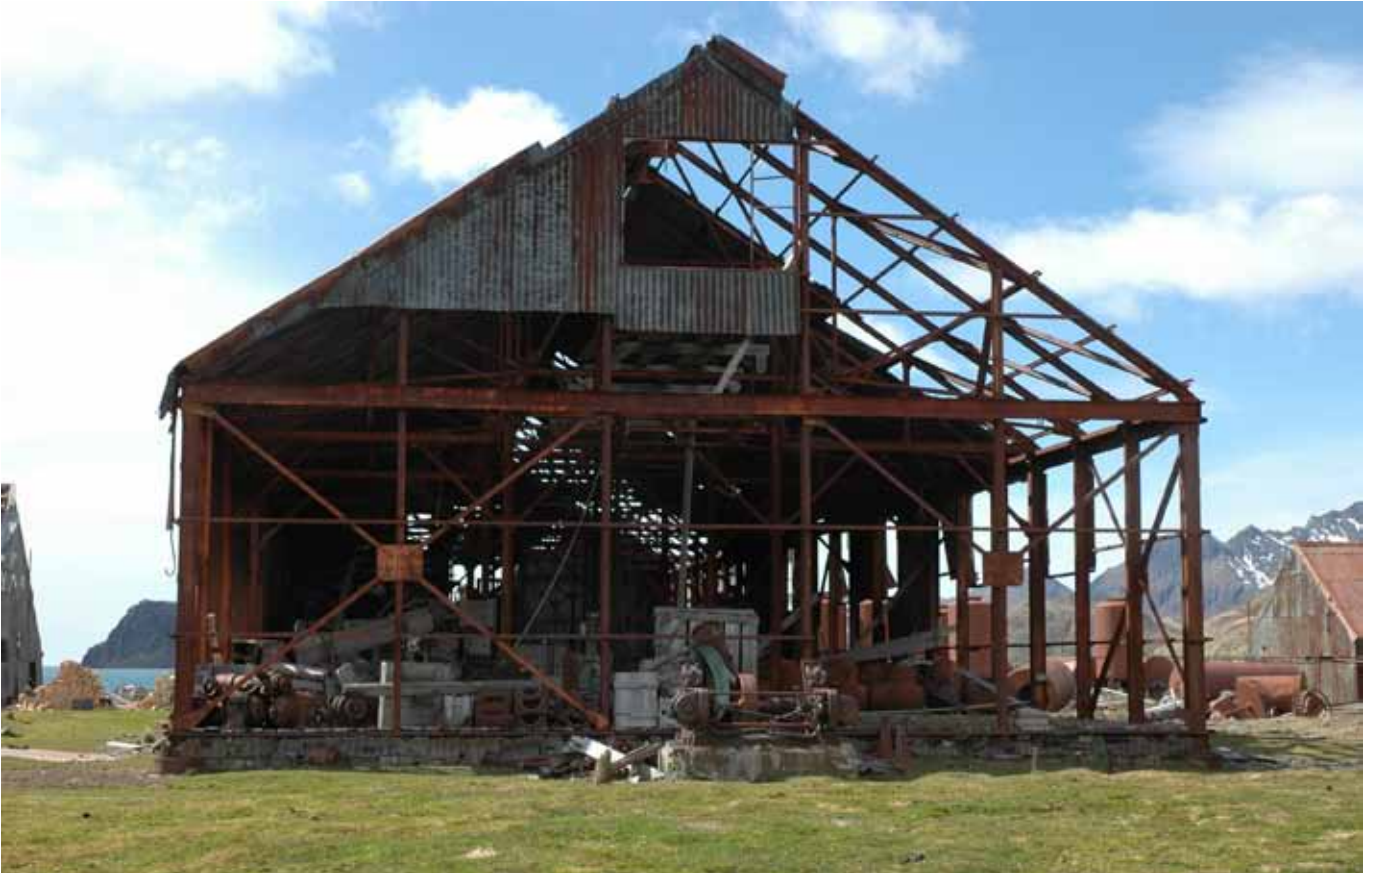
4.3.3 The west elevation

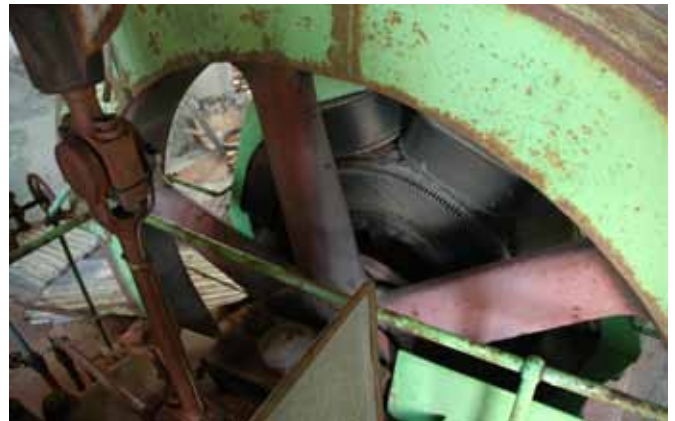
5.2.2 Detail of reciprocating dynamo

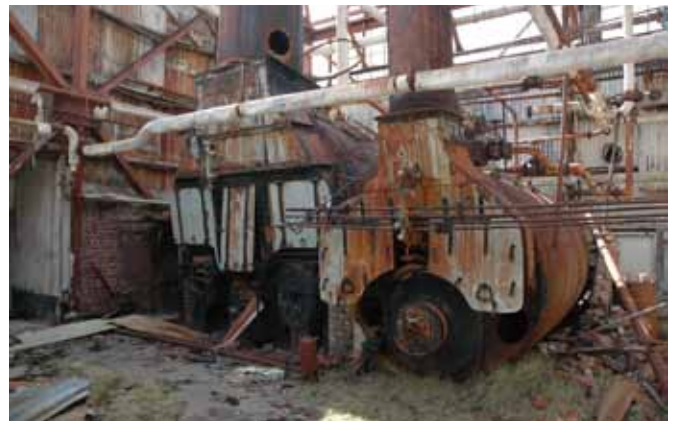
5.2.6 Secondary boilers

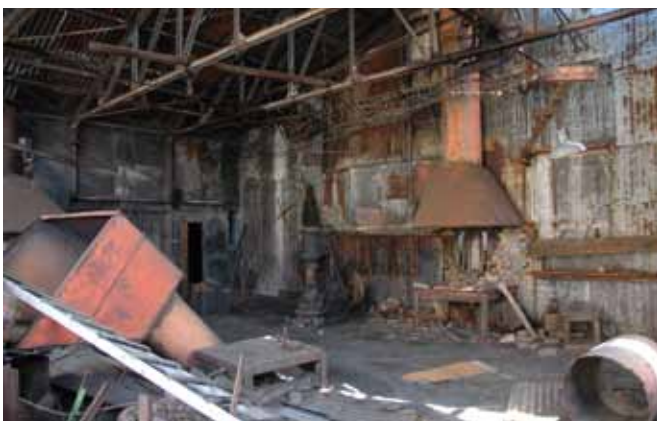
6.4 The Forge in the southern wing

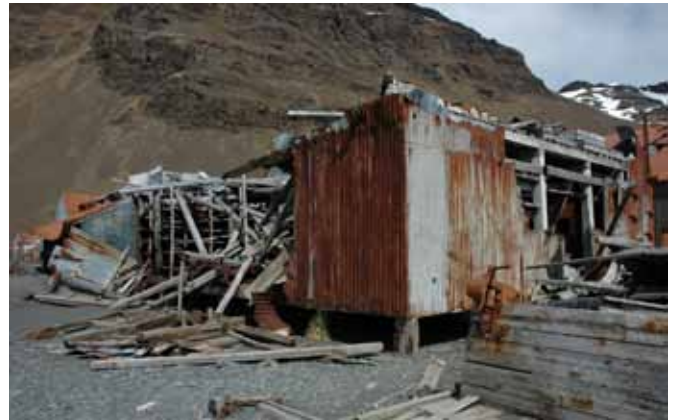
The roof of the building has fallen in with the southern gable overturning southwards. The attic floor remains at the end of the building (still with packing cases stacked on it at the south end) but has collapsed in the central area. The suspended ground floor remains in place though the floor joists are in poor condition. There is a lean-to pipe store on the east side of the building which has a seriously sagging corrugated iron roof.

8.1 The north and east sides

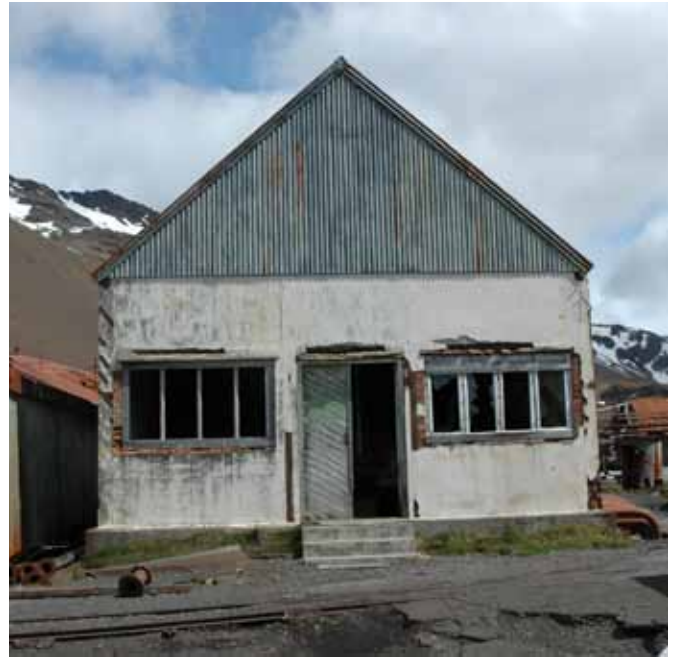
9.2 North elevation

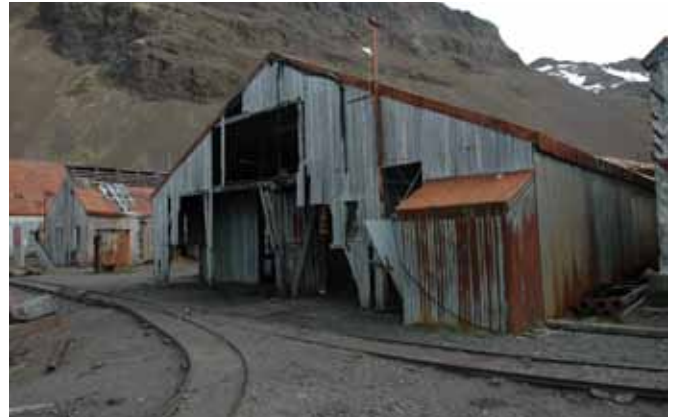
The east wall has lost a good deal of its boarding which is allowing access to the seals. The building is unlikely to survive many more years.

10.1 The east elevation

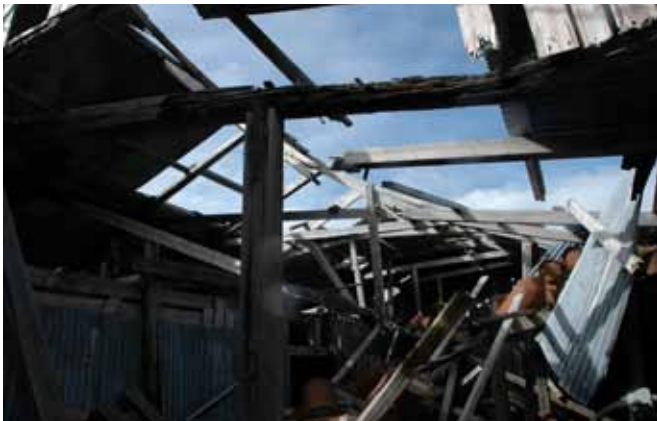
A timber framed building with walls clad in vertical timber boarding, which has been over clad with corrugated iron on the north side. The roof is covered in corrugated iron which is dressed down over the eaves. The central area of the building has had an upper floor but this is now collapsed. Perhaps 80 percent of the roof has collapsed overall and the interior is now a jumble of timbers on top of a collection of old fuel drums.

10.2 Interior

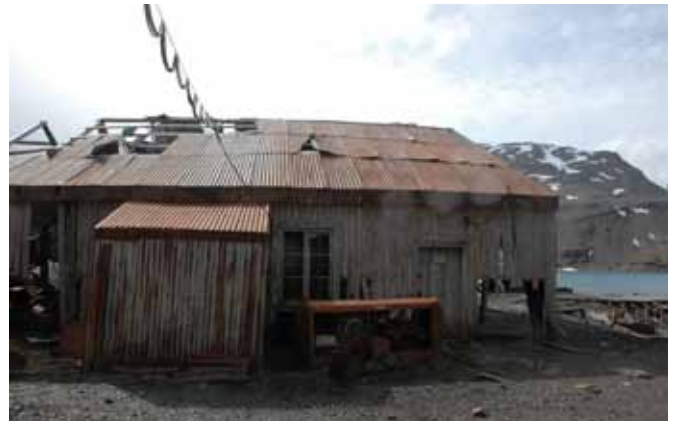
10.3 The south elevation, east end

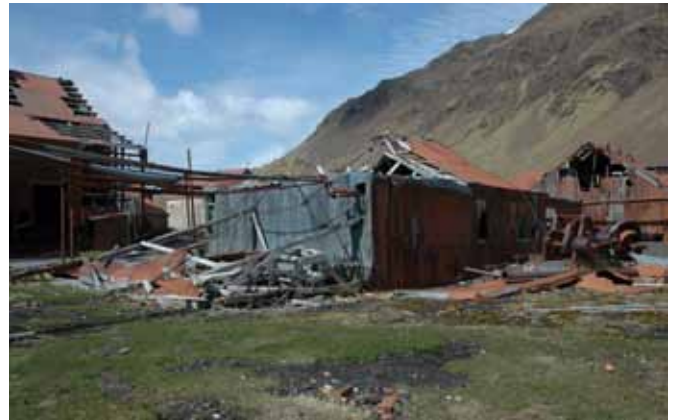
A single storey timber framed building clad in corrugated iron. The majority of the roof of the building has collapsed along with the south gable end and part of the east wall. The west wall is still standing but is leaning against the rubble of the collapsed roof. A good deal of the woodworking machinery remains inside. There is a steam engine and winch to the west side of the building.

11.1 The north and west sides

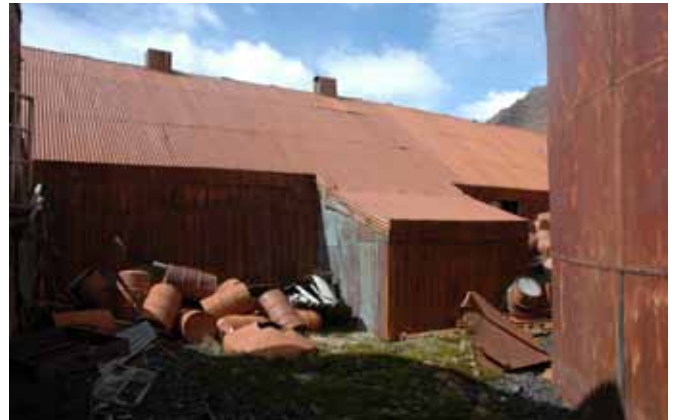
12.1 The west elevation of the main wing

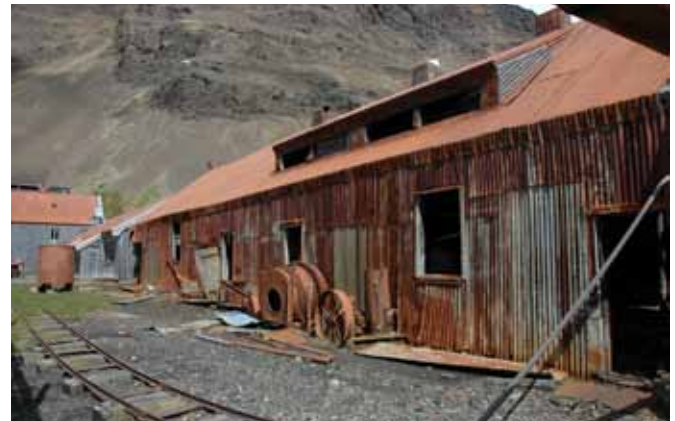
12.2 The east elevation of the main wing

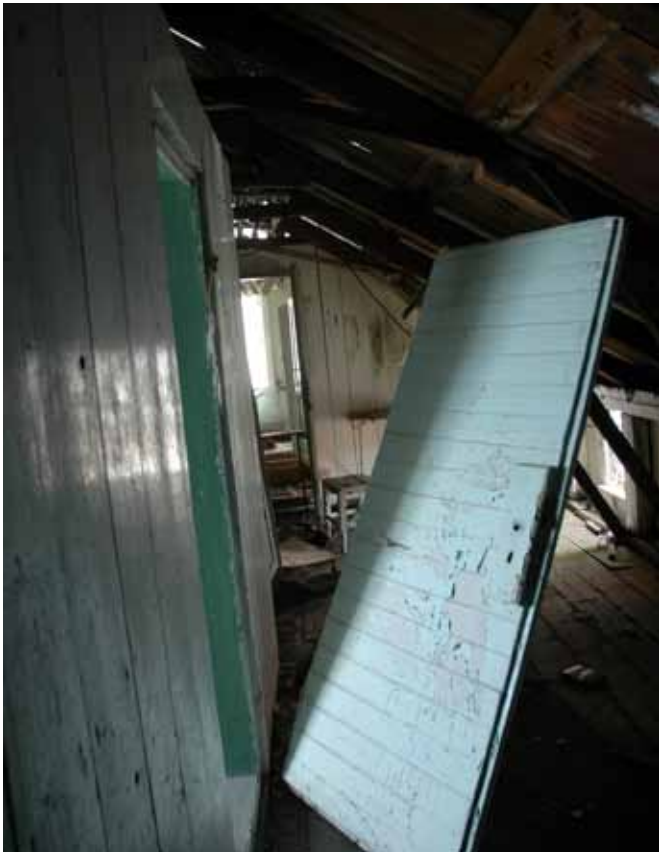
15.6 First floor passage and bedroom beyond

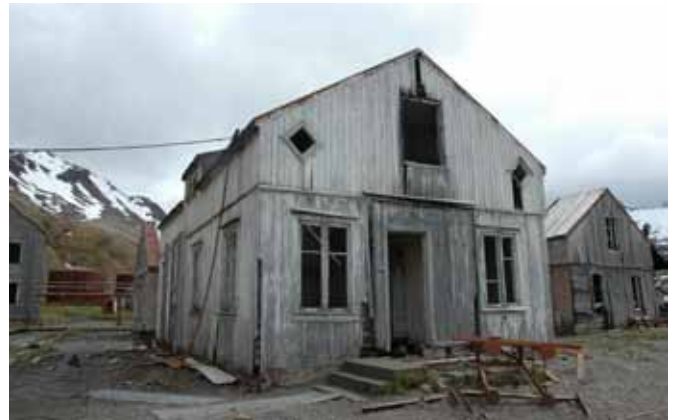
The house is two storey though most of the upper rooms are contained in the roof space with a low eaves and windows in the gable ends. The roof is covered in corrugated iron which is turned down over the eaves and there are the remnants of two brick chimneys. The roof sheeting is starting to come away on the south slope. There have been tie downs over the ridge and the chain of the easternmost one remains in position – though it is no longer effective.

16.1 East elevation

The suspended timber ground floor has fallen into the cellar at the east end and has sagged visibly over the rest of the floor. The upper floor all remains but this too is distorted. Where the structure is visible it is clear that there is a good deal of rot in the lower courses of the structural boarding. It would also seem that this is not a new problem as repairs have been carried out previously.

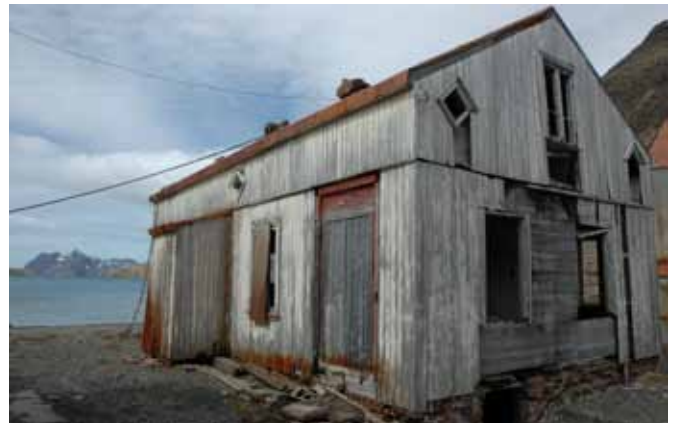
16.2 North and west elevations

There is an entrance door in the east front and an entrance porch (with a collapsed floor) on the north side. The cellar is accessed down steps and through a door on the west side of the house. Side hung timber casement windows largely remain in place though no glass remains and some of the windows are boarded up.

This building is now fully open to the elements and is in a poor way. Its destruction is likely to be accelerated over the next few years.

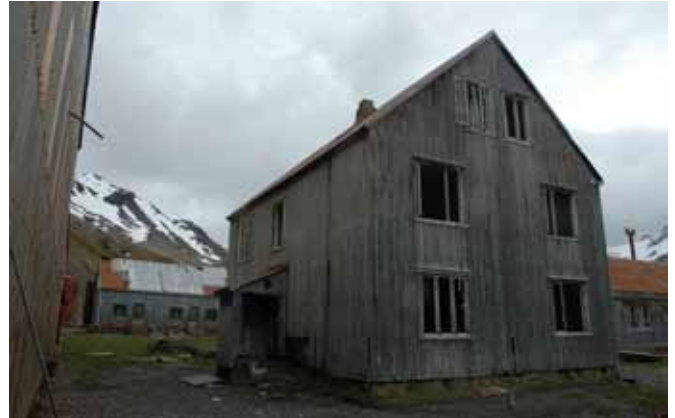
17.1 East elevation

The east front has two windows on the ground floor and two windows on the first floor and two closer spaced windows on the attic floor. The entrance is on the south side. There are four further windows on the north side and only two high level loft windows on the west side. The west side is clad with corrugated iron whereas all the other walls are clad in timber. The entrance porch is in corrugated iron with one ground floor window and two first floor windows on the west side. Some of the window casements (side hung) remain in place. The casements were originally eight-light windows, four over two, but several of the casement frames have broken away.

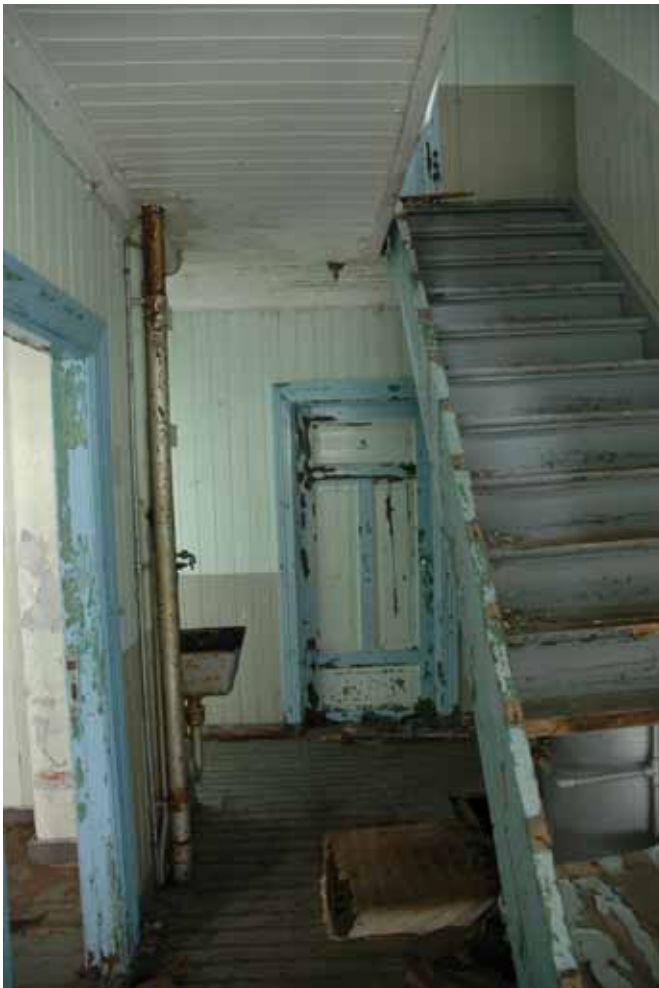
17.4 The entrance area and stair

The ground floor has largely collapsed inside the building and the first and second floors were not accessed. The rooms had loose bunk beds so it is not easy to see how many people used each space. There is a central brick chimney through the ridge. The corrugated iron on the south side is in reasonable order but it is missing from the west end of the north side, perhaps 15 percent of the roof sheeting is missing here. The boarding of the walls in poor condition below this area and there is also damage on the southern side adjacent to the porch.

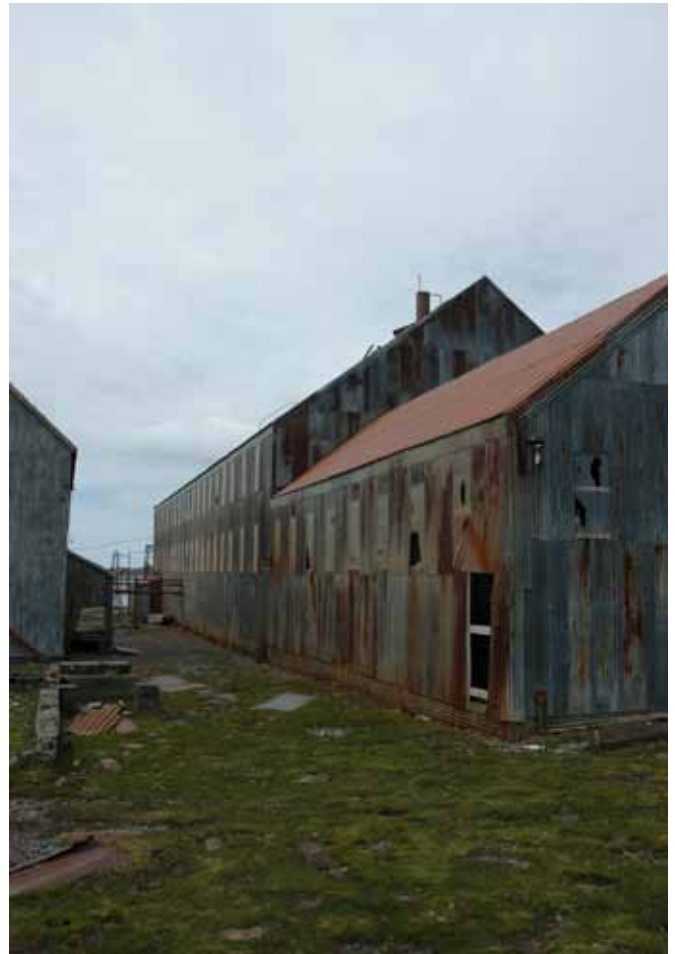
19.3 North elevation

The sheeting on the north wall is also in reasonable order with the exception of the window lights. There are two rows of eighteen lights; thirteen of them now have holes in them, some of them substantial. A large portion of sheeting on the north slope of the roof is now missing. The top three sheets are missing over 70 percent of the roof slope with perhaps 60 percent of the

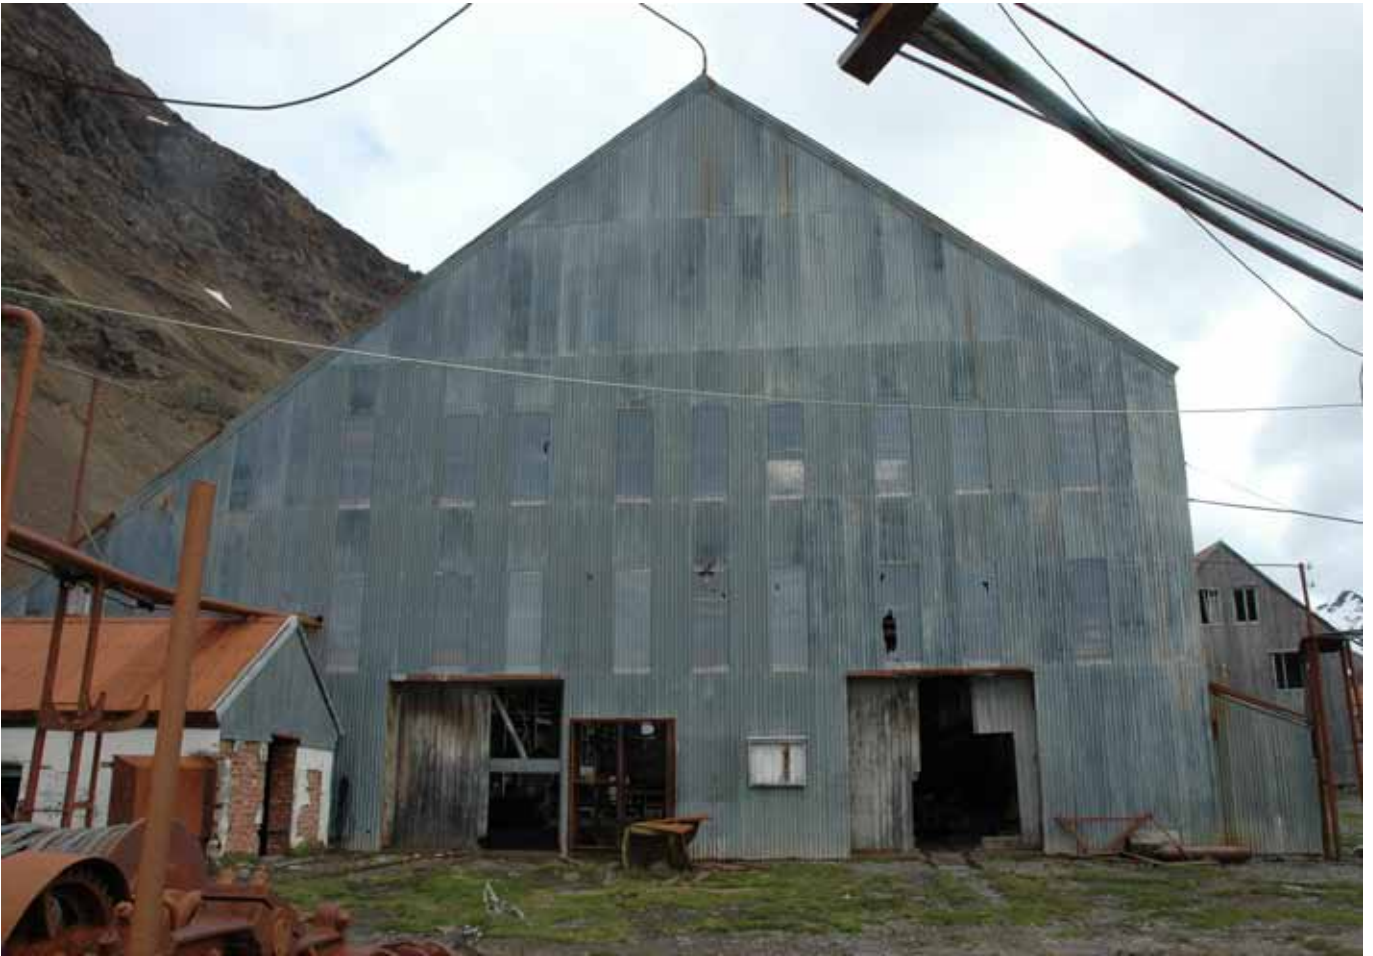
19.5 West elevation

This is a substantial steel framed building with the plating shop being a smaller, but still substantial, extension to the west on the north side of the west elevation. The roof and walls of the plating shop are generally in good order. The sheeting is in good condition with the exception of the plastic panels used as window lights. These have cracked and four have now failed. There is some disturbance in the northwest corner where some sheets are missing. The plating shop is raised on concrete plinth approximately 350mm above the adjacent floor level. The sheeting of the main part of the building comes down to the floor at the rear but the concrete plinth raises approximately 400mm above ground level on the east side. The wall sheeting of the mechanical workshop is generally good, again with the exception of the glazed window panels. There are twenty of these on the south side and all of them are damaged. The south roof slope is generally intact but half the ridge is missing and there are now ten sheets missing from halfway up the west side of the slope.

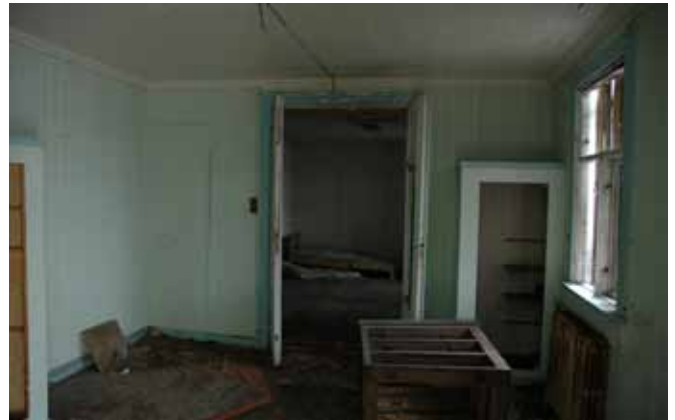
20.5 Typical ground floor room

Internally the ground floor has collapsed; the walls are covered in vertical boarding with timber boarded ceilings and a timber cornice. The house is fitted out with six panelled door and moulded architraves. The upper floors were not accessed.

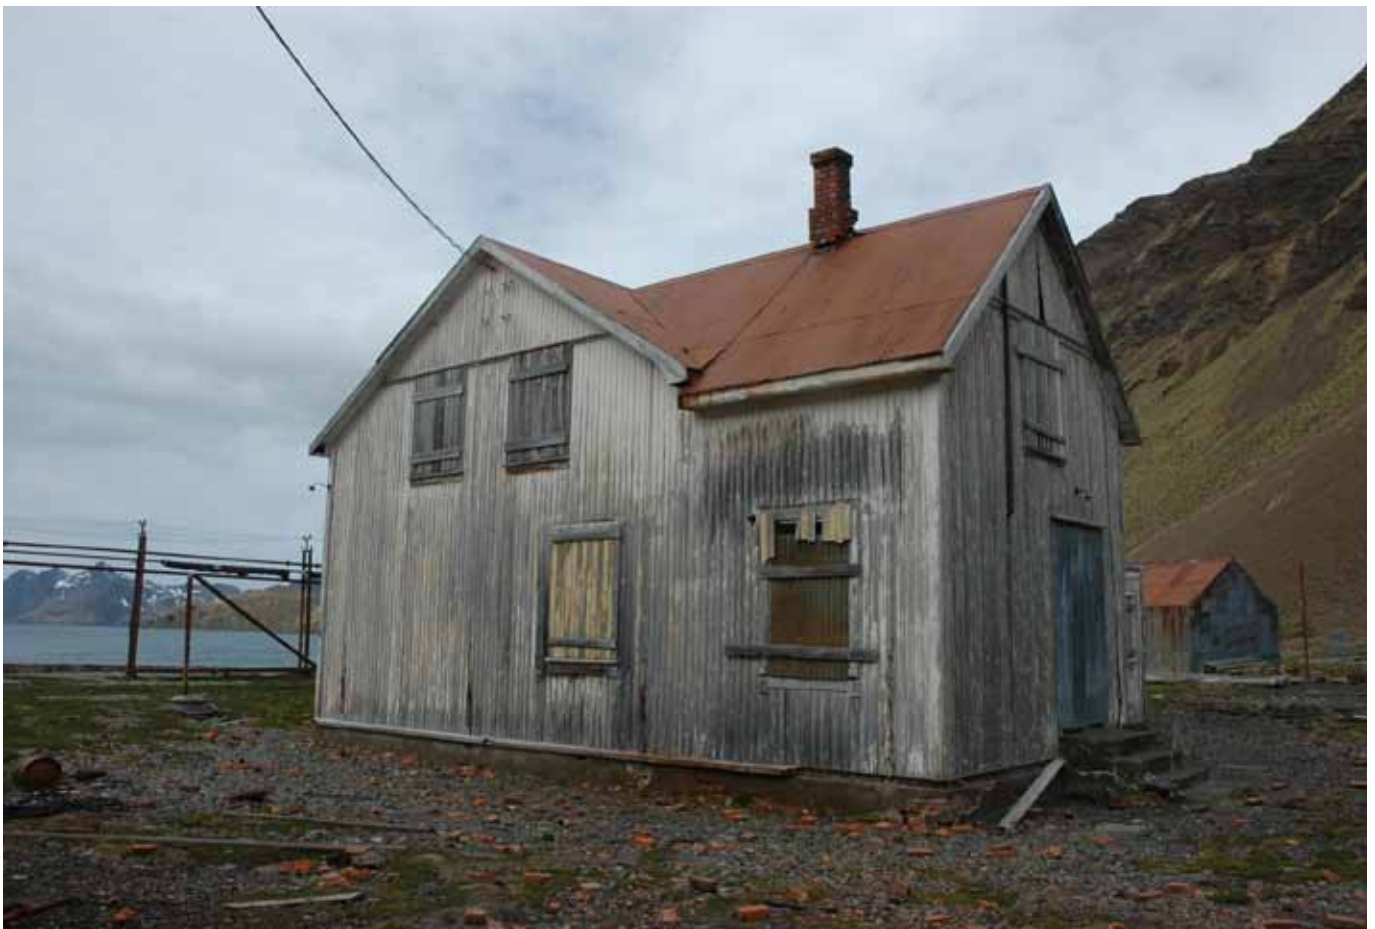
20.4 North elevation

Roof sheeting is missing on the outshot on the west side. There is one missing sheet on the main west roof slope above this area. One sheet is starting to tear away on the north side of the west projecting gable roof. There are three brick chimneys all still standing and the remains of a radio aerial attached to one of them with the stays fallen away. The building has had a tie down wire running across inside the roof which remains in position on the north and east sides; only one can be seen on the west side and none on the south side, possibly being concealed by later extension.

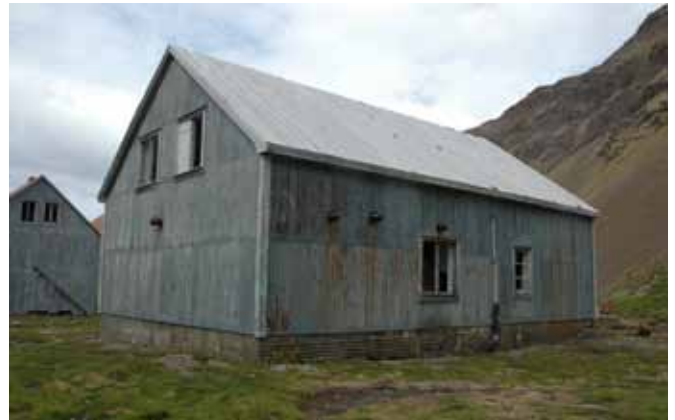
24.1 North and west elevations

All the sheeting is generally in satisfactory condition although some sheets are coming loose. On the north side of the building at present is reasonably solid but it has now lost the whole of its corrugated sheeting from the west side and the majority of it, 85 percent, from the east side and is now completely exposed to the weather.

The building at the moment is relatively solid but deterioration is likely to start soon.

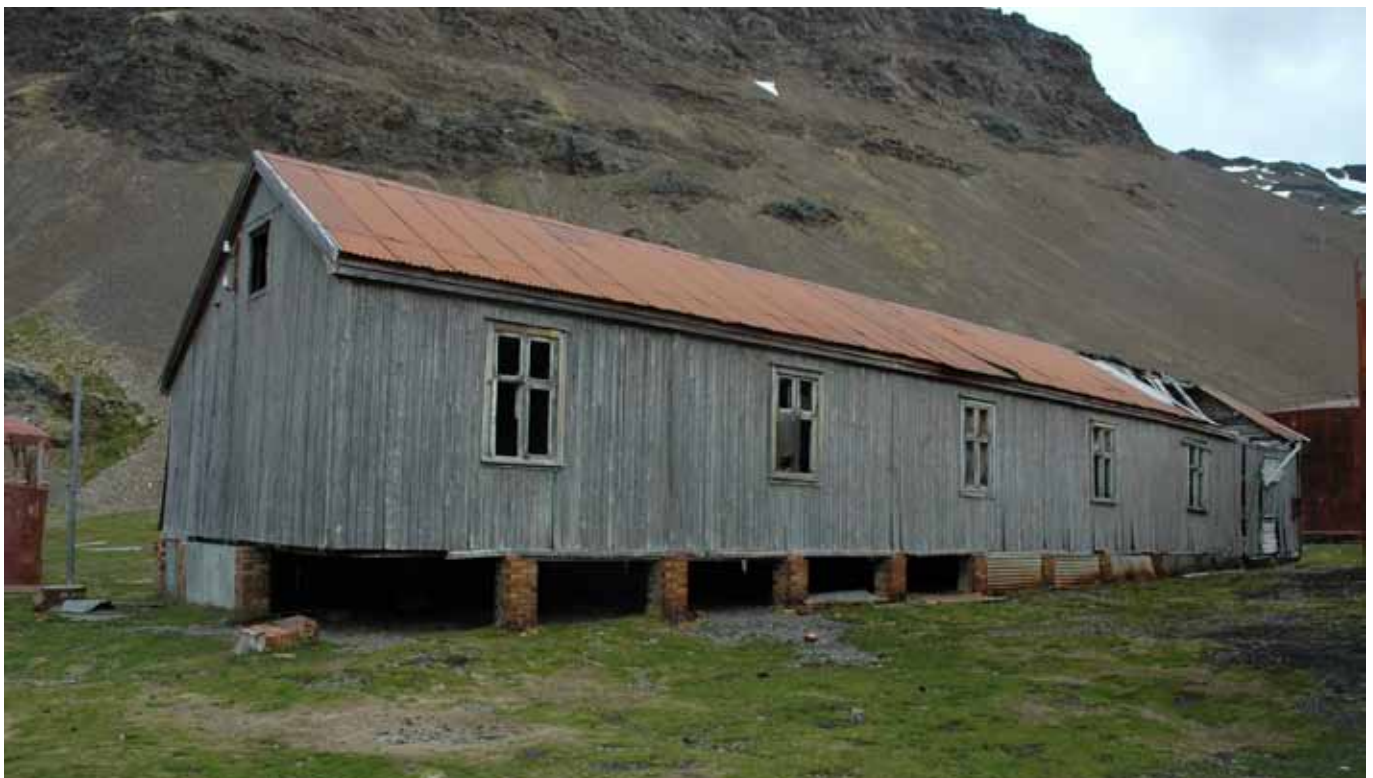
25.2 The north elevation

There are six windows along the north side suggesting that there are six rooms each fitted out with four double bunks (i.e., 48 men in the building). Internal walls are boarded out and with fitted bunks and there are timber boarded ceilings in all rooms. The roof space has small lights at either end but does not appear to have been used as there is no boarding in this area. The windows were side opening casements which have now largely fallen away. The roof slope on the south side is intact but the roof sheeting is missing at the northwest corner of the north slope and the roof is collapsed around this area.

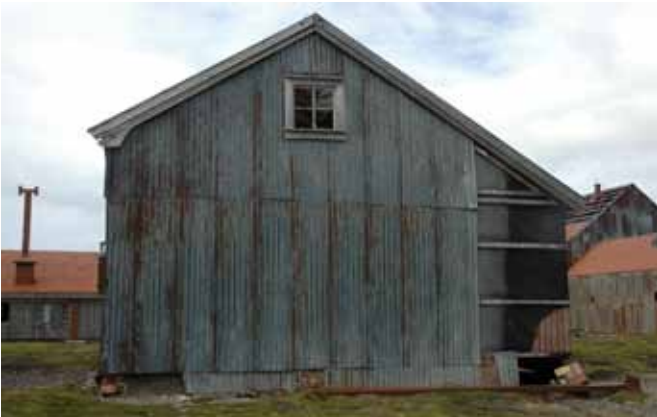
25.5 The west elevation

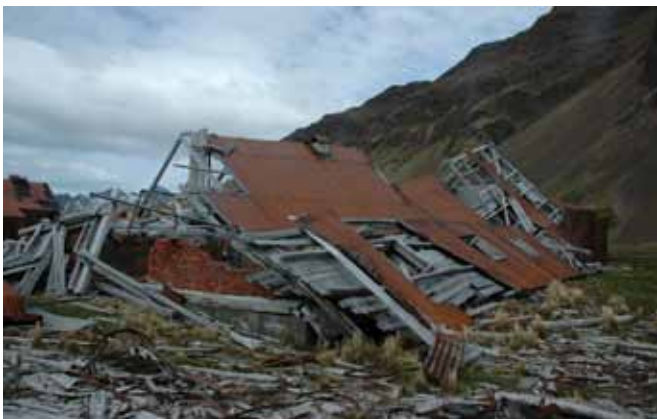
26.3 The roof looking southeast

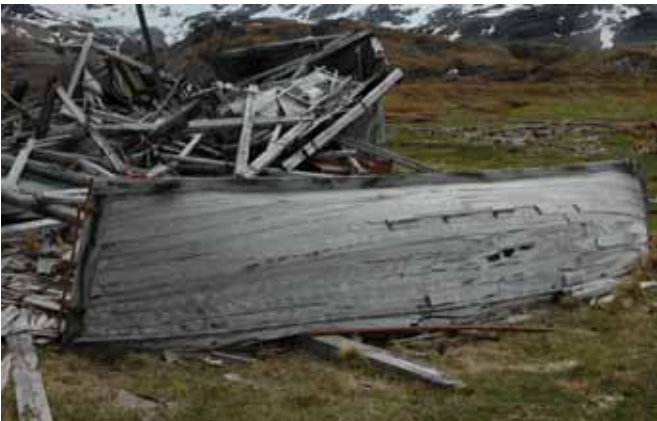
This building has collapsed entirely. It was fairly crudely built of unsquared timber with corrugated iron externally and timber boarding internally. Only the north end wall remains partially in position and some traces of the south gable end of the building like the pig house has collapsed eastwards with the east wall lying with the remnants of the roof on top of it.

27.1 Boat on the west side of the building

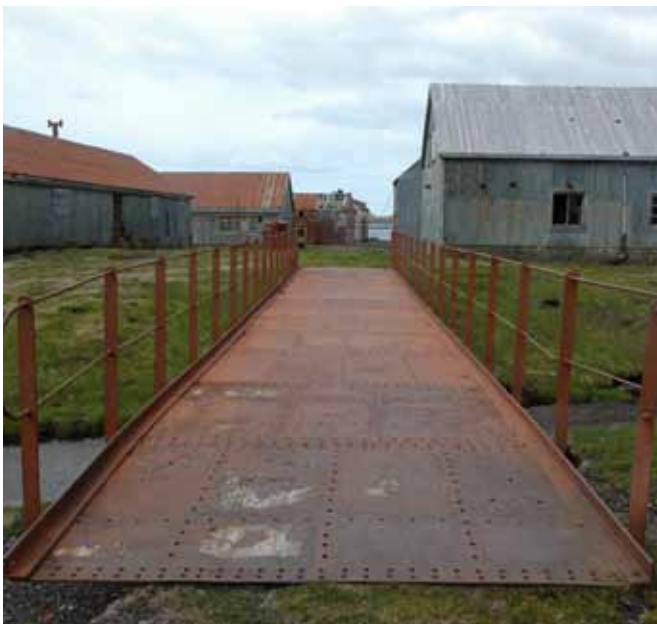
33.2 The deck looking east

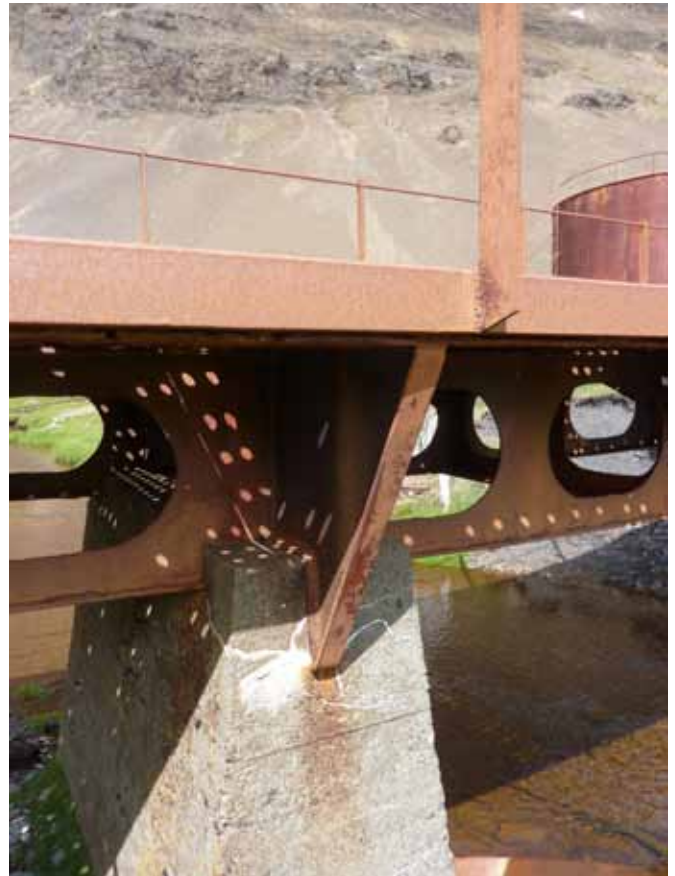
33.3 Construction detail

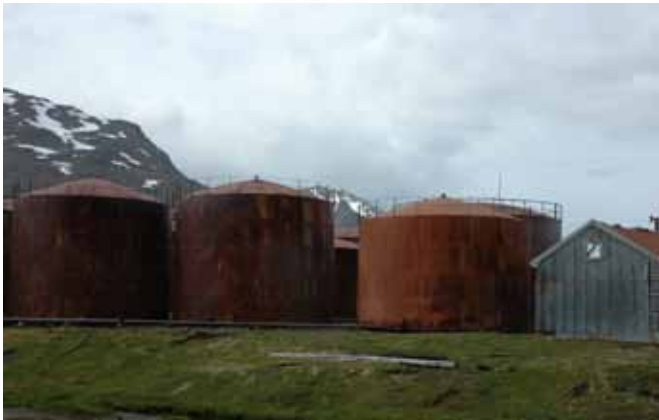
The tanks on the east side of the river are also in better condition than most of the tanks seen at other sites. All are intact, all have roofs, guard rails and access ladders still in place and there is little sign of any significant corrosion. The exception being the northernmost tank, which has a hole cut in it and has had barrels thrown inside it. Looking up through here you can see that there are a significant number of holes in the roof, though the worst hole is actually where a repair has been made previously and a thinner sheet of steel welded underneath causing a small lip to trap water. There are no obvious signs of holes in other tank roofs though it has to be said these are difficult to inspect.

34.4 Tanks 41, 42 and 43

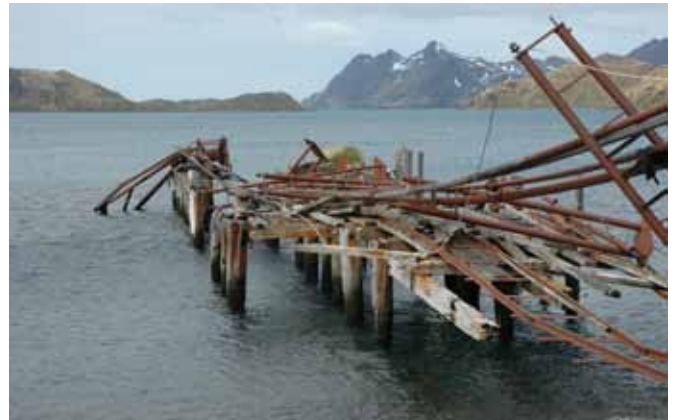
Jetty No.28 is the smallest and in least good condition with no decking remaining and several of the timbers now eroded to the point of almost none existence. This too has pipework running out to the end of the pier presumably for refuelling boats. A winch remains right out on the end but little remains of the decking.

28.1 Jetty seen from Building No.21

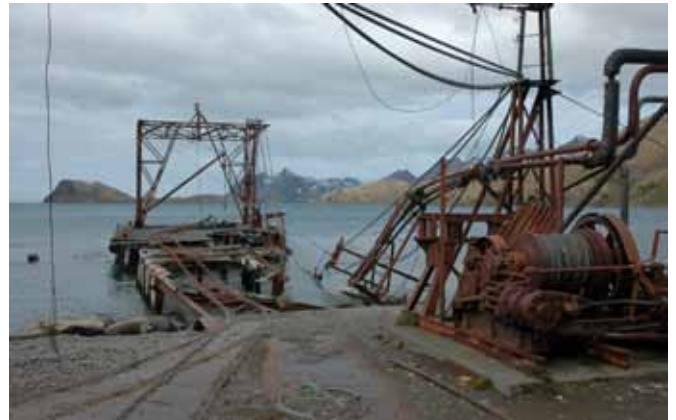
Jetty No.29 has a section remaining in the sea but all that remains joining it to the land is the railway. It has a steel construction supporting a derrick on the end. As with No.30 its piles are round and closely spaced. These have been doubled up in places. This jetty is unusable at present. The construction of all the jetties is much the same though this central jetty has steelwork running out from the workshop area joining to the timber jetty though this has now collapsed off its timber bearings. The remains of a gantry taking pipe out to the pier end also remains in position.

29.1 Looking out along the Jetty from Building No. 19
