DISUSED WHALING STATIONS

Stromness Harbour Gazetteer

Gazetteer, July 2011

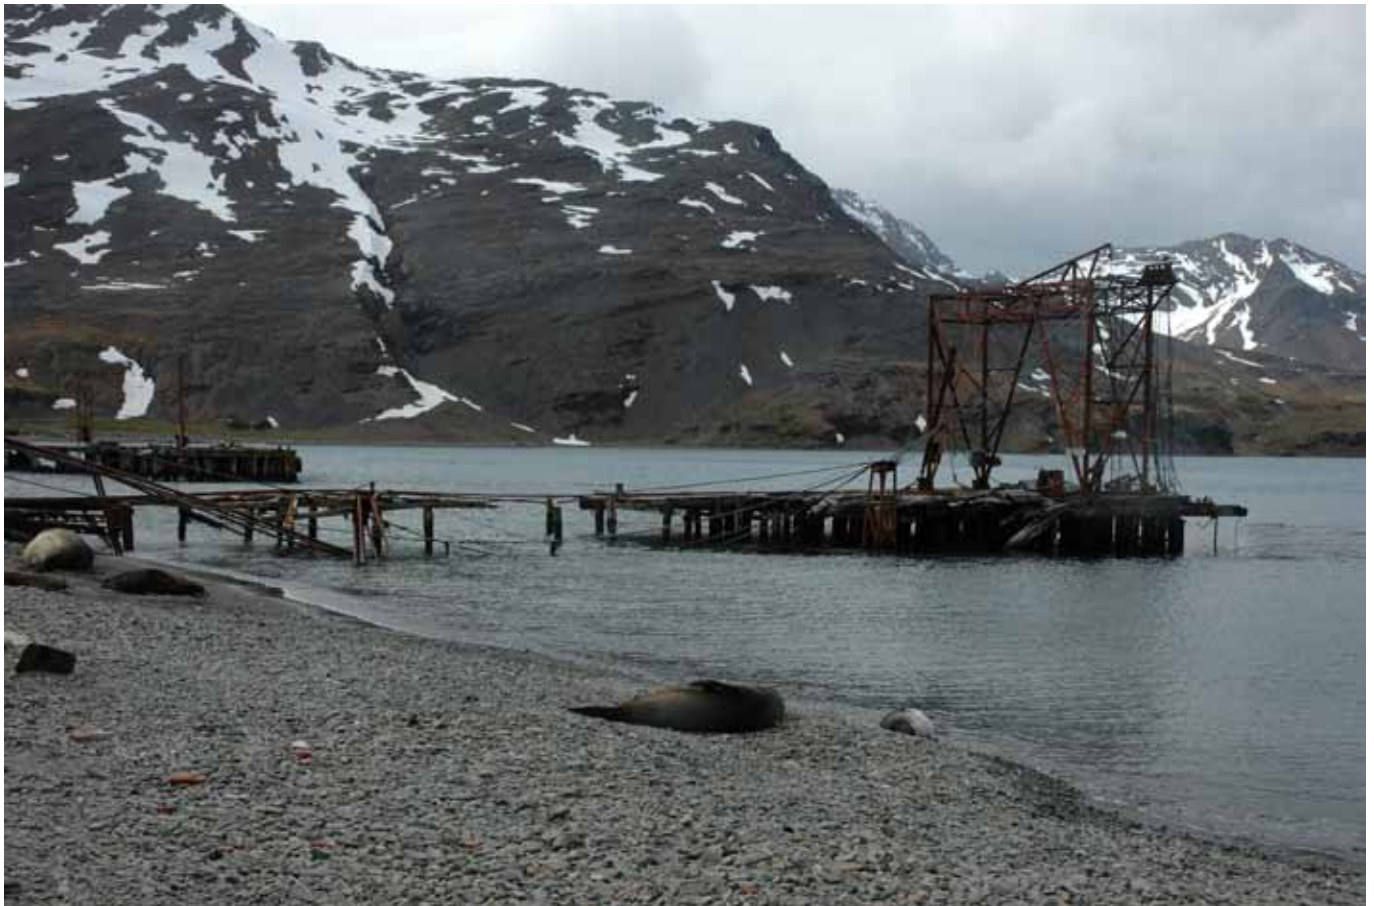
29.2 Jetty 29 from the south

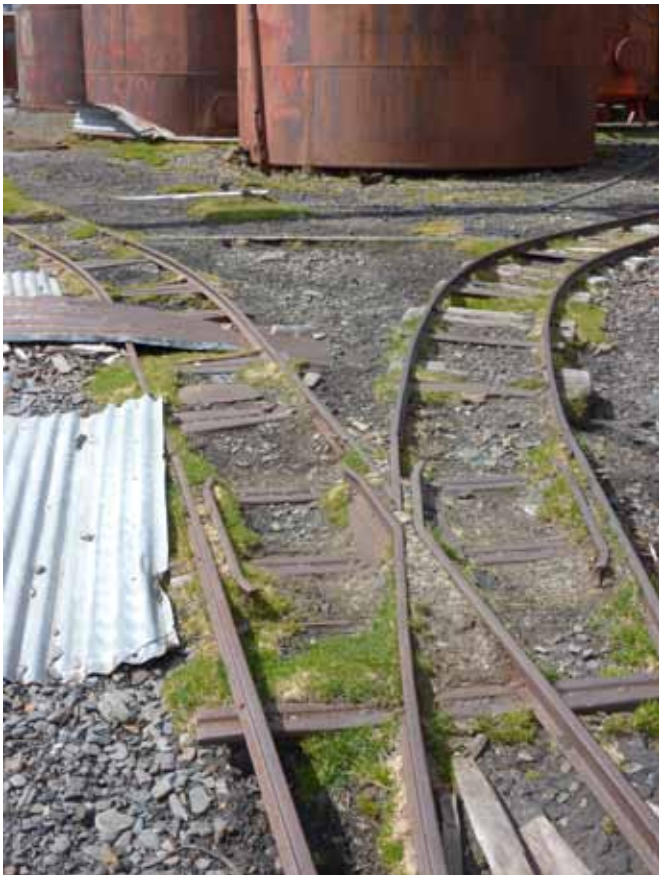
62.2 Track by Tank 36
